**FINAL INTERIM ACTION WORK PLAN  
AMERICAN LINEN SUPPLY CO-DEXTER AVENUE SITE  
700 DEXTER AVENUE NORTH  
SEATTLE, WASHINGTON**

**Facility Site Identification Number: 3573  
Cleanup Site Identification Number: 12004**

**AUGUST 2018**

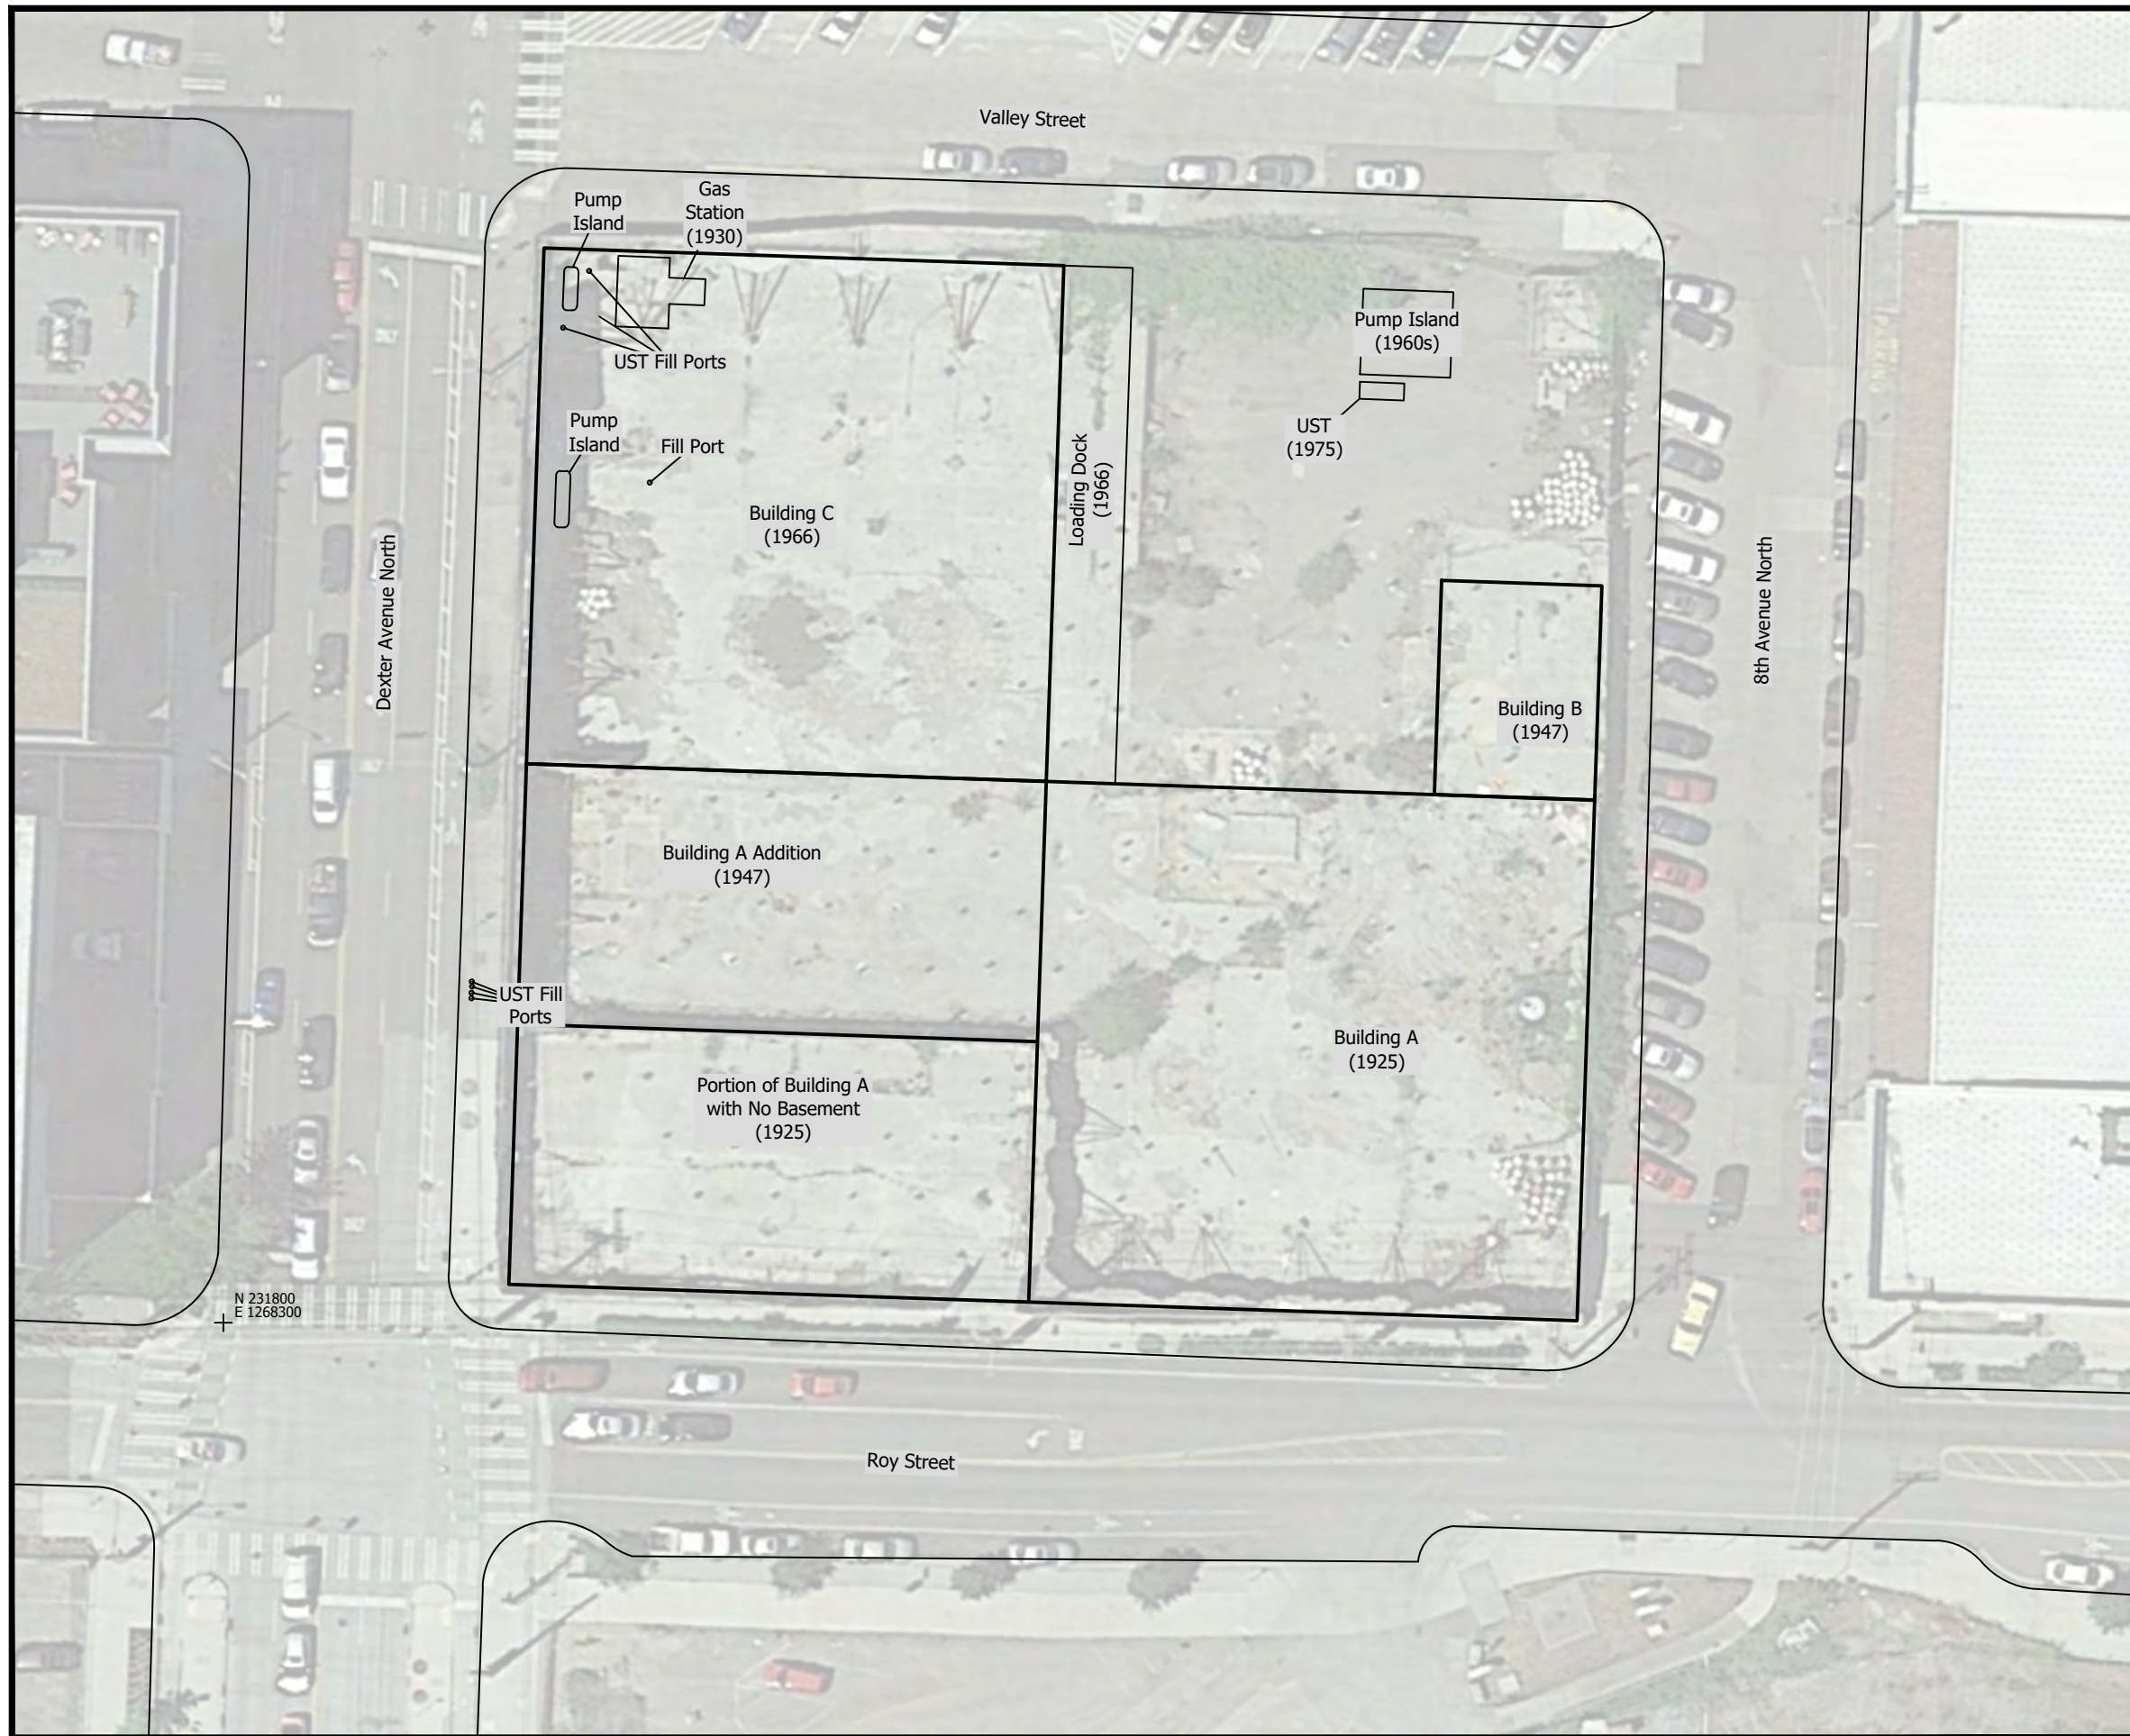
**2**

No buildings are currently present at the Property. The Property is almost entirely covered by concrete or asphalt, with small patches of vegetation or exposed soil (Figure 2). Concrete building foundations or slabs cover the surface of the northwest quarter of the Property, the southern half of the Property, and the southeast portion of the northeast quarter of the Property. Most of the northeast quarter of the Property is covered with asphalt. Most of the Property lies below the surrounding streets due to the now-exposed basements of the former buildings. The building formerly in the southwest quarter of the Property did not have a basement under the southern half of it, so that portion of the Property is at grade with the surrounding streets, as is the part of the Property along the northern and eastern Property lines in the northeast quarter. The Property is relatively flat, with an elevation of generally 40 feet (ranges from 36 to 42 feet) above the North American Vertical Datum of 1988 (“NAVD88”) across most of the Property. The greatest variance in the surface elevation occurs in the southwest corner, where it is approximately 51.9 feet without the basement level. Although full utility services are available in the area (water, sanitary sewer, and storm drainage by Seattle Public Utilities, power by Seattle City Light, natural gas by Puget Sound Energy, and telecommunications by Century Link), utilities are not currently hooked up to the Property.

Between April 2011 and March 2012, SES conducted an investigation to evaluate the configuration and integrity of the Property sanitary sewer system, including the sewer line cleanouts, drains, and sumps (SES, 2013b). In April 2011, a plumbing company video recorded the condition of accessible portions of the Property sanitary sewer lines. The contractor video recorded the southern line from Sump No. 4 to near Sump No. 2, the eastern line from Sump No. 2 to near the 8<sup>th</sup> Avenue North ROW, and the northern line from just north of Sump No. 5 to the eastern side of the northwest wing of Building A (Figure 2).

(EX01 and EX02) along the southern sewer line alignment near Sump No. 2 (Figure 2) to observe the conditions and structural integrity of the sewer line in the area of boring B-9 (Figure 4), which exhibited elevated concentrations of PCE in shallow soil. Test pit EX01 exposed the 6-inch-diameter, cast iron sewer line, and although the line appeared to sag slightly at the belled joint connections, no obvious perforations or breaks in the line were observed. SES collected soil samples from excavation EX01 and submitted for analytical testing for CVOCs. Based on the low photoionization detector (“PID”) measurements in screened soil samples, SES did not submit soil samples from EX02 for laboratory analysis.

Four 6,000-gallon USTs (Tanks 1 through 4) associated with the former laundry boiler system and a fifth 500- to 600-gallon UST (Tank 5) were removed from the Property by SES on March 22, 2013 (SES, 2013a; Figure 2). Droplets of liquid mercury were found when the concrete foundation near Tank 2 was removed; the mercury was contained and disposed of as hazardous waste at a regulated facility. A limited amount of petroleum-contaminated soil was observed in the vicinity of Tanks 1 and 4. It was thought that this soil was a result of tank overfill. Tanks 1 through 5 contained no measurable product and were cleaned by Marine Vacuum Services, Inc., prior to disposal at Seattle Iron and Metal in Seattle. Tanks 1 through 4 each measured approximately 28 feet long by 6 feet in diameter, were constructed of single-walled steel, and appeared to be in good condition, with no visible perforations or rust. Tank 5 measured approximately 10 feet long by 3 feet in diameter, was constructed of single-walled steel (though a lighter gauge than Tanks 1 through 4), and appeared to be in poor condition, with
