## Remedial Investigation Report

***Naches Pit Stop***

AEG Project #: 16-102

Date of Report: September 10, 2018

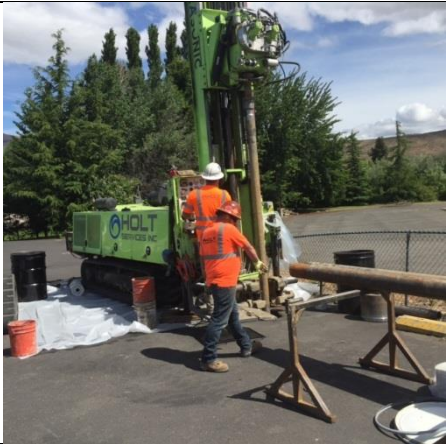
| <p>Photo #5:</p> | <p>Photo looking northeast at the location of monitoring well MW-5.</p> | | <p>Photo #6:</p> <p>Photo looking at soil cuttings from monitoring well MW-5.</p> |

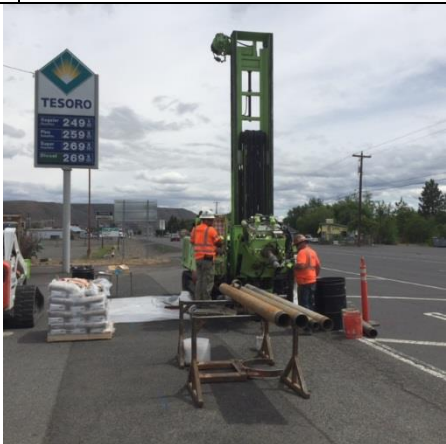
| <p>Photo #7:</p> | <p>Photo looking east at the location of monitoring well MW-6.</p> | | <p>Photo #8:</p> <p>Photo looking at soil cuttings from monitoring well MW-6.</p> |

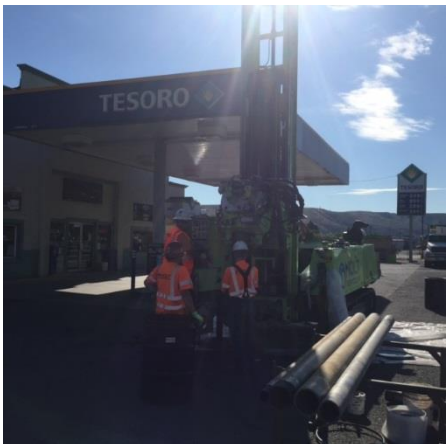
| <p>Photo #9:</p> | <p>Photo looking east at the location of monitoring well MW-7.</p> | | <p>Photo #10:</p> <p>Photo looking at soil cuttings from monitoring well MW-7.</p> |

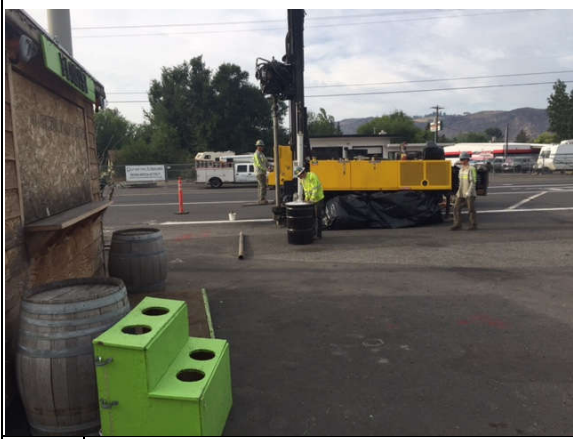
| <p>Photo #23</p> | <p>Photo looking south at location of boring B-4.</p> | <p>Photo #24</p> | <p>Photo looking at typical soil cores from boring B-4.</p> |

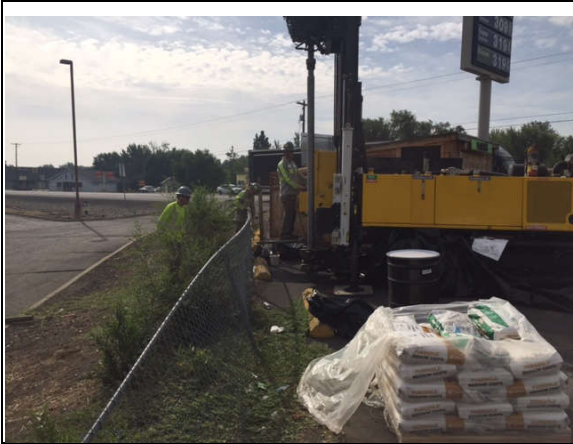
| <p>Photo #25</p> | <p>Photo looking east at location of boring B-5.</p> | <p>Photo #26:</p> | <p>Photo looking at typical soil cores from boring B-5.</p> |

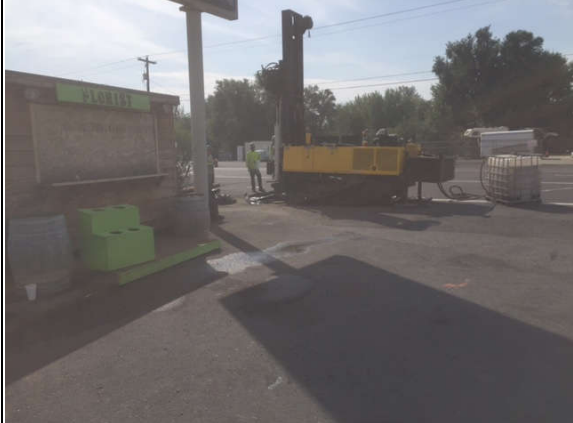
| <p>Photo #27:</p> | <p>Photo looking south at location of monitoring well MW-9.</p> | <p>Photo #28:</p> | <p>Photo looking at typical soil cores from monitoring well MW-9.</p> |
