August 31, 2018
Project 2004-004.002

Re: Second Quarter 2018 Groundwater Monitoring Report, Former Provisioner's Express, Inc. Facility, 2102 West Valley Highway North, Auburn, Washington, Ecology Facility ID 91612121, Cleanup Site ID 6847, VCP Project No. 3206

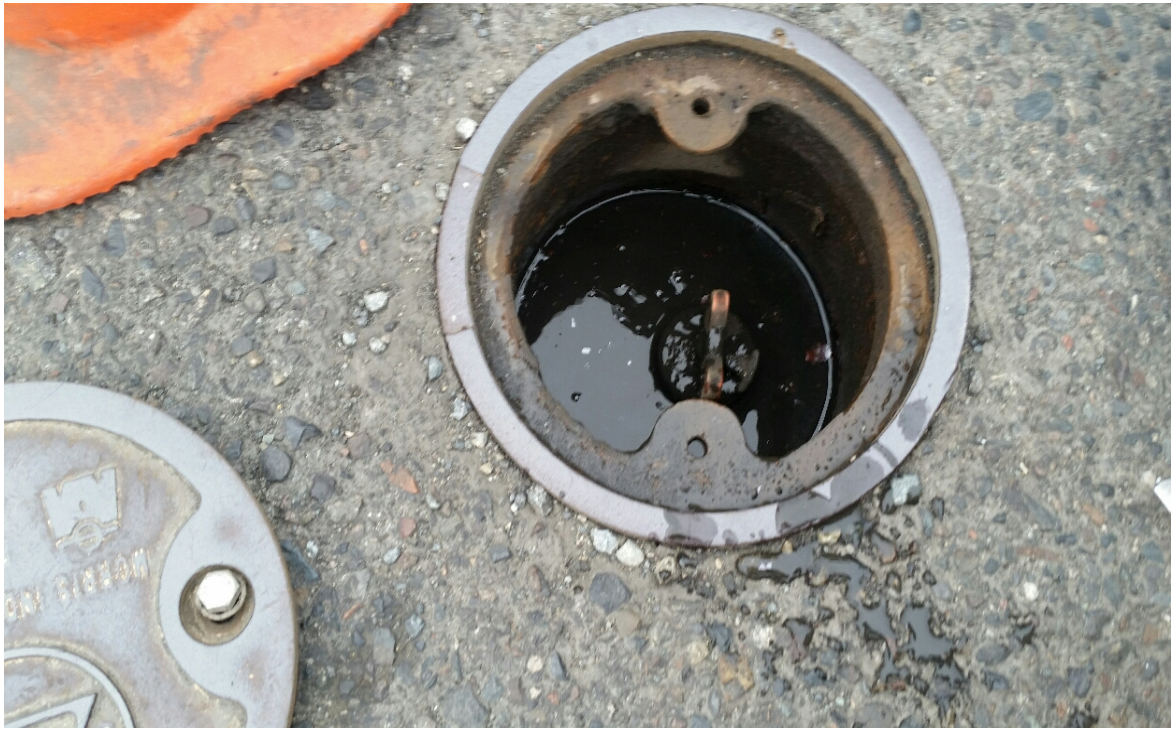
During collection of depth-to-water measurements, asphalt sealant was encountered in the monument for MW-8. After removal of the asphalt sealant, it was discovered that the locking expansion plug for the monitoring well was loose, and that asphalt sealant had seeped past the plug. Visible material was skimmed from the well surface and

MW-8 prior to sampling on May 17, 2018.

On June 5, 2018, ETG returned to clean, develop, and re-sample MW-8 due to the asphalt sealer contamination encountered during the May 17, 2018 groundwater monitoring event. The following sections present the actions taken to clean the monitoring well, complete additional well development after cleaning, and to collect a groundwater

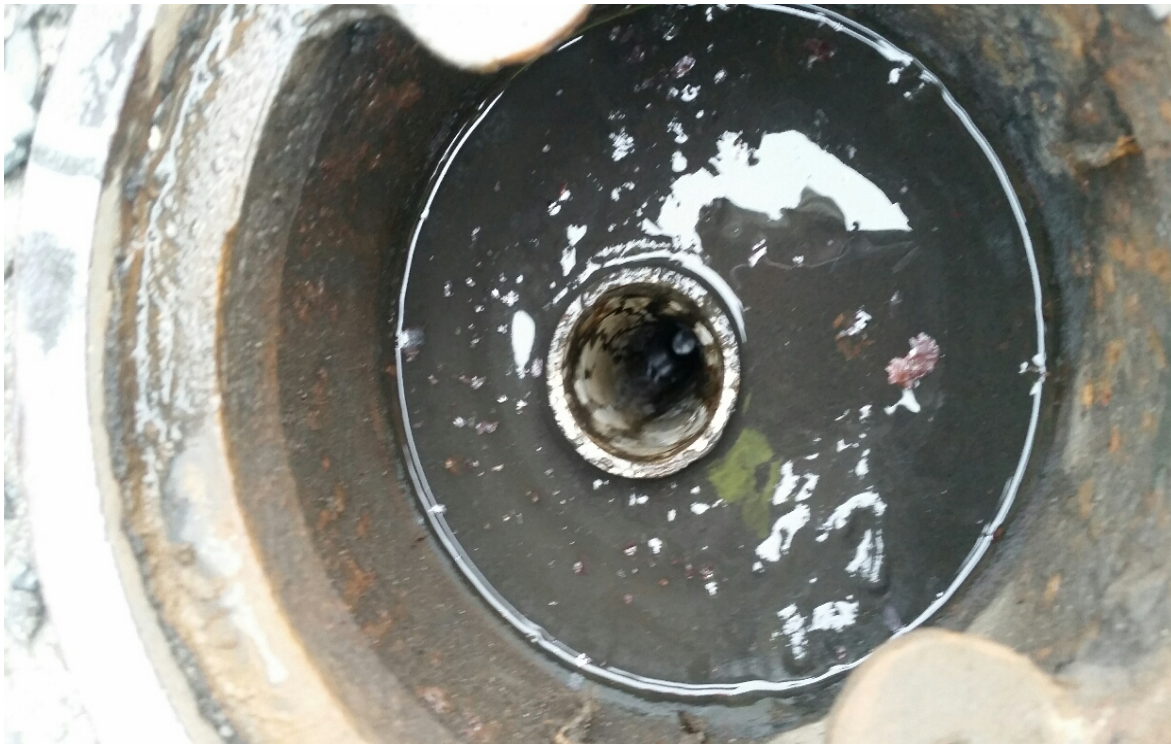
MW-8 prior to sampling on May 17, 2018, with j-plug removed.

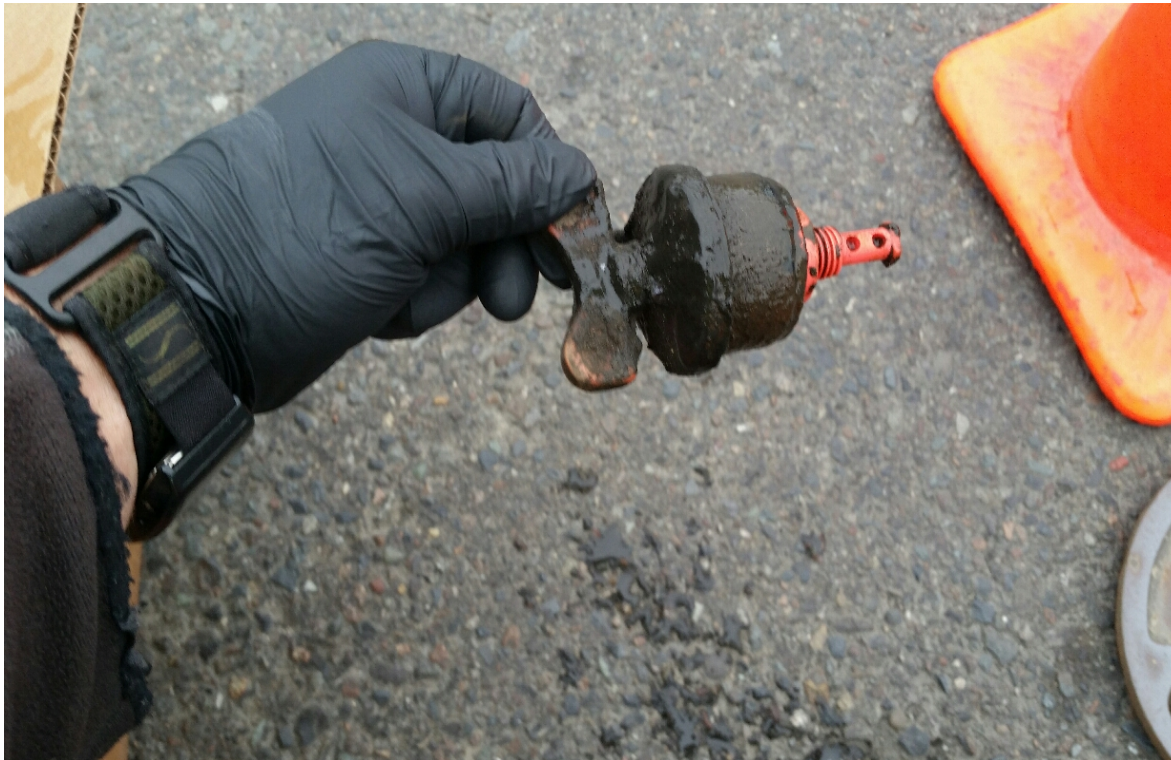
Notes: DTB = 13.62'. ESTES PERSONNEL + RTH CLEANED OUT OILY SLUDGE FROM MONUMENT + J-PLUG. J-PLUG WAS NOT TIGHT + ALLOWED SLUDGE TO LEAK INTO WELL. SKIMMED OIL FROM SURFACE. DISCARDED TUBING. NEW TUBING WITHA PUMPING IN REVERSE UNTIL GET @ SAMPLER DEPTH.

MW-8 j-plug on May 17, 2018.

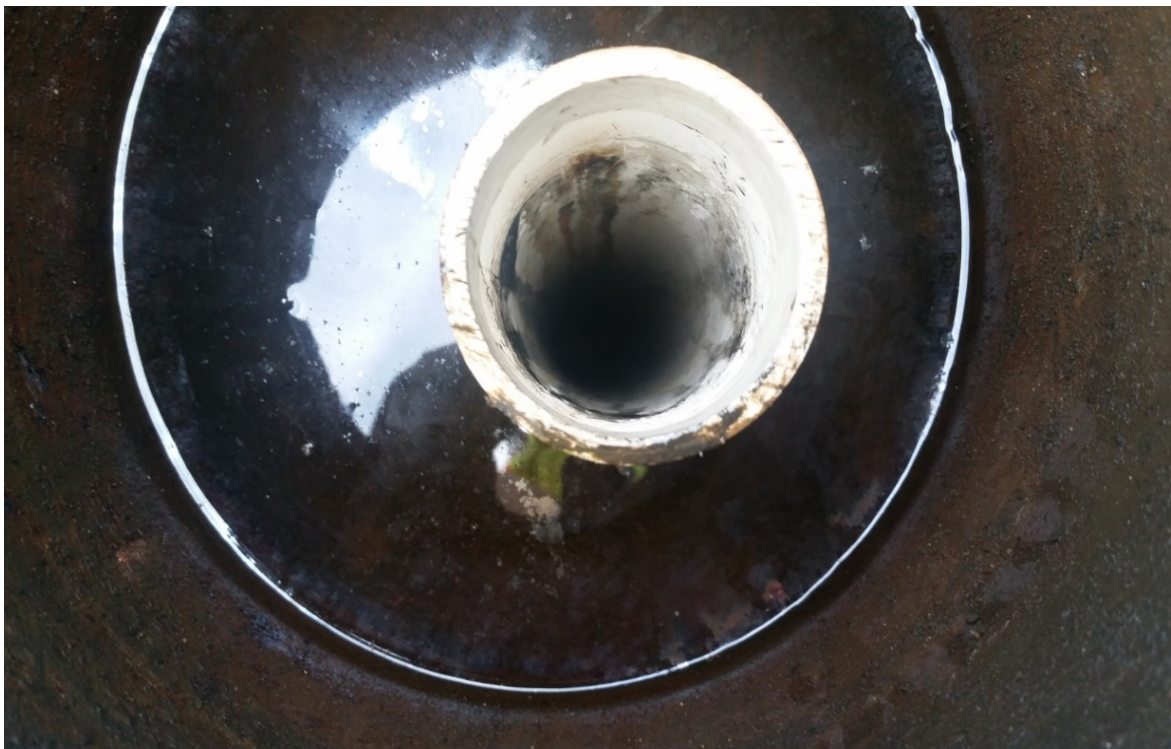
MW-8 prior to cleaning and resampling on June 5, 2018.

On June 5, 2018, ETG cleaned the casing for monitoring well MW-8, using clean absorbent pads to wipe the well casing. The cleaning was completed above the groundwater level to minimize transfer of asphalt sealant into the saturated portion of the well. Once the absorbent pads no longer indicate asphalt sealant, a final methanol treated absorbent pad was using for a final wipe of the casing above groundwater.

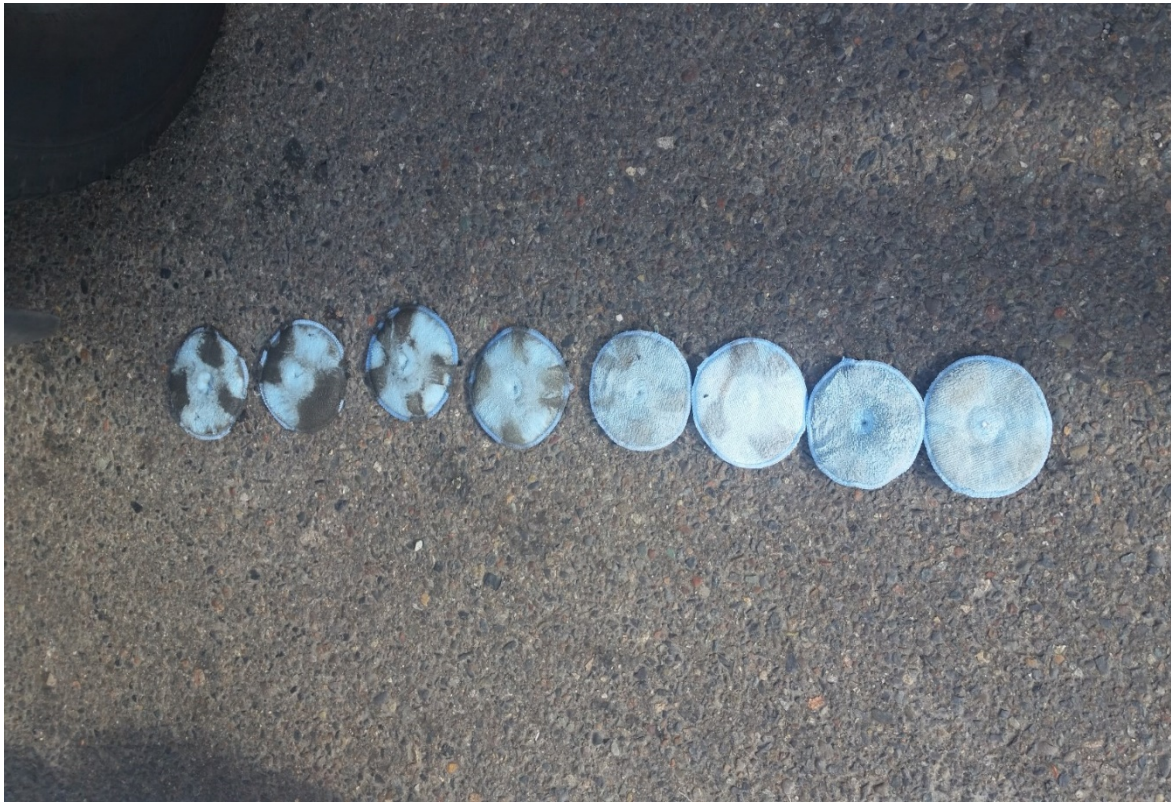
Progression of MW-8 cleaning pads on June 5, 2018.

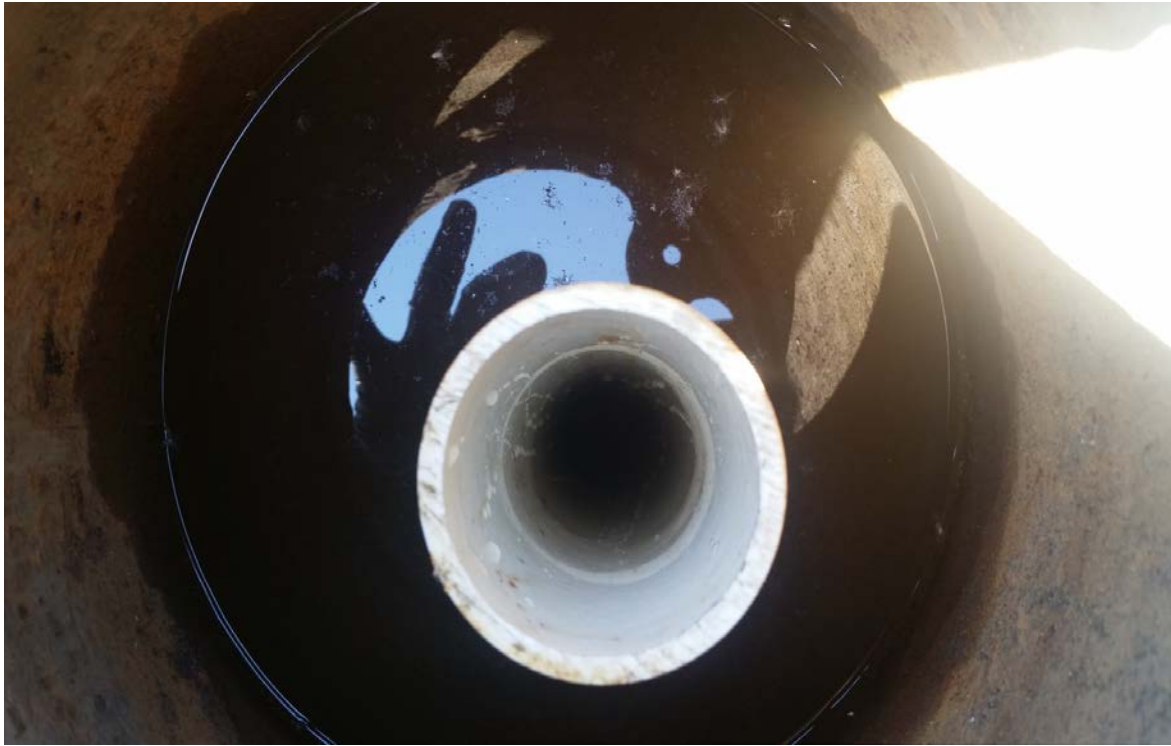
MW-8 at completion of cleaning, prior to resampling on June 5, 2018.

Following cleaning of MW-8's casing and monument, monitoring MW-8 was developed by extracting water with a development beginning at the top of the groundwater surface and lowering the pump as groundwater dropped in elevation. This process was repeated approximately 15 times until the purge water no longer changed in color between purging events. A total of 25 gallons of groundwater was removed from the well and stored in a USDOT-approved 55-gallon drum on-Site pending proper disposal.
