# Remedial Investigation Report

Former Plaid Pantry Store #112  
1002 W. Fourth Plain Boulevard  
Vancouver, Washington  
Washington Department of Ecology VCP Site ID SW1314

Plaid Pantries, Inc.  
10025 SW Allen Boulevard  
Beaverton, Oregon

EES Project #1179-01  
September 19, 2018

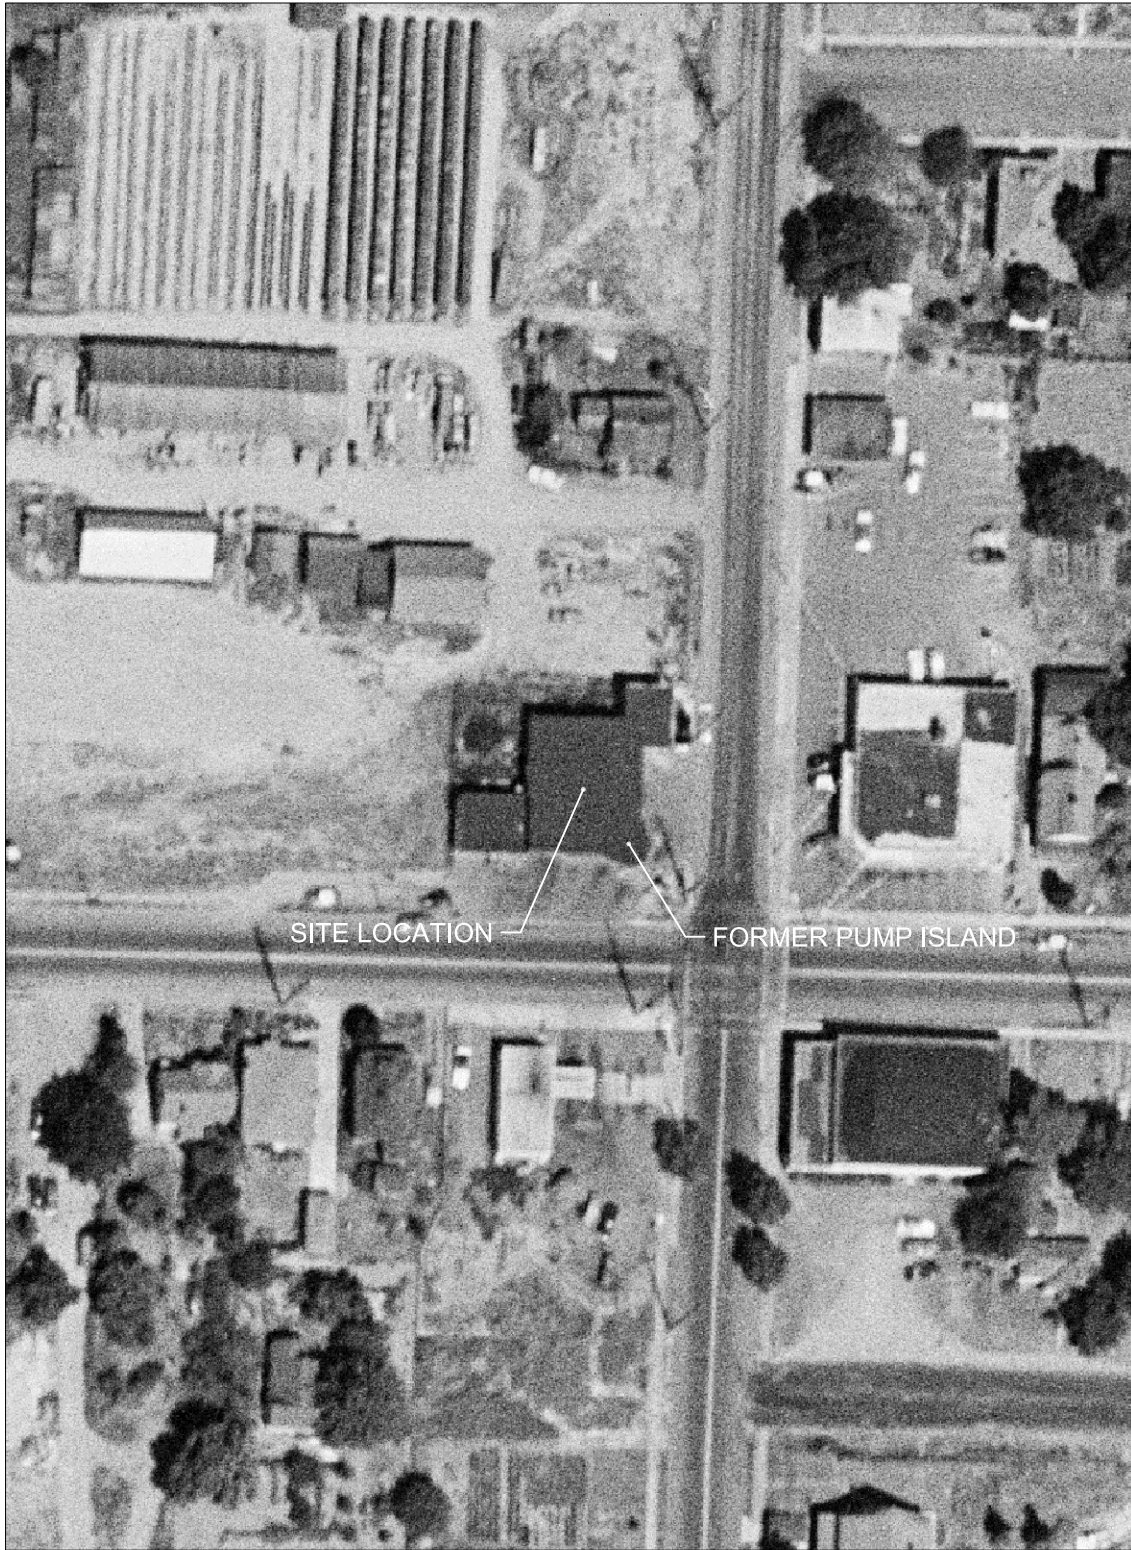
1955 Aerial Photo

PNG acquired aerial photographs of the Plaid #112 site vicinity from Environmental Data Resources (EDR) and the Washington Department of Transportation (WDOT). EDR provided aerial photographs dated 1951, 1955, 1960, 1963, 1970, 1975, 1984, 1986, 1990, 1994, 2000, 2005 and 2006. WDOT provided photographs dated 1955, 1966, 1970, 1978, and 1984. In general, the aerial photographs show two stages of commercial development at the Plaid #112 site. Aerial photographs for 1955, 1966, 1978, and 1984 are attached as Figures 1 through 4.
