STATE OF WASHINGTON
DEPARTMENT OF ECOLOGY

Re: No Further Action at the following Site:

- **Site Name:** Schlueter Property
- **Site Address:** 1515 196th St SE, Bothell, WA 98012
- **Facility/Site No.:** 2886743
- **Cleanup Site No.:** 1348
- **VCP Project No.:** NW3148

Enclosure A

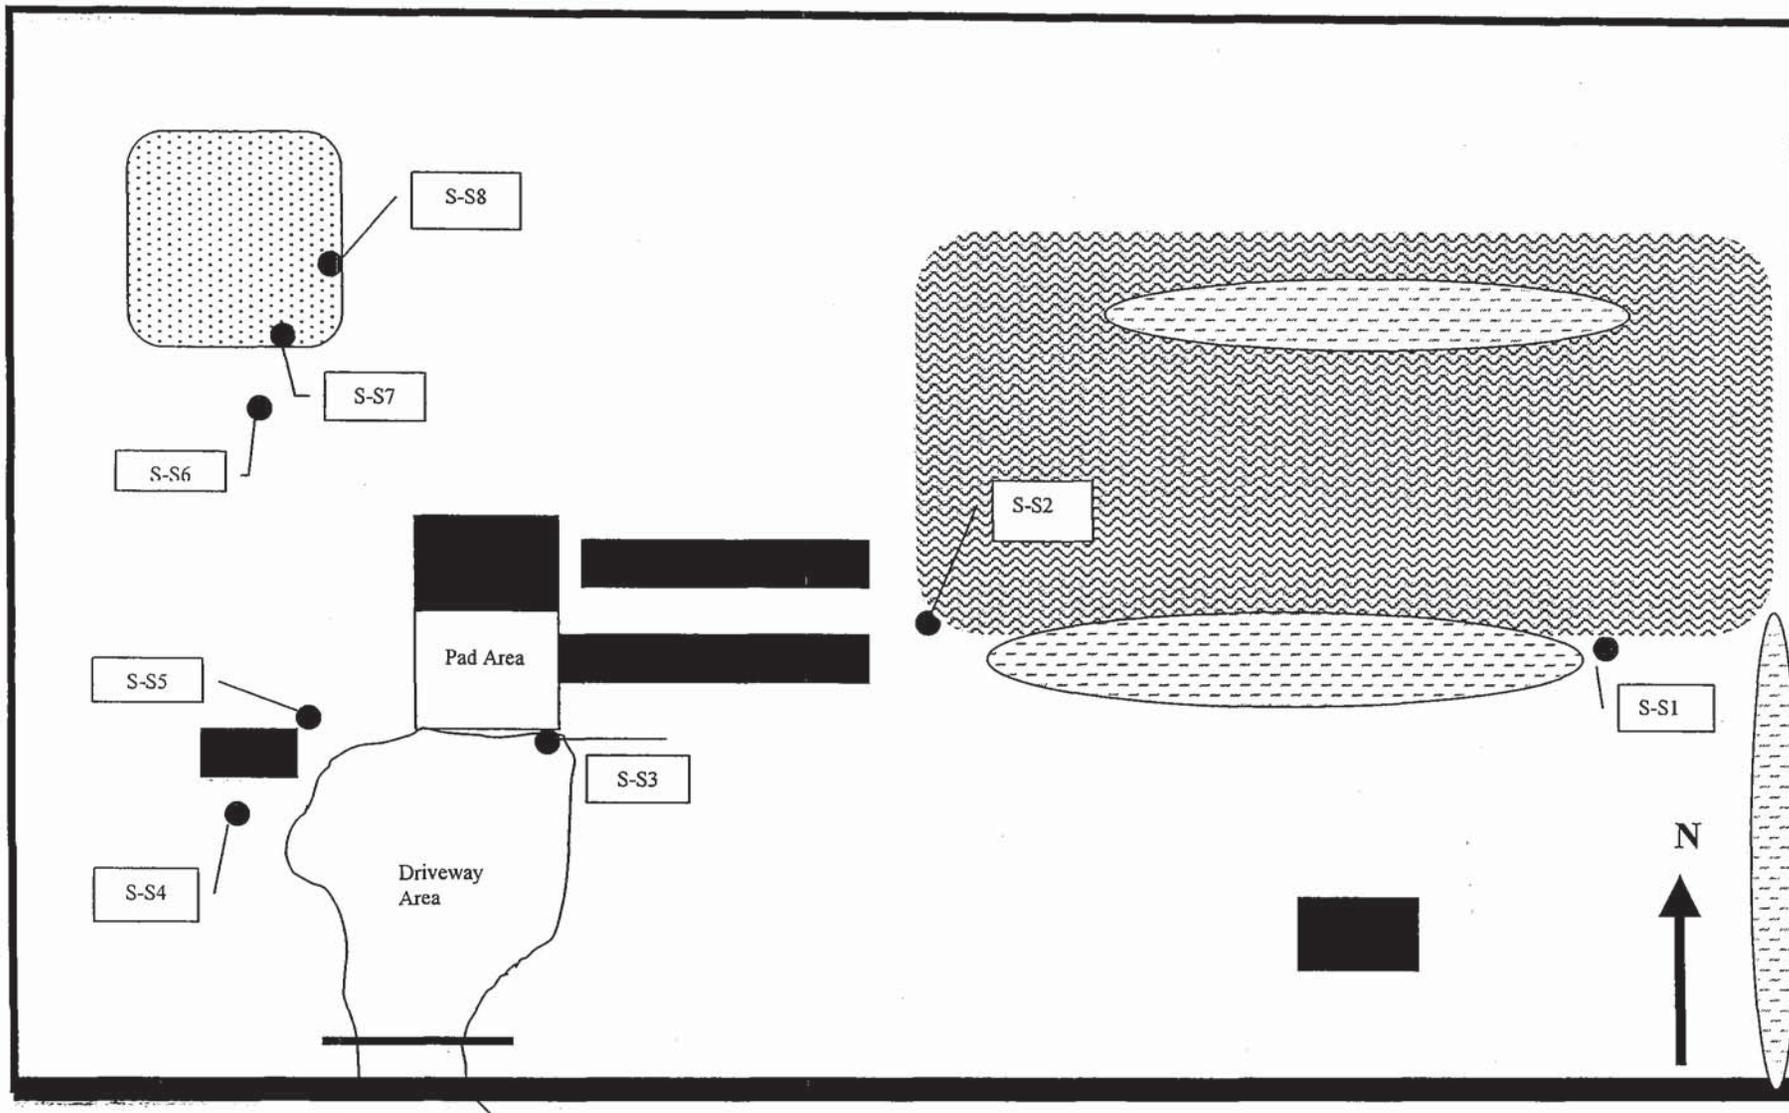
Enclosure A, Figure 2

Release and Extent of Contamination: Pursuant to complaints of illegal dumping on the Property and an Environmental Report Tracking System (ERTS) referral from Ecology, the SHD conducted a site inspection in February 2005 that included collection of soil samples (**Figure 2**). Potential sources of contamination observed on the Property included drums and piles of material that appeared to be sandblast grit. The SHD selected the following chemicals of concern due to observations of soil staining, oil-like waste, and sand blast grit: diesel- and oil-range petroleum hydrocarbons (TPHd and TPHo), arsenic, cadmium, chromium, and lead.

SHD collected eight soil samples from ground surface to depths of 3 to 19 inches. Sample results (**Table 1**) showed concentrations of the following chemicals above MTCA Method A soil cleanup levels: cadmium (four locations), lead (one location), and TPHo (one location). The sample showing the TPHo exceedance (concentration of 70,000 mg/kg) was collected from visually stained soil below a leaking 5-gallon oil bucket.

Figure 1
 Schleuter Property
 1515 196th Street SE
 February, 2005
 Snohomish Health District

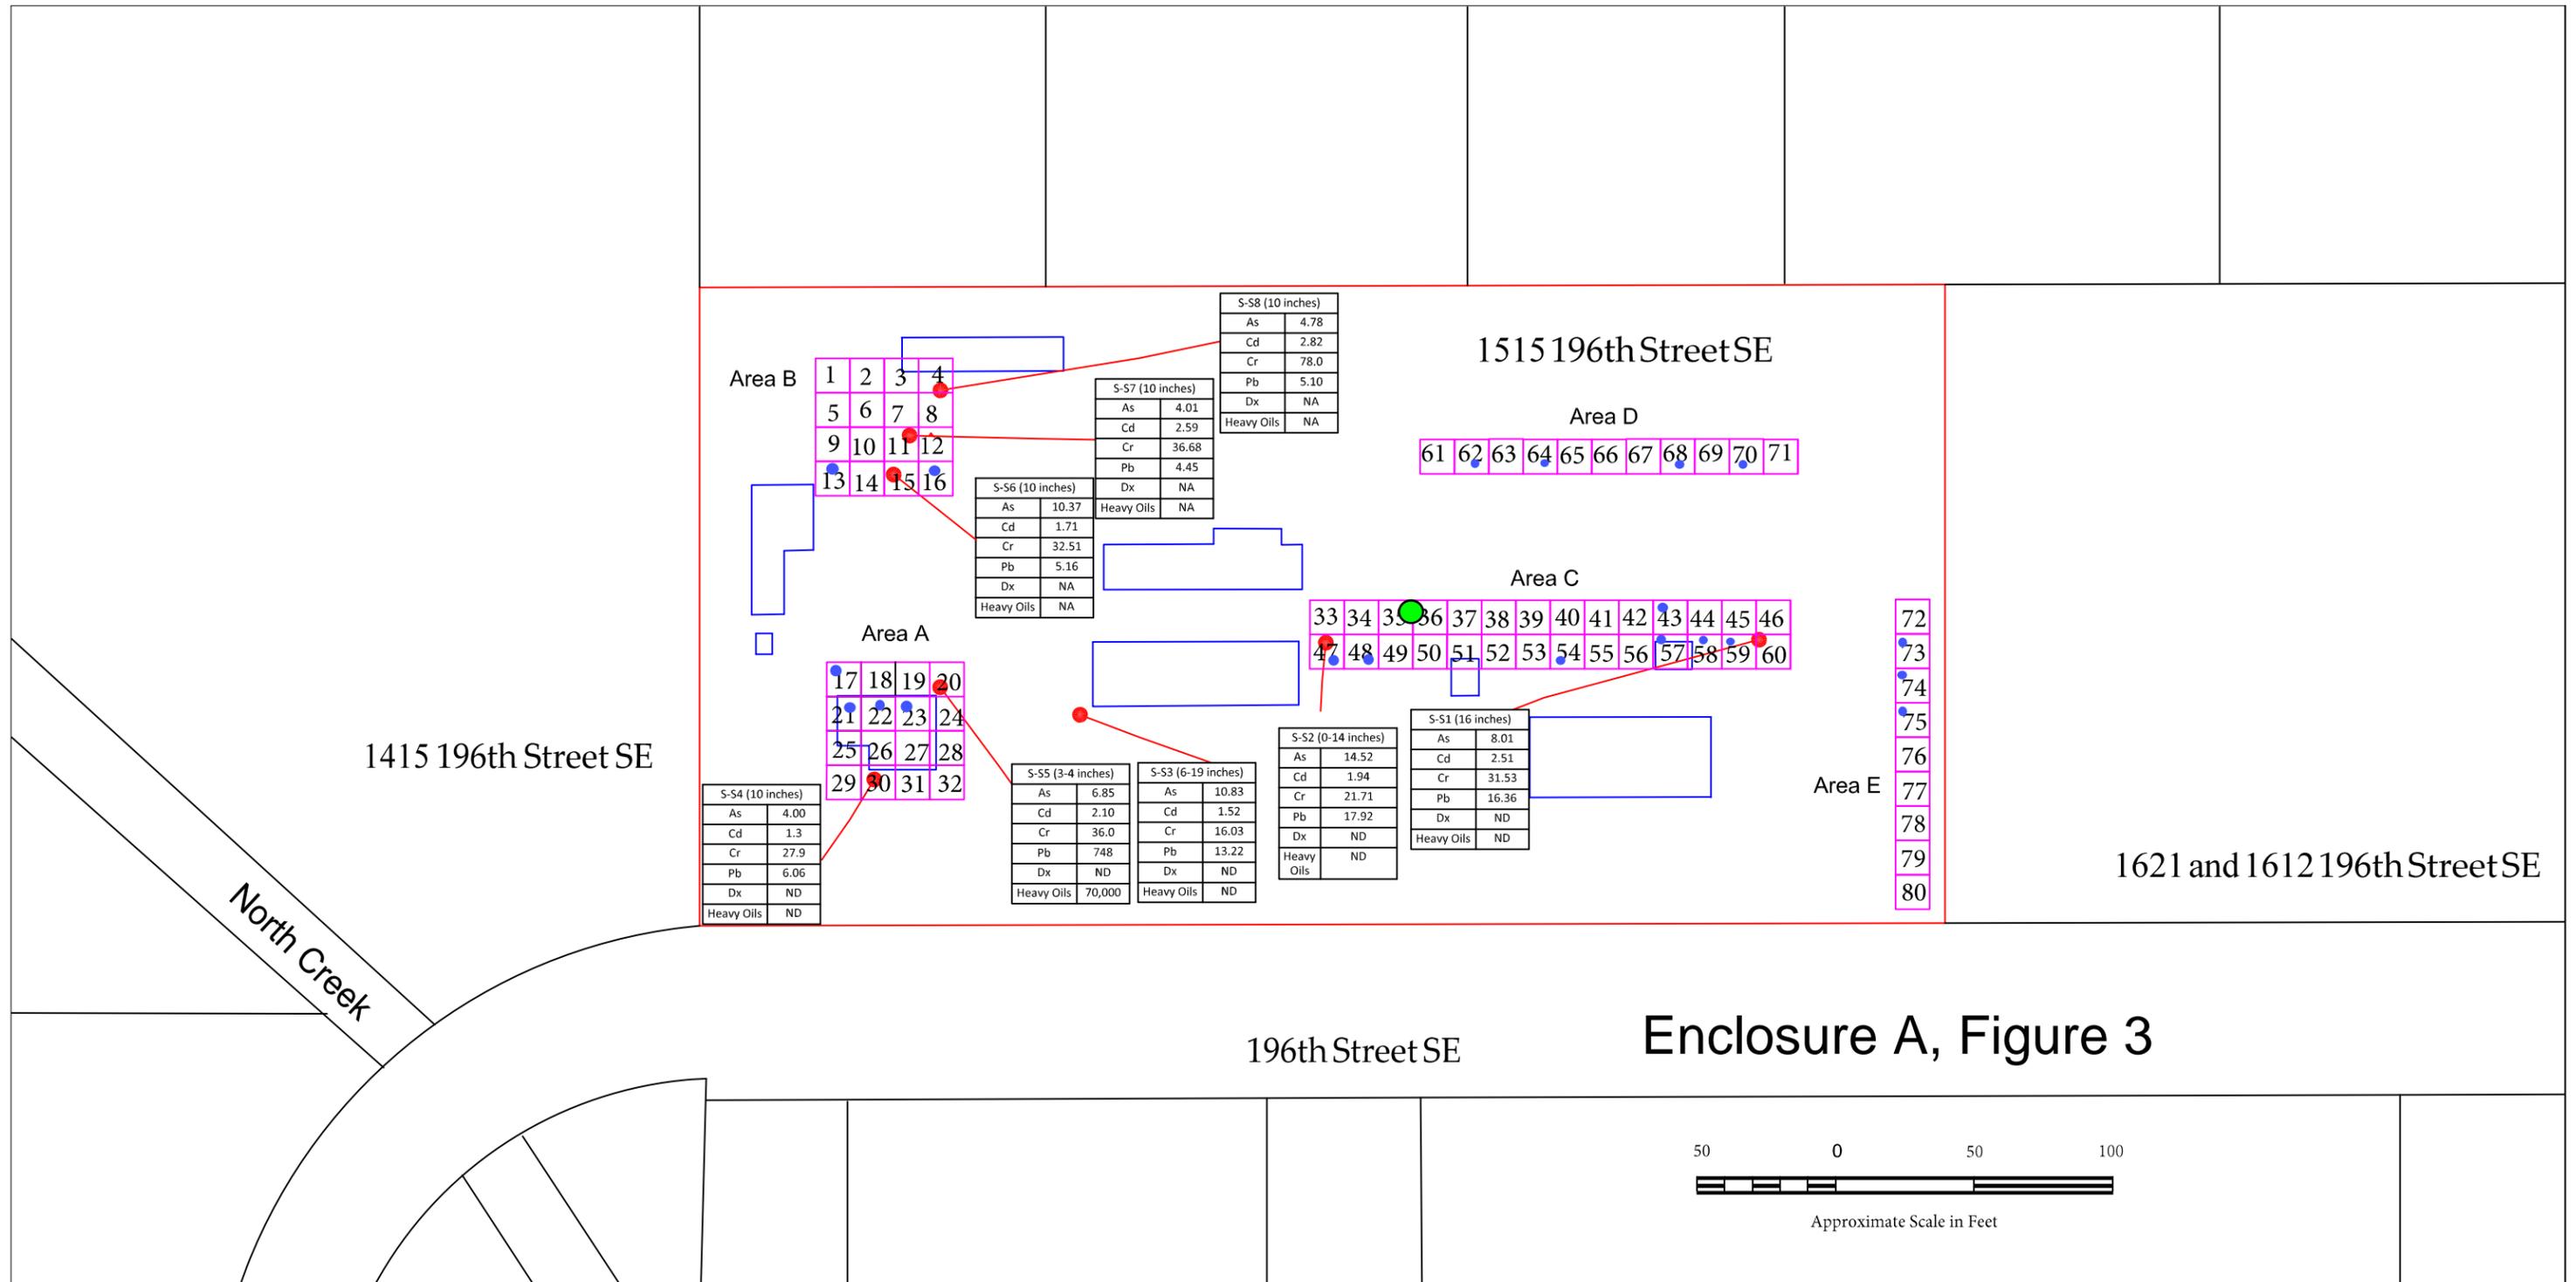
PROJECT: Schlueter RIFS	
SHEET TITLE: Site Figure	
DESIGNER: SKL	JOB NO. P966-B17
DRAWN BY: SKL	SCALE: As Shown
CHECKED BY: JDS	FIGURE: 2
DATE: May 5, 2017	FILE: 966 Figure 2.dwg

Migizi established a grid pattern in the five areas of the Site where observed and potential contamination occurred as identified by the April 2005 Site investigation by SHD (**Figure 3**). A statistical random grid sampling method (as described in *Guidance for Remediation of Petroleum Contaminated Sites, Toxics Cleanup Program Publication No. 10-09-057, Revised June 2016*) was used to select grid points for collection of soil samples below the surficial layer of gravel, from depth intervals of 6 to 10 inches. Samples were tested for the following chemicals of concern: TPHg, TPHd, TPHo, BTEX, cadmium, and lead. Sample results showed the following chemical concentrations above MTCA Method A cleanup levels at grid location number 75 (**Table 2** and **Figure 4**): TPHg, benzene, and xylenes.

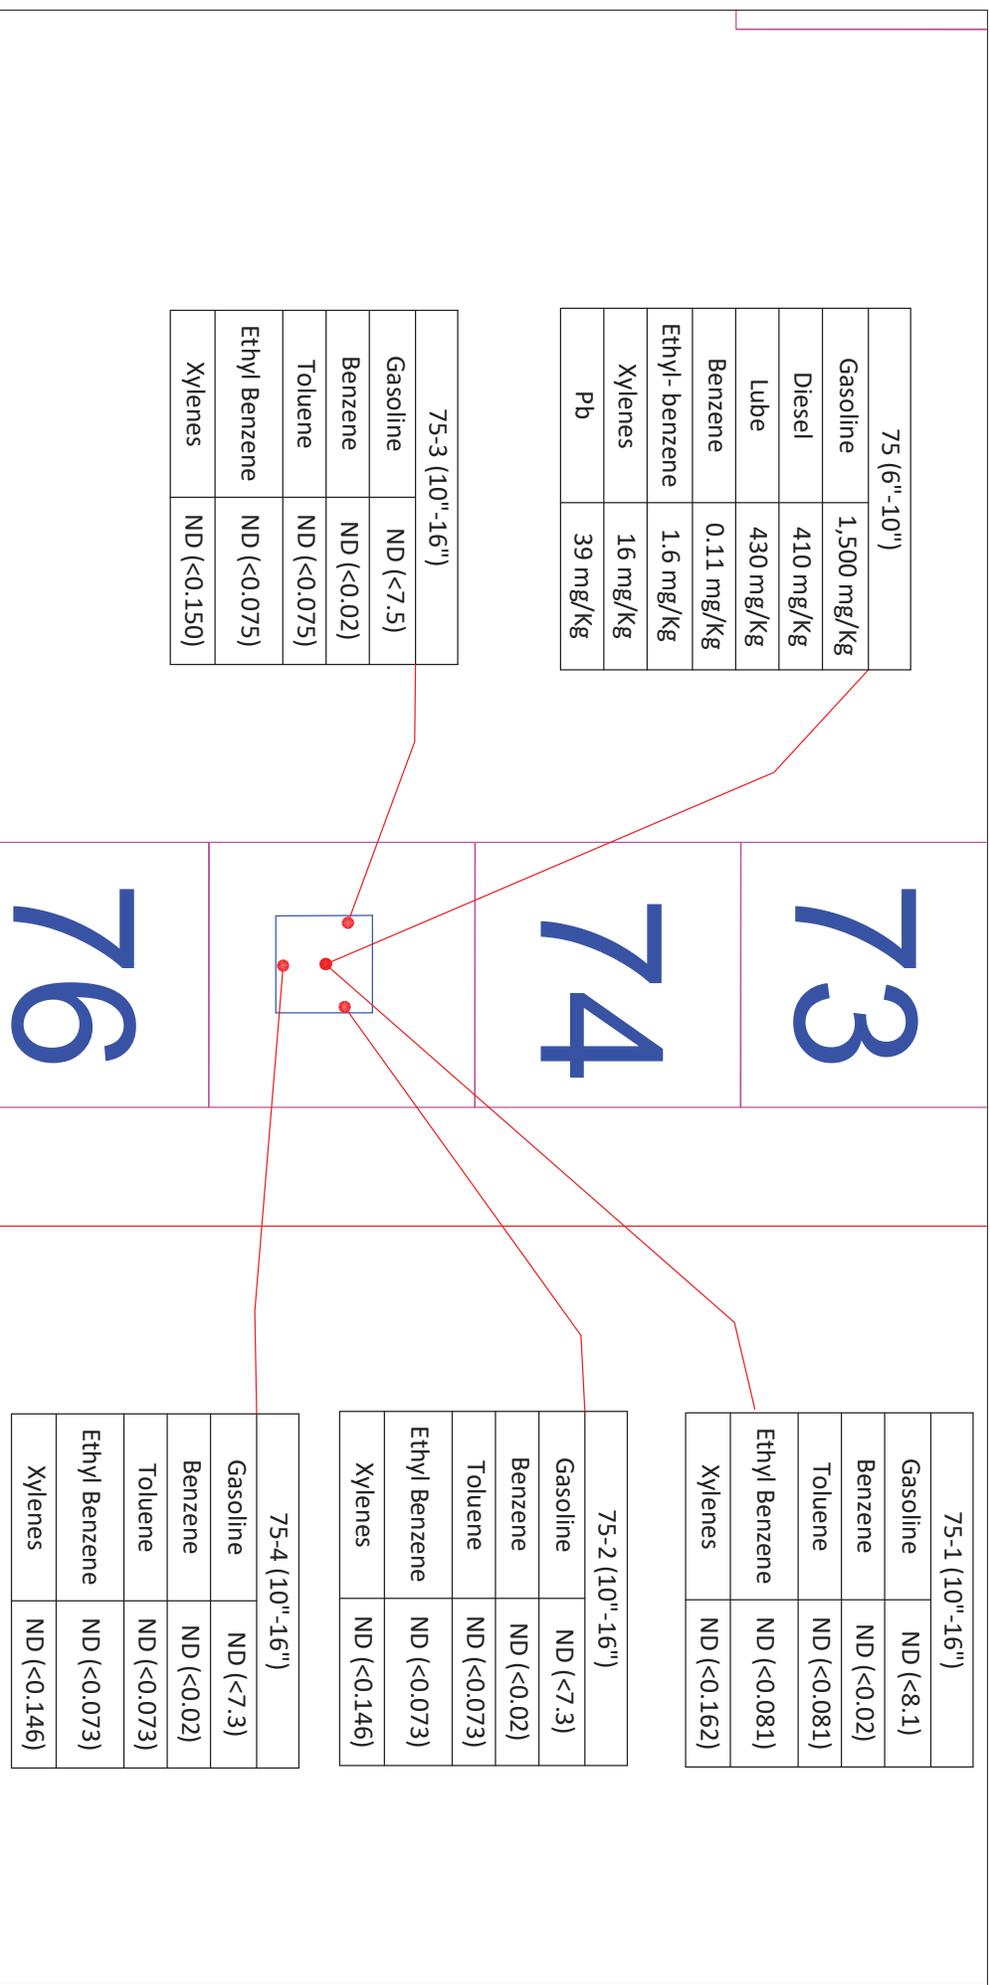
Enclosure A, Figure 5

Cleanup Actions: Additional soil samples were collected at grid location number 75 to assess the lateral and vertical extent of the detected chemicals. The cleanup implemented at the Site consisted of excavation and off-Site disposal of 2.51 tons (approximately 1.9 cubic yards) of soil at this location (**Figure 5**). Confirmation soil samples collected from the sides and bottom of the final excavation limits showed results below cleanup levels. The sample results confirm that soil impacts were limited to the upper 16 inches (1.3 feet) of the soil column at that location.

75 (6"-10")	
Gasoline	1,500 mg/Kg
Diesel	410 mg/Kg
Lube	430 mg/Kg
Benzene	0.11 mg/Kg
Ethyl- benzene	1.6 mg/Kg
Xylenes	16 mg/Kg
Pb	39 mg/Kg

75-3 (10"-16")	
Gasoline	ND (<7.5)
Benzene	ND (<0.02)
Toluene	ND (<0.075)
Ethyl Benzene	ND (<0.075)
Xylenes	ND (<0.150)

75-1 (10"-16")	
Gasoline	ND (<8.1)
Benzene	ND (<0.02)
Toluene	ND (<0.081)
Ethyl Benzene	ND (<0.081)
Xylenes	ND (<0.162)

75-2 (10"-16")	
Gasoline	ND (<7.3)
Benzene	ND (<0.02)
Toluene	ND (<0.073)
Ethyl Benzene	ND (<0.073)
Xylenes	ND (<0.146)

75-4 (10"-16")	
Gasoline	ND (<7.3)
Benzene	ND (<0.02)
Toluene	ND (<0.073)
Ethyl Benzene	ND (<0.073)
Xylenes	ND (<0.146)

Excavated Soil inside Sample Grid 75

SHEET TITLE: Soil Excavation and Sampling Plan

Ecology has determined the cleanup you performed meets the cleanup standards established for the Site. The cleanup implemented at the Site consisted of excavation and off-Site disposal of 2.51 tons (approximately 1.9 cubic yards) of soil with concentrations of TPHg, benzene, and xylenes above cleanup levels. Confirmation soil samples collected from the sides and bottom of the excavation showed results below cleanup levels.

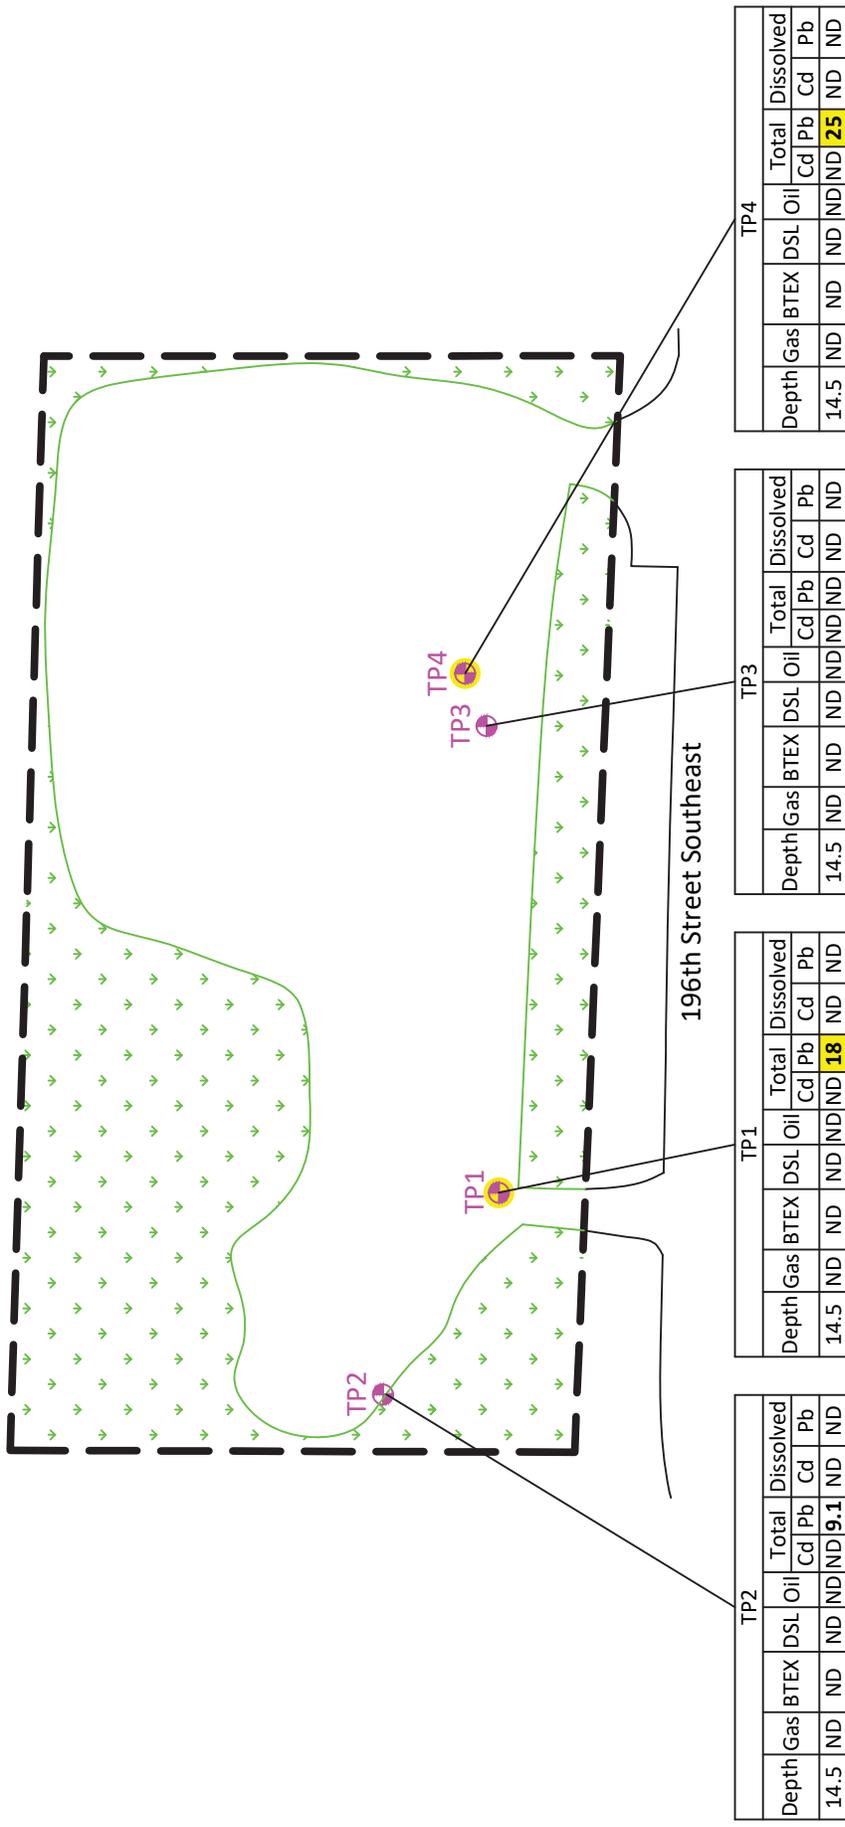
Enclosure A, Figure 6

Ground Water Sampling: Ground water samples were collected from temporary monitoring probes at four locations near the Property boundary (Figure 6), in positions likely downgradient (in the direction of shallow ground water flow) from the Property. Ground water sampling results confirmed that chemicals of concern were below MTCA Method A cleanup levels.

Corporate Office 17522 Bothell Way Northeast Bothell, Washington 98011 Phone: 425.415.0551 Fax: 425.415.0311	
Schluefer Property		Figure 2	
RGI Project Number 2018-158	Property Plan with Test Probe Locations and Groundwater Analytical Data		Date Drawn: 08/2018
Address: 1515 196th Street Southeast, Bothell, Washington 98012
