## CLEANUP ACTION REPORT

Broadcast Apartments Property  
1420 East Madison Street  
Seattle, Washington  
VCP No. NW2954

August 17, 2016

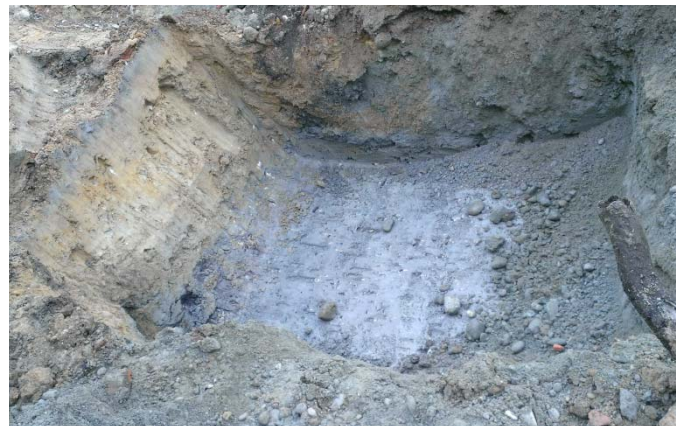
UST01 was encountered on January 6, 2016, in the central portion of the Property. This tank had a capacity of 300 gallons and contained approximately 3" of oily water at the time of removal. UST01 was observed to be in poor condition, with significant corrosion, pitting, and numerous holes observed in the tank walls.

Elevated PID readings, strong hydrocarbon odors, and gray staining were observed in soil directly beneath each of the USTs and on the sidewalls of the tank pits. Discrete soil samples were collected from each of the UST excavations and analyzed for DRPH, ORPH, and chlorinated VOCs. Soil samples collected from the UST01 and UST02 tank pits contained concentrations of DRPH exceeding the cleanup level. Soil samples collected from the UST03 tank pit contained concentrations of DRPH and ORPH below applicable cleanup levels. Based on field screening and analytical results, impacted soil in these areas was classified as PCS and segregated from non-impacted soil. Widespread soil impacts encountered in the central portion of the Property appear to be primarily attributable to the release from UST01.

Photograph 4. Taken January 8, 2016, looking south in the vicinity of UST01. Note the boundary between non-impacted soil and stained PCS.

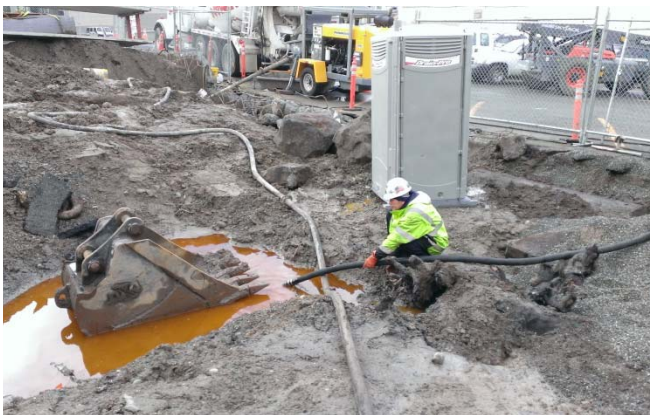
UST02 was encountered on January 15, 2016, in the western portion of the Property. This tank had a capacity of 675 gallons and contained approximately 230 gallons of oily water at the time of discovery. On January 18, 2016, W.G. Clark notified SoundEarth that rainwater had filled and displaced the contents of UST02, pooling in puddles to the south and east of the tank. A thin sheen of petroleum was observed on the puddles. Marine Vacuum Services, Inc. pumped approximately 1,300 gallons of oily water from within UST02 and the surrounding puddles.

Photograph 5. Taken January 18, 2016, looking southwest. MarVac pumping out displaced contents of UST02.
