**ADDITIONAL SITE
CHARACTERIZATION REPORT**

Performed at:
Swindahl Properties LLC
2218 Marine View Drive
Tacoma, Washington 98422

July 20, 2018

Project Number: 218-6004

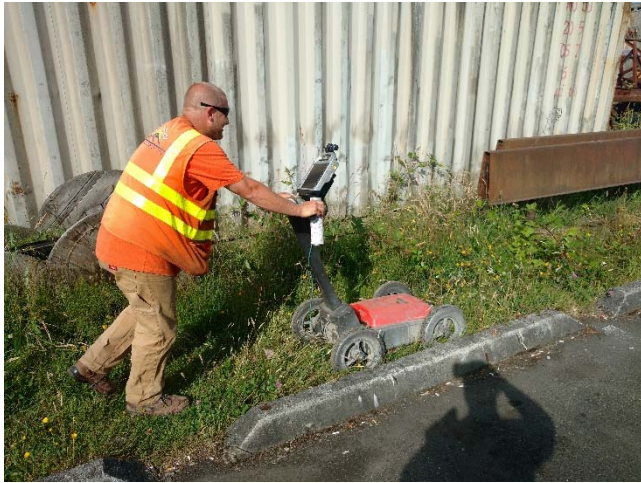
GPR survey prior to drilling

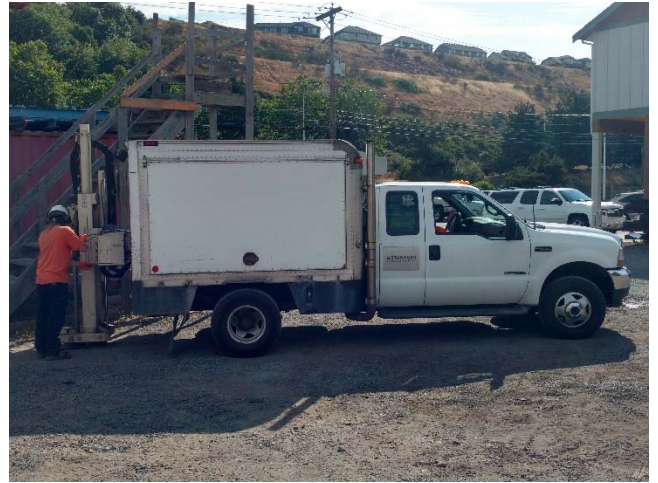
During the June 29, 2018 mobilization, drilling operations utilized a Truck-mounted Direct Push Drilling Rig. The subsurface soil borings were performed by equipment owned and operated by Licensed Driller from Standard Environmental Probe of Olympia.

Truck-mounted direct push drill rig

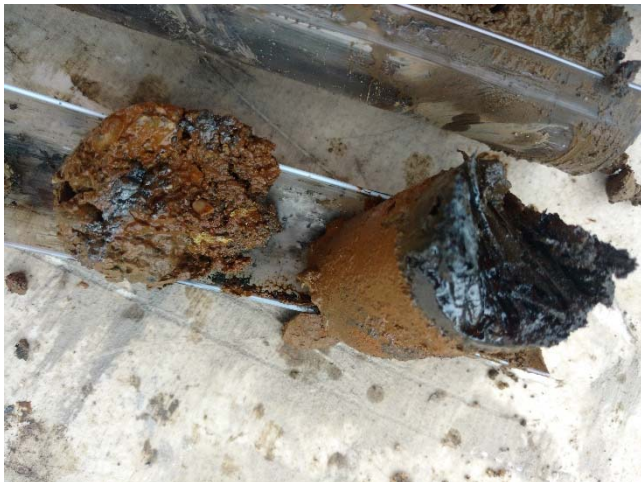
Close-up of sticky dark gray stained material

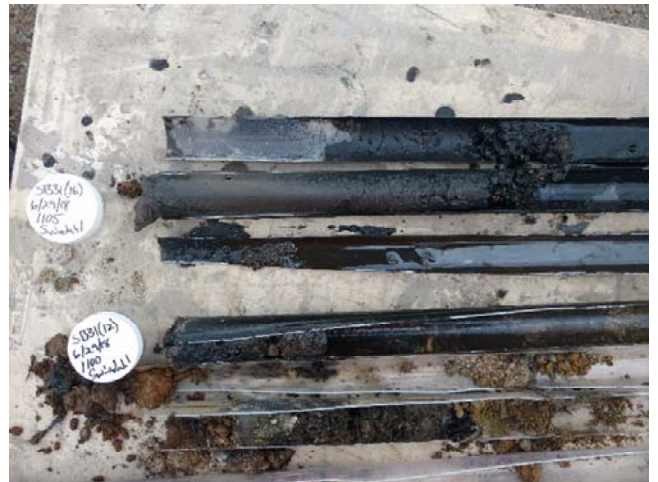
During sampling activities at soil boring SB31, field observations included a dark gray stained interval that also smelled oily. Concentrations of total petroleum hydrocarbons as diesel (TPHd) and oil (TPHo) did not exceed the CULs. However, the detections of TPHo at 1,600 mg/kg from the 8 and 12-foot sample interval at SB25 meant further analyses based on Table 830-1 of the MTCA needed to be completed to rule out carcinogenic polycyclic aromatic hydrocarbons (“cPAHs”).

A gray stained sample was observed at SB31. Based on the field observations, the sample appeared to be in the heavy oil range of hydrocarbons. Additional analyses for TPHd and TPHo not previously anticipated were requested of the samples collected at the soil boring and vicinity to delineate any exceedances of the CULs.

Samples from SB31 where dark oily sheen, stain and odor were observed

Further Action is Recommended. 1) Aerotech recommends the continuation of groundwater monitoring to obtain four consecutive quarter of clean data below groundwater CULs; and 2) Perform a Remedial Investigation and Feasibility Study with a Disproportionate Cost Analyses to evaluate options to address the remaining concentrations of Arsenic and Lead to be submitted to the Ecology Voluntary Cleanup Program to achieve a No Further Action Determination.

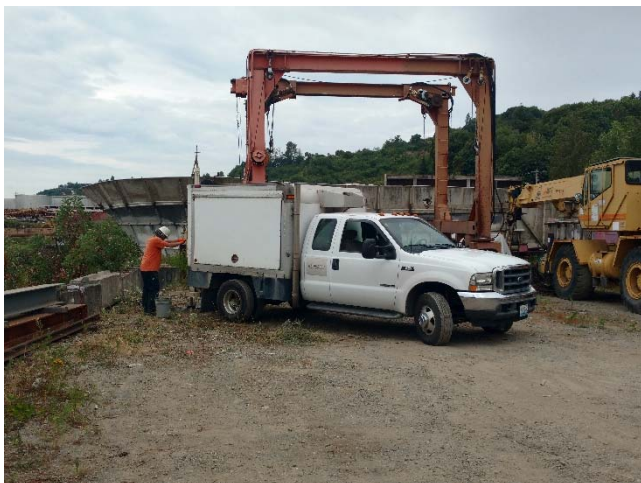
Results of cPAH analyses exceeded the MTCA Method A CUL of 0.1 mg/kg at SB25 from the sample collected at 12 feet below grade surface. An additional sample interval collected at 16 feet below grade did not contain any cPAHs above the CULs.

View of Soil Boring SB25

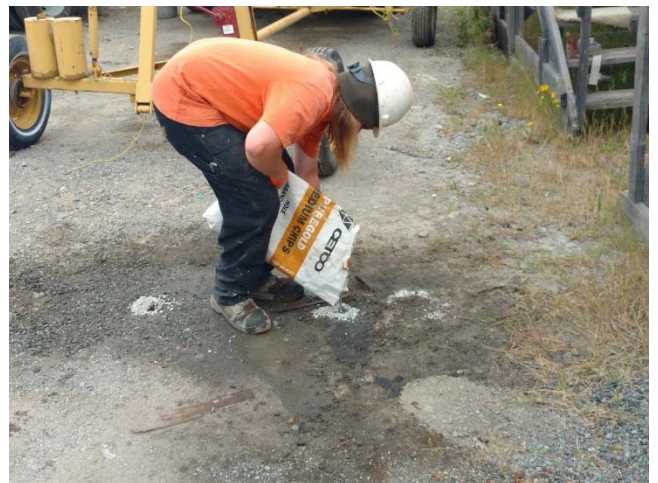
Backfilling soil borings with bentonite to surface

If a well is not installed, the boring is backfilled from total depth to approximately 5 feet below ground surface (bgs) with either neat cement or bentonite grout using a tremie pipe. The boring is backfilled from 5 feet bgs to approximately 1 foot bgs with hydrated bentonite chips. The borehole is completed from 1 foot bgs to surface grade with material that best matches existing surface conditions and meets local agency requirements. Site-specific backfilling details are shown on the respective boring log.
