Tiki Car Wash  
Bellevue  
LUST ID#: 2910

## Enhanced Fluid Recovery Pilot Test Report Tiki Car Wash

Washington State Department of Ecology  
Consent Decree # 93-2-077106

EA Engineering, Science, and Technology, Inc.  
12011 NE 1<sup>st</sup> Street, Suite 100  
Bellevue, Washington 98005  
Contract No. 30700-12292

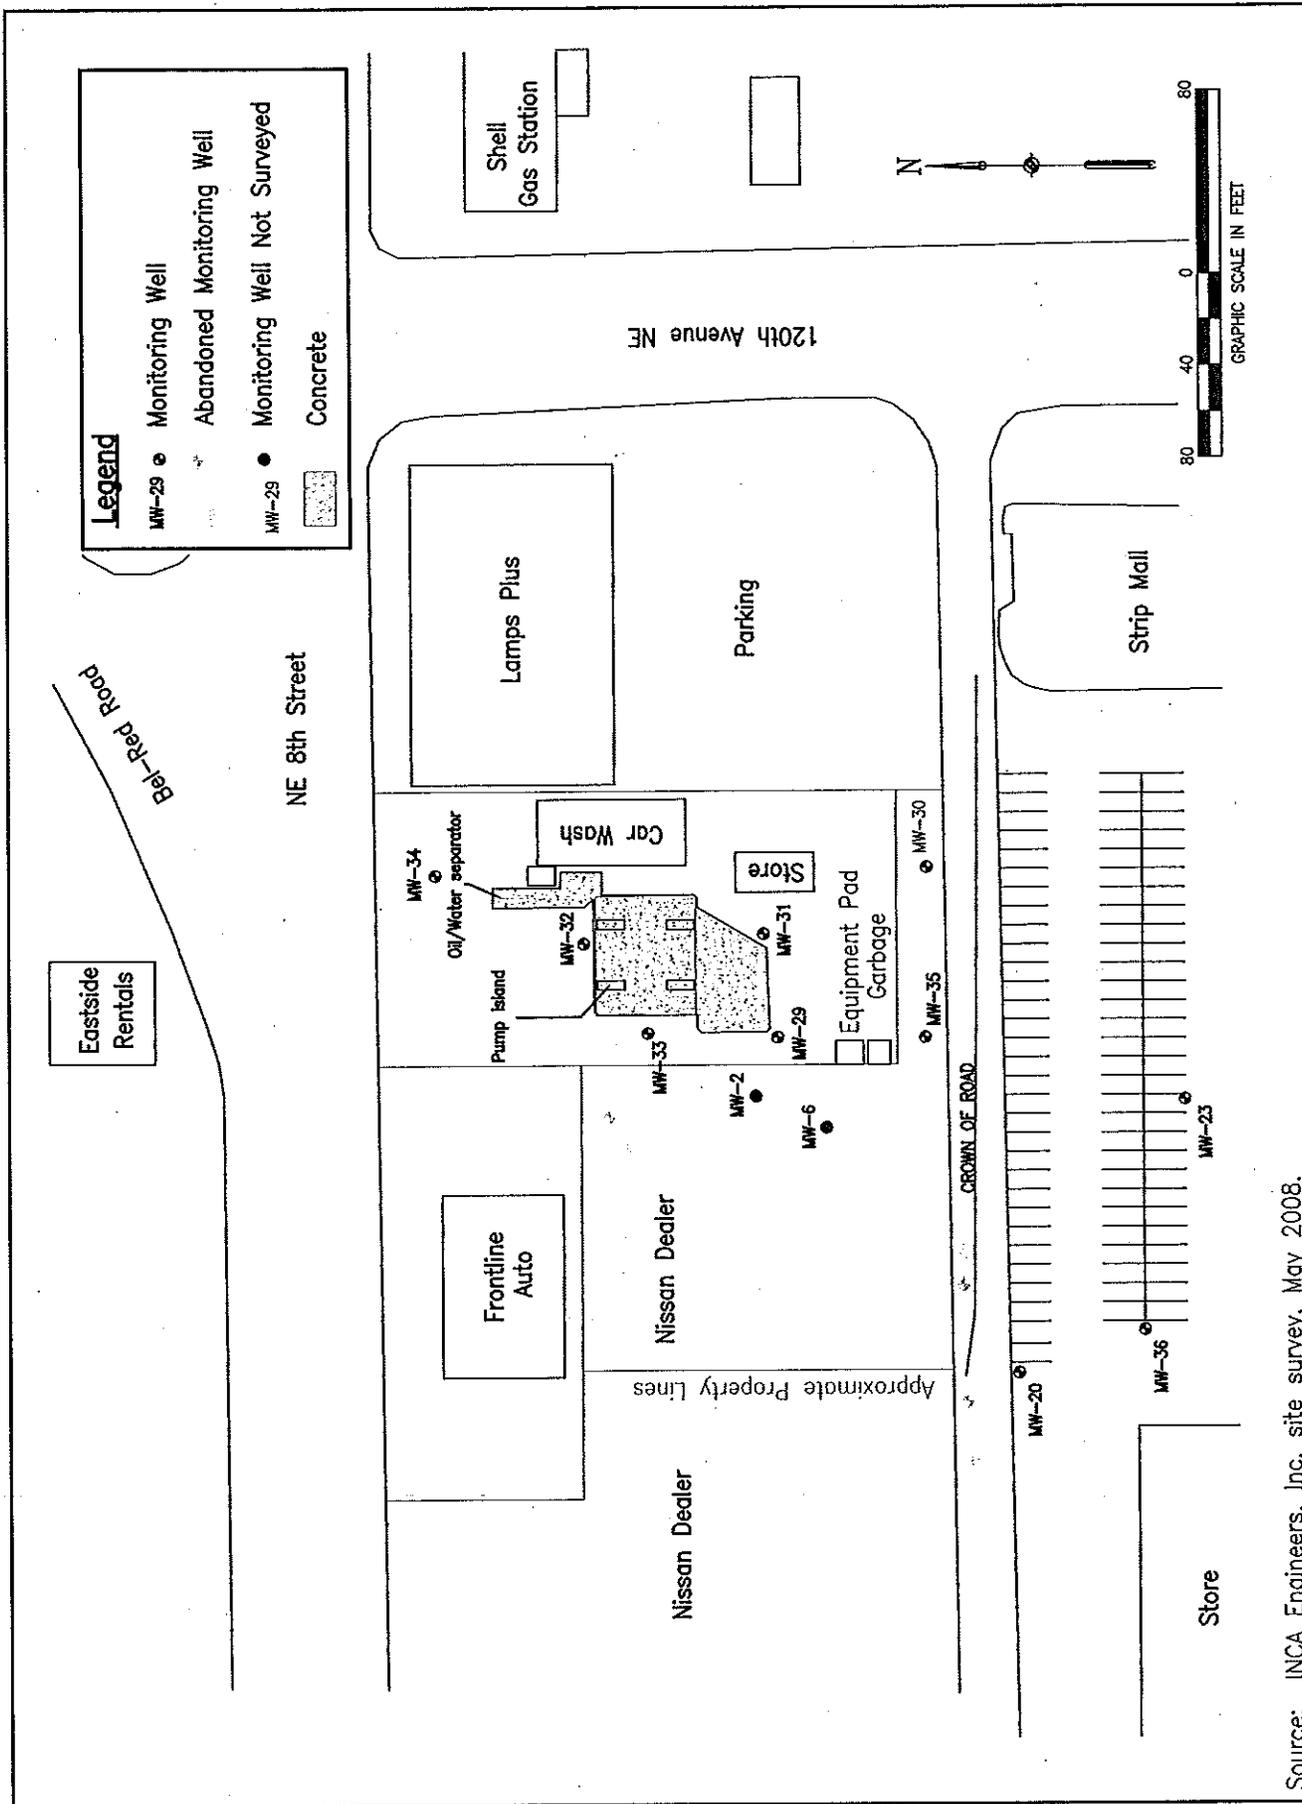
Figure 2. Tiki Car Wash Site Layout

Source: INCA Engineers, Inc. site survey, May 2008.

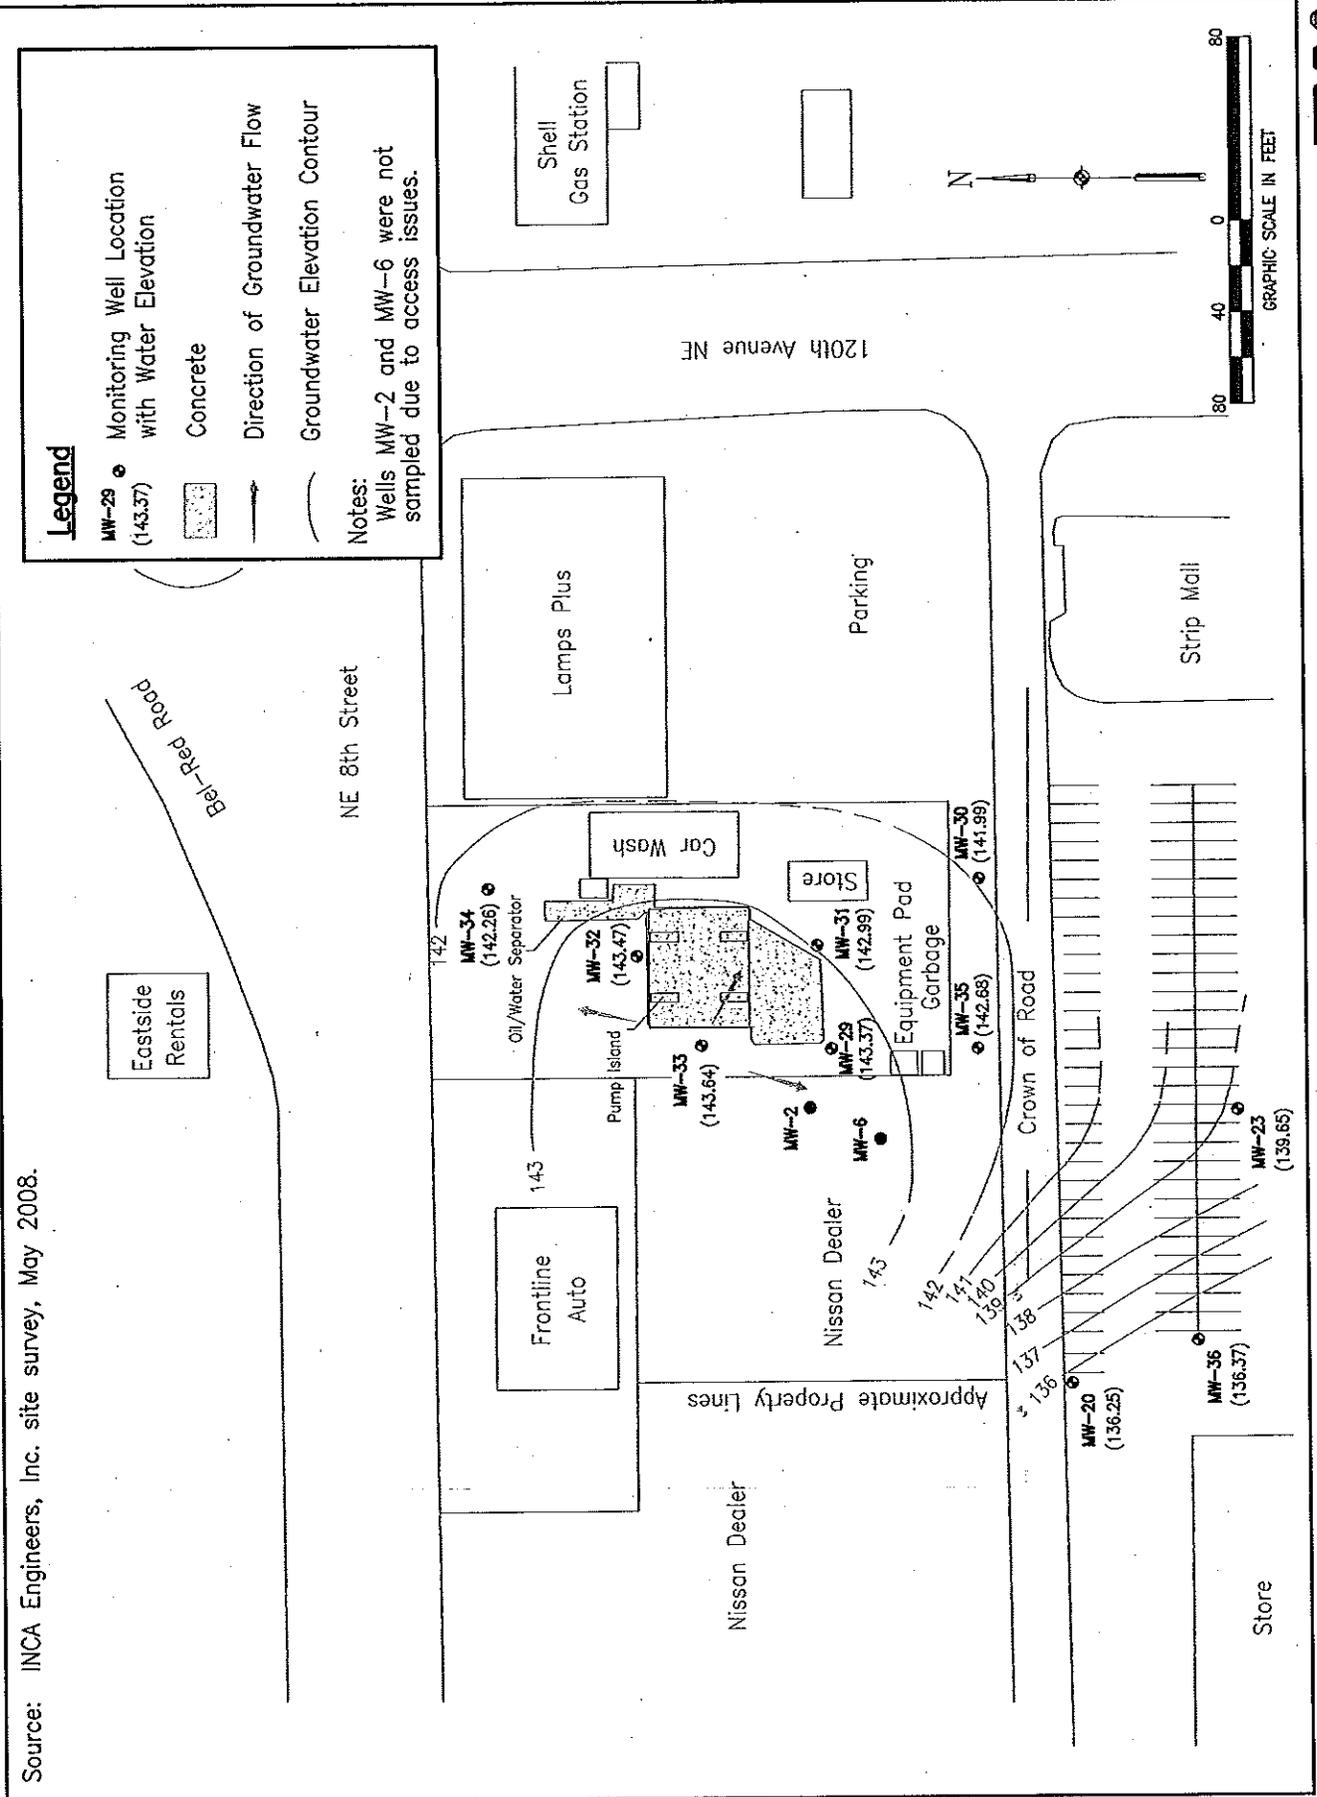
Figure 3. Groundwater Elevations and Flow Direction, June 2008, Tiki Car Wash.

Source: INCA Engineers, Inc. site survey, May 2008.

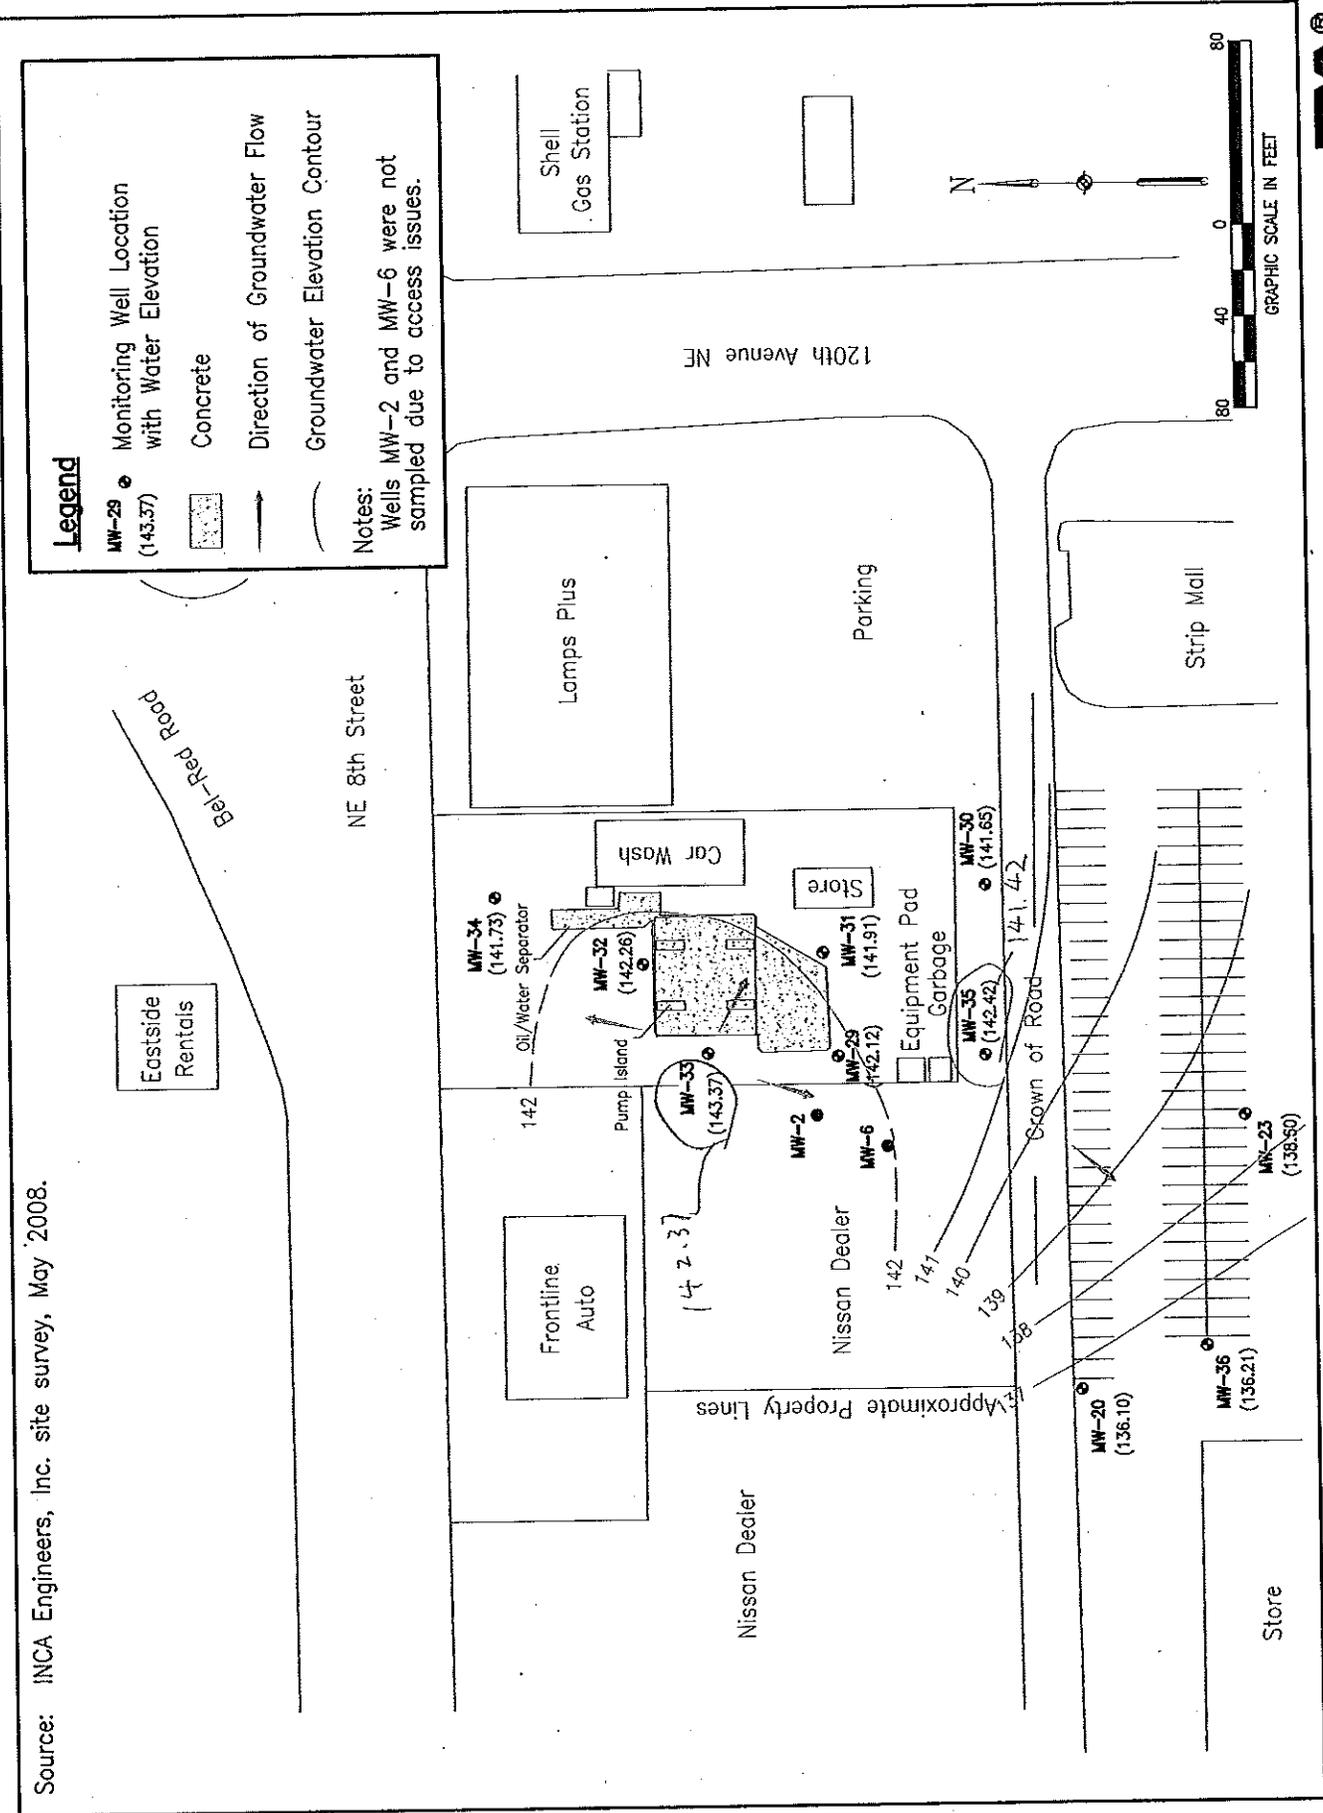
Figure 4. Groundwater Elevations and Flow Direction, October 2008, Tiki Car Wash.

Source: INCA Engineers, Inc. site survey, May 2008.

Analytical results for groundwater samples collected on 18 March 2008 represent site conditions prior to the EFR pilot test and are presented in Table 1 are summarized below. GRO and DRO concentrations are shown on Figure 4. Measured concentrations in groundwater will be compared against the MTCA Method A cleanup criteria, which are presented in Table 1.

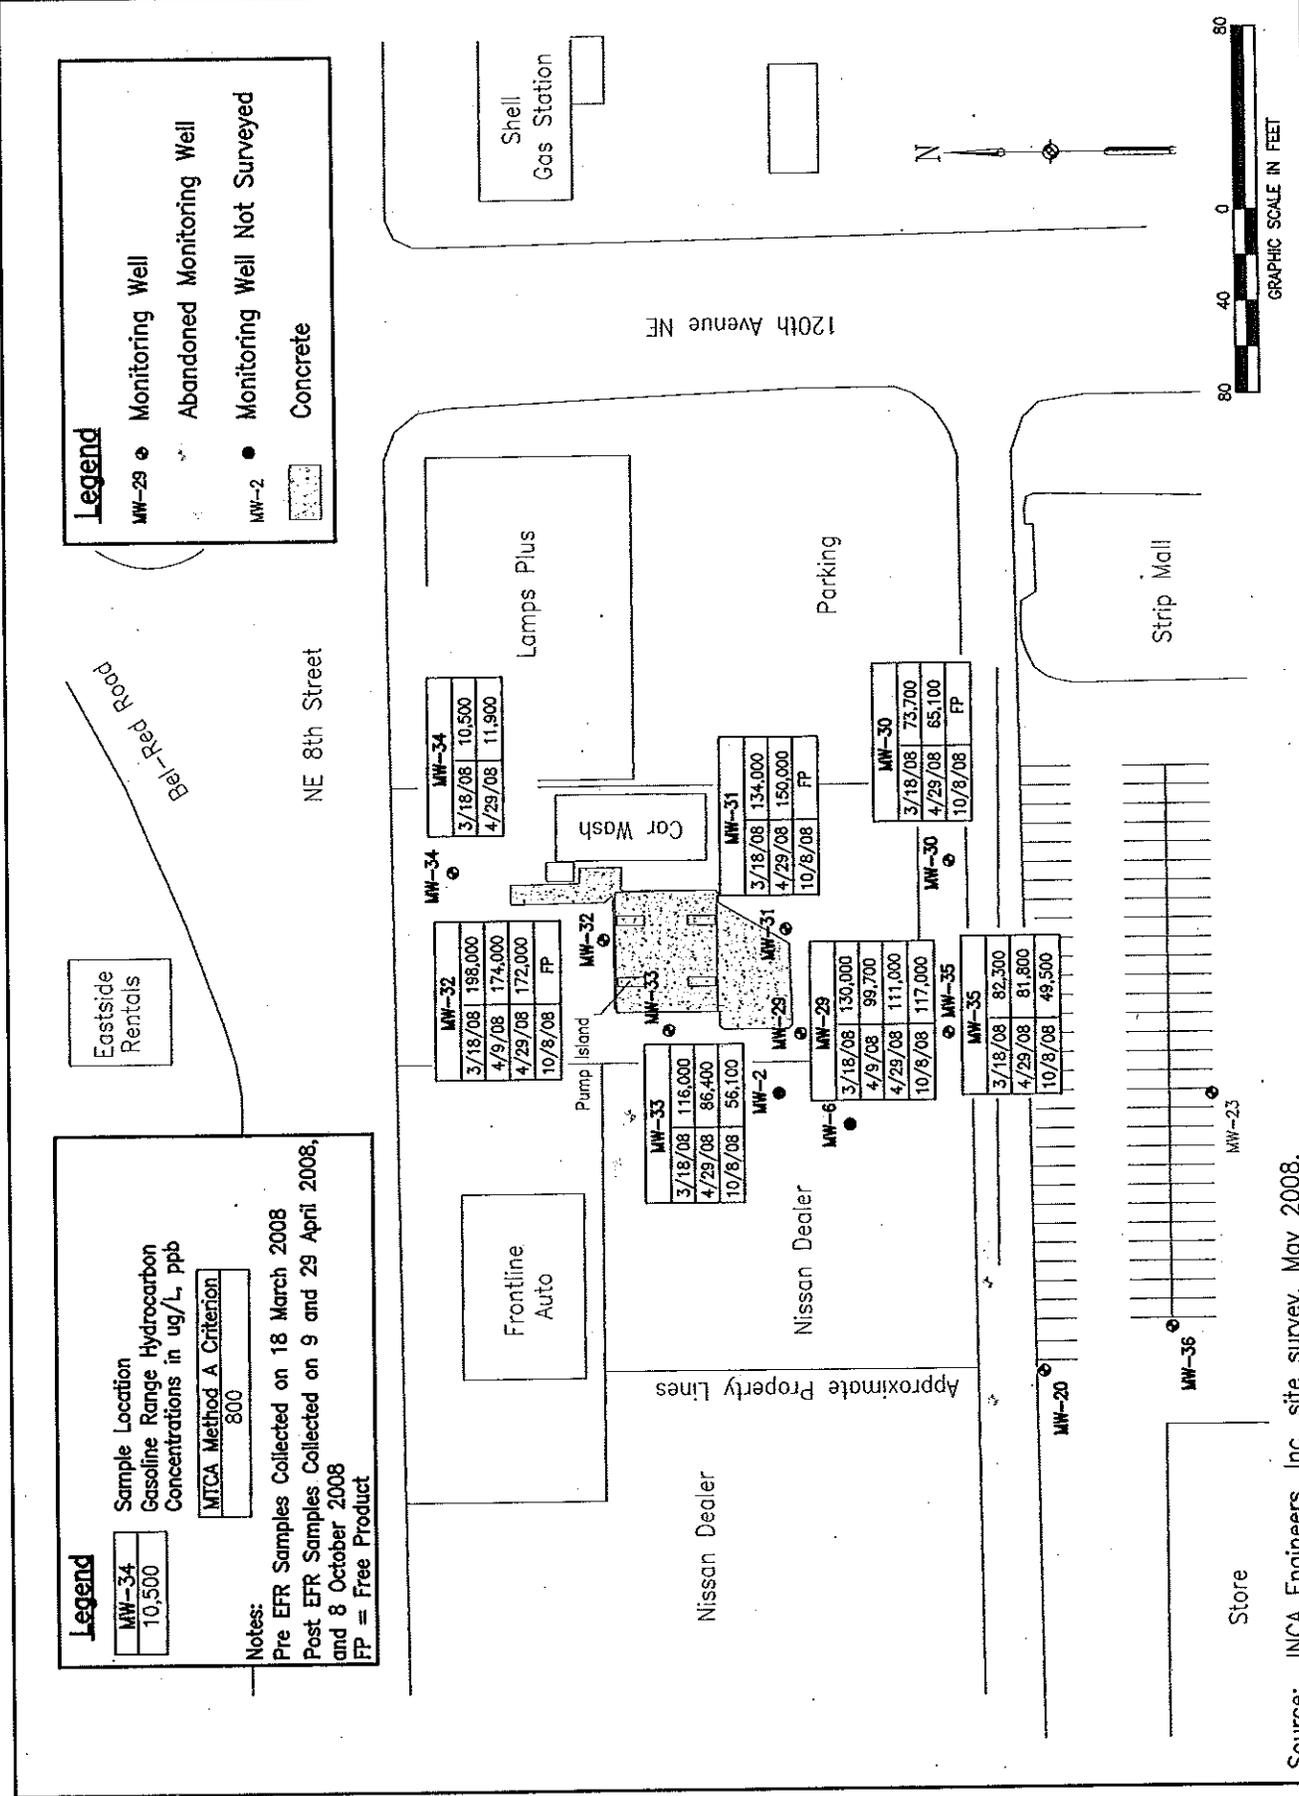
Source: INCA Engineers, Inc. site survey, May 2008.

On 8 October 2008, groundwater samples were collected from wells MW-29, MW-30, MW-33, and MW-35. Groundwater samples were not collected from MW-31 and MW-32 due to the presence of free product (0.29 and 0.04 ft, respectively). Field observations indicated the free product from monitoring well MW-32 appeared fresher than the fuel observed in monitoring well MW-31. Analytical results are summarized below and presented in Table 1 and Figure 5.
