**Re: No Further Action at the following Site:**

- **Site Name:** Winger Property/Golden Homes
- **Site Address:** 19647 Viking Way NW, Poulsbo, Washington
- **Facility/Site No.:** 5181107
- **VCP Project No.:** NW 3107

### **Description and Diagrams of the Site**

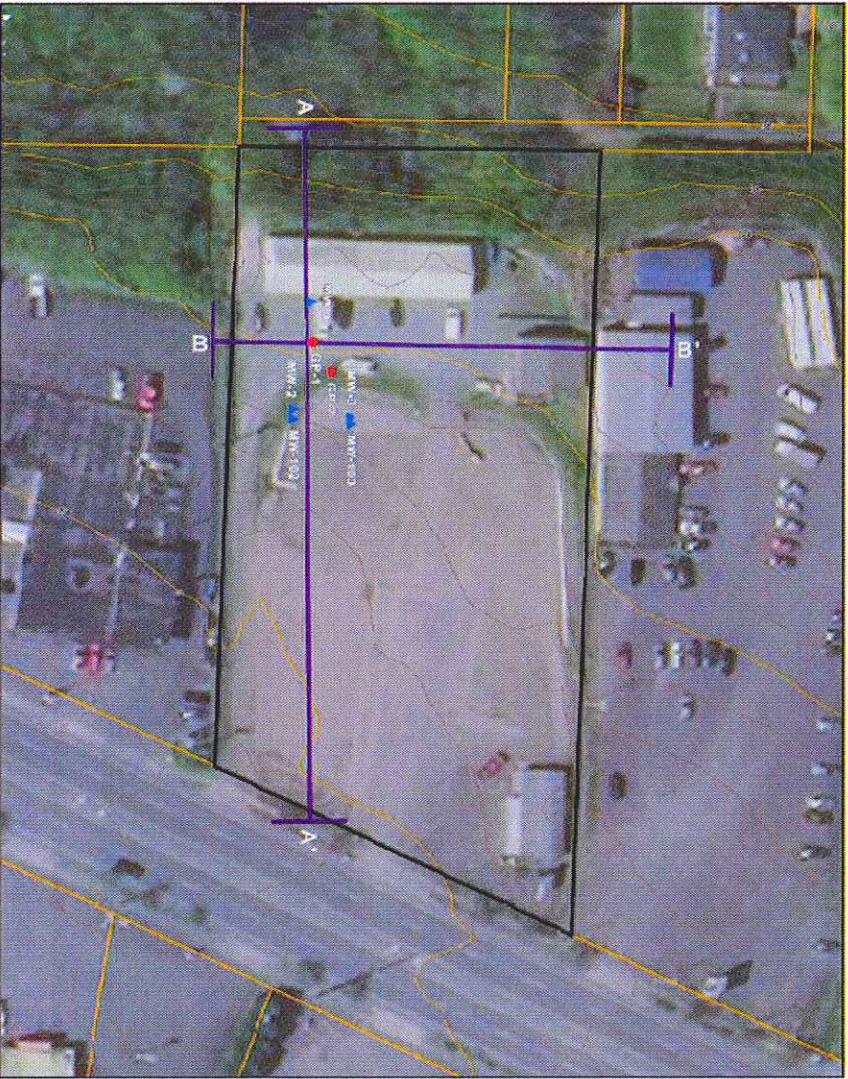
- SITE
- GEOPROBE BORGNO
- GROUND WATER MONITORING WELL
- CROSS SECTION
- PARCEL BOUNDARY
- CONTOUR 10 FT
- CONTOUR 2 FT

**SITE AND EXPLORATION PLAN**

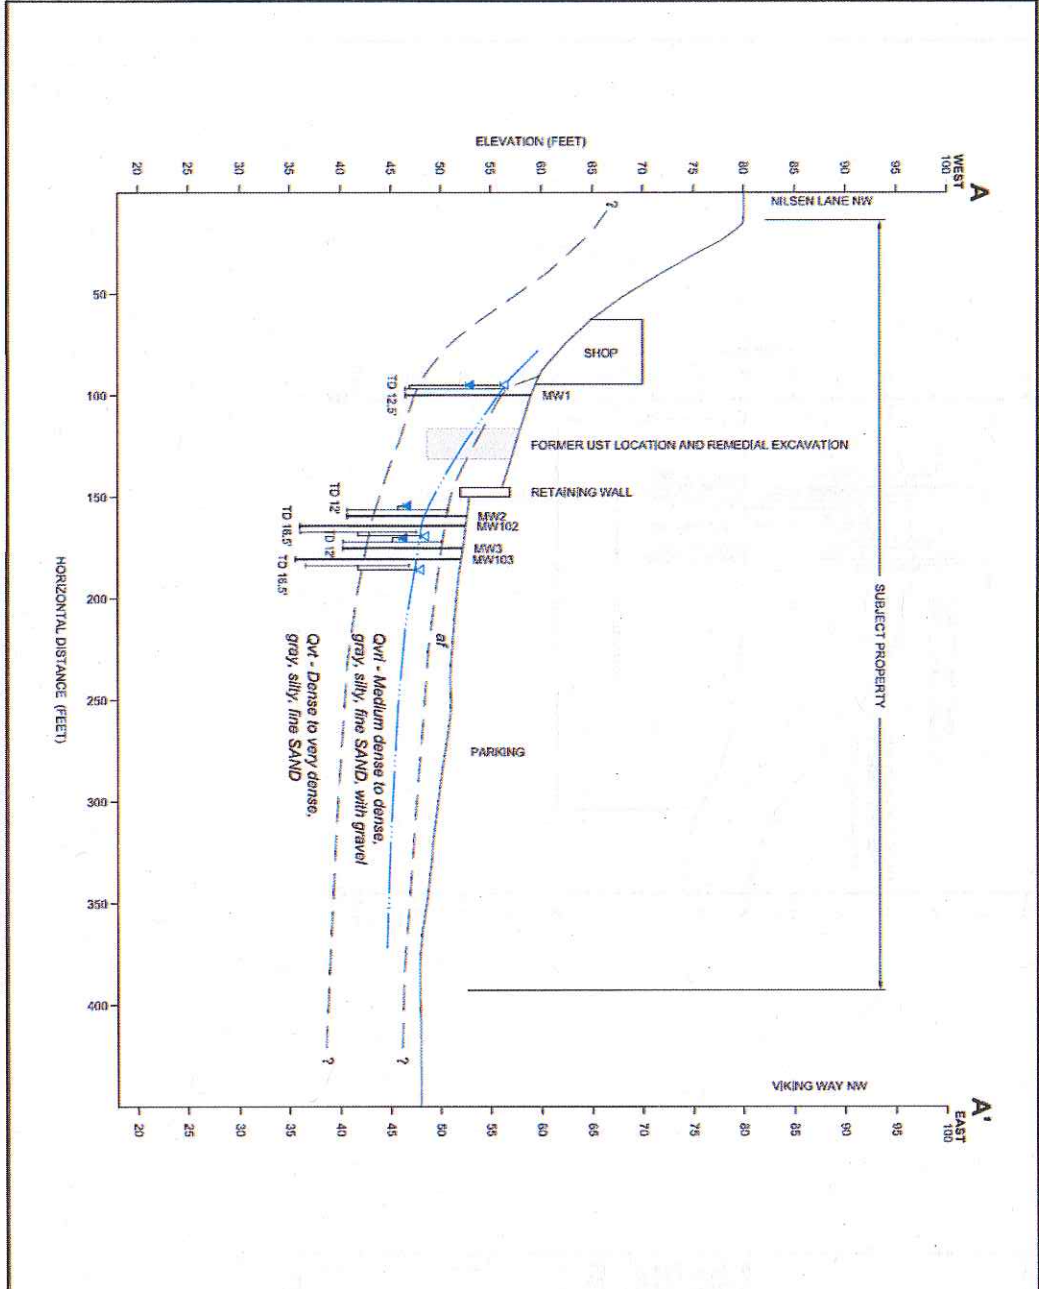
PROJ. NO. KV160499A DATE: 12/16 FIGURE: 3

1. THE DISBURSED CONTAMINANTS PRESENTED IN THIS GEOLOGIC CROSS-SECTION ARE BASED ON AN INTERPRETATION OF CONTAMINANT EXPOSURES BY THE WASHINGTON STATE DEPARTMENT OF ECOLOGY. FOR MORE INFORMATION ON THE DISBURSED CONTAMINANTS AND PRESENTED IN THIS GEOLOGIC CROSS-SECTION SHOULD NOT BE CONSIDERED AS A WARRANTY OF ACTUAL SUBSTANCE CONCENTRATIONS AT WATER CONTACTS OR WATER SUBSIDIARILY OVER BANK DISTANCES.

**CONCEPTUAL SITE MODEL**  
**GEOLOGIC CROSS-SECTION A-A'**  
 GOLDEN HOMES  
 POULSBO, WASHINGTON

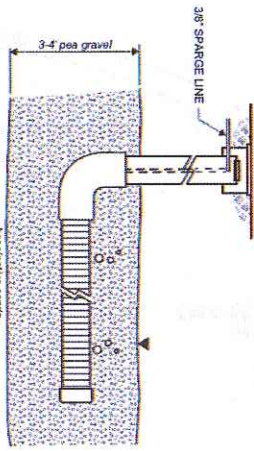
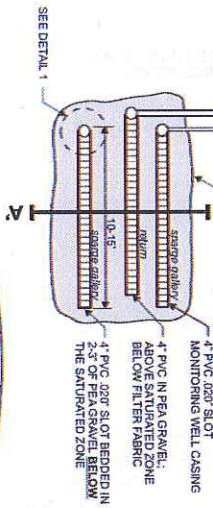
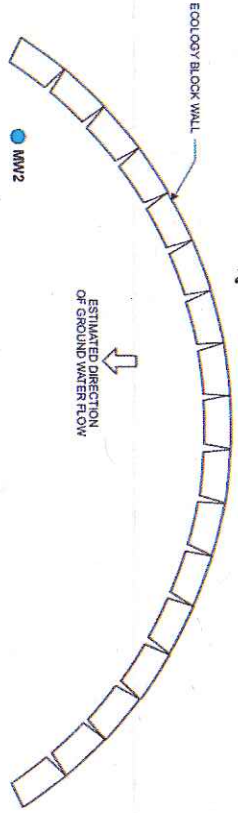
AIR SPARGING SYSTEM  
 GOLDEN HOMES  
 POLUISBO, WASHINGTON  
 PROJ. NO. KY160495A DATE 12/16 FIGURE 6

When no noticeable signs of petroleum contamination were found, the landfarmed soil was used for on-site fill. An air-sparging system was installed and operated for one year to reduce residual soil contamination.
