SEDIMENT REMEDIAL INVESTIGATION LAKE RIVER INDUSTRIAL SITE

DATA MEMORANDUM

SEDIMENT REMEDIAL INVESTIGATION

LAKE RIVER INDUSTRIAL SITE

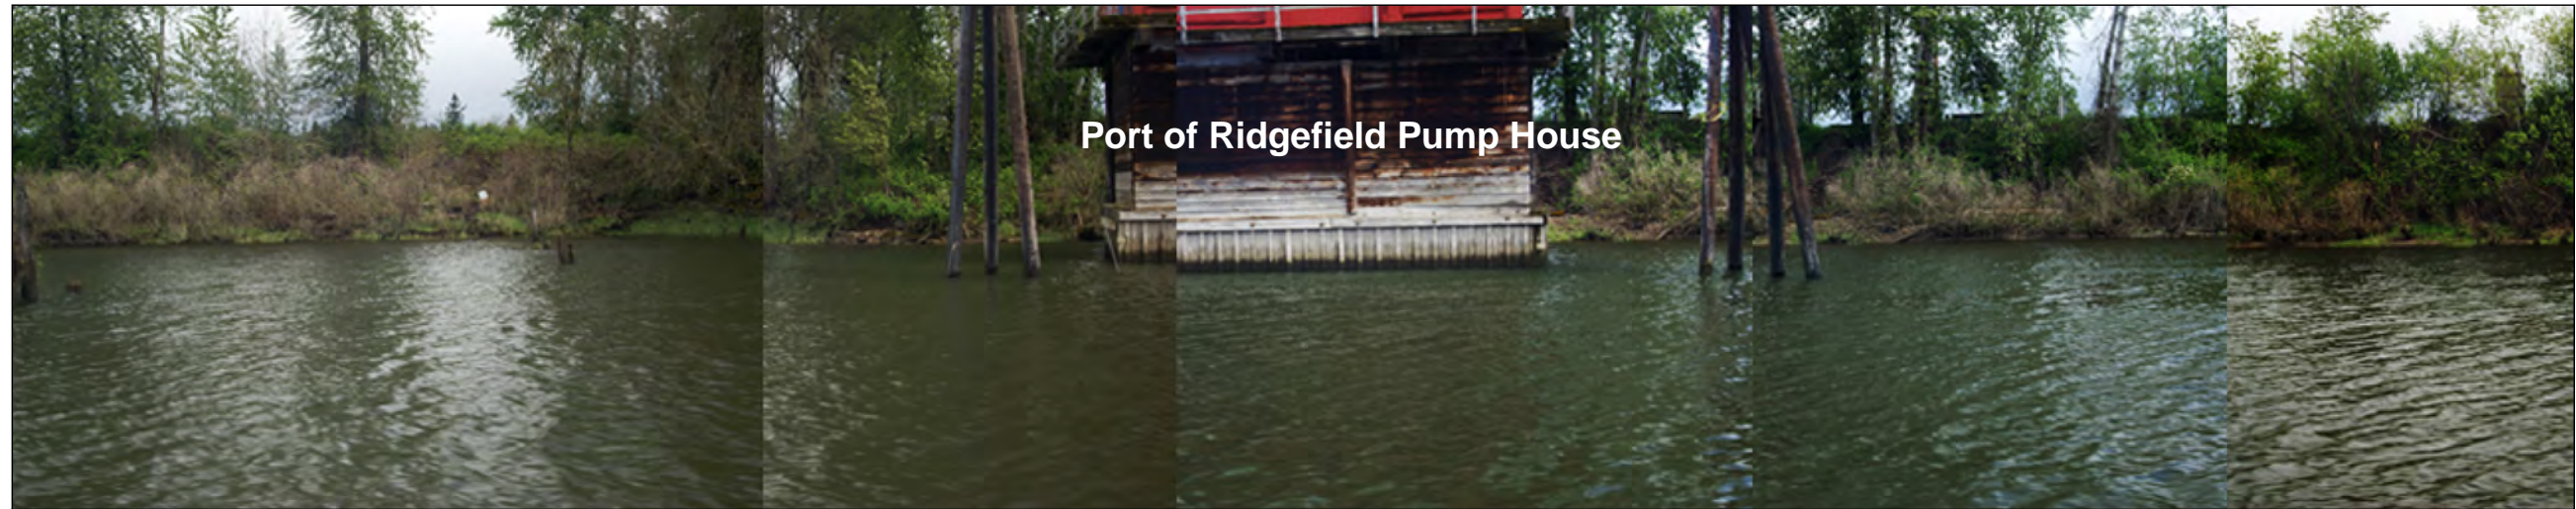
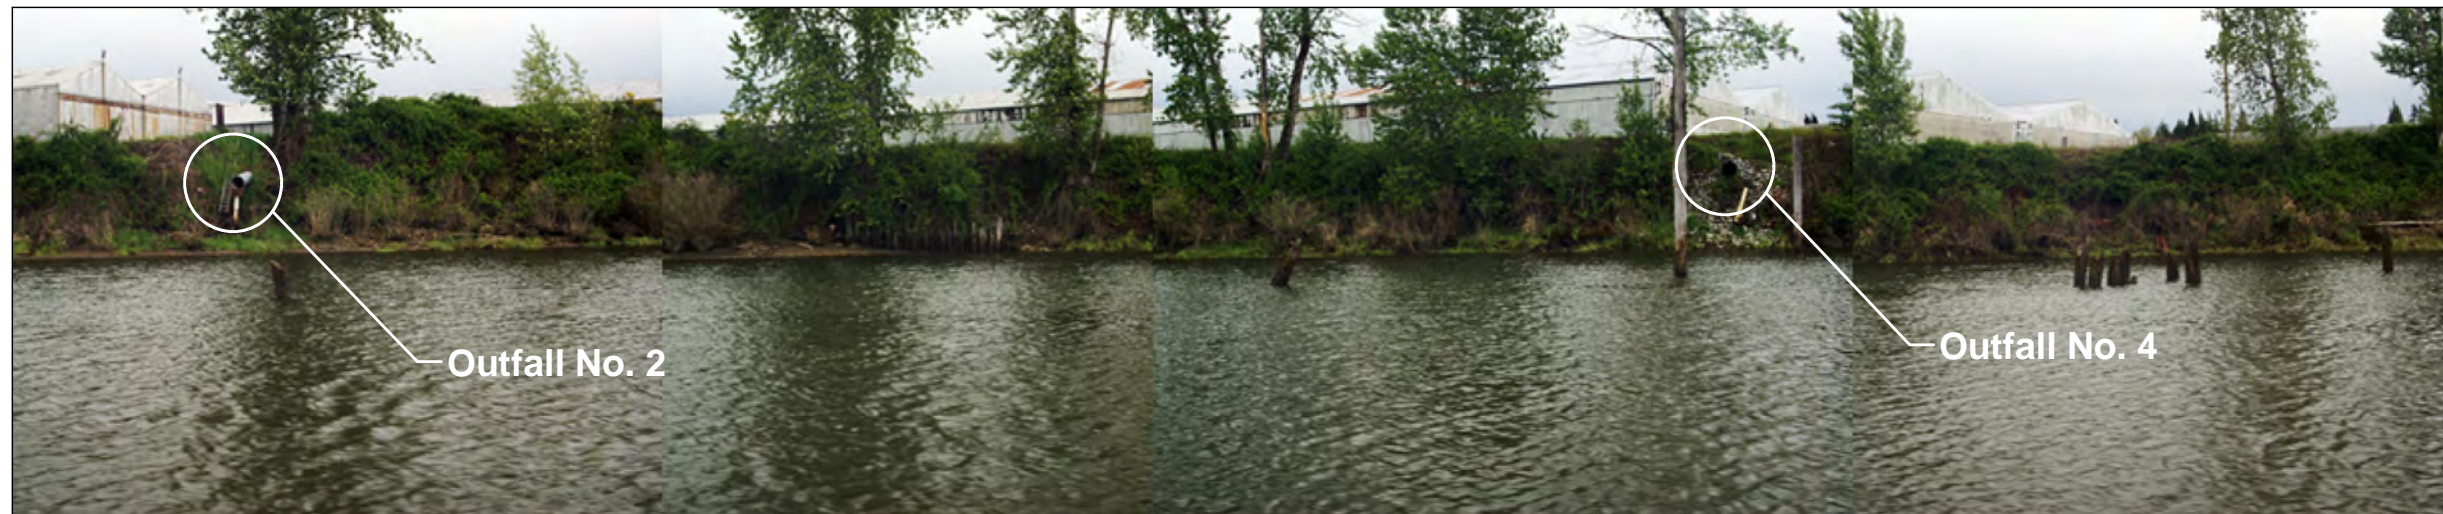
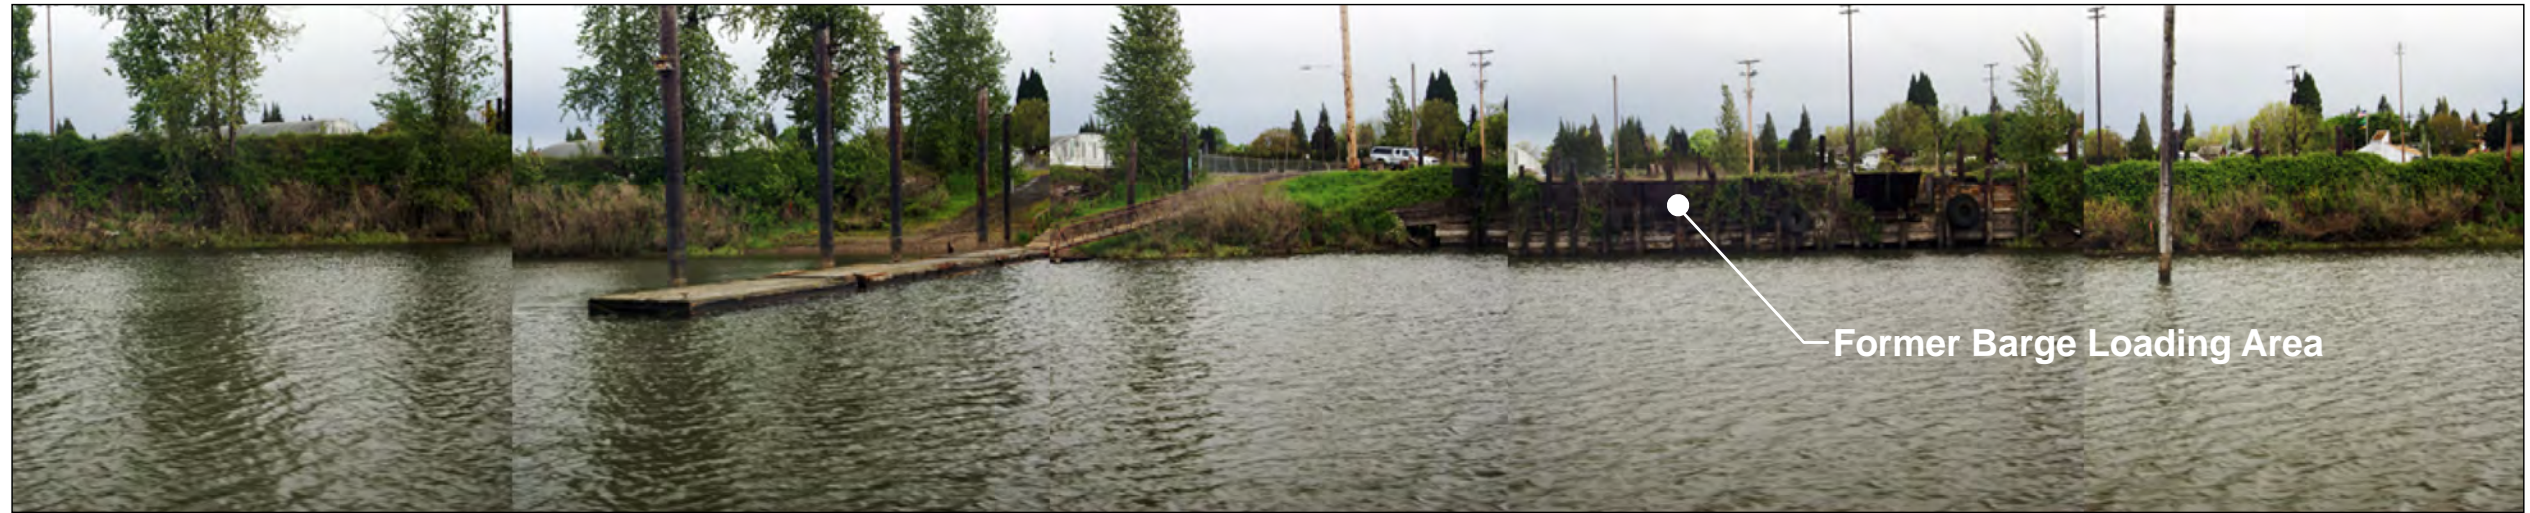
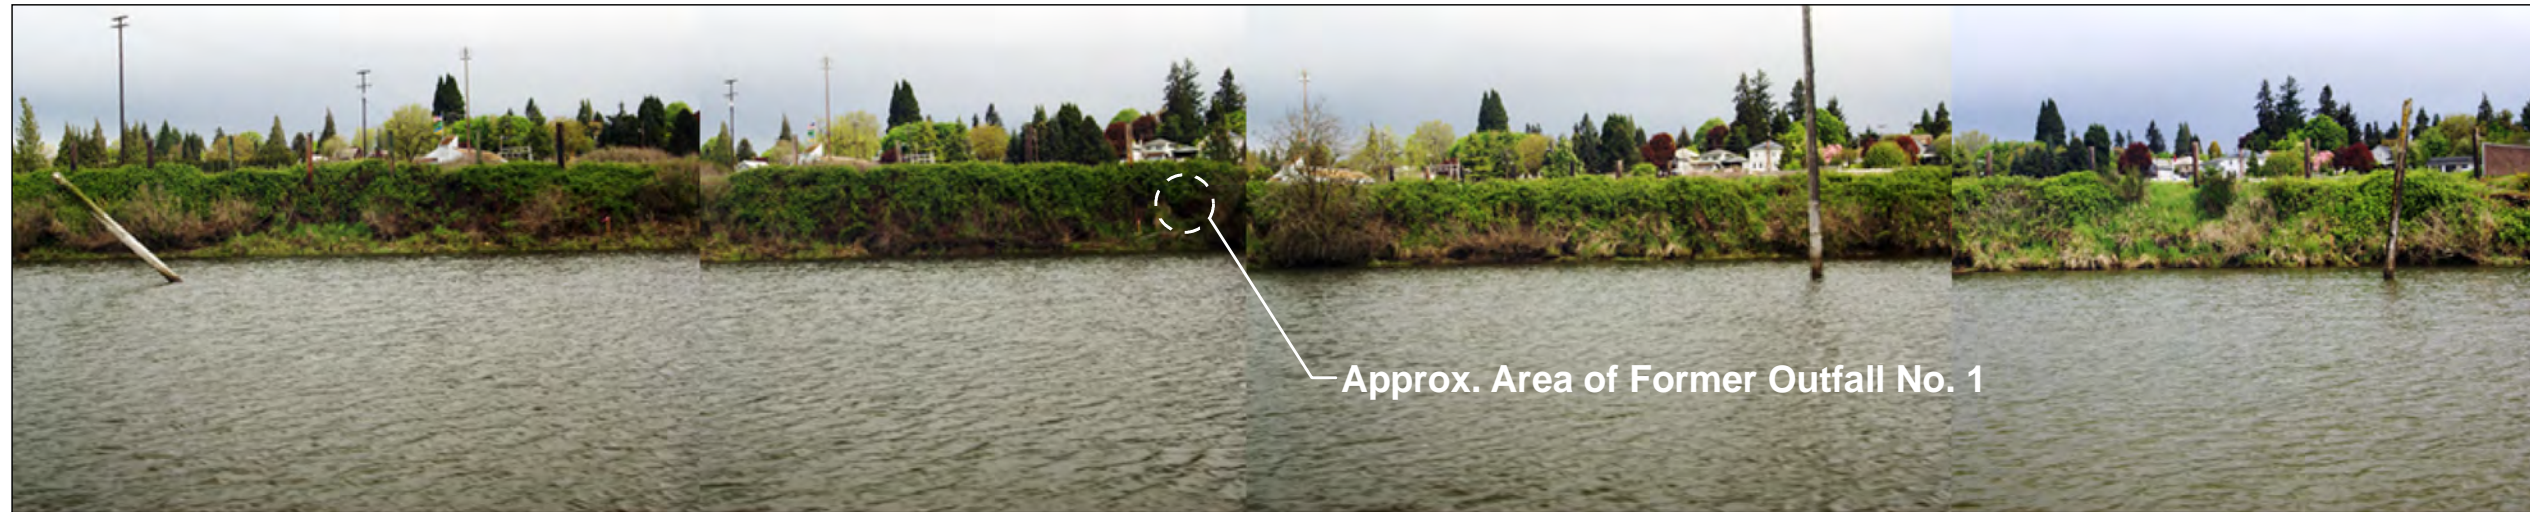
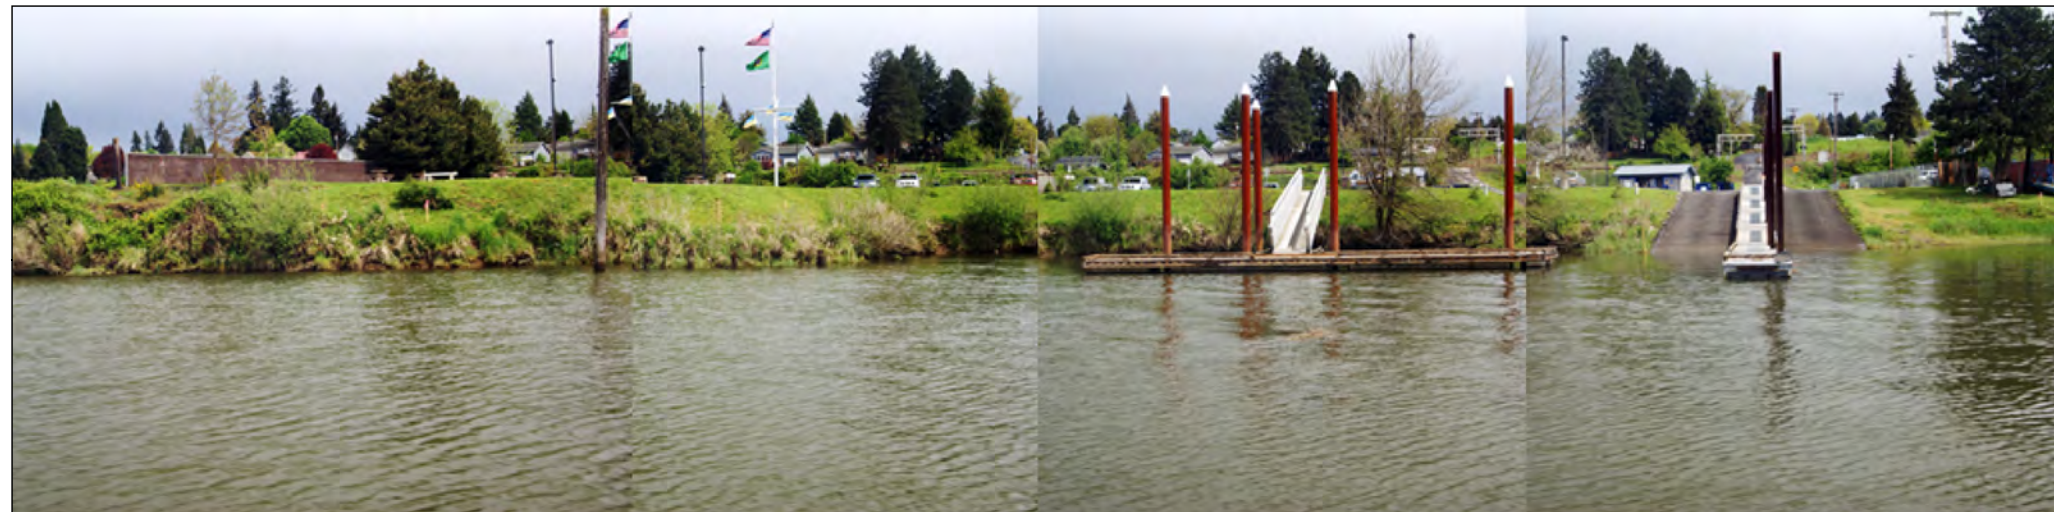
A reconnaissance survey was completed in conjunction with the information review to further develop the sediment sampling design. The reconnaissance survey included an inspection of shoreline conditions at a low water level to identify potential groundwater seeps, document shoreline conditions, and qualitatively evaluate sediment physical and biological characteristics. The reconnaissance survey also included documentation of existing utilities and shoreline and in-water structures. As part of the reconnaissance survey conducted at the time of sediment sampling, photographs were taken of the entire LRIS shoreline from an equal distance and compiled. The shoreline photograph compilation is presented in Figure 4 (1 of 2 and 2 of 2). The results of the reconnaissance surveys are included in the update to the CSM presented in Section 4.

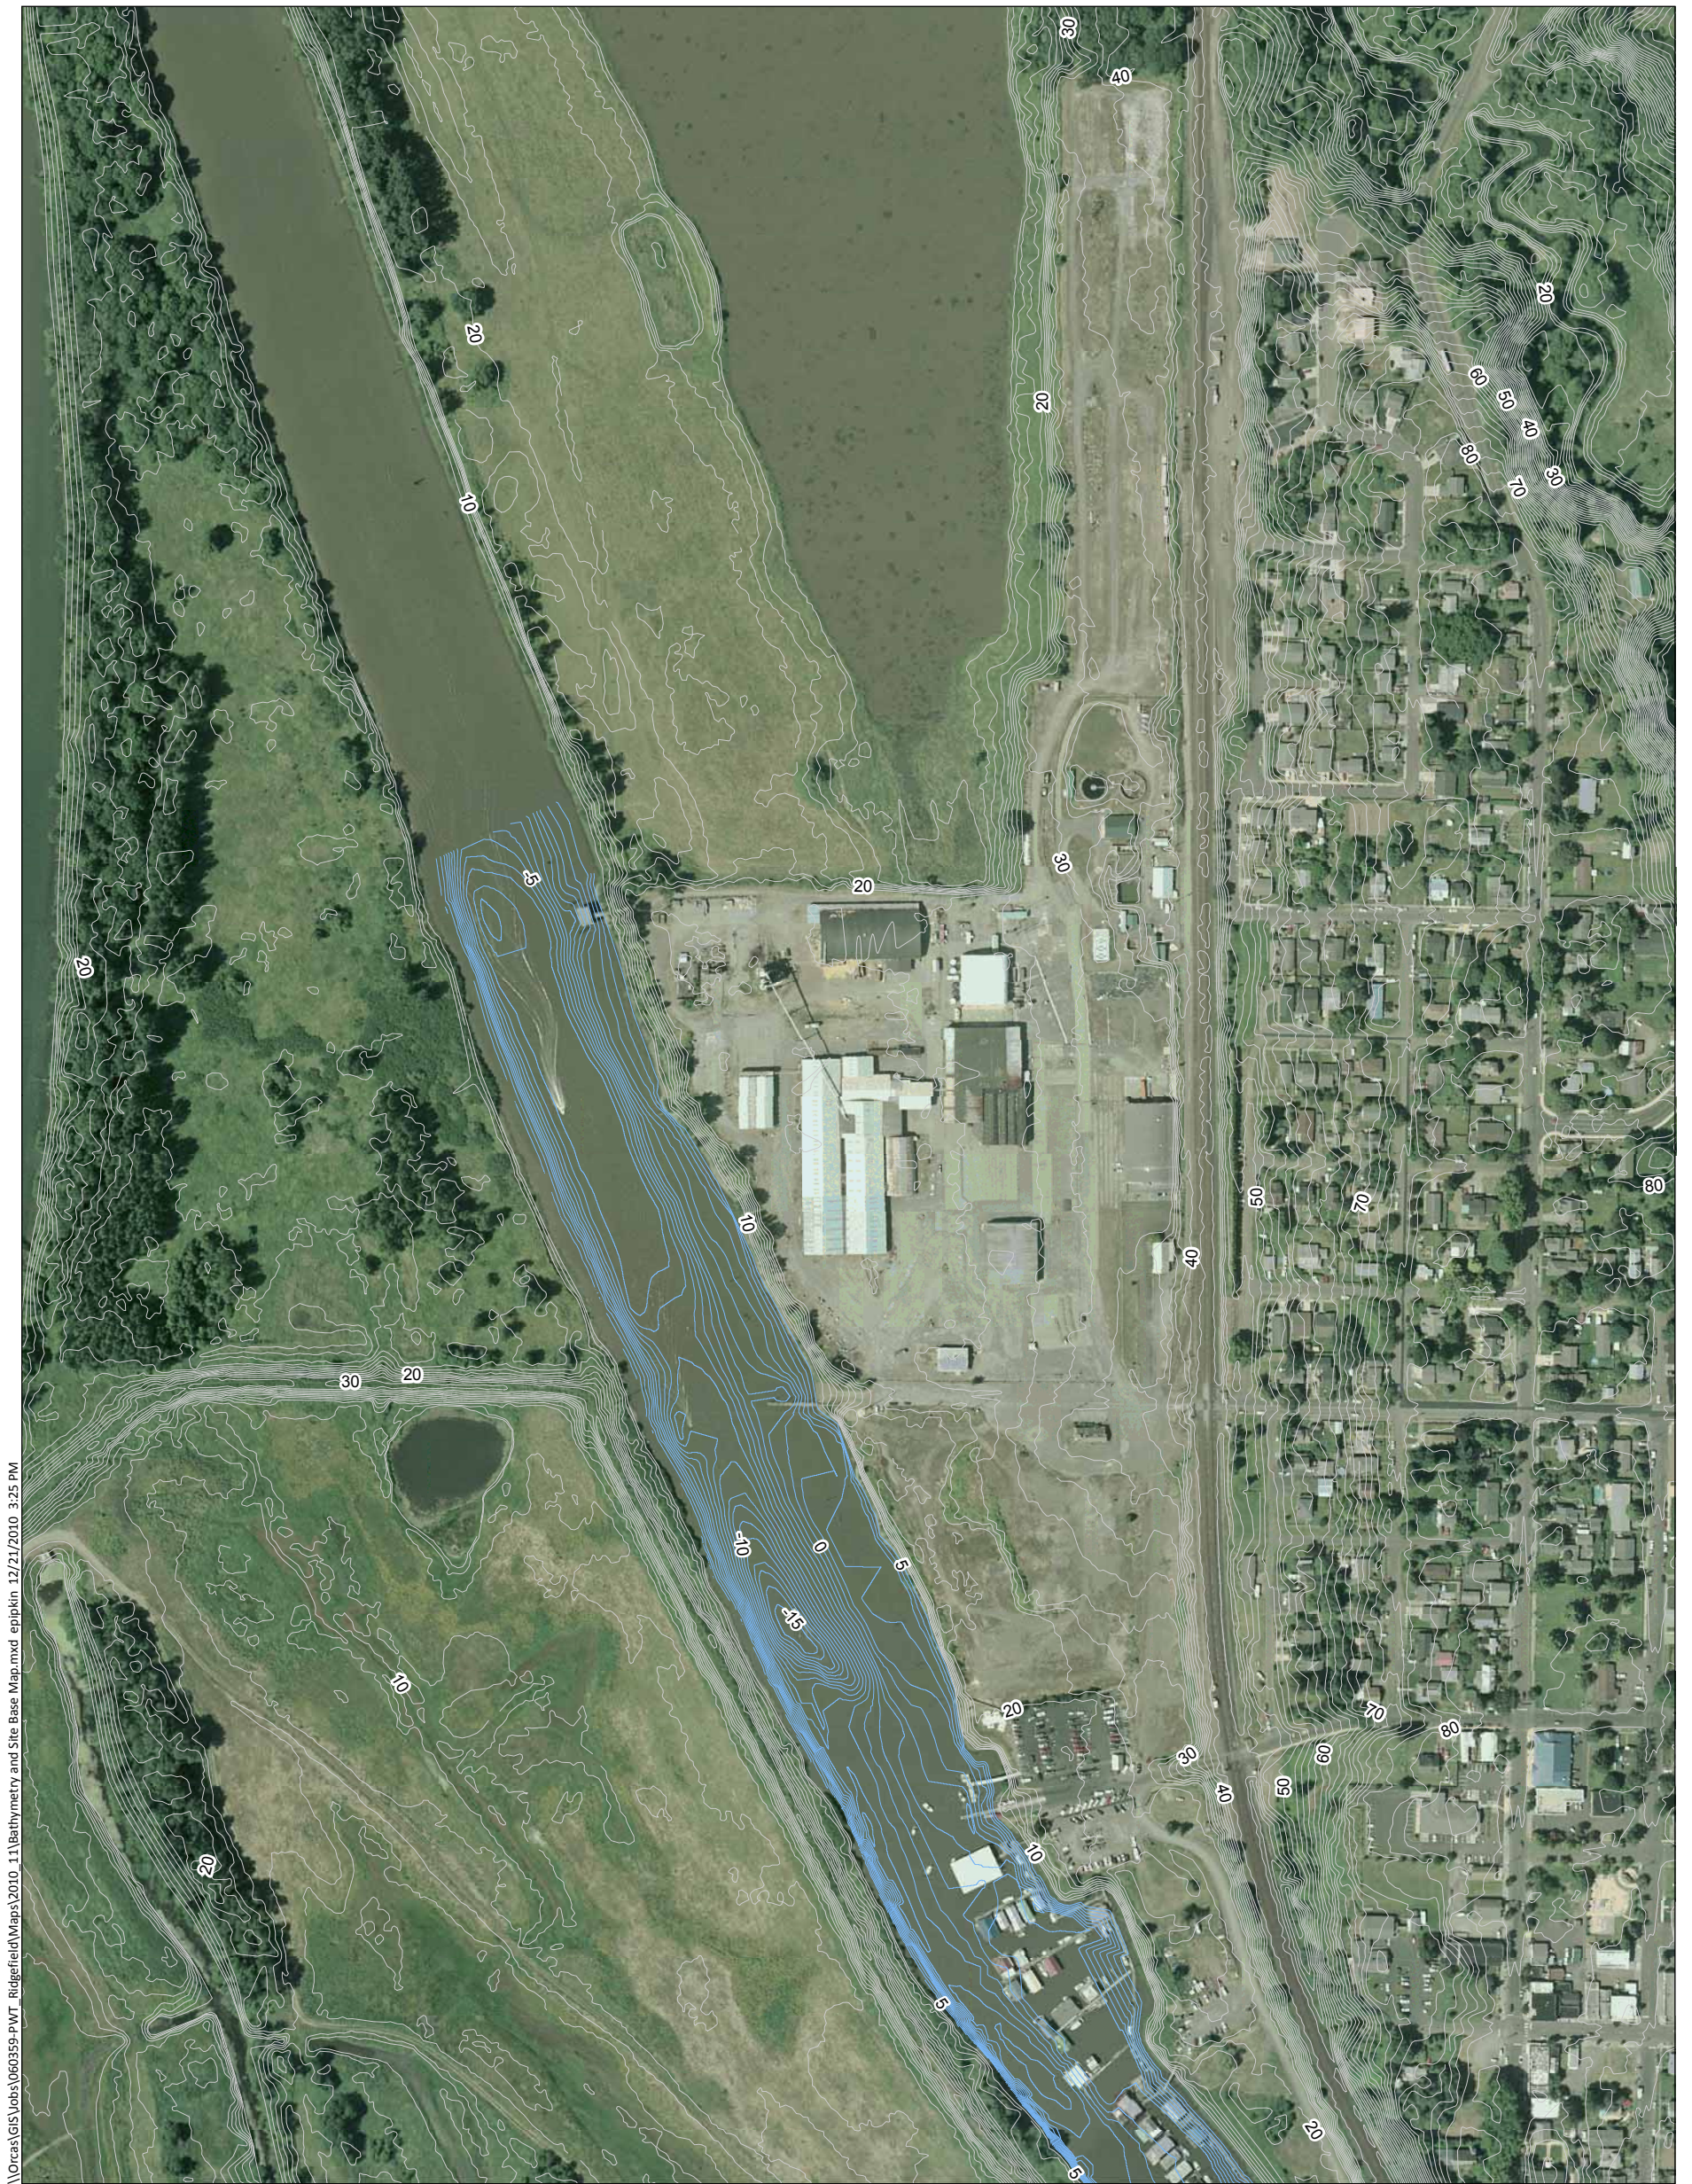
Figure 5
 Bathymetry and Site Base Map
 LRIS Ridgefield, WA
 Draft Sediment RI Data Memorandum

1. Horizontal Datum: WA State Plane South HARN NAD83 (feet)
2. Vertical Datum: NGVD29 (feet)
3. Topographic contours do not reflect work conducted as part of interim action performed during summer and fall of 2010 in Cells 3 and 4.

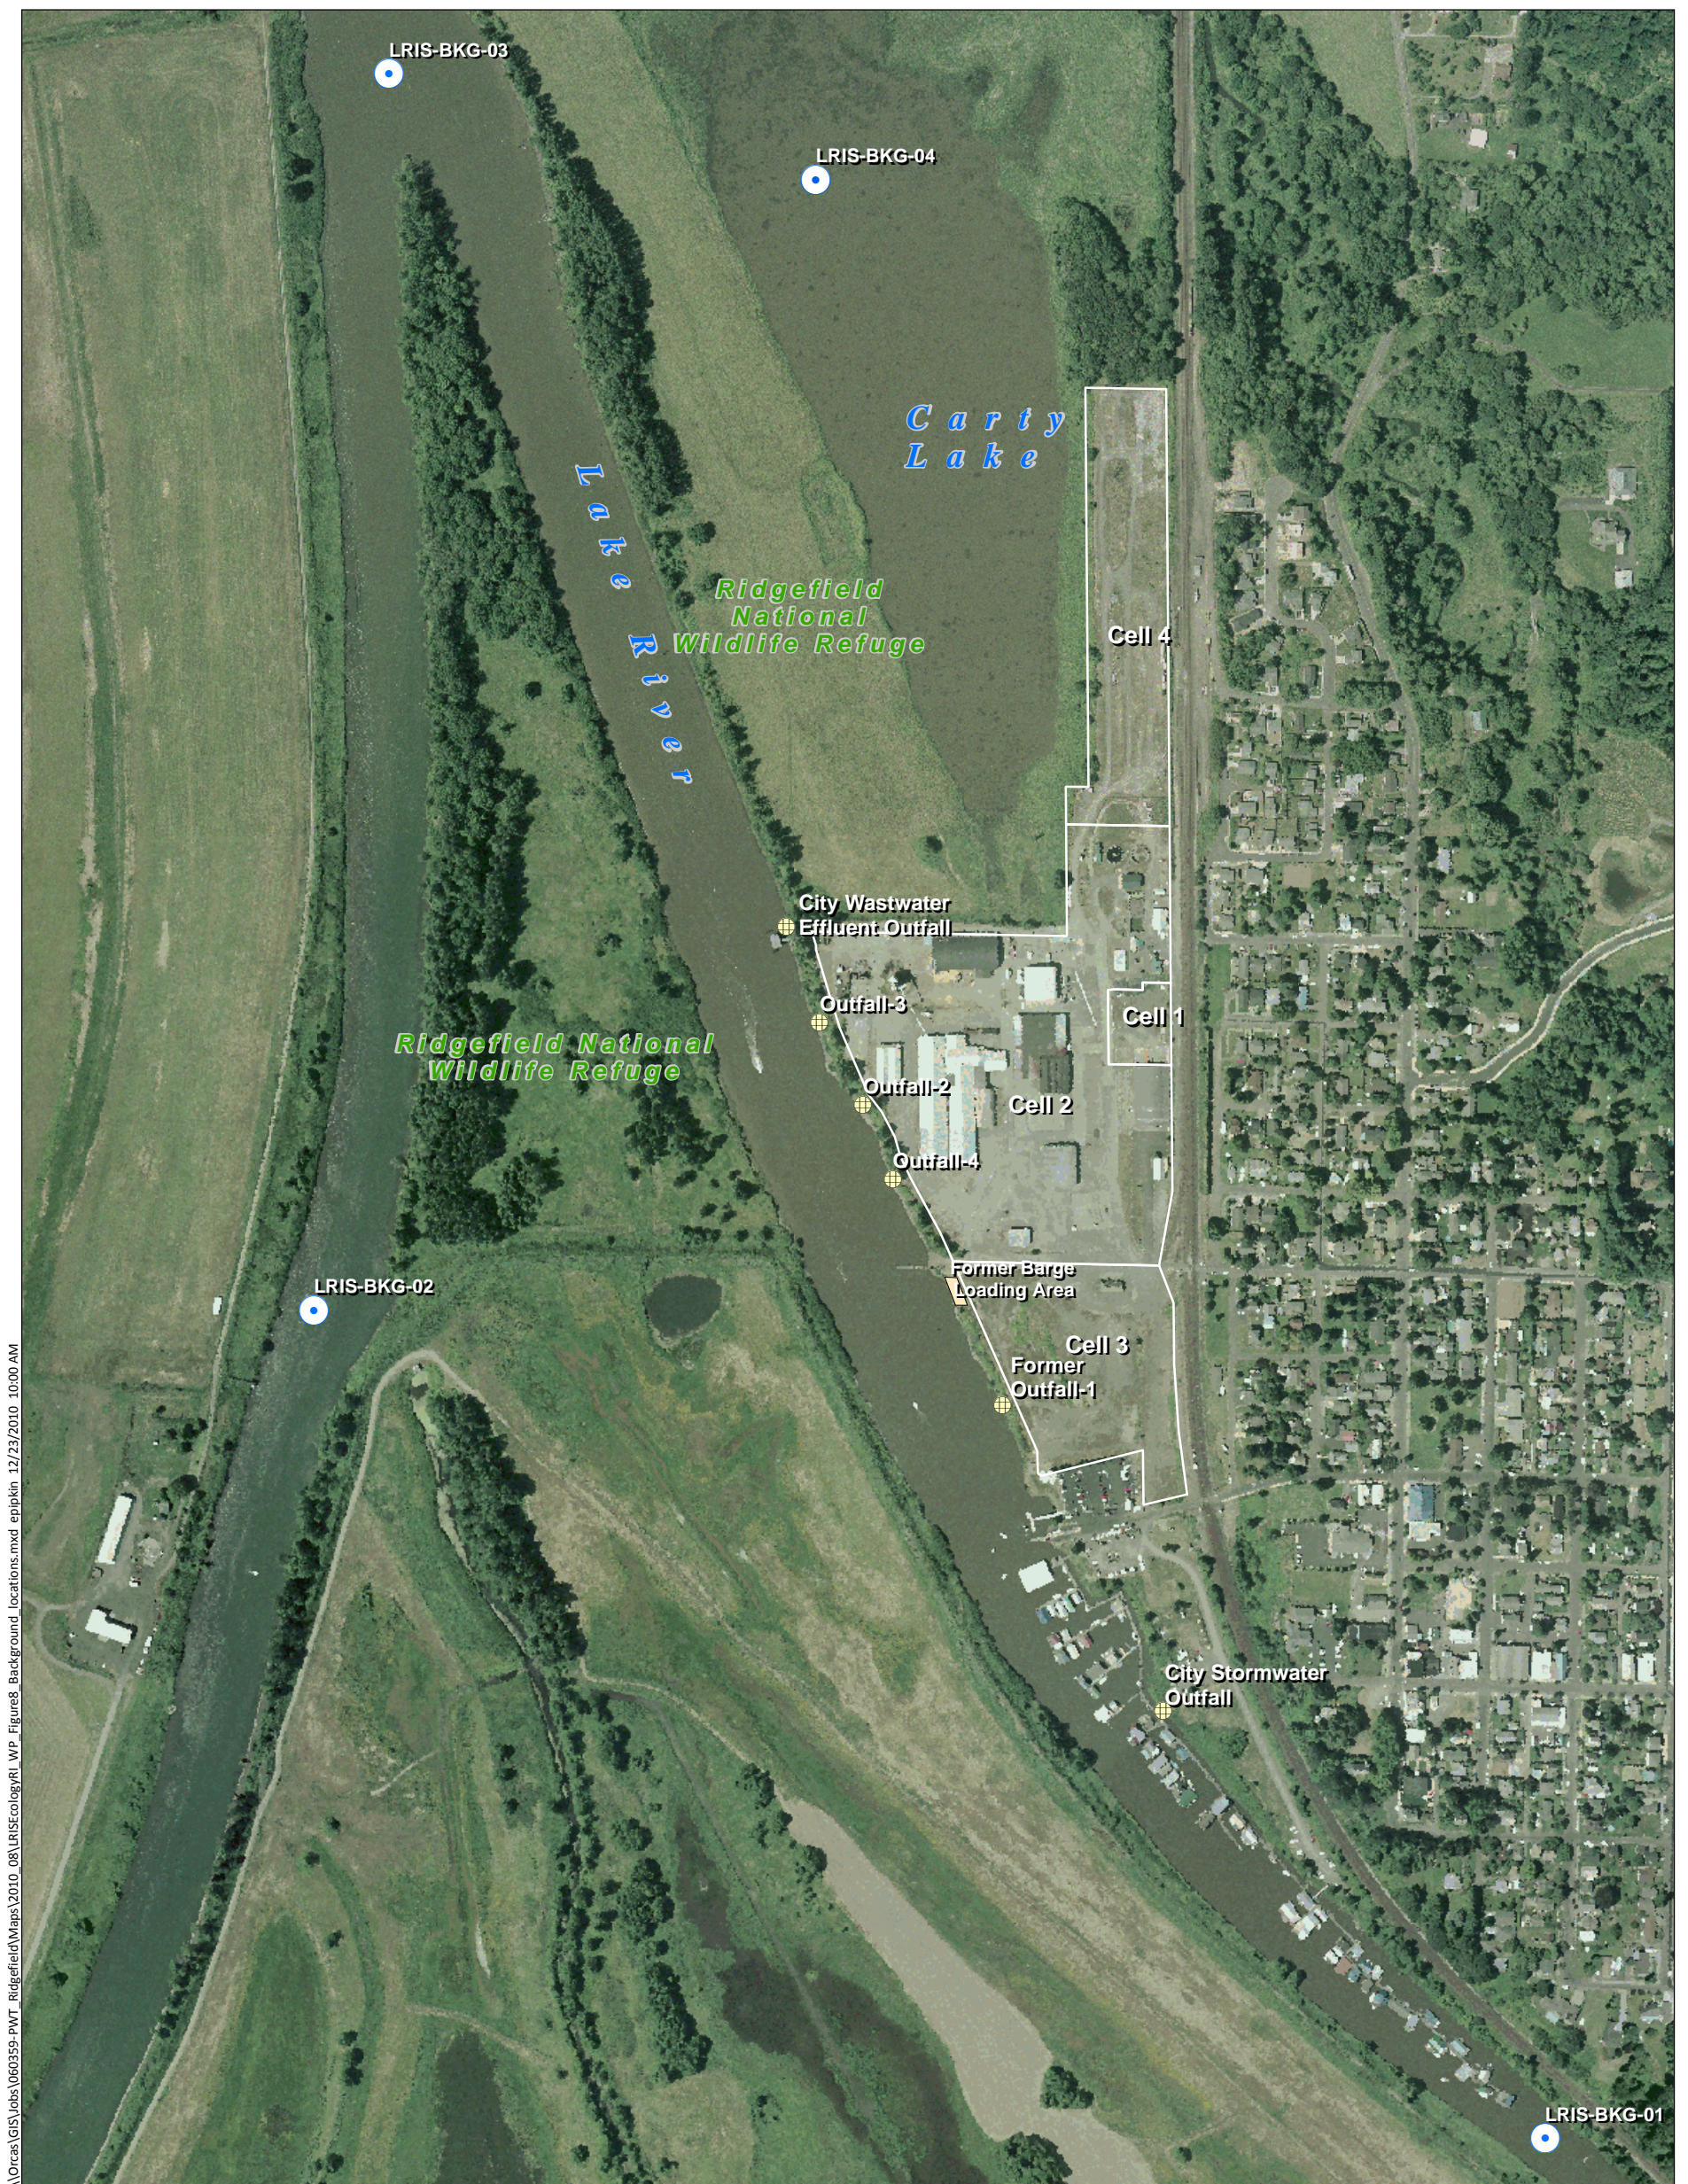
Figure 8
 Background Surface Sediment Sampling Locations
 LRIS Ridgefield, WA
 Draft Sediment RI Data Memorandum

Background surface sediment samples were collected from four locations: at the north end of Carty Lake, south of the LRIS in Lake River, north of the LRIS, and in Bachelor Slough. Figure 8 presents the locations of the background surface sediment stations.

The background sample collected at the north end of Carty Lake (see Figure 8) did not detect IHSs above screening criteria, but did detect dioxins/furans at a TEQ concentration of 18.1 ng/kg. As discussed earlier, this concentration was elevated relative to the background samples collected from Lake River and Bachelor Slough.
