**PHASE I ENVIRONMENTAL
SITE ASSESSMENT
REPORT**

**COMMERCIAL PROPERTY
7802 SOUTH TACOMA WAY
TACOMA, WASHINGTON
TAX PARCEL #0220254028, #0220254010, &
#0220254140**

Stemen Environmental, Inc.

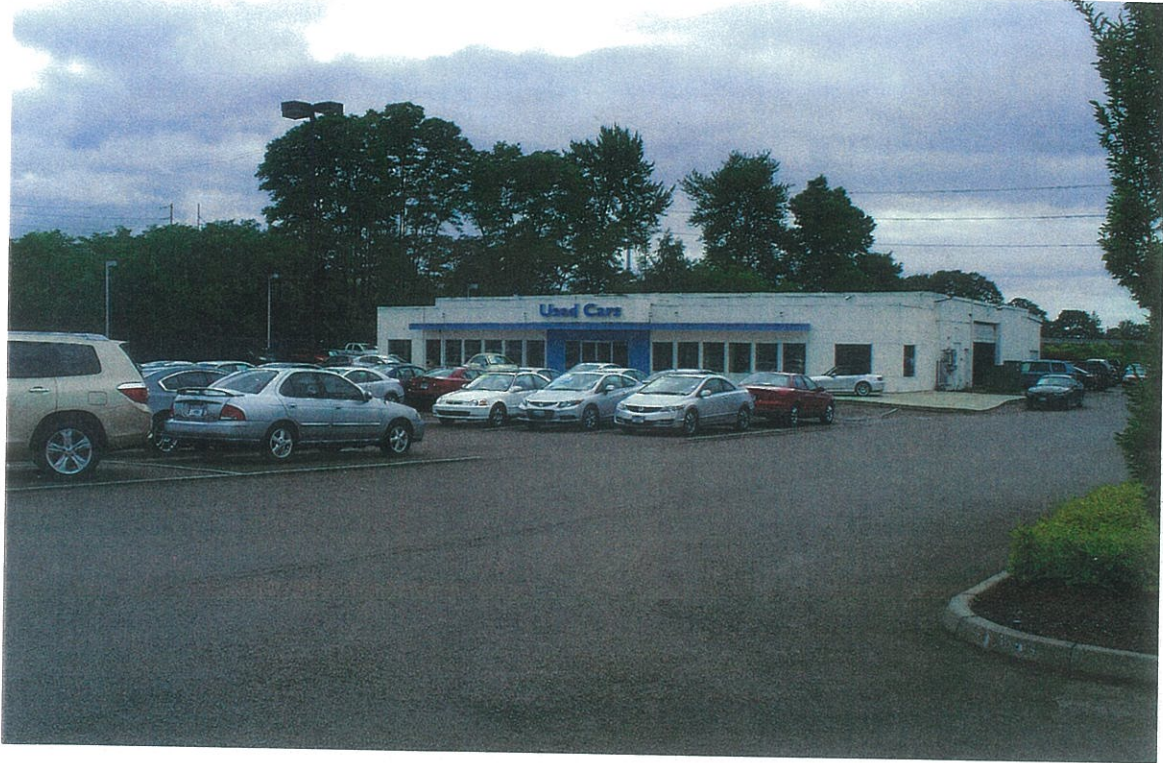
ON-SITE COMMERCIAL BUILDING

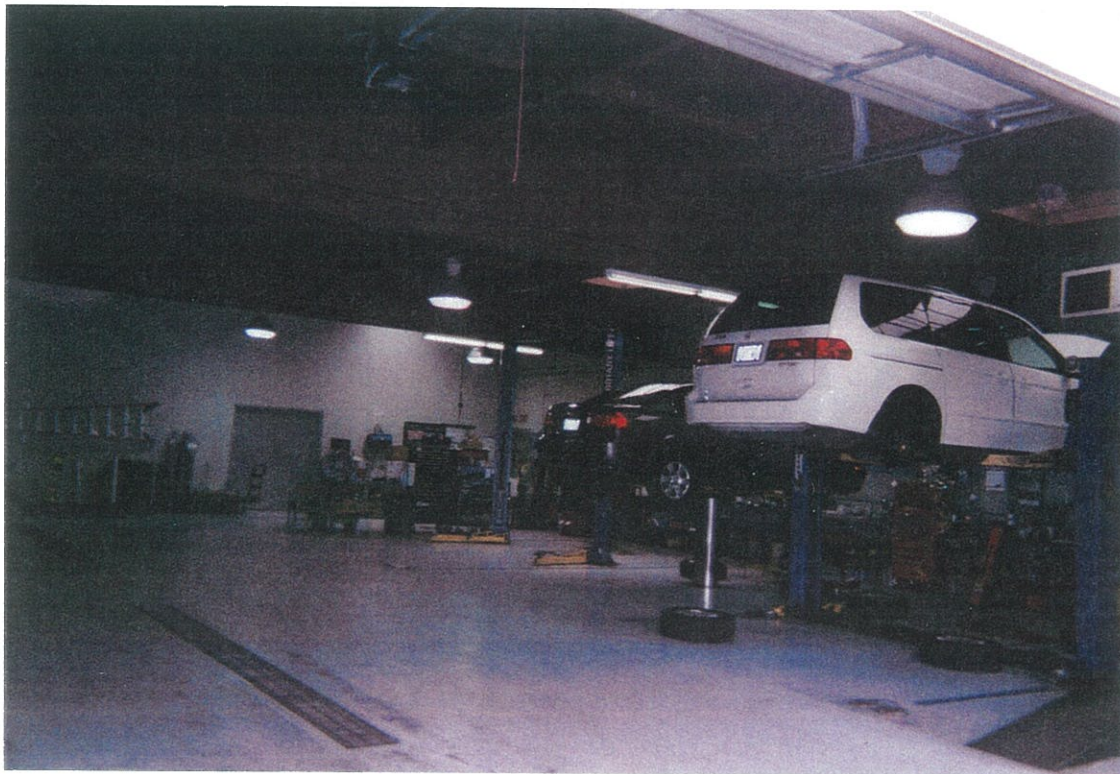
I also observed trough type floor drains in the central portions of the service garage. The drains and the shop area appeared to be well maintained.

MAINTENANCE/SERVICE GARAGE AREA

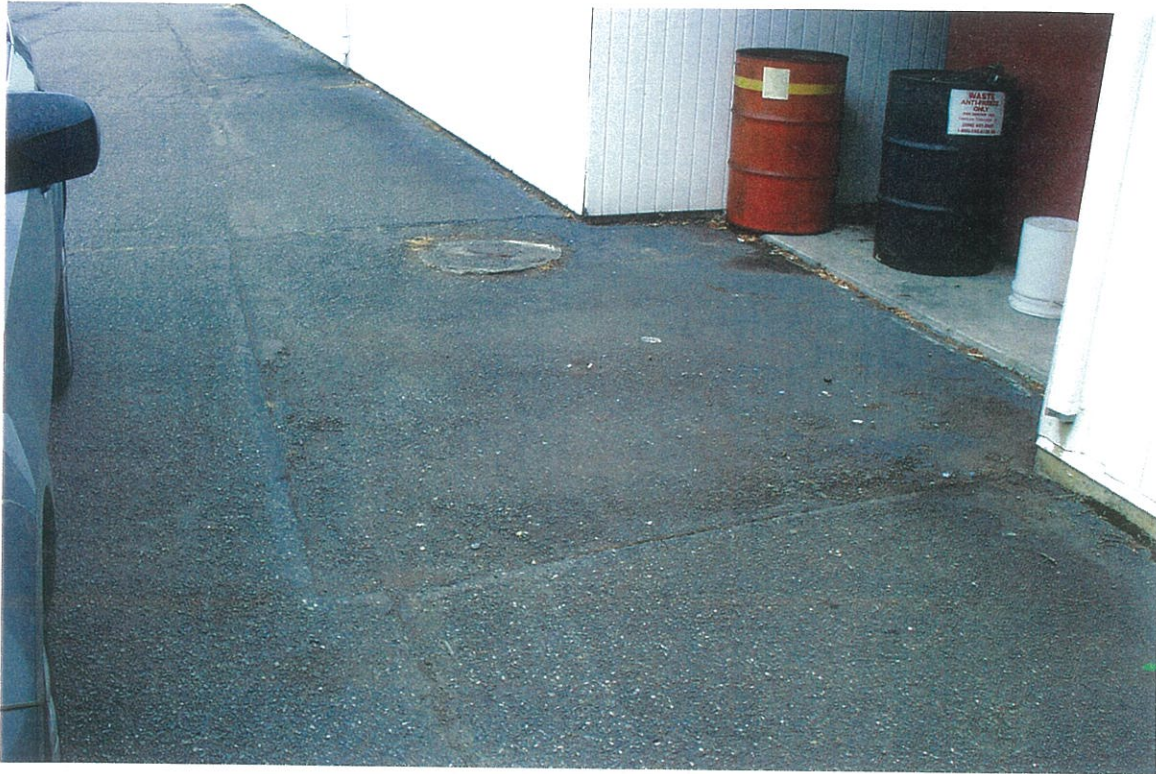
The environmental integrity of the subsurface soil left in-place in the floor and sidewalls of the underground storage tank excavation pit at the completion of the 1989 tank removal project is not known and therefore represents a recognized environmental condition that could potentially have an adverse impact on the environmental integrity of the subject property.

1989 WASTE OIL TANK EXCAVATION AREA AND WATER SAMPLING WELL

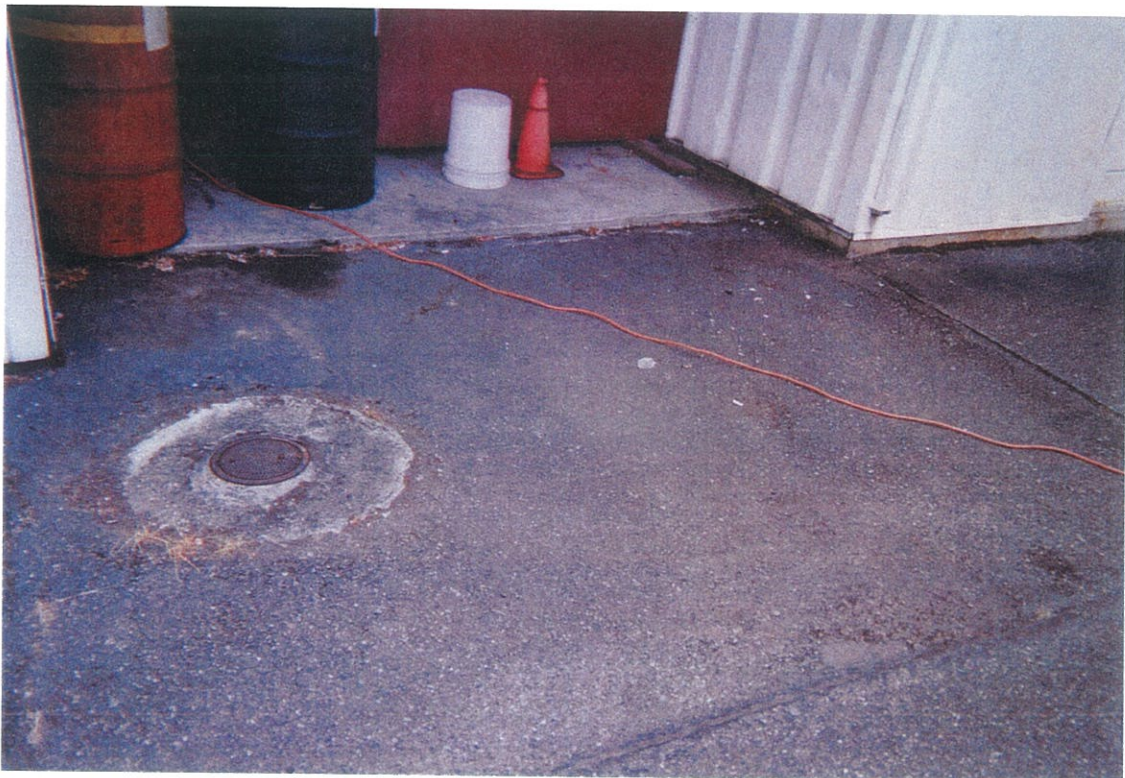
An aboveground used oil storage tank located outside and along the western exterior wall of the service garage building in a covered area. I observed no significant staining on the surfaces around the aboveground oil storage tanks. The oil storage area did not have any secondary containment protection.

1989 WASTE OIL TANK EXCAVATION AREA AND CURRENT WASTE OIL ABOVEGROUND STORAGE TANK

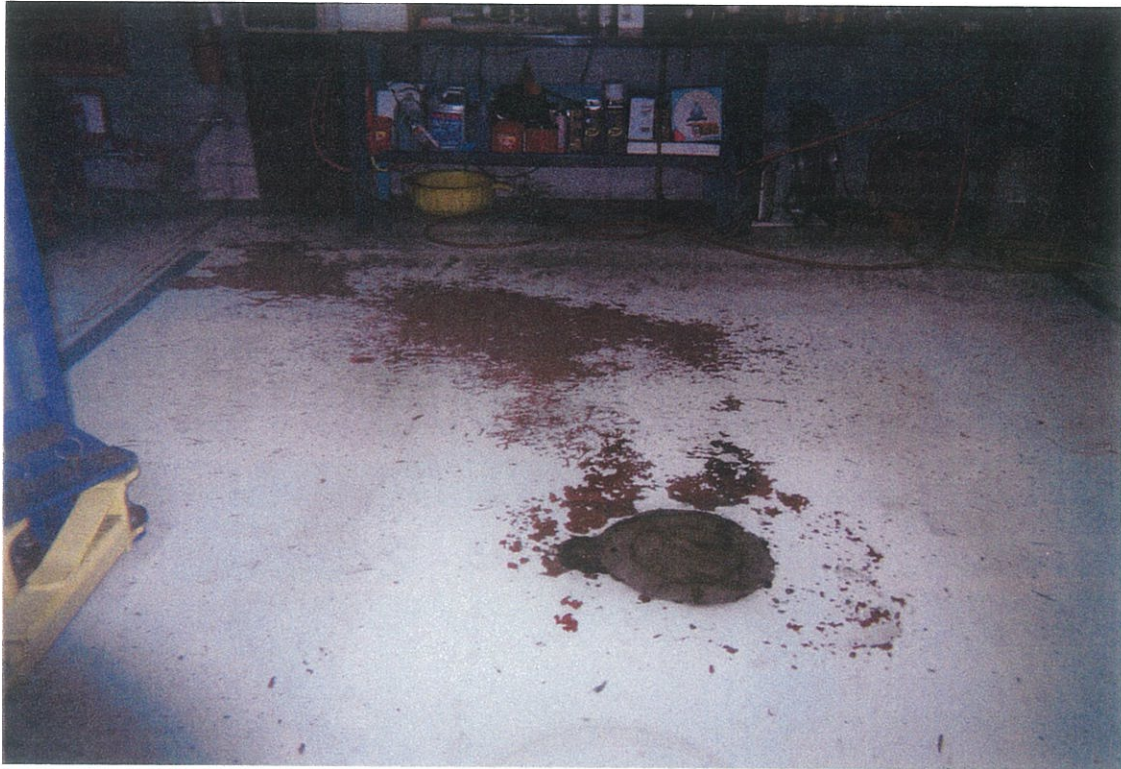
The current environmental integrity of the subsurface soils directly adjacent to, surrounding, and/or beneath these single post underground hydraulic lift systems is not known and therefore represents a recognized environmental condition that could potentially have an adverse impact on the environmental integrity of the subject property.

I observed the areas where four (4) single post underground hydraulic lift systems were previously abandoned in-place The environmental integrity of the subsurface soils and/or water surrounding these abandoned lift systems is not known.

ABANDONED SINGLE POST UNDERGROUND HYDRAULIC LIFT IN
MAINTENANCE/SERVICE AREA

I recommend the sampling of the subsurface soils and/or waters in areas directly surrounding the abandoned in-place single post underground hydraulic lift locations, the in-use single post underground hydraulic lift location, the former burial location of the previously removed underground used oil storage tank, the former burial location of the previously removed underground gasoline storage tanks, the perimeter of the burial pit containing the in-service underground gasoline storage tank and the out of service underground used oil storage tank, the currently in-use fuel dispensing island and along the northern perimeter of the subject property.

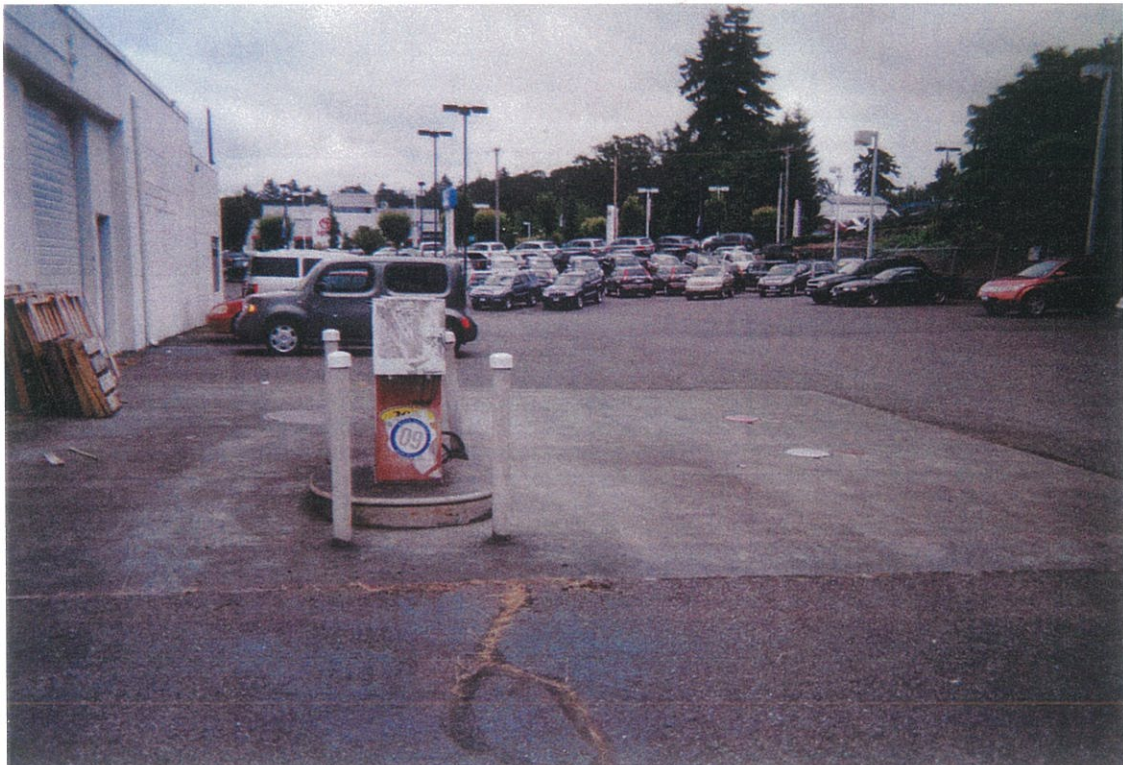
The current environmental integrity of the subsurface soils and/or groundwater immediately surrounding and/or beneath these tanks is not known and therefore represents a recognized environmental condition that could potentially have an adverse impact on the environmental integrity of the subject property.

I observed the location of the out of service underground used oil storage tank, the currently active underground gasoline storage tank and the associated gasoline dispenser.

4,000 GALLON GASOLINE UST, 500 GALLON WASTE OIL UST, AND FUEL
DISPENSING ISLAND

I recommend the immediate removal of the out of service 500 gallon waste oil underground storage tank that is not in compliance with applicable regulations. Due to the fact that the 4,000 gallon gasoline underground tank is buried in a common excavation pit with the out of service underground waste oil storage tank, the excavation activities associated with the out of service waste oil storage tank could potentially have an adverse impact on the physical integrity and/or stability of the underground gasoline storage tank system, I feel that it would be appropriate to the remove both of the tanks and the associated fuel dispensing island at the same time.
