Memorandum

To: Mr. Ron Timm, Washington State Department of Ecology
CC: Carol Wiseman, Weyerhaeuser, and Sandy Forman, Pacific Topsoil
From: Lynn Grochala, Floyd|Snider
Date: November 8, 2018
Project No: Weyer-Mill E, Task 1
Re: **Former Mill E/Koppers Site 2018 Annual Performance and Compliance Monitoring Report**

**2018 Annual Performance and Compliance Monitoring Report
Former Mill E/Koppers Facility
Everett, Washington**

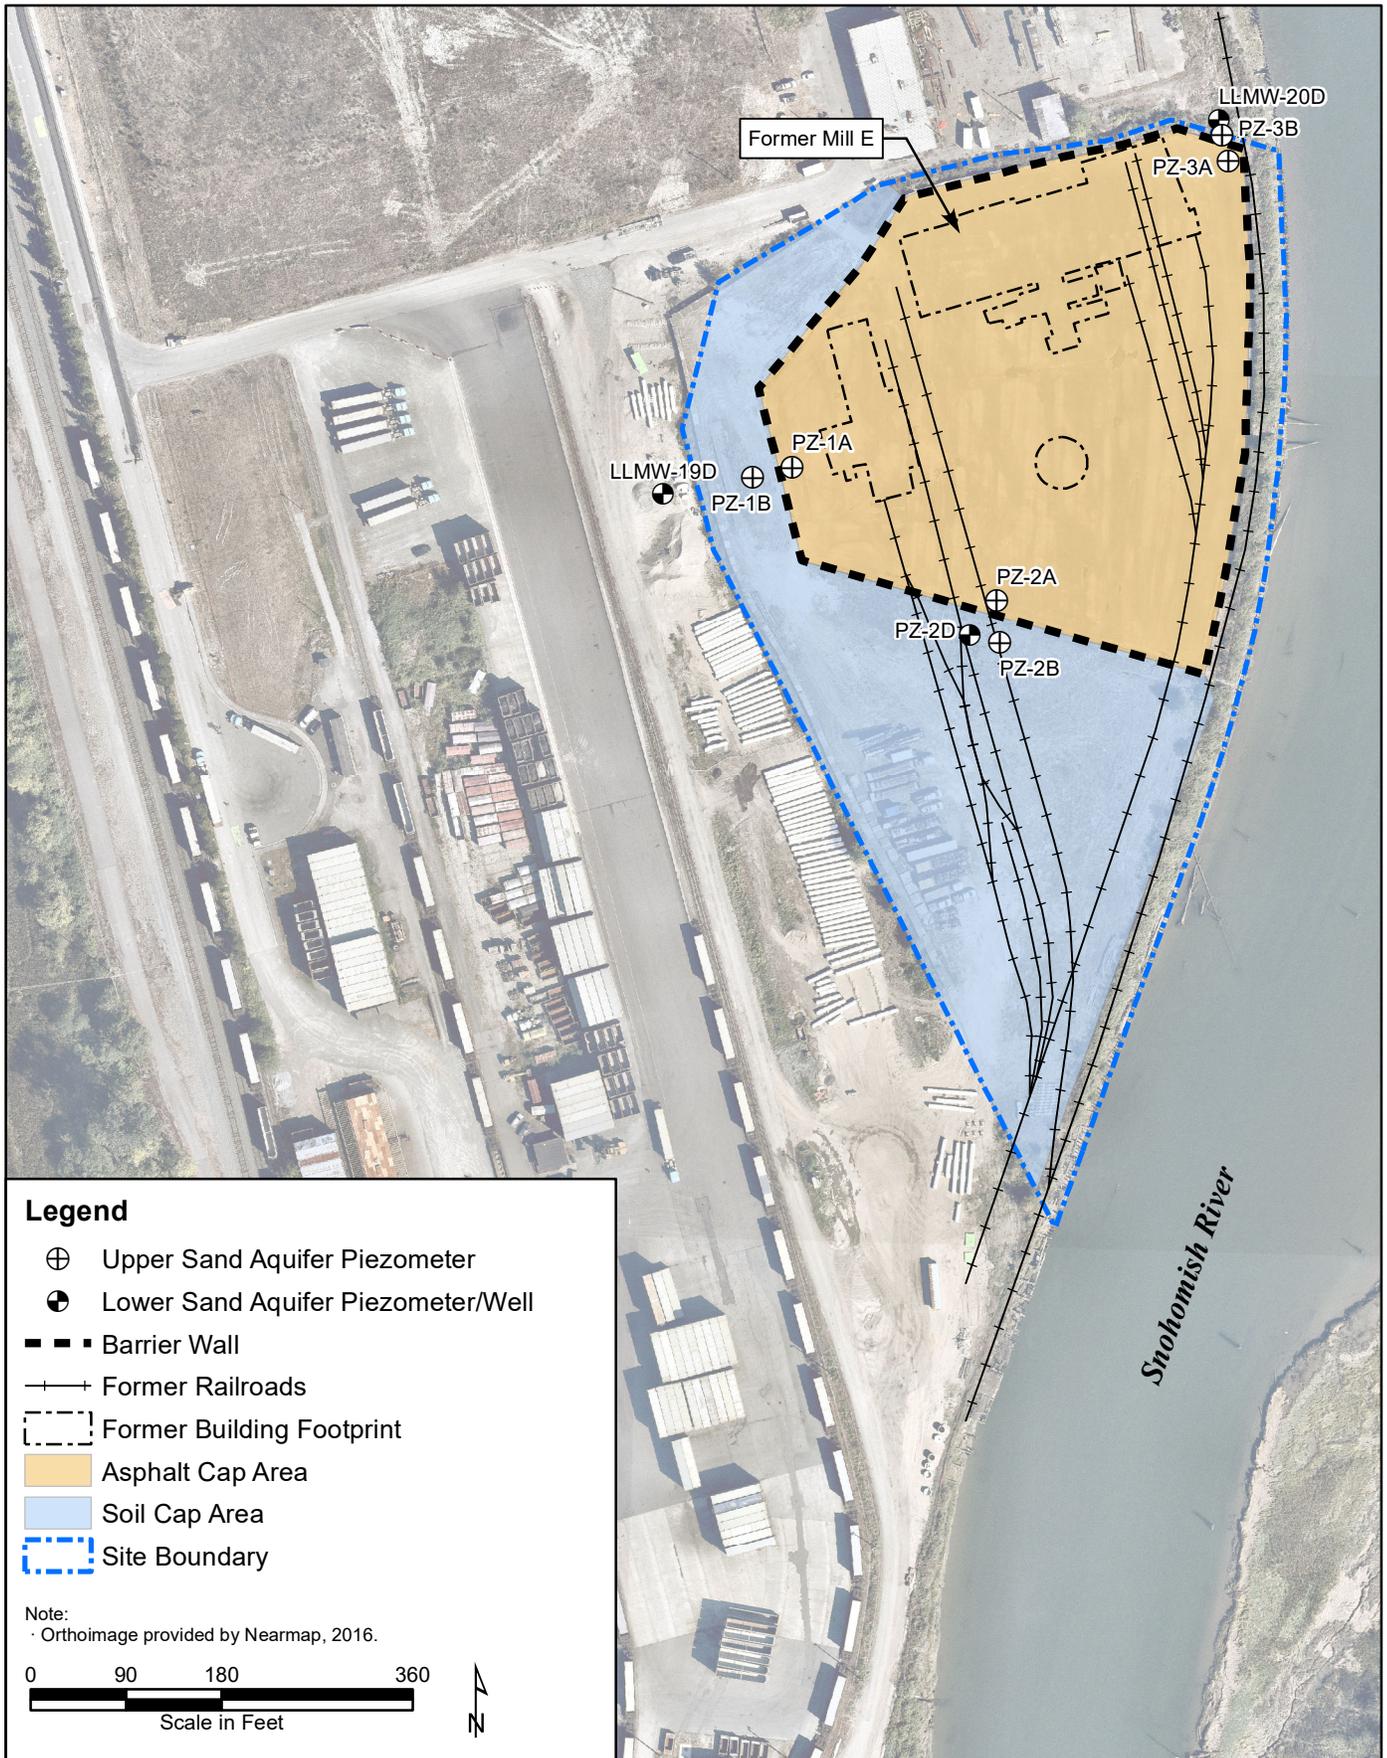
Floyd|Snider performed the annual performance and compliance monitoring for the Former Mill E/Koppers Facility in Everett, Washington (the Site) on September 24, 2018, in accordance with the *Performance and Compliance Monitoring Plan* (PCMP; EMCON 1998) and the *Performance and Compliance Monitoring Plan Addendum* (PCMP Addendum; Floyd|Snider 2017). The PCMP Addendum was approved by the Washington State Department of Ecology (Ecology) in a correspondence dated August 23, 2017. The geographic location of the Site is shown on Figure 1. Pertinent Site features, including piezometers and monitoring wells, are shown on Figure 2.

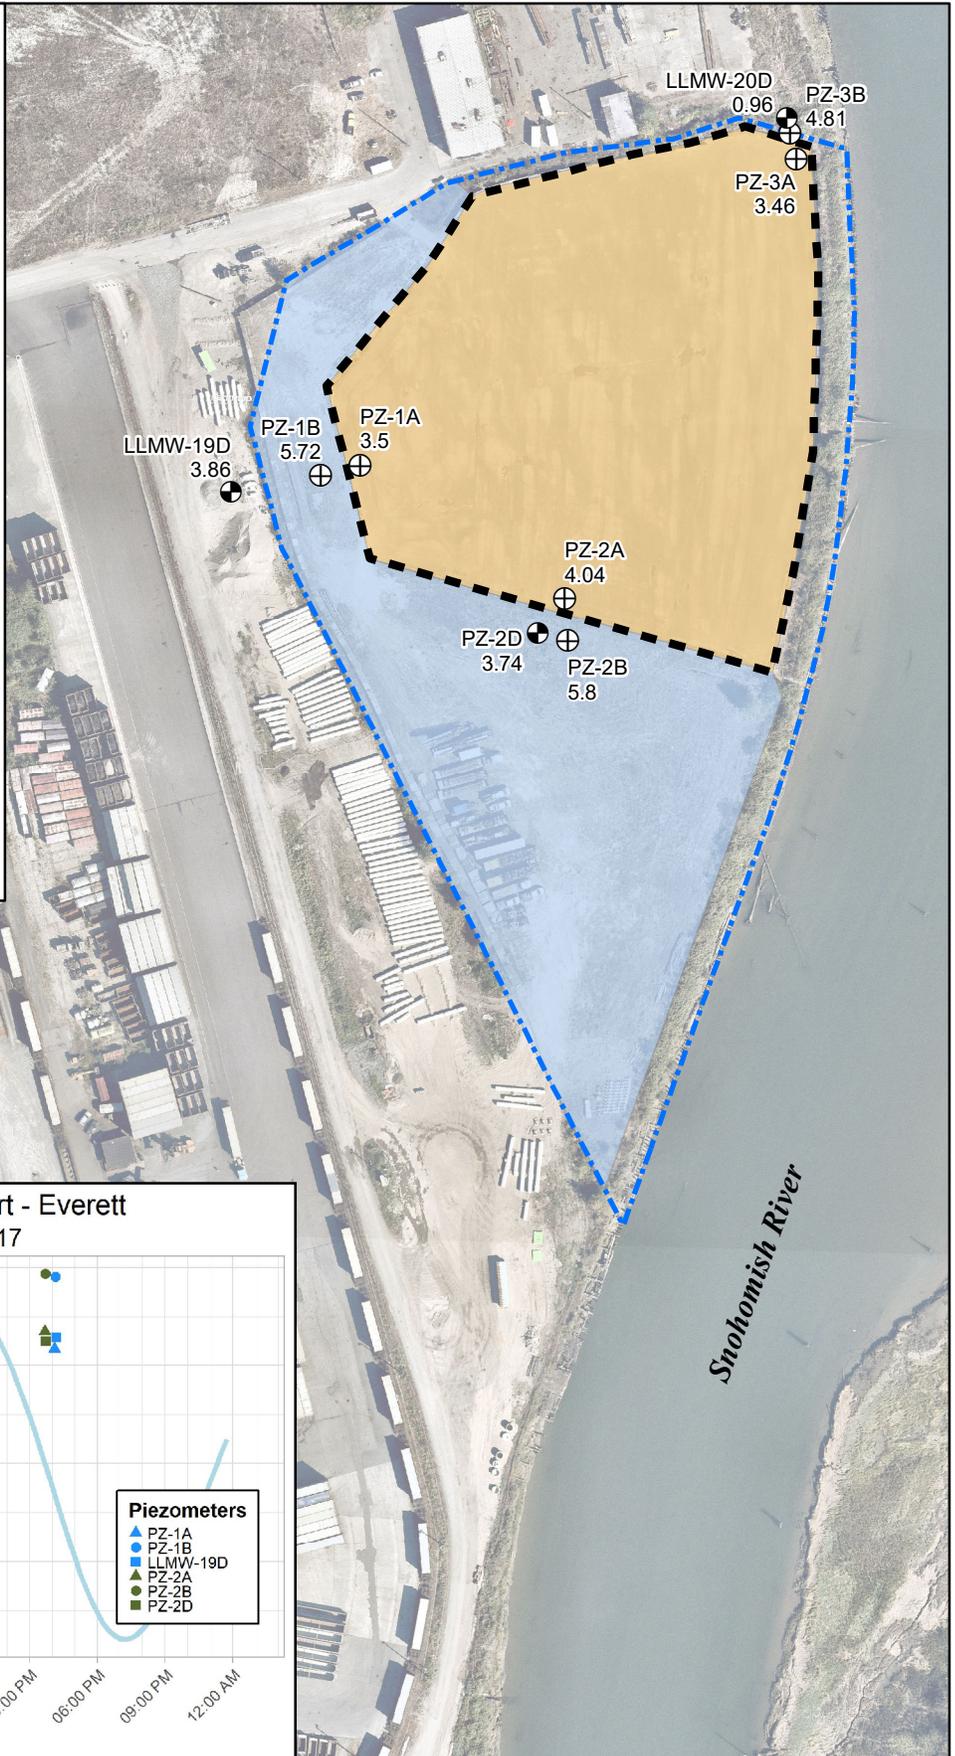
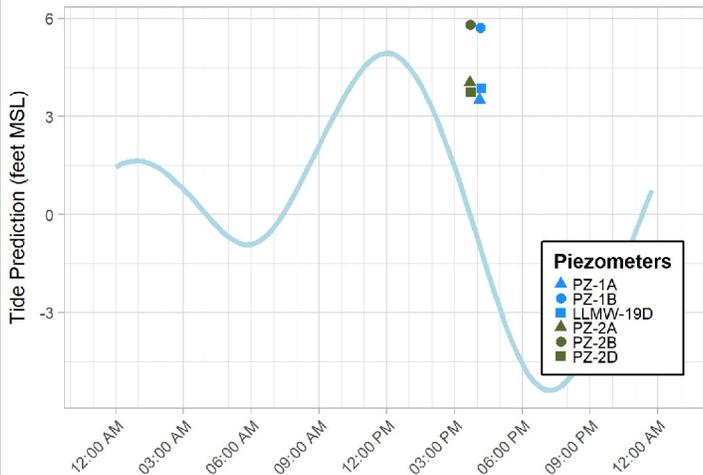
NOAA Tide Chart - Everett
 12/28/2017

Groundwater level monitoring was completed on a quarterly basis during this annual reporting period in accordance with Section 3.2 of the PCMP Addendum. Monitoring events were conducted on December 28, 2017, and March 21, June 15, and September 24, 2018. Depth to groundwater was measured with an electronic water level meter at three piezometers inside the barrier wall screened in the Upper Sand Aquifer (PZ-1A, PZ-2A, and PZ-3A), three piezometers outside the barrier wall screened in the Upper Sand Aquifer (PZ-1B, PZ-2B, and PZ-3B), and three wells/piezometers outside of the barrier wall screened in the Lower Sand Aquifer (LLWM-19D, PZ-2D, and LLMW-20D). Piezometer and well locations with measured groundwater elevations during this reporting period are shown on Figures 3a, 3b, 3c, and 3d.

Tide cycle elevations used in coordination of the groundwater level monitoring events are based on the National Oceanic and Atmospheric Administration tide predictions for Everett, Washington, converted to MSL. Measured groundwater elevations are presented in Table 1 and are compared to the 24-hour tidal cycle in Figures 3a through 3d.

- Groundwater elevations were measured on 12/28/2017. PZ-3B was inaccessible during the December 2017 event; therefore, PZ-3A, PZ-3B, and LLMW-20D were measured on 1/23/2018.
- Orthoimage provided by Nearmap, 2016.

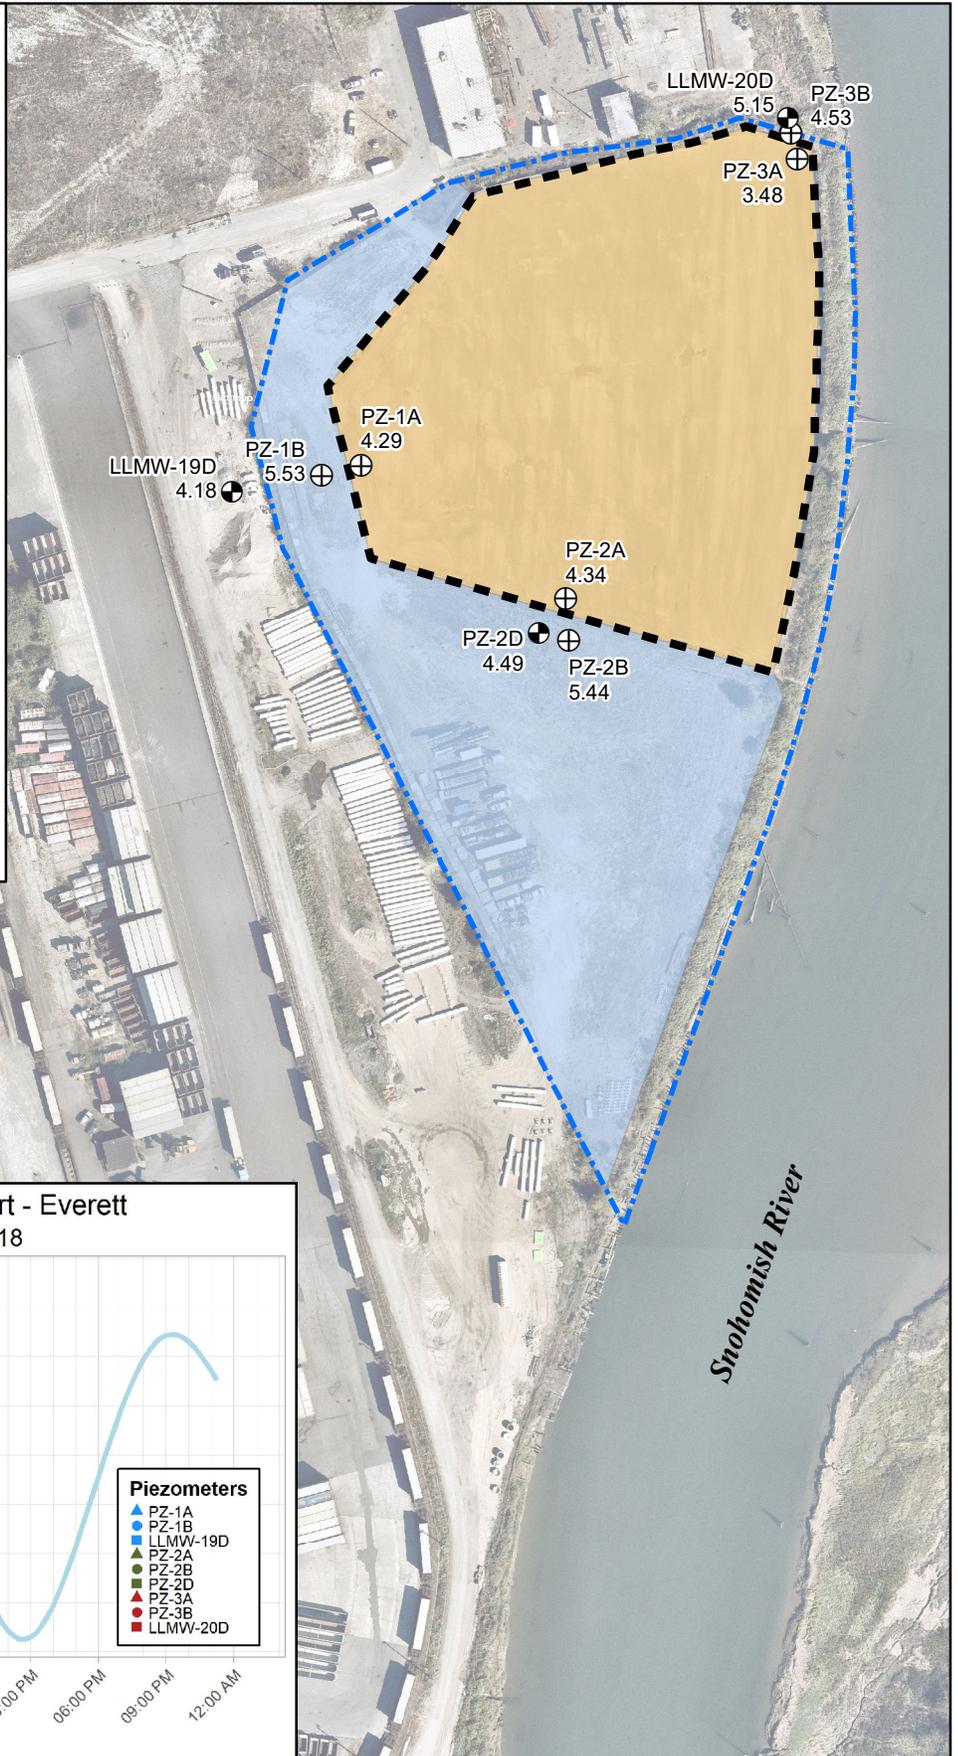
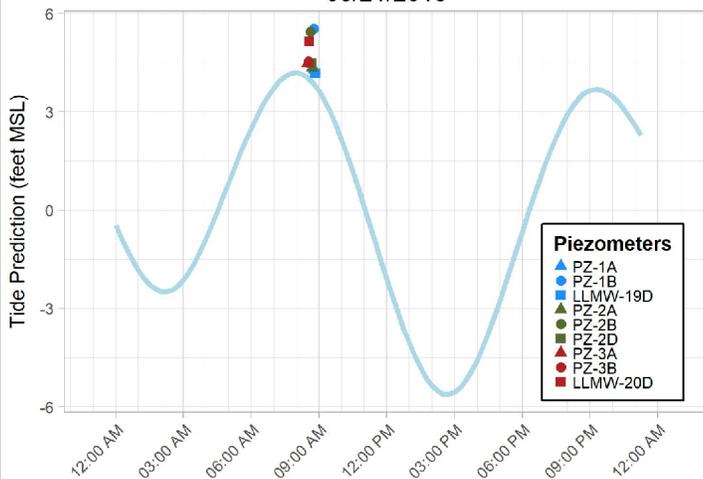
NOAA Tide Chart - Everett
 03/21/2018

Notes:
 · Groundwater elevations were measured on 3/21/2018.
 · Orthoimage provided by Nearmap, 2016.

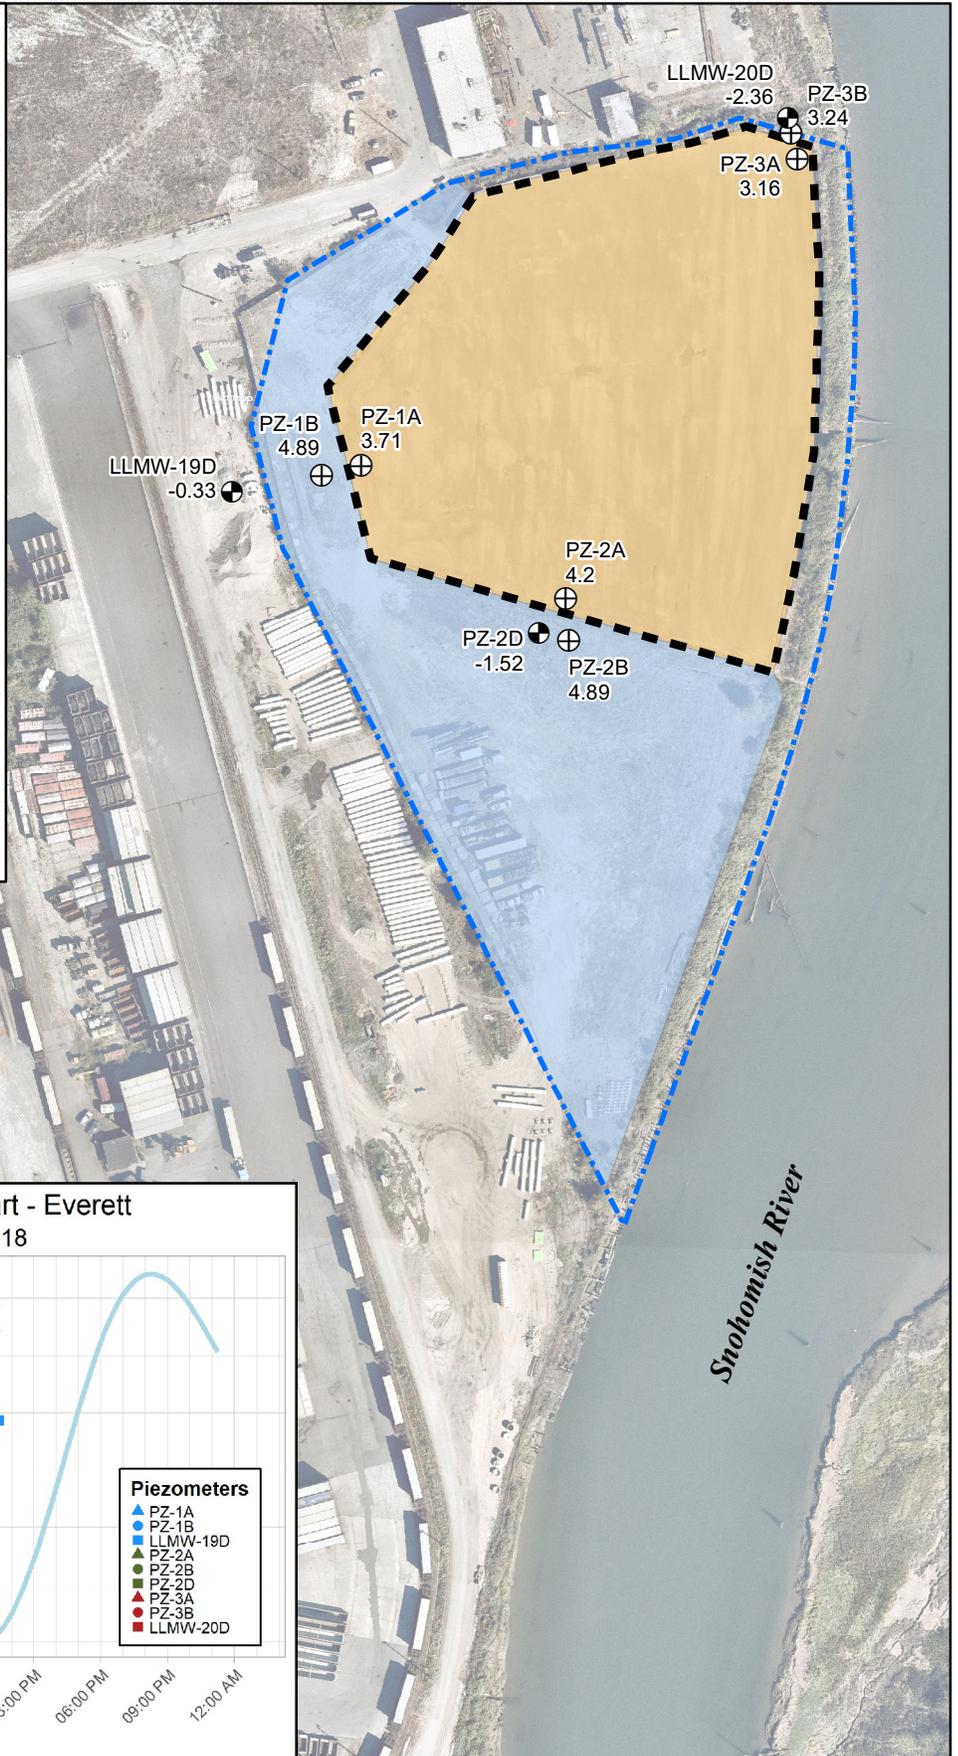
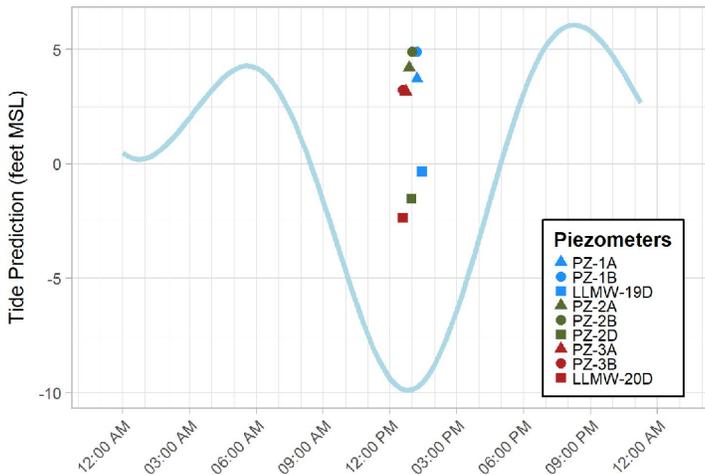
NOAA Tide Chart - Everett
 06/15/2018

Notes:
 · Groundwater elevations were measured on 6/15/2018.
 · Orthoimage provided by Nearmap, 2016.

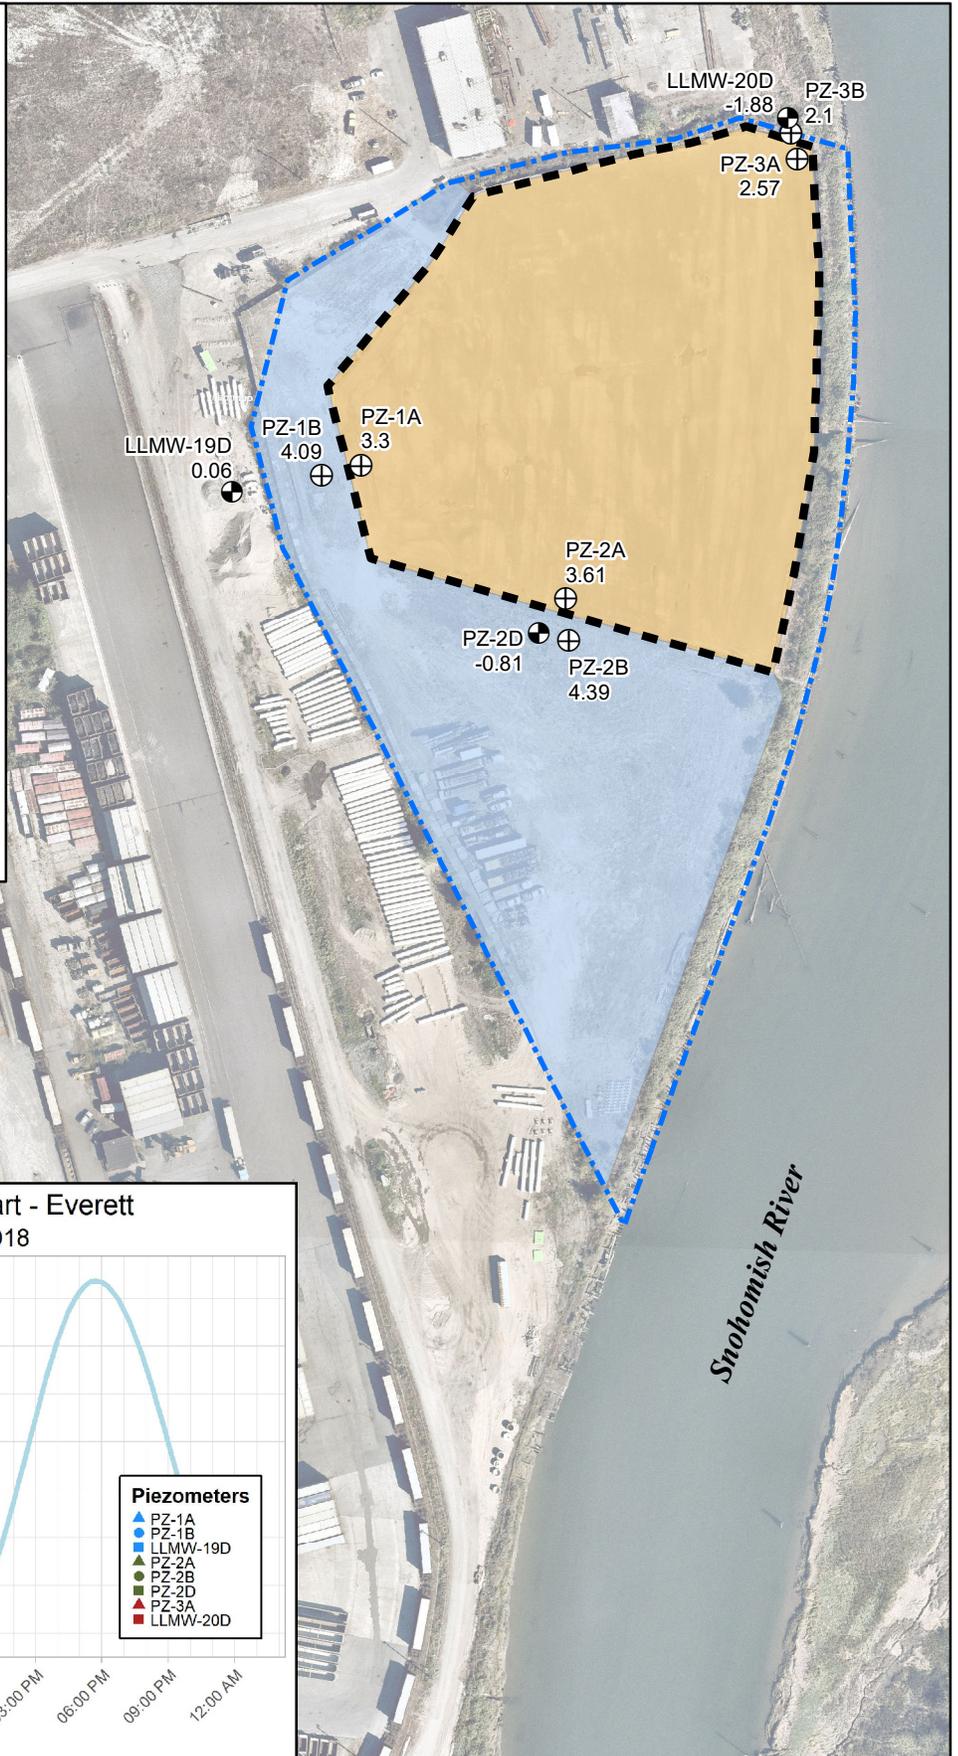
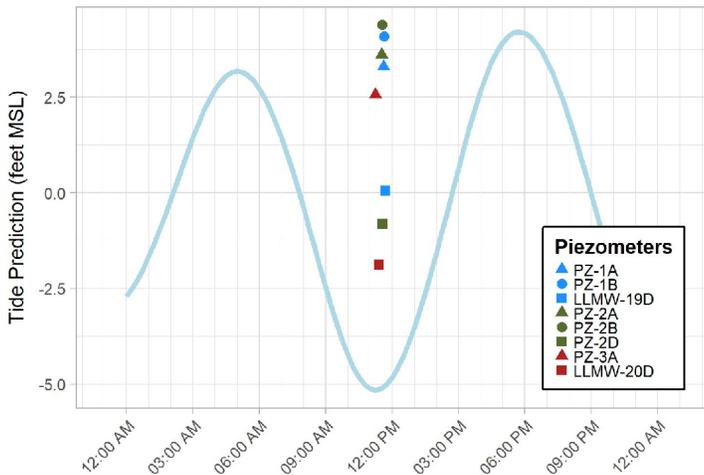
NOAA Tide Chart - Everett
 09/24/2018

Piezometer PZ-3B was determined to be dry during the September 24, 2018, monitoring event; therefore, a groundwater level elevation could not be recorded. This indicates the surrounding water table is at abnormally low levels due to low rainfall during the 2018 dry season. PZ-3B has been noted as dry on a few occasions in the past, in 1999, 2002, and 2009.

Notes:
 · Groundwater elevations were measured on 9/24/2018.
 · Orthoimage provided by Nearmap, 2016.

In addition, because piezometer PZ-3B was dry during the September 2018 monitoring event, Floyd|Snider recommends an additional monitoring event in December 2018 to measure water elevations at PZ-3A, PZ-3B, and LLMW-20D when the water table has returned to normal conditions. The results of this additional monitoring event will be included in the 2019 Annual Performance and Compliance Monitoring Report.

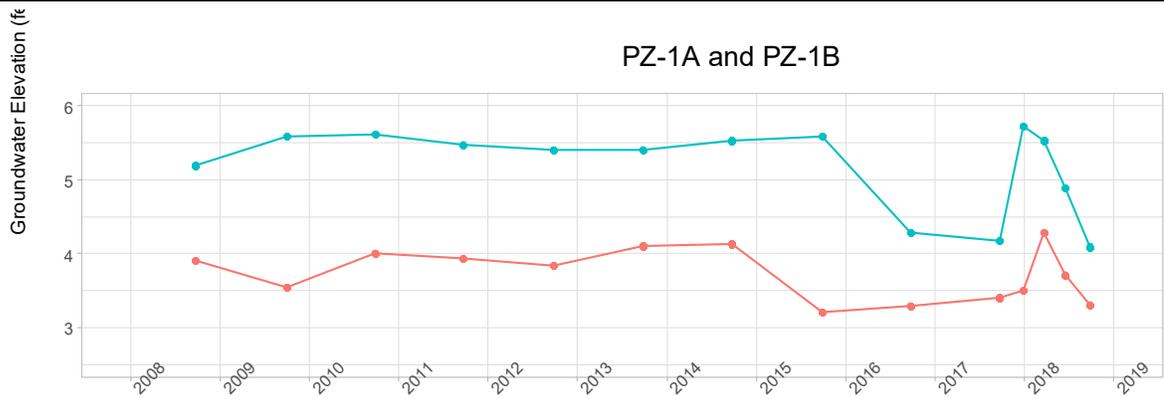
Piezometers PZ-1A PZ-1B

Comparison of the groundwater elevations for each set of piezometers in the Upper Sand Aquifer (inside and outside barrier wall) from 2007 to 2018 are presented in Figure 4. Groundwater elevations inside the barrier wall have consistently been lower than outside the barrier wall for all three pair locations during each monitoring event.

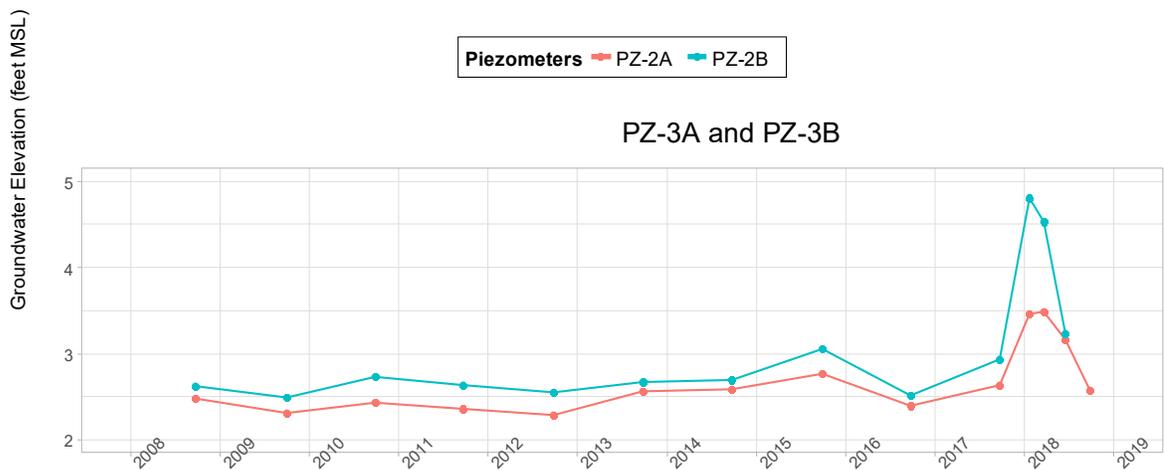
Piezometers PZ-3A PZ-3B

1. Top of well casing and groundwater elevations referenced to MSL (Shaw 2003; GeoEngineers 2016).
2. "A" wells are located inside the barrier wall in the Upper Sand Aquifer; "B" wells are located outside the barrier wall in the Upper Sand Aquifer.
3. The average water level elevation is shown for wells with multiple measurements over a single year.
4. PZ-3B was dry during the September 2018 monitoring event.

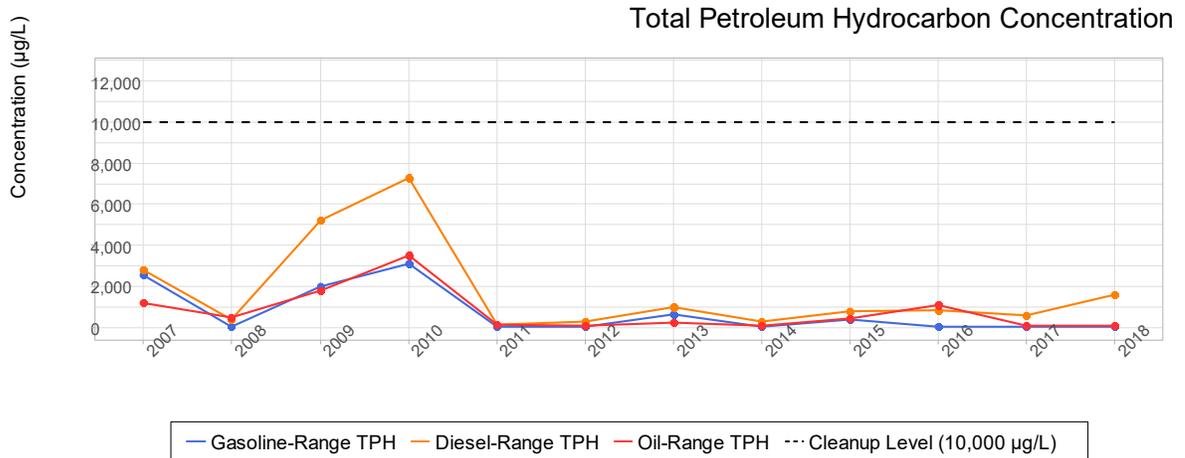
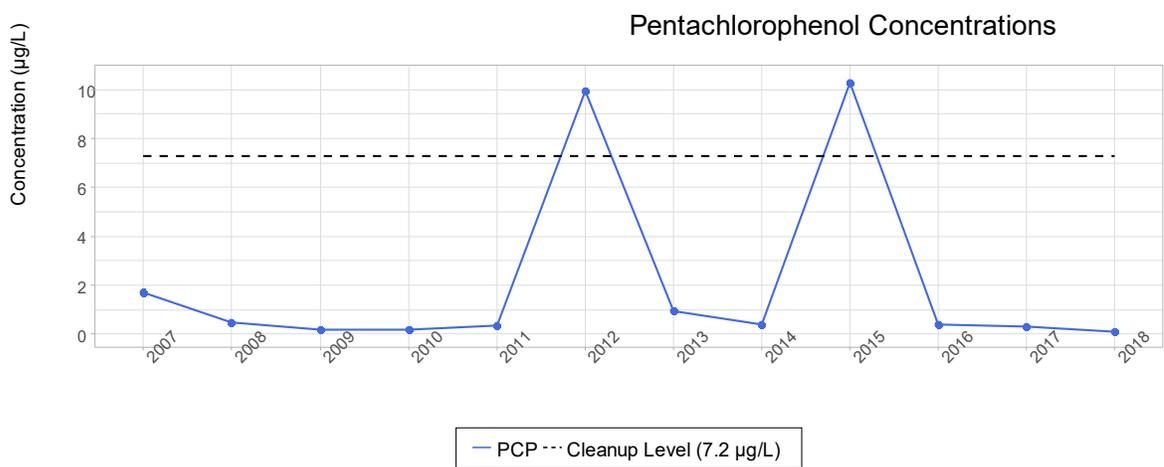
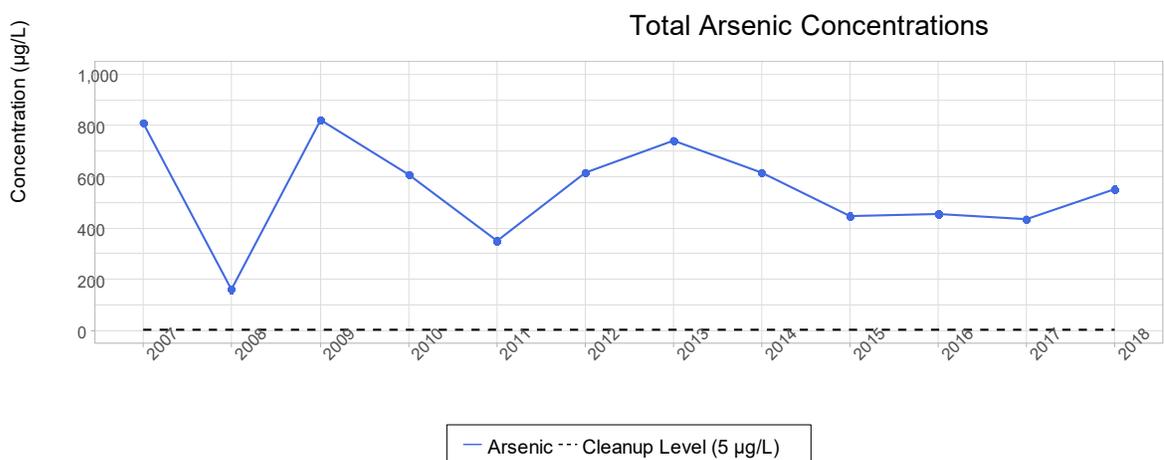
Groundwater analytical results are presented in Table 4 and a copy of the analytical report is included in Attachment 1. The results are compared to the Model Toxics Control Act (MTCA) cleanup levels for the Site established in the 1998 Consent Decree. The concentration of diesel-range TPH was less than its respective cleanup level. PCP and gasoline- and motor oil-range TPH were not detected at concentrations greater than laboratory reporting limits. Arsenic was detected at a concentration of 551 micrograms per liter ($\mu\text{g/L}$), which is greater than the cleanup level of 5 $\mu\text{g/L}$, but within the range of previous sampling events from the past 5 years. Changes in the concentrations of TPH, PCP, and arsenic over time (over the past 10 years) are presented in Figure 5.

1. Criteria are the cleanup levels established in the 1998 Consent Decree.

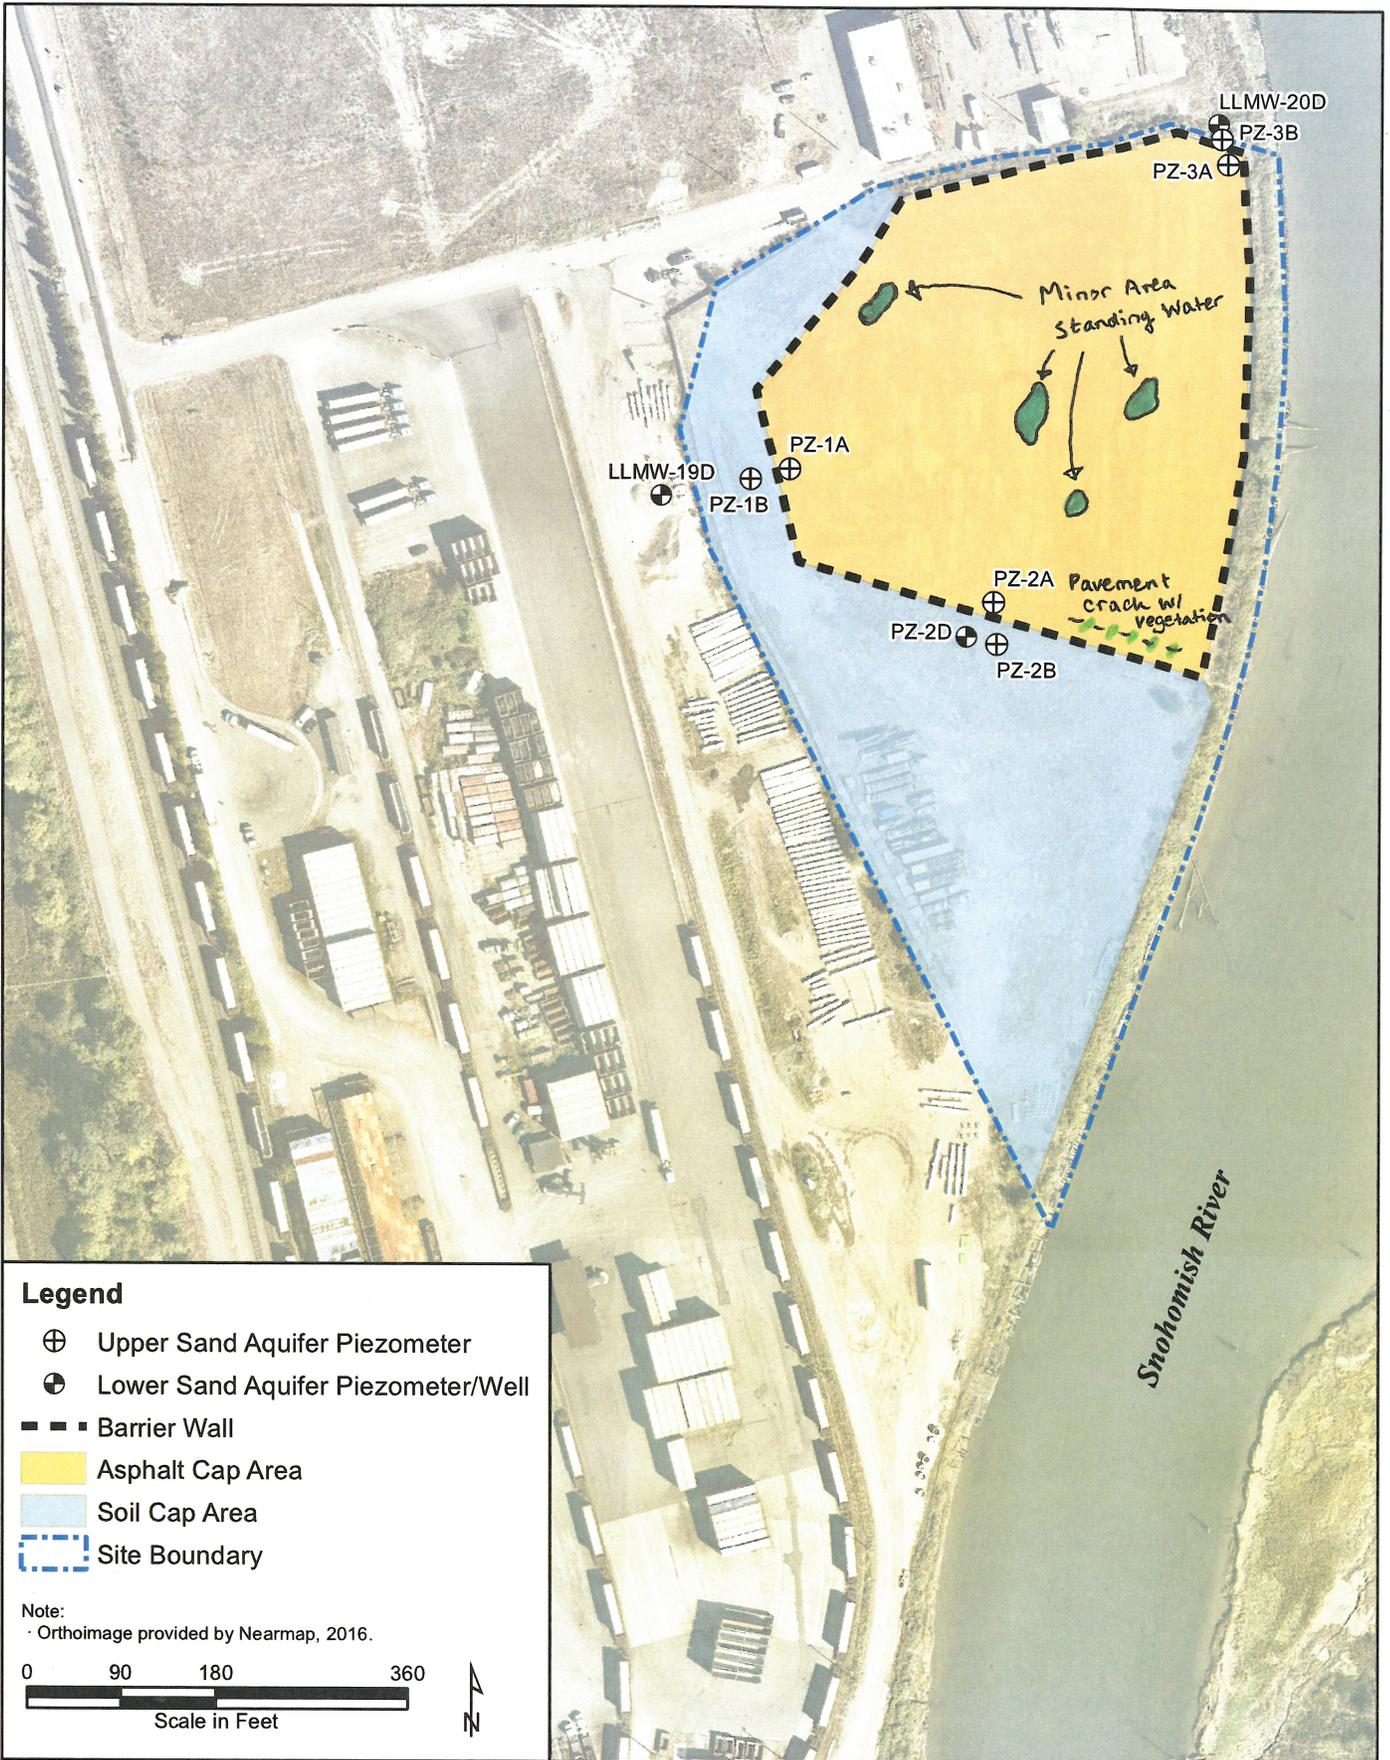
As part of the Former Mill E/Koppers Facility Performance and Compliance Monitoring Plan (EMCON 1998) an inspection of the Asphalt Cap and Soil Cover is to be conducted annually. Any damage will be noted on the following checklist with locations referenced on the attached site plan.

Yes	No	If Yes, describe (locations identified on attached plan, photos of all described items will be included with the report):
Cracked or damaged asphalt	<input checked="" type="checkbox"/>	<input type="checkbox"/>	<u>Minor cracks present as noted on figure. No concern re: direct contact exposure.</u>
Areas of uneven settlement or standing water	<input checked="" type="checkbox"/>	<input type="checkbox"/>	<u>Some minor areas of standing water. All areas < 10 ft. diameter and < 1 in. ponded depth.</u>
Cracked or damaged drainage ditches	<input type="checkbox"/>	<input checked="" type="checkbox"/>	_____
Debris in drainage ditches	<input checked="" type="checkbox"/>	<input type="checkbox"/>	<u>Accumulated sediment in ditches. < 1 in. in depth.</u>
Vegetation in drainage ditches	<input type="checkbox"/>	<input checked="" type="checkbox"/>	_____
Sloughing or crumbling of edges of asphalt cap	<input type="checkbox"/>	<input checked="" type="checkbox"/>	_____

An asphalt cap and soil cover inspection was performed under the supervision of a Professional Engineer from Floyd|Snider on September 24, 2018. Field observations of cap integrity were documented on a field inspection checklist and Site Plan. The field inspection checklist and Site Plan, along with photographs of all relevant field observations, are included as Attachment 2. All nonconformities noted in the inspection checklist were considered minor and not a current concern to the performance objectives. These observations included limited cracking and rutting in the asphalt and vegetation in the asphalt cracks. Overall, the asphalt cap and soil cover were observed to be in good condition and are adequately meeting the performance objectives to prevent direct contact with contaminated soil and minimize infiltration. To keep the asphalt cap in good working condition, visible weeds will be removed from the cracks (physically or torching) prior to spring 2019.

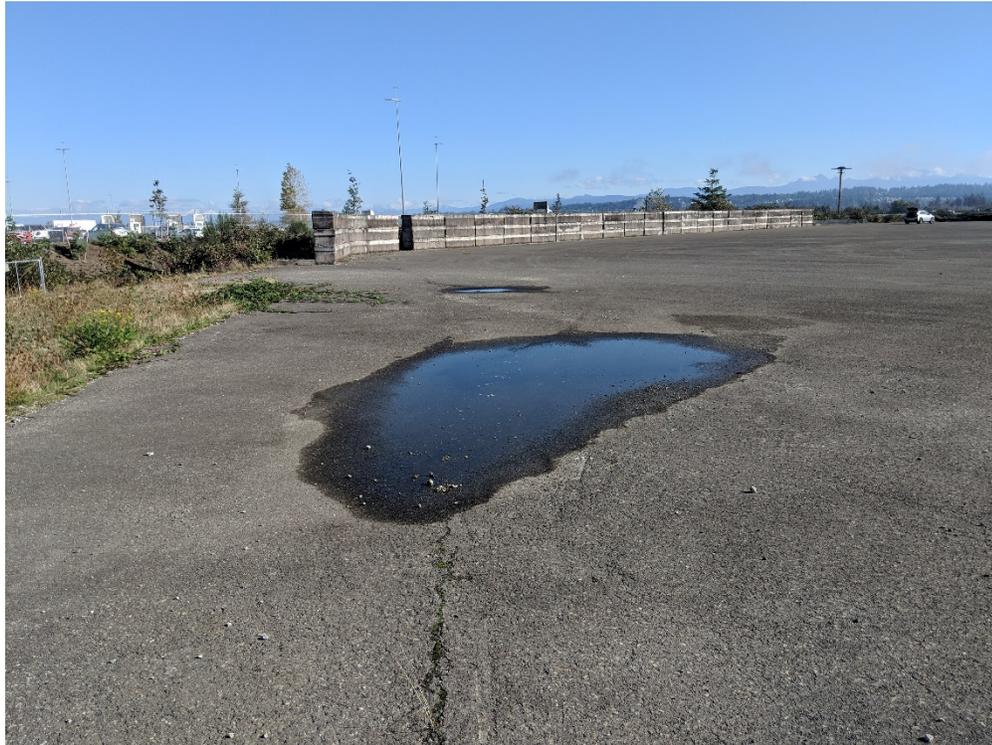
Photograph 1. Crack in asphalt and ponding on northwest side of the cap (looking north).

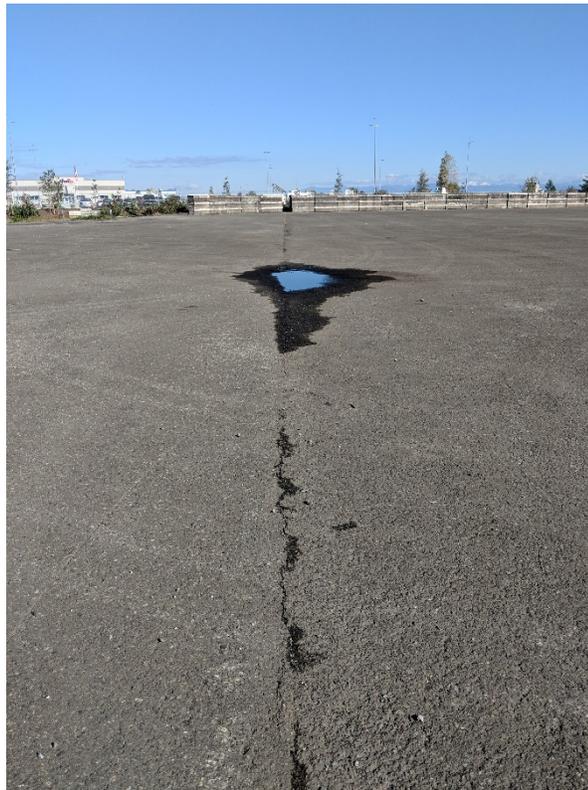
Photograph 2. Crack in asphalt through the center of the cap and ponding (looking north).

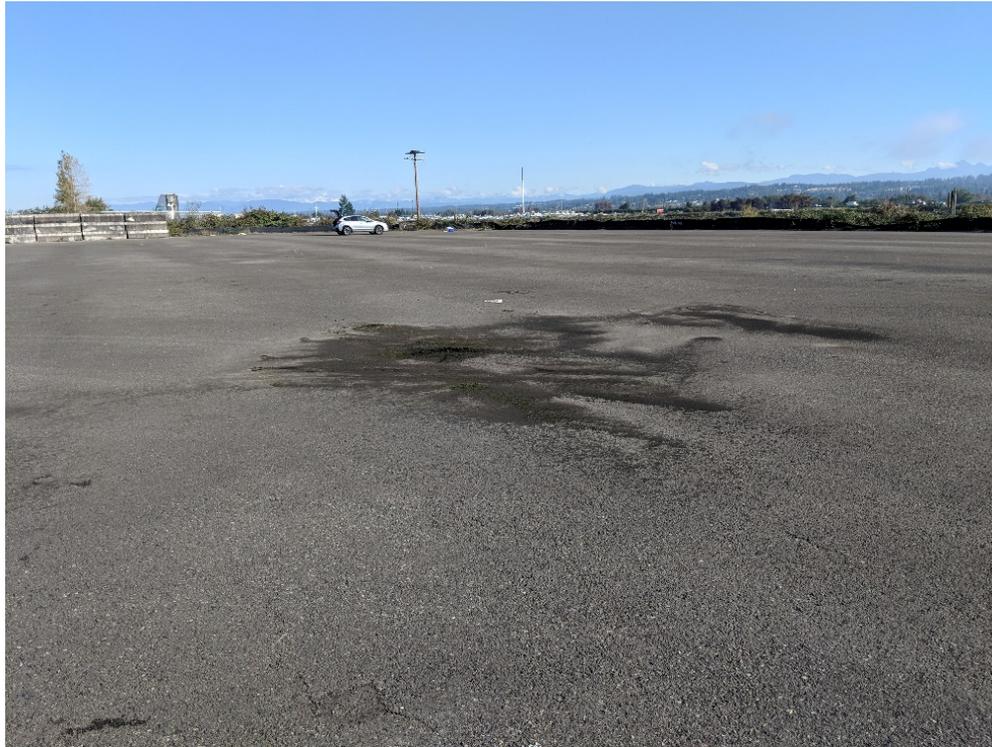
Photograph 3. Settled area with deposited dust and debris (looking northeast).

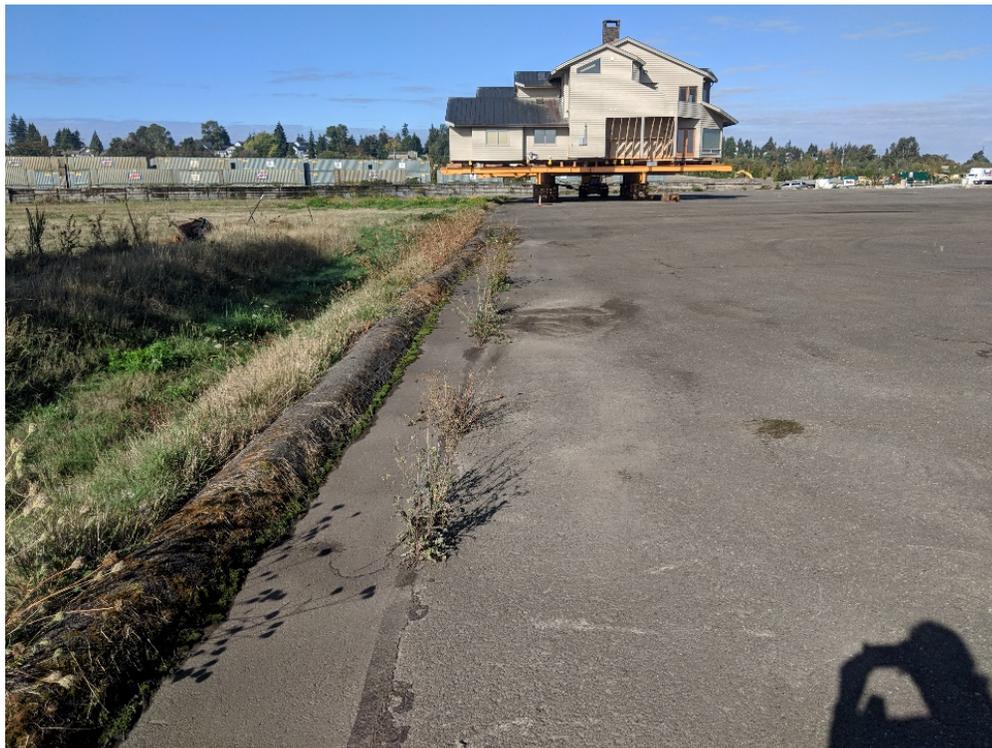
Photograph 4. Crack in the asphalt with growing vegetation along the south edge of the cap (looking west).

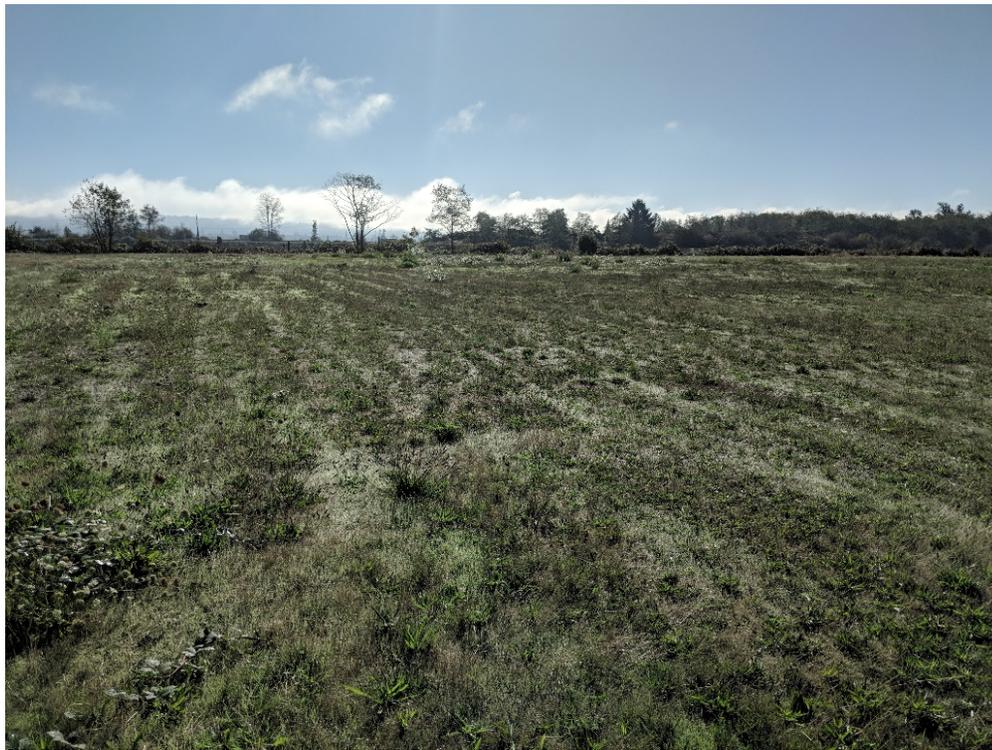
Photograph 5. Southeast side of soil cover (looking east).

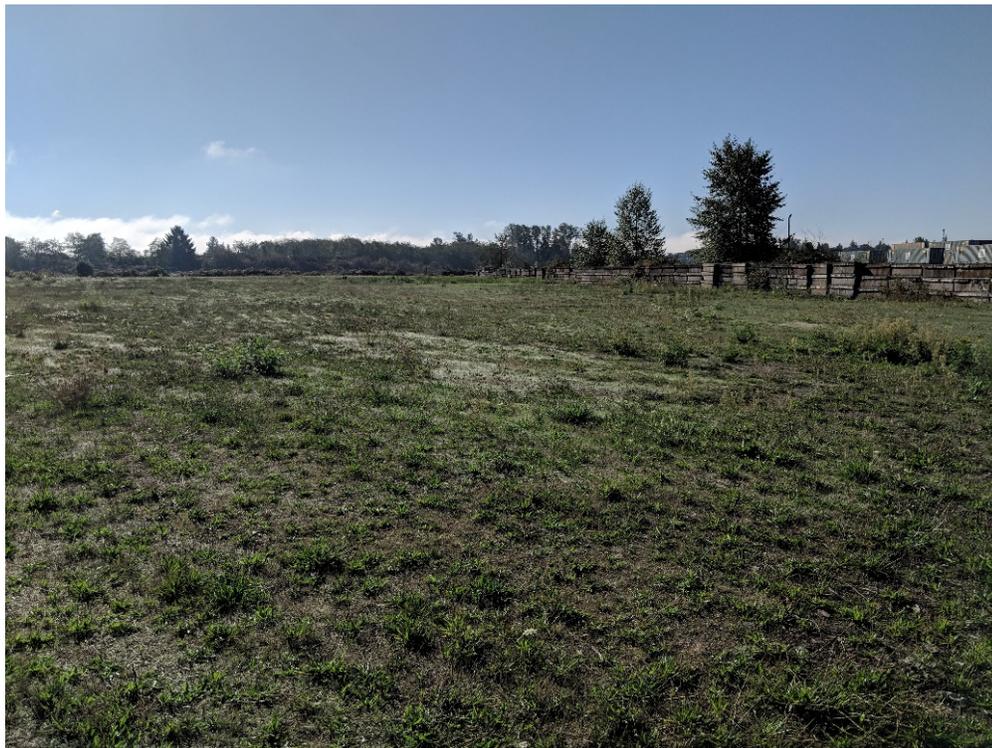
Photograph 6. Northwest side of soil cover (looking west).
