**Port of Longview
TPH Site**

Interim Action Work Plan

ABANDONED FUEL PIPELINE DEMOLITION INTERIM ACTION WORK PLAN / SITE PLAN

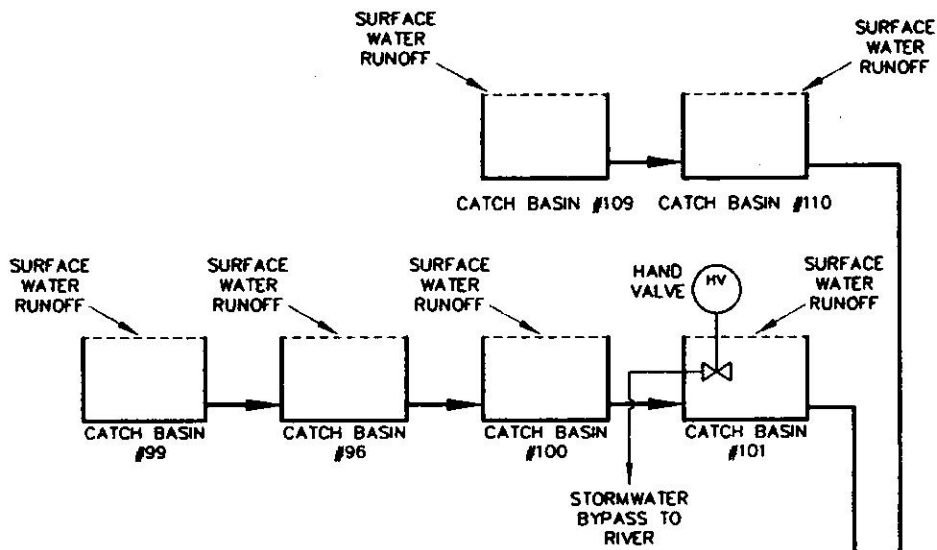
BERTH 1 SHIP UNLOADING CONTAINMENT AREA

In summary, Berth 1 consists of an area that can capture process water and incidental stormwater through a series of daisy-chained catch basins to a sump pump system, from which the captured water is pumped to a Rain for Rent tank(s). Catch basins 101 and 111 are fitted with hand valves to either allow stormwater to be discharged to the river through under-dock piping or redirected through alternate piping to the catch basin where the sump pump is located. This allows for collection of process water and incidental stormwater within the contained area.
