Re: Navy Hoist Remedial Excavation Completion Report, Port of Seattle Terminal 91

This letter describes remedial excavation conducted at the Terminal 91 Building 136 area (DU B.36) in July 2018 to address contamination associated with hydraulic lifts that were discovered during routine maintenance paving (Figure 1). December 2017 reconnaissance sampling confirmed petroleum in soil and groundwater samples exceeding Model Toxics Control Act (MTCA) Method A cleanup levels adjacent to the hoists (Pacific Groundwater Group [PGG] 2018).

APPENDIX A SITE PHOTOGRAPHS

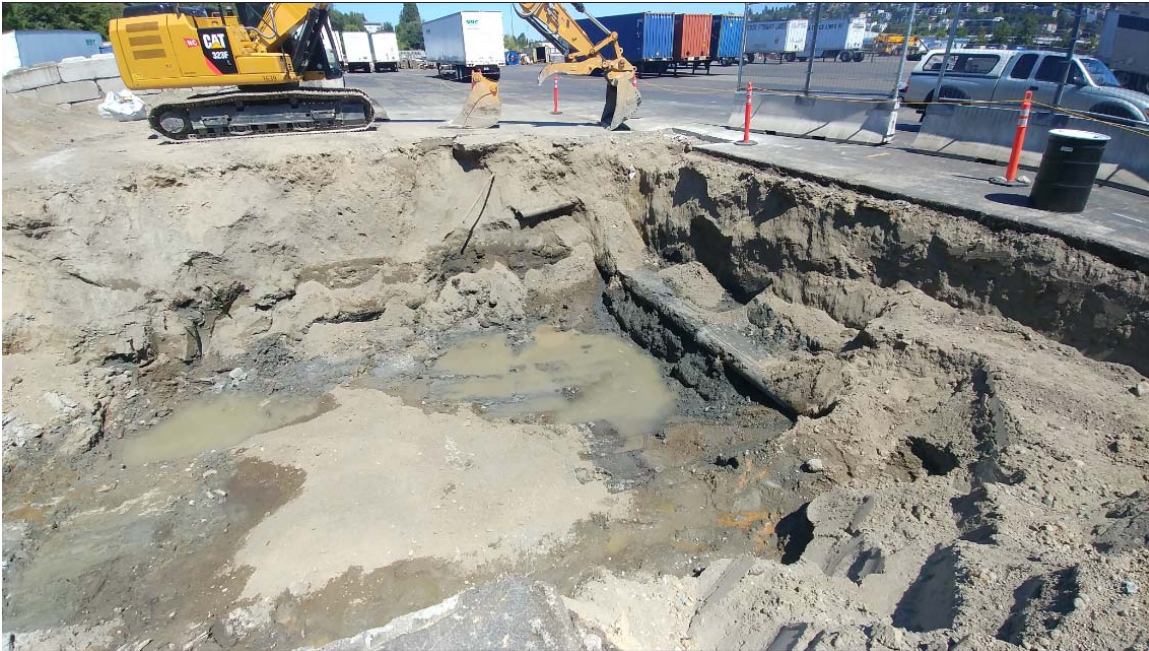
Excavation at conclusion of excavation, with view looking NNE. North-south oriented sewer line is visible on right side of excavation. A steel or iron pipe with a capped end is visible in the NE corner of the excavation; that pipe is of unknown origin and connection. July 16, 2018.

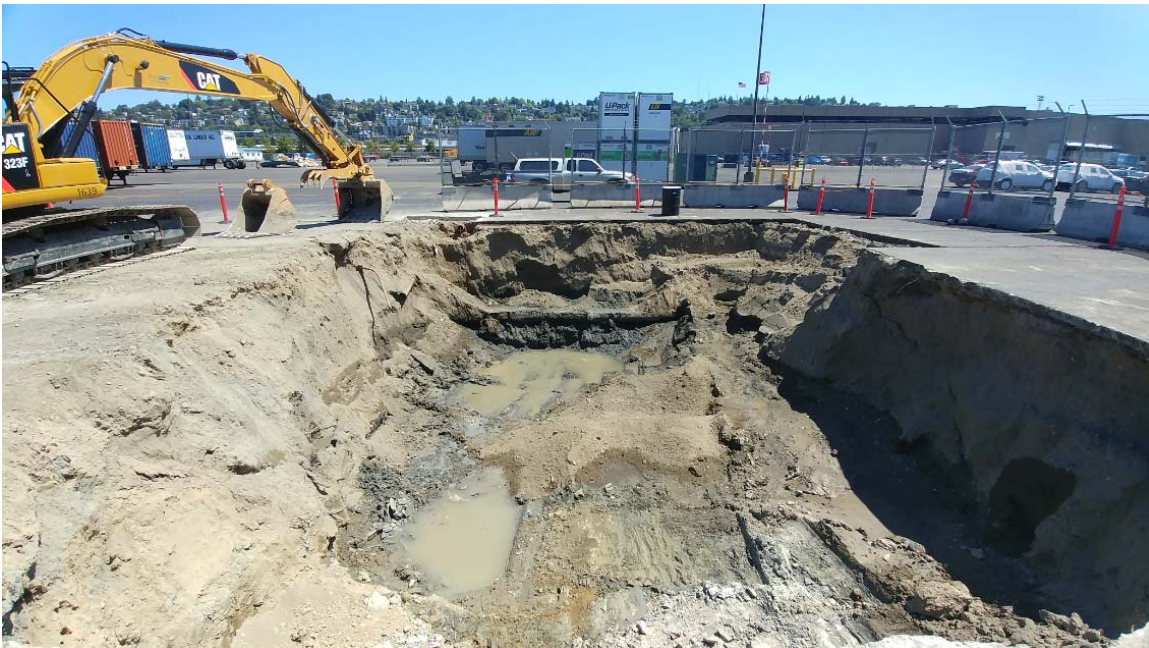
Excavation at conclusion of remediation, with view looking E. July 16, 2018.

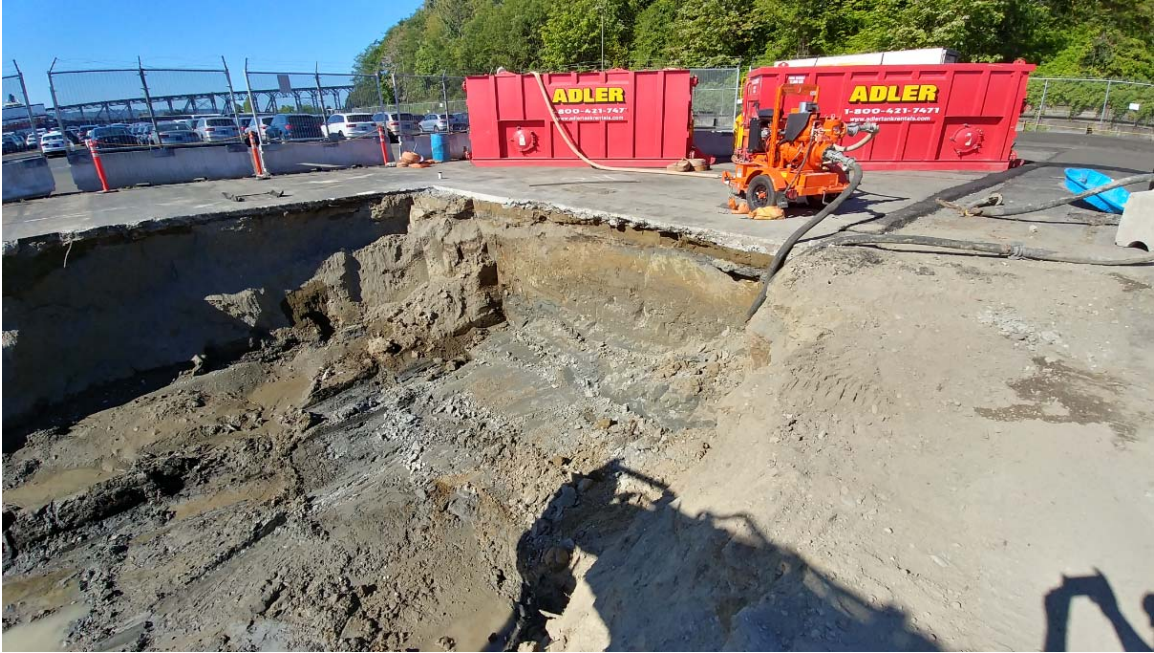
View to the SW showing clean western edge of excavation, dewatering pump, and discharge tanks. July 13, 2018.

The excavation was dewatered to allow soils to be removed without free liquids, as required for disposal at Waste Management and to simplify soil handling. Groundwater that accumulated in the base of the excavation was pumped into an adjacent temporary storage tank (see photos in Appendix A). Approximately 10,000 gallons of oily water were disposed of by tanker truck to Marine Vacuum Services, Inc. (MarVac) in Seattle, Washington. Bills of landing for the water disposal are included in Appendix B.

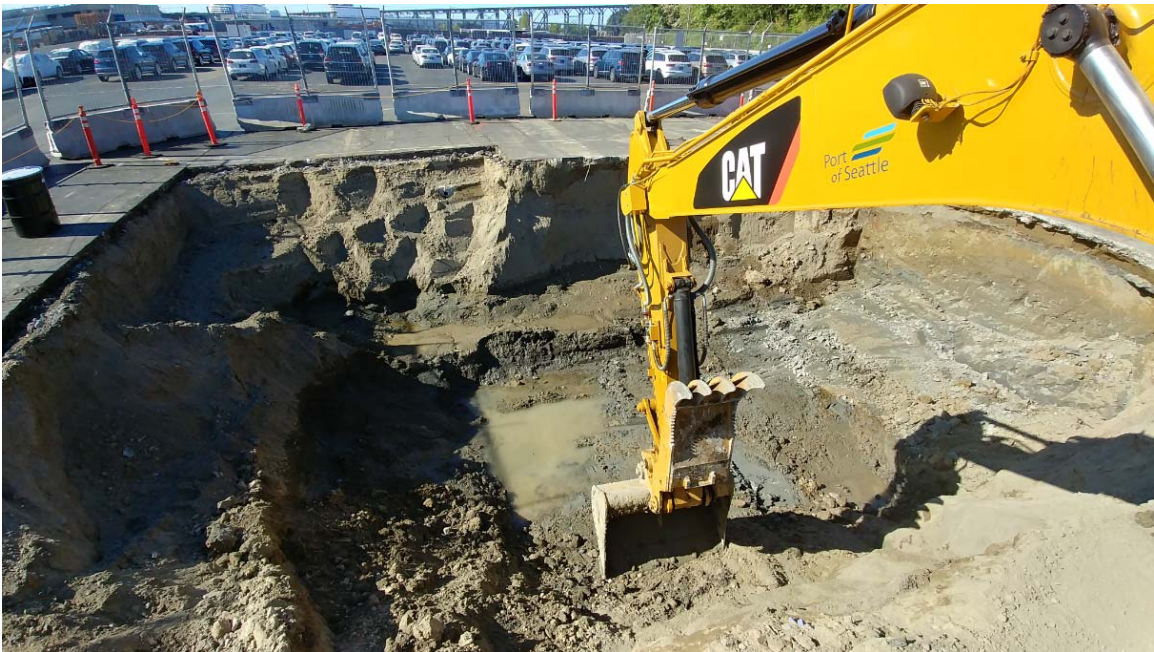
Nearing the completion of excavation with view to south. The capillary zone and slow groundwater seepage into the excavation are visible on the south wall of the excavation. July 13, 2016.

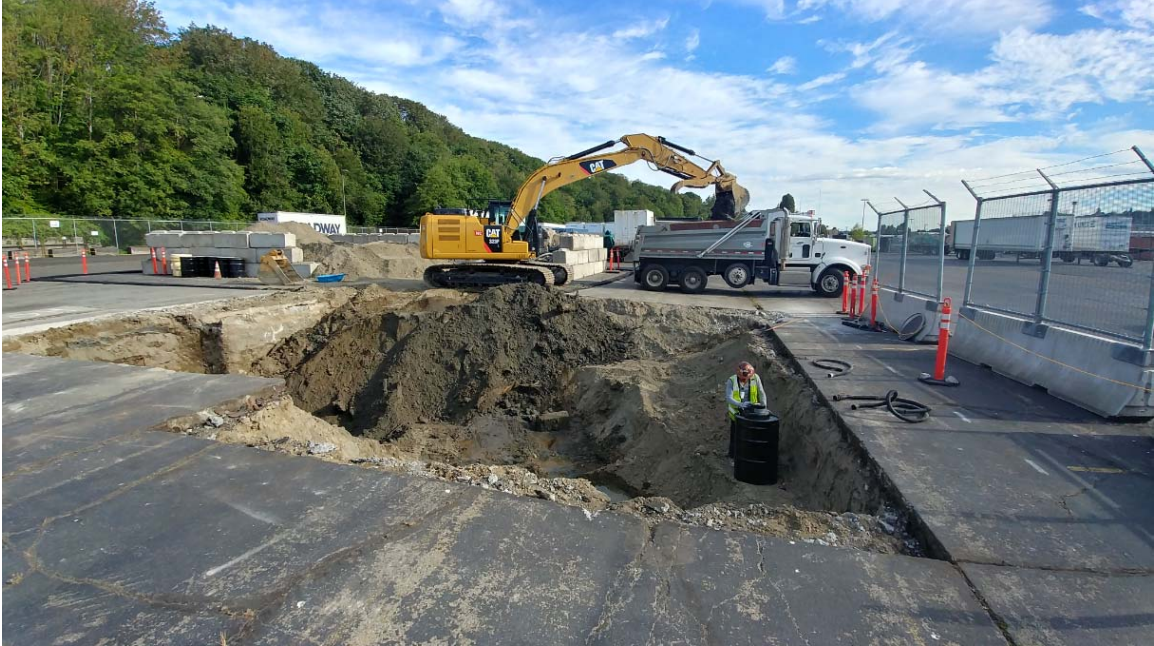
Direct-loading impacted soils into truck for disposal. The western concrete hydraulic lift trough is visible at the left (west) side of the excavation. July 6, 2018.

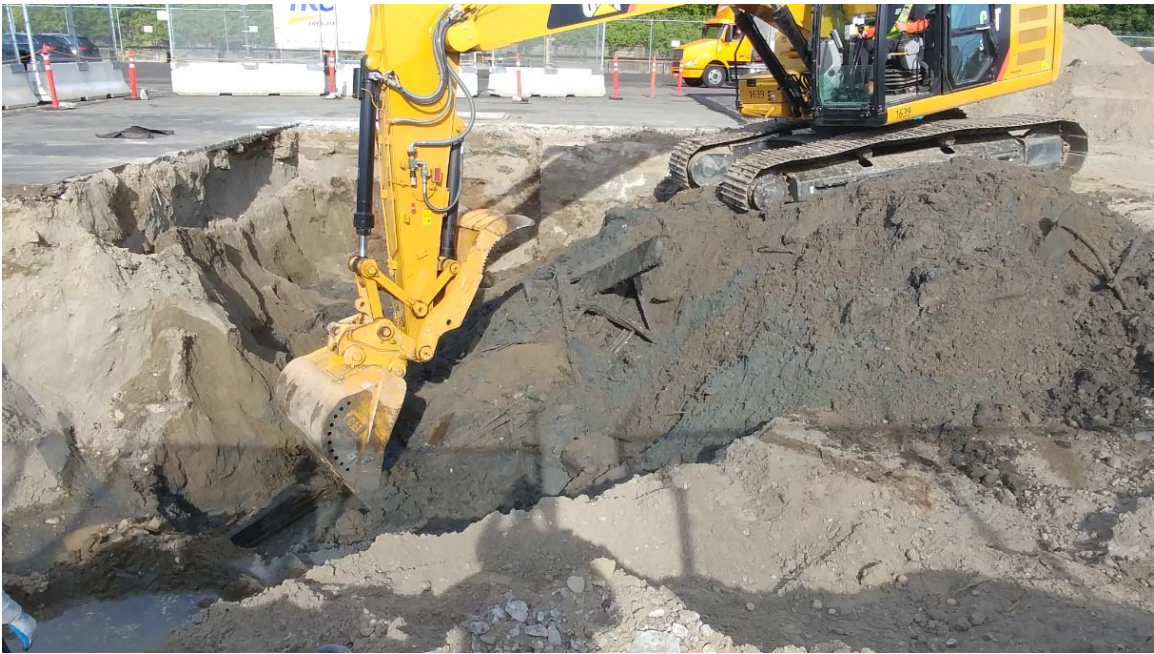
Removing impacted soils. Wooden boards formerly part of the wooden trough are visible just below the excavator bucket. July 6, 2018.

During excavation, observations of soil types and the presence of woody debris were consistent with reconnaissance boring observations. Photos during excavation are included in Appendix A. Woody debris was observed at the contact between native sands near the water table and overlying fill. Woody debris included logs and what appeared to be a wooden trough traversing the excavation in a northwest to southeast direction. The trough was approximately 10 feet below ground surface and below the water table. Field observations did not indicate petroleum impacts inside the trough. The lateral extent of the trough beyond the excavation is not known.

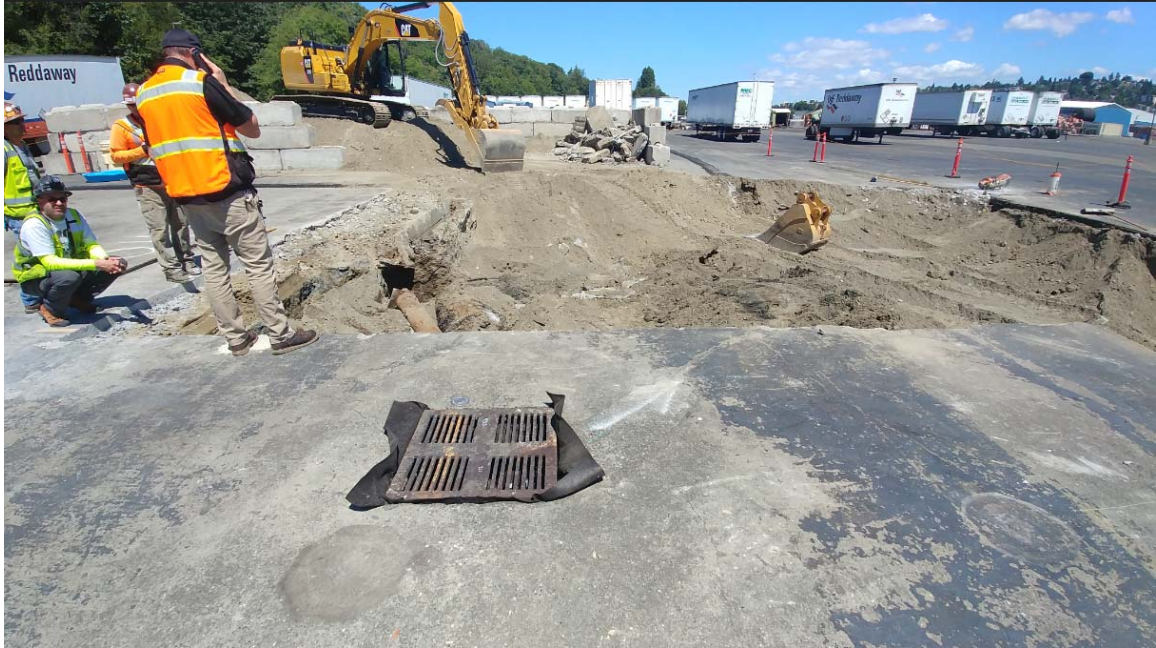
Stockpiling clean overburden to the northwest of the excavation. West hydraulic lift trough is still in place on left side of excavation. The east trough has been broken up and removed. July 3, 2018.

Clean overburden without indication of petroleum impacts was stockpiled onsite. Composite soil samples from the stockpiled material were non-detect for TPH-diesel and -oil (Table 1). Impacted soil was loaded directly from the excavation into trucks for offsite disposal. A total of 494 tons of impacted soil was transported to Waste Management for disposal. Disposal manifests are included in Appendix B.
