November 2017
Port Gamble Bay Cleanup Project

Port Gamble Season 1 and Season 2 Cleanup Action Report Summary

Prepared for Pope Resources, LP/OPG Properties, LLC

Anchor QEA, LLC
720 Olive Way, Suite 1900
Seattle, Washington 98101

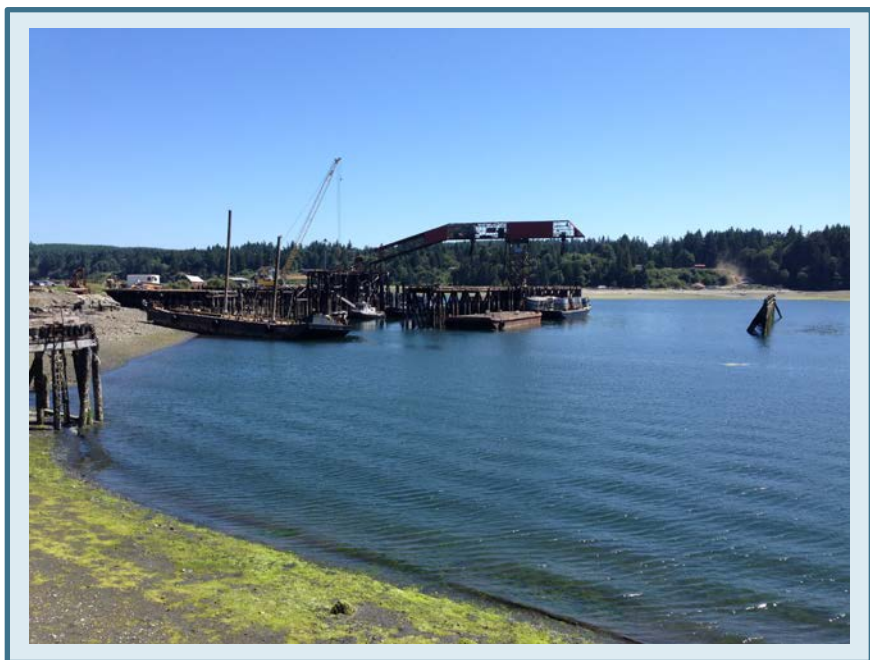
Pre-Construction SMA-2 Shoreline

Intertidal excavation and capping activities began on October 6, 2105, with removal and stockpiling of large riprap from the SMA-2 intertidal shoreline. On October 26, 2015, following the removal of riprap from the shoreline, OMCI began intertidal excavation and capping in SMA-2. Intertidal areas were excavated “in the dry” using land-based excavation and dozer type equipment. To accomplish this, work shifts were scheduled during nighttime low tides. Intertidal excavation progressed from south to north within SMA-2, and the excavation was generally sequenced from higher elevations to lower elevations.

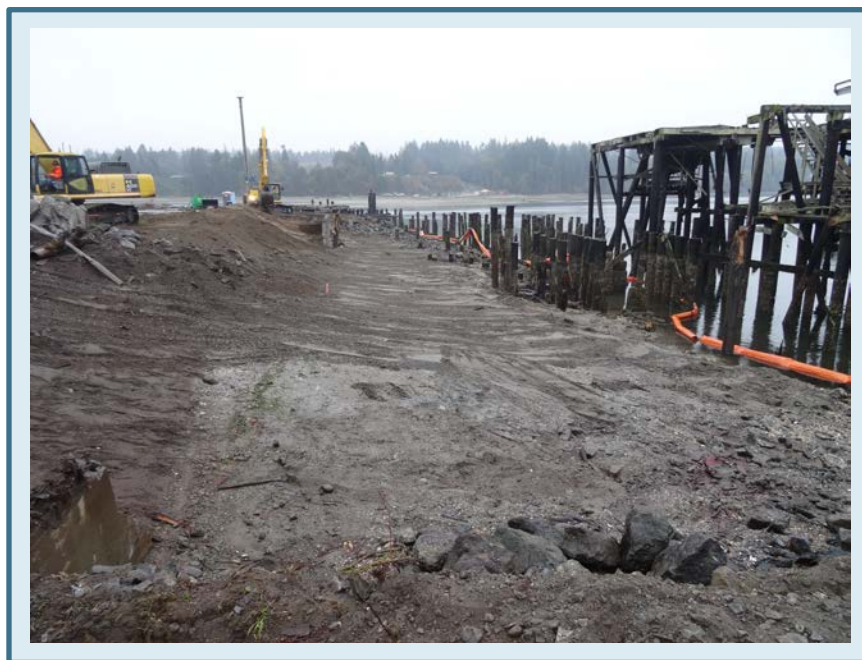
During Construction SMA-2 Shoreline

Intertidal capping was completed concurrent with excavation actions. Excavation equipment as well as excavated material was kept separate from equipment hauling or placing cap material to prevent potential cross-contamination between excavated sediments and cap materials. Stockpiles of clean cap materials and excavated intertidal material were kept separate from each other to avoid cross-contamination. At a minimum, an initial (6-inch) layer of cap material was placed over the excavated area during the same tide cycle that the excavation occurred, prior to the incoming tide. The full cap thickness was constructed generally within the same day or during the work shift immediately following completion of excavation. Intertidal excavation and capping during Season 1 was completed on December 29, 2015.

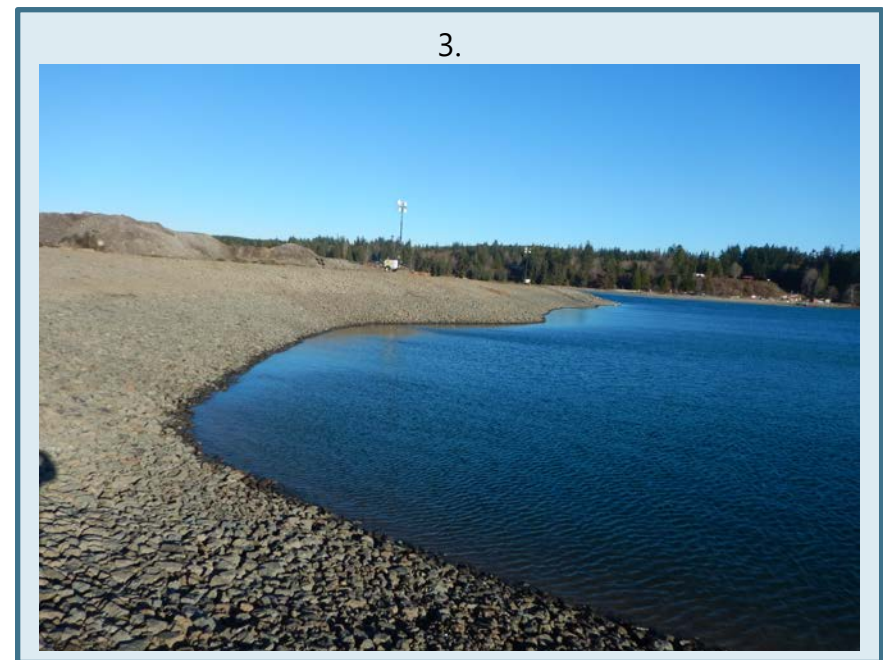
Post-construction SMA-2 Shoreline

All of the required intertidal excavation and capping in SMA-2 was completed during Season 1, with the exception of a small area in the footprint of a former pier structure (Pier 4), which was completed following the removal of the structure in Season 2. Pier 4 was not removed in Season 1 because it was needed as a contingency loading/off-loading area during Season 2 (the potential use of all three loading facilities was maintained for both seasons). All excavation areas and engineered cap layers were surveyed as the work progressed to confirm that the required depth of excavation and cap layer thickness was successfully achieved.

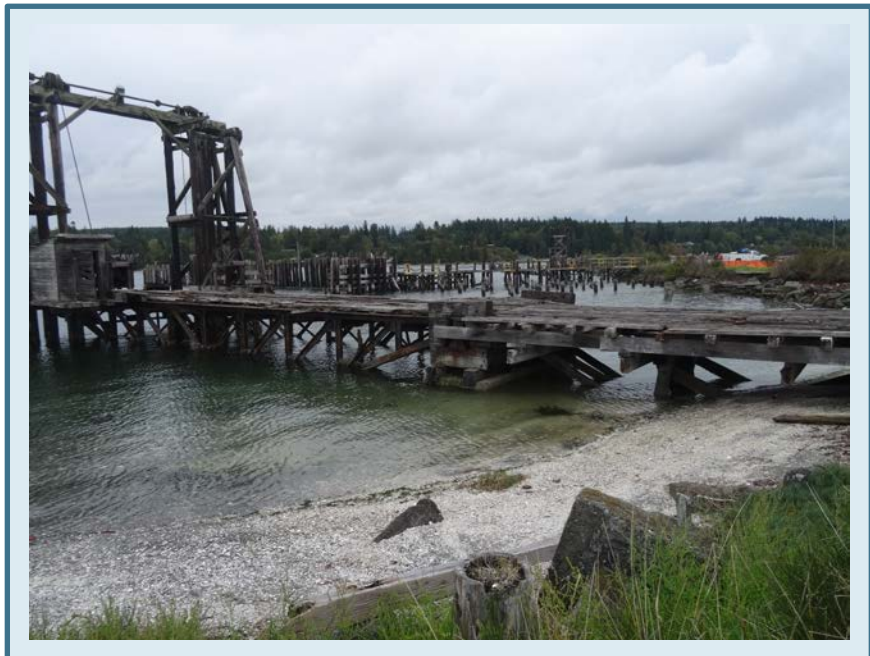
Pre-Construction SMA-1 Shoreline

Intertidal excavation and capping activities began in late July 2016, following the removal and stockpiling of large riprap from the SMA-1 intertidal shoreline. Intertidal areas were excavated “in the dry” using land-based excavation and dozer type equipment. To accomplish this, work shifts were scheduled during daytime low tides in late July and August 2016, and for work in proximity to the loading facilities, shifts were scheduled during nighttime low tides in late November and December 2016 (former Pier 4 area). In SMA-1, localized areas of erosion due to seeps in the shoreline bank were encountered during excavation and resulted in over steepened banks. This issue was addressed by a cap design modification and included backfilling over-steepened sections of the intertidal slope with layers of armor rock and aggregate to construct a stable slope.

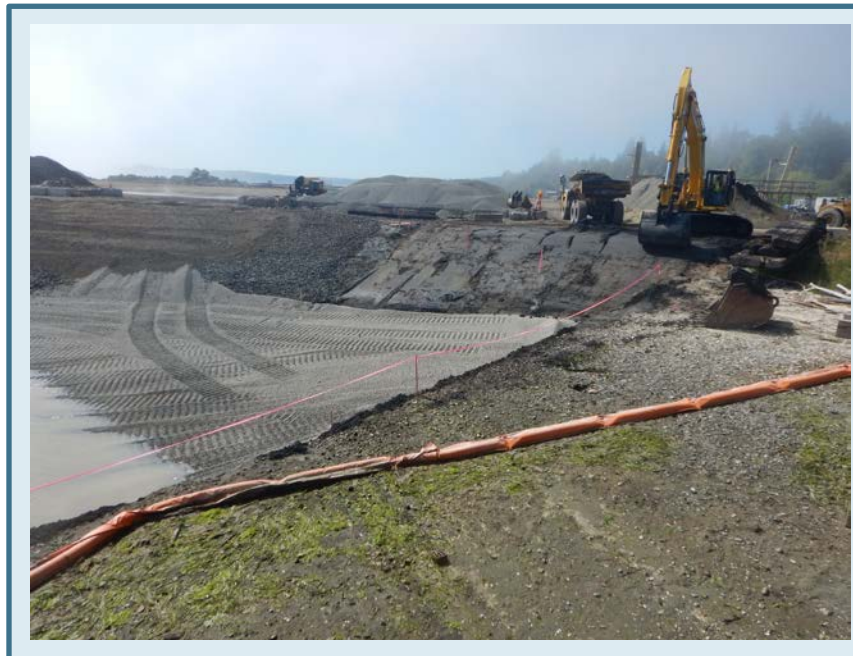
During Construction SMA-1 Shoreline

Intertidal excavation progressed from south to north, and the excavation was generally sequenced from higher elevations to lower elevations. Intertidal capping was completed concurrently with the excavation as described above in Section 3.1.1.3. Intertidal excavation and capping in Season 2 was completed in early January 2017. All excavation areas and engineered cap layers were surveyed as

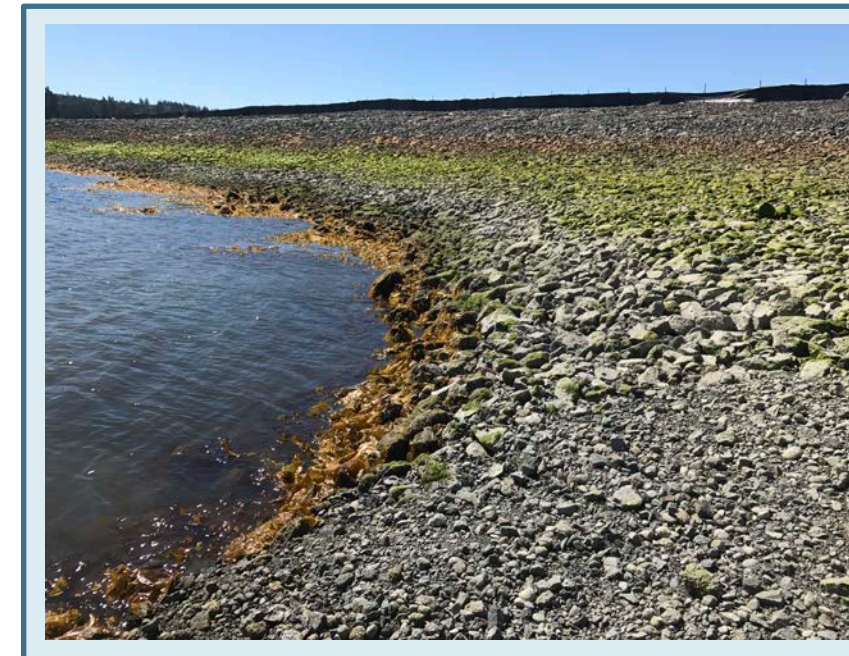
Post Construction SMA-1 Shoreline

the work progressed to confirm that the required depth of excavation and cap layer thickness was successfully achieved.

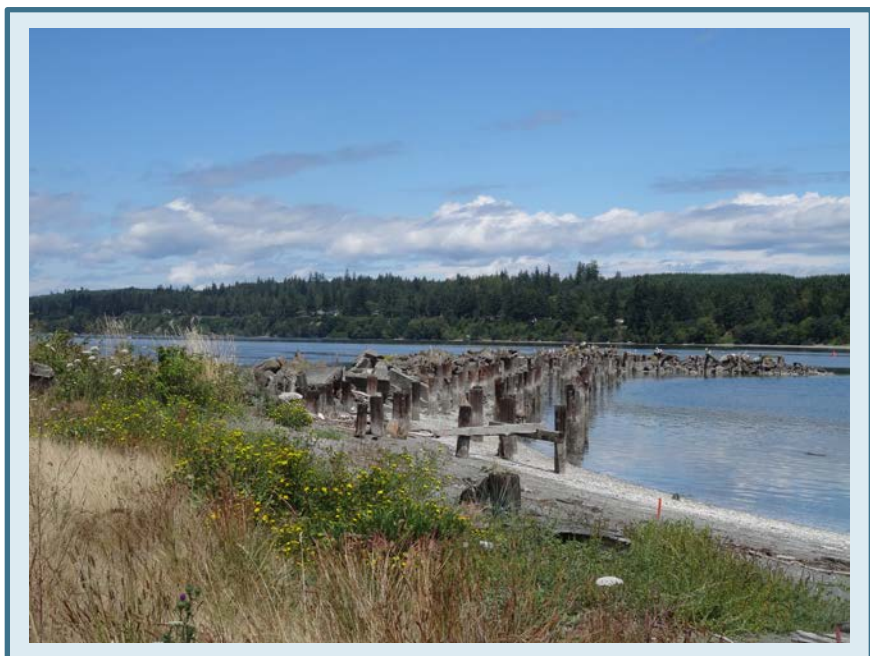
Pre-Construction Jetty

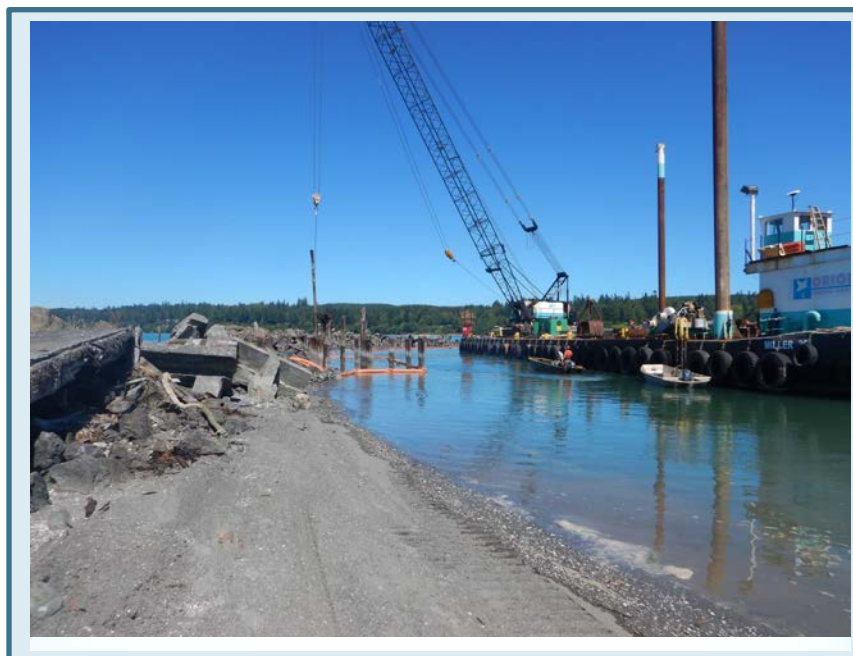
During Construction Jetty

- Removal of large concrete debris from the jetty crest and placement of armor rock
- **South Mill (SMA-2):** An approximate 20-acre area located immediately south and east of (adjacent to) the former Mill Site, SMA-2 also contained localized deposits of subtidal wood waste (including sawdust, chips, and bark), particularly adjacent to the former alder mill chip loading area. Construction activities performed in SMA-2 included:

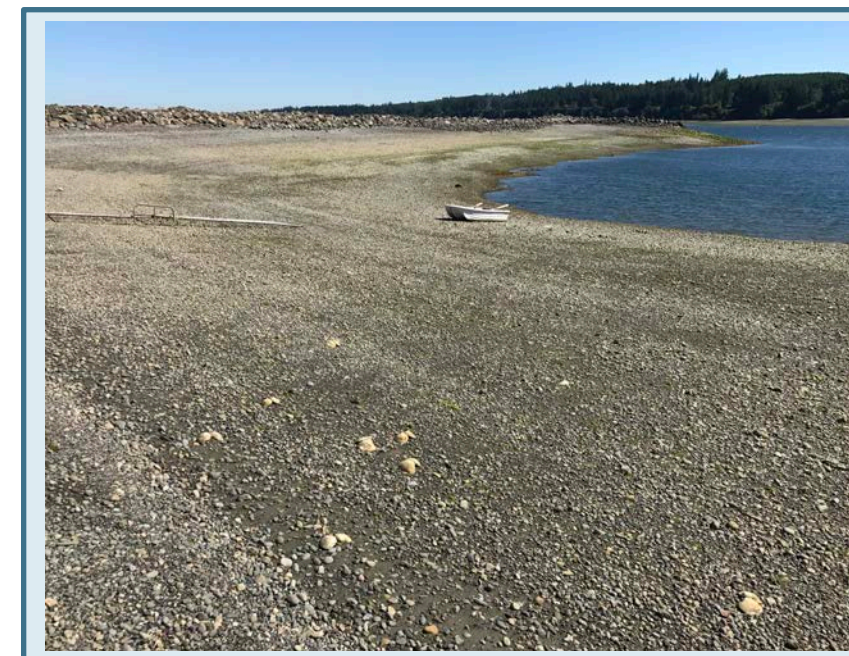
Post-Construction Jetty
