Revised 2011 Annual Report Ground Water Monitoring and Interim Action Performance Monitoring

Pasco Landfill Site Pasco, Washington

Project Number: 03911-2

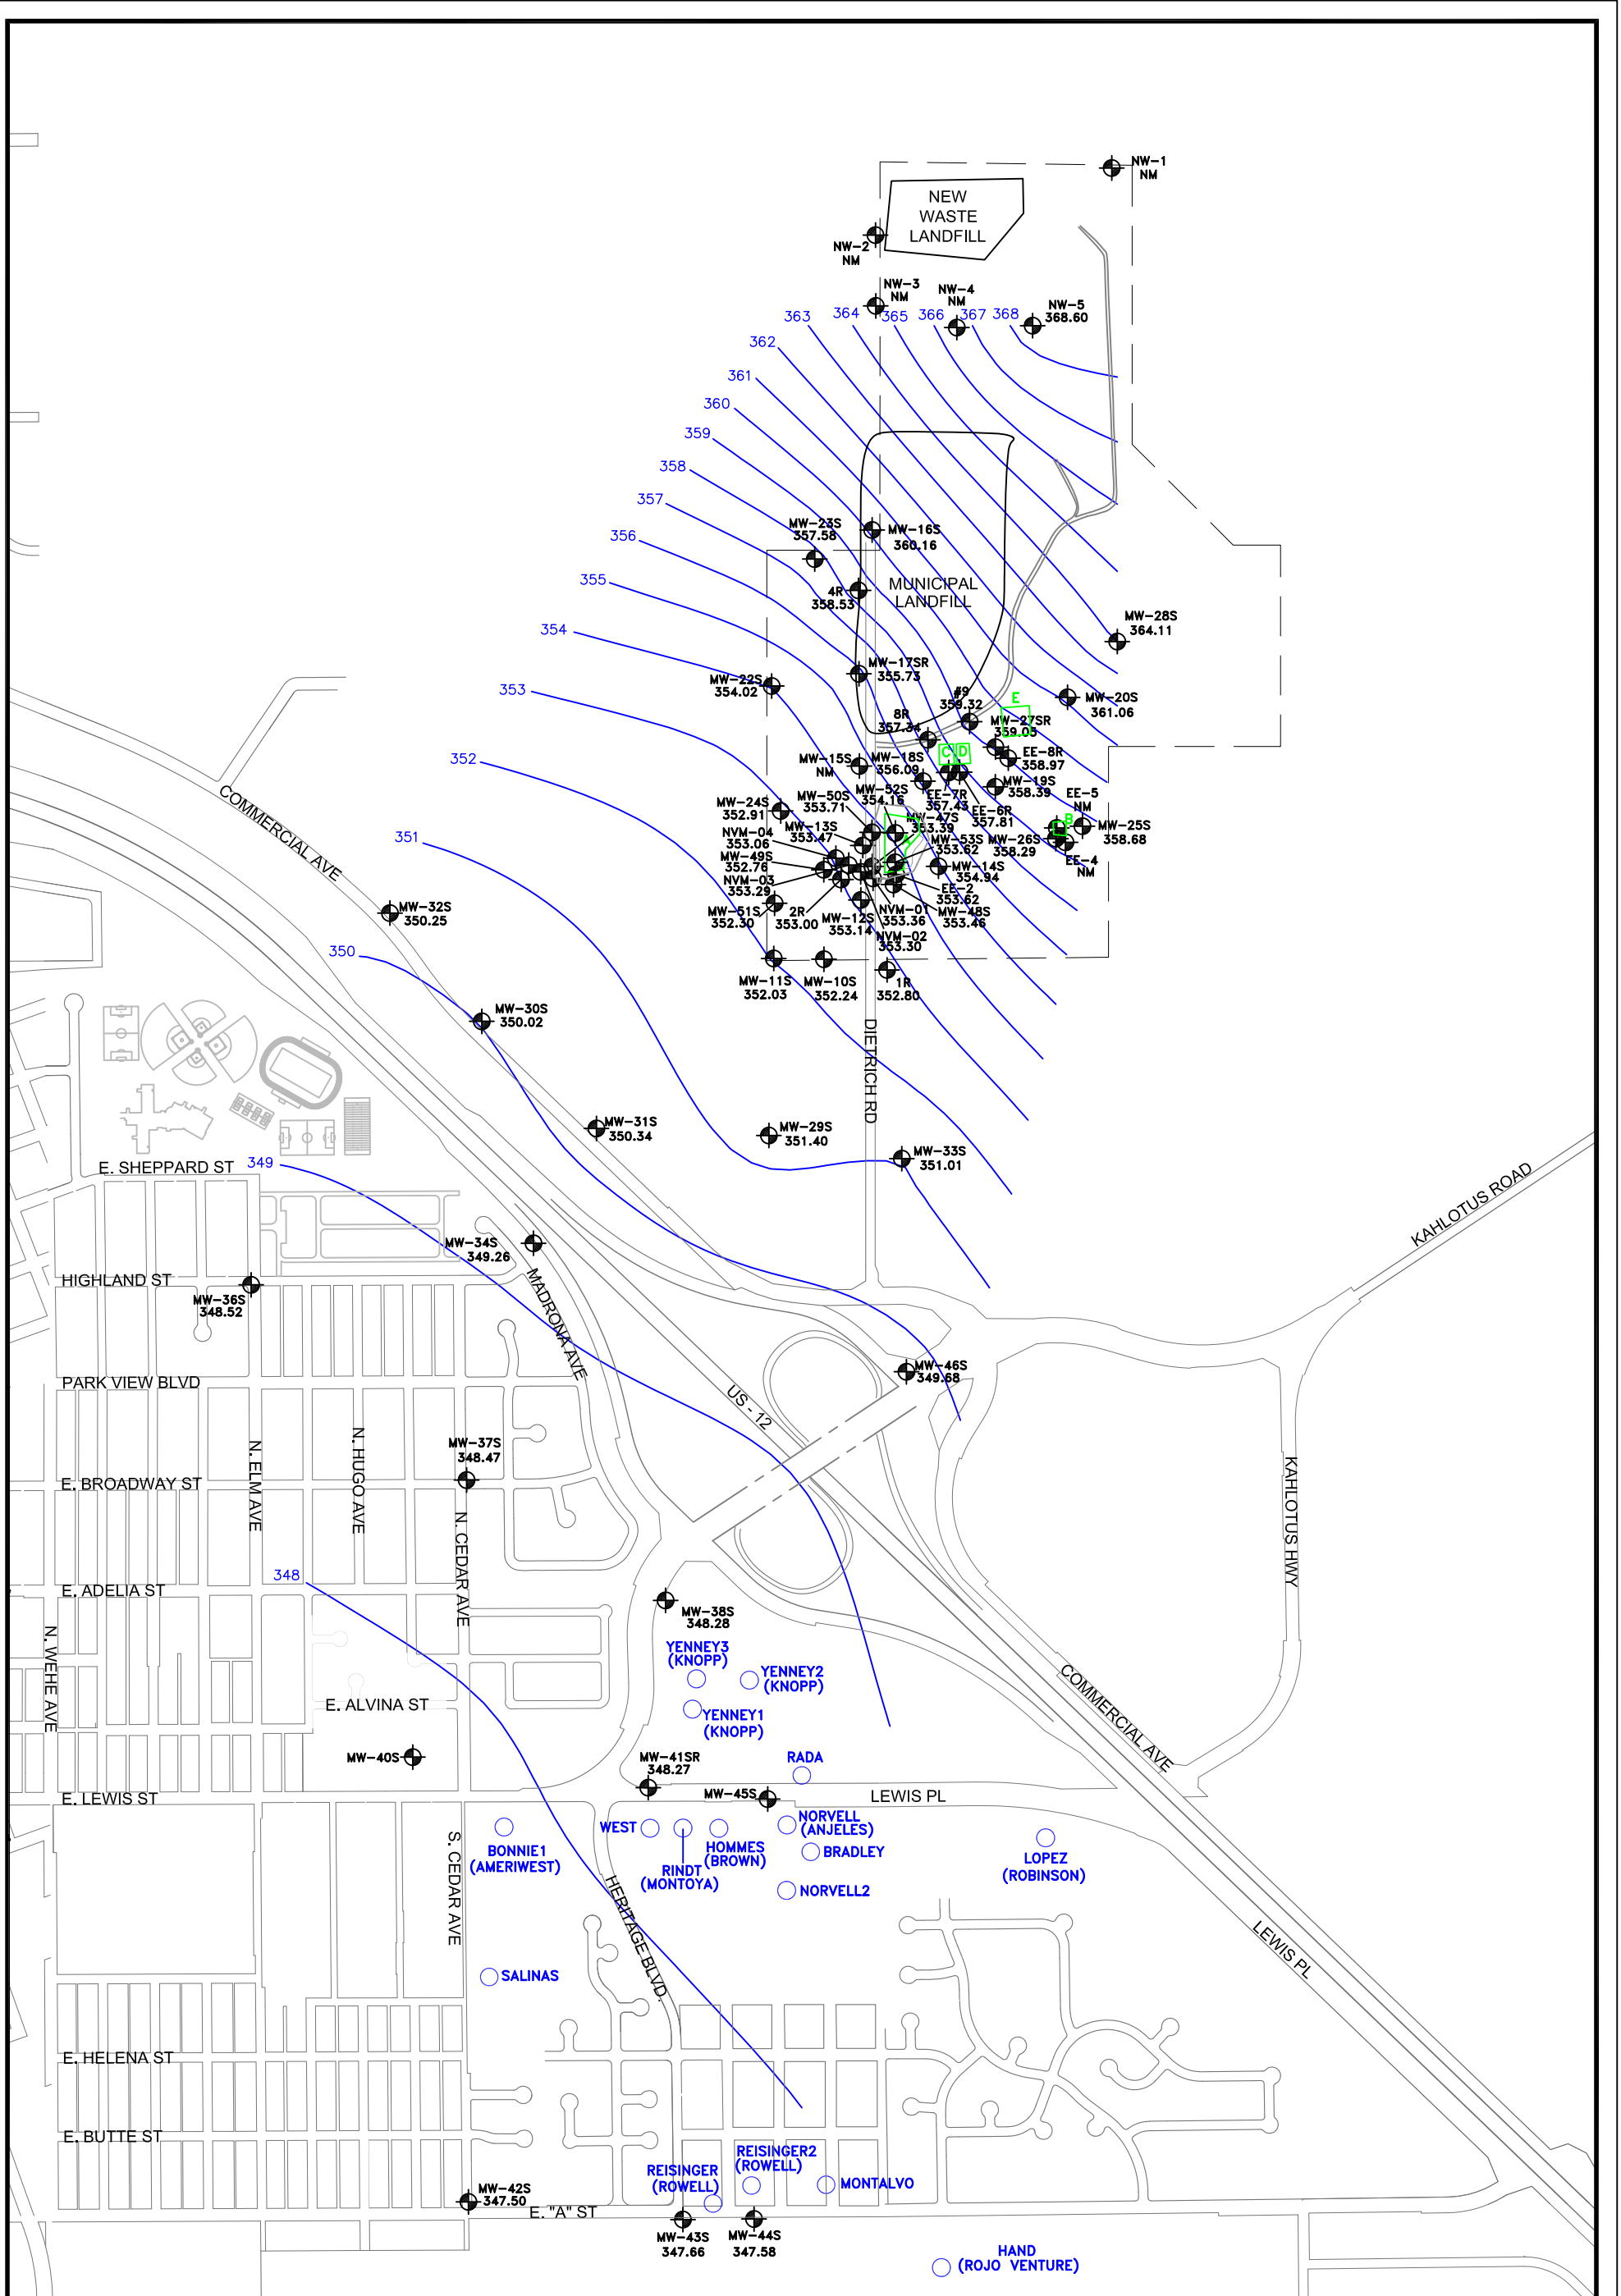
MW-42S 347.50 SHALLOW AQUIFER MONITORING WELL WITH WATER ELEVATION IN FEET, NAVD88 (NM = NOT MEASURED)

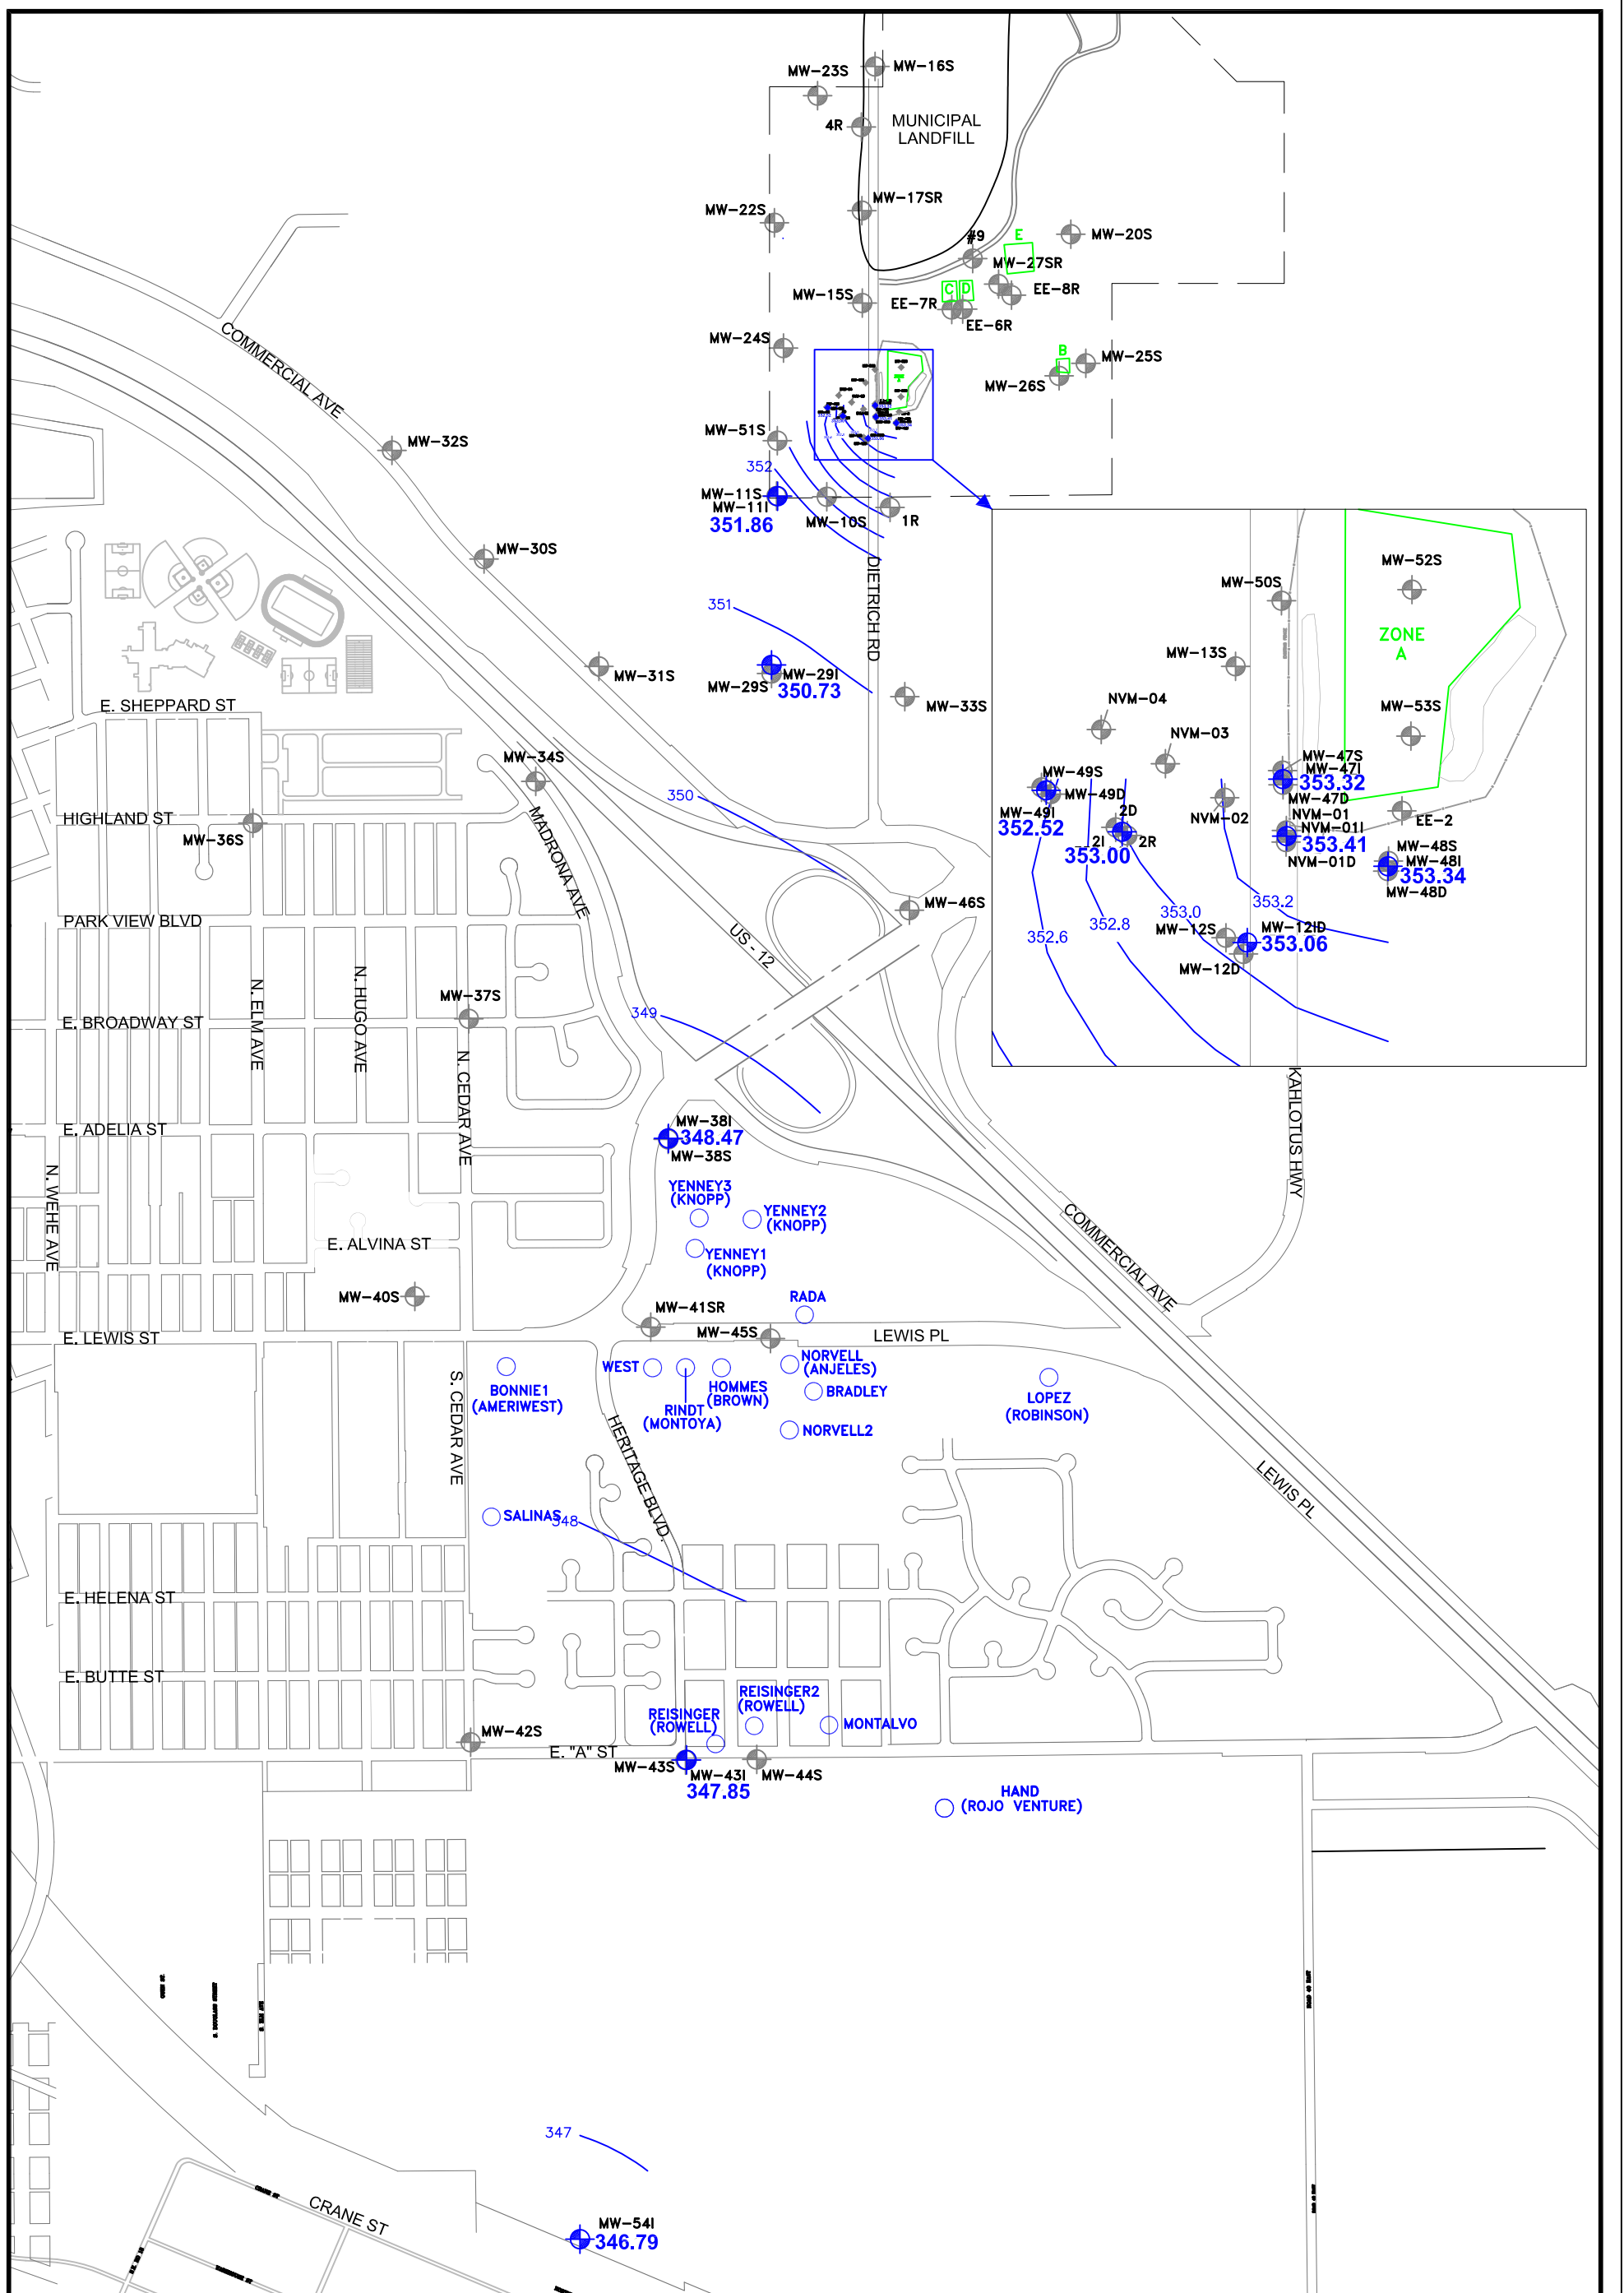
MW-47I 354.47 INTERMEDIATE AQUIFER MONITORING WELL WITH WATER LEVEL IN FEET, NAVD88
 MW-47D SHALLOW AND DEEP MONITORING WELLS (INCLUDED FOR LOCATION REFERENCE)
 WATER ELEVATION CONTOUR (CONTOURS ARE DRAWN EVERY 0.2 FEET FROM MW-47I TO MW-111 AND EVERY FOOT FROM MW-111 TO MW-54I.)

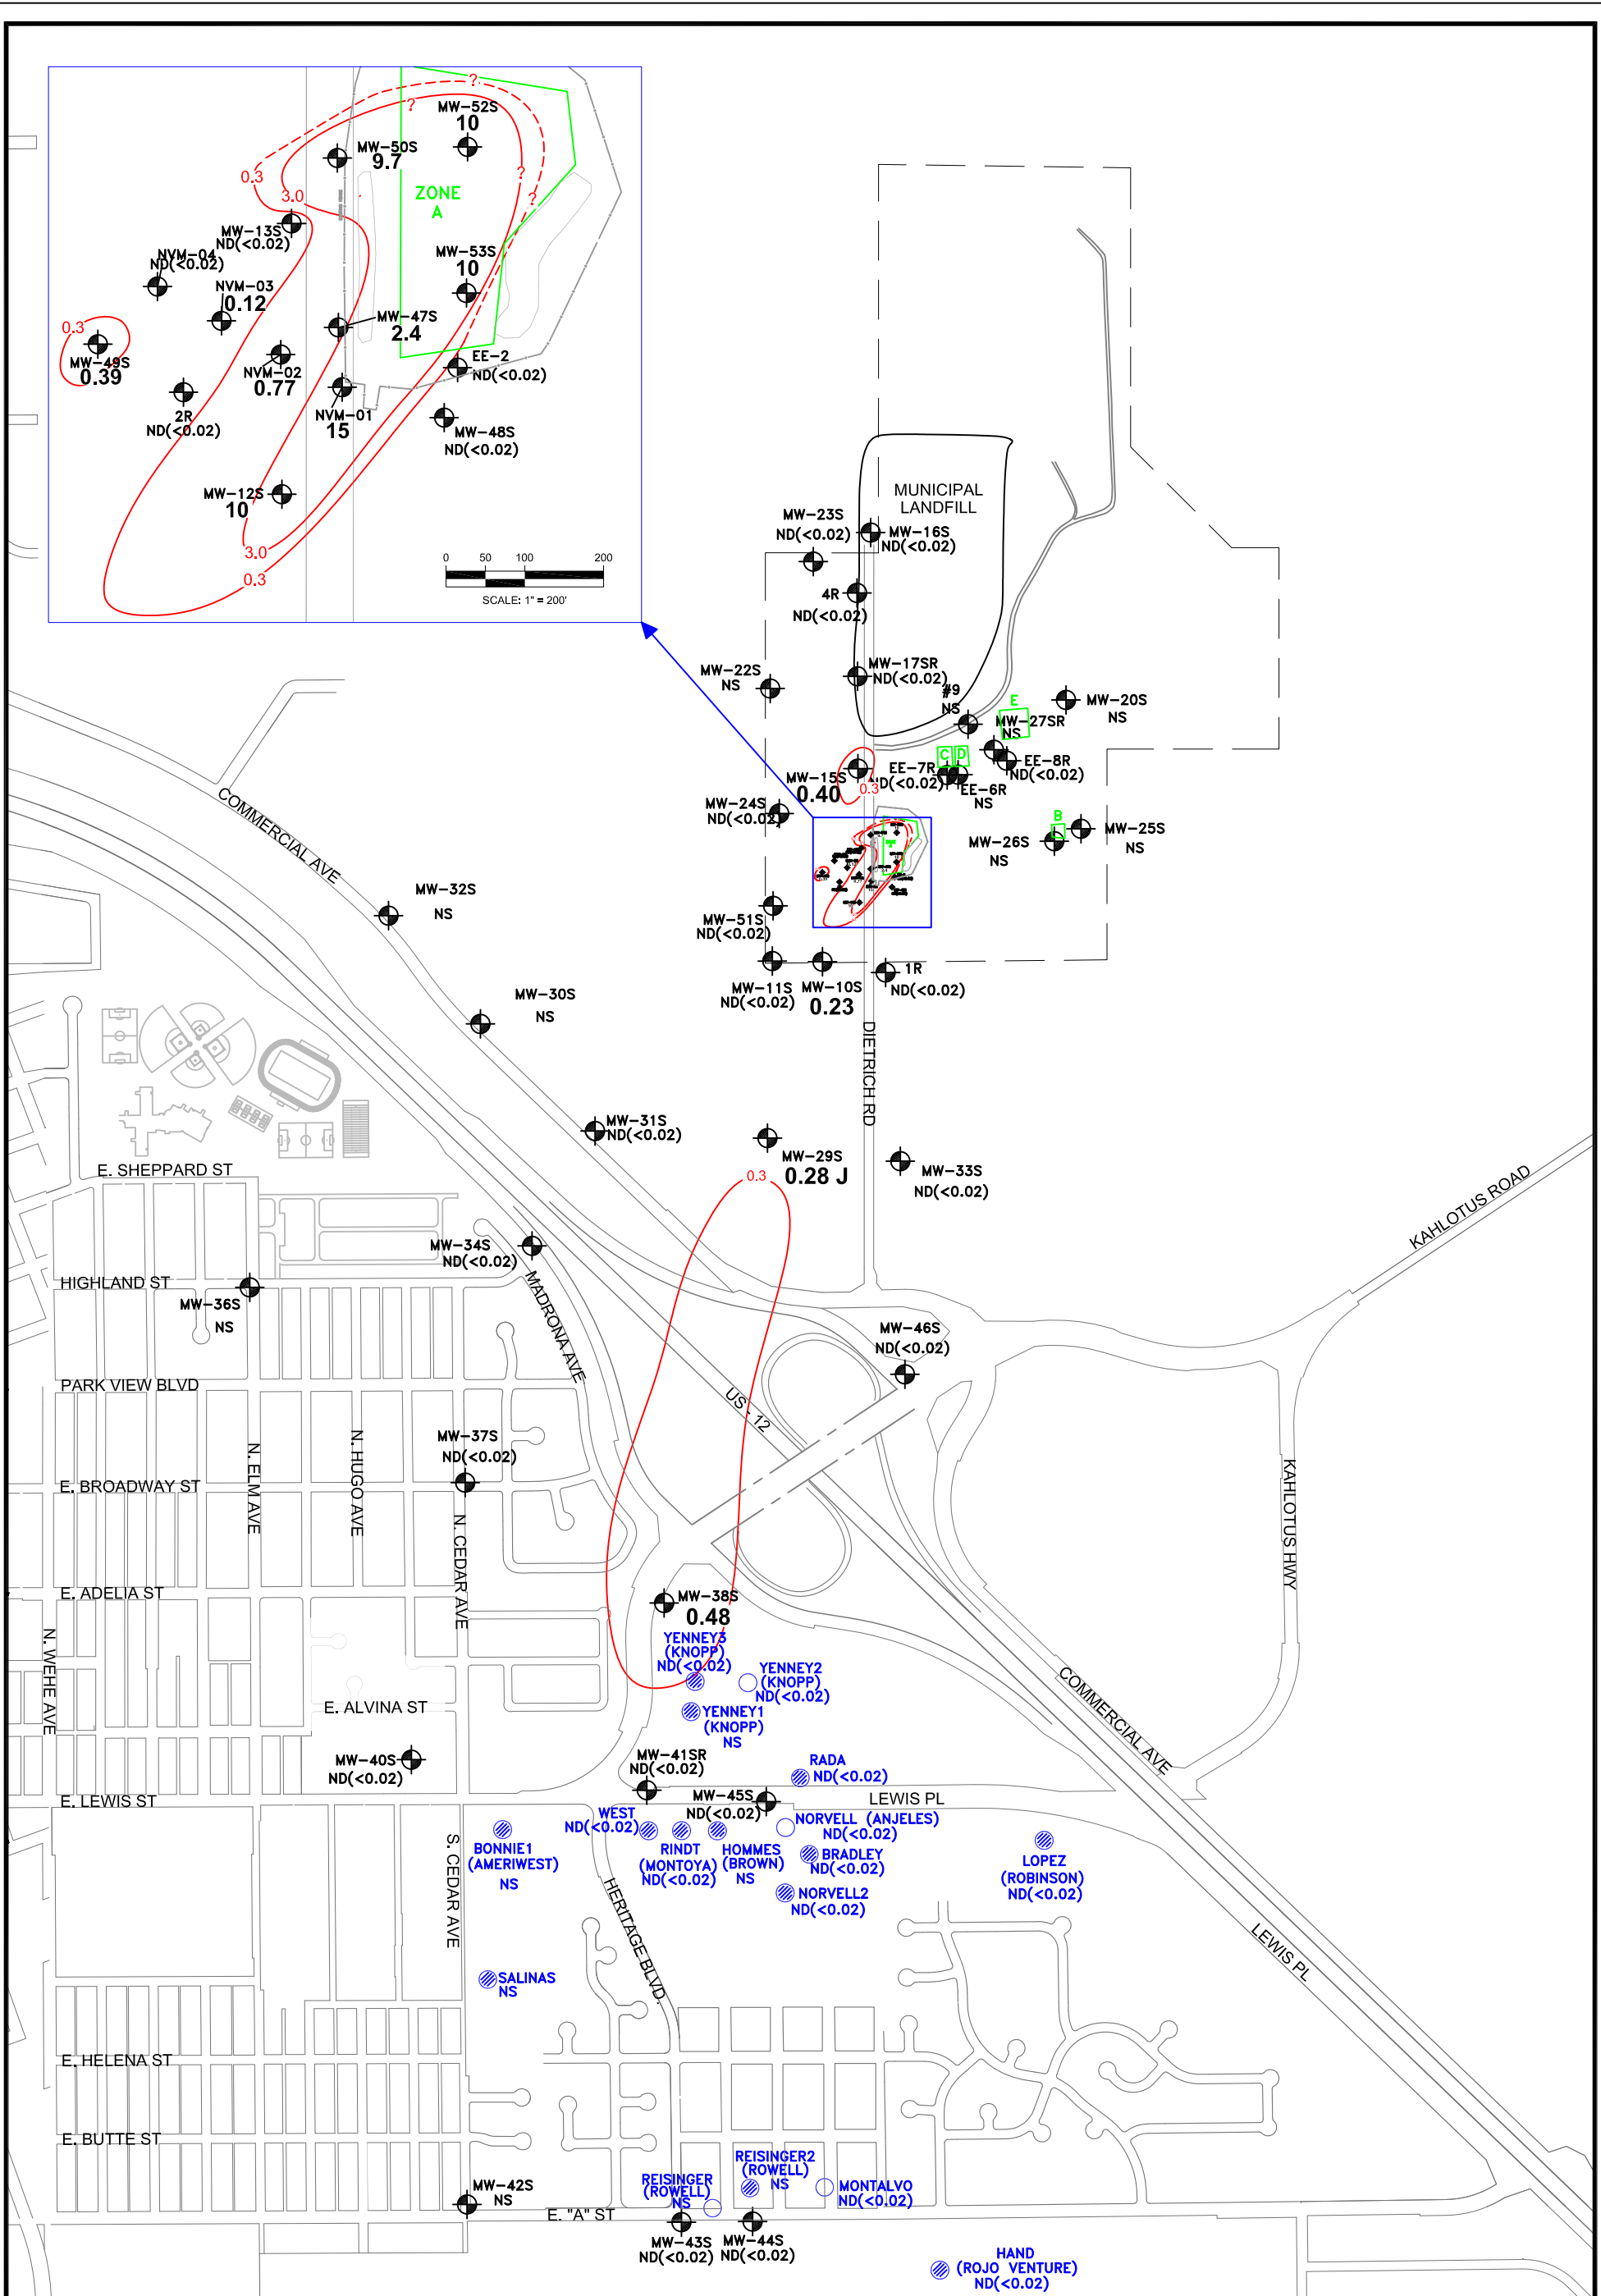
ND	Not Detected	MW-38S	Monitoring Well
NS	Well Not Sampled	0.48	Concentration in Ground Water (ug/L)
NA	Not Analyzed	HAND	Residential Well
DV	Refused Data Refused During Data Validation Process	BONNIE1	Residential Well, Non-Potable Water Use (According to City of Pasco Survey)
		0.3	Trichloroethene Concentration Contour
		- - -	Dashed Where Inferred, Querried Where Uncertain
		●	Wells Colored Blue Not Used to Create Contours
			Trichloroethene Draft Cleanup Level = 0.3 ug/L

TCE concentrations were detected in shallow and intermediate wells along the inferred axis of the dissolved-phase plume from MW-29S/I downgradient to MW-54I. The highest TCE concentrations downgradient of the Site were observed at MW-38S with decreasing concentrations in both the upgradient and downgradient directions.

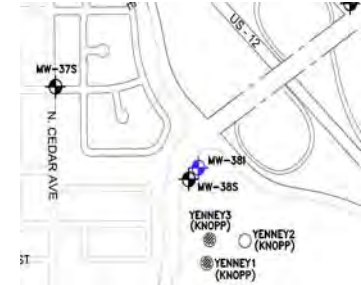
SUBSURFACE PROFILE				SAMPLE			PID (ppm)	Well Data	Comments
Depth	Elevation	Log	USCS Code	Description	Interval	Recovery	Blows per 6"	Sample			
0	428.5			Ground Surface							
			SP	Poorly-Graded Sand Red-brown; damp; mostly fine sand Becomes brown Becomes olive gray; grades to mostly fine sand with trace silt and trace gravel				MW38I@15.5 Grab	1.0		Above ground completion Concrete surface seal
5									1.6		2" Sch. 40 PVC Blank

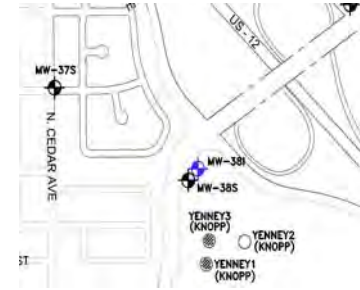
Boring/Well Designation: MW-38I

SUBSURFACE PROFILE				SAMPLE			PID (ppm)	Well Data	Comments
Depth	Elevation	Log	USCS Code	Description	Interval Recovery	Blows per 6"	Sample				
30	398.5		SP	Black (Salt and Pepper); damp; mostly medium sand				2.0		2" Sch. 40 PVC Blank	
35				Grades to fine to medium sand with trace silt				1.4		Bentonite grout	
40								1.7			
45	387.0		SP	Olive gray; damp; mostly fine sand				1.2			
50	380.5		SP-SM	Poorly-Graded Sand with Silt Olive gray; moist; mostly fine sand with few silt			MW38I@50	0.6			
	378.5

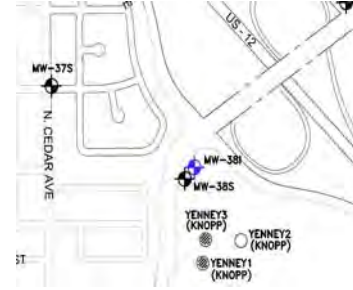
Boring/Well Designation: MW-38I

SUBSURFACE PROFILE				SAMPLE			PID (ppm)	Well Data	Comments
Depth	Elevation	Log	USCS Code	Description	Interval	Recovery	Blows per 6"	Sample			
80	350.5	[Dotted pattern]	SP	Black; saturated; mostly fine to medium sand	[Thick black line]	[Grey bar]			2.0	[Hatched pattern]	2" Sch. 40 PVC Blank
	348.5			Black; saturated; mostly fine to medium sand with few gravel							
85		[Dotted pattern]	GW	Well-Graded Gravel with Sand Black;saturated; mostly fine to coarse gravel with little sand	[Thick black line]	[Grey bar]		MW38I@80 Grab	0.5	[Hatched pattern]	Bentonite grout
				Grades to mostly fine to medium gravel with little sand and trace silt							
90		[Dotted pattern]			[Thick black line]	[Grey bar]			0.2	[Hatched pattern]	10/20 Colorado Silica Sand
95											
100		[Dotted pattern]			[Thick black line]	[Grey bar]				[Hatched pattern]	2" PVC 0.01" Well Screen

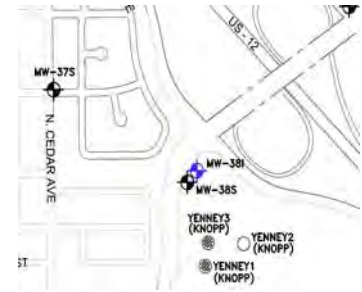
SUBSURFACE PROFILE				SAMPLE			PID (ppm)	Well Data	Comments
Depth	Elevation	Log	USCS Code	Description	Interval Recovery	Blows per 6"	Sample				
	327.5			End of Borehole			MW38I@101	0.0			
105											
110											
115											
120											
125

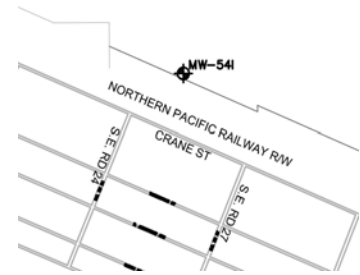
Boring/Well Designation: MW-54I

SUBSURFACE PROFILE				SAMPLE			PID (ppm)	Well Data	Comments
Depth	Elevation	Log	USCS Code	Description	Interval Recovery	Blows per 6"	Sample				
0	374.0			Ground Surface							
			SP	Poorly-Graded Sand with Silt Red-brown; moist; mostly fine sand with few silt Becomes brown					2.1	Above ground completion Concrete surface seal	
5	369.0		SP	Olive gray; damp; mostly fine sand Becomes dry; grades to medium sand; angular White friable mineral Grades to no gravel					3.6	2" Sch. 40 PVC Blank Bentonite grout	
10									3.5		
15				Becomes dark gray							
	356.0		SW	Well-Graded Sand with Gravel Gray; dry; mostly fine to coarse sand with little gravel					3.0		
20									2.4		
				Becomes saturated							
25	349.0										Water Level 24.8' ATD

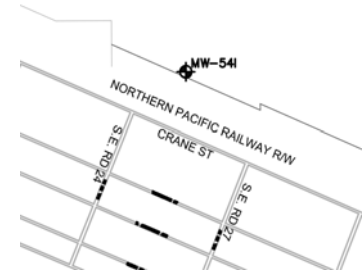
SUBSURFACE PROFILE				SAMPLE		PID (ppm)	Well Data	Comments
Depth	Elevation	Log	USCS Code	Description	Interval Recovery	Blows per 6"	Sample			
30	342.0		SP	Poorly-Graded Sand with Gravel Black (salt and pepper); saturated; mostly fine to medium sand with few gravel			MW543I@26.5	3.2	2" Sch. 40 PVC Blank	
				Becomes saturated					Bentonite grout	
35			GW	Well-Graded Gravel with Sand Black; saturated; mostly fine to coarse gravel with some sand				4.9	Bentonite pellets	
40			GW	Dark gray; saturated; mostly fine to coarse gravel with some sand, few silt and trace cobbles				3.2	10/20 Colorado Silica Sand	
45								3.0	2" PVC 0.01" Well Screen	
50	324.0			End of Borehole
