Coastal Engineering Evaluation of Shoreline Erosion Memorandum

DRAFT MEMORANDUM

To: Linda Berry-Maraist, Pope Resources/Olympic Property Group
From: Kathy Ketteridge, Ph.D., P.E., and John Laplante, P.E., Anchor QEA, LLC
Cc: Clay Patmont, Anchor QEA, LLC
Re: Port Gamble Bay Cleanup Project Coastal Engineering Evaluation of Shoreline Erosion

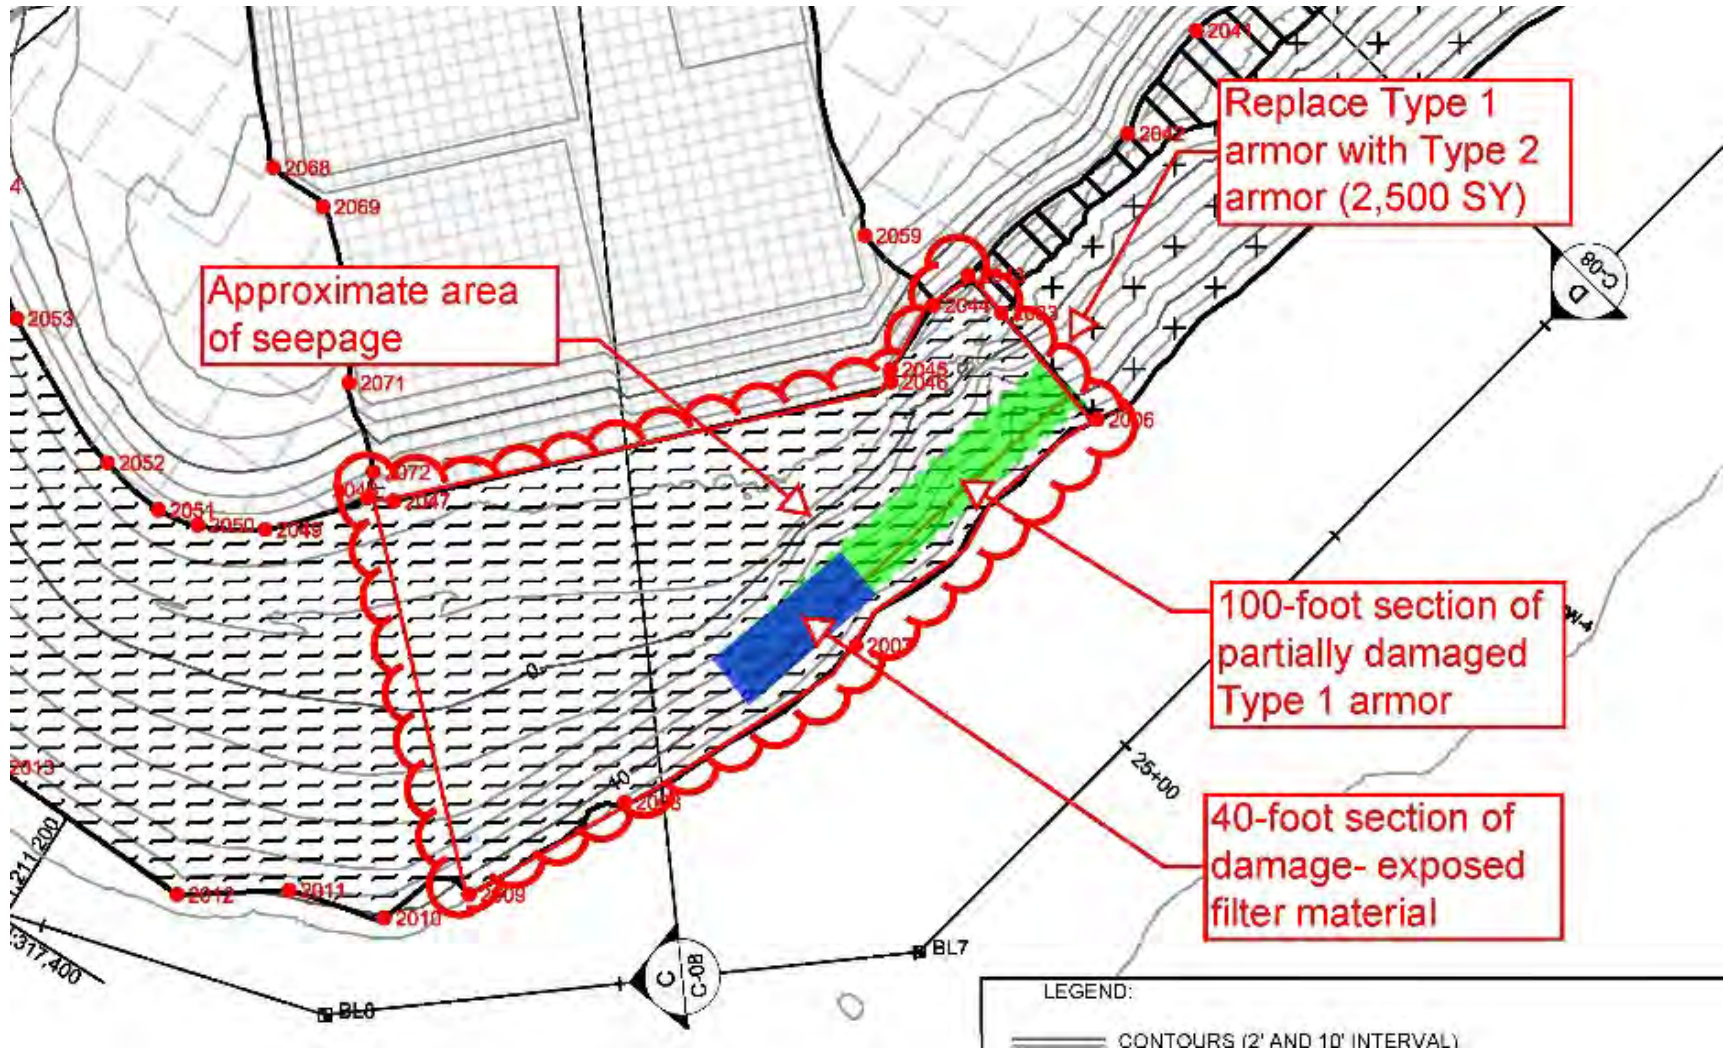
Recommended Repairs – Conceptual Plan

- Wave action
 - Upsize the armor rock from Type 1 to Type 2
 - Coastal engineering evaluation confirming this recommendation
- Toe undermining
 - Buttress toe of slope with larger armor rock to provide weight counteracting seepage and additional protection from potential prop wash forces
 - Geotechnical engineering evaluation confirming this recommendation

- Recommendations for repairs being prepared
- Anticipated recommendation for repairs, subject to completing engineering evaluation:
 - Backfill oversteepened toe with larger armor rock, to 3H:1V
 - Substitute Type 2 armor for Type 1 armor in area of damage
- Refine if needed after engineering evaluations complete
- Submit to Ecology on or before 12/23
- Feedback needed 12/27 to maintain schedule

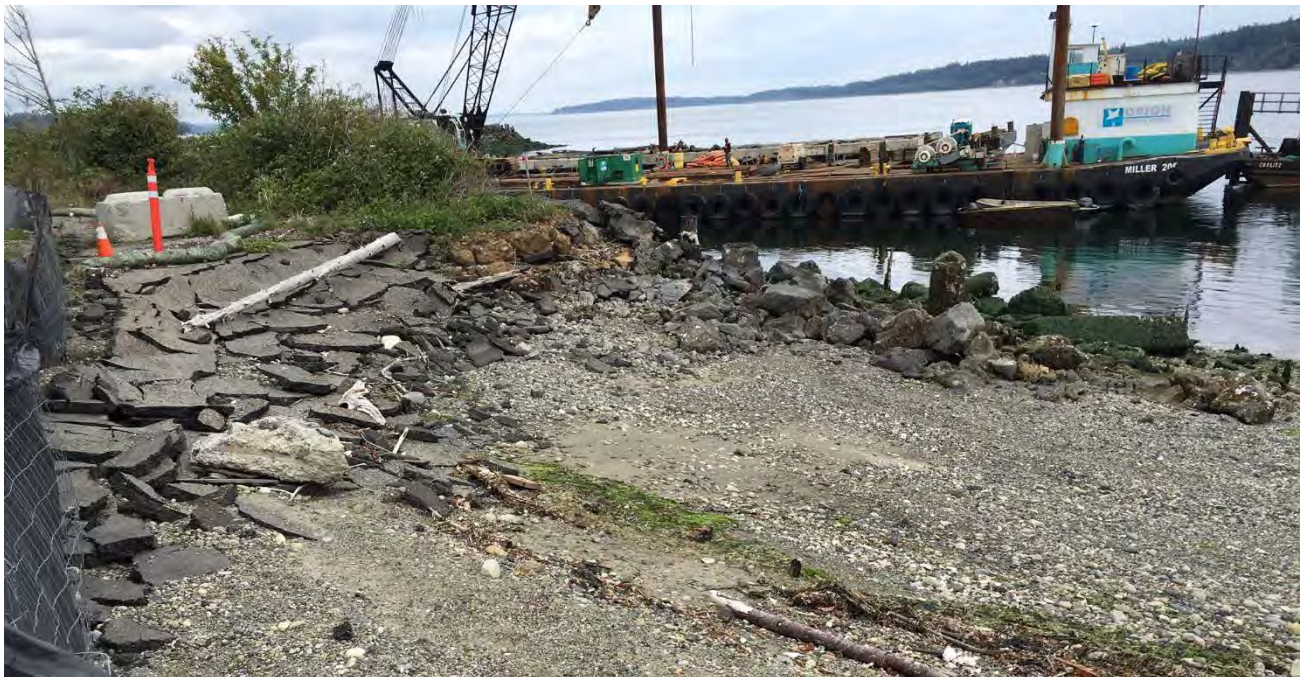
Photograph 1

The shoreline erosion in this area occurred after creosote-treated piling were removed as part of Site remediation. The shoreline area above mean higher high water has eroded in this area, undermining asphalt paving at the top of the slope, as shown in Photograph 1. Figure 2e shows a pre- and post-storm survey transect that illustrates the erosion that has occurred at this location. In general, the slope of the beach in the upper intertidal area is adjusting to match the milder slope present in the lower intertidal area.

Shoreline Erosion in Area 1

Design recommendations to address shoreline erosion in this area are shown in Figure 2e. These design recommendations are focused on preventing erosion of the entire slope from top of bank to the lower vertical extent of wave impact (where natural sediments could be eroded during storms). Damaged asphalt at the top of the slope will be removed and the shoreline armored from the top of the bank down to elevation of -5 feet mean lower low water, which is consistent with armoring extent designed for adjacent capping areas (see Port Gamble EDR, Appendix D). The armor will extend horizontally from the existing armored slope to the south of Area 1 (Area 2A) to the west to cover the entire pocket beach area. Armor will consist of a layer of Type 3 material covered with large salvaged armor rock.

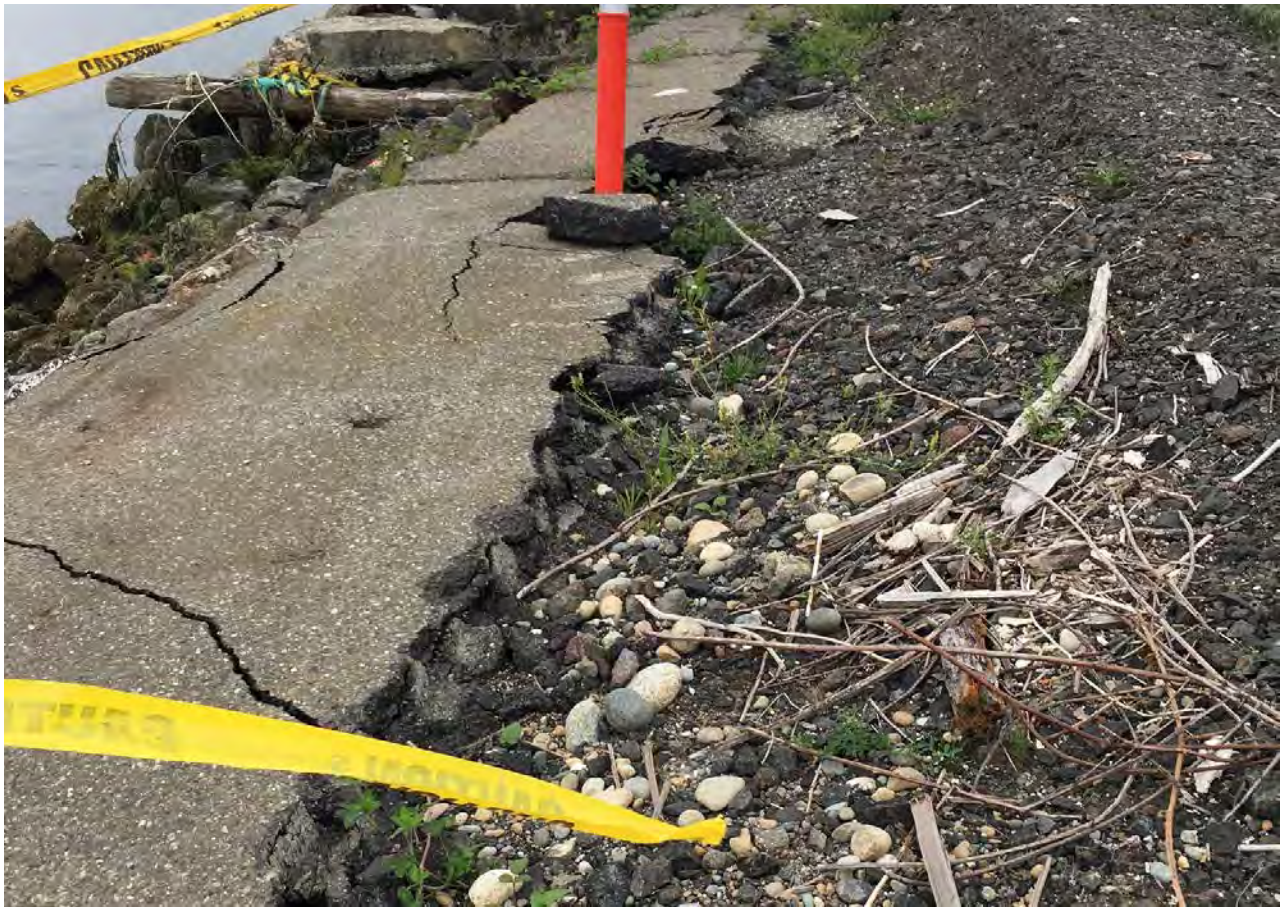
Photograph 2

Similar to Area 1, asphalt at the top of the slope was damaged due to wave runup and overtopping, as shown in Photograph 2, which occurred after the structure in this area (the former Eastern Wharf) was removed. Figure 2d shows a pre- and post-storm survey transect that shows no movement of the armor rock on the slope occurred as a result of the storm events.

Shoreline Erosion in Area 2

The following recommendations to address shoreline erosion (shown in Figure 2d) were carried out prior to publication of this memorandum:

- Damaged asphalt at the top of the armored slope was removed
 - Armor rock at the top of the slope was left in place
 - The area where asphalt was removed was armored from the top of the remaining armor rock on the slope to the top of the bank
 - Placed armor consisted of a layer approximately 1 foot thick of Type 3 material covered with large salvaged armor rock (varied in size from 1 to 3 feet in diameter).
-

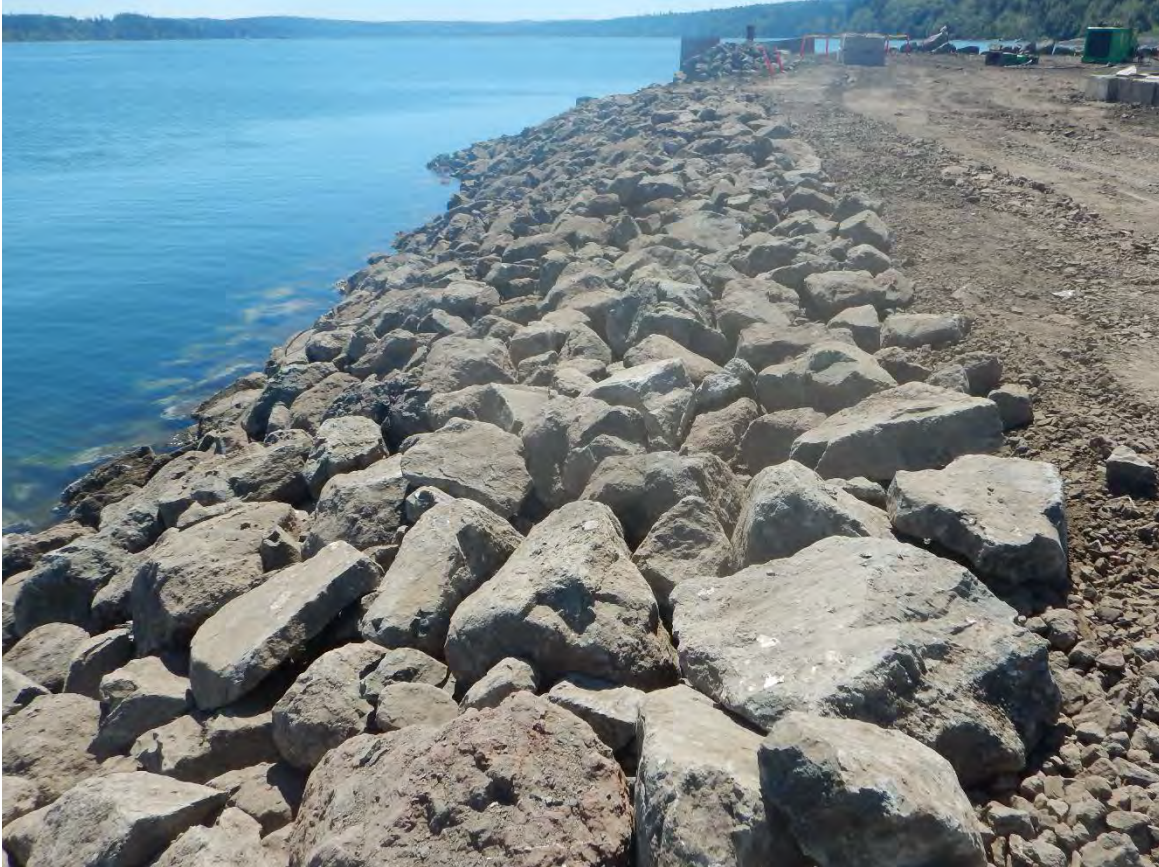
Photograph 3

The work described above was completed on August 12, 2016. The completed stabilization work is shown in Photograph 3.

Completed Shoreline Repair in Area 2

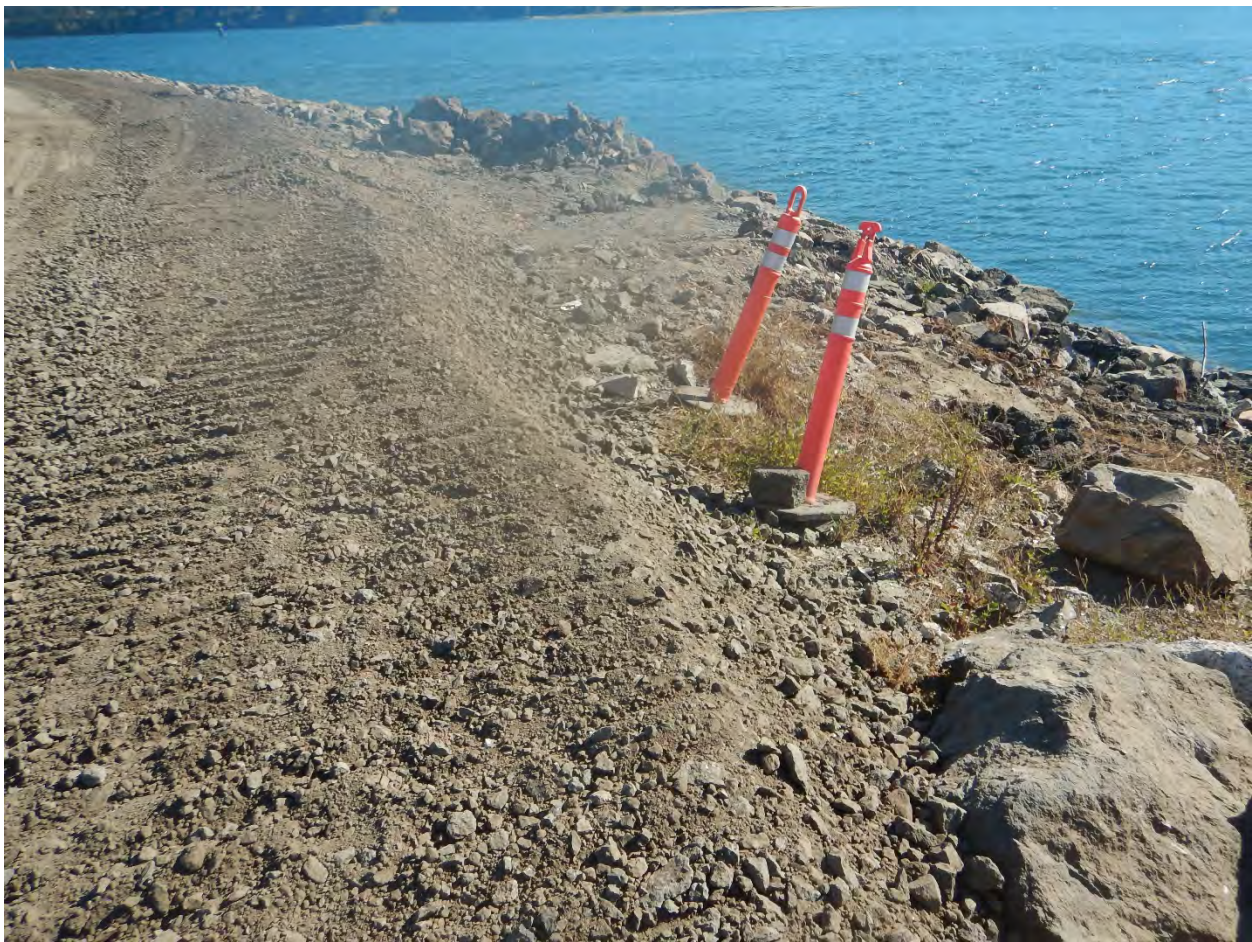
Photograph 4

Shoreline Area 2B Prior to October 2016 storm event

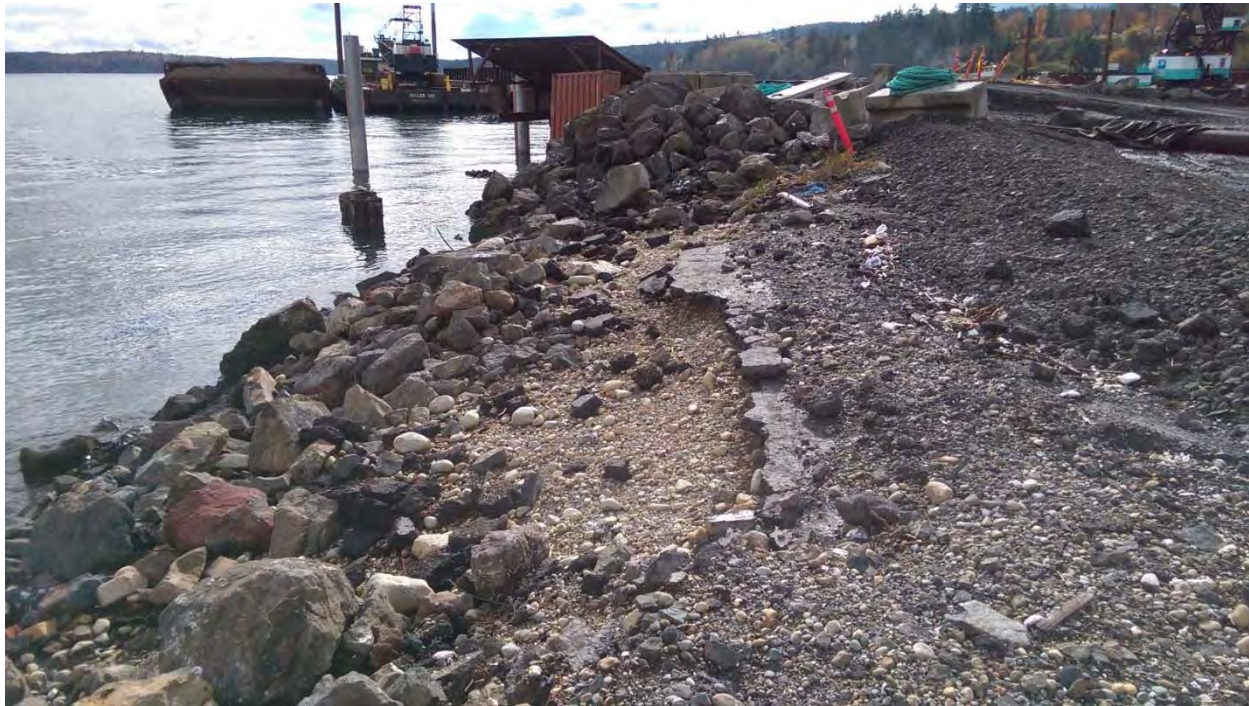
Erosion of the area during the October storm event was focused along the top of the bank and upper portions of the slope due to a lack of armoring in those areas, as shown in Photograph 4. Photograph 5 shows an image of this area following the October 2016 storm, which illustrates erosion of the top portion of the slope and bank line. Similar to other areas of erosion, the upper shoreline has eroded back to a milder slope to match the existing slope in the lower intertidal area.

Shoreline Area 2B Following to October 2016 storm event

Recommendations to address erosion in Area 2B (as shown in Photograph 5) should be in-line with slope armoring suggested at Area 2A, which has already been completed:

- Damaged asphalt at the top of the armored slope should be removed
- The bank should be armored from mid-slope where armor currently exists to the top of bank (upper extent of armoring in adjacent area as shown in Photograph 5).
- Placed armor should consist of Type 3 material covered with large salvaged armor rock

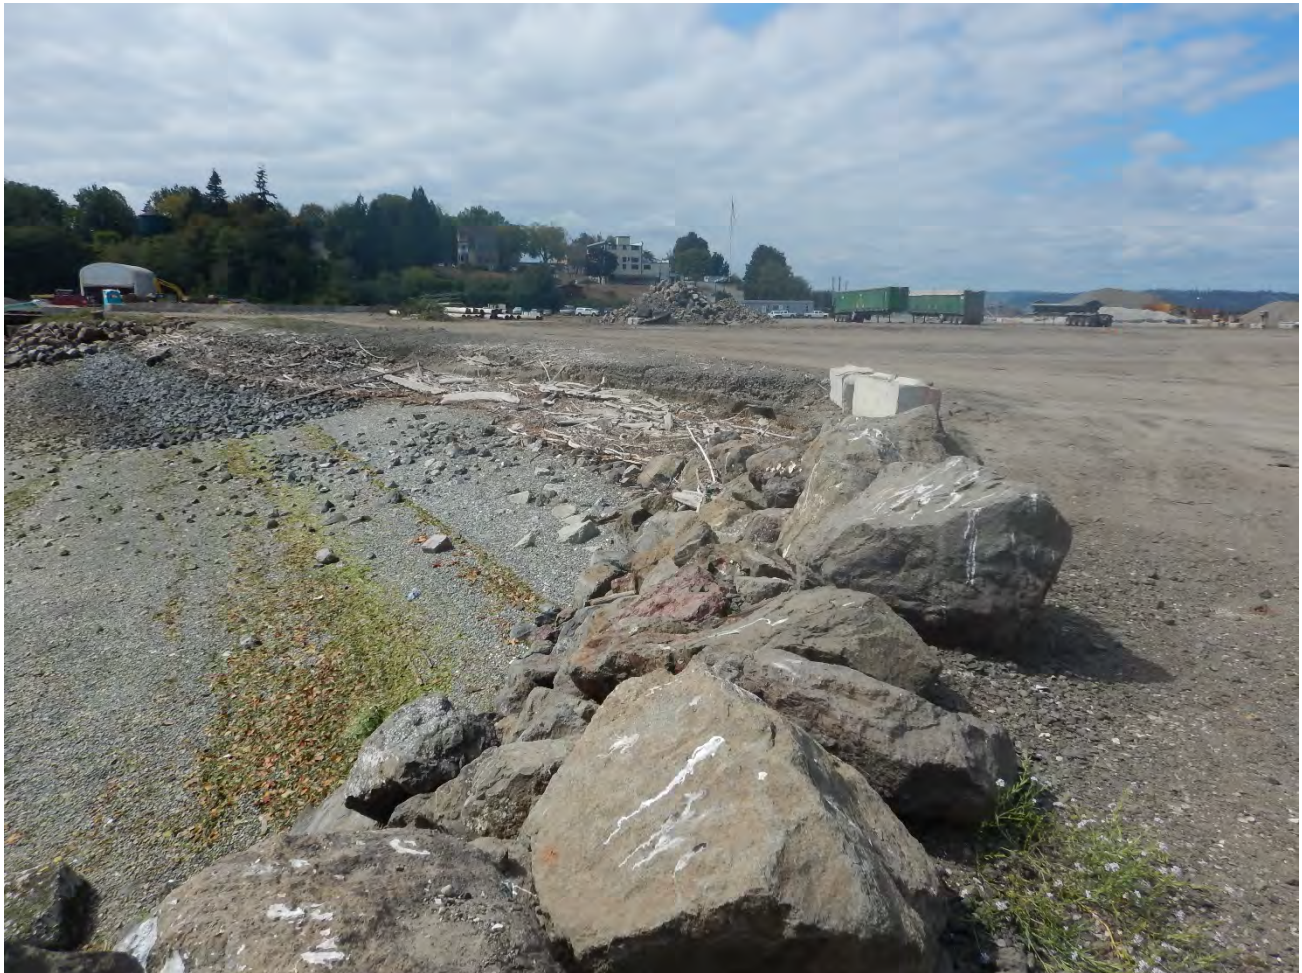
Photograph 4

Erosion of the area during this storm event was intensified due to the two adjacent armored areas, as seen in Photograph 4. Figure 2c shows a pre- and post-storm survey transect that shows the shoreline erosion in this area. Similarly to Area 1, the upper shoreline has eroded back to a milder slope to match the existing slope in the lower intertidal area.

Shoreline Erosion in Area 3

Design recommendations to address shoreline erosion in this area are shown in Figure 2c. These design recommendations are focused on preventing erosion of the entire slope from top of bank to the lower vertical extent of wave impact (where natural sediments could be eroded during storms). The shoreline in this area will be armored between the end of the

Type 2 cap area and the armored shoreline at the location of the temporary transload area. Armor will consist of a layer of Type 3 material covered with large salvaged armor rock. The armor will extend from the top of the bank down to elevation of -5 feet mean lower low water, which is consistent with armoring extent designed for adjacent capping areas (see Port Gamble EDR, Appendix D).

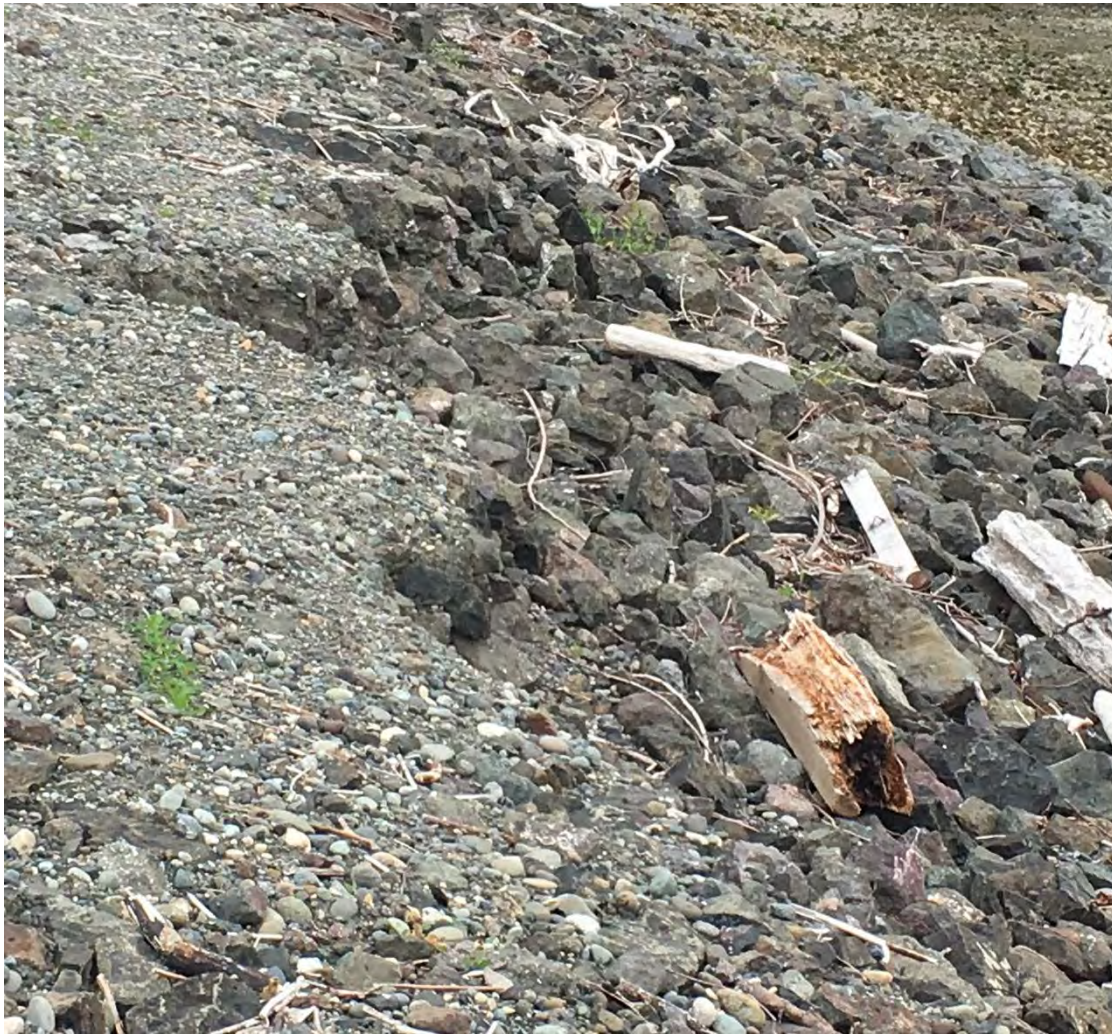
Photograph 5

The upper intertidal shoreline in Areas 4 and 5 were capped with Type 2 armor rock. Some of the armor rock was displaced in the upper inner tidal zone due to wave impact from the storm events. As stated previously, localized movement of armor rock can occur during a design storm event; this design decision allows for a balance of using a more habitat-friendly armor rock size while still ensuring the protectiveness of the remedy. Specifically, the armor was sized to allow for “start of damage,” or movement of some armor rock but not failure of the slope (USACE, 2002). The March 13 storm, as documented in Section 1, was up to a 100-year storm event based on wind velocity data, which was the design storm event for the slope. In addition, the high winds that occurred during that storm event lasted for approximately 32 hours, which is significantly longer than the typical design storm event in the Puget Sound area.

Figure 2b shows a survey transect within Area 4 that illustrates Type 2 rock movement where the majority of the design rock thickness was displaced. However, as seen in Photograph 5, the extent of this level of damage is small, affecting approximately 20 to 30 feet of shoreline.

Shoreline Erosion in Area 4

Design recommendations to address movement of the Type 2 cap material localized within Area 4 include adding additional armor rock larger than the Type 2 rock previously placed in that area. As mentioned above, Type 2 rock was sized using design wave conditions (See Port Gamble EDR, Appendix D) assuming movement of some armor rock during the design

storm event (100-year return period) but not failure of the slope (USACE, 2002). Ecology has expressed concerns about this area, and would prefer a more conservative armoring solution for this area. Therefore, a larger armor rock has been sized for placement in Area 4 assuming a “zero damage” factor as opposed to the “start of damage” factor used in the previous calculations to balance stability and habitat goals for the project. Using the same design significant wave height (2.7 feet) the armor rock size assuming “zero damage” (or no movement of the rock at all) is 1.5 feet. Based on this, Anchor QEA recommends placing two-layers of 1 to 1.5 foot rock within Area 4 where significant movement has occurred (the approximate extent of this damage is shown in Figure 1).

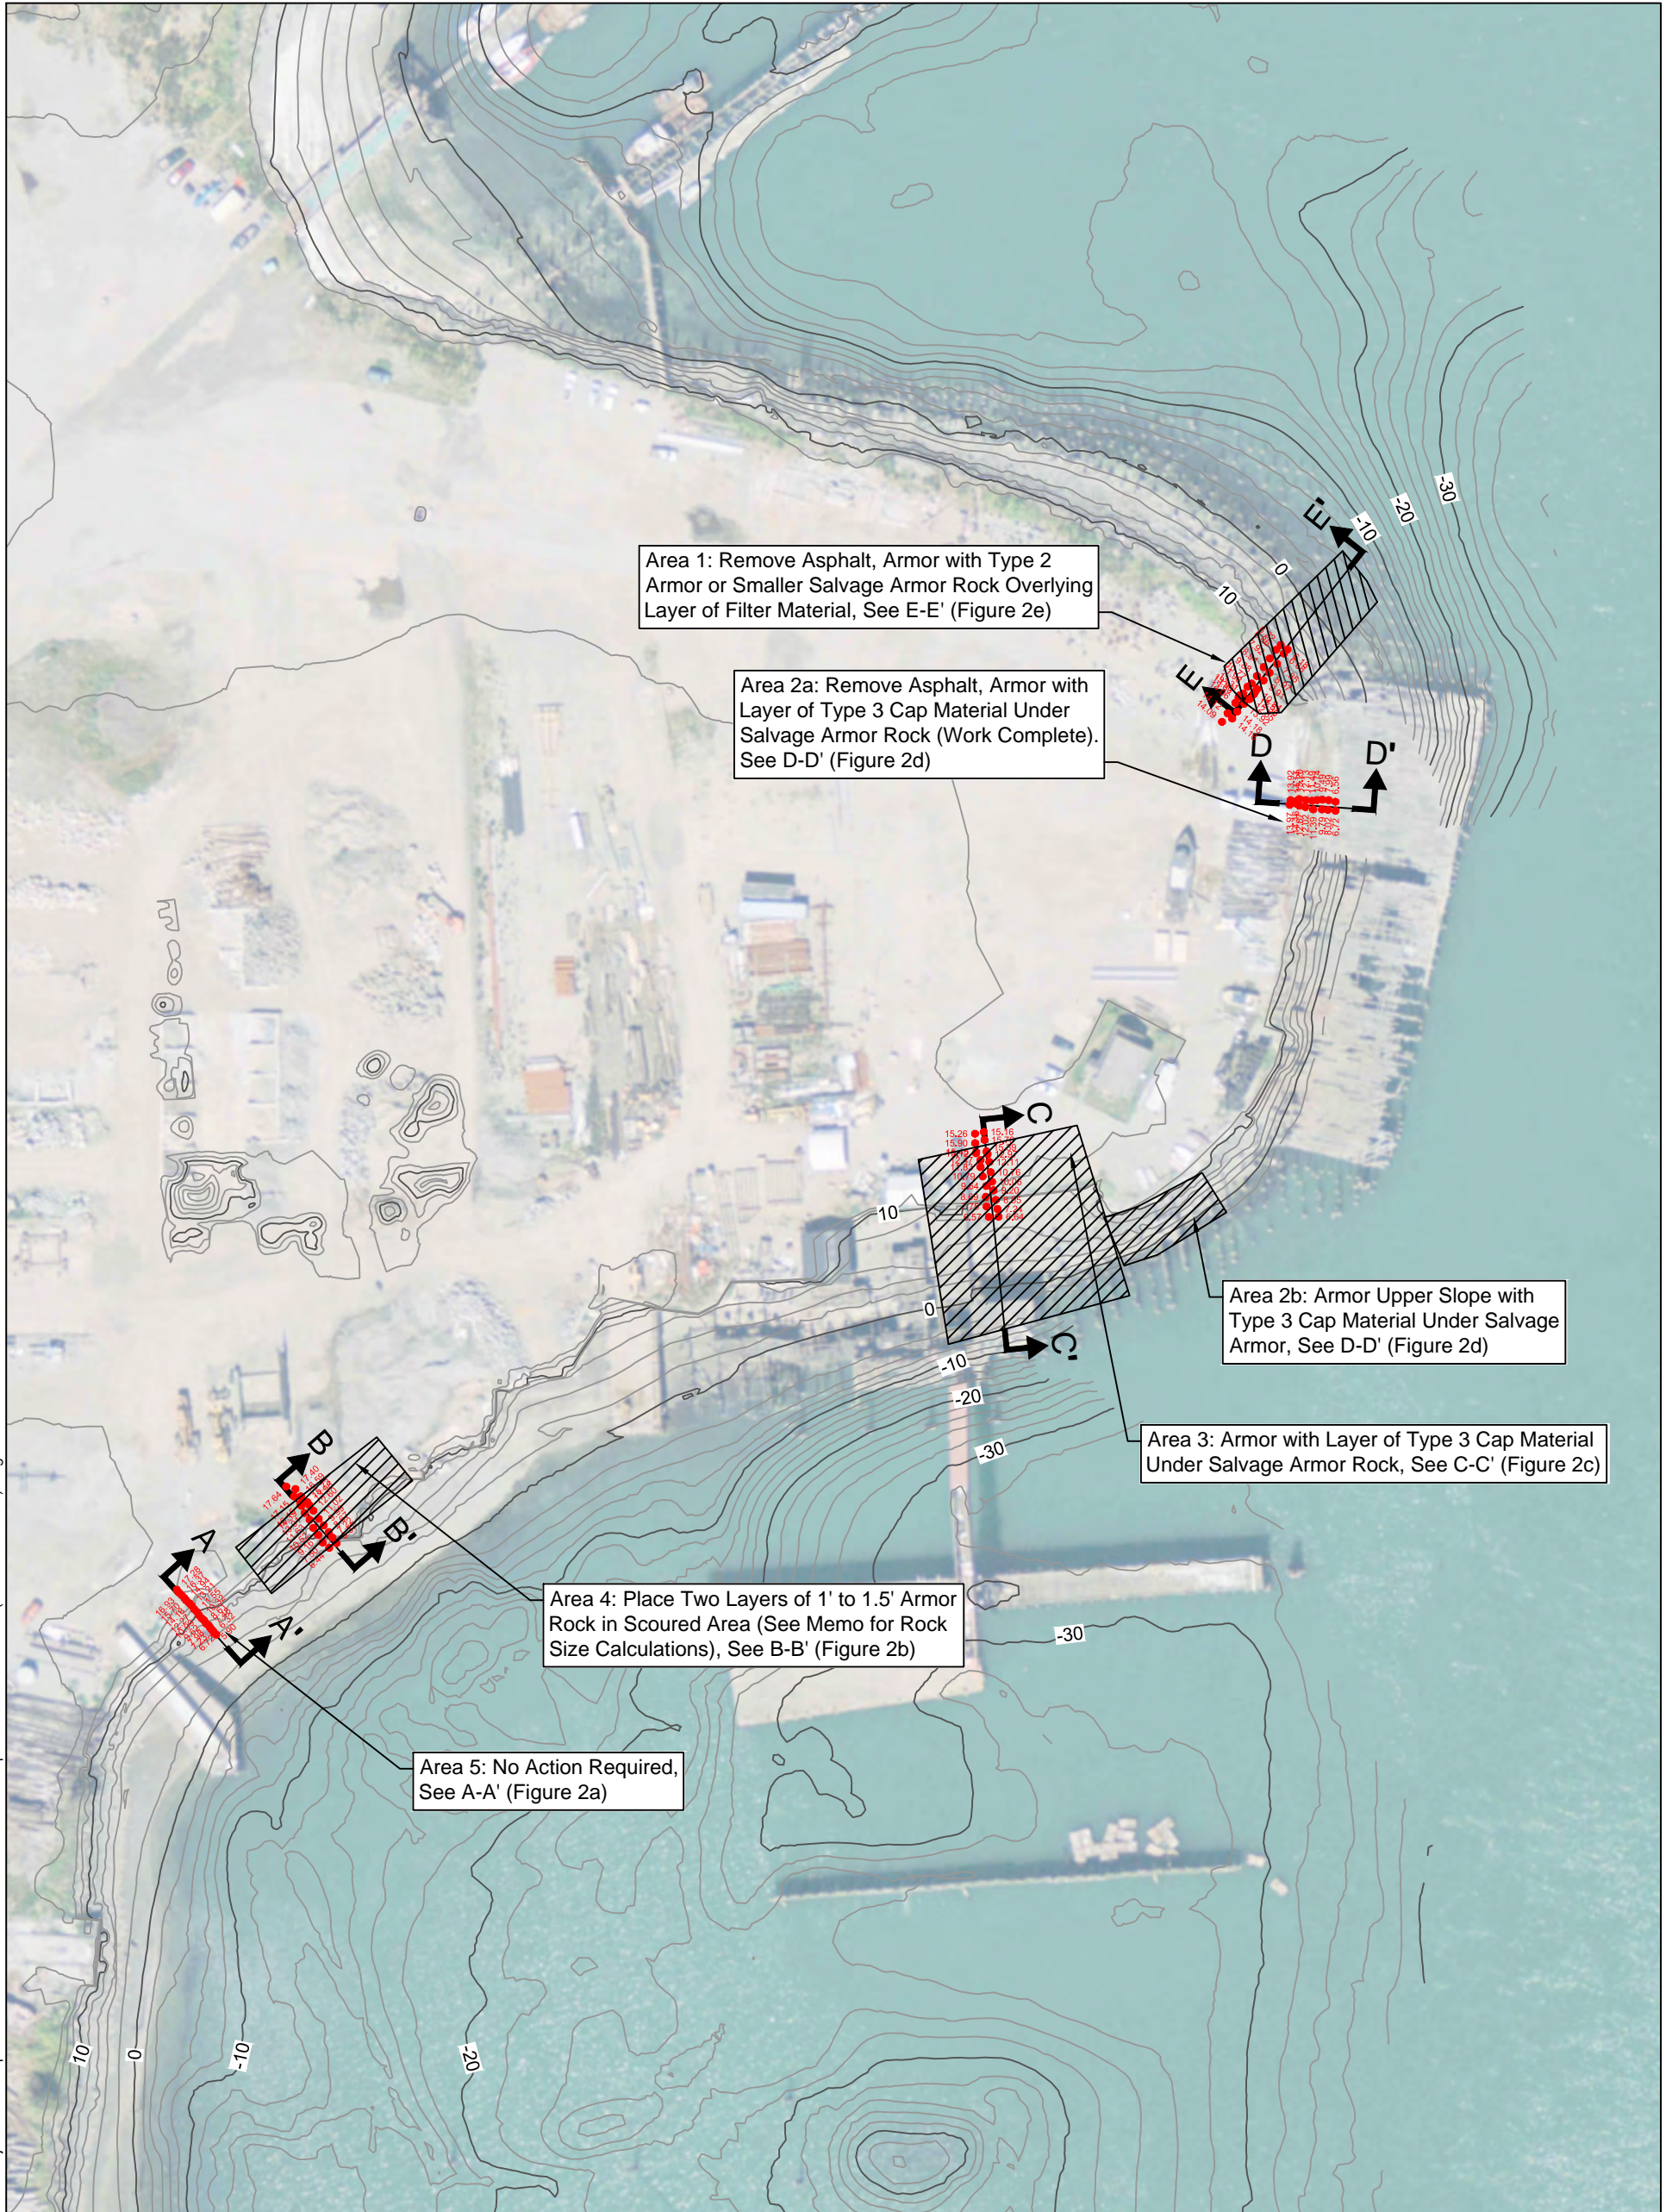
K:\Projects\0388-Pope Resources\Port Gamble Sediment Cleanup RI-FS\0388-WK-107 (Pocket Beaches).dwg F1

Area 1: Remove Asphalt, Armor with Type 2 Armor or Smaller Salvage Armor Rock Overlying Layer of Filter Material, See E-E' (Figure 2e)

Area 2a: Remove Asphalt, Armor with Layer of Type 3 Cap Material Under Salvage Armor Rock (Work Complete). See D-D' (Figure 2d)

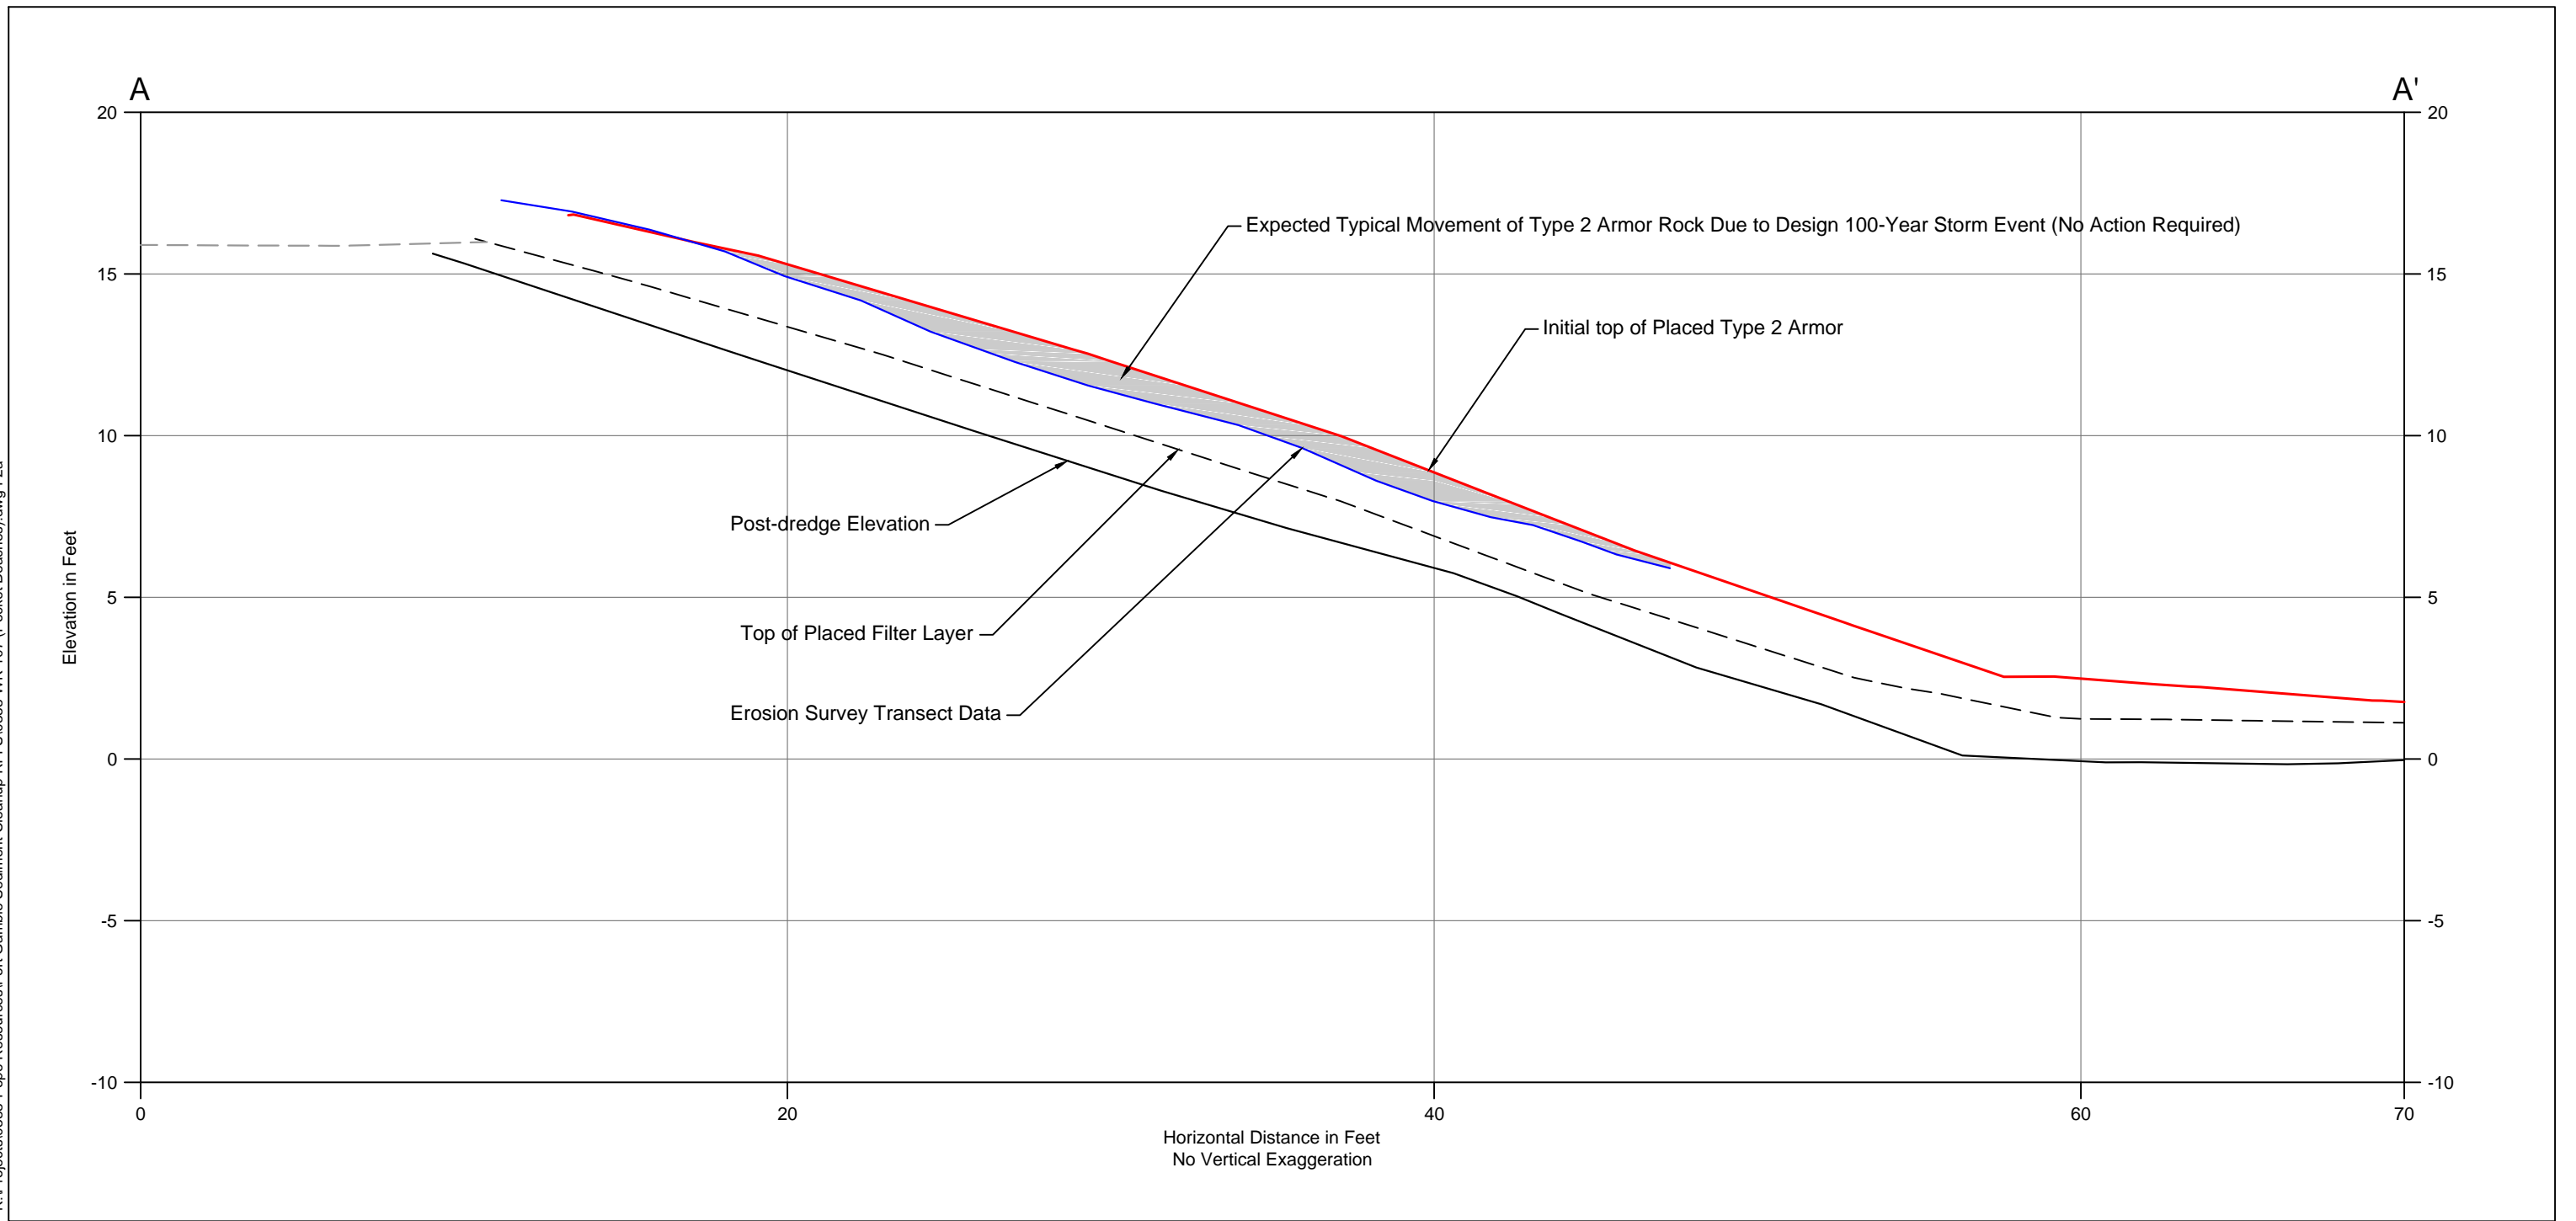
K:\Projects\0388-Pope Resources\Port Gamble Sediment Cleanup RI-FS\0388-WK-107 (Pocket Beaches).dwg F2a

Figure 2a shows a survey transect in Area 5 that illustrates more typical and expected movement of rock on the slope; this area still has acceptable coverage of armor rock over the filter material.

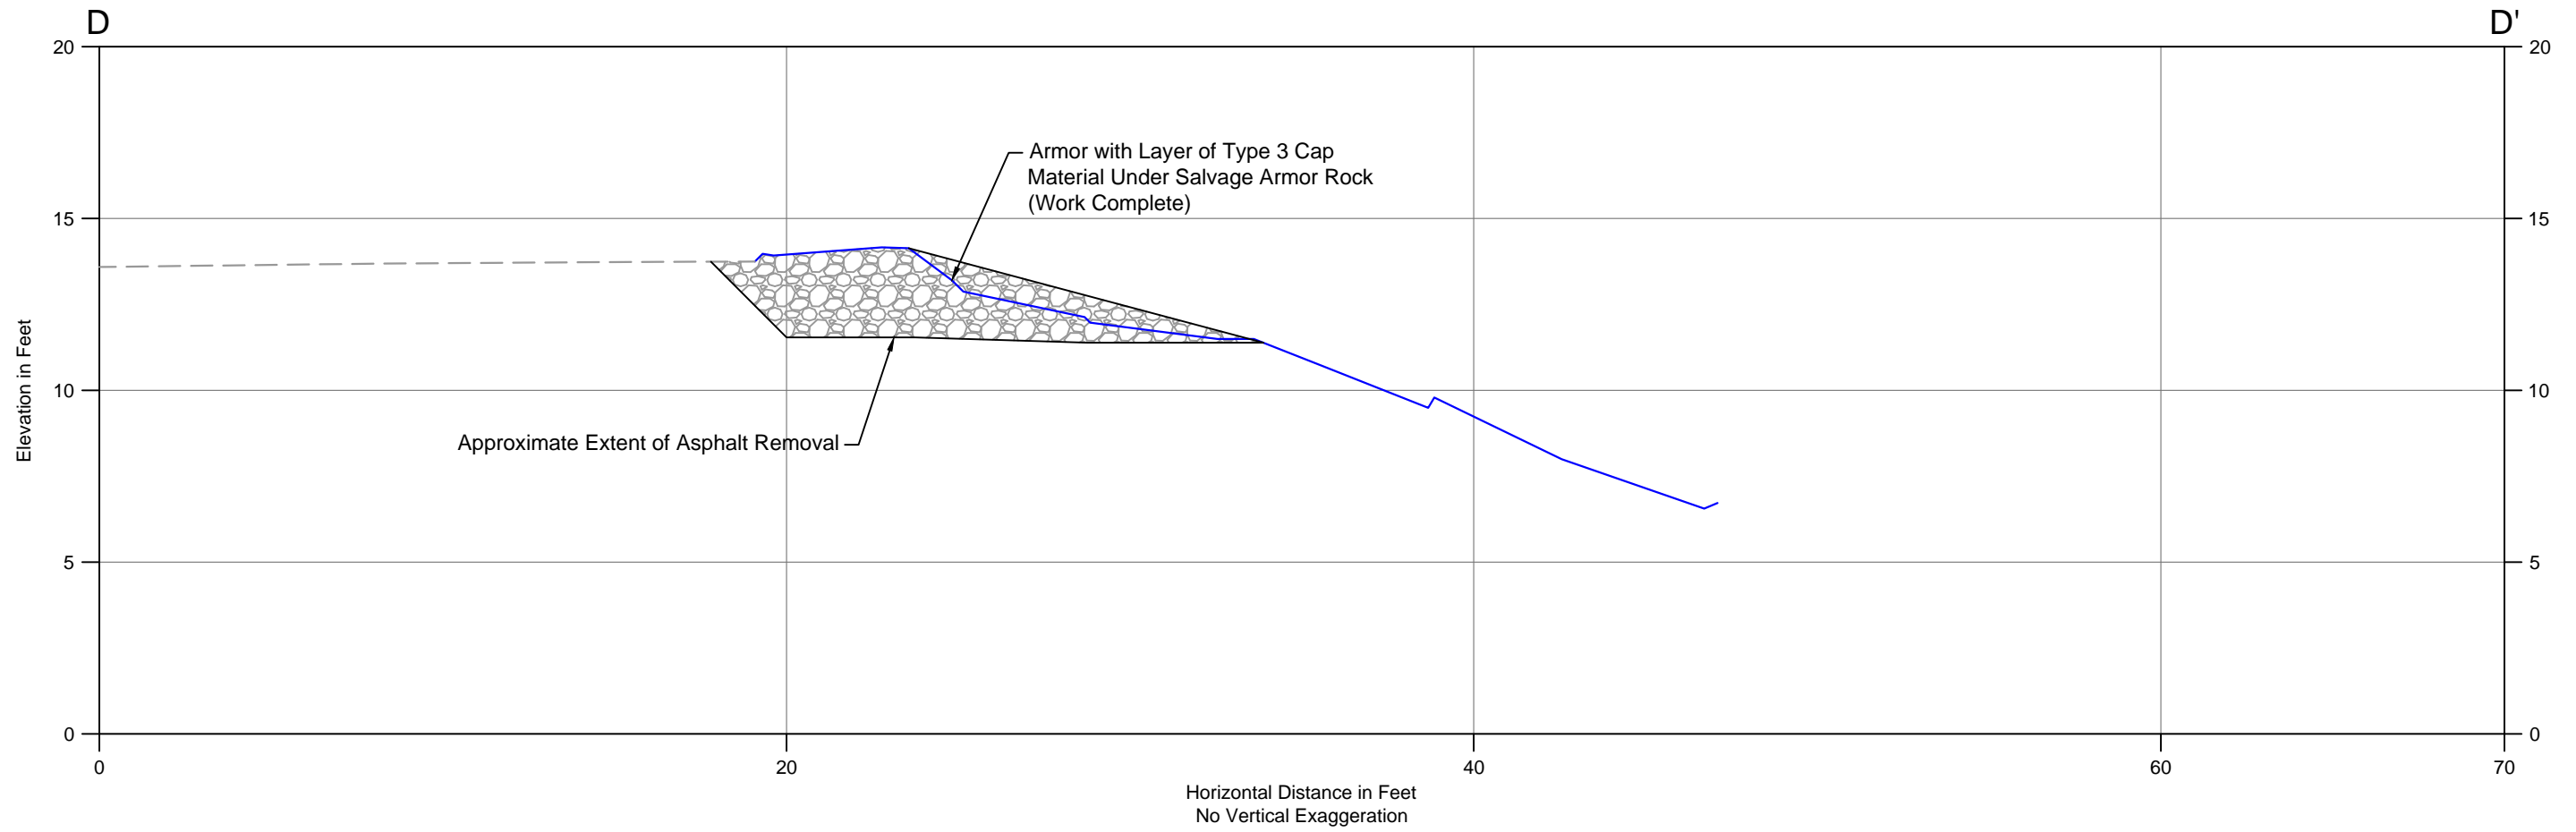
K:\Projects\0388-Pope Resources\Port Gamble Sediment Cleanup RI-FS\0388-WK-107 (Pocket Beaches).dwg F2d

SOURCE: Topography from Triad, dated 2012. Bathymetry from eTrac, dated August 17, 2016. Pocket beach sample locations from Orion, dated August 6, 2016.
HORIZONTAL DATUM: Washington State Plane North, NAD83, U.S. Feet.
VERTICAL DATUM: Mean Lower Low Water (MLLW).
NOTE: Work shown has been completed.
