Coastal Engineering Evaluation of Shoreline Erosion Memorandum

DRAFT MEMORANDUM

To: Linda Berry-Maraist, Pope Resources/Olympic Property Group
From: Kathy Ketteridge, Ph.D., P.E., and John Laplante, P.E., Anchor QEA, LLC
Cc: Clay Patmont, Anchor QEA, LLC
Re: Port Gamble Bay Cleanup Project Coastal Engineering Evaluation of Shoreline Erosion

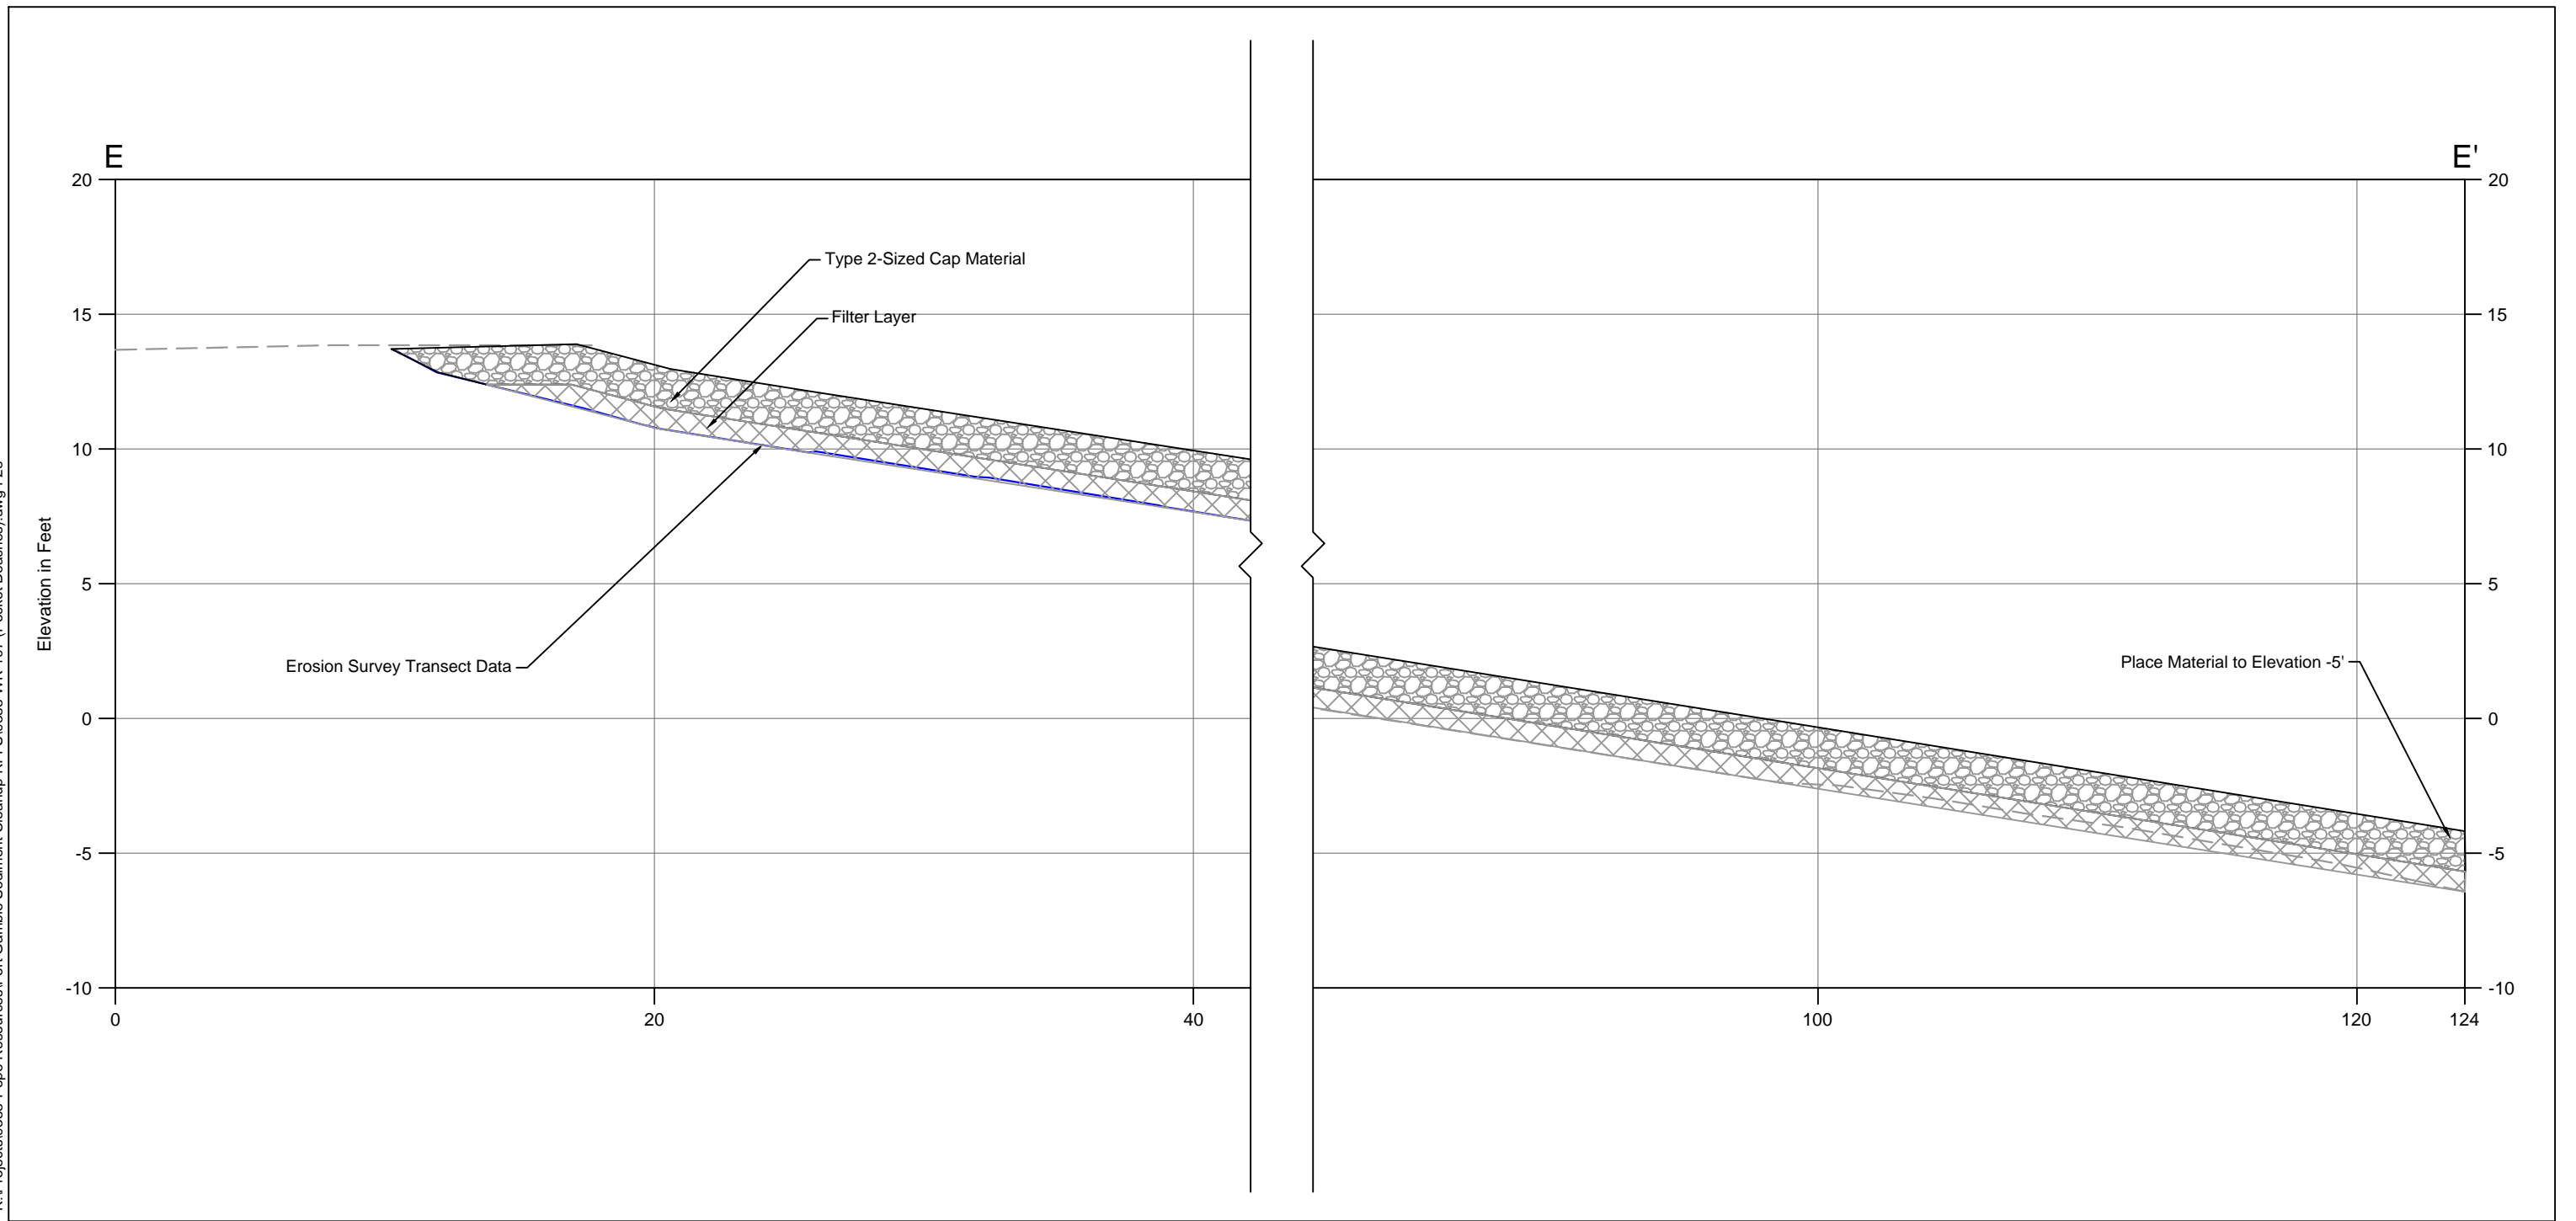
K:\Projects\0388-Pope Resources\Port Gamble Sediment Cleanup RI-FS\0388-WK-107 (Pocket Beaches).dwg F2e

The shoreline erosion in this area occurred after creosote-treated piling were removed as part of Site remediation. The shoreline area above mean higher high water has eroded in this area, undermining asphalt paving at the top of the slope, as shown in Photograph 1. Figure 2e shows a pre- and post-storm survey transect that illustrates the erosion that has occurred at this location. In general, the slope of the beach in the upper intertidal area is adjusting to match the milder slope present in the lower intertidal area.

Design recommendations to address shoreline erosion in this area are shown in Figure 2e. These design recommendations are focused on preventing erosion of the entire slope from top of bank to the lower vertical extent of wave impact (where natural sediments could be eroded during storms). Damaged asphalt at the top of the slope will be removed and the shoreline armored from the top of the bank down to elevation of -5 feet mean lower low water, which is consistent with armoring extent designed for adjacent capping areas (see Port Gamble EDR, Appendix D). The armor will extend horizontally from the existing armored slope to the south of Area 1 (Area 2A) to the west to cover the entire pocket beach area. Armor will consist of a layer of Type 3 material covered with large salvaged armor rock.

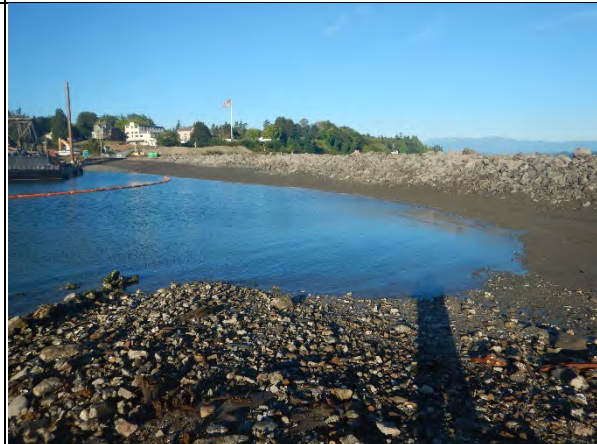
Comment: SMA-1 jetty after completion of piling removal, concrete removal, and rip rap placement

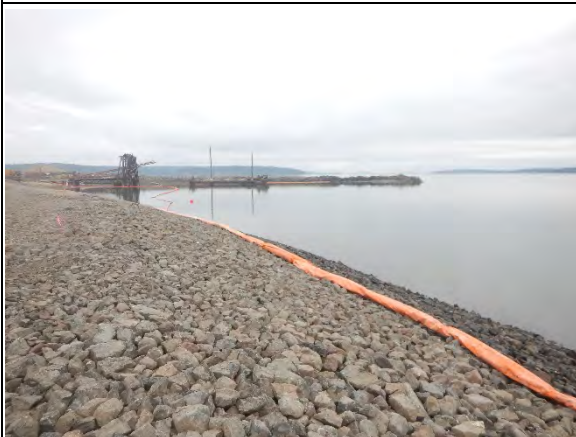
Comment: SMA-1 jetty after concrete and piling removal and rip rap replacement
