**Groundwater Monitoring Well
Installation Report**

Performed at:
Fife RV Center
3410 Pacific Highway East
Fife, Washington 98424

AEROTECH
Environmental Consulting Inc.

August 16, 2017

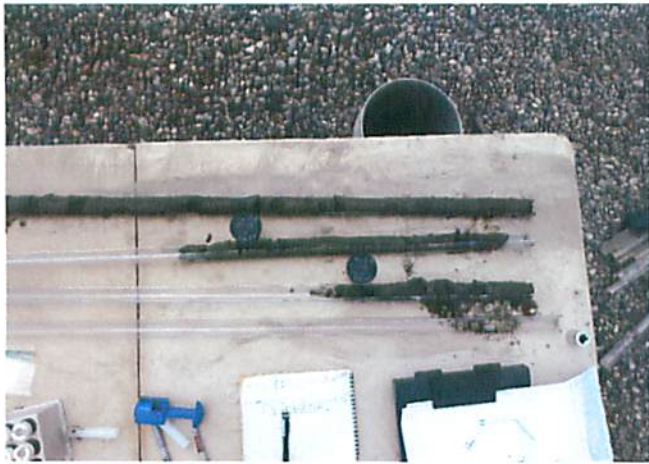
FIFE RV, 3410 Pacific Hwy East, Fife, Wa - Core samples
- MW-7

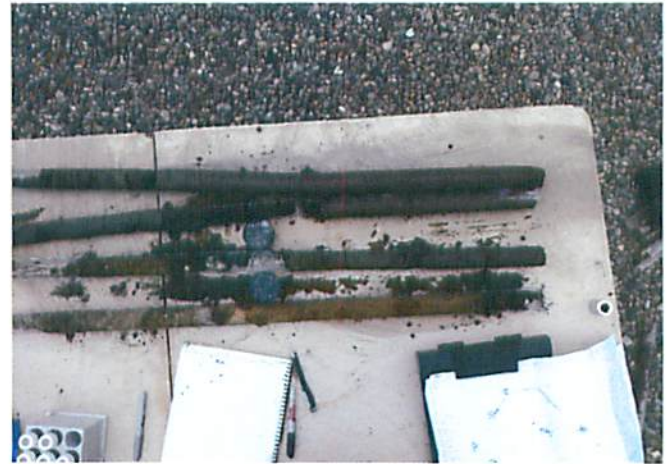
Core samples - MW-8

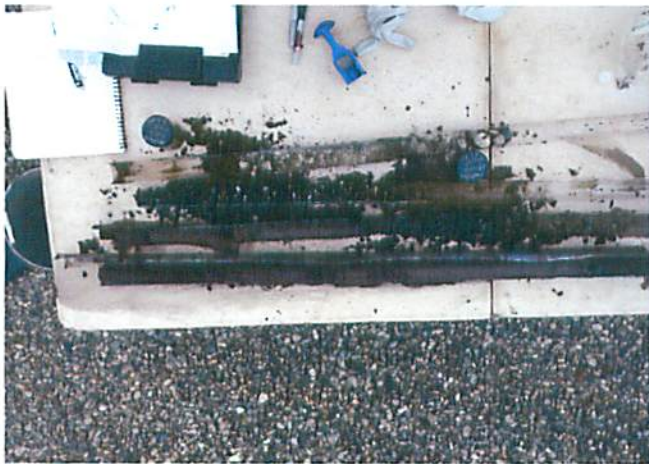
Core samples - MW-9

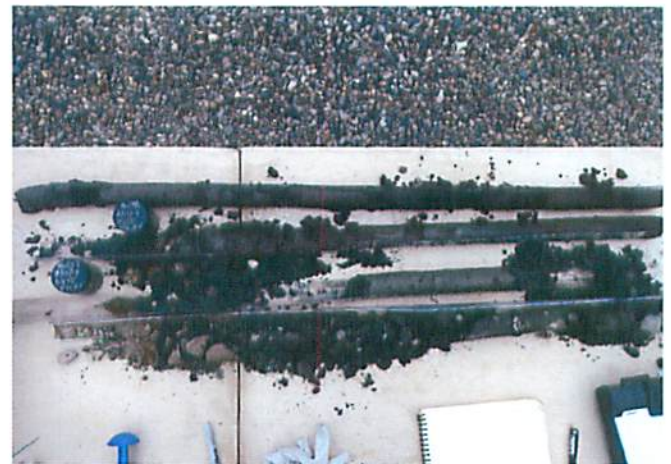
Core samples - B-1

A total of 8 discrete soil samples were collected on July 14, 2017 at four soil boring locations. Olfactory indications believed to reflect the possible presence of petroleum-impacted soil were observed in association with PID responses between 123 and 462ppm at one of four locations, borehole B-1.

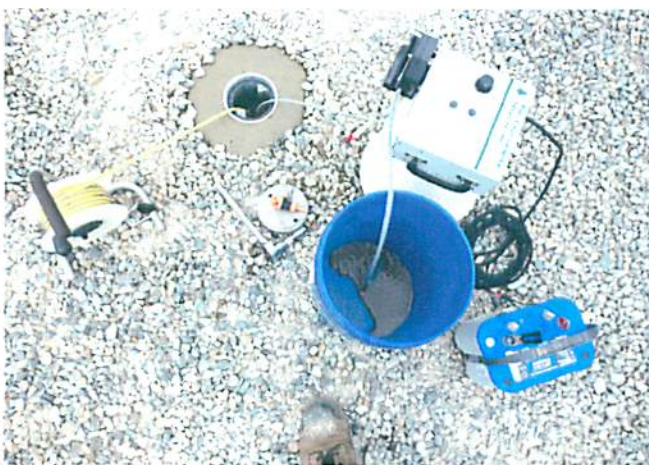
Groundwater Monitoring Well Development
