# GROUNDWATER MONITORING REPORT:

4th Quarter - August 2017

Fife RV Center 3410 Pacific Highway East Fife, Washington 98424

RE: Groundwater Monitoring Report – 4th Quarter – August 2017

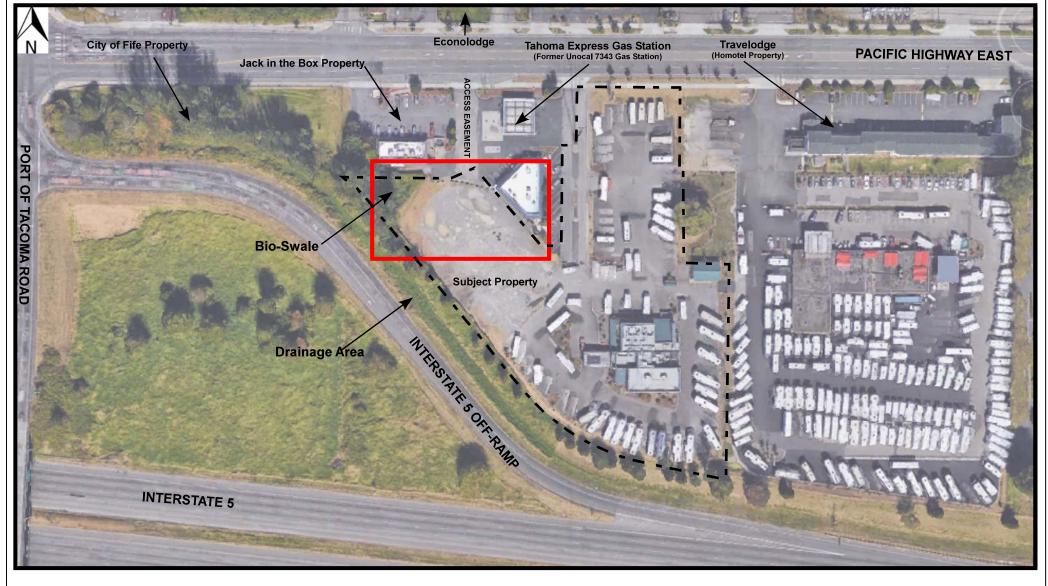
# SITE VICINITY MAP

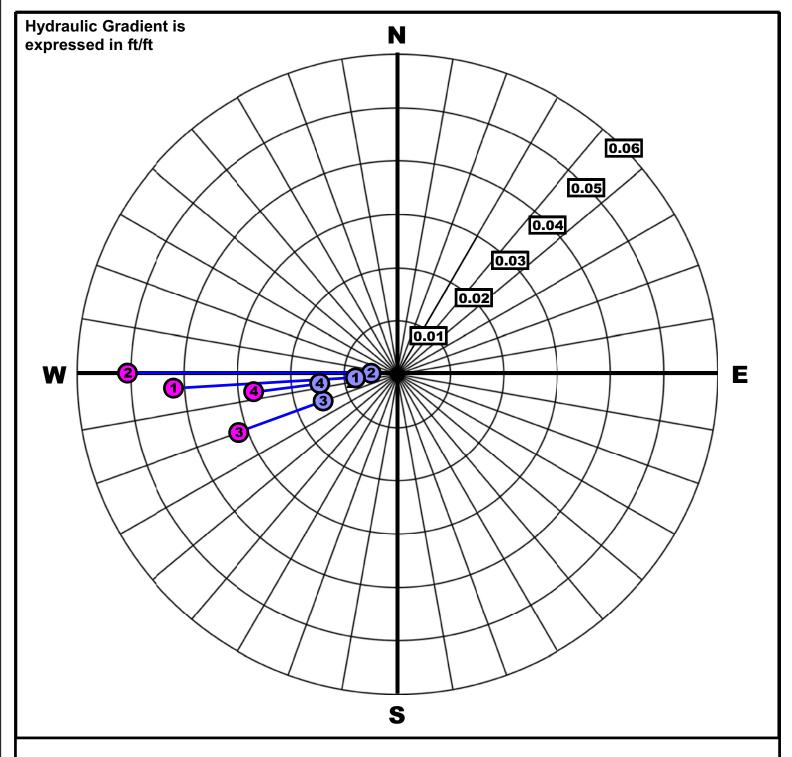
7

# HYDRAULIC GRADIENT RANGE AND SHALLOW GROUNDWATER FLOW DIRECTION FROM MW3

- 1 11/18/16
- 2 02/20/17
- 3 05/23/17
- 4 08/01/17

2 Maximum Calculated Gradient

(2) Minimum Calculated Gradient
