COMPLETION AND COMPLIANCE MONITORING REPORT

SLAG DISPOSAL, BECKWITH PROPERTY SITE
SOUTH 218TH STREET AND 90TH AVENUE SOUTH
KENT, WASHINGTON

Submitted by:
Farallon Consulting, L.L.C.
975 5th Avenue Northwest
Issaquah, Washington 98027
Farallon PN: 831-022

May 2012

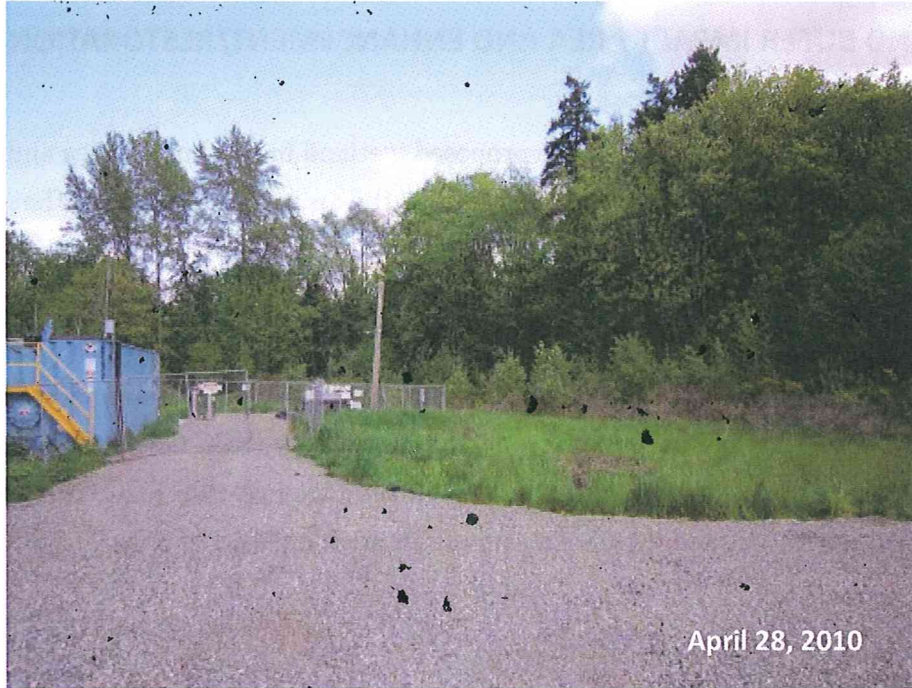
Photograph 1: Wetland I Buffer on Right Side of Photograph, Facing North

The wetland buffer habitat within the western portion of the existing 50-foot buffer of Wetland I (where wetland buffer impacts will occur) provides poor quality habitat functions. The wetland buffer within the proposed area of excavation is dominated by a mosaic of native and nonnative grass and herbaceous species with no trees, and shrubs are limited to the nonnative species Scot's broom and Himalayan blackberry (see Section 3). Wetland buffer habitat conditions within or near the proposed buffer impact areas are shown on Photograph 1 and 2.

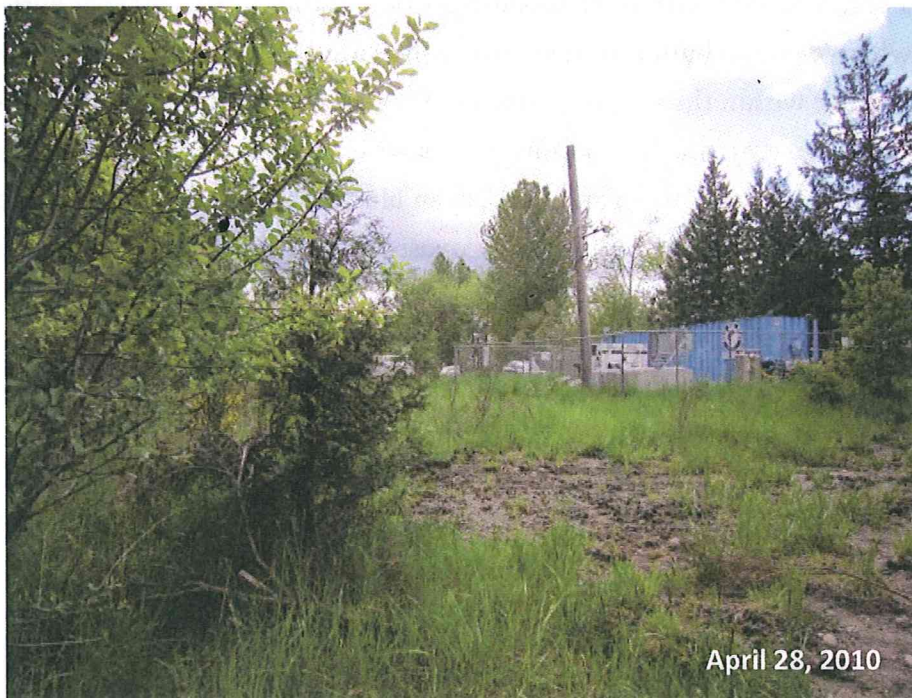
Photograph 2: Wetland I Buffer Proposed to be Impacted on Right Side of Photograph, Facing South

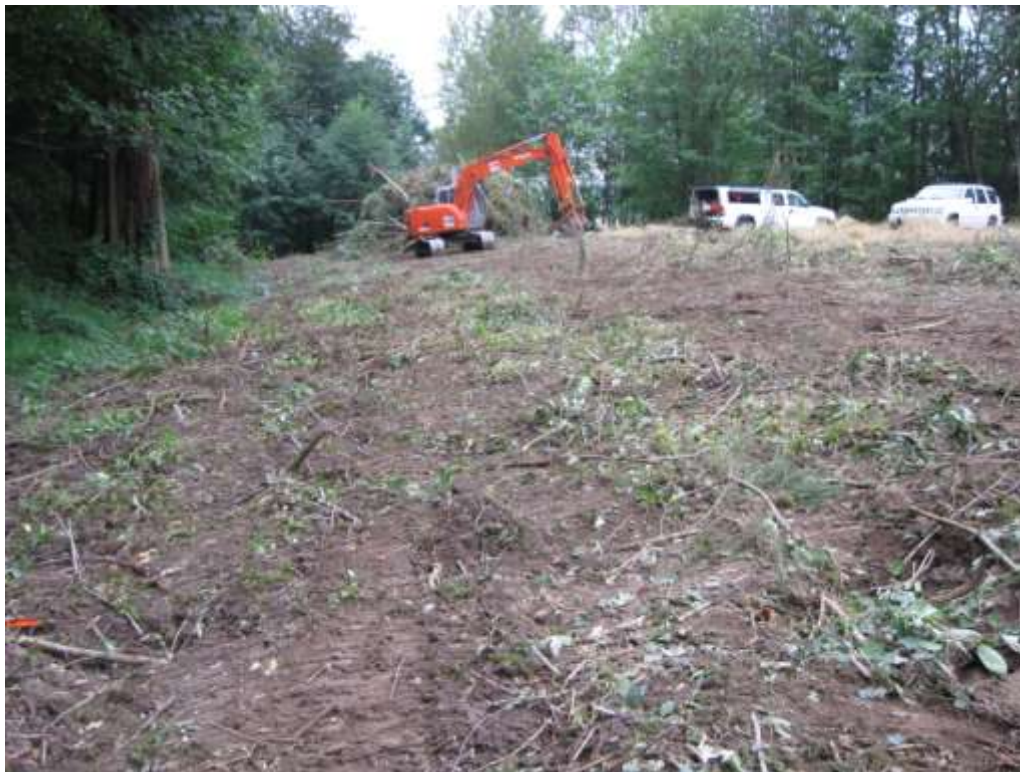
Photograph 1: Removing vegetation on east half of Site, August 9, 2010.

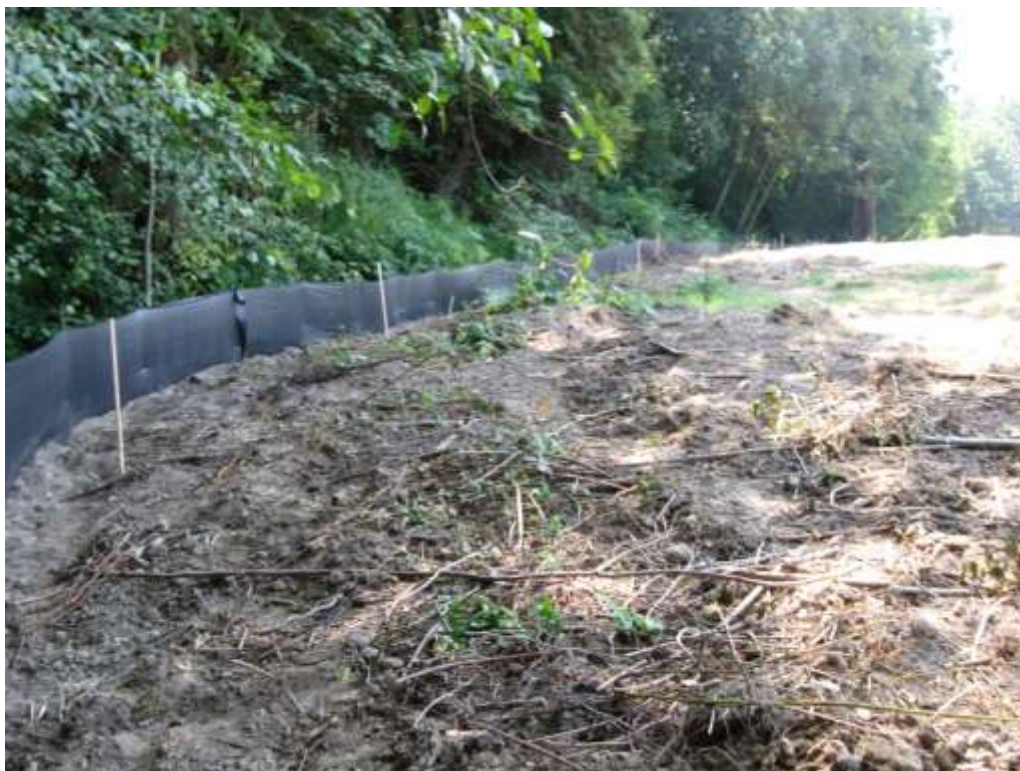
Photograph 2: Staking sample grid layout at 25-foot intervals, August 17, 2010.

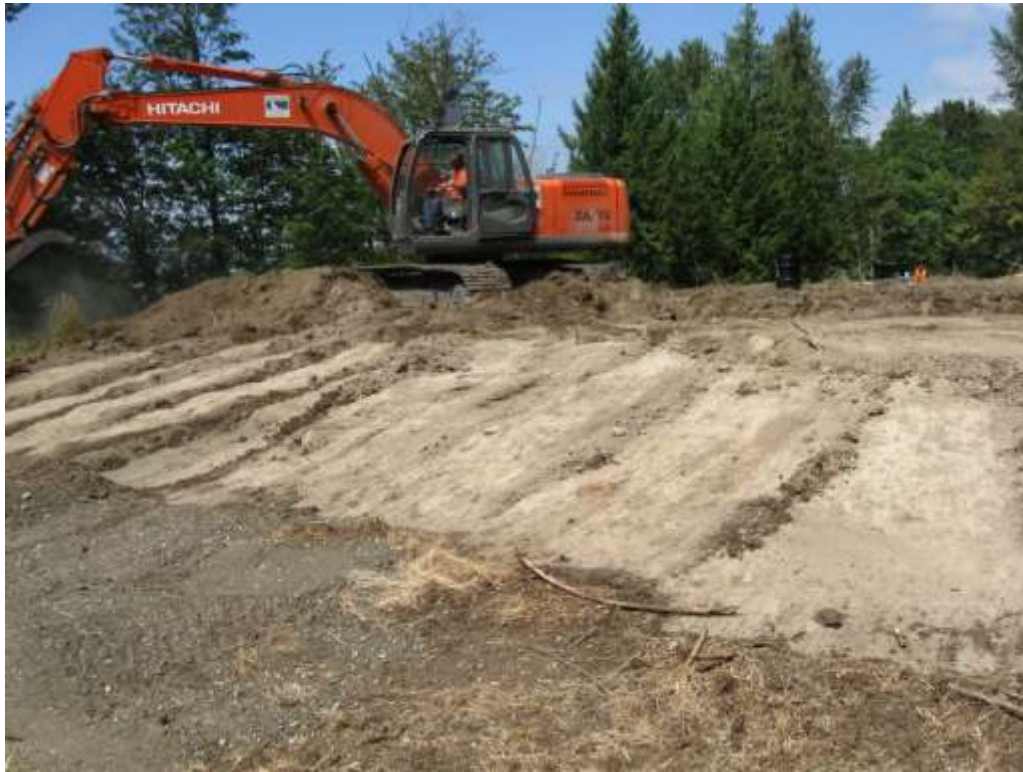
Photograph 3: Removing topsoil at center of Site, August 18, 2010

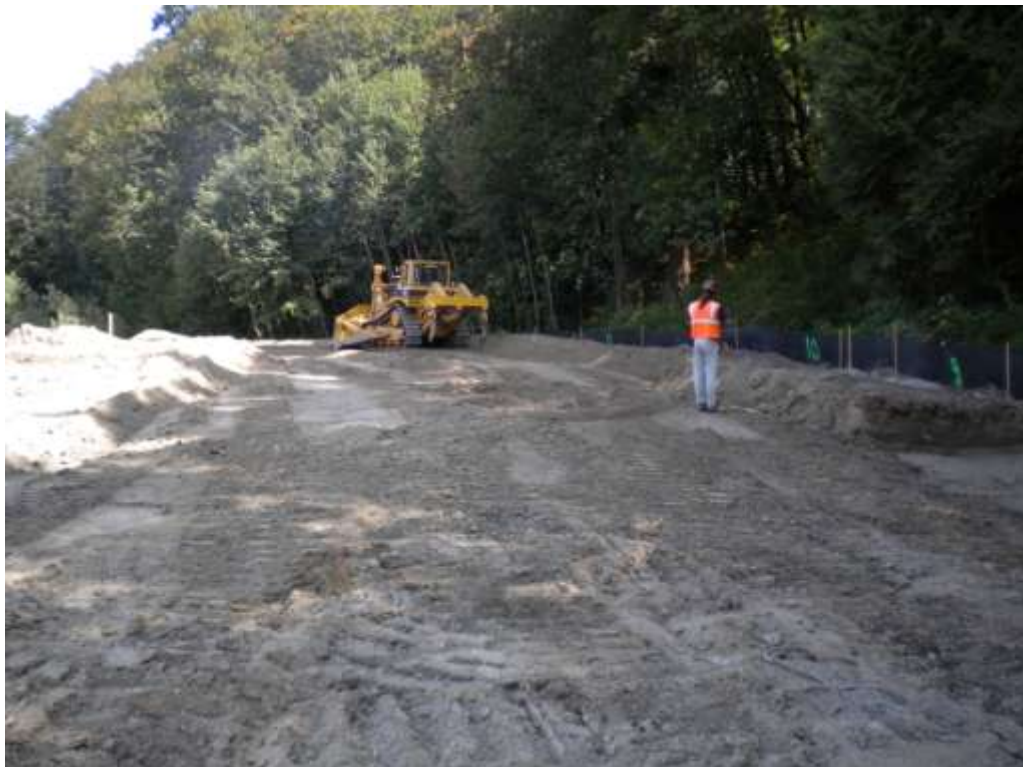
Photograph 4: Removing clean overburden on east half of Site, August 19, 2010.

Test pits were excavated prior to removal of the overburden and a soil sample was collected from the test pit wall at the lower limit of the overburden based on visual inspection. The soil sample was field-tested for pH using the pH meter. Where field testing indicated that pH concentrations were below 8.5, the depth was noted and staked and the overburden was stripped and stockpiled.

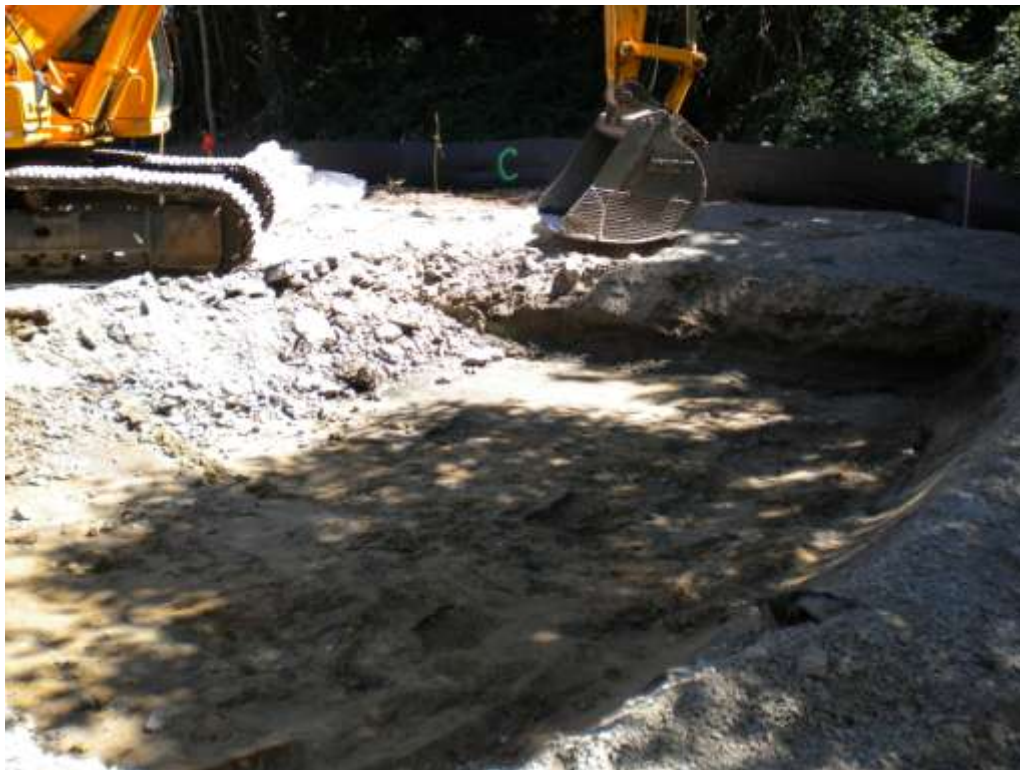
Photograph 5: Removing slag on south portion of Site to install wheel wash, August 22, 2010

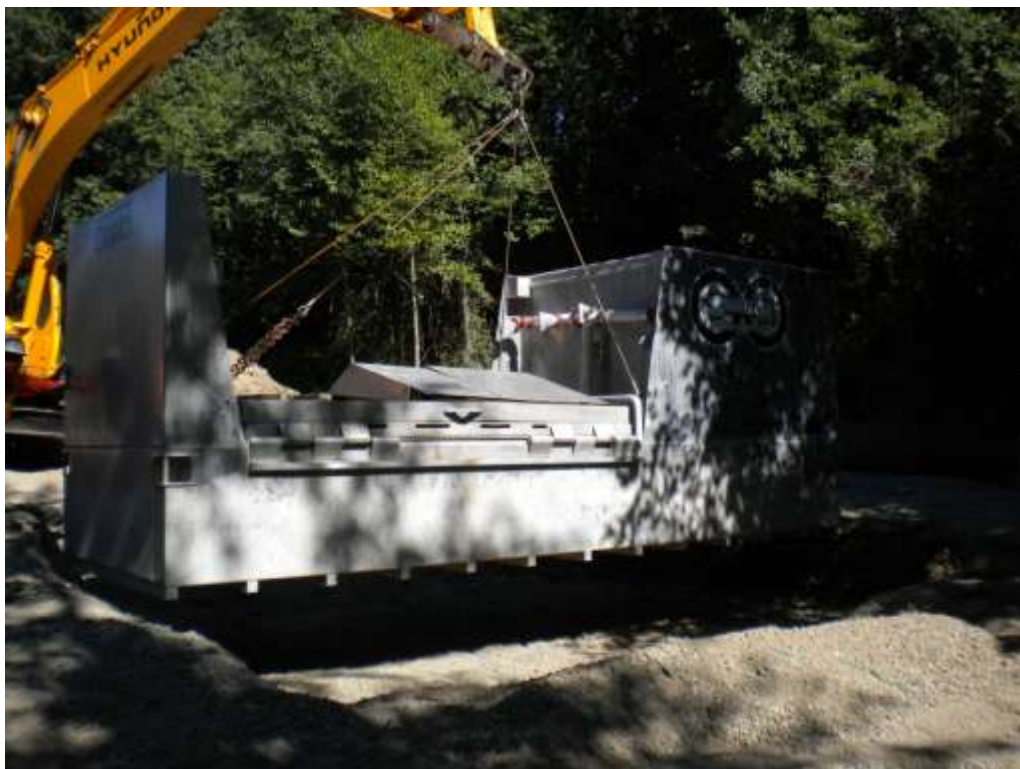
Photograph 6: Installing wheel wash on south portion of Site, August 22, 2010.

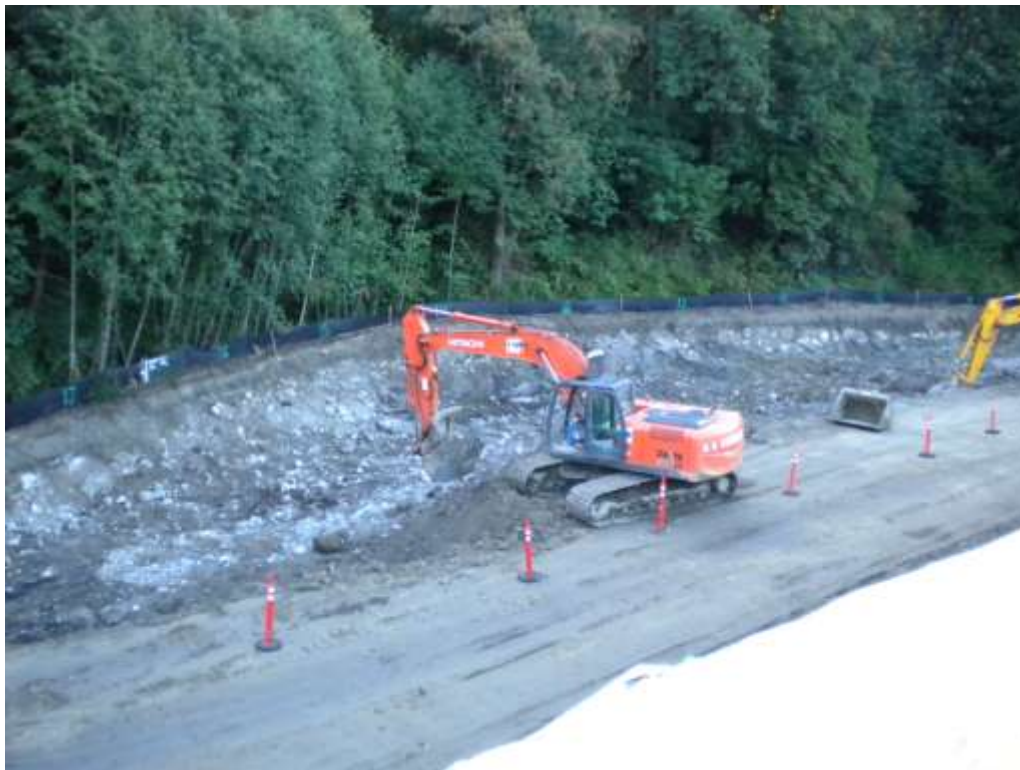
Photograph 7: Removing slag on east portion of Site, September 1, 2010

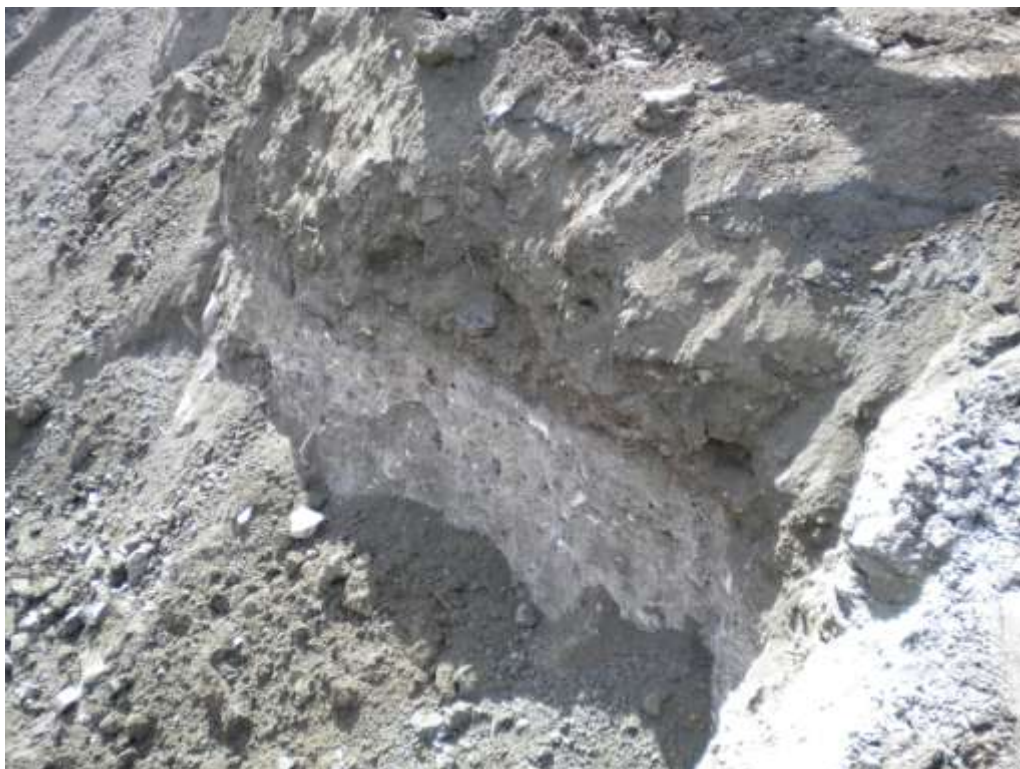
Photograph 8: Close-up view of slag and lime ash, September 1, 2010.

Slag was placed as fill on the Site between 1984 and 1990. The slag was a waste product from smelting recycled steel. Lime was used in the smelting process, and the slag contained lime ash. The lime ash caused elevated pH in water that came into contact with it.

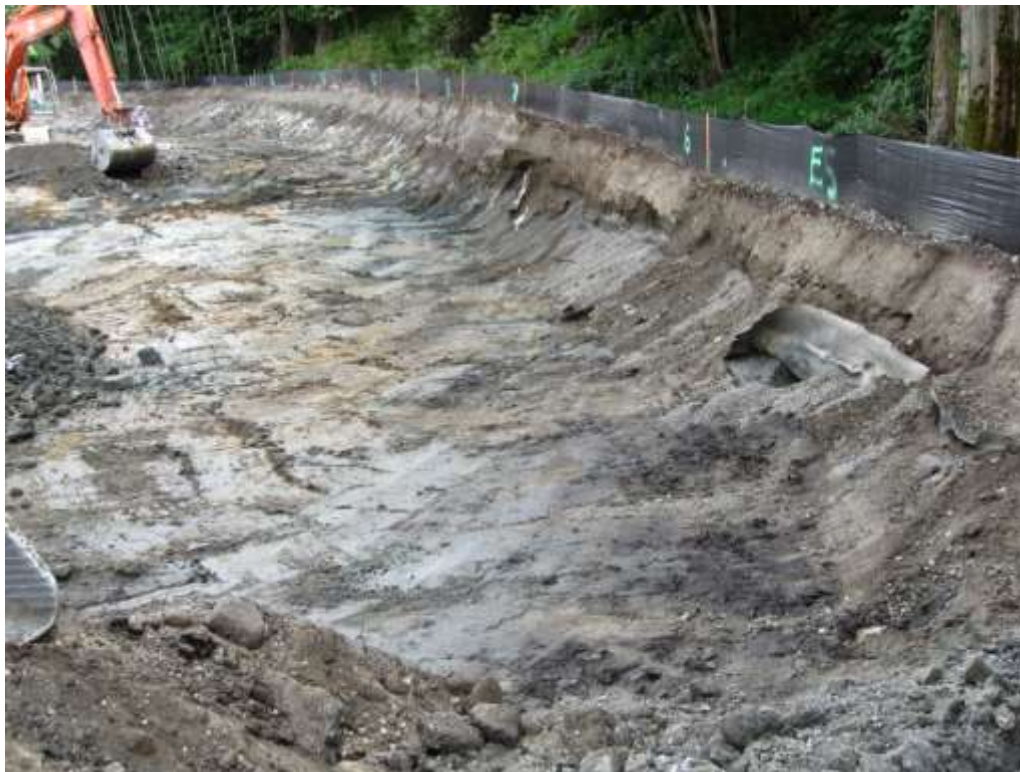
Photograph 9: Clean silt, clay bottom, and old liner with pea gravel on east portion of Site, September 7, 2010.

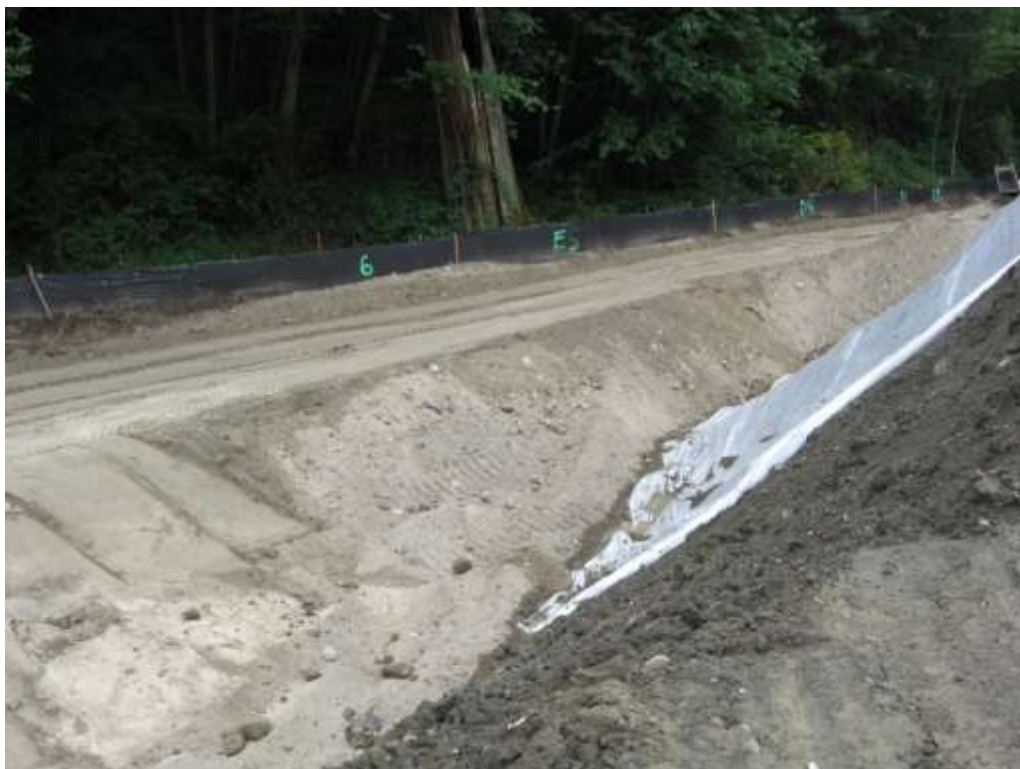
Photograph 10: Clean backfill on east portion of Site, September 9, 2010.

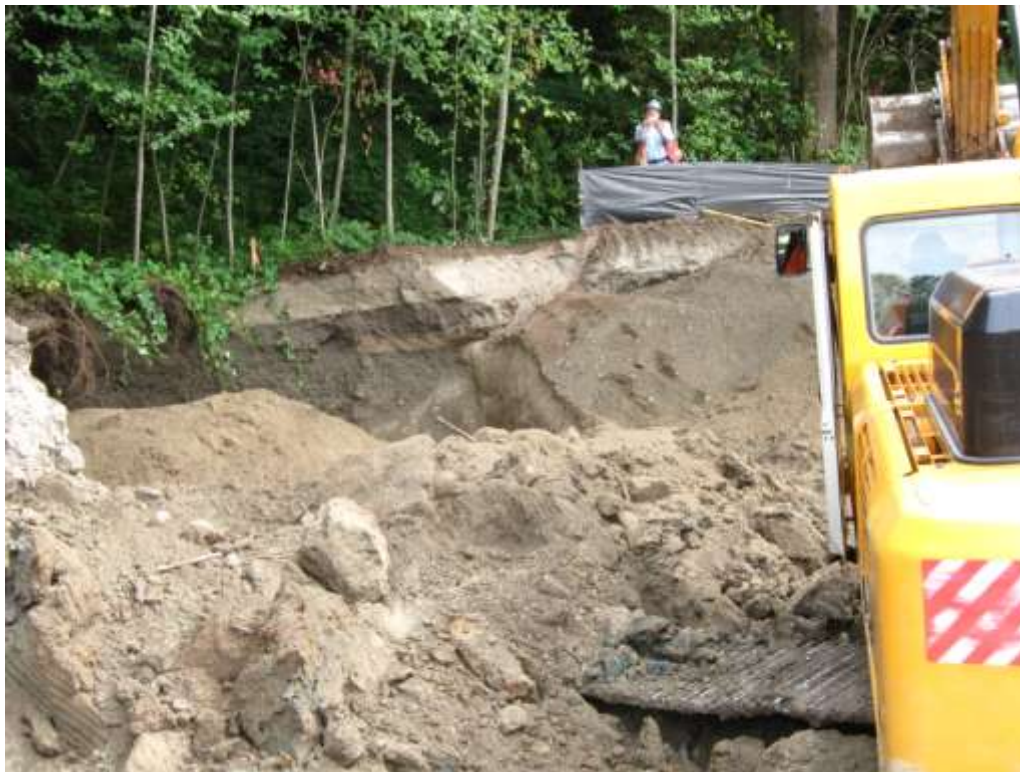
Photograph 11: Slot-cut at northeast side of Site, September 16, 2010.

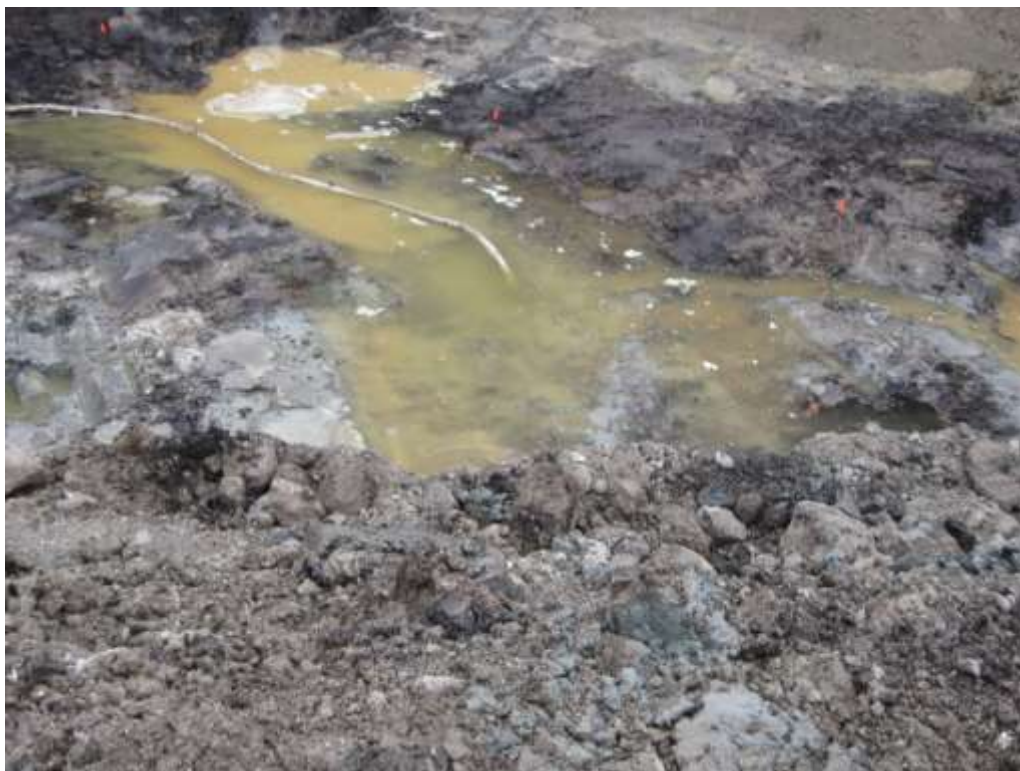
Photograph 12: Dewater low spot in center of excavation, September 18, 2010.

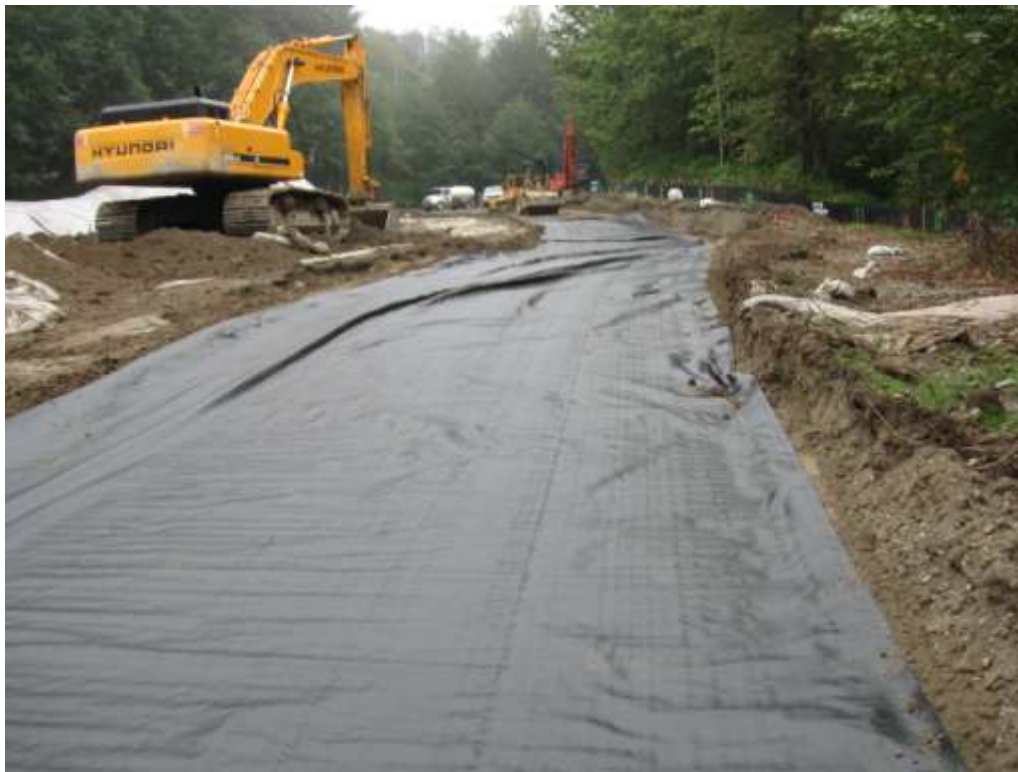
Photograph 13: Laying down Geotech fabric to construct new haul road on west side of Site, September 22, 2010.

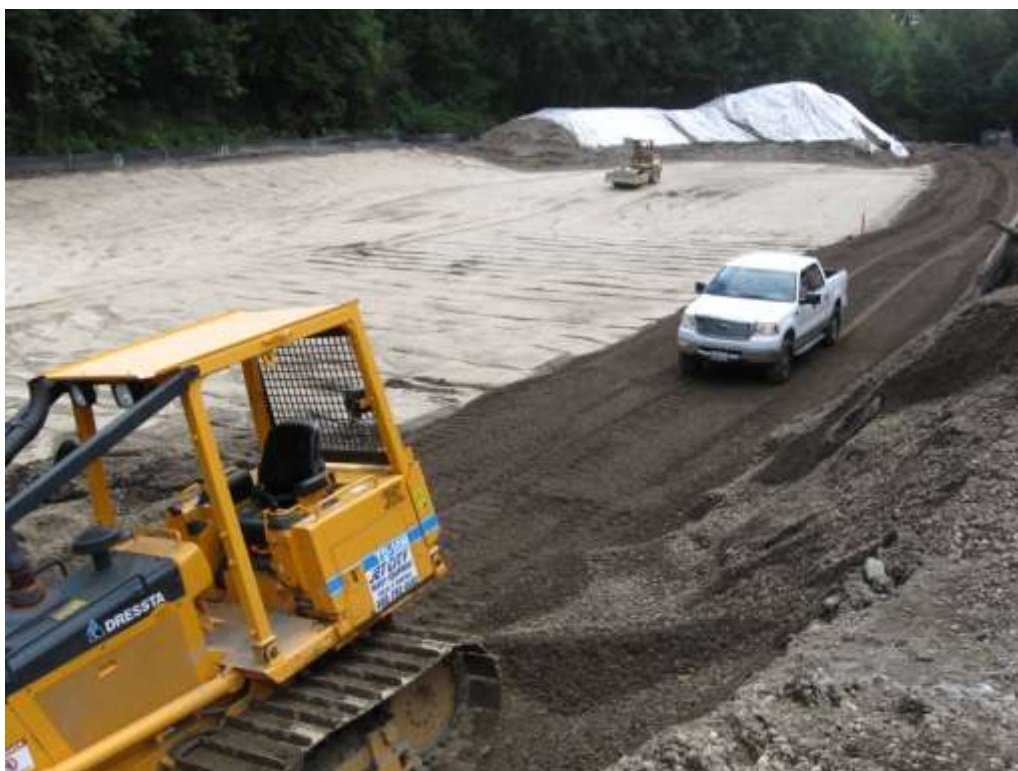
Photograph 14: Compacting clean backfill on east half of Site, October 8, 2010.

Backfill was placed in 1-foot loose lifts and compacted to a minimum of 85 percent of maximum density as determined by the standard Proctor compaction test (ASTM D698). Compaction was verified by Mayes Testing Engineers, Inc. of Tacoma, Washington and test results are provided in Appendix J.

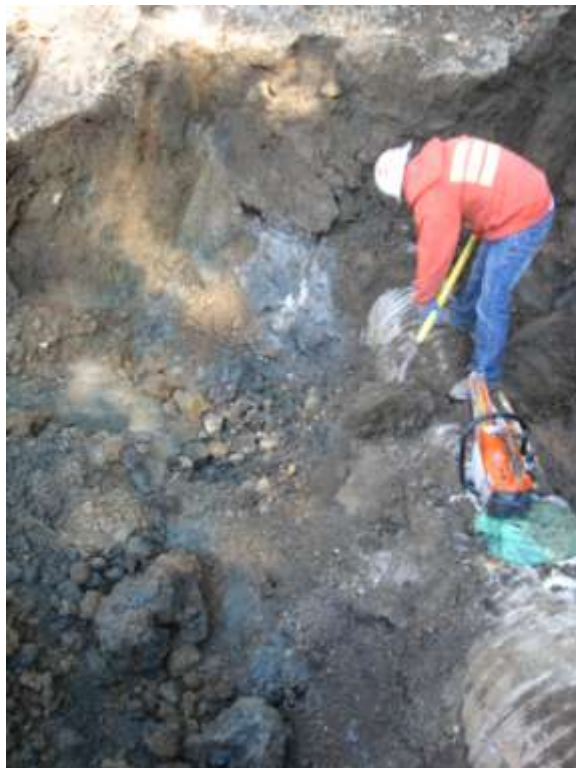
Photograph 15: Removing slag and lime ash around culvert on north portion of Site, October 19, 2010.

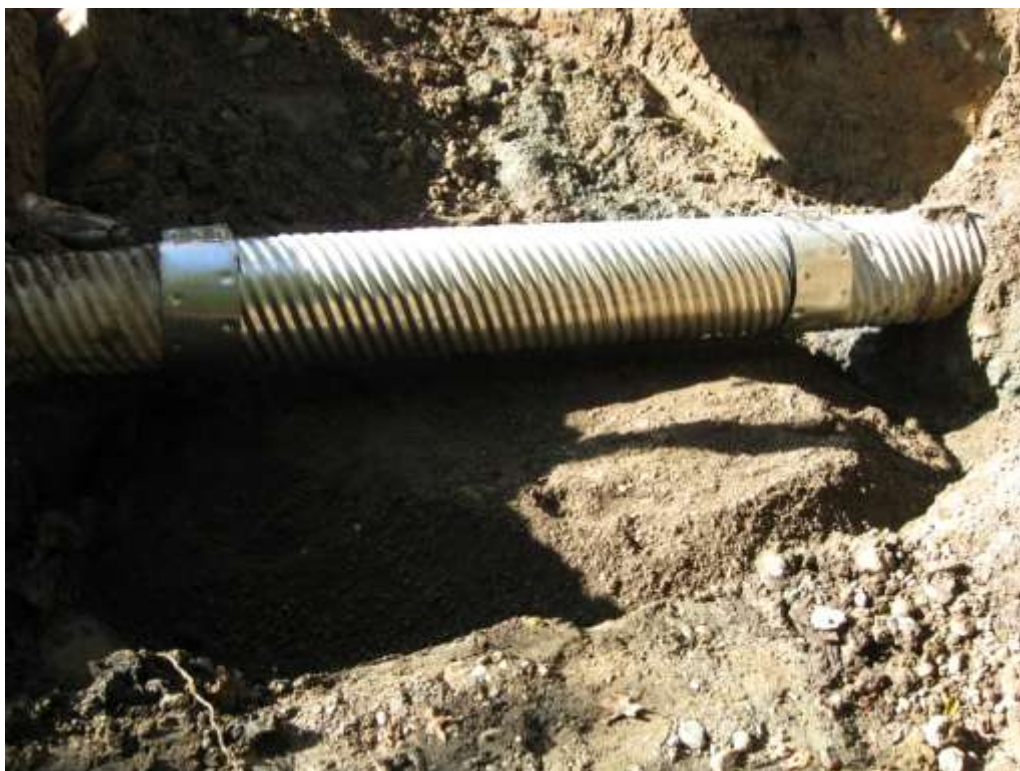
Photograph 16: New section of culvert with banding on north portion of Site by 218th Street, October 19, 2010.

The culvert at the north end of the Site that drains the detention pond was reconstructed to match pre-existing conditions following slag excavation. No other Site drainage features were impacted by excavation or construction activities.

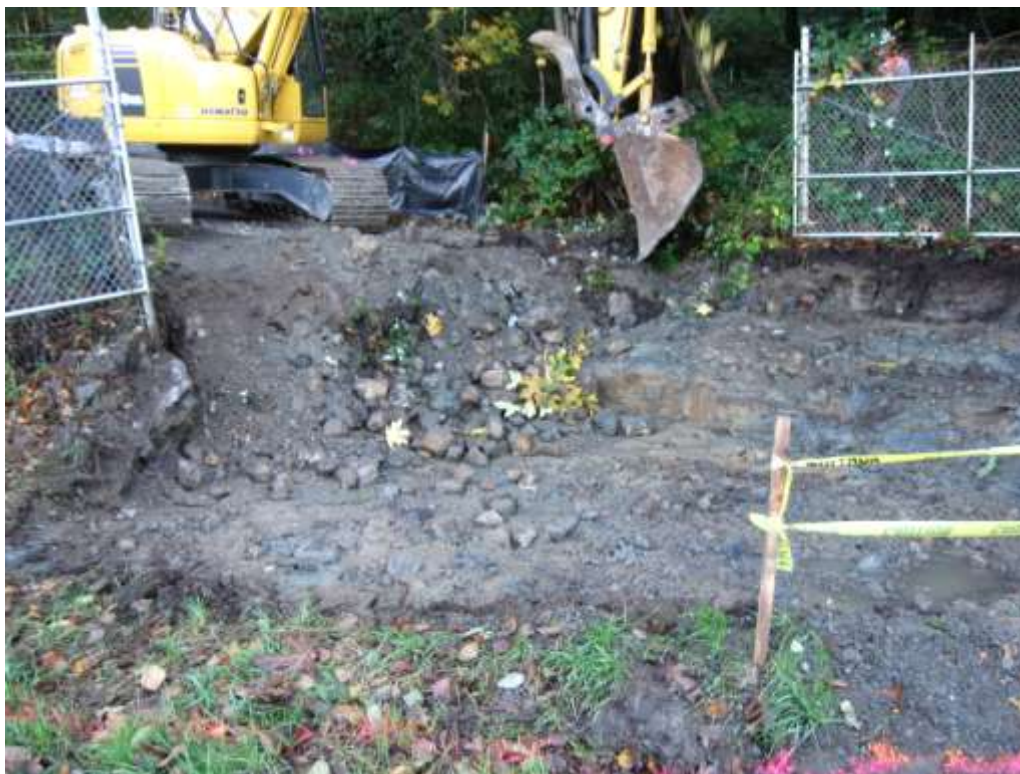
Photograph 17: Removing slag from between gates at southwest entrance to Site, October 25, 2010.

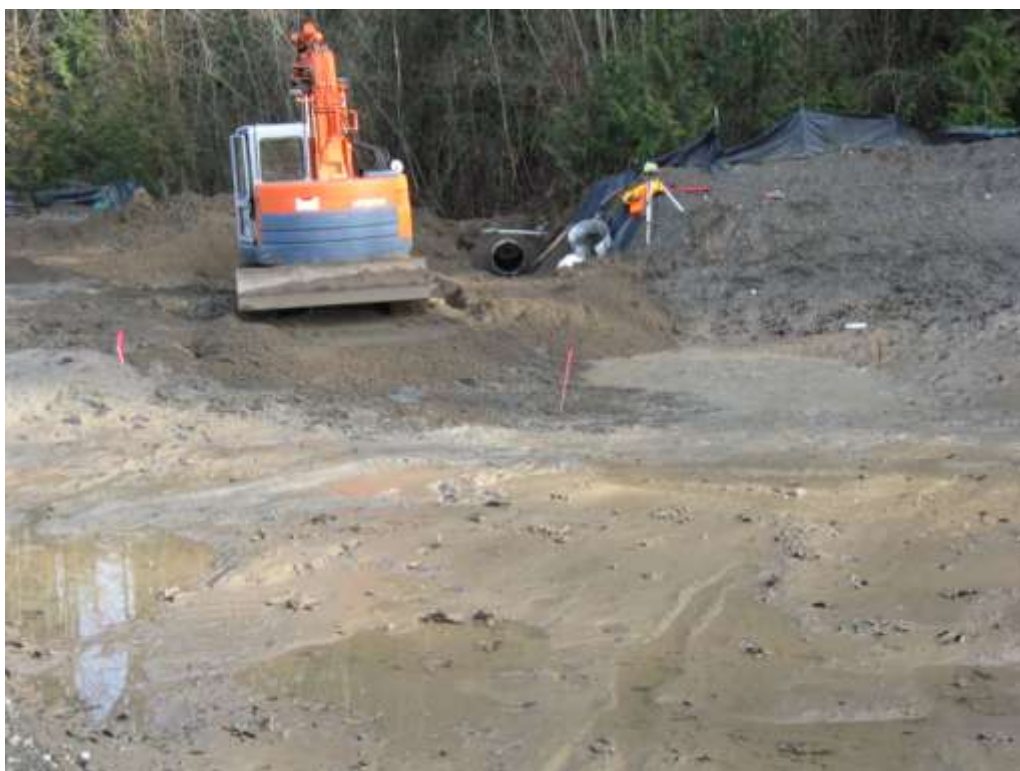
Photograph 18: Trench excavation between ponded water and detention pond to install new culvert, January 26, 2011.

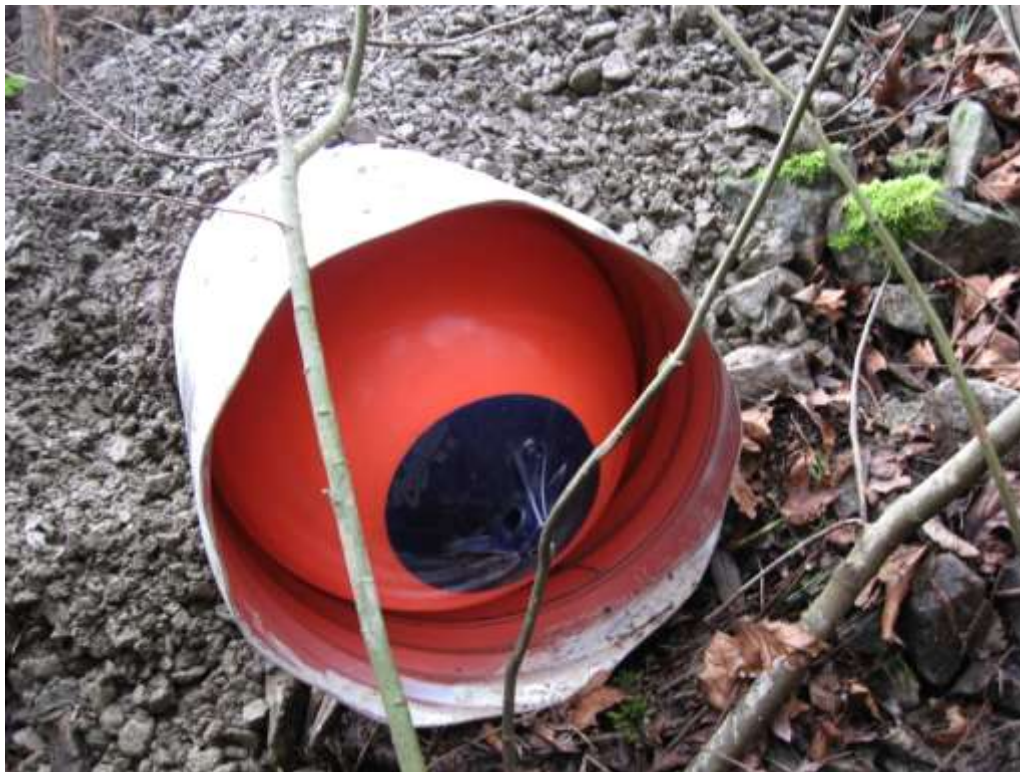
Photograph 19: Rubber buoy in outlet of new culvert on north portion of Site before turbidity test, January 27, 2011.

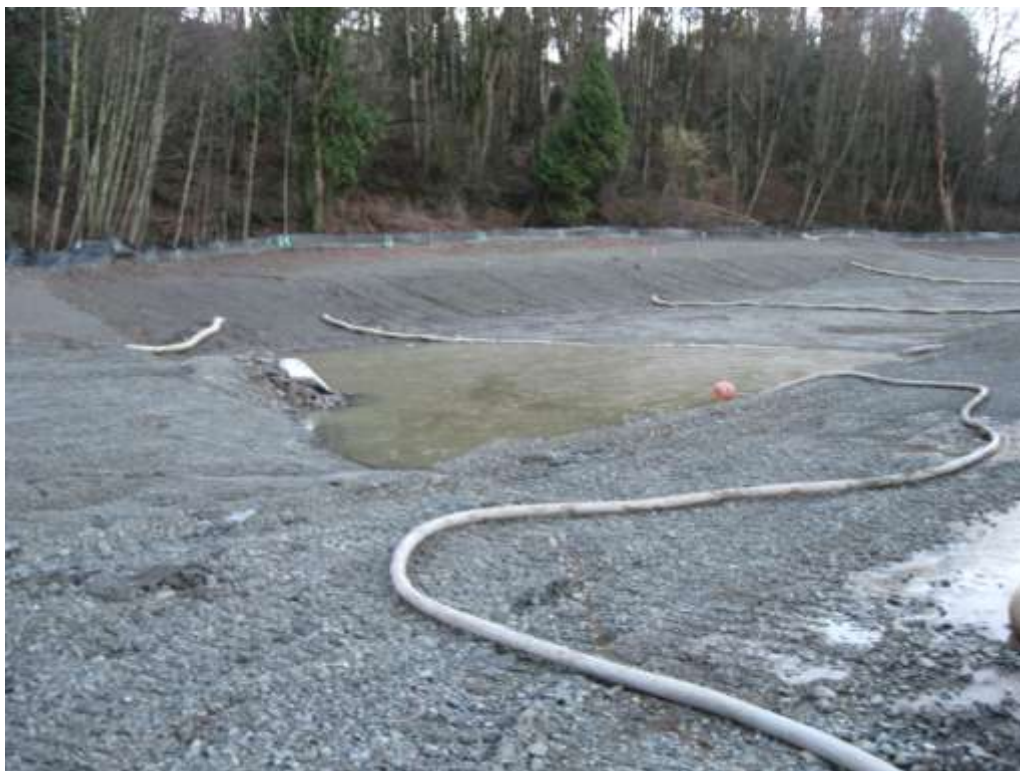
Photograph 20: Erosion control wattles, ponded water, and new culvert on east half of Site, February 1, 2011.

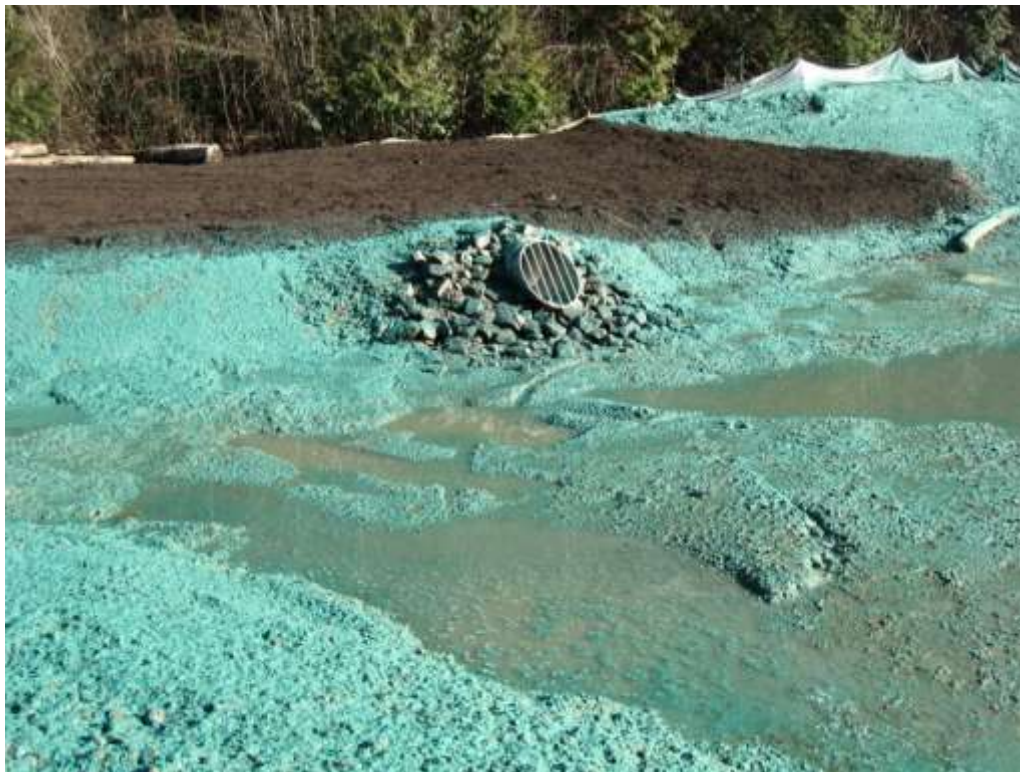
Photograph 21: Hydroseed on north portion of Site by detention pond and wetland buffer, February 2, 2011.

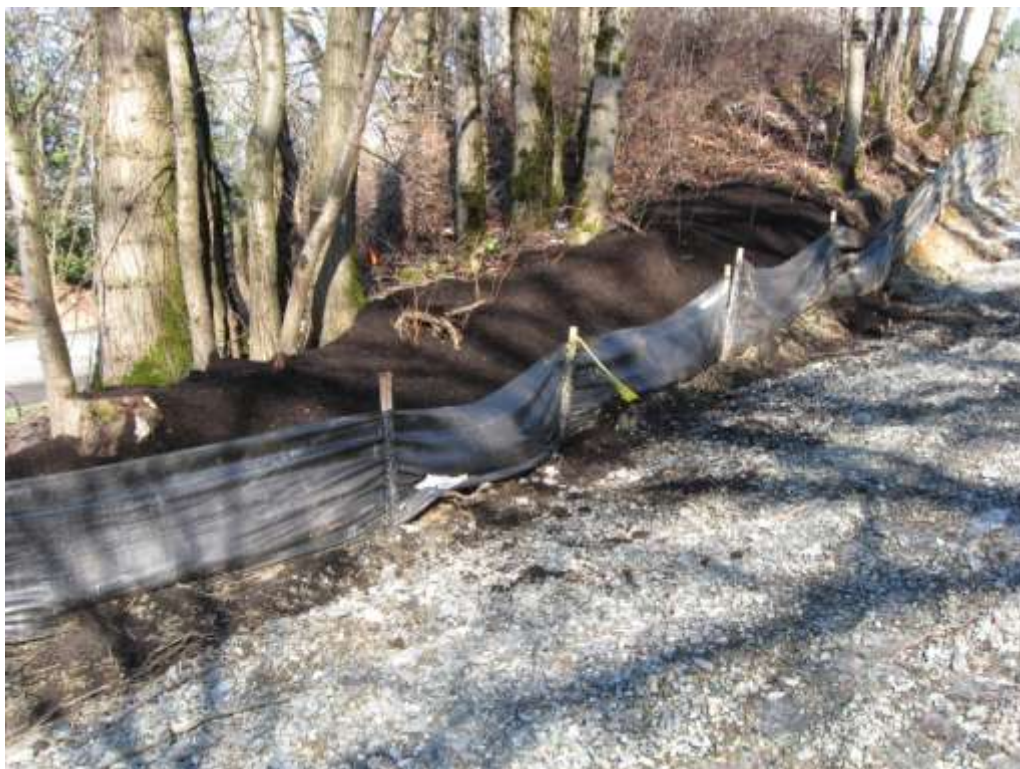
Photograph 22: Completed wetland M restoration near southwest Site entrance, February 25, 2011.

Slag was excavated from the buffer area of Wetland I and the buffer area of Wetlands M and N. These areas were restored in accordance with the *Wetland Buffer Enhancement/Restoration Plan* dated June 2010 and the letter regarding Beckwith Property Slag Site Remediation, Wetland M and N Buffer Work dated November 14, 2010, both prepared by Anchor (Appendix A). During the final week of January 2011, approximately 398 tons of imported fill material was used to rebuild the disturbed buffer area surrounding Wetland I. A cottonwood tree in Wetland M that suffered root damage during slag excavation was cut down and placed in the buffer restoration area of Wetland I. In early February 2011, topsoil supplied by Cedar Grove Composting, Inc. of Maple Valley, Washington was placed in the disturbed buffer areas of Wetlands I, M, and N and inspected by the City of Kent.

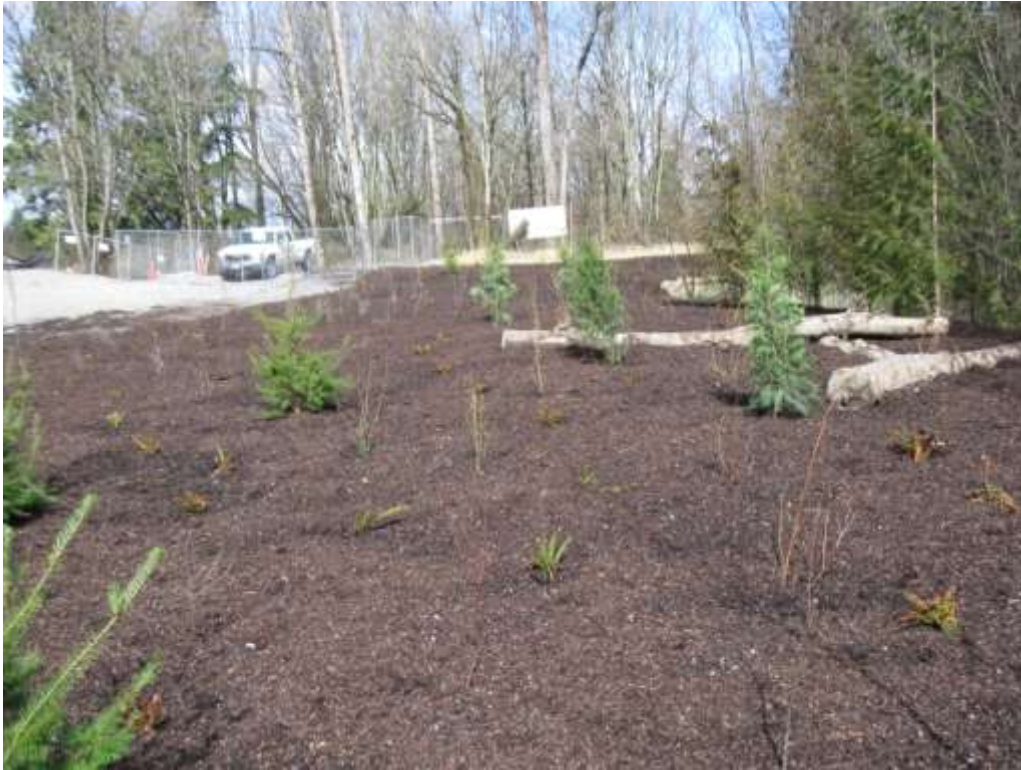
Photograph 23: Completed wetland buffer restoration on north portion of Site, March 22, 2011.

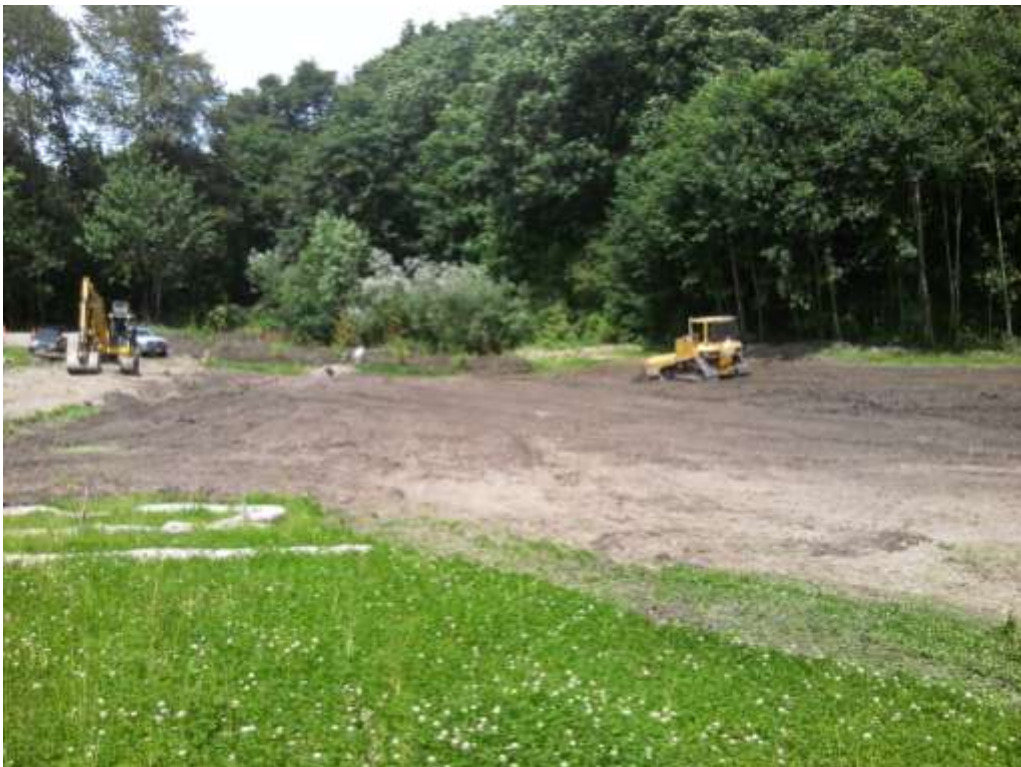
Photograph 24: Final grading at north end of Site, June 30, 2011.

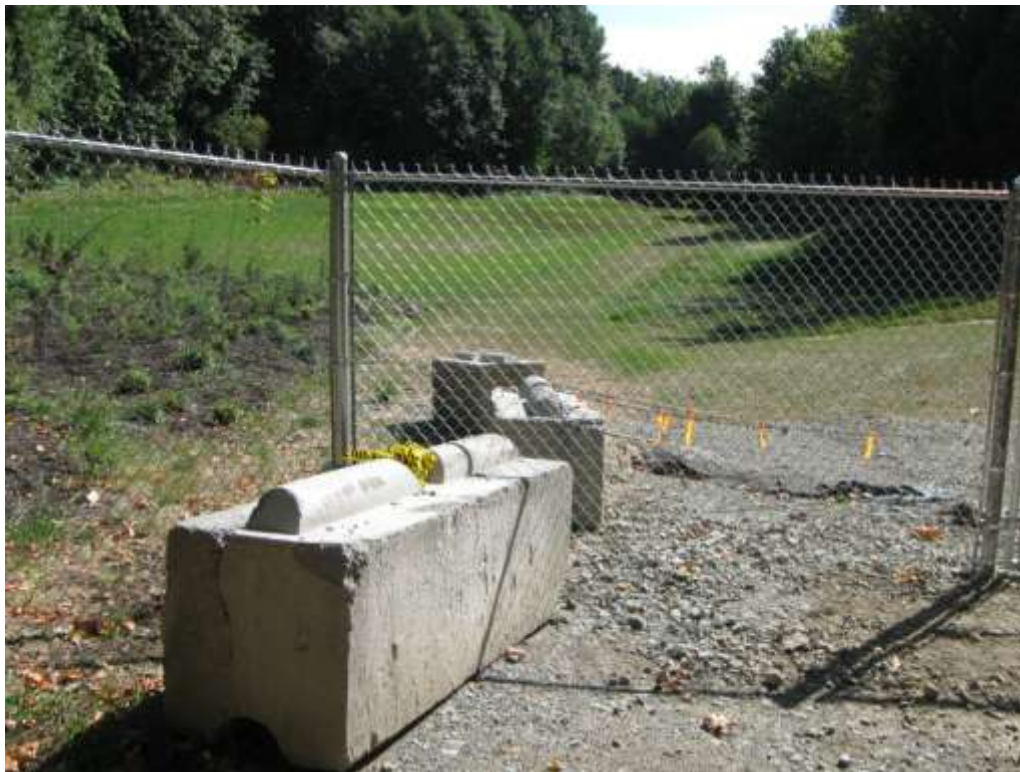
Photograph 25: Restoration of re-graded areas, September 2, 2011.

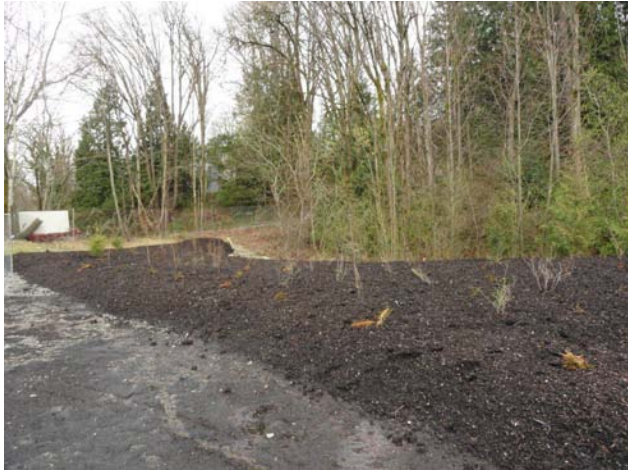
Photograph 1
Photo Point 1: Wetland I Buffer Facing North from West Side of Buffer

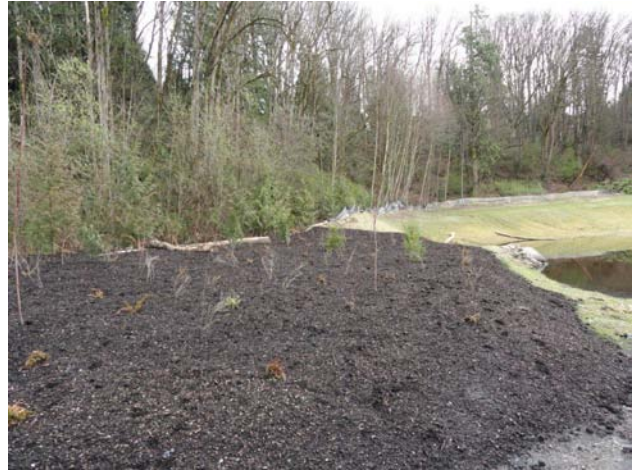
Photograph 2
Photo Point 2: Wetland I Buffer Facing South from West Side of Buffer

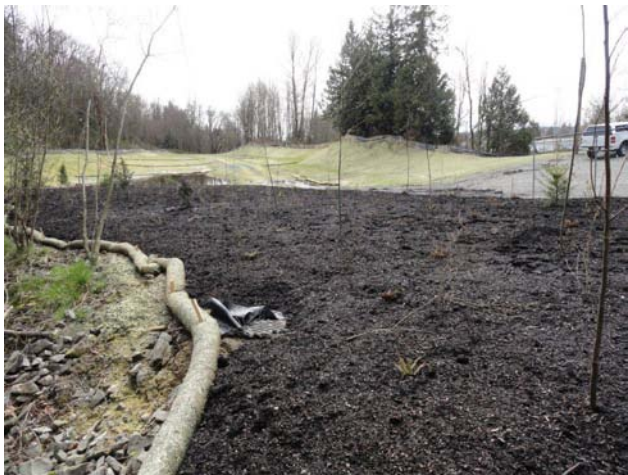
Photograph 3
Photo Point 3: Wetland I Buffer Facing South from Middle of Buffer
