COMPLETION AND COMPLIANCE MONITORING REPORT

SLAG DISPOSAL, BECKWITH PROPERTY SITE
SOUTH 218TH STREET AND 90TH AVENUE SOUTH
KENT, WASHINGTON

Submitted by:
Farallon Consulting, L.L.C.
975 5th Avenue Northwest
Issaquah, Washington 98027
Farallon PN: 831-022

May 2012

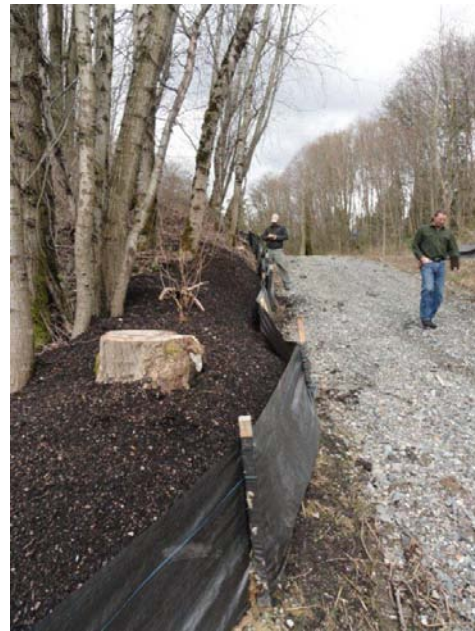
Photograph 4
Photo Point 4: Wetland M Buffer Facing North from East Side of Buffer
