**UNDERGROUND STORAGE TANK REMOVAL
PACIFIC PLAZA GARAGE
1250 PACIFIC AVENUE
TACOMA, WASHINGTON**

DECEMBER 31, 2008

**Underground Storage Tank Removal
File No. 16574-001-01**

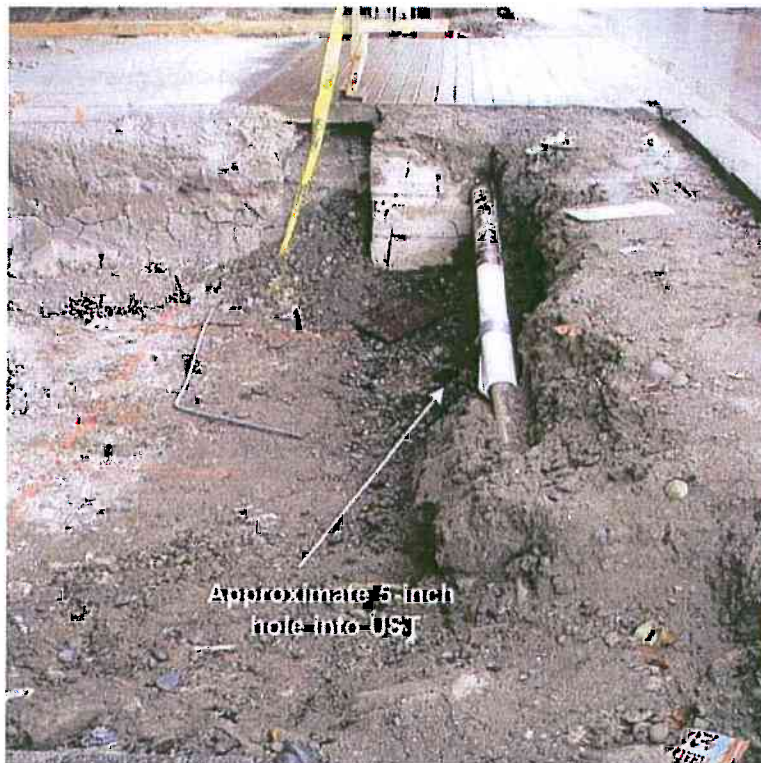
Discovery of UST looking north. Orange paint shows the location of the new footing. Gray pipe shows the approximate southwest corner of the UST. White pipe is an abandoned phone line. (April 4, 2008)

It appeared that the fill pipe had been removed and the access port located on the UST was covered with a rock prior to excavation activities (see Figure 4). A Comcast utility line was located on top of the eastern side of the UST. Product piping was observed north of the UST. The piping inside of the building was reportedly removed during recent construction activities. Absher was not aware of the UST at the time of the removal of the product piping.

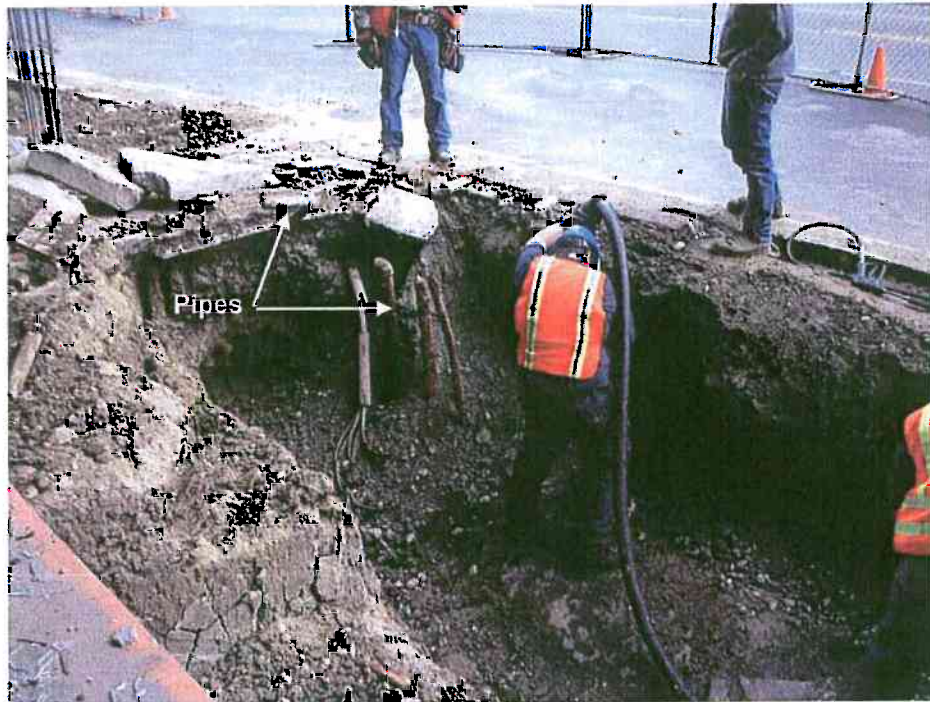
Phoenix Environmental removing oil and sludge from underground storage tank (UST) looking northeast. (April 10, 2008)

H and K excavated the surface material from the top of the UST on April 10, 2008. Phoenix Environmental removed approximately 700 gallons of oil and 100 gallons sludge from the UST with a vactor truck. The UST was rinsed three times. Cobbles and sand were observed inside the UST.

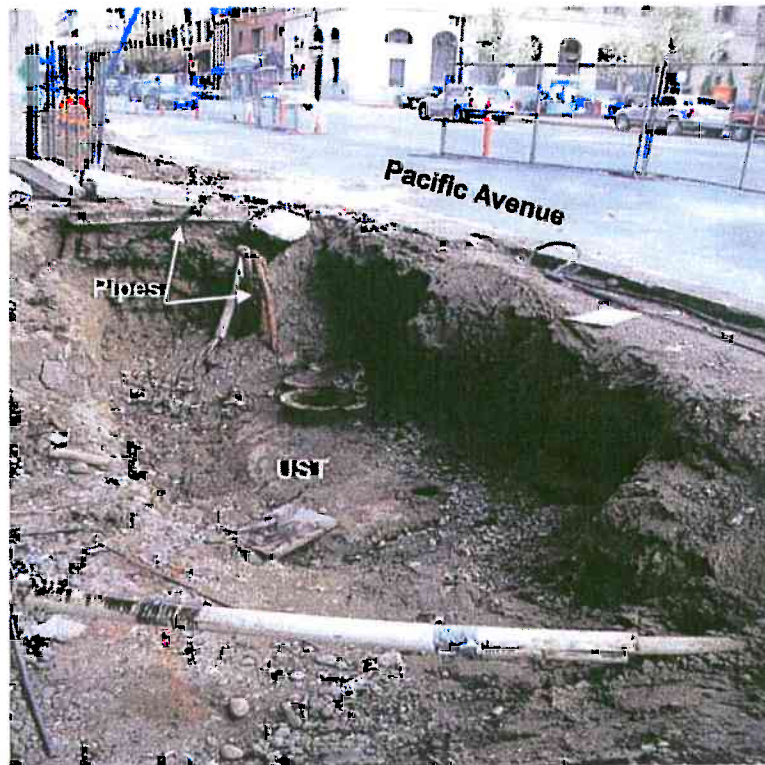
Top of UST exposed looking north. (April 10, 2008)

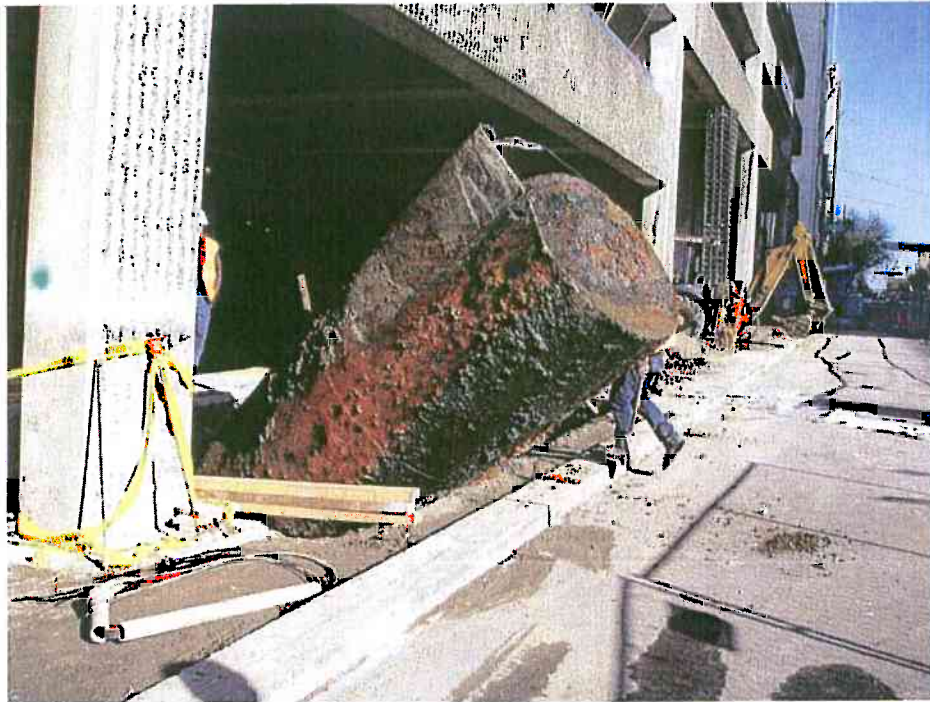
Underground storage tank during removal looking northwest. (April 11, 2008)

H and K removed the UST with an excavator under the observation of a representative of GeoEngineers and Phoenix Environmental on April 11, 2008. Mr. Rob Olsen, UST Site Inspector with Tacoma Pierce County Health Department (TPCHD), was not on site during the removal of the UST. Mr. Olsen did observe the excavation area following removal of the UST.

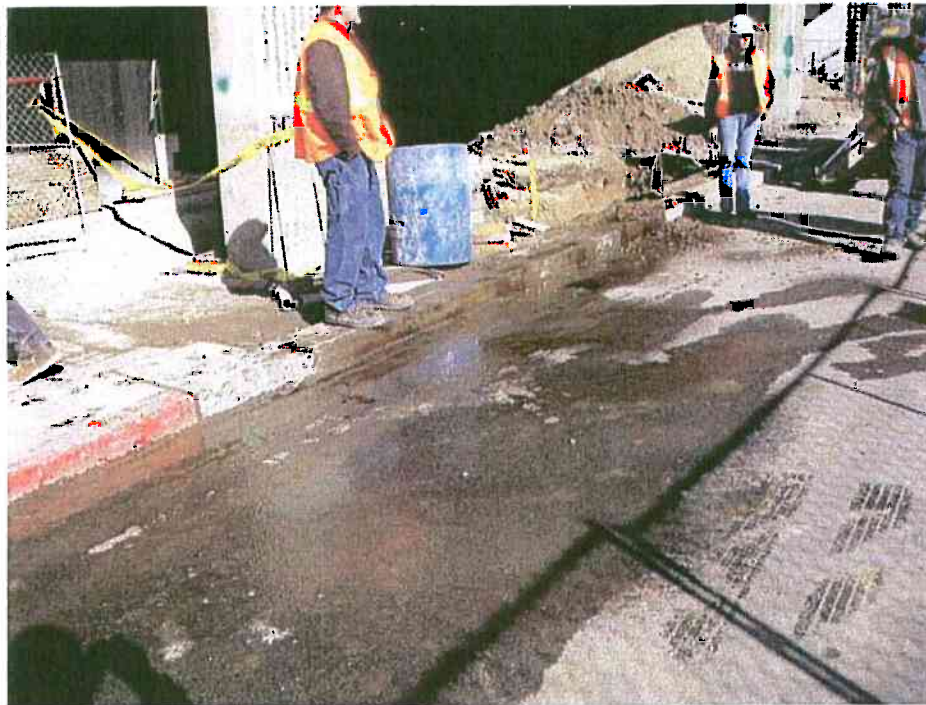
Petroleum spill on the asphalt from removal. (April 11, 2008)

Minor amounts of water entered the UST between April 10 and April 11, 2008 prior to removal. Oily water spilled onto Pacific Avenue during removal of the UST. Oil absorbent diapers and booms were placed within and around the area to contain the spill and prevent the oily water from entering the catchbasin located on the northwest corner of Pacific Avenue and South 13th Street. A vactor truck hose was placed inside the catchbasin to collect water as Phoenix Environmental washed the street using a power sprayer immediately following the spill (see Figure 7). Oil residue was not visible in the area of the spill following the cleanup activities. The disposal tickets for the oily water and oil absorbent diapers and booms are provided in Appendix A.

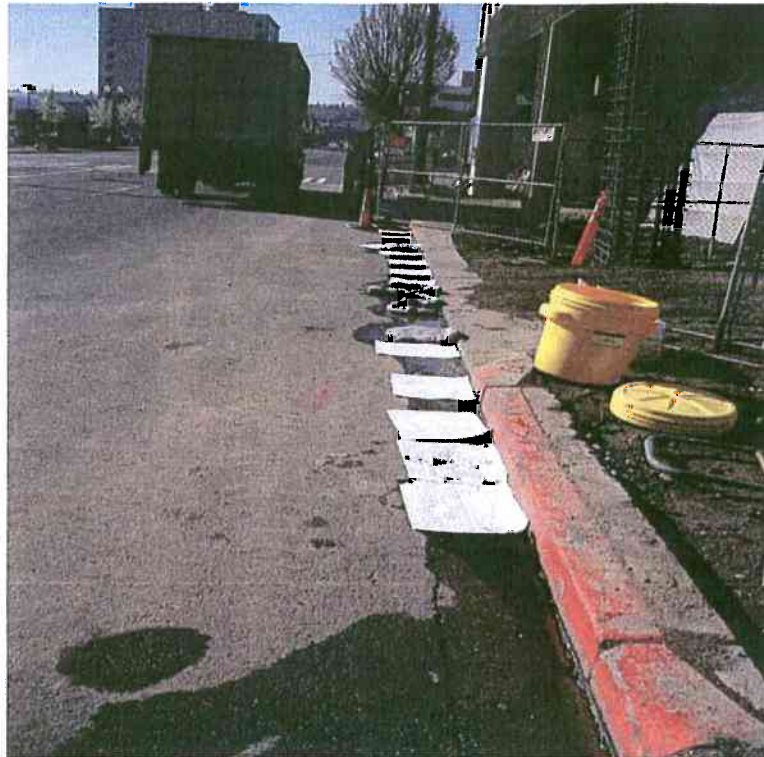
Cleanup action for petroleum spill on asphalt during removal looking south. (April 11, 2008)

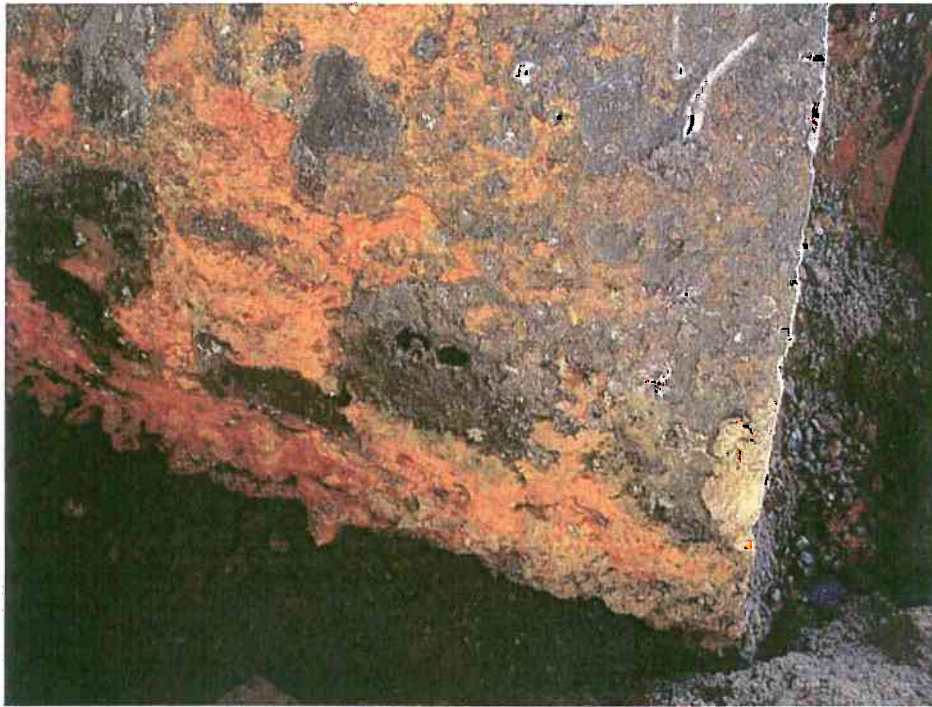
Multiple discernable holes that ranged in size from approximately 1/8 inch to 1.5 inches were observed throughout the UST. Blue-gray wet soils were observed on the bottom 6 inches of the UST (see Figure 6). The UST was placed onto a flatbed truck lined with visqueen liner following removal and transported to Phoenix Environmental in Tacoma for final rinsing and disposal.

Typical holes and rust observed on underground storage tank. (April 11, 2008)

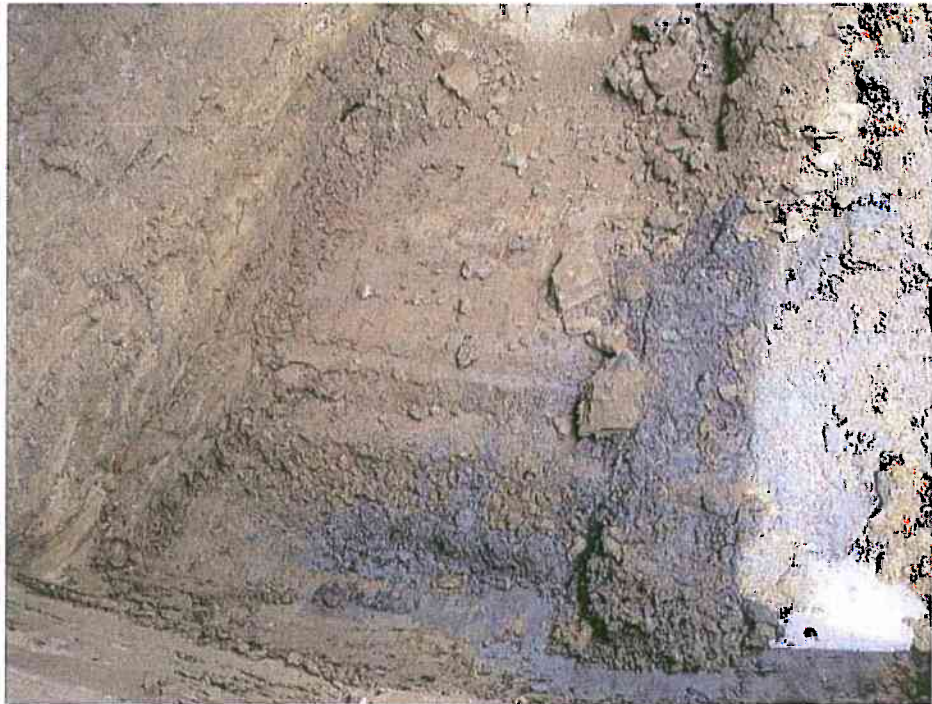
Light brown fill consisting of silty sand with gravel and bricks was observed to a depth of approximately 3 feet bgs on the west side of the excavation. The silty sand was underlain by sandy silt to the total depth of the excavation. Blue-gray sandy silt with a petroleum odor was observed between 7.5 feet and 8.5 feet within the majority of the western portion of the excavation. Blue-gray sandy silt extended to the depth of the excavation on the northwest portion of the excavation. A slight to moderate petroleum-like odor and sheen were observed in the blue-gray soils.

Example of blue-gray soils and brown sandy silt in southwest portion of excavation (approximately 7 feet bgs). (April 14, 2008)

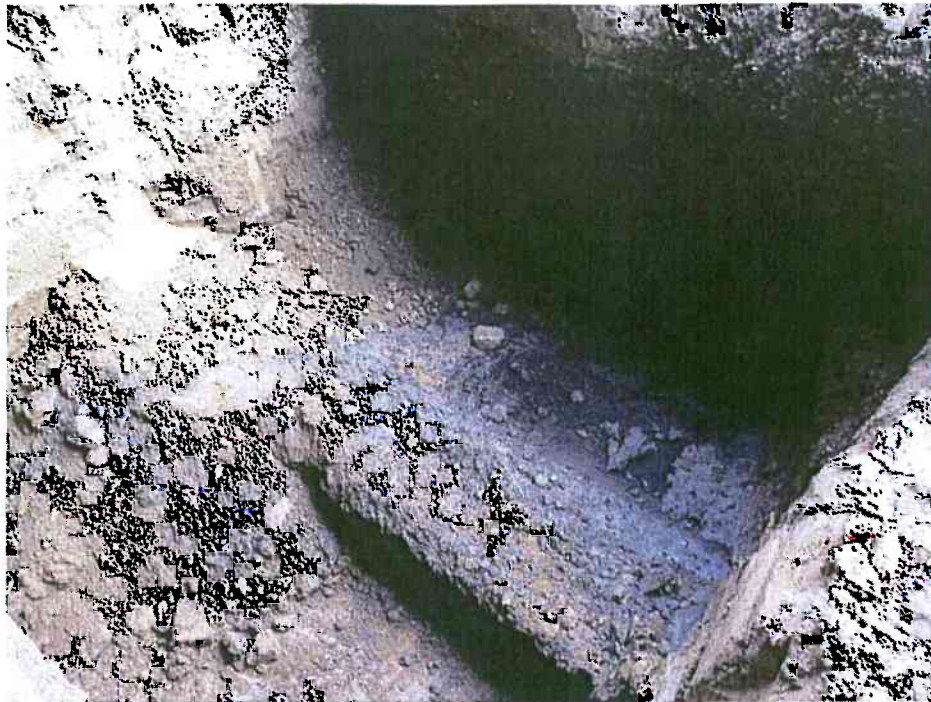
The fill material on the eastern portion of the excavation consisted of brown gravel with sand and silt was encountered to the total depth 7.5 feet below ground surface (bgs). Gravel with blue-gray sand and silt was observed from approximately 7.5 feet bgs to the total depth of the excavation. A slight to heavy petroleum-like odor and sheen were observed in the blue-gray soils.

**Example of blue-gray soils eastern portion of excavation (approximately 8.5 feet bgs).
(April 14, 2008)**

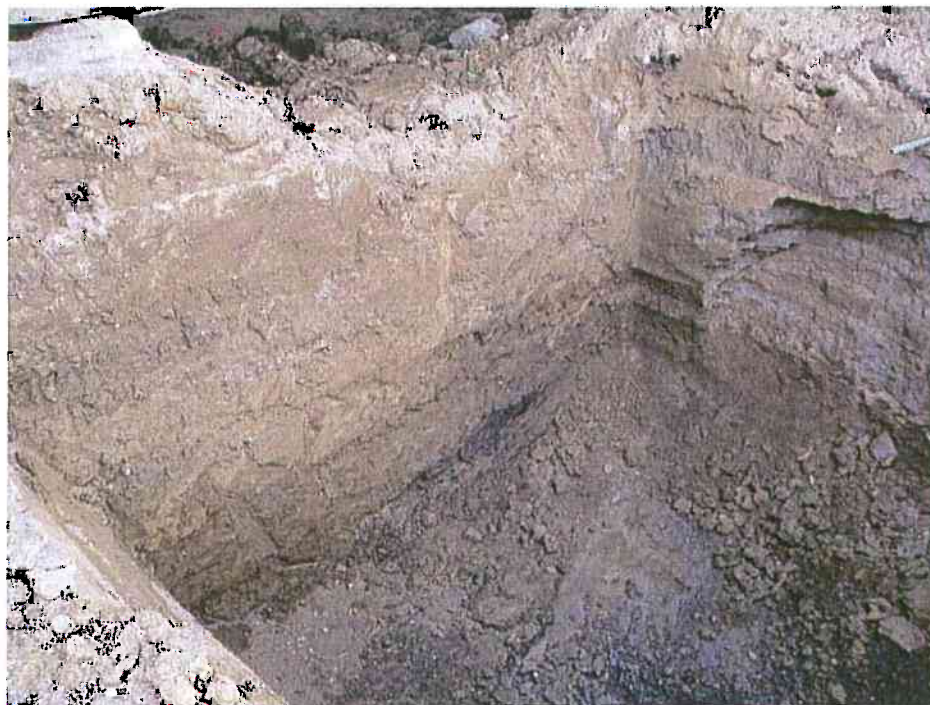
Final extent of excavation on west and northwest wall. (April 14, 2008)

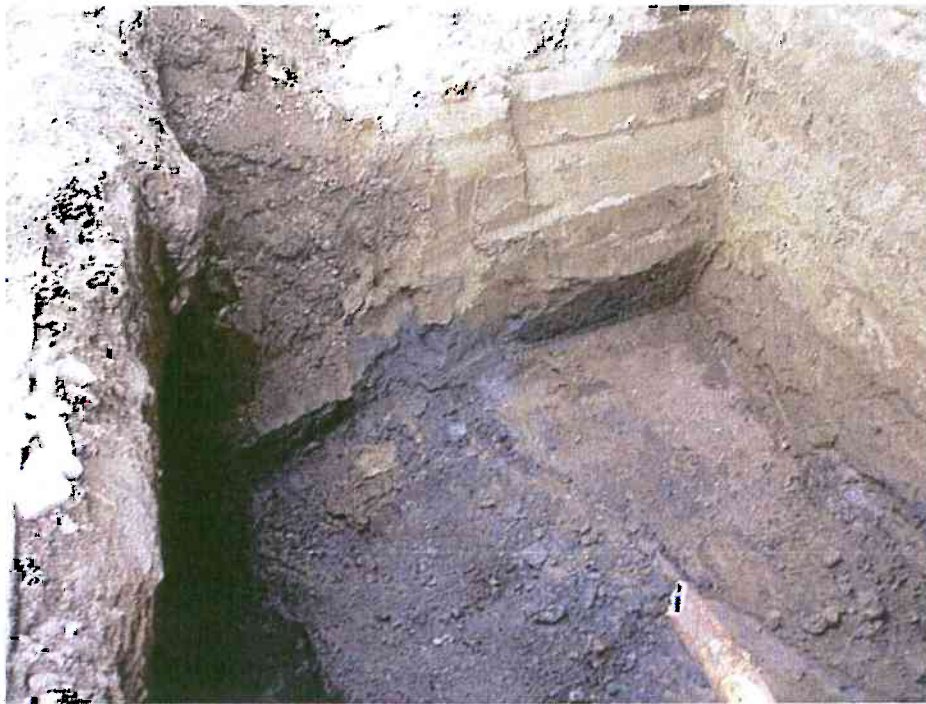
Final extent of excavation on south wall. South wall soil sample (Conf-S.Wall) collected in blue-gray soils (April 14, 2008)
