PERMANENT CLOSURE NOTICE FOR UNDERGROUND STORAGE TANKS

**DECOMMISSIONING OF UNDERGROUND STORAGE TANKS,
UST SITE ASSESSMENTS, AND REMEDIAL CLEANUP ACTIONS
AT THE SHORT STOP #7 GASOLINE STATION**

December 2015

Short Stop #7 Gasoline Station in Cle Elum, Washington

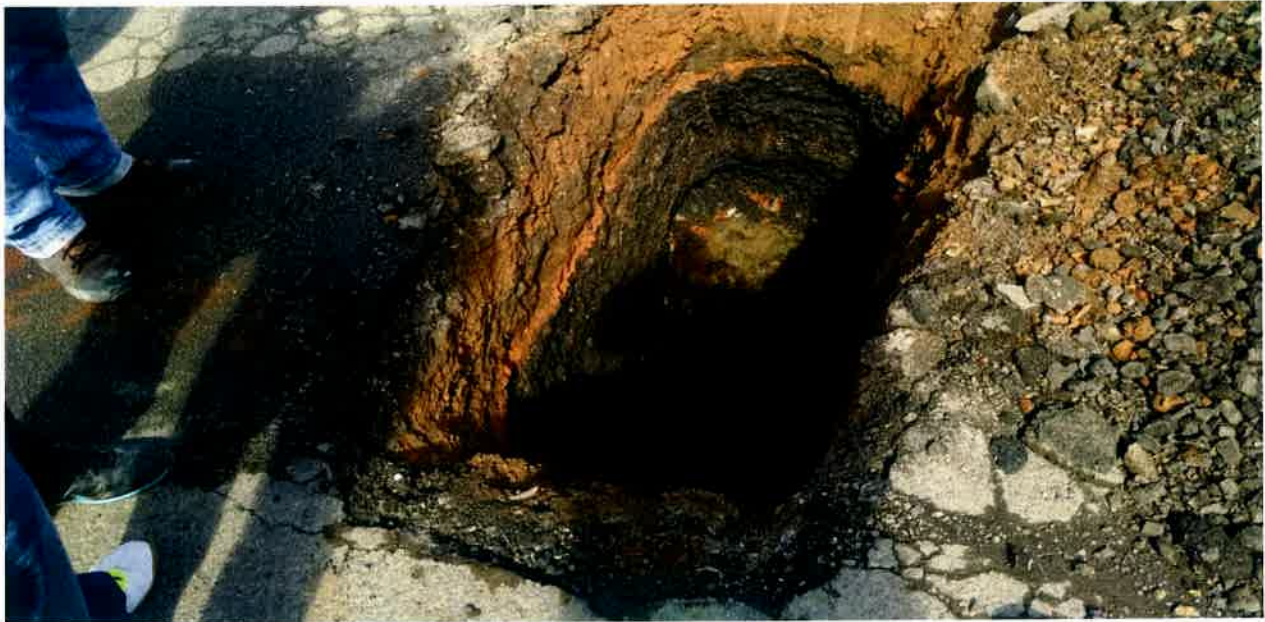
It was first considered in March of 2015, that a new large-tank would be installed during April, at the Short Stop #7 Station without performing the removal of the five existing tanks. That 24,000 gallon tank was eleven feet in diameter and 34 feet in length, and was to be installed on the West side of the Pump Island. The existing five USTs are located on the East side of the Island. I investigated the soils at the Station and dug a small test pit to the West of the fueling island where the new tank was to be installed. Below is a photo of that test pit.

Below four inches of asphalt was found a twenty-nine inches thick layer of brick debris, (including whole bricks). Beneath that, was a four foot thick layer of coal debris with some larger chunks of coal, and then a foot thick layer of ash and burned wood debris above rounded river rock at the groundwater table at eight feet depth. No real soil was found. Samples of the "soils" and the groundwater were submitted to the Friedman & Bruya Laboratory in Seattle and tested for petroleum hydrocarbons.

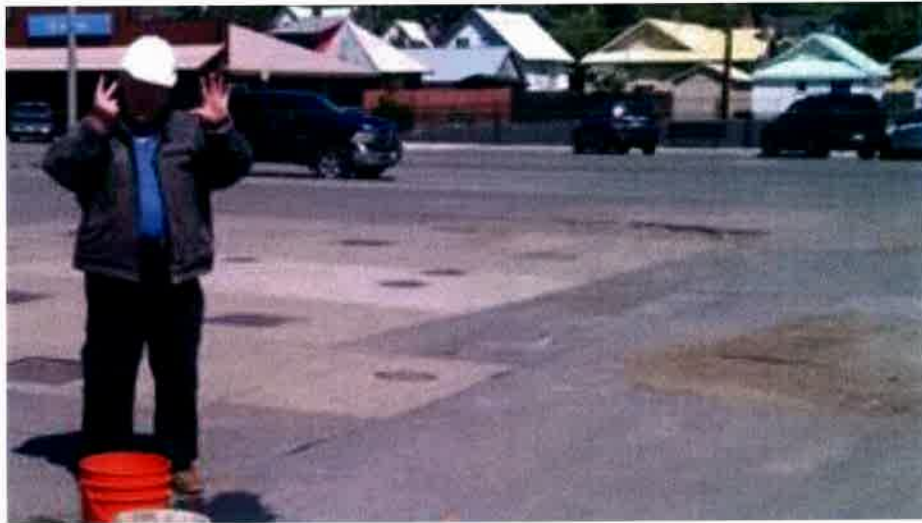
The first test pit was at the northeast corner of the concrete slab covering the Tank Pit Nest.

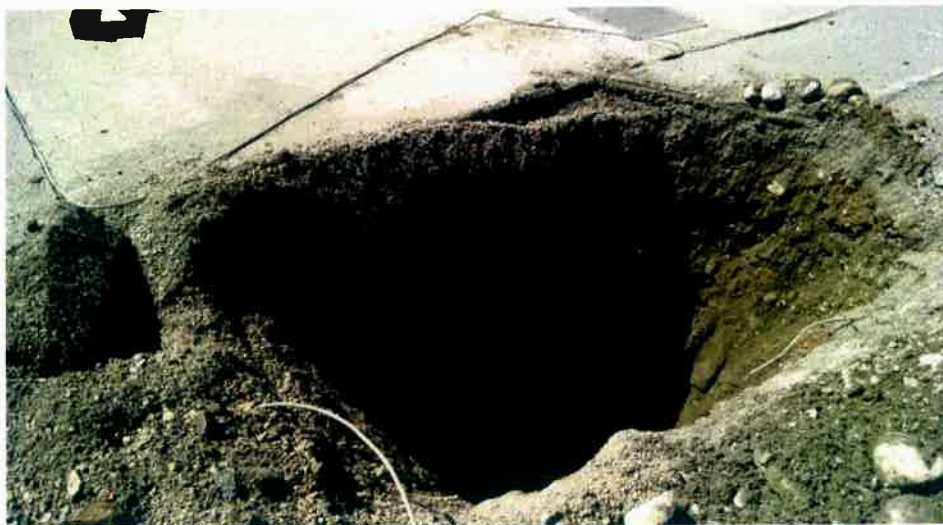
It may be seen in the first test pit photo that the upper soil was backfill and not the brick debris found in the previous test pit investigation. However, the coal debris was found in the deeper level down to the round river rock at the eight foot deep groundwater table, as found in the previous test pit investigation.

Both test pits evidenced a "petroleum sheen" and had a hydrocarbon odor within the coal debris layer.

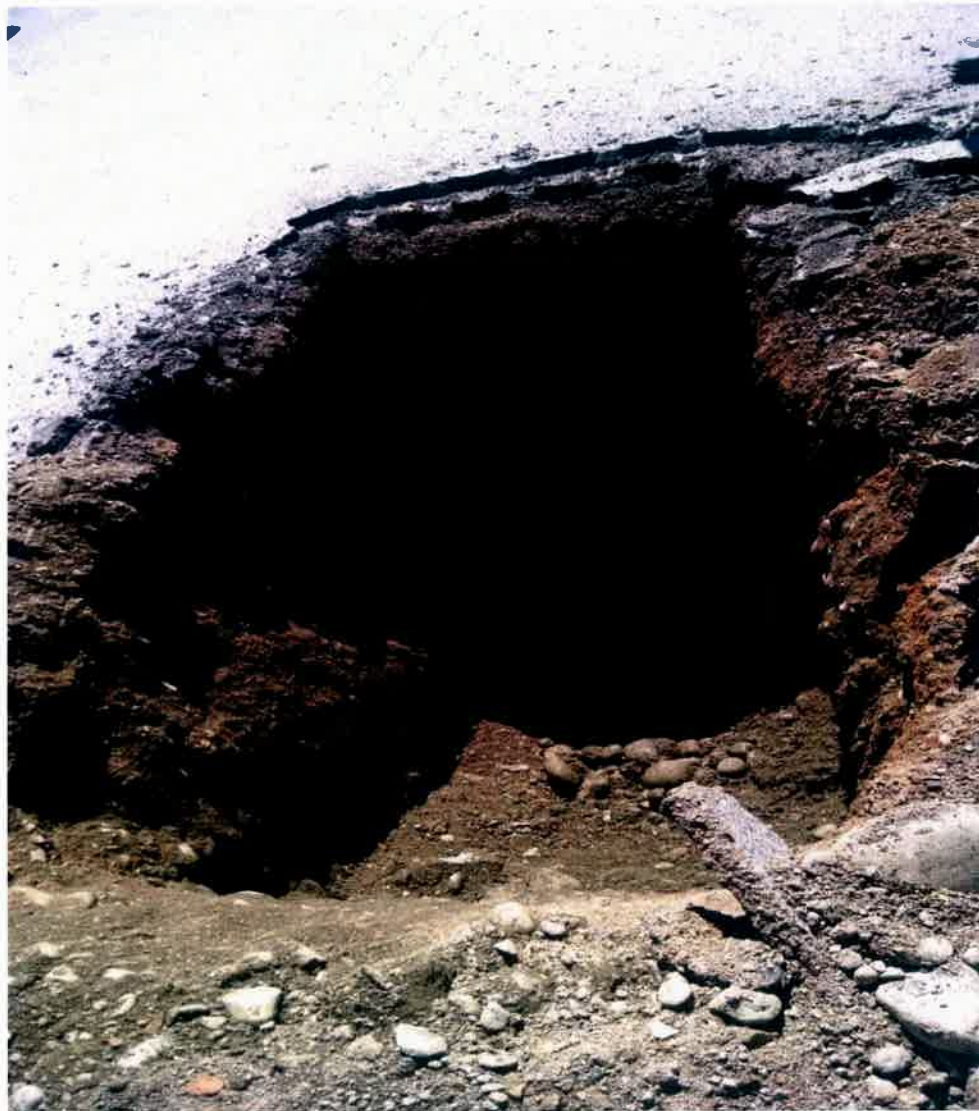
The second test pit was adjacent to the east side of the Tank Pit Nest near a Groundwater Monitoring Well. This test pit had the upper layer of the brick debris, followed by the coal debris layer down to the river rock at the eight foot water table.

Soil samples were taken from both Pits and submitted to the F&BI Lab for analyses.

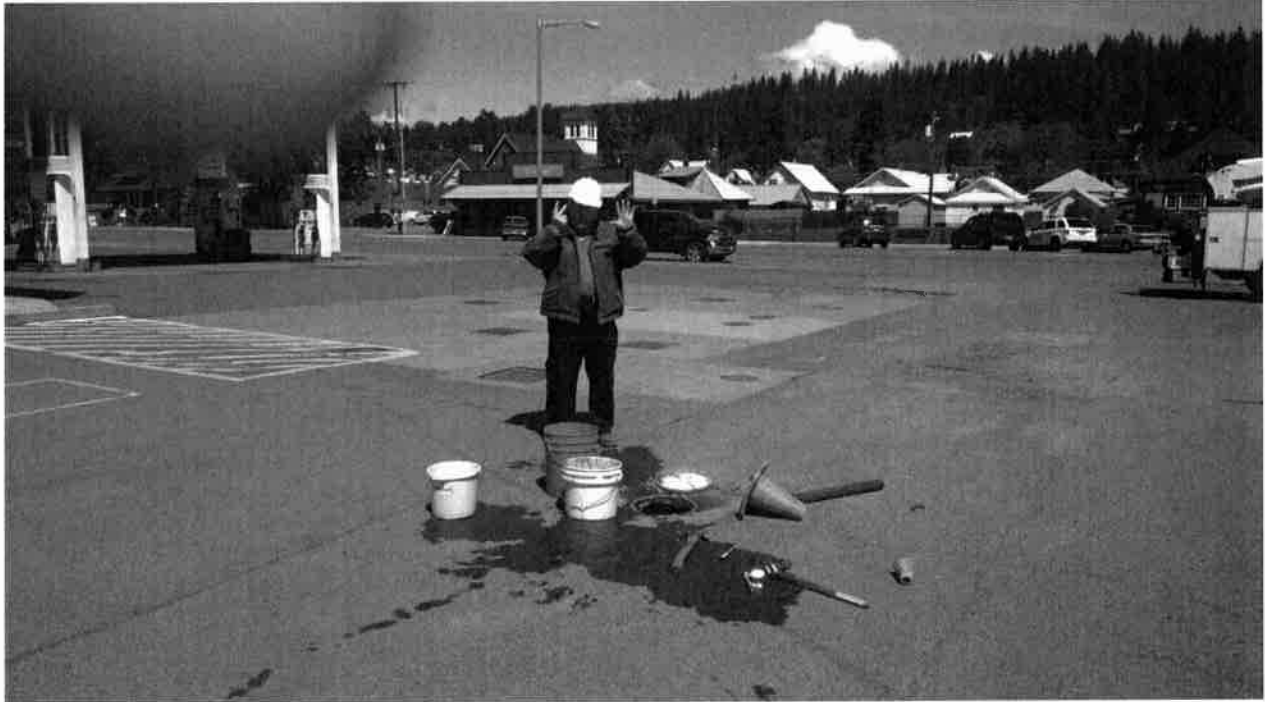
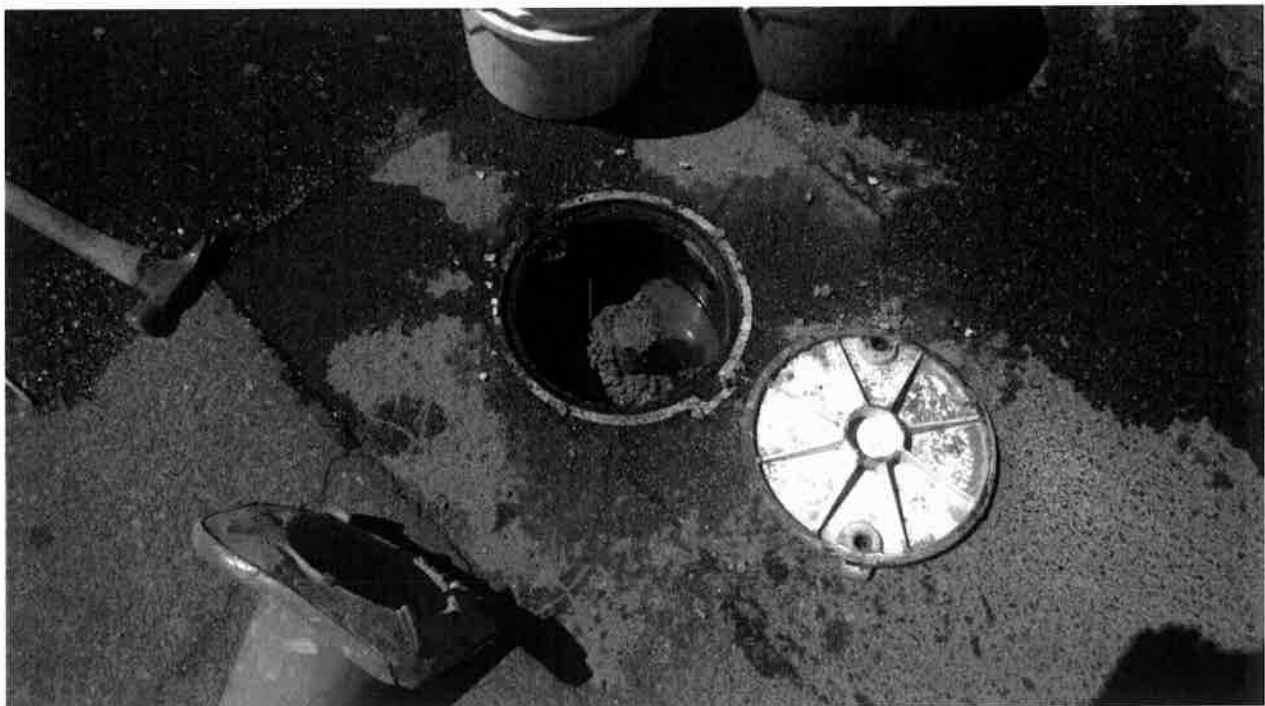
Following is a photo of this MW location after completion of this Decommissioning effort. The signals shown by my hands indicate that this was the fifth photo taken, and that the diameter of the GW MW was "two inches". Also in the background, may be seen two locations of soil exploration test pits adjacent to the "UST nest" holding the five UST's.

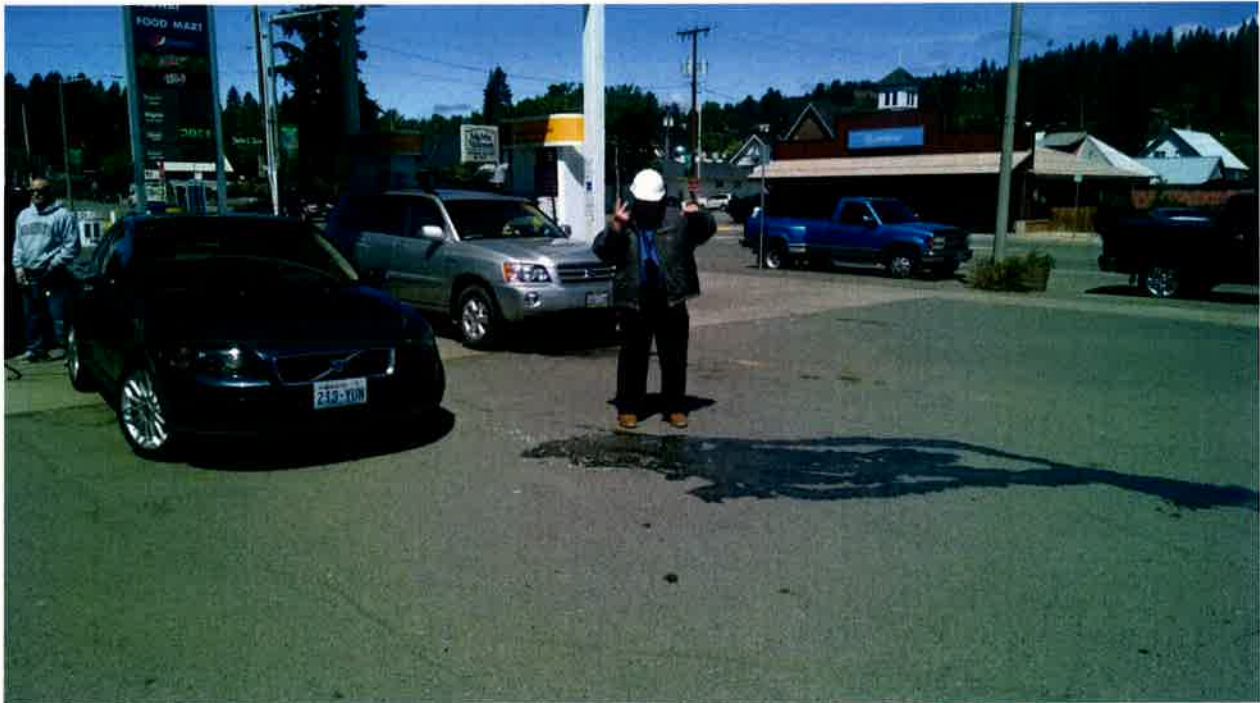
This photo shows the location of the former GW MW#32 (nearest to the Pump Island). Hand signals indicate that the well casing was two-inches in diameter and the other hand indicates that this was the final picture of this work effort! (It may be seen that this work effort was done while the busy station was in full operation !)

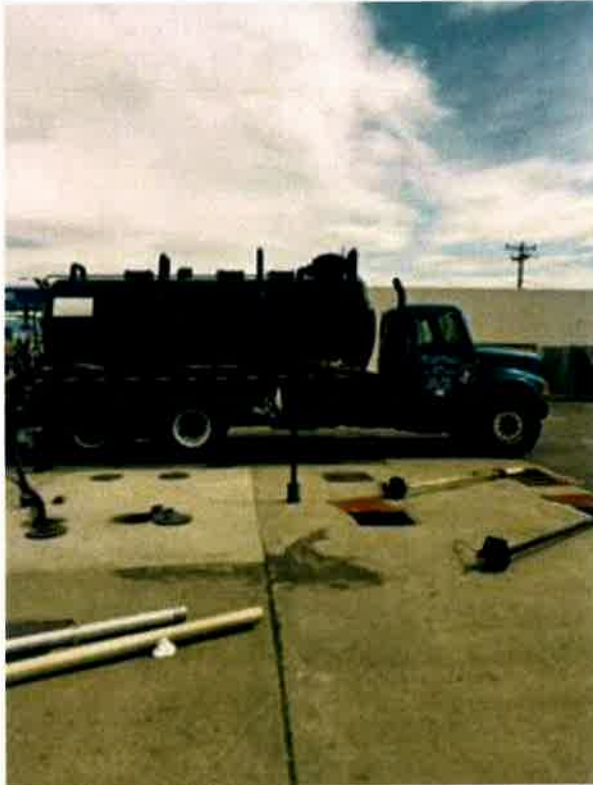
"MarVac" performing Pump and Triple Rinse of the five USTs.

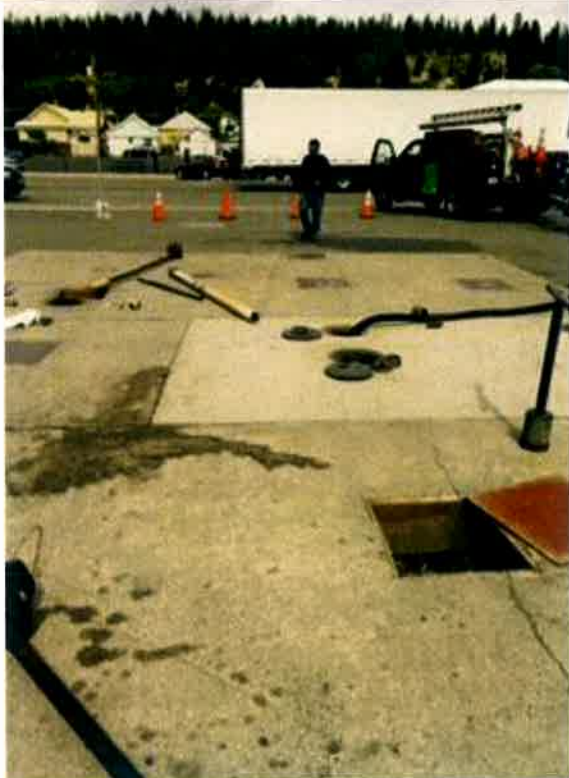
After Mar-Vac had certified the five USTs to be "Clean", Mr. Wilkerson of NES, proceeded to "Inert" the five USTs by placing "Dry Ice" (solid Carbon Dioxide) pellets into each of the USTs. The Dry Ice sublimates into carbon dioxide gas, which being heavier than both gasoline vapor and air, forces those vapors upward and out from the USTs, thereby making the tanks inert from explosion when the contents within a tank is at a level of less than ten-percent Oxygen.

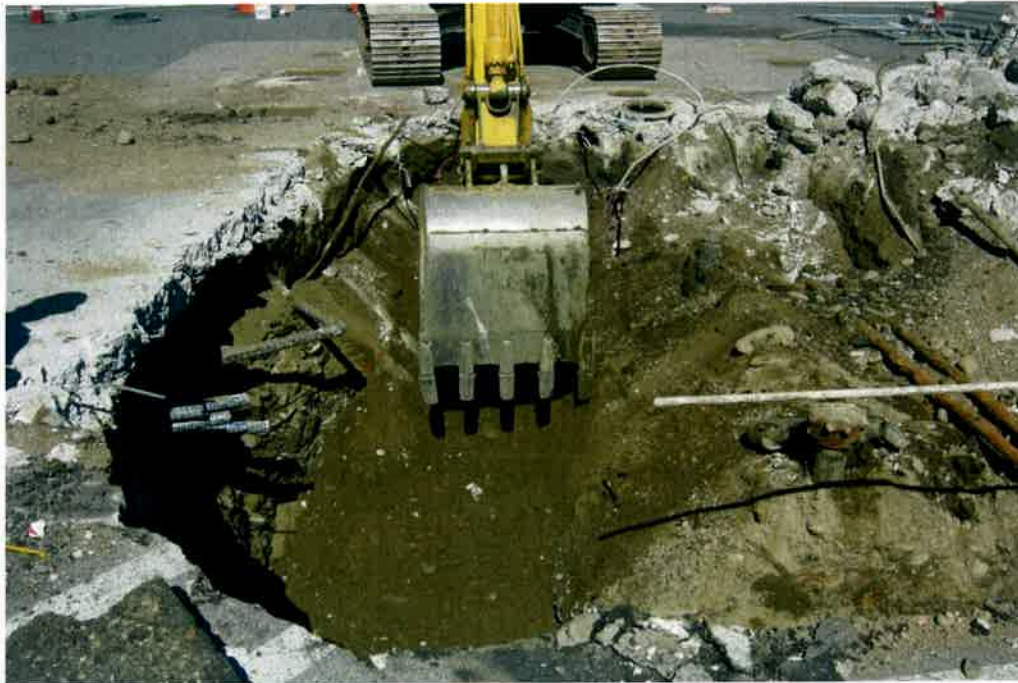
Removal of the five USTs began on Wednesday, September 9th. Concrete breaking and excavating of clean backfill soils above the USTs began. (Note numerous old piping runs from former tank installation operations.) Mr. Wilkerson and Mr. Webster discussed the removal of the two 4,000 gallon Diesel USTs. The large 6,000 gallon Gasoline tank ("G1") is located within the pit right background. (Note the clean backfill soil pile and Webster's blue gloves used for obtaining soil samples during the Decommissioning effort.)

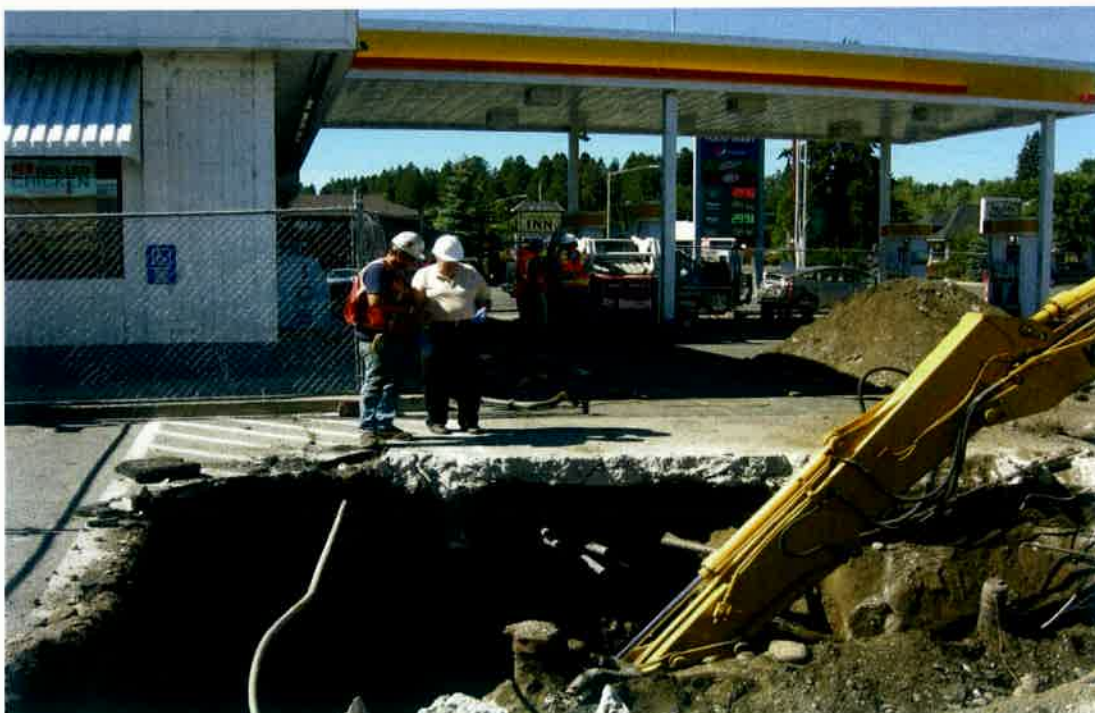
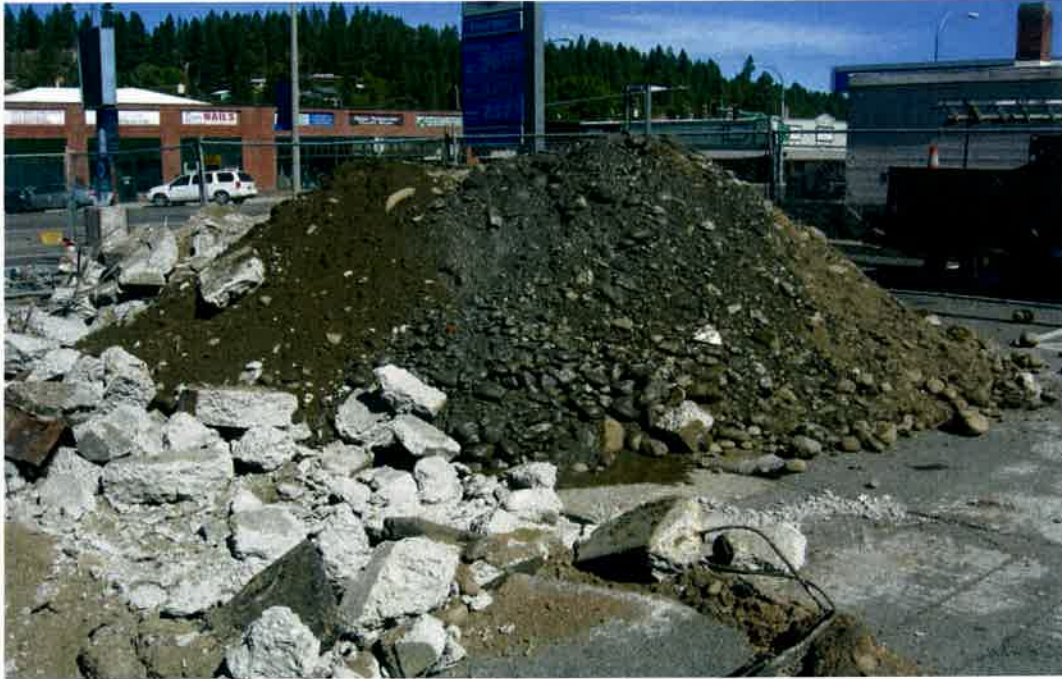
Webster had to warn the excavator Operator about mixing contamination with clean soils.

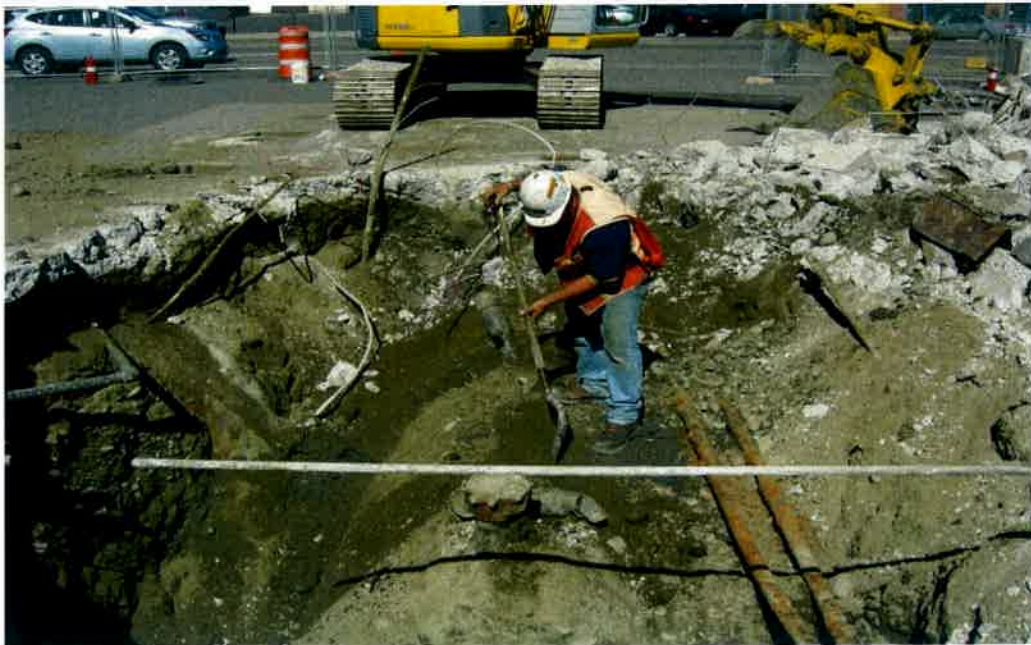
Mr. Wilkerson cleans dirt from the top of the Diesel UST (identified by me as "D2"). UST "D1" is beneath the soil on the right side of this photo. As the NES excavator (a 140) was found to be undersized for this UST removal operation, and the NES Operator Martin, was having problems in removing the first UST from the pit, a more experienced Operator, Mr. Riley Evans, was chosen. Because the tanks were placed so tightly in the Tank Pit, it was required that UST "D1" be removed first by excavating the far eastern side of the Tank Pit and "rolling it out" into the "expanded" Tank Pit.

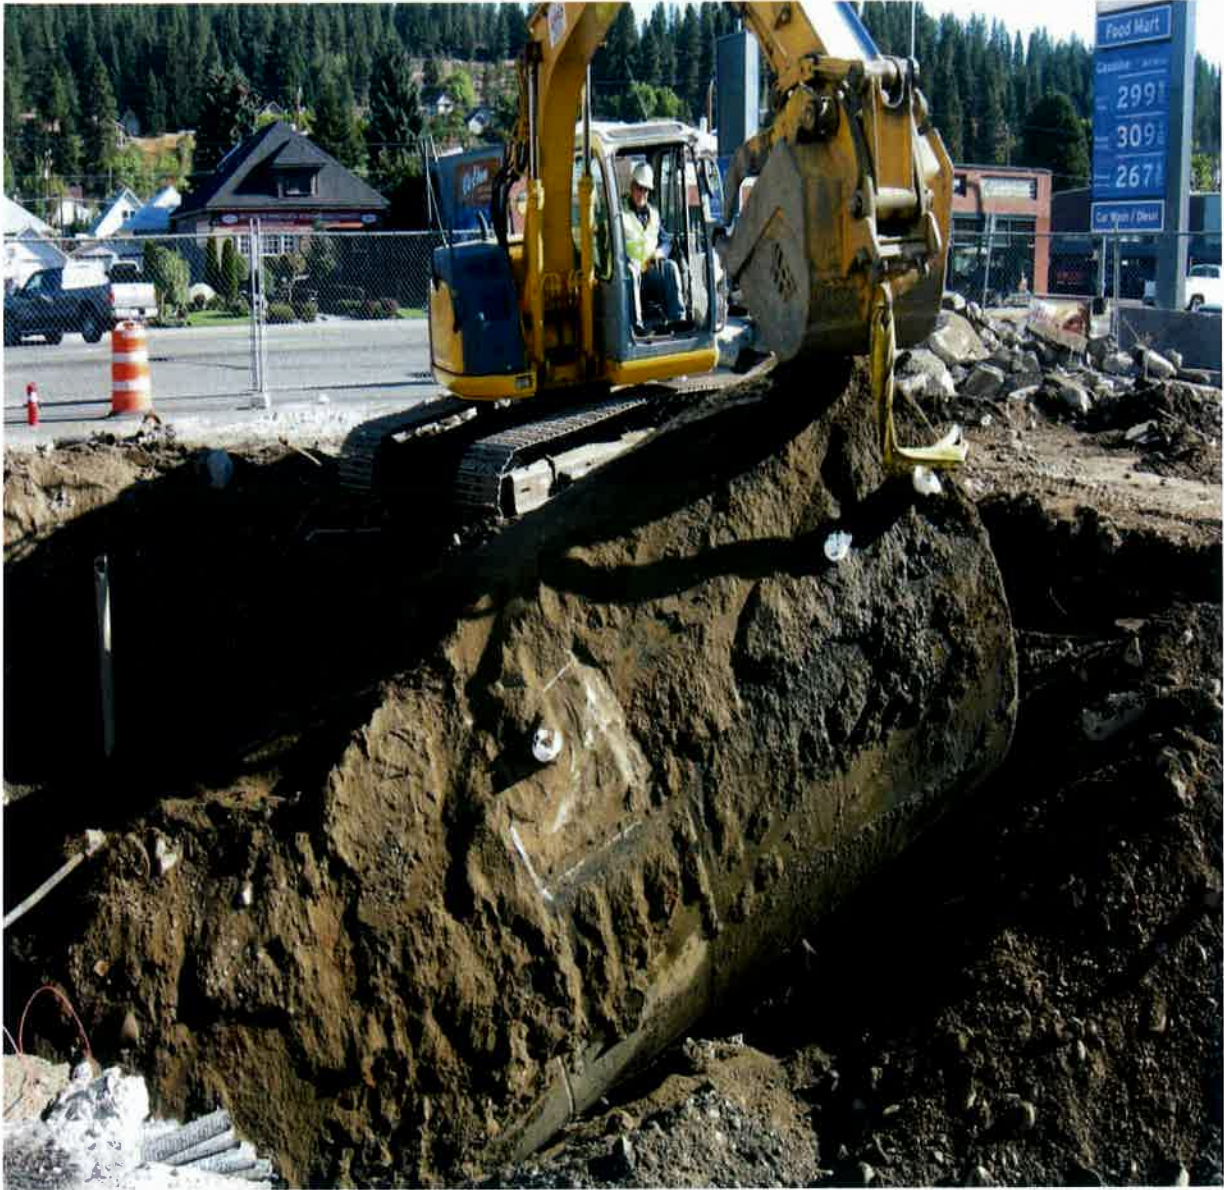
"Up comes" the big Gasoline UST ("G1). This third decommissioned UST was a 6,000 gallon tank, (eight feet in diameter and 17 feet in length). Because of the "dry summer" the groundwater table level was now found to be at nine-feet below grade. The excavator Operator, Mr. Evans used all his skill to "Break" the groundwater suction, and pull this UST from the ground.

Note: One of the two "Tank Pit" leak test monitoring wells that had been earlier Decommissioned, (during the Decommissioning of the four Groundwater Monitoring Wells), may be identified by the vertical white plastic pipe seen in the left background.

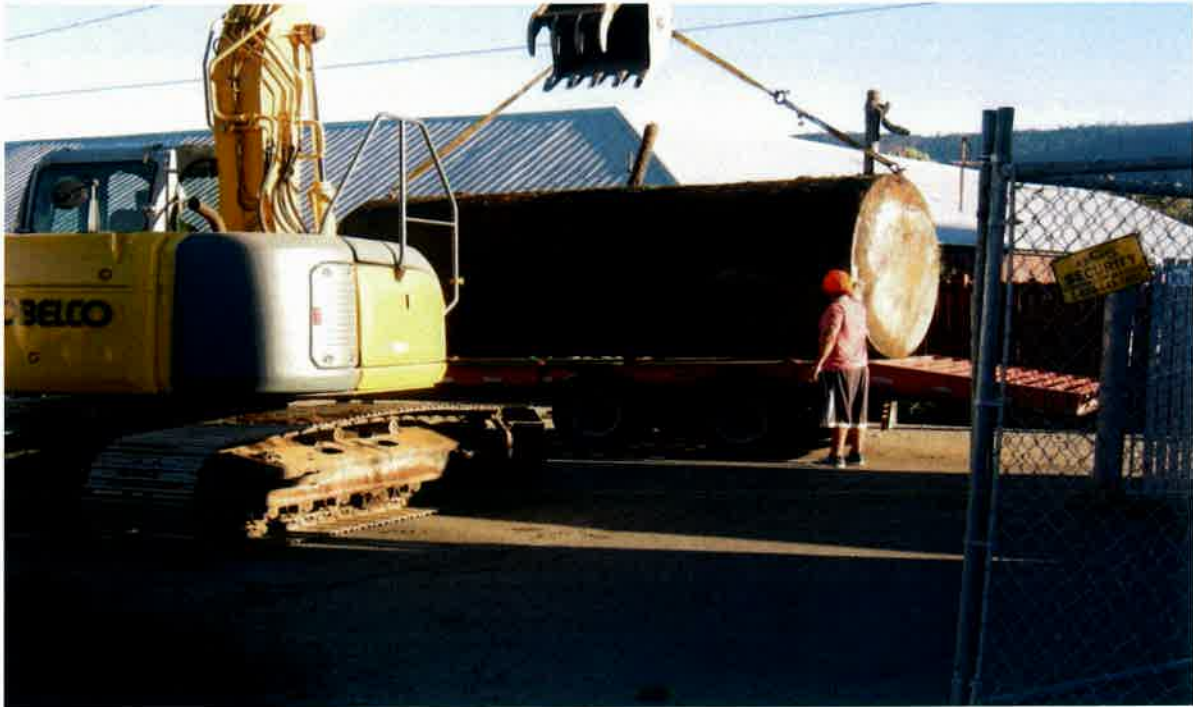
Each of the two 4,000 gallon Diesel USTs ("D1" and "D2"), were removed from the USTs Pit Nest, cleaned of loose soils, inspected for any leakage areas, and loaded onto a large flat-bed trailer, to be moved from the site to the salvage yard on Wednesday, September 9th. This photo shows the second UST being loaded late in the day. The third UST removed from the pit, the large 6,000 gallon Gasoline UST ("G-1") had to wait until the morning of the next day to be removed from the site.

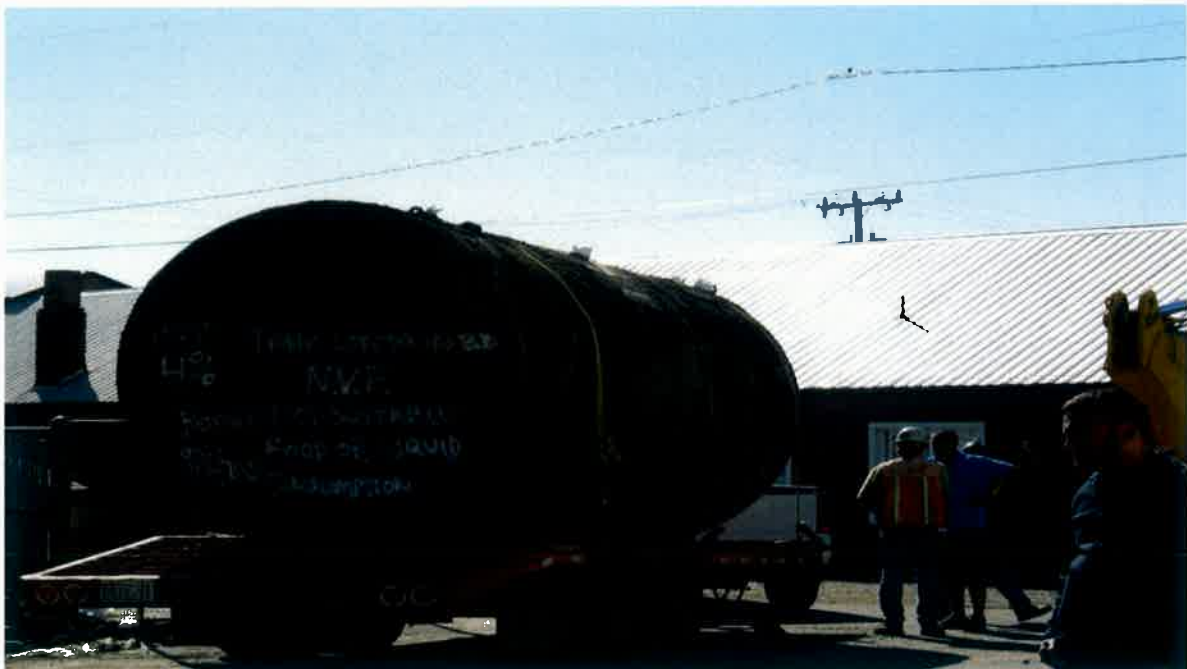
There goes the "cleaned" and "labeled" big "G1" UST early the next morning !

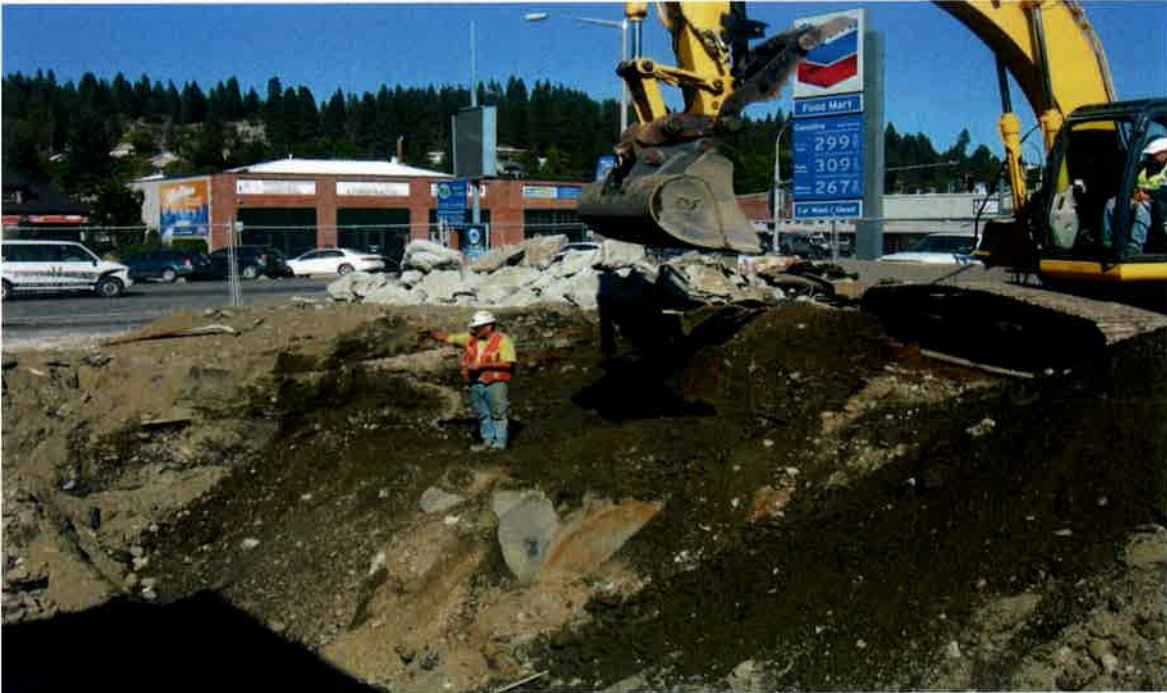
Mr. Wilkerson checks out the Oxygen content in "G2", the first of the remaining two Gasoline USTs ("G2" and "G3"). These two 4,000 gallon Gasoline tanks were six feet in diameter.

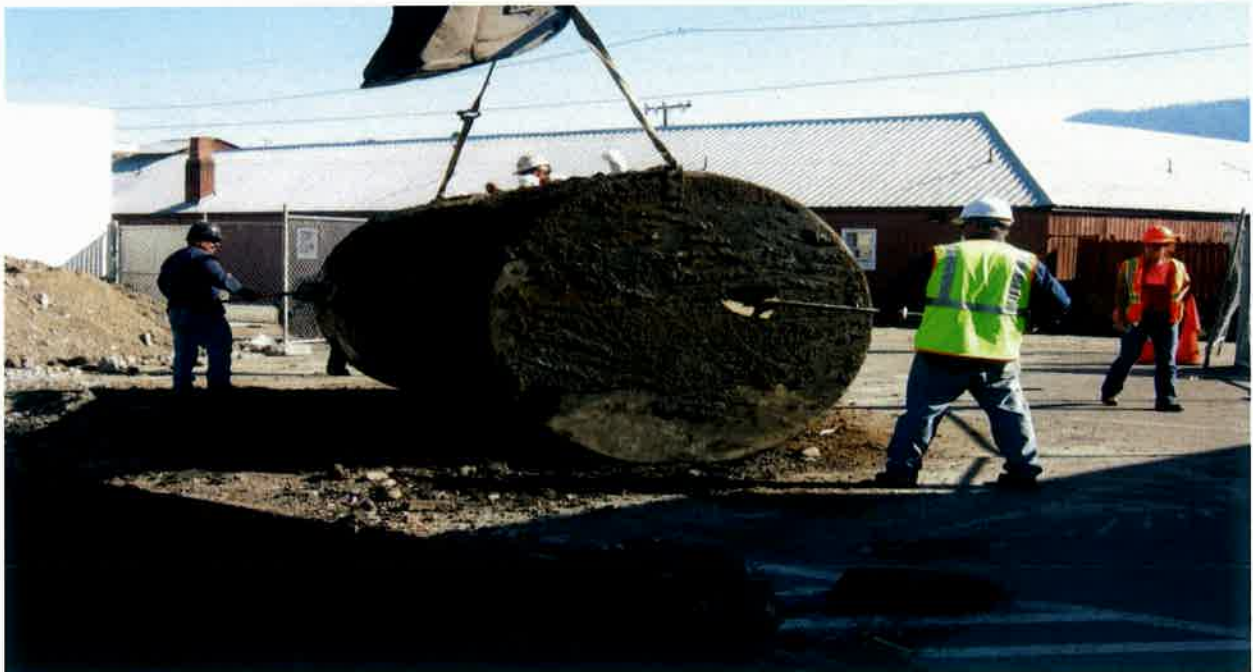
The final UST, ("G3"), is cleaned before being trucked from the site. The person on the right side, (in "red") is the Washington State Department of Ecology UST Decommissioning Site Inspector.

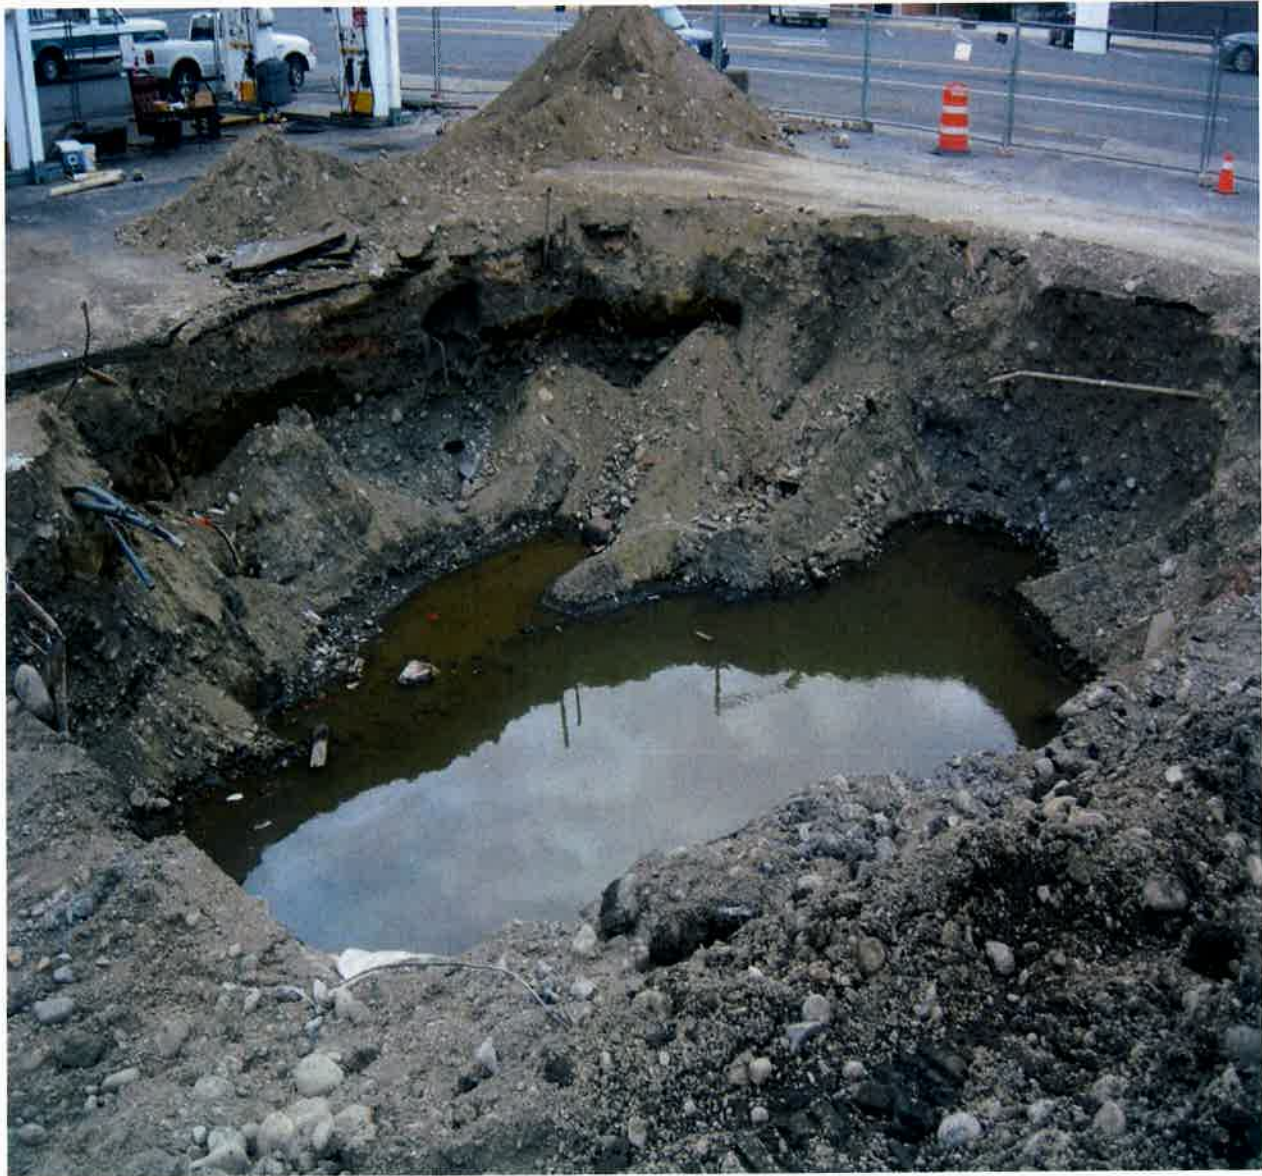
This is a photo of the Tank Pit Nest excavation on the morning of Friday, September 11th. The bottom of the depression has filled with groundwater in the area of the Pit where the large "G1" UST was removed. It was found that the groundwater table depth, which in April was found to be at the depth of eight feet, was now at a depth of nine feet below the surface. (The summer of 2015 had been very dry.) A slight petroleum hydrocarbon "sheen" is visibly seen on the water surface. Also please note the "open cave" in the center top of the west wall. That was an abandoned former piping-run trench which had been filled with pea-gravel. The last operating pipe-run trench may be seen on the left side of the dirt wall, where a number of metal pipes, wrapped in black tape, exist. Additional abandoned pipe runs are seen on both to far right side, and to left side, of the existing pit.

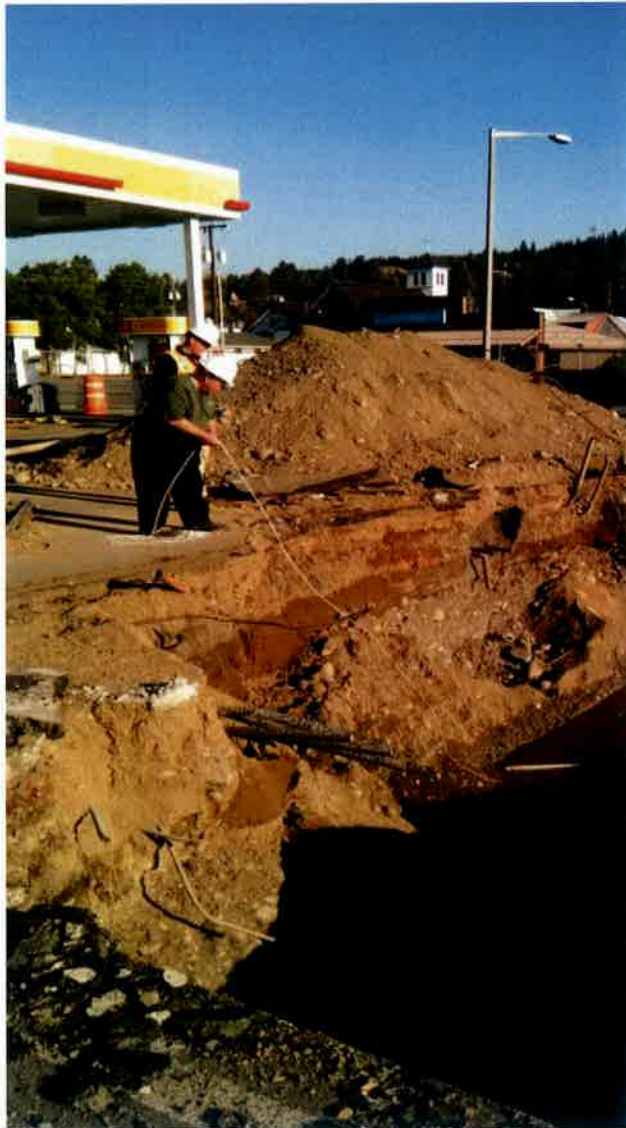
Early on the morning of September 11th, Webster "fished" with a monitoring well "Bailer" into the "pond" where the USTs had been removed and groundwater had accumulated overnight. A "composited" groundwater sample was collected in a brown bottle (w/HCl) and delivered, that day, to the F&BI Lab in Seattle for analysis of R8 Dissolved Metals.

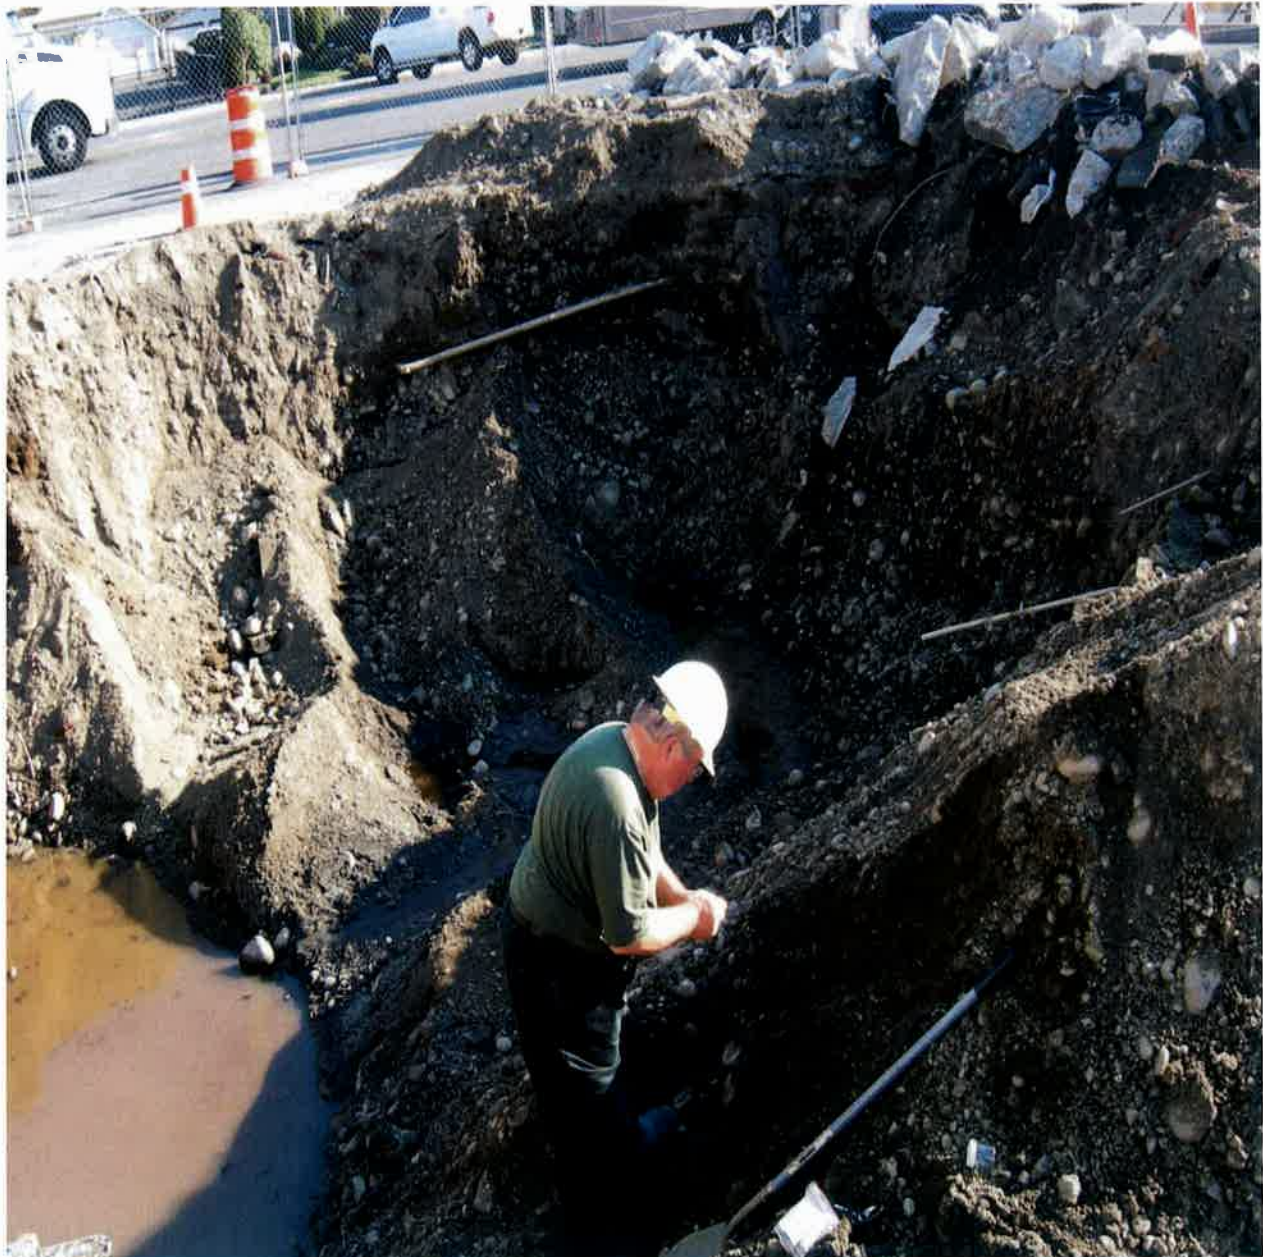
Webster investigated the soils remaining in the Tank Pit Nest after the removal of the five USTs. (Note the number of small pipes protruding from the east bank of the pit wall.)

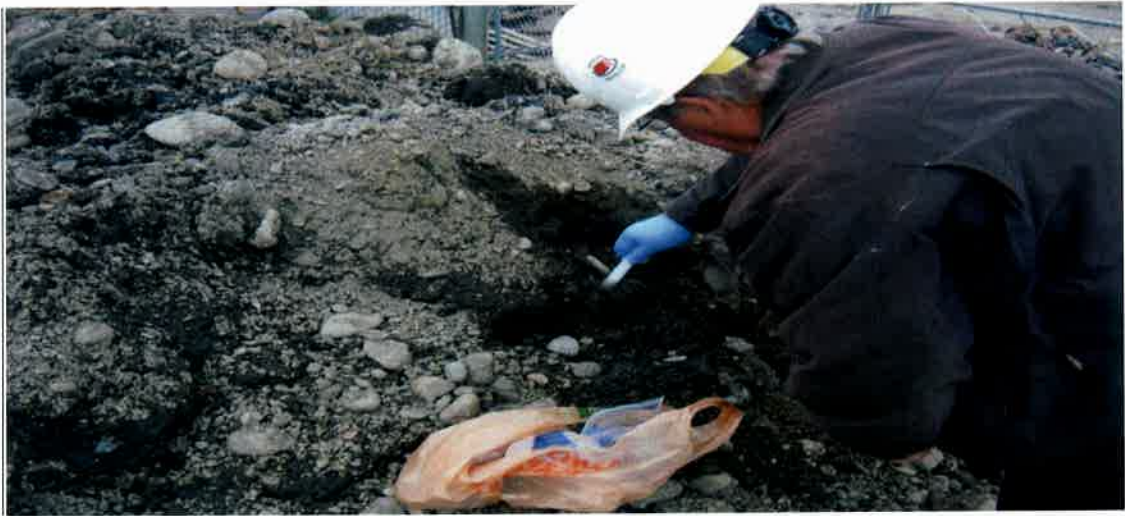
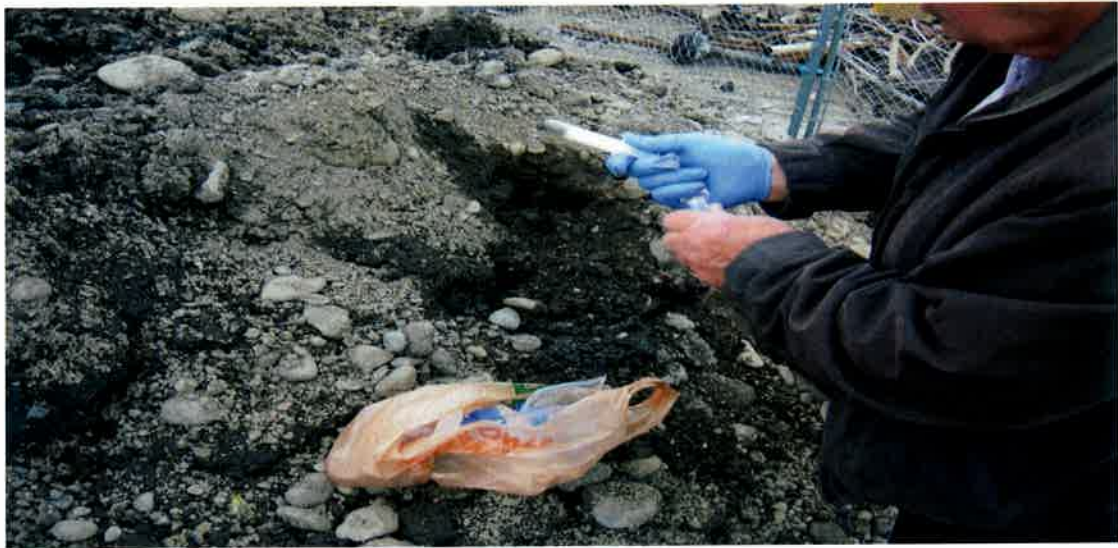
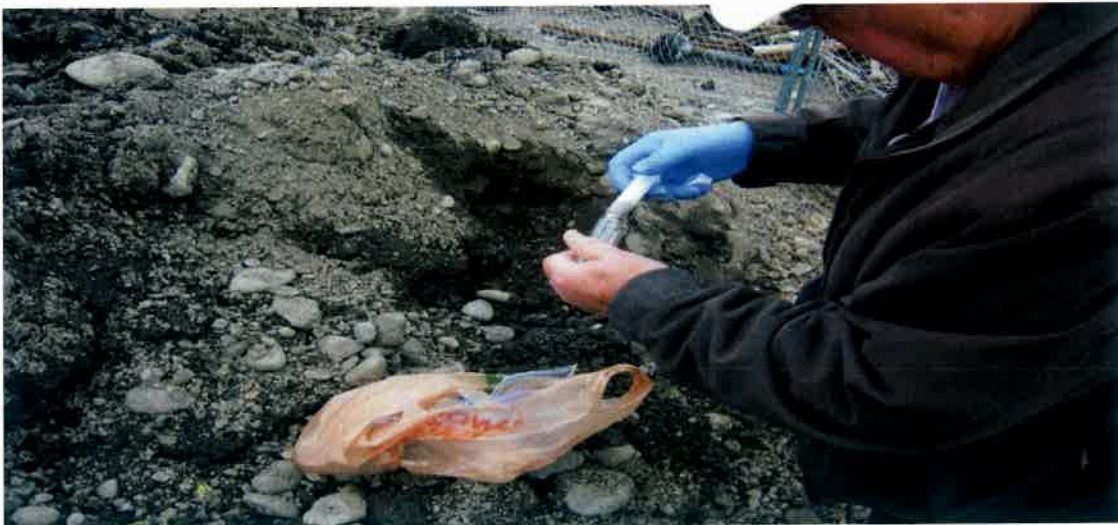
Sampling the Contaminated Waste Pile adjacent to the Alley.

On Monday, 9/14/15, a 290 Excavator arrived to replace the 210 Excavator which was having problems running because of computer errors. All small Waste Piles were collected and piled into a larger "Waste Pile" adjacent to the Alley and samples were taken. All "Clean Piles" had been composited into larger "New Clean Piles" under the Pump Island canopy, but samples had not been taken. Early Tuesday morning, 9/15/15 samples of the "New Clean Piles" were taken. Both of these sample sets were given to the Libby Lab early on Tuesday and testing results were completed on Tuesday before quitting time.
