PERMANENT CLOSURE NOTICE FOR UNDERGROUND STORAGE TANKS

**DECOMMISSIONING OF UNDERGROUND STORAGE TANKS,
UST SITE ASSESSMENTS, AND REMEDIAL CLEANUP ACTIONS
AT THE SHORT STOP #7 GASOLINE STATION**

December 2015

Short Stop #7 Gasoline Station in Cle Elum, Washington

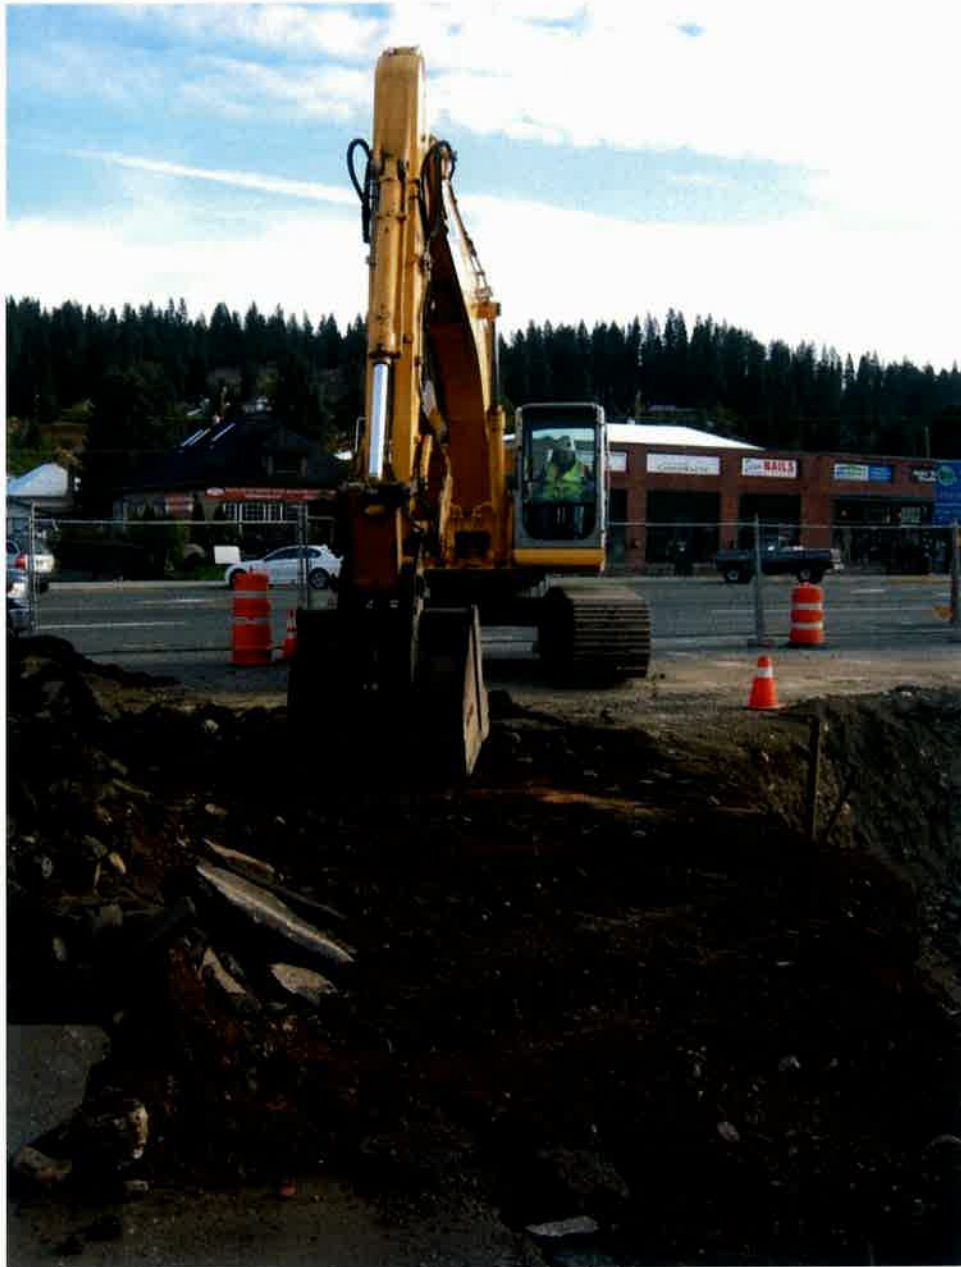
As most "Clean Soil" piles were moved to new locations North of the Pump Island beneath the canopy, the ten-foot wide strip of asphalt area between the East side of the Pump Island concrete pad and the excavation pit was then removed. Note the dark red brick debris "soil" layer on the surface. The clean layer was excavated down to contaminated soil as shown by PID readings. This clean soil was removed from this area and stockpiled under and near the canopy.

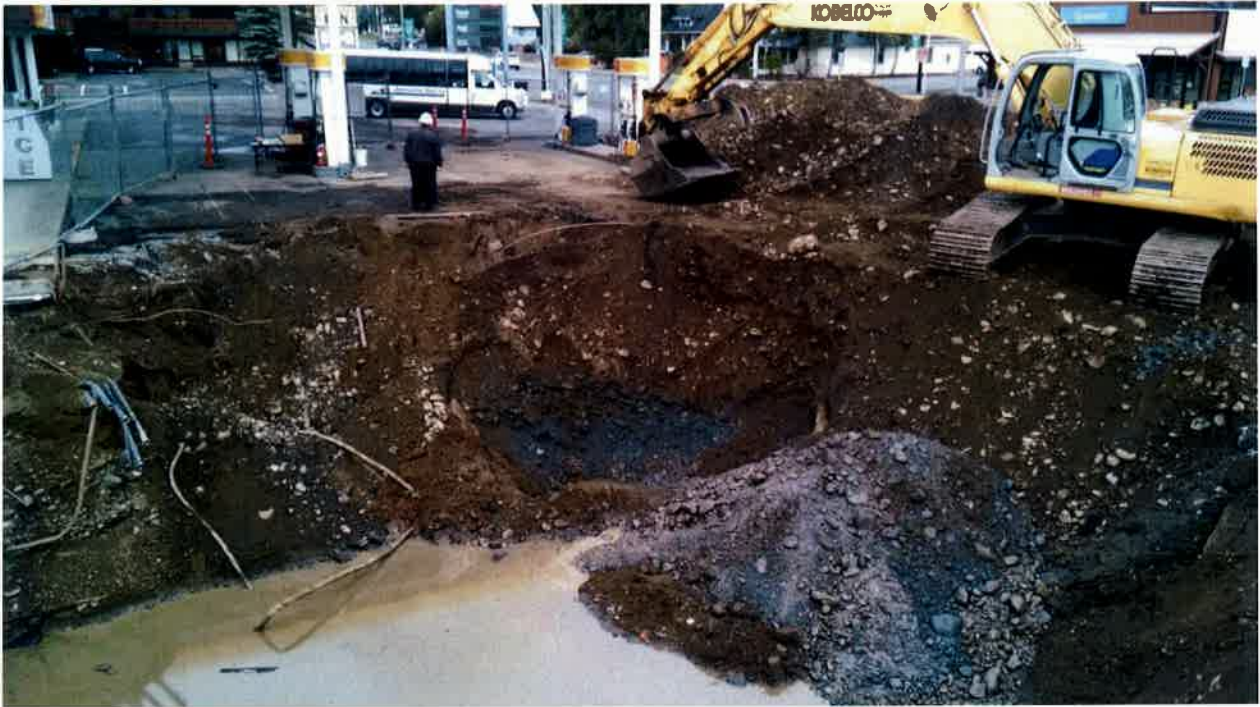
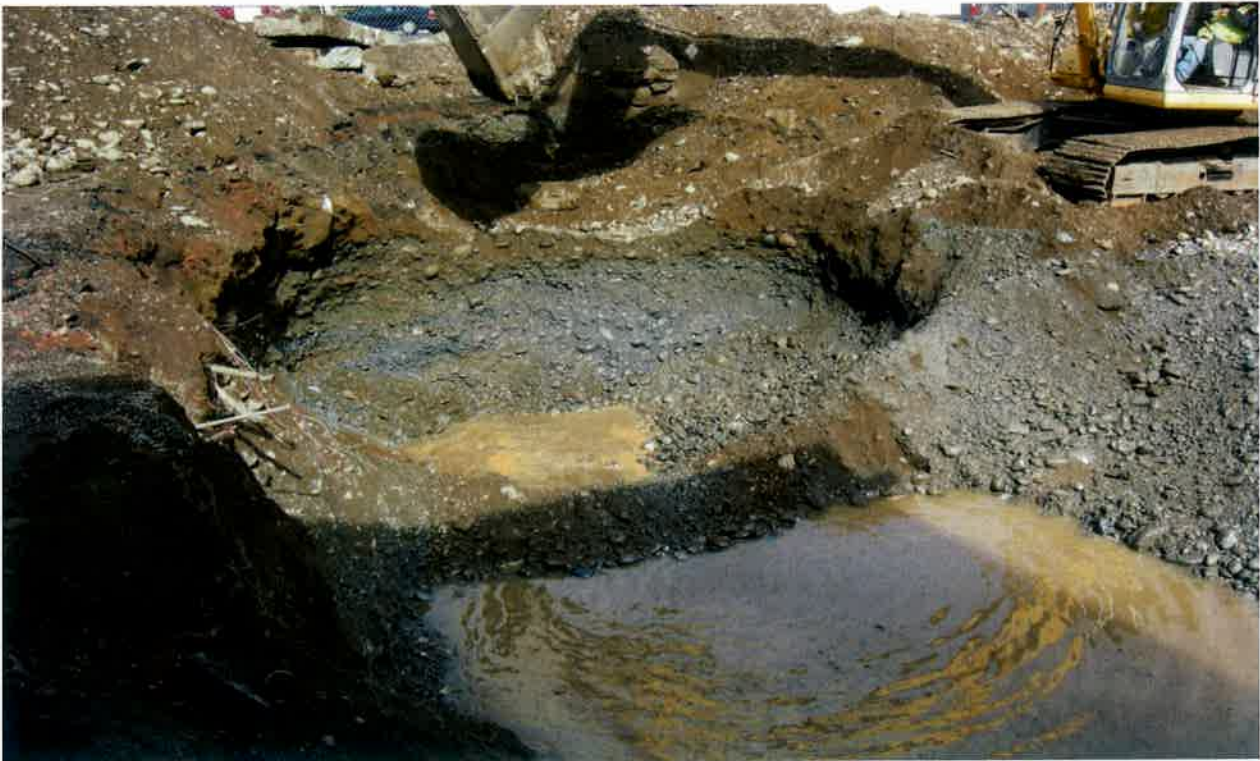
These photos are showing the Northwest end of the Pit, near and beyond where the location of the large "G1" Gasoline tank was located. Note that in the lower picture, the top of the contamination is four feet above the groundwater table, which may indicate that the groundwater table level has widely varied over the years.

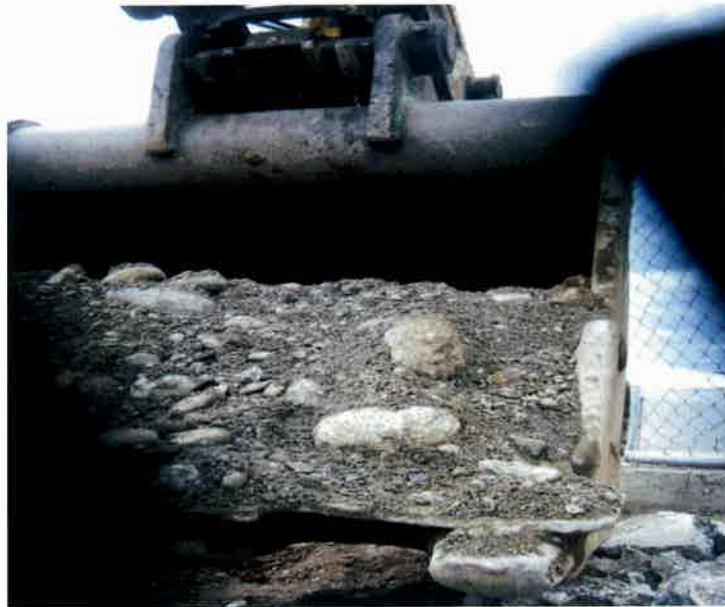
PID readings ranged up to 1,000 in the "dry" contaminated soils in the northwest end of the Pit.

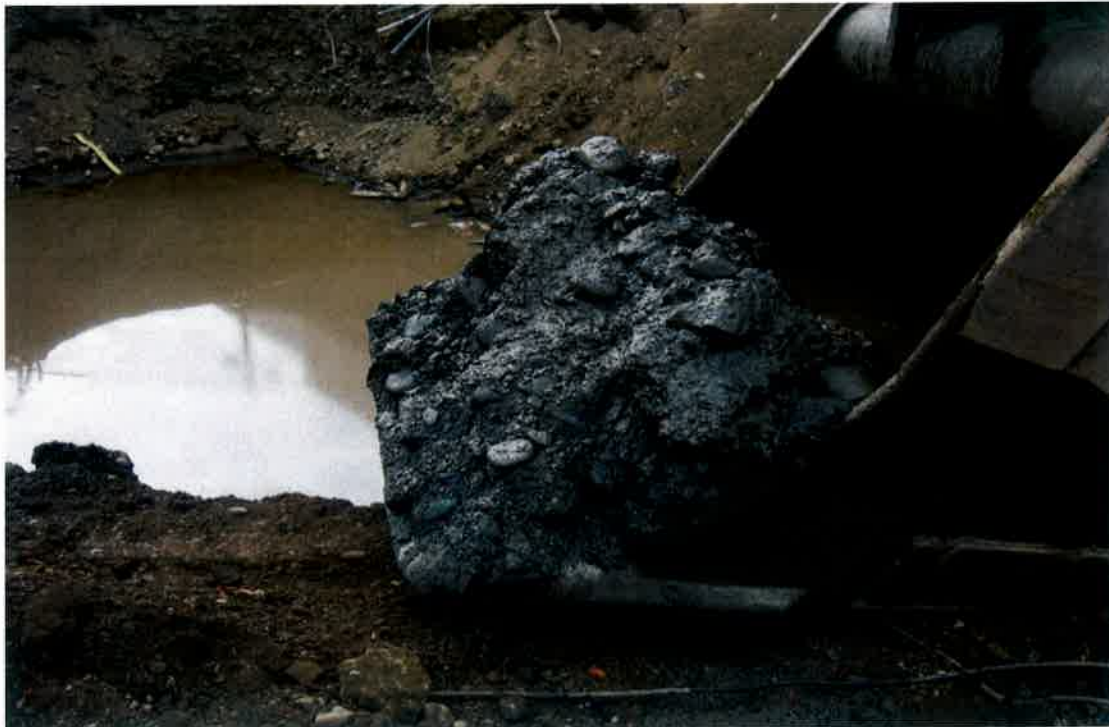
An exploration bucket scoop from the soils beneath the surface of the Groundwater along the West Wall produced this bucket load of extremely contaminated mud and medium and large river rock. PID readings from within this bucket exceeded 1,000.

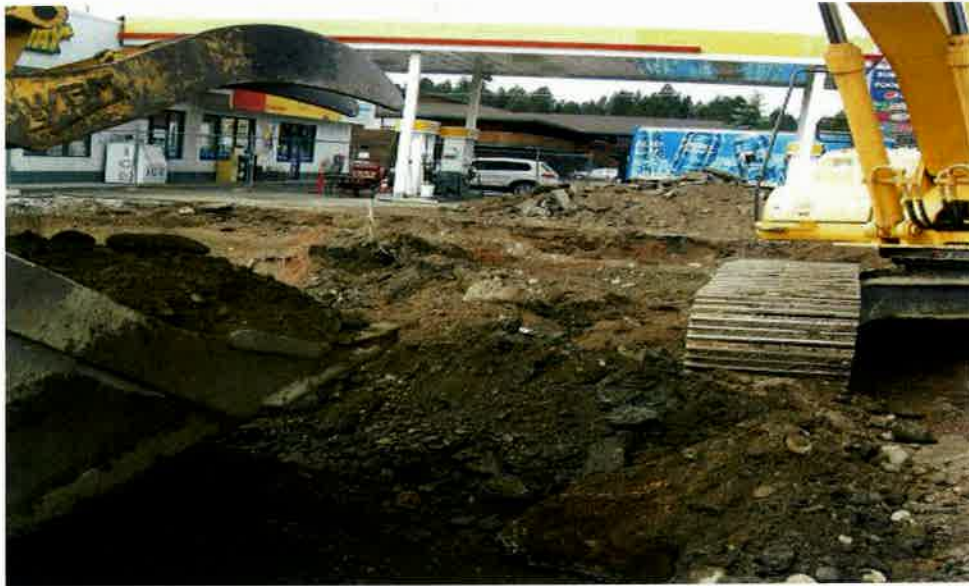
Additional removal of the clean top layer of soil around the pit area was made. Each excavator bucket load of soil was evaluated by sight, nose and/or PID to "sort" the soil.

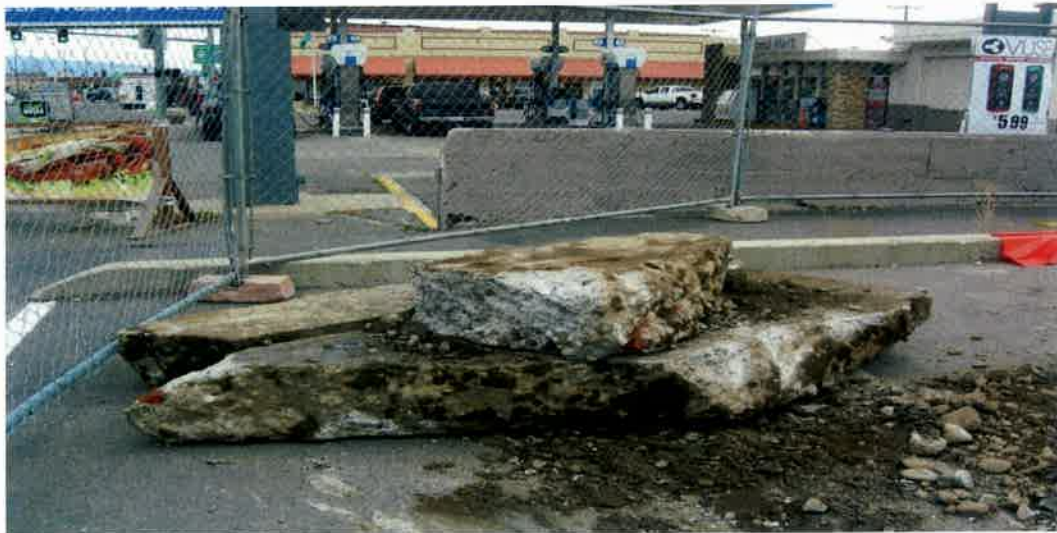
Some large thick slabs of concrete were unearthed and placed in the far northeast corner of the site.

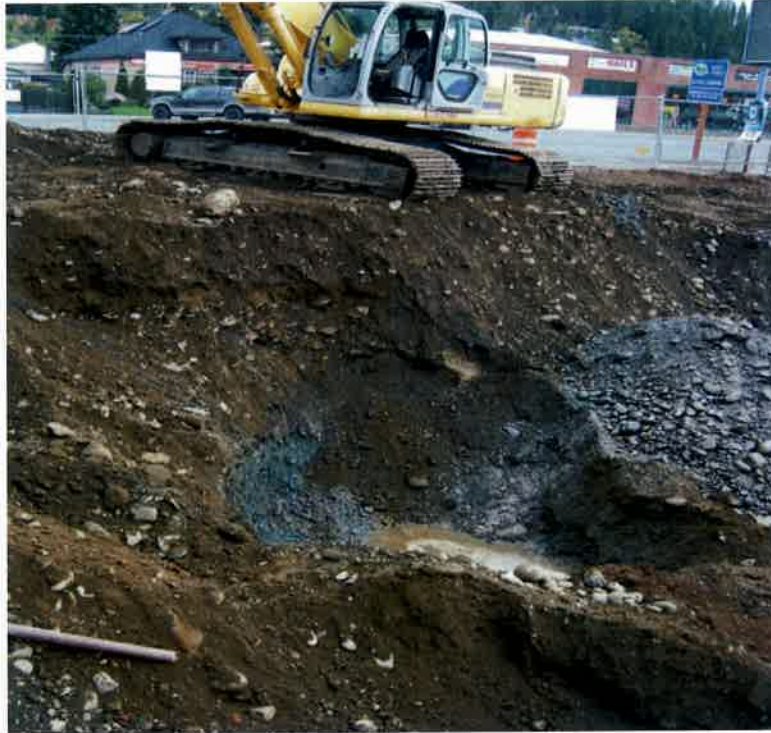
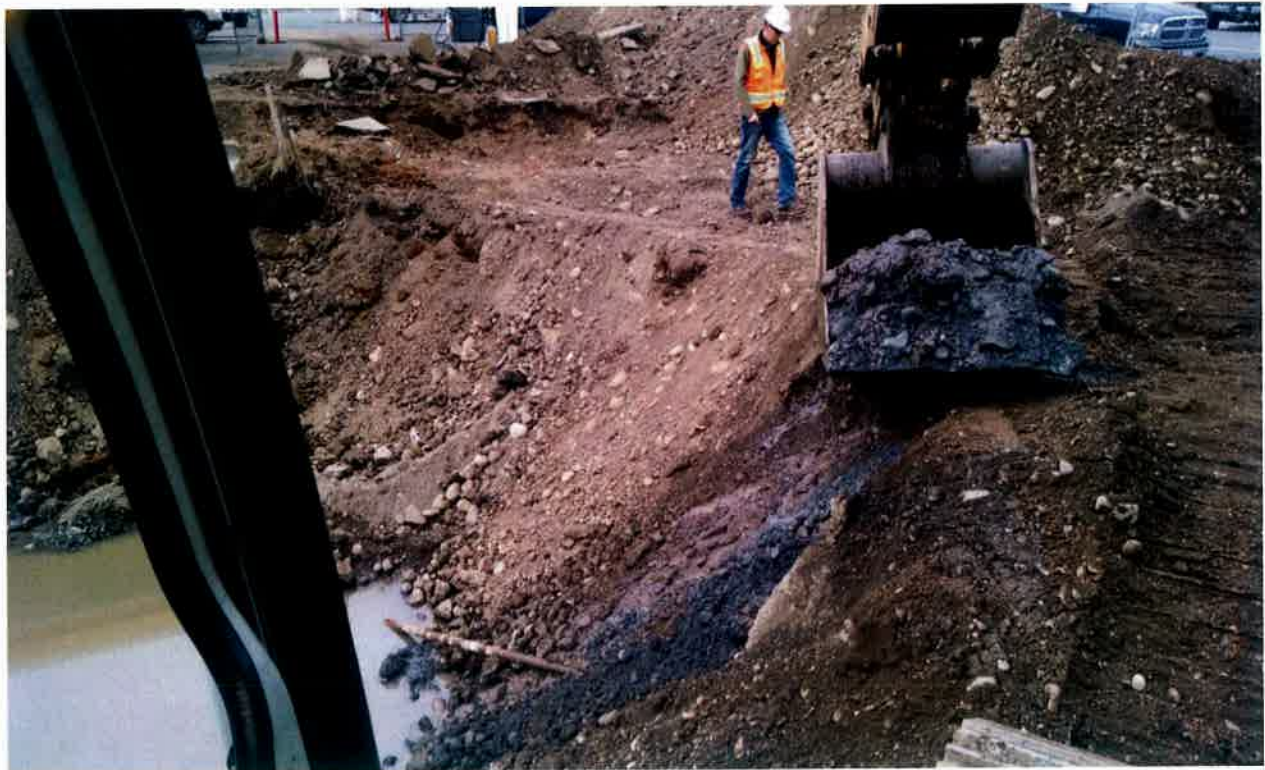
In exploring the pit North wall twenty feet east of the previous samples, it was found that heavy sidewall contamination continued to exist more than four feet above the groundwater table. The Leidos Inspector, Mr. Brown, is shown coming over to inspect the contents of the excavator bucket.

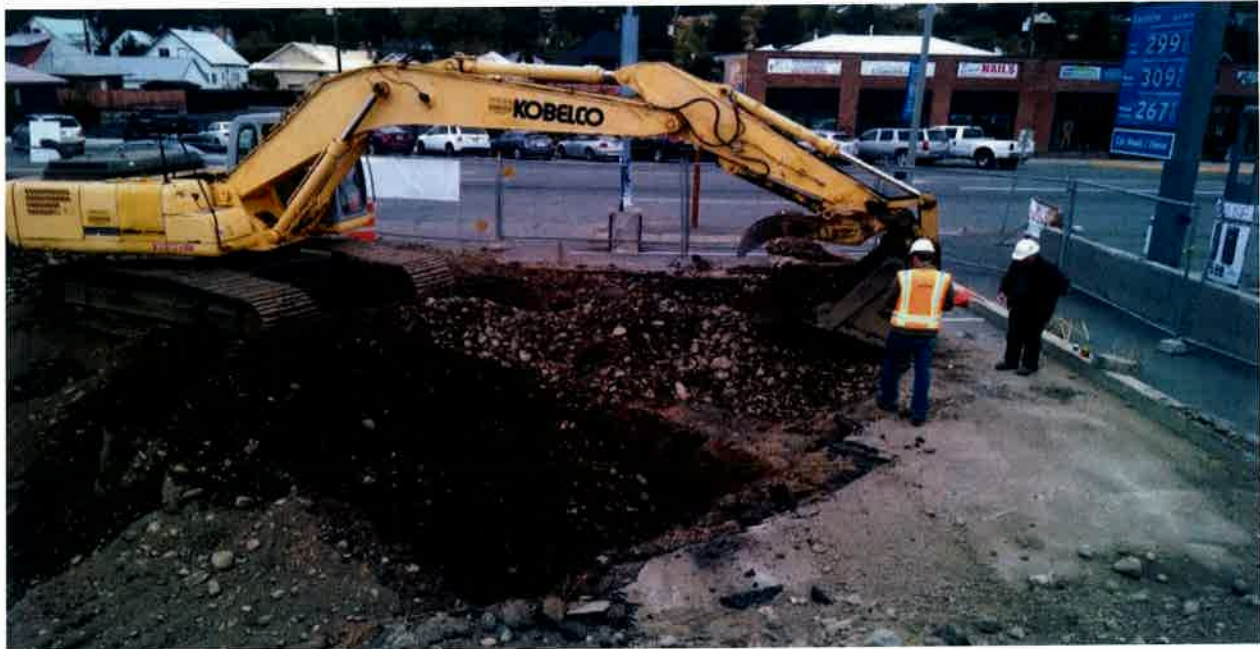
Use of the handheld PID checked soil samples from a "test pit" in the far NE corner of the site, and found no indication of contamination above the groundwater table. This indicated that the on-site soil contamination (above the groundwater table) did not exist here, however, a "blue colored" layer of river rock did exist below the groundwater table. The tall man in the warning vest is Mr. Stuart Brown, the Leidos Site Inspector.

Delivery of the first of three ordered 55-gallon drums of "ORC" arrived Friday, 9/18/15, at 5:30 pm. One drum was taken to the far East side of the site, adjacent to the Chevron Station concrete wall. (See the above picture.) The "ORC" drum was opened, and three 25 pound bags of Calcium Peroxide "power" were opened and emptied into the excavator bucket. The powered ORC was "sprinkled" over the surface of the groundwater "pond", atop the water on the west side of the Pit by the excavator Operator. A number of times the excavator bucket returned and three more bags were opened into the bucket. Both the Operator and "I" (opening the bags of ORC and placing the powder into the excavator bucket) wore gloves and half-face respirators (with particulate and carbon filters) for necessary respiratory protection. 250 pounds of Calcium Peroxide were "spread over the surface" of the groundwater "pond" within the western bottom of the "Pit", and then the water surface "mixed" by use of the excavator bucket until 6:40 pm.

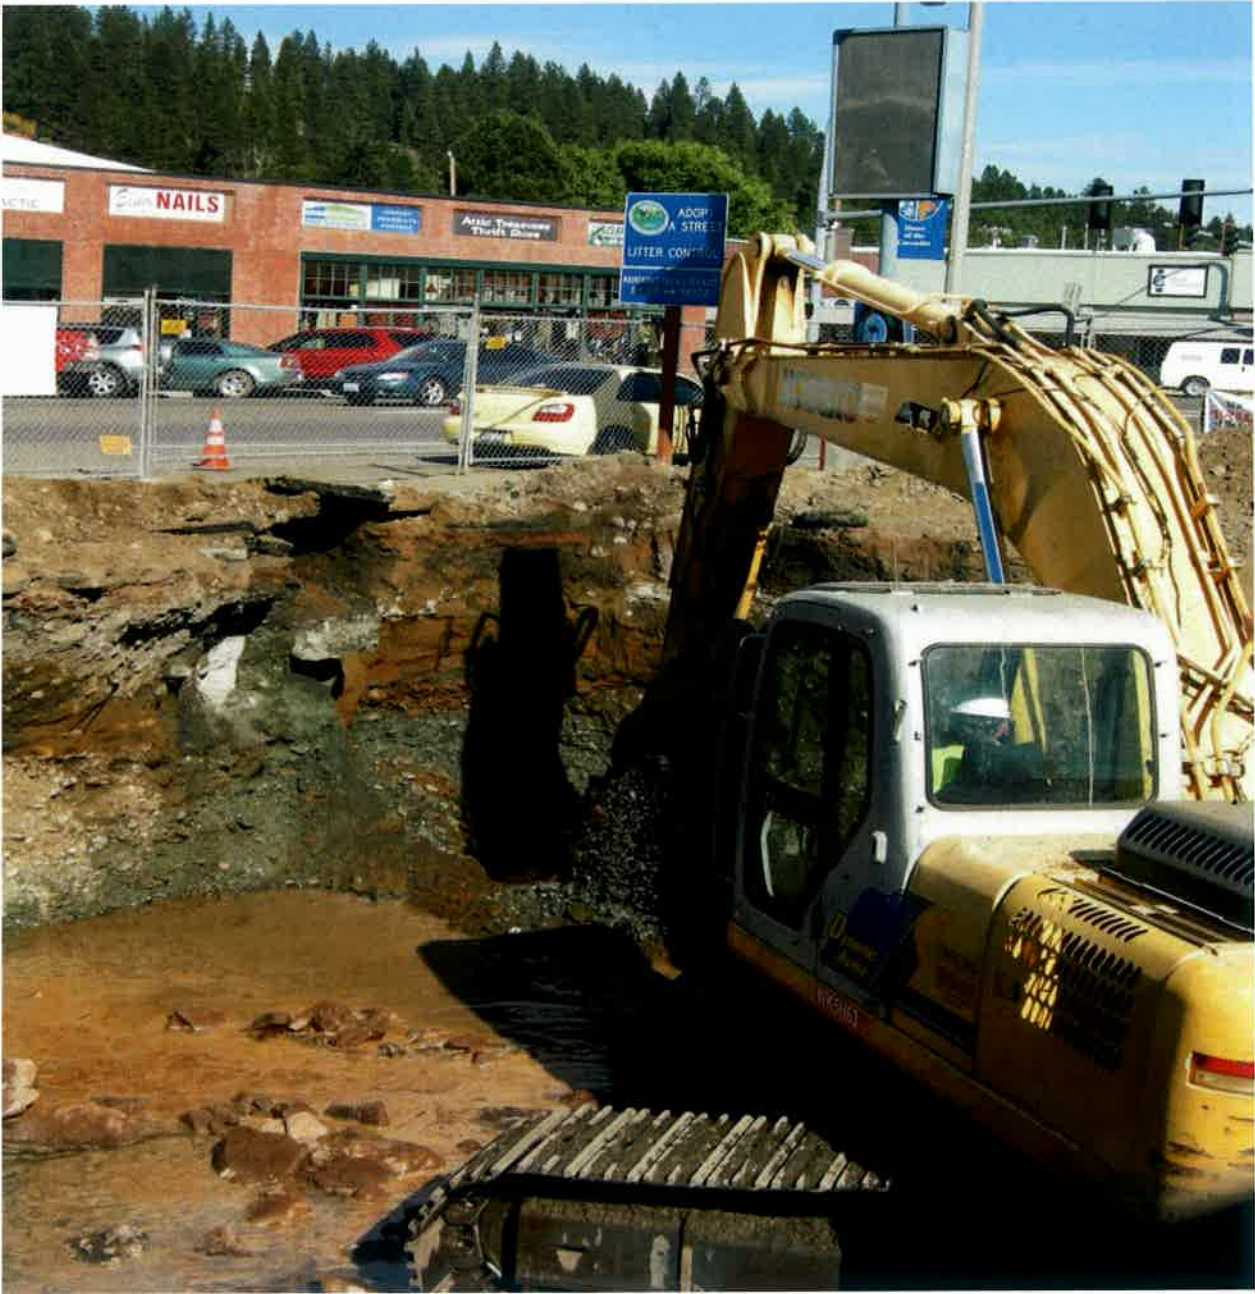
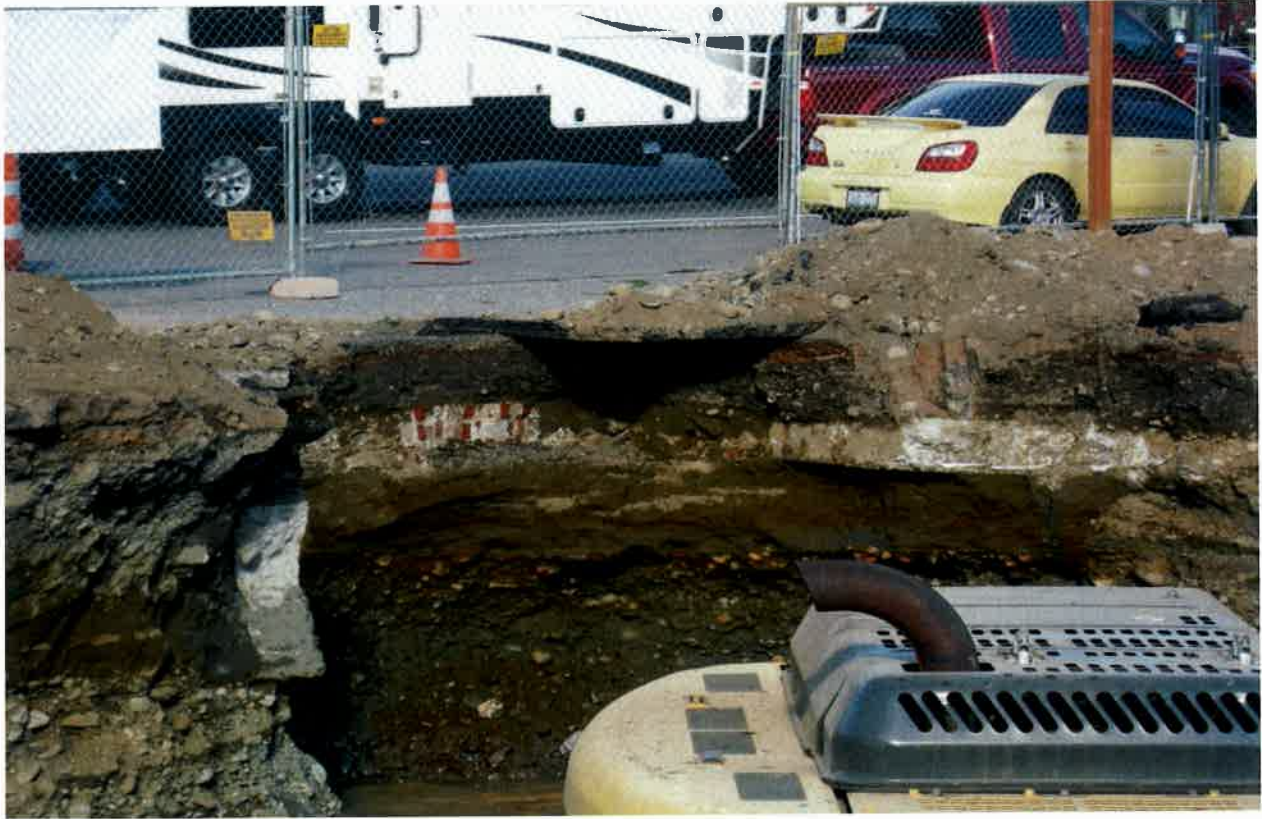
Excavation exploration continued in a clockwise method around the "Pit". A pocket of heavily contaminated soil had been found along the northern wall of the Pit. This area was excavated in layers. Interesting layers were found in this area. Clean brick debris, a thick brickwork layer, and thick concrete slabs, together with the clean brown sandy soil, and a lower layer of gray rocky soil were found as may be seen in the following photos. Clean soil was set aside in order to reach the contaminated material.

Excavation ended about three feet from the West First Street sidewalk (which was closed and protected with fencing). Parking spaces directly in line with the excavation hole were also blocked off with red warning cones.

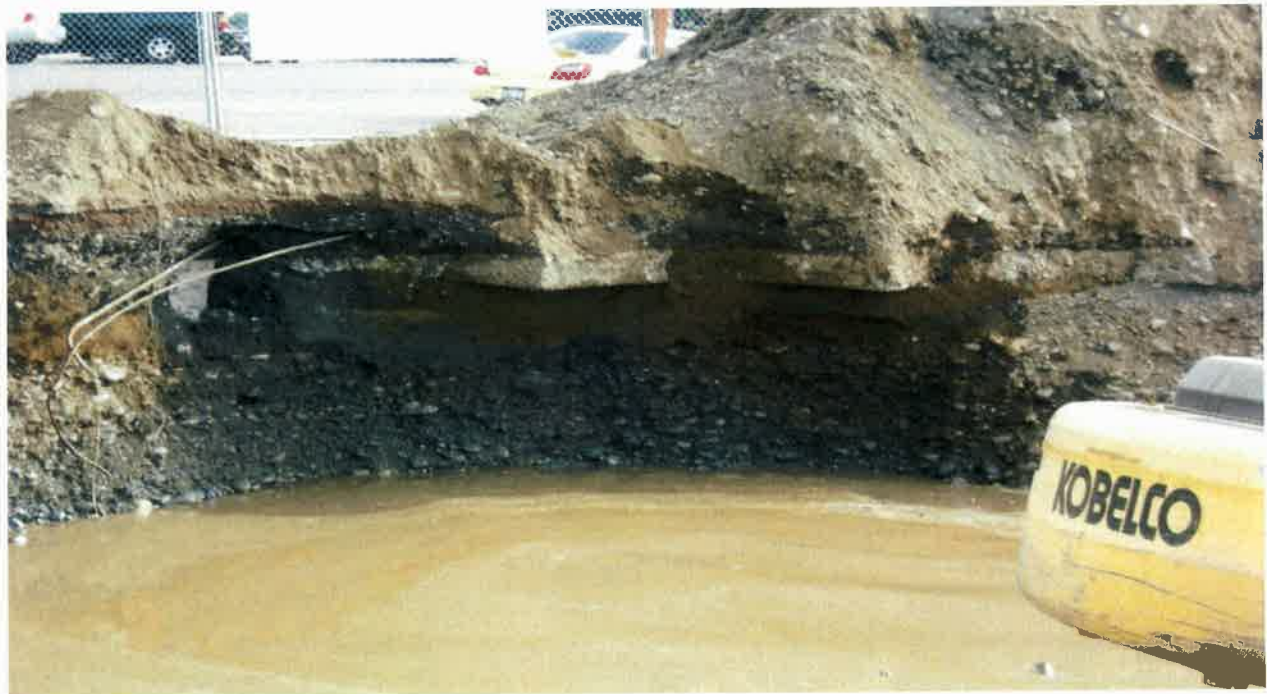
Early in the morning, while excavating on the southeast side of the pit, the excavator Operator discovered an additional UST located in the south-central portion of the property. I called this UST the "Surprise Tank"! ECY was immediately notified and NES was requested to come back and properly "Decommission" the tank. The "small" steel "Surprise Tank" measured to be 45 inches in diameter and 144 inches in length, ("1,000" gallons approximately size). The top of this tank had three "small" holes on the top, (two 2-inch diameter and one 1½-inch diameter). The tank was checked for contents with a UST eleven-foot long dip stick having one-inch markings. The tank was found to contain exactly nine-inches of Gasoline. ECY was immediately notified of this Surprise Tank discovery and NES was requested to return and properly "Decommission" the tank.

This photo was taken from the excavator on the top edge of the East side of the pit. The laborer, Aaron Warner, is collecting a sample of the Gasoline from the tank. The "Bailer" was transported to the top of the pit by walking up the ramp, and then emptied into a pint sized brown glass sample bottle, and then, done again and again. Three pint sized composited "samples" of the tank Gasoline were obtained by use of the groundwater "Bailer", placed on ice, and Webster "ran" those three samples to the Friedman & Bruya Laboratory in Seattle for analyses. The upper half of the photo shows a pond water reflection of "two white steel posts and the red & yellow edge of the Canopy" above the soil pit edge on the western side of the pit, and the reflection of the shadow of the excavator.

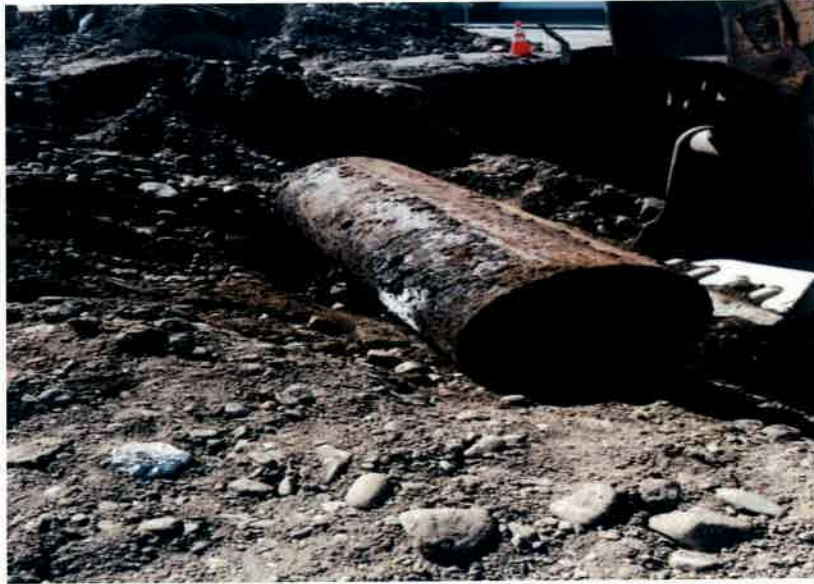
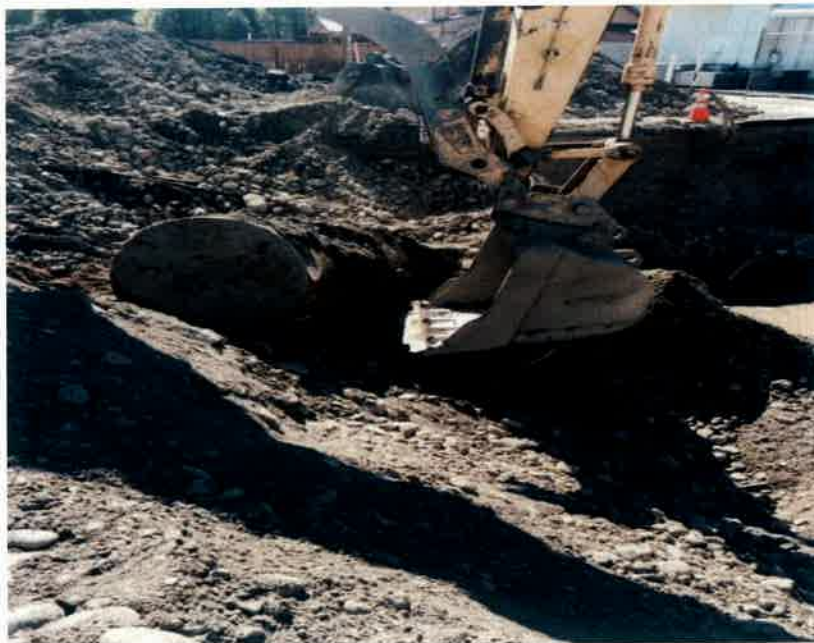
Inspection of the Surprise Tank showed that the sides of the tank had rusted-through along the sides of the tank ten-inches above the bottom. Anything that had been inside the tank above the rusted-out level had most likely been released. PID readings of the soil beneath the tank were very high and a "ripe" Gasoline odor was present. The bottom of the Surprise Tank was less than seven feet below the 2015 ground surface

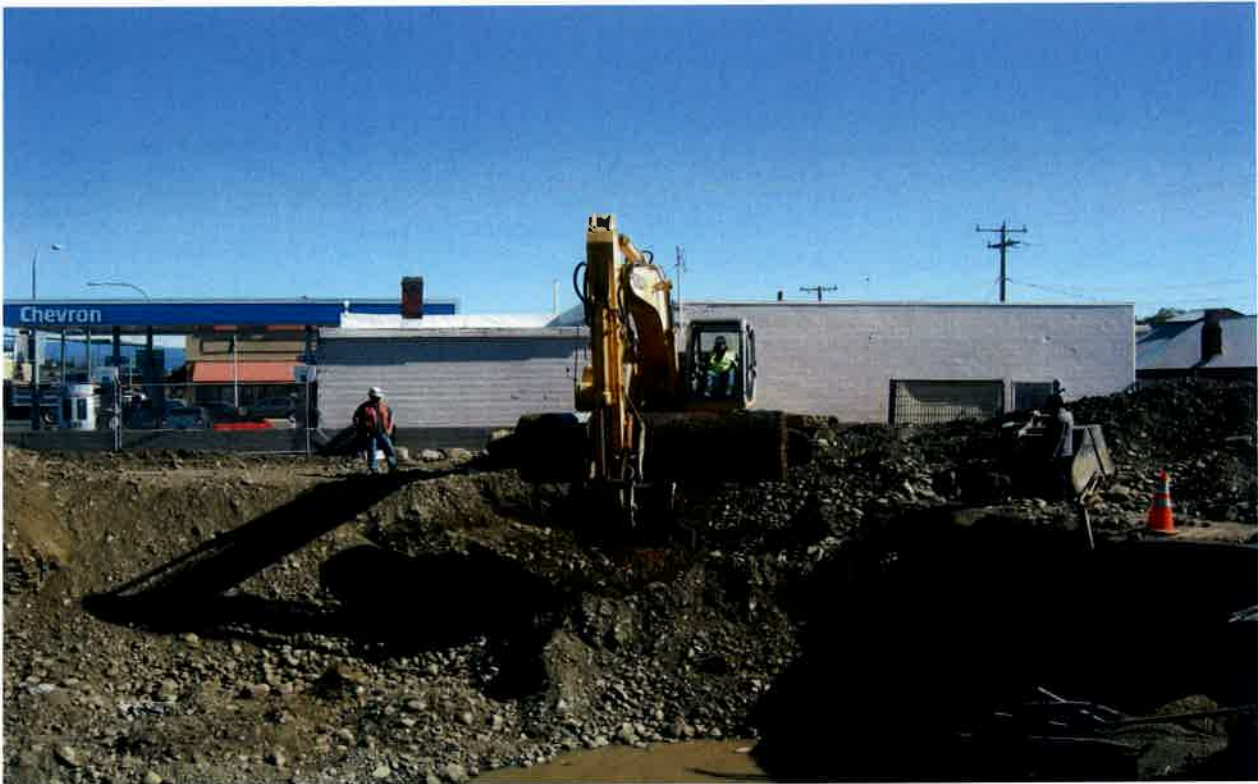
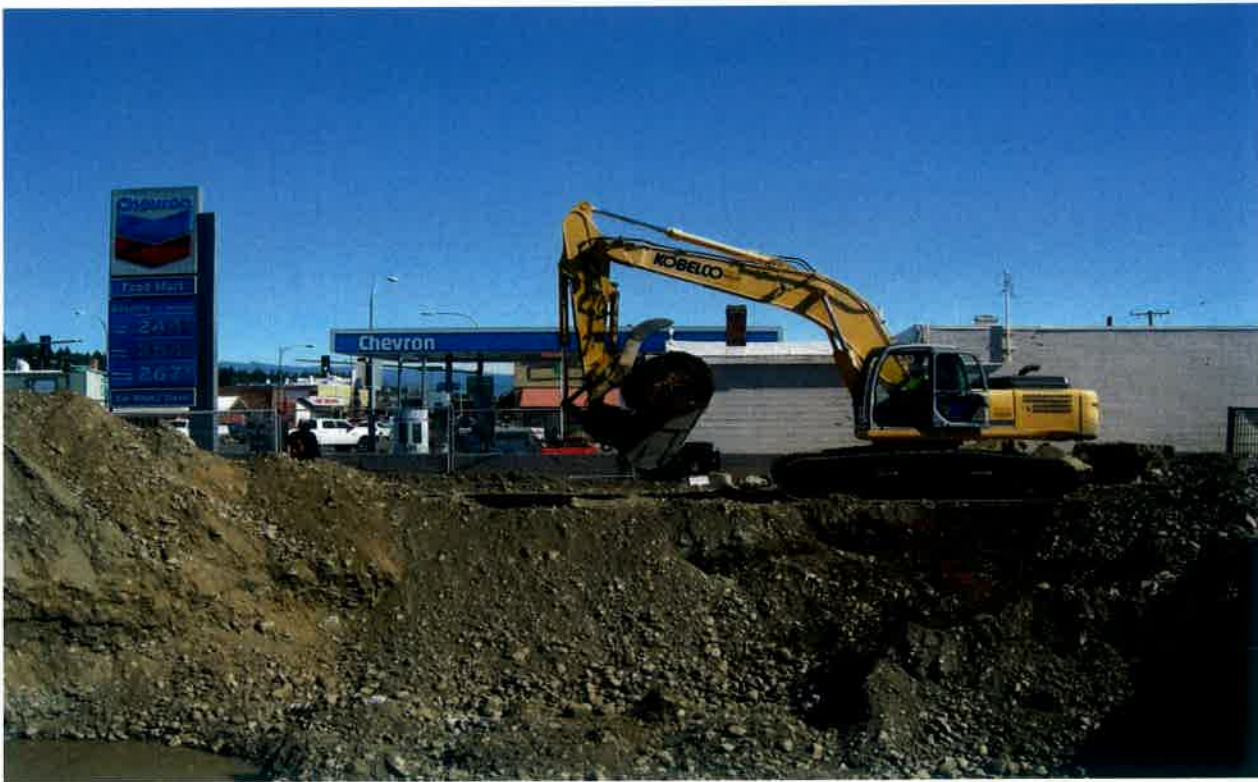
Mr. Wilkerson directs the excavator Operator to remove the "Surprise Tank" for transportation.

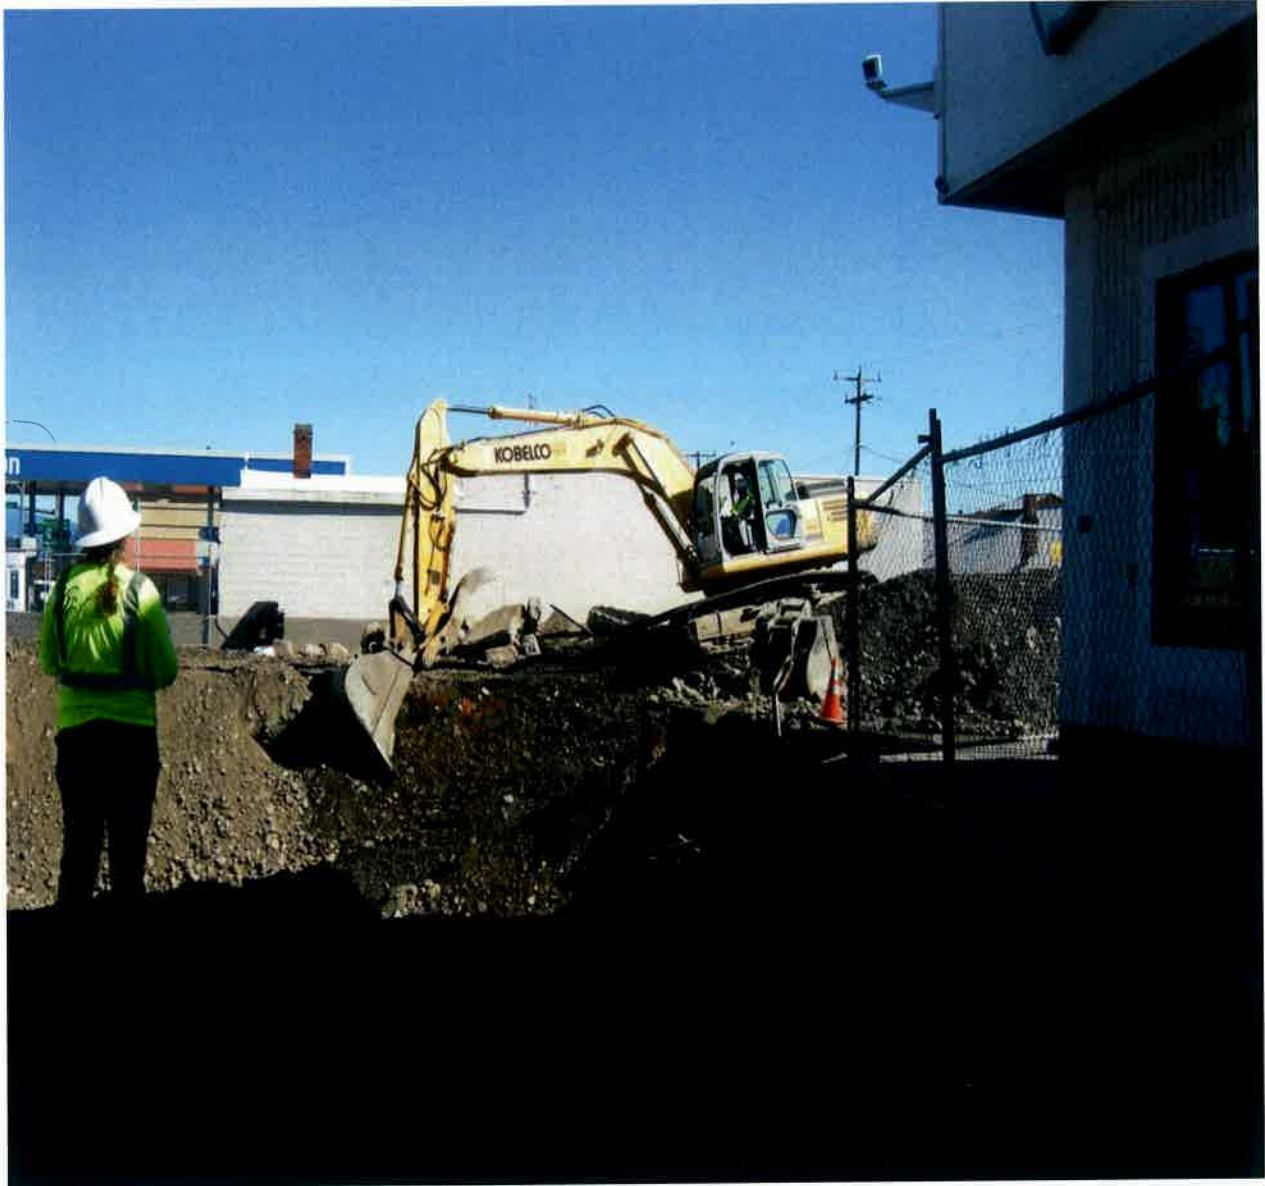
The replacement Leidos Inspector, Susan Hoffman, observed the excavator Operator investigating the area where the Surprise Tank had been removed. Strong "ripe" vapors were being released during this exploration procedure and two PIDs, setting on a table more than fifty-feet away, were beeping and displaying readings in excess of 20 ppm. This "ripe" odor continued for an extended period and the Leidos Inspector, Susan, retired to the Leidos truck, as she said that Leidos policy requirements dictated that she could not remain in areas in excess of 1 ppm., without full respiratory protection.

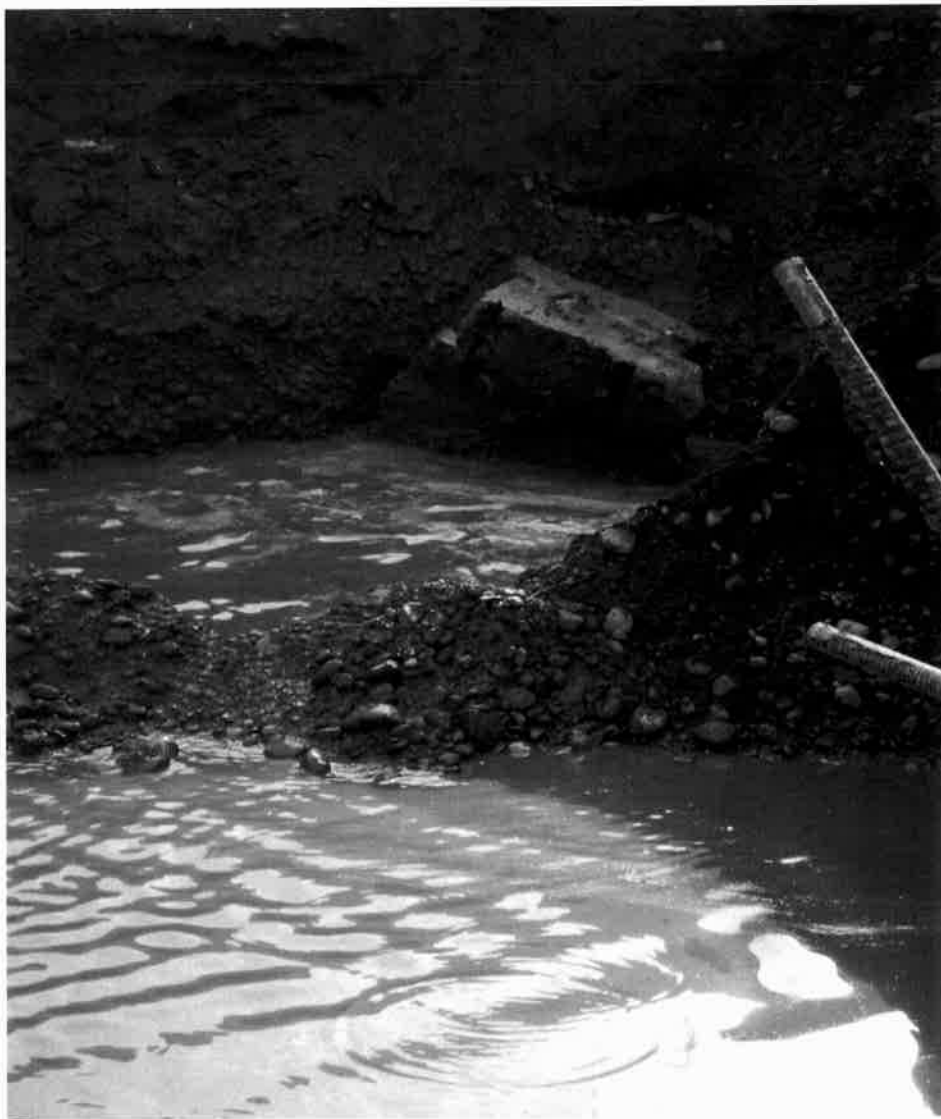
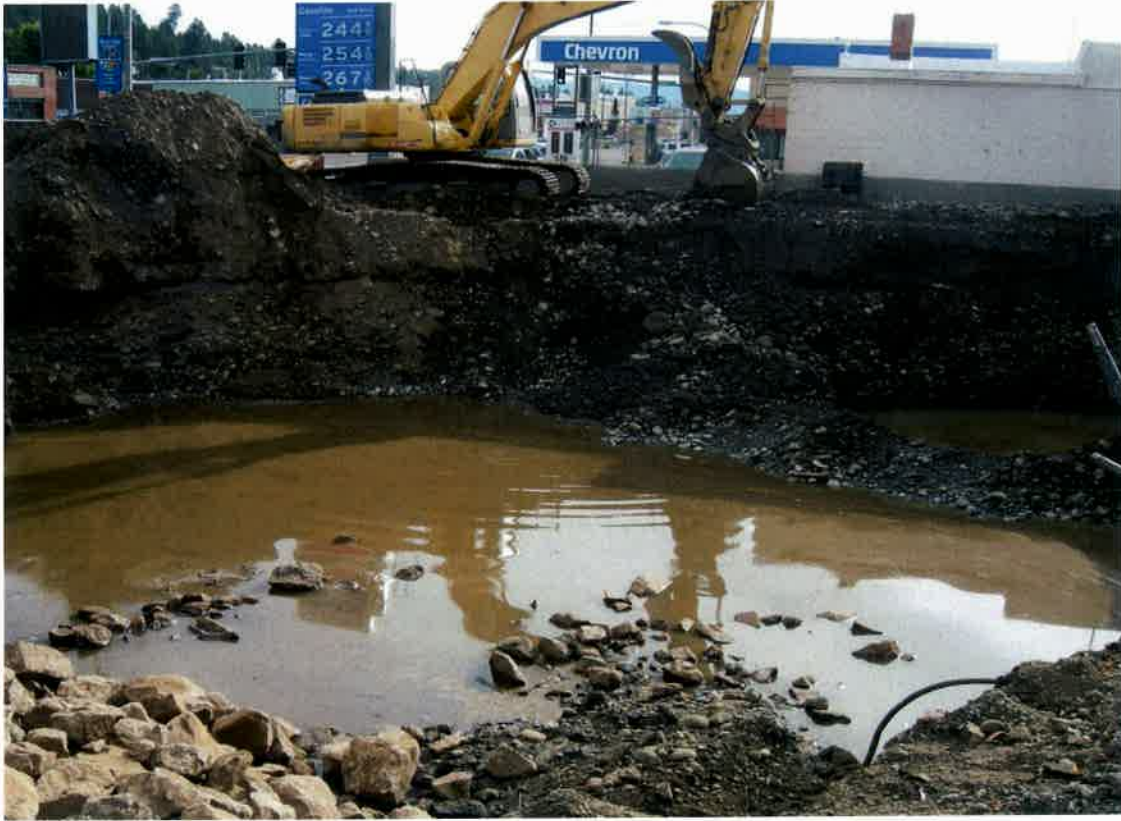
Strange items were found while excavating near the Surprise Tank Pit. A huge concrete block with a square top surface was found in the Eastern sidewall and slid into the bottom of the small Pit. It had no direct relationship to the Surprise Tank. It was removed and properly disposed of, at a landfill.

Photo of large existing Pit and adjacent "smaller" Surprise Tank Pit.

(NOTE: It should be said here – that this early morning Thursday 9-24-15 photo is a good reference source of where the extent of both above ground and underwater soil contamination had been chased and removed on this site. This will be expanded upon and explained later in this report.)

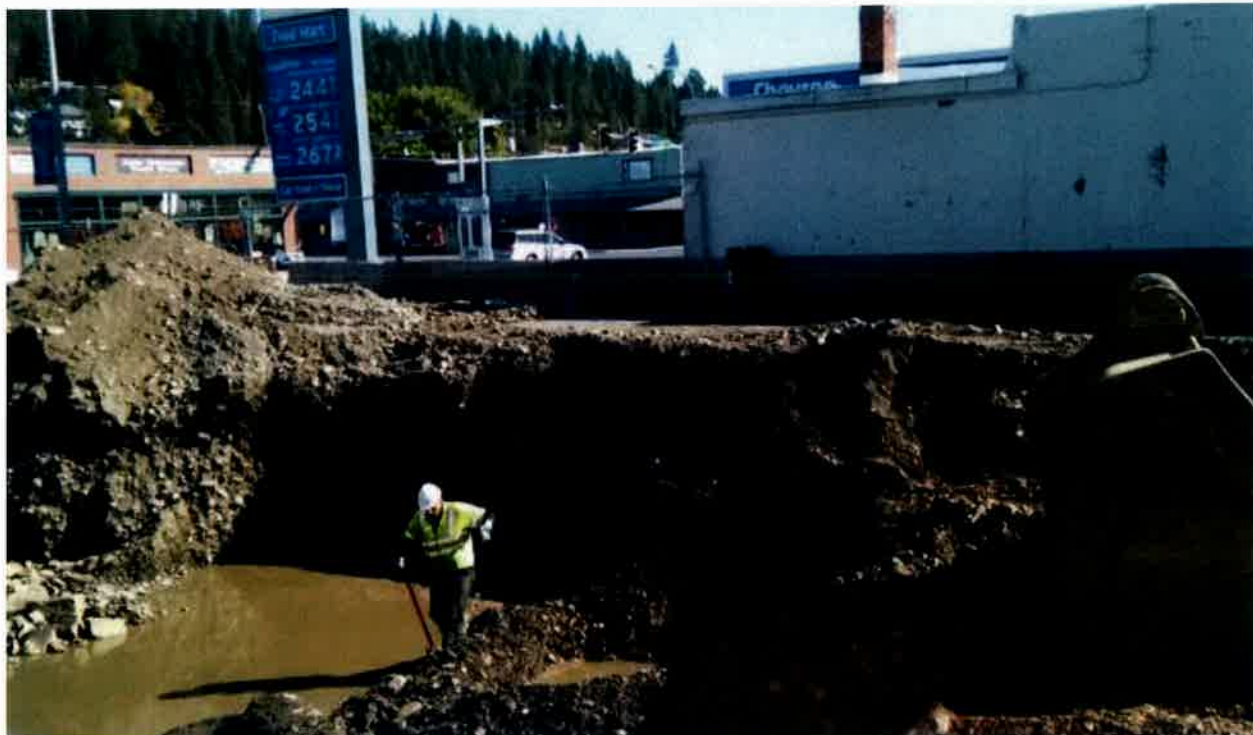
Picture of the Laborer, Aaron Warner, returning with the requested three Sidewall samples.

On Tuesday, September 29th morning, "Load-out" of the "Waste Pile" by five truckloads was done. The Leidos Inspector, Susan Hoffman, who had missed the late Monday "Sidewall sample collection effort", requested three confirmation samples from the far eastern Pit sidewall. I advised her that Aaron had already taken a sample (SW#9) exactly where she thought that she could see contamination, but, I ask Aaron to return to that area and take three samples (high, middle and low) on the East Pit sidewall, where she had directed.

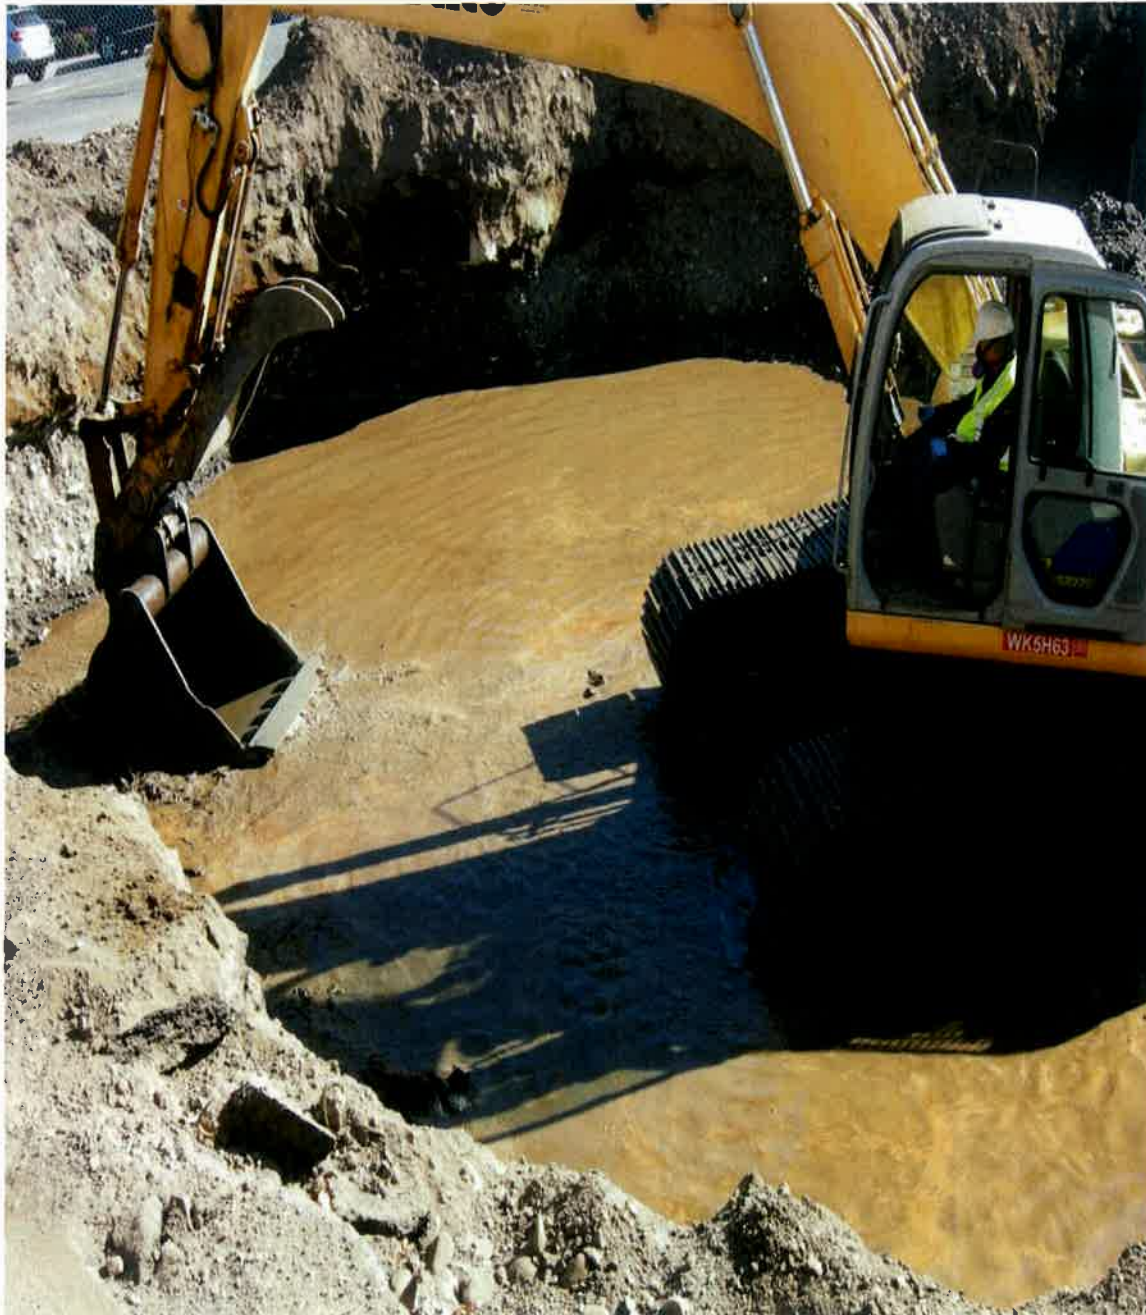
Excavator “walking on water” in preparing the “rock pad” for the two new USTs, by using the 60,000 pound excavator tracks and bucket to compact the rocks in-place.
