PERMANENT CLOSURE NOTICE FOR UNDERGROUND STORAGE TANKS

**DECOMMISSIONING OF UNDERGROUND STORAGE TANKS,
UST SITE ASSESSMENTS, AND REMEDIAL CLEANUP ACTIONS
AT THE SHORT STOP #7 GASOLINE STATION**

December 2015

Short Stop #7 Gasoline Station in Cle Elum, Washington

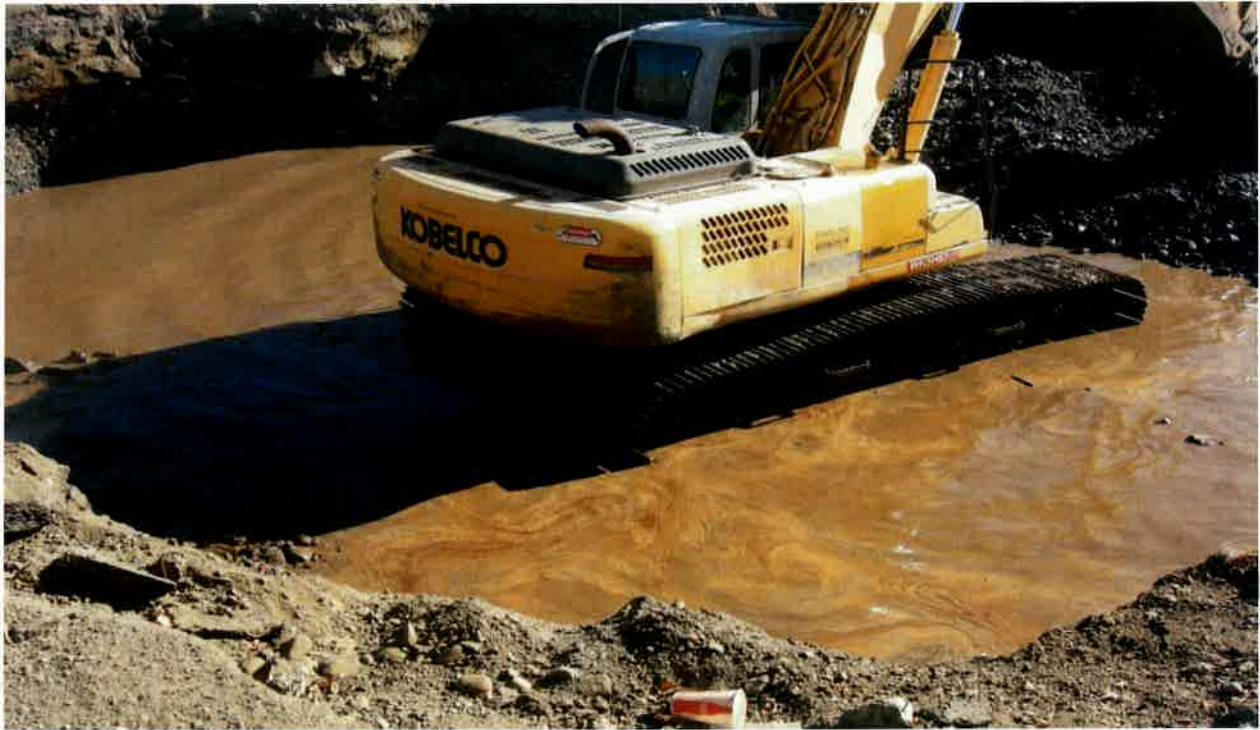
A few more finishing touches are required in preparing the new Tank Pit to receive the two new tanks. Groundwater was presently at the depth nine-feet. The rock surface must be compacted at a depth of 12 inches below the existing Groundwater Table in order to place the required twelve-inch thick pea-gravel "pad" that the two new USTs will rest upon. This will allow the six-foot diameter tanks, when placed on the pea-gravel bedding, to have the desired three-foot "bury depth" needed for the plumbing, backfill, and concrete slab cover.

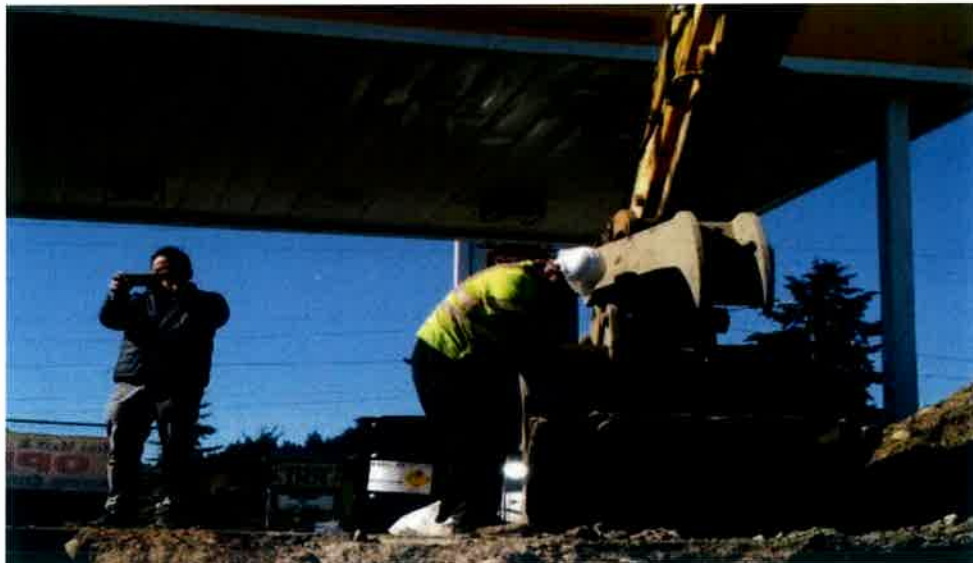
425 pounds of ORC from the two remaining barrels of ORC were spread upon the water surface by the excavator Operator after the completion of the rock bedding compaction effort. The Laborer loading the ORC into the bucket is wearing gloves and a half-face respirator, while the Owner, Mr. Jhuty, is taking a picture of the operation.

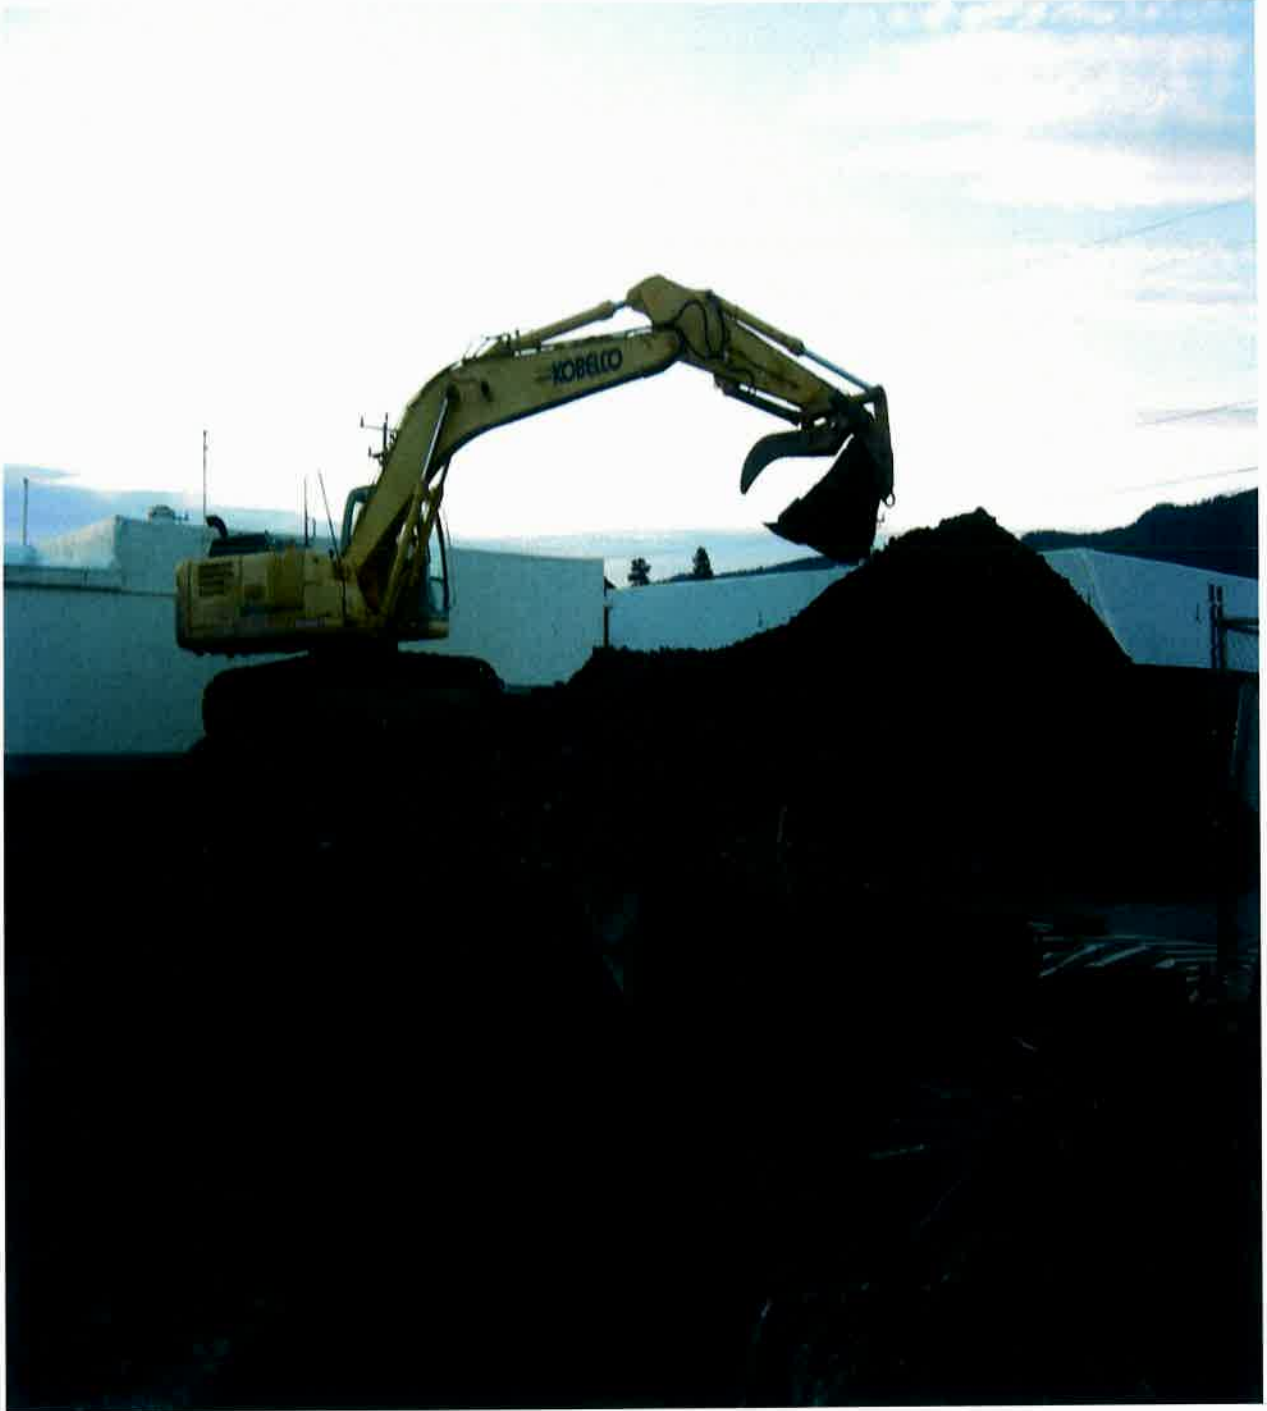
Ready for final "load-out" of contaminated soils on the next morning.

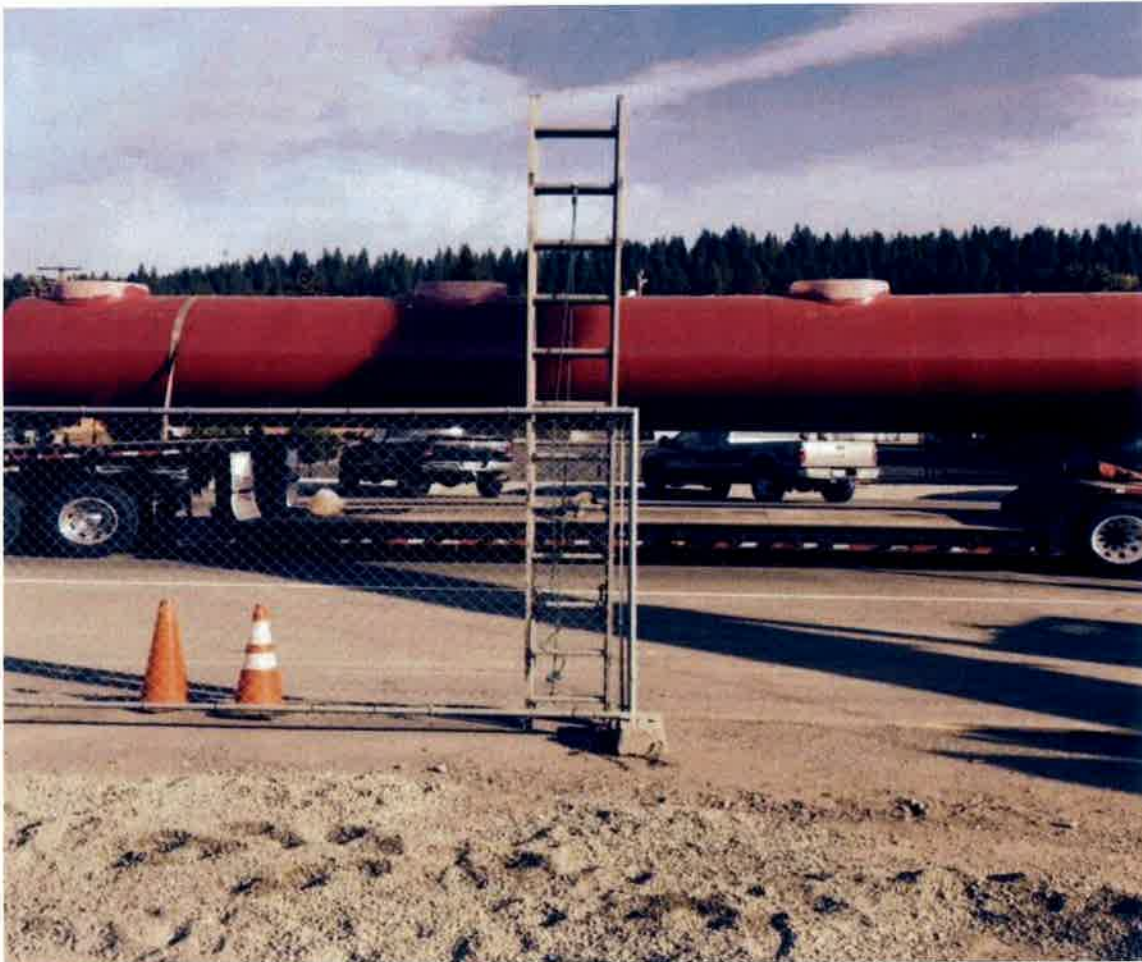
The new Tanks arrived into Cle Elum ! One UST has three compartments, while the other has a single compartment. Each 12,000 gallon UST was six feet in diameter and forty-seven feet in length.

The Cle Elum Police Chief was of great assistance, as his force directed traffic on West First Street, (the busy main street of the city), while each of the two large red tanks were removed by a crane, (see the shadow of the crane sitting on the sidewalk), and deposited each UST into the "prepared area" within the new Tank Pit.

A one-foot layer of Pea-gravel had been placed atop the large backfilled rock surface, which had been compacted with the use of the 30-ton excavator. The thick layer of pea-gravel had brought the level of the Tank Pit to the top of the Groundwater Table level, where a layer of thick black Visqueen was laid atop the pea-gravel.

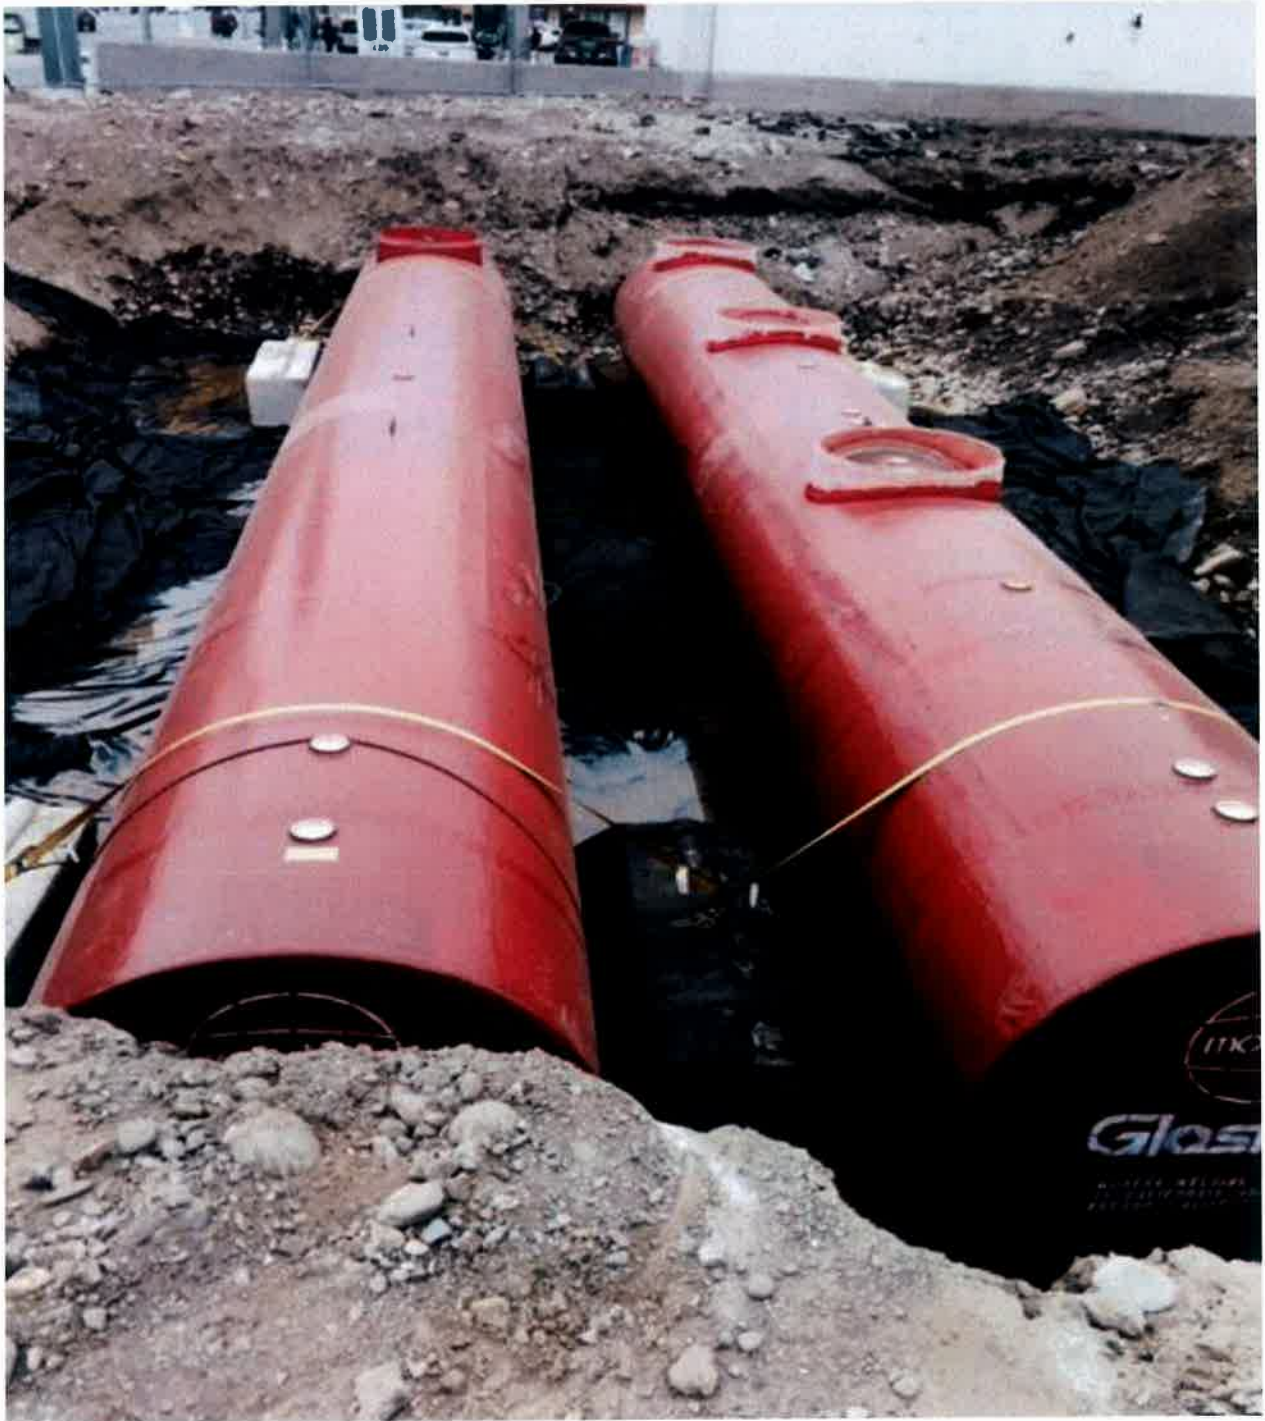
The two new USTs installed in the new Tank Pit.

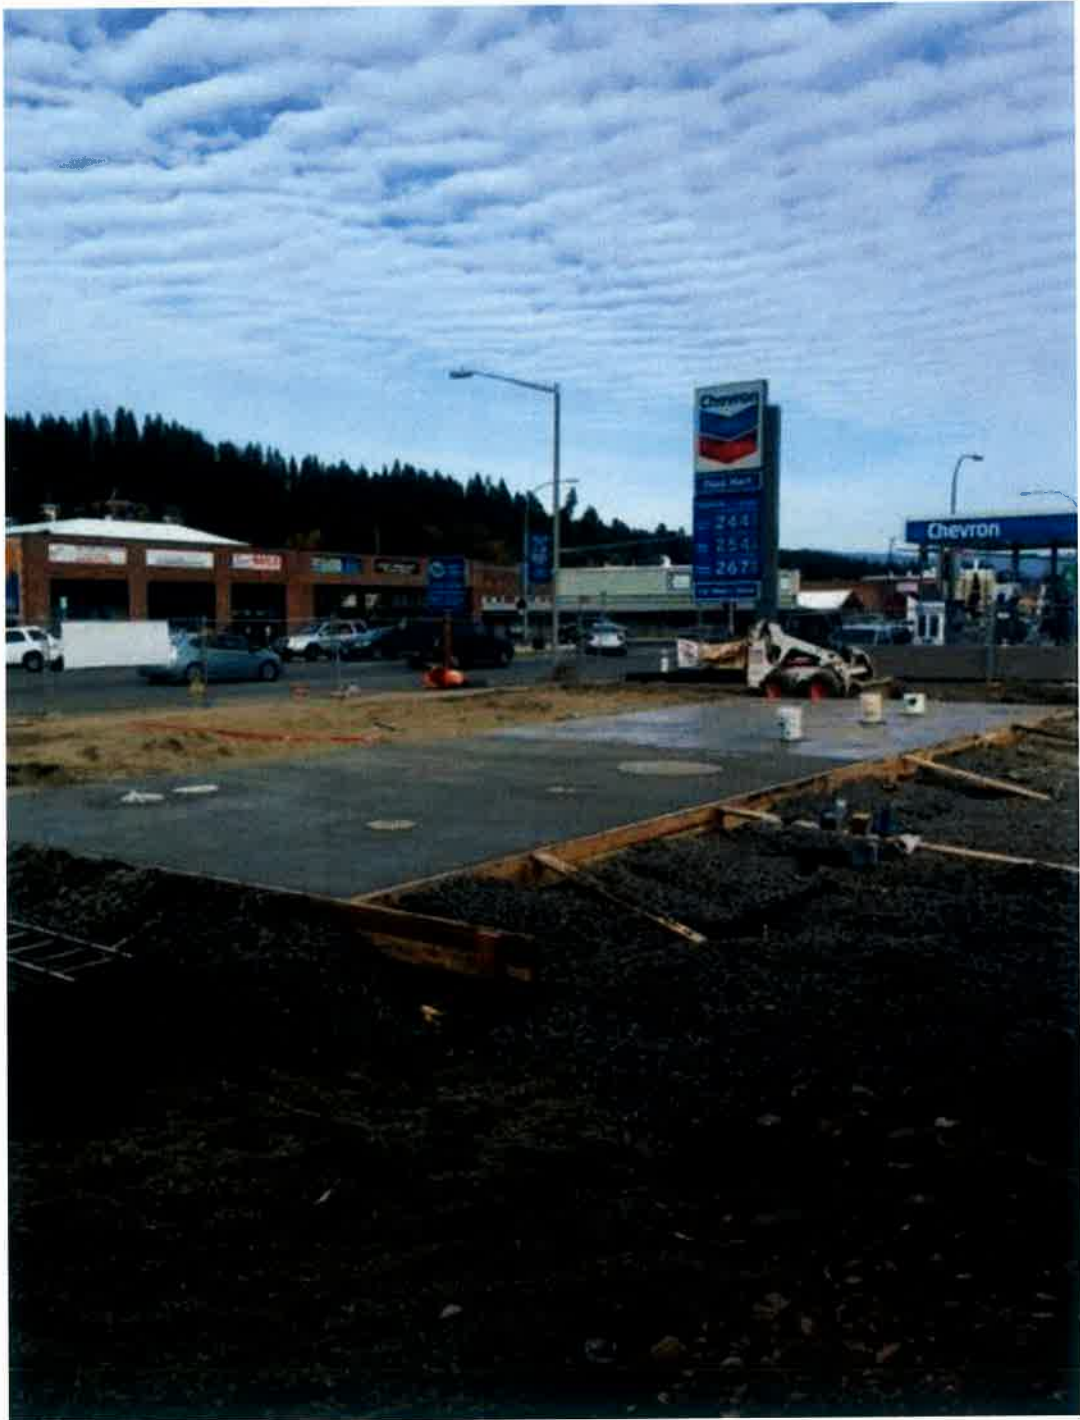
A “Concrete Slab” was poured atop the Tank Pit of the two new USTs
