INTERIM ACTION REPORT

Former Chevron Service Station No. 90129

4700 Brooklyn Avenue NE, Seattle, WA

Project No. 160092 • January 4, 2019 Final

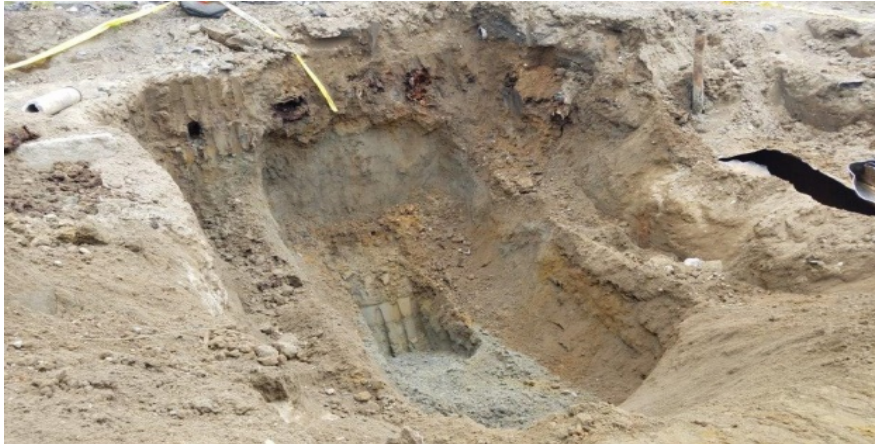
Photo 9: Stained Soil Beneath UST 4

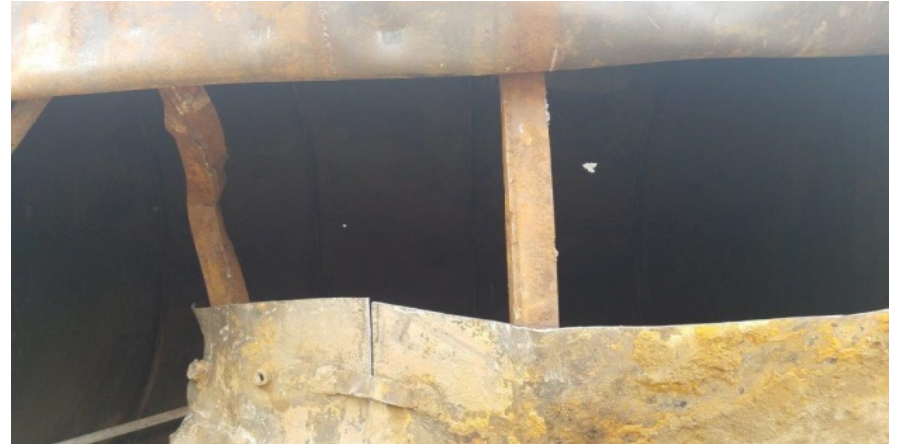
Photo 10: Holes in UST 4
