## Phase II Environmental Site Assessment

*Conducted on:*  
**12th Avenue Parking Lot  
110 & 124 12<sup>th</sup> Ave  
Seattle, Washington**

AEG Project #: 14-142  
Date of Report: November 14, 2014

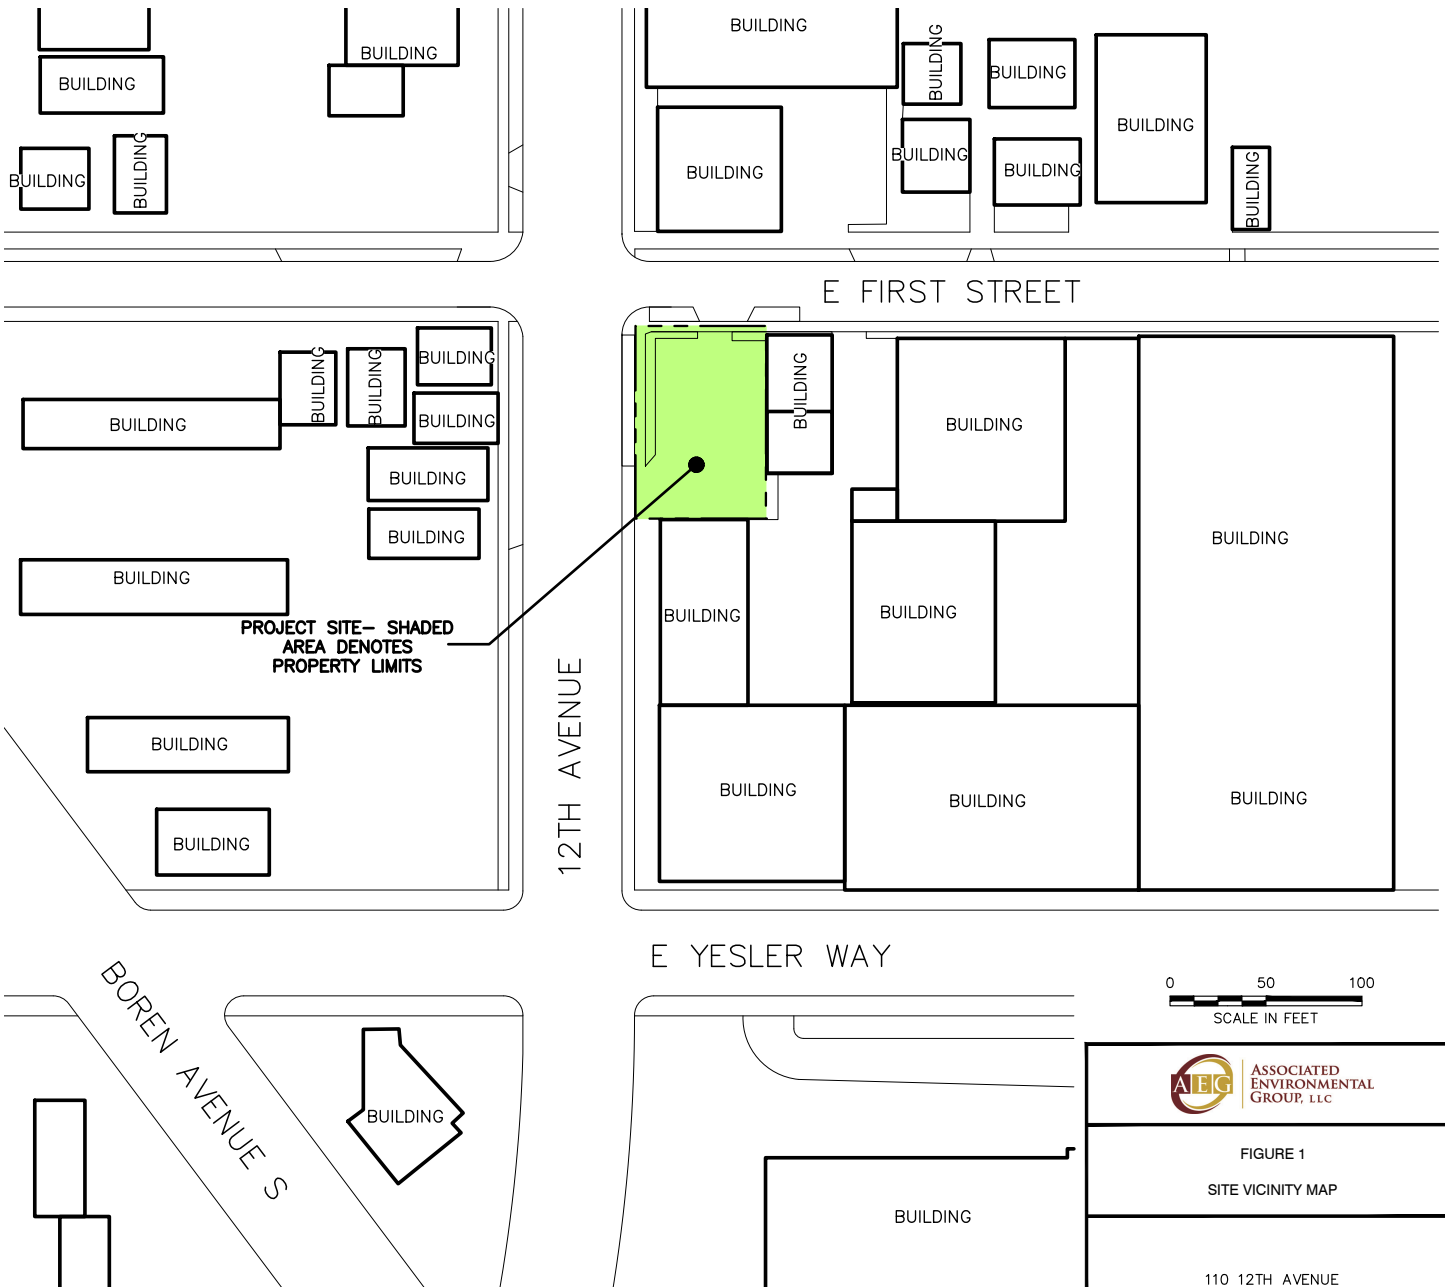
FIGURE 1  
SITE VICINITY MAP

The Site and the adjacent parcel to the south is located on the corner of 12<sup>th</sup> Ave and East Fir Street in Seattle, Washington. The Site and the adjacent parcel are positioned on approximately a 1/2 acre lot and is currently occupied by Saba Ethiopian Cuisine, Thanh Son Tofu (out of business), a parking lot, and Universal Auto Body & Services. The parking lot (the Site), where the Phase II was completed, is situated in the northwestern portion of the parcels, facing west. Gravel and dirt covers the parking throughout. The immediate vicinity of the Site is mixed residential, multi-family housing, and commercial businesses. Figure 1, *Vicinity Map*, presents the general layout of the Site.

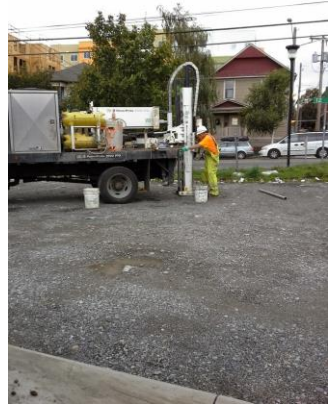
- The soil sample collected from approximately 13½ feet bgs in **boring B-6**, contained **gasoline-range TPH** at a concentration of 480 mg/kg which is **above** Ecology's MTCA levels.

Photo #2: *Boring B-6 being advanced. Photo looking east.*

- One well near boring B-6 where gasoline-range TPH was found in in the soil and where sufficient water to sample was not present at the depth drilled.

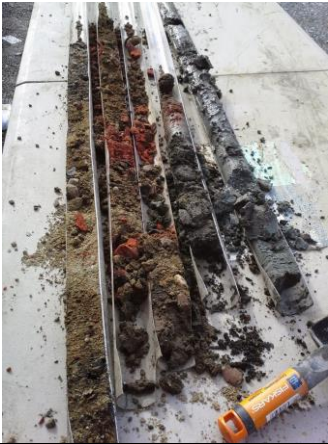
- The groundwater sample from **boring B-3** indicates that gasoline-range TPH and benzenes are present at concentrations **above** the respective MTCA Method A cleanup levels. Toluene ethylbenzene, and xylene were also detected, at a concentration **below** the MTCA level. In the groundwater sample from boring B-3, the following concentrations were detected:

Photo #3: *Core samples from B-3.*

- Two wells along the southern property boundary near borings B-3 and B-4 where gasoline-range TPH and benzene were found in the water samples;
  - One well located near boring B-2 where low levels of gasoline-range TPH and diesel were found in the soil.

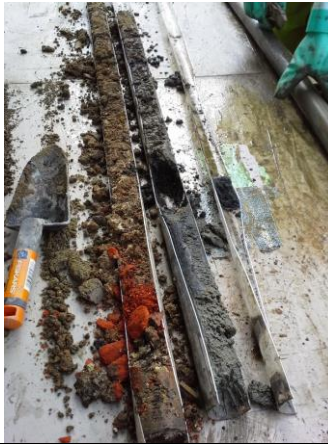
- The groundwater sample from **boring B-4** indicates that benzene is present at a concentration of 15 ug/l, **above** the MTCA Method A cleanup level of 5 ug/l.

Photo #4: *Core samples from B-4.*

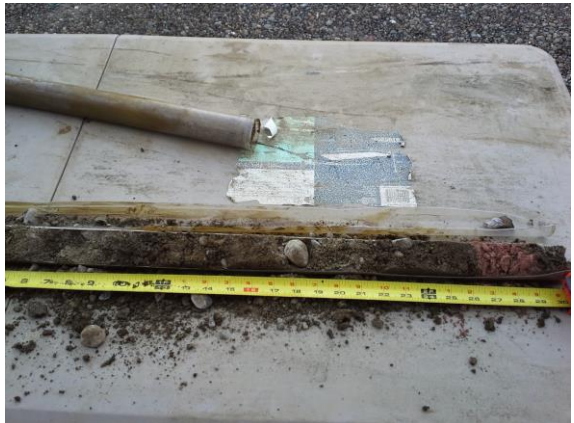
- The soil sample collected from approximately 20 feet bgs in boring B-2 indicated concentrations of diesel- and gasoline-range TPH at concentrations **below** MTCA Method A cleanup levels.

Photo #5: *Core samples from B-2.*
