# INTERIM REMEDIAL ACTION COMPLETION REPORT

NORTH CASCADE FORD PROPERTY  
SEDRO-WOOLLEY, WASHINGTON

*Prepared for*  
**VSF PROPERTIES, LLC**  
*November 8, 2016*  
*Project No. 0747.01.06*

*Prepared by*  
*Maul Foster & Alongi, Inc.*  
*1329 N State Street, Suite 301, Bellingham, WA 98225*

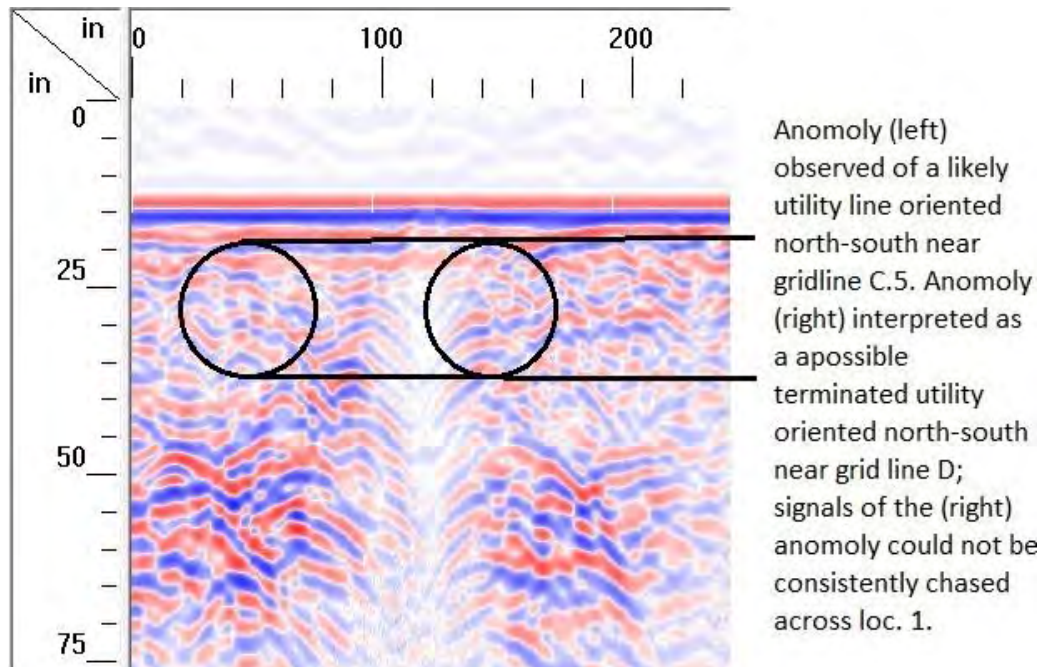
**Image A:** GPR scans from Location 1

One utility line was observed to reside in the vicinity of grids C.2/1-11, stretching continuously from south to north for the extent of the area scanned. The utility was interpreted to be approximately 24" below the existing grade.

Signals indicative of a similar unknown utility were sporadically observed along grid line D running parallel with the observed line at grid C.2 (Image A). However, these signals could not be found to be continuous and may be attributed to the existing concrete curb which extends along grid line C.8 across the entire length of the scanned area Location 1.

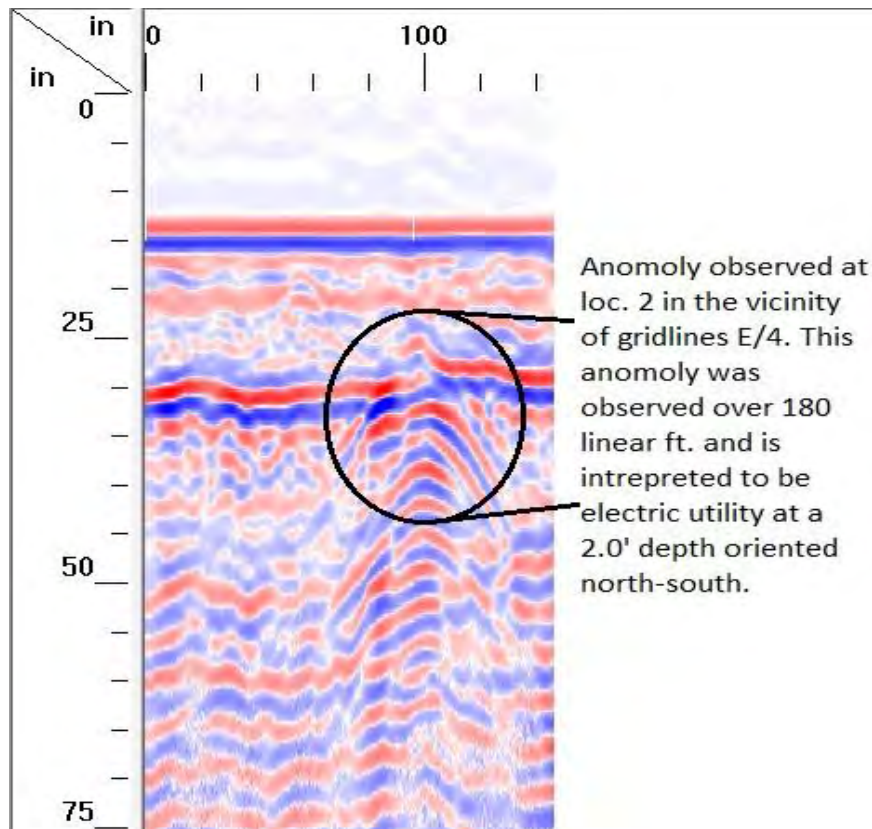
**Image E:** GPR scans from Location 2

At Location 2, three separate continuous signals were observed and interpreted as active electric lines each at a depth of approximately 24.0" below the existing grade. One line was interpreted to extend from gridline E.2/1 to gridline B.8/21.5. This was the longest observed utility line on site and was observed to run parallel, offset several feet to the west, of the row of existing light posts in Location 2 (Image E).

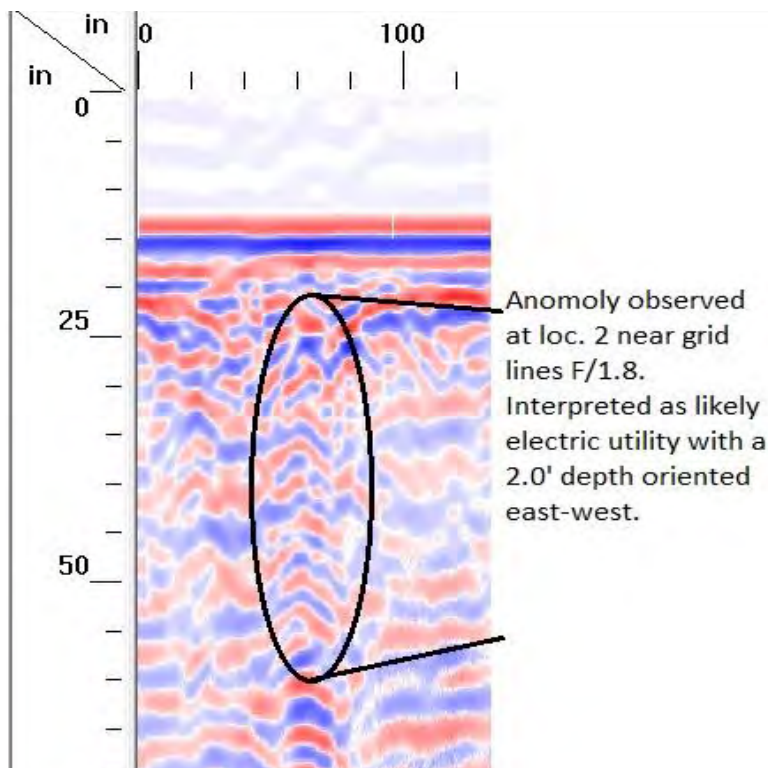
**Image F:** GPR scans from Location 2

Signals interpreted as a second electric utility line were observed to extend along gridlines E-G/2 from the base of the southernmost light post in Location 2 extending beyond the Location 2 west boundary (Image F). Signals interpreted as the third electric utility line observed in Location 2 were found to begin on the west face of the

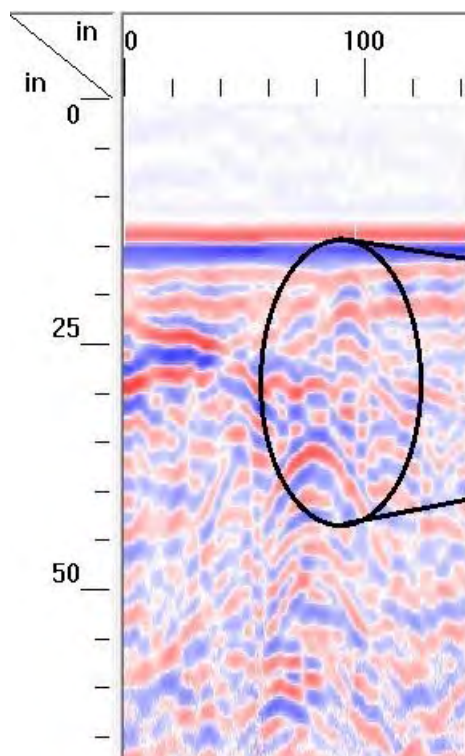
**Image H:** GPR scans from Location 2

Anomaly observed at Loc. 2 interpreted to be a 16" deep storm drain (SD2) running north to south, image taken at grid lines F/15.

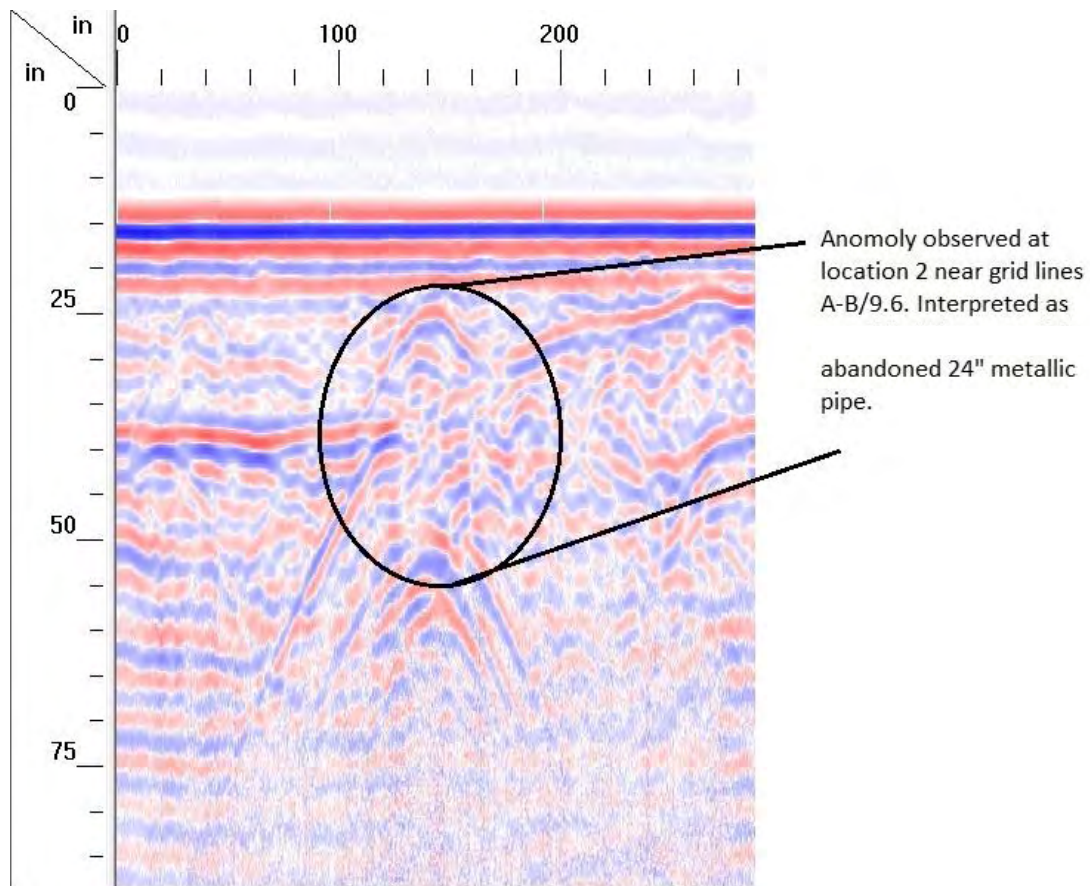
**Image I:** GPR scans from Location 2

Within Location 2, in the vicinity of gridlines A-B.5/8.7-10 (noted on grid map), a strong discontinuous signal was observed at a depth of around 24" to 30". The signal was associated with a zone of disturbance, but was relatively confined and was interpreted as an approximately 24-inch diameter metal pipe or other similar obstruction (Image I).

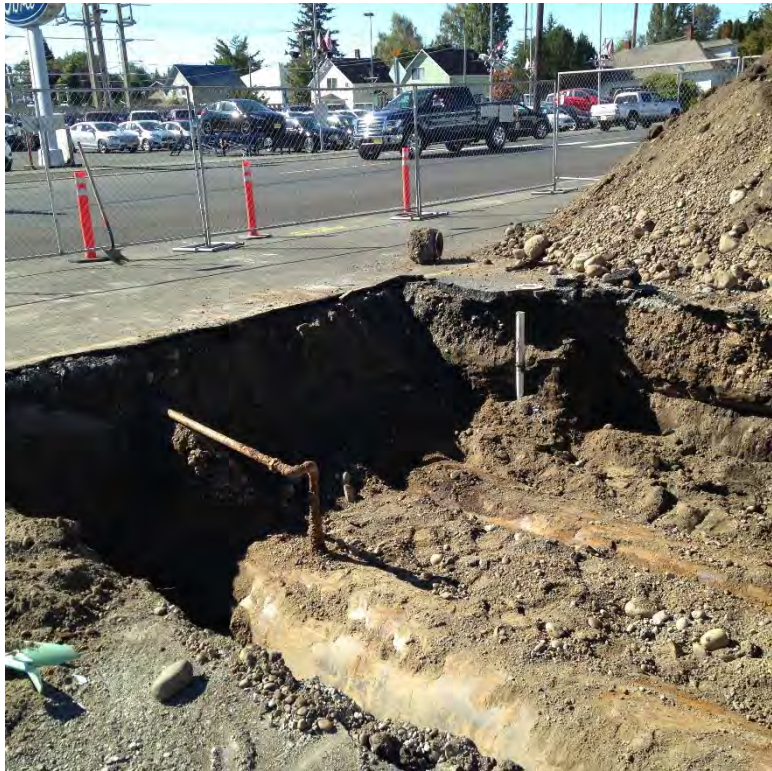
Looking southwest at underground storage tanks (leaded gasoline tank to east and heating oil tank to west).  
September 26, 2016

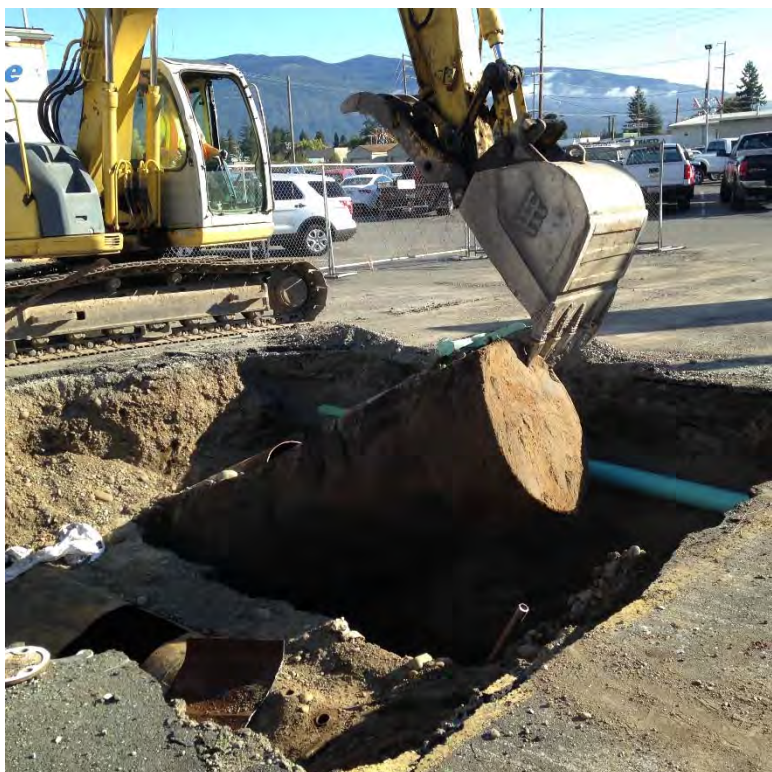
2

Looking northeast at removal of leaded gasoline tank; green sewer line visible in photo.  
September 27, 2016

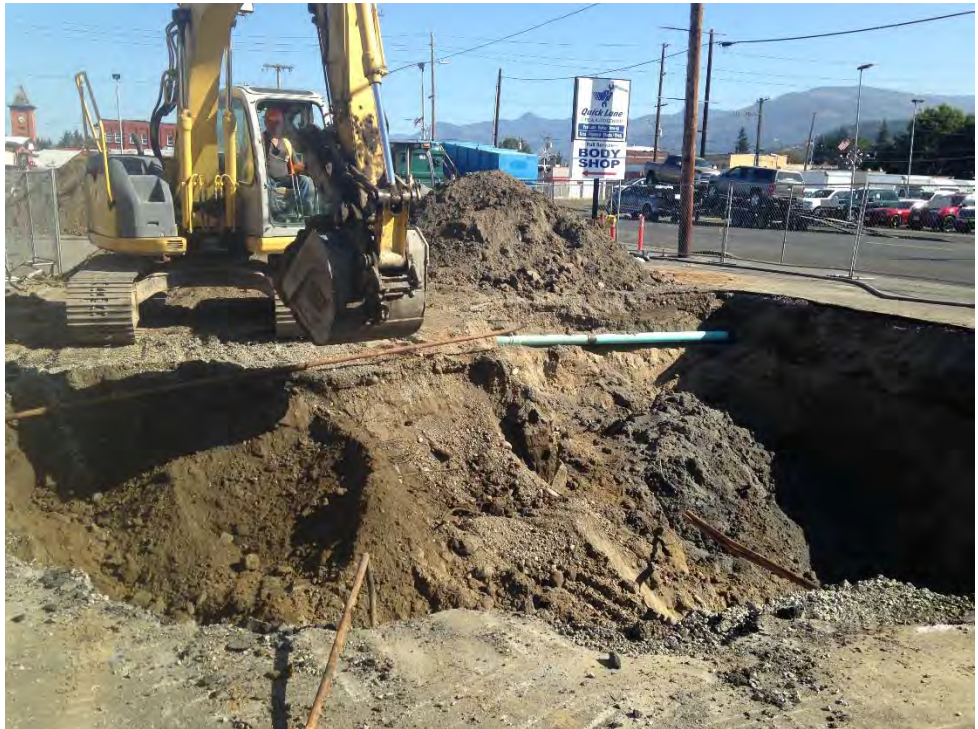
Looking southeast at heating oil tank supply line (north-south trending pipe) and sewer line (green). Former vent line is shown in the foreground.

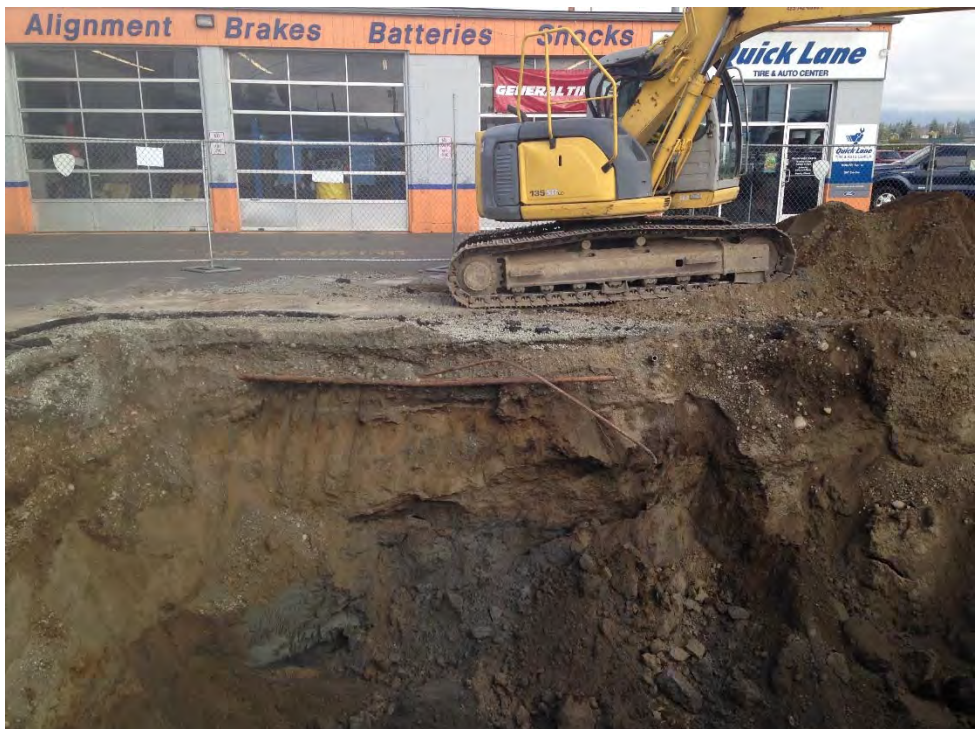
4

Looking north at former vent lines from the two underground storage tanks.

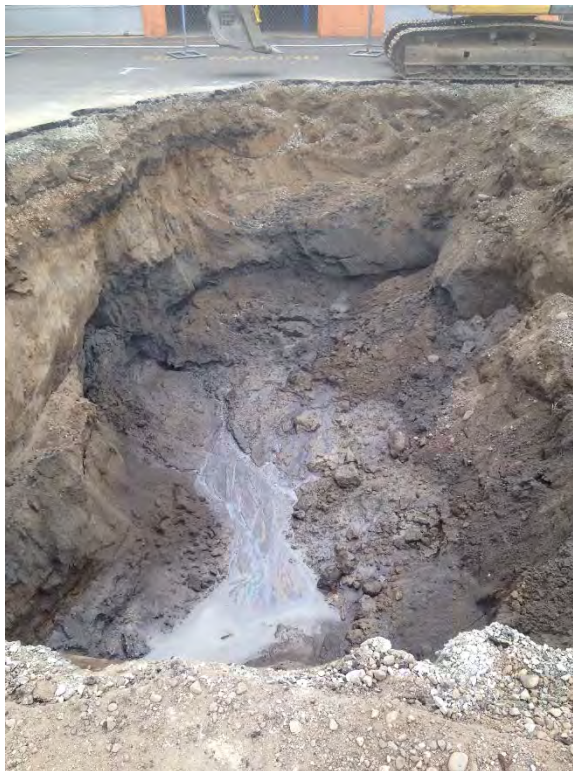
Looking north at base of  
excavation.  
September 29, 2016

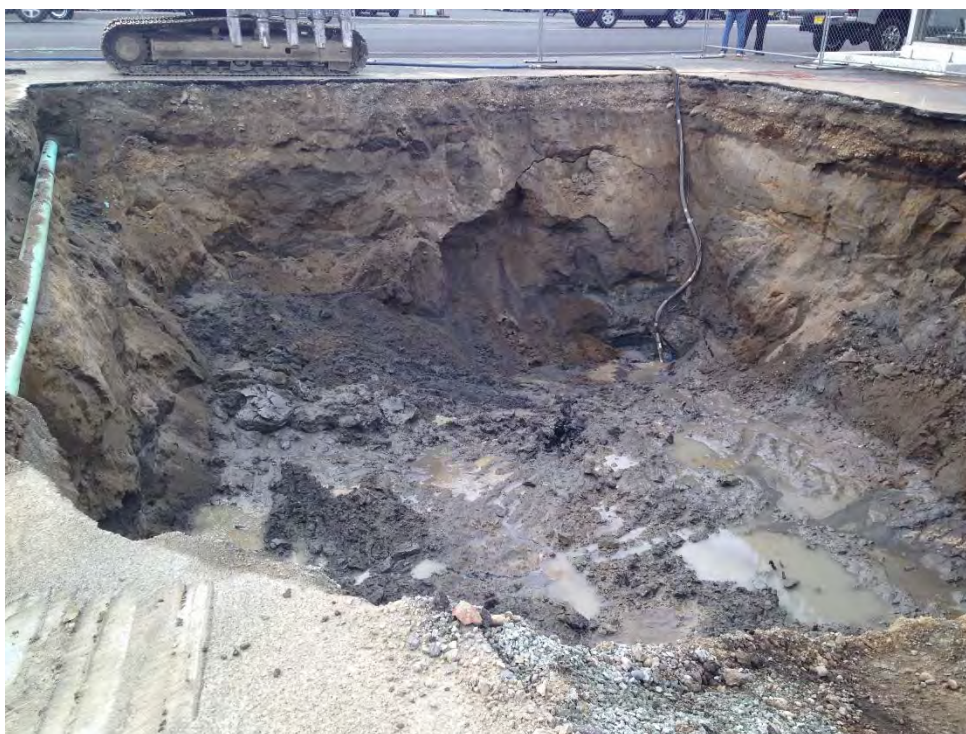
6

Looking south at  
sloughing excavation  
sidewalls.  
October 3, 2016

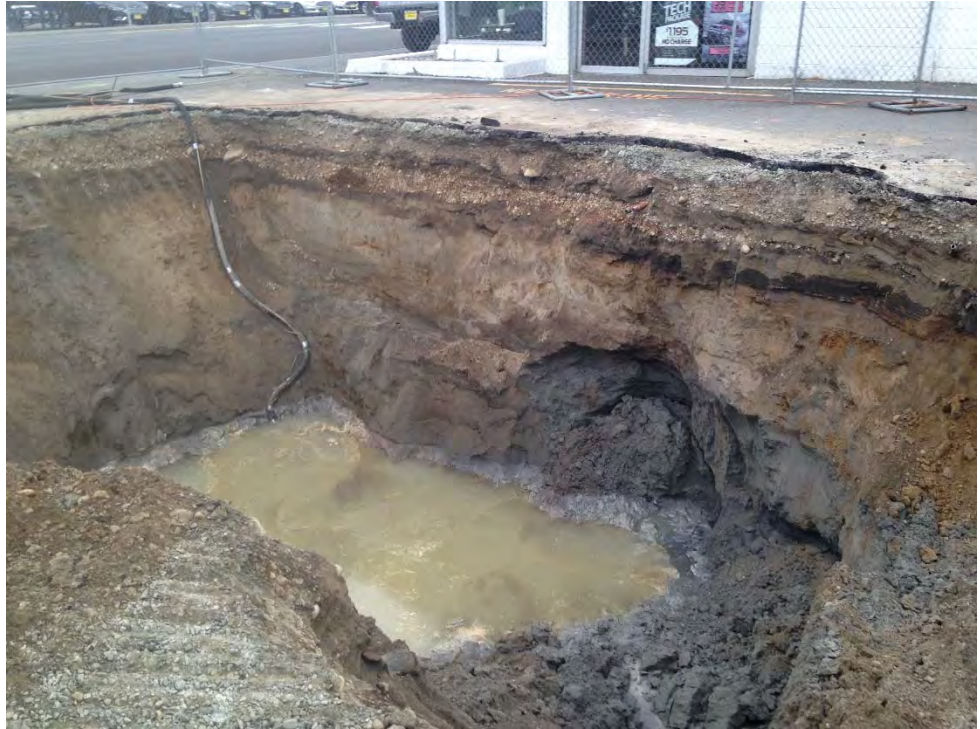
PCS was identified along the west and north sidewalls of the final excavation extents (see Figure 4-1) from approximately 7 to 15 feet bgs; PID measurements recorded along the west and north sidewalls were 900.8 and 358.8 ppm, respectively. PCS was left in place in the west and north sidewalls because it was not feasible to excavate any closer to the building in that depth range. The excavation was offset a minimum of 15 feet away from the building foundation, with a vertical sidewall slope. Based on the building structural assessment (see Section 3.2), Kingworks recommended excavating no closer than five feet to the building, with a 1:1 sidewall slope to protect the structural integrity of the building. It may have been feasible to excavate shallower material closer to the building (up to five feet away), but it was not feasible to excavate at the depth PCS was observed. In addition, significant sloughing was observed along the sidewalls of the excavation due to the type of soils present in the excavation and the depth of groundwater (see Photos No. 6 through No. 8 in Appendix E).

Looking southwest at  
sloughing excavation  
sidewalls (pre-dewatering)  
and soil staining.  
October 3, 2016 AM

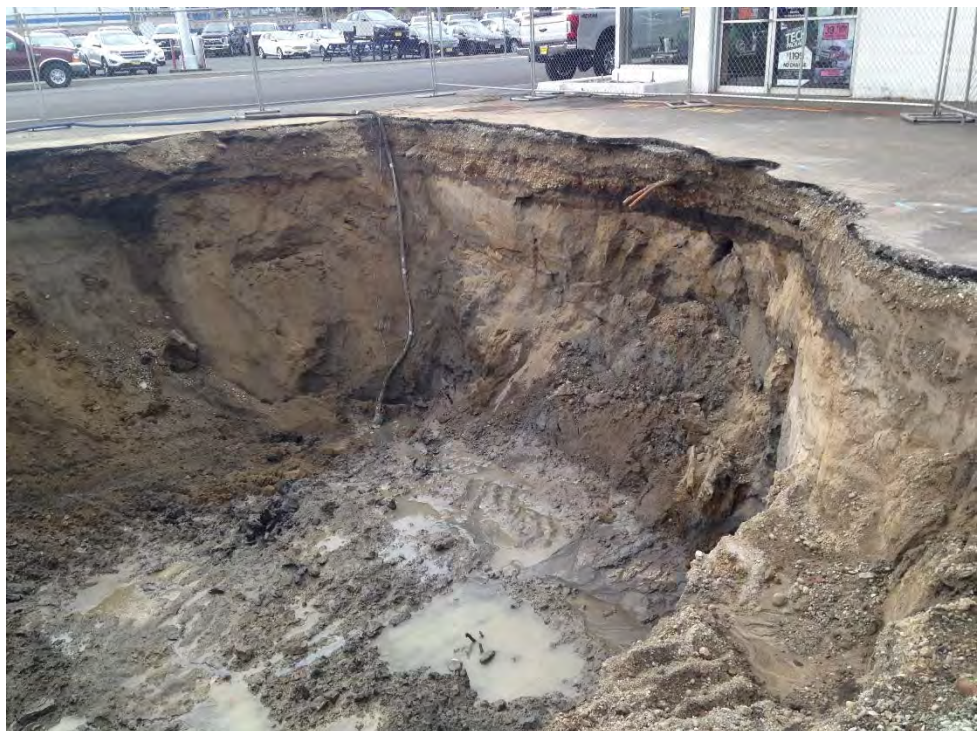
8

No groundwater was encountered in the excavation during UST and equipment removal, but groundwater was encountered during PCS excavation at approximately 10 to 11 feet bgs. A sheen was initially observed in the excavation, but decreased during dewatering efforts and as the excavation footprint expanded. Groundwater management, treatment, and sampling activities are discussed in Section 5.2.

Looking southwest at  
sloughing excavation  
sidewalls (post-  
dewatering).  
October 3, 2016 PM

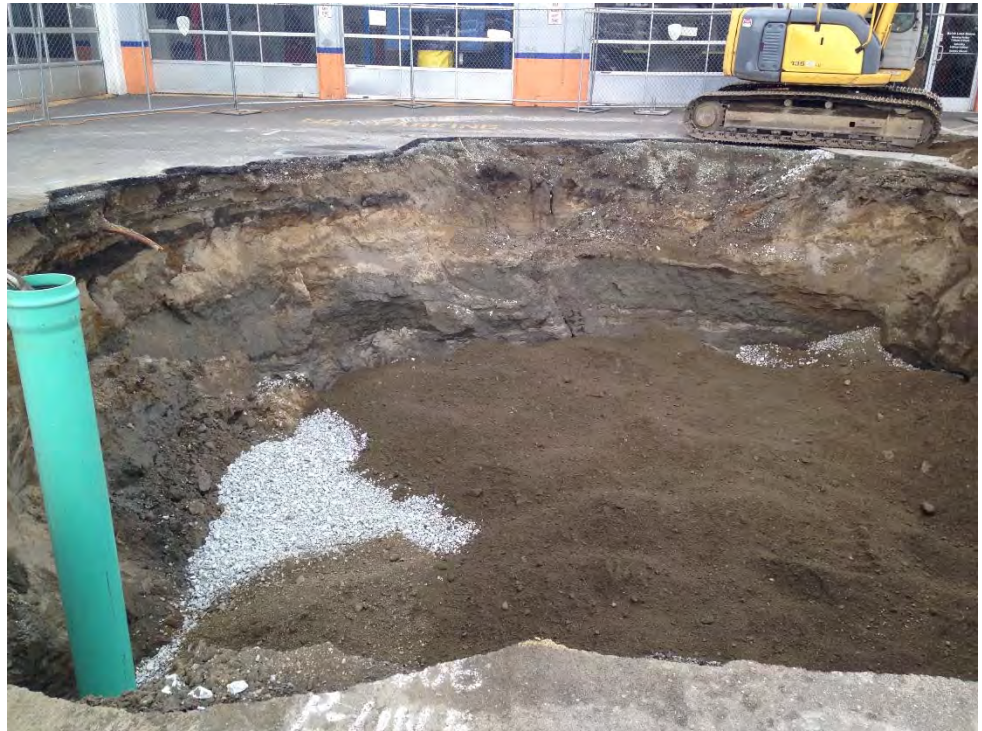
Looking north at base of excavation with gravel sub-base, lift of gravel borrow, and temporary well point.

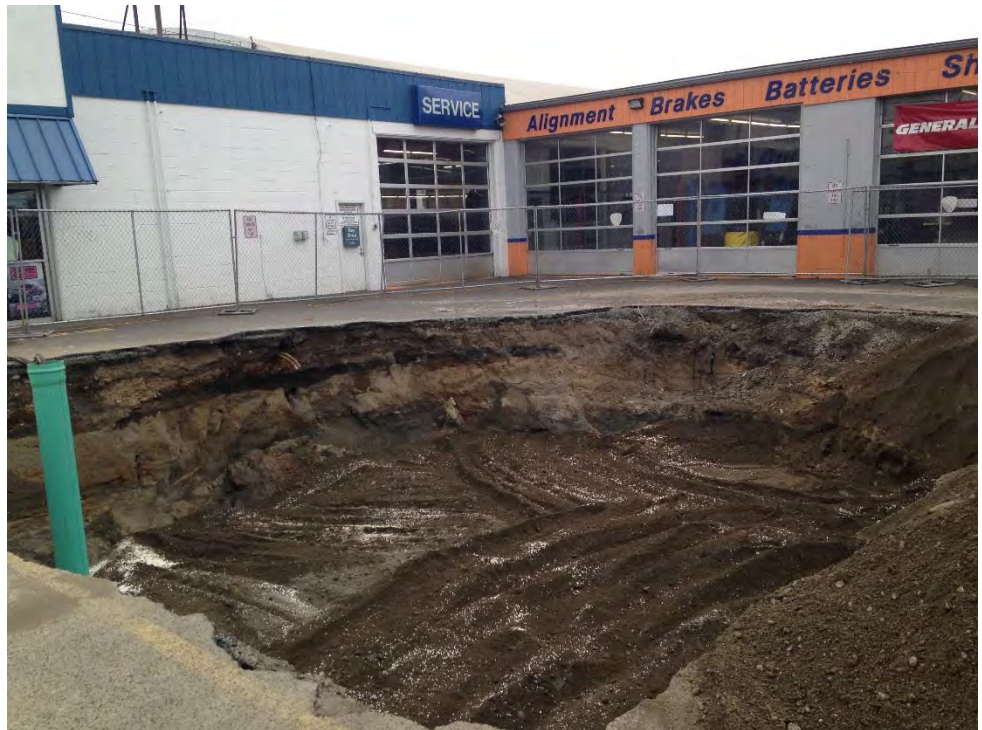
10

ORC-A, an ISBR product, was used as a backfill amendment in the excavation to treat remaining total petroleum hydrocarbons in the vadose zone and in groundwater. ORC-A product specifications are included in Appendix M. ORC-A accelerates the naturally occurring microbial degradation of petroleum hydrocarbons in saturated soil and groundwater by enhancing aerobic biodegradation processes. ORC-A provides a controlled-release supplemental source of oxygen, which enables the indigenous microorganisms to expedite the biodegradation process. The ORC-A product will, when hydrated (with groundwater), produce a controlled release of oxygen for up to 12 months on a single application, which will assist in accelerating aerobic contaminant biodegradation in groundwater and saturated soils.

Looking northwest at lift of gravel borrow mixed with ORC-A® amendment.

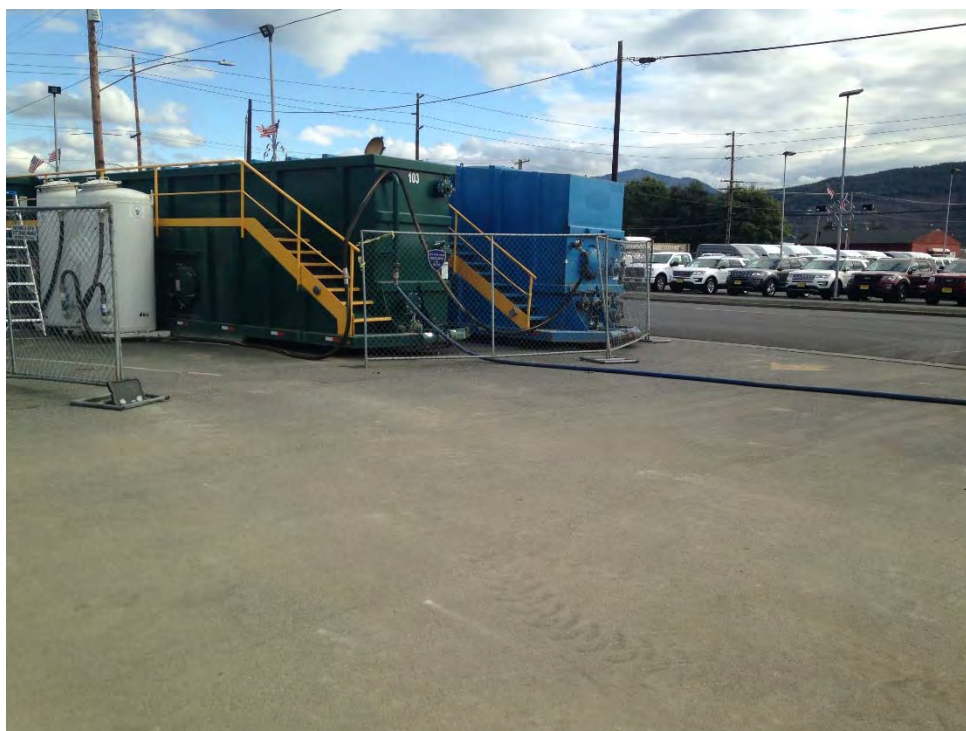
On site water treatment  
system.
