# Technical Memorandum

**TO:** Jed Helle, Absher Construction  
**FROM:** Jennifer Wynkoop  
**DATE:** September 28, 2018  
**RE:** **Historical Review of the Jefferson Avenue Site  
Tacoma, Washington  
Project No. 1412002.010.011**

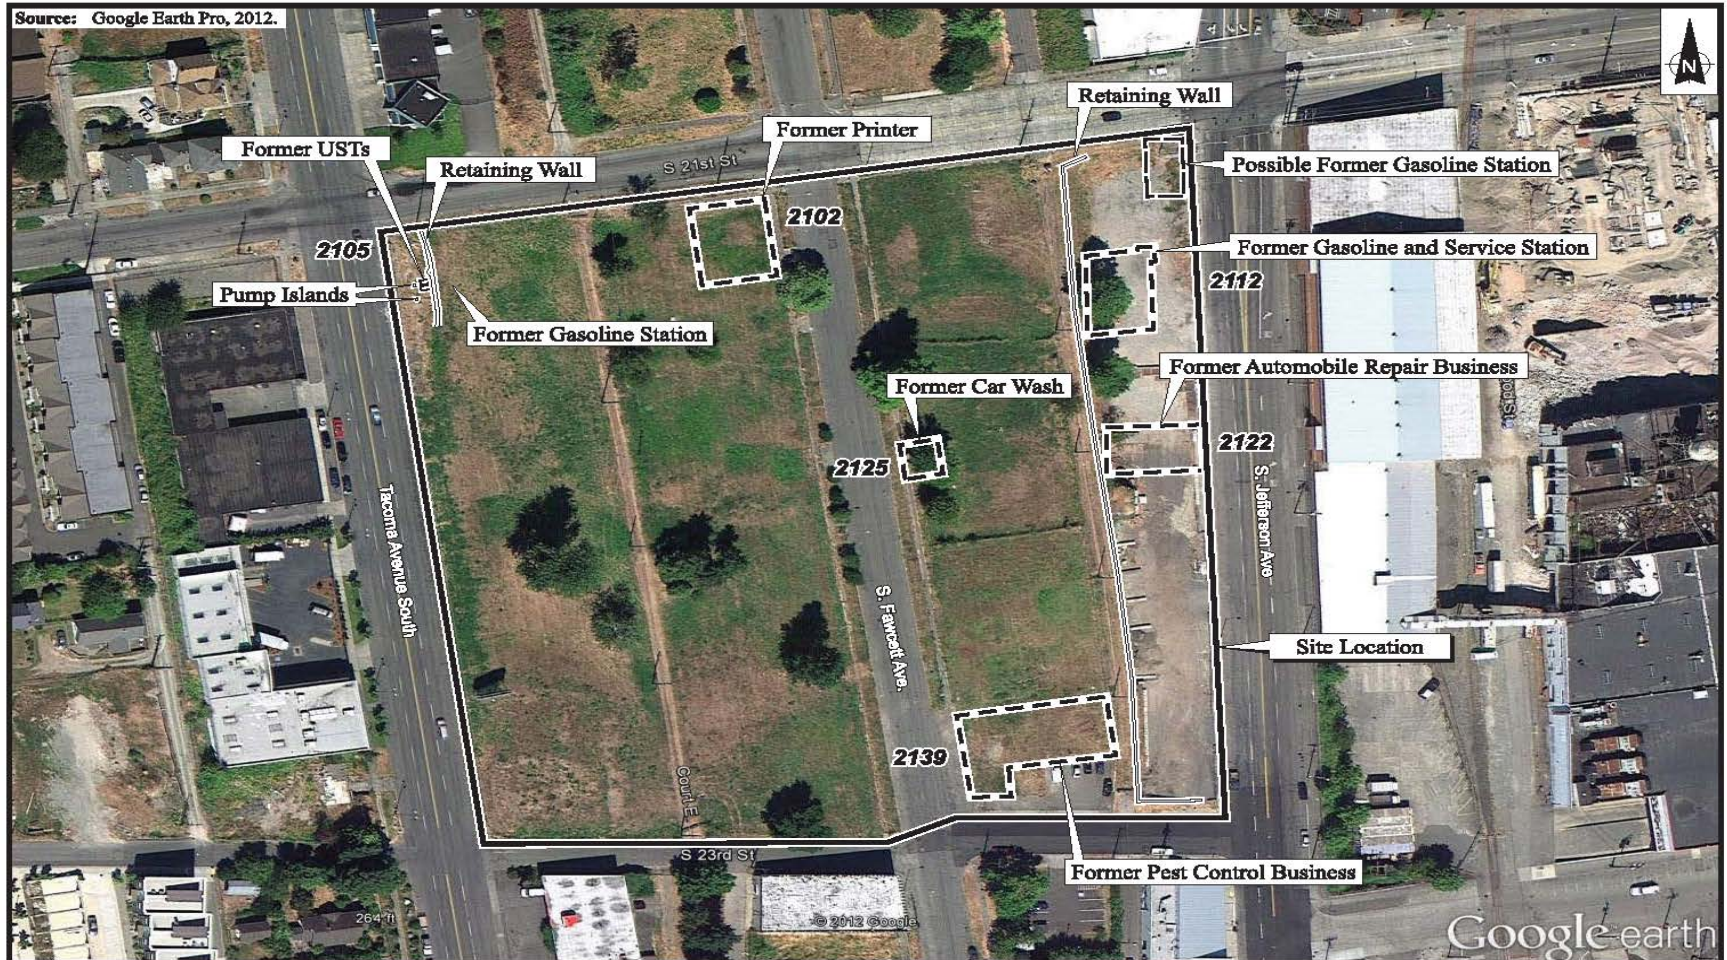
Figure  
**1**

The Jefferson Avenue Site (Site) has been in use since 1896. Historical operations at this Site identified as areas of potential concern include gasoline stations, a car wash, a printer, an automobile repair businesses, and a pest control business (Figure 1).

**Site Map**

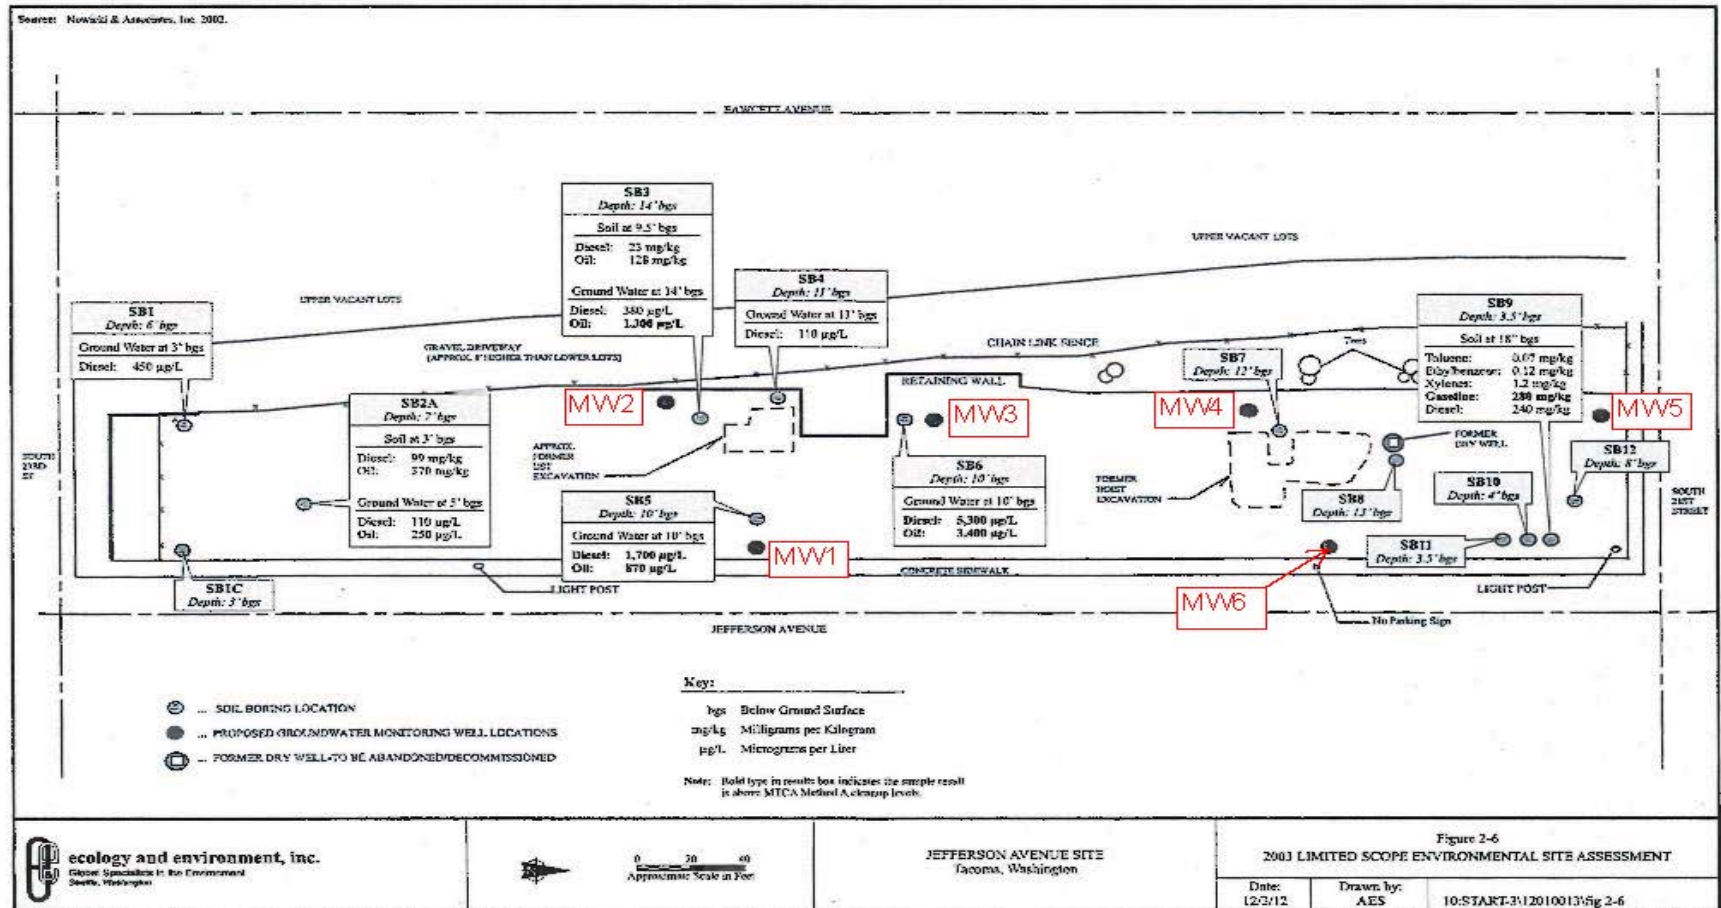
In March 2003, investigations at the Site were conducted to assess the presence of residual contamination in soil and groundwater (Figure 2). Impacted soil was noted in only one location. Three groundwater grab samples taken from three soil borings had concentrations of TPH-D and/or TPH-O at concentrations higher than MTCA Method A cleanup levels. However, permanent monitoring wells (MW1 through MW6) were installed in June 2003. These six wells were sampled at four separate events between March 2004 and January 2005 and analyzed for TPH-G, TPH-D, TPH-O, and BTEX compounds. Initially, TPH-D above the Method A cleanup level, was detected at MW6 but subsequent sampling did not detect petroleum hydrocarbons at that well. None of the other wells had detections above the cleanup levels for any constituent.

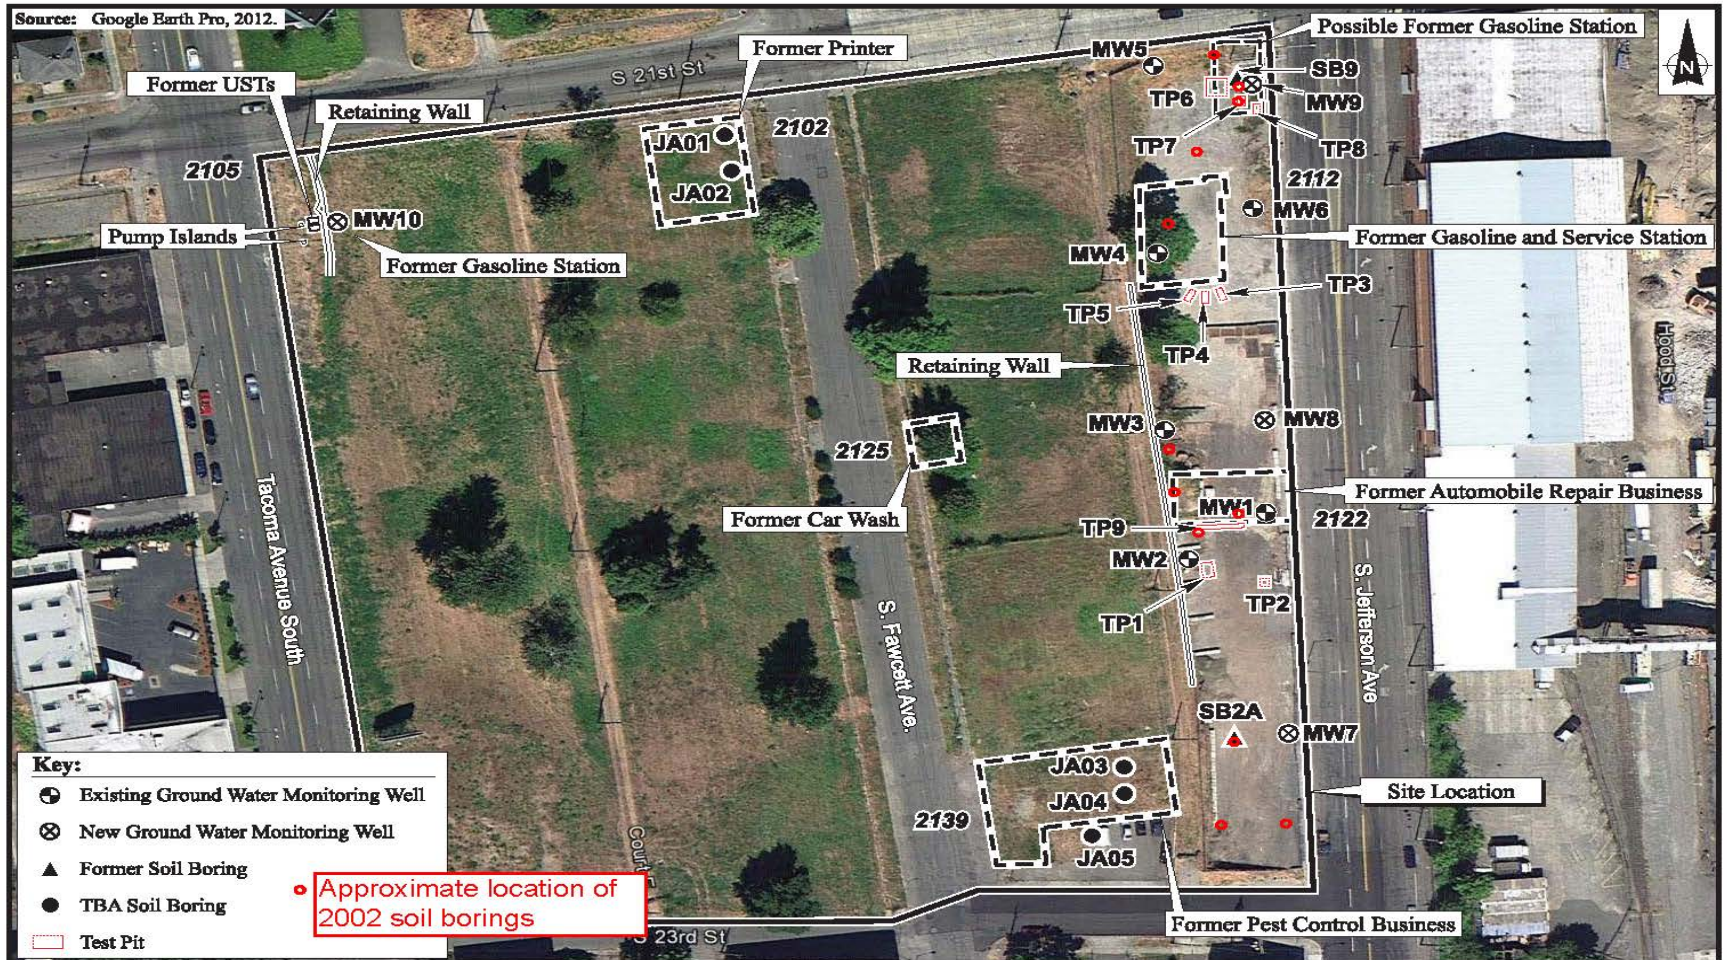
| <p>ecology and environment, inc.<br/>Global Specialists in the Environment<br/>Seattle, Washington</p> | <p>JEFFERSON AVENUE SITE<br/>Tacoma, Washington</p> | | <p>Figure 4-1<br/>SAMPLE LOCATION MAP</p> | | |

In 2012, an additional sampling event occurred at the Site conducted by E&E for EPA and the City. The goal of this sampling event was to determine if concentrations of constituents identified during the 2002 and 2003 investigations were still present. An assessment was performed of the entire vacant city block owned by the City. This assessment included a ground penetrating radar (GPR) assessment to look for possible unidentified USTs, as well as the installation of four additional monitoring wells (MW7 through MW10), excavation of nine test pits at locations identified by the GPR to be potential USTs (TP1 through TP9), and drilling five soil borings (JA01 through JA05; Figure 3). The results of this investigation are presented in the January 2013 TBA report (E&E 2013). Soil and groundwater samples were collected from all 10 monitoring wells (MW1 through MW10), 8 soil borings at various depths (5 soil borings plus 3 monitoring well borings), and 2 of the 9 test pits (TP6 and TP9). These samples were analyzed for varying combinations of volatile organic compounds (VOCs), semivolatile organic compounds (SVOCs), pesticides, polychlorinated biphenyls (PCBs), TPH-G, TPH-D, TPH-O, and target analyte list metals including lead. Analysis of samples from investigations of all former operational areas resulted in non-detect concentrations or concentrations below MTCA Method A cleanup levels with three exceptions:

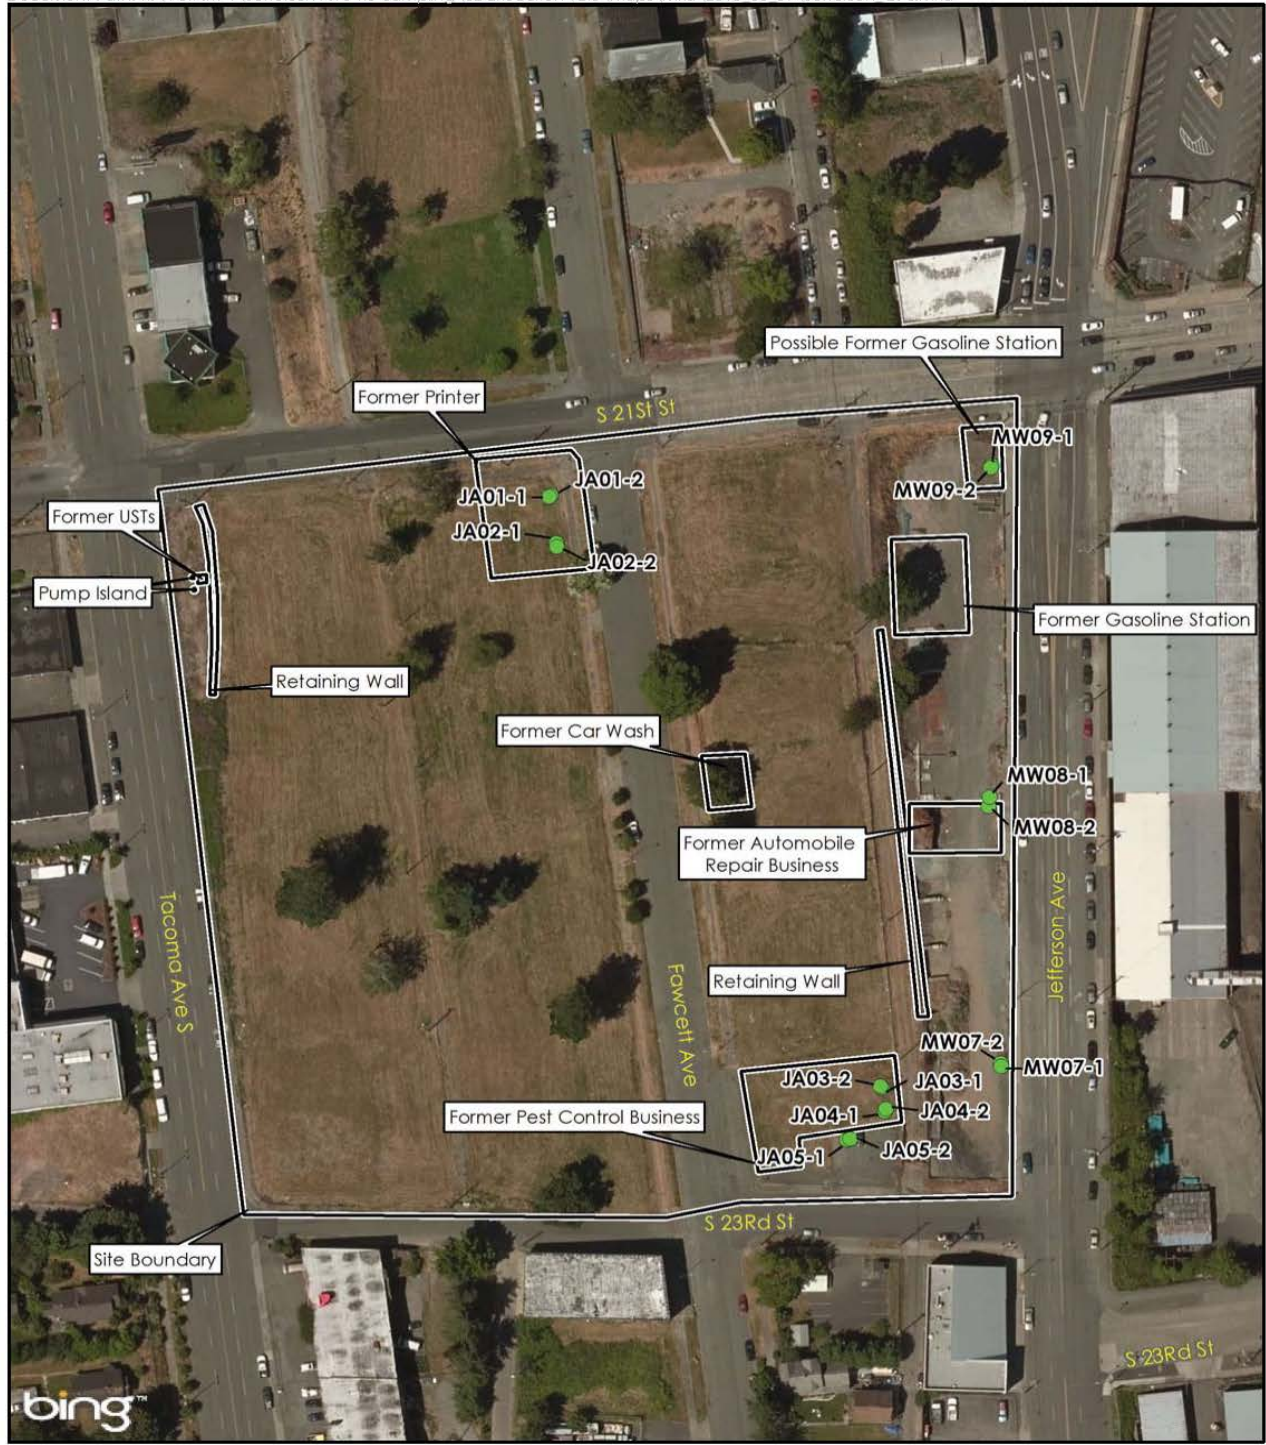
9/11/18 Y:\11412\002\Historical Review\Fig 4 Boring Locations.docx

As described in the TBA, in 2014 and 2015, EPA and E&E resampled groundwater at all monitoring wells, including two re-excavated test pits (TP06 and TP09), and eight re-drilled soil borings at the Site (Figure 4)<sup>1</sup>. These samples were analyzed in varying combinations for VOCs, PCBs, SVOCs, and pesticides. These investigations covered the former gas stations, former printer, former car wash, and former pest control business. Results of this investigation are reported in the April 2015 TBA Addendum report (E&E 2015). No analytes were detected at concentrations that exceeded regulatory standards for soil or groundwater during the resampling event.

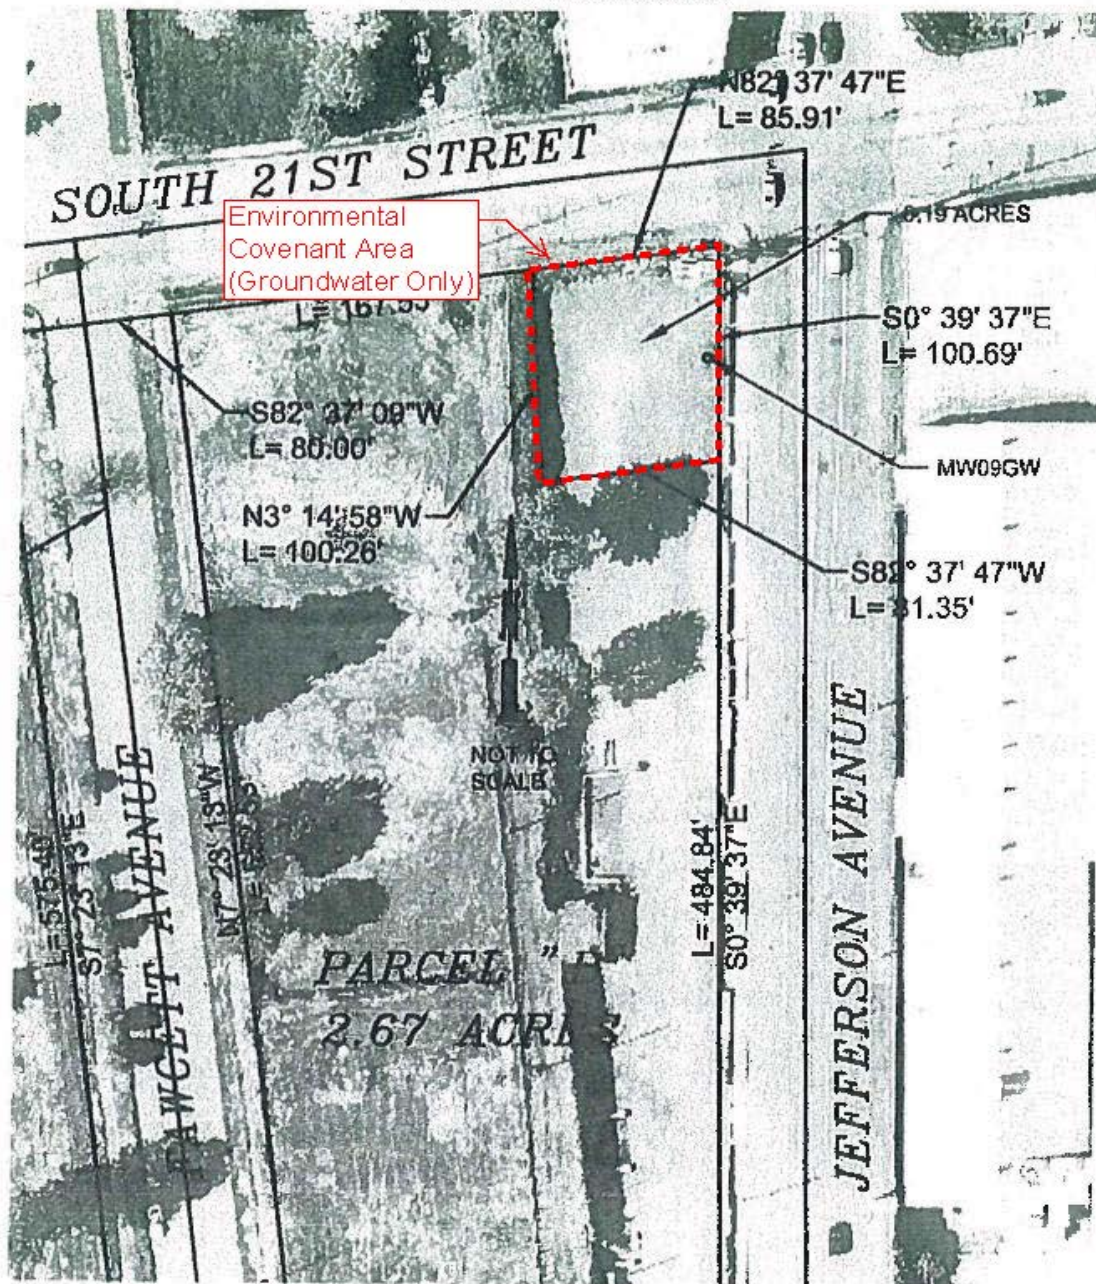
Exhibit B -- PROPERTY MAP

The one remaining issue at the Site relates to arsenic in groundwater in the northeast corner of the Site. The groundwater impacts were limited to a single well (MW9). A covenant restricting the use of groundwater for domestic purposes is in place for a limited area in the northeast corner of the site (Figure 5).

Ecology issued an NFA for this Site in February 2014, removing the Site from the Confirmed and Suspected Contaminated Sites List (Ecology 2014). An Environmental Covenant for Institutional Controls was issued in response to the arsenic concentrations in groundwater identified at MW9 in the northwestern most portion of Parcel 2021080011 (Figure 5). The Covenant restricted the extraction of the groundwater located beneath the defined area for purposes other than temporary construction dewatering, investigation, monitoring, or remediation.

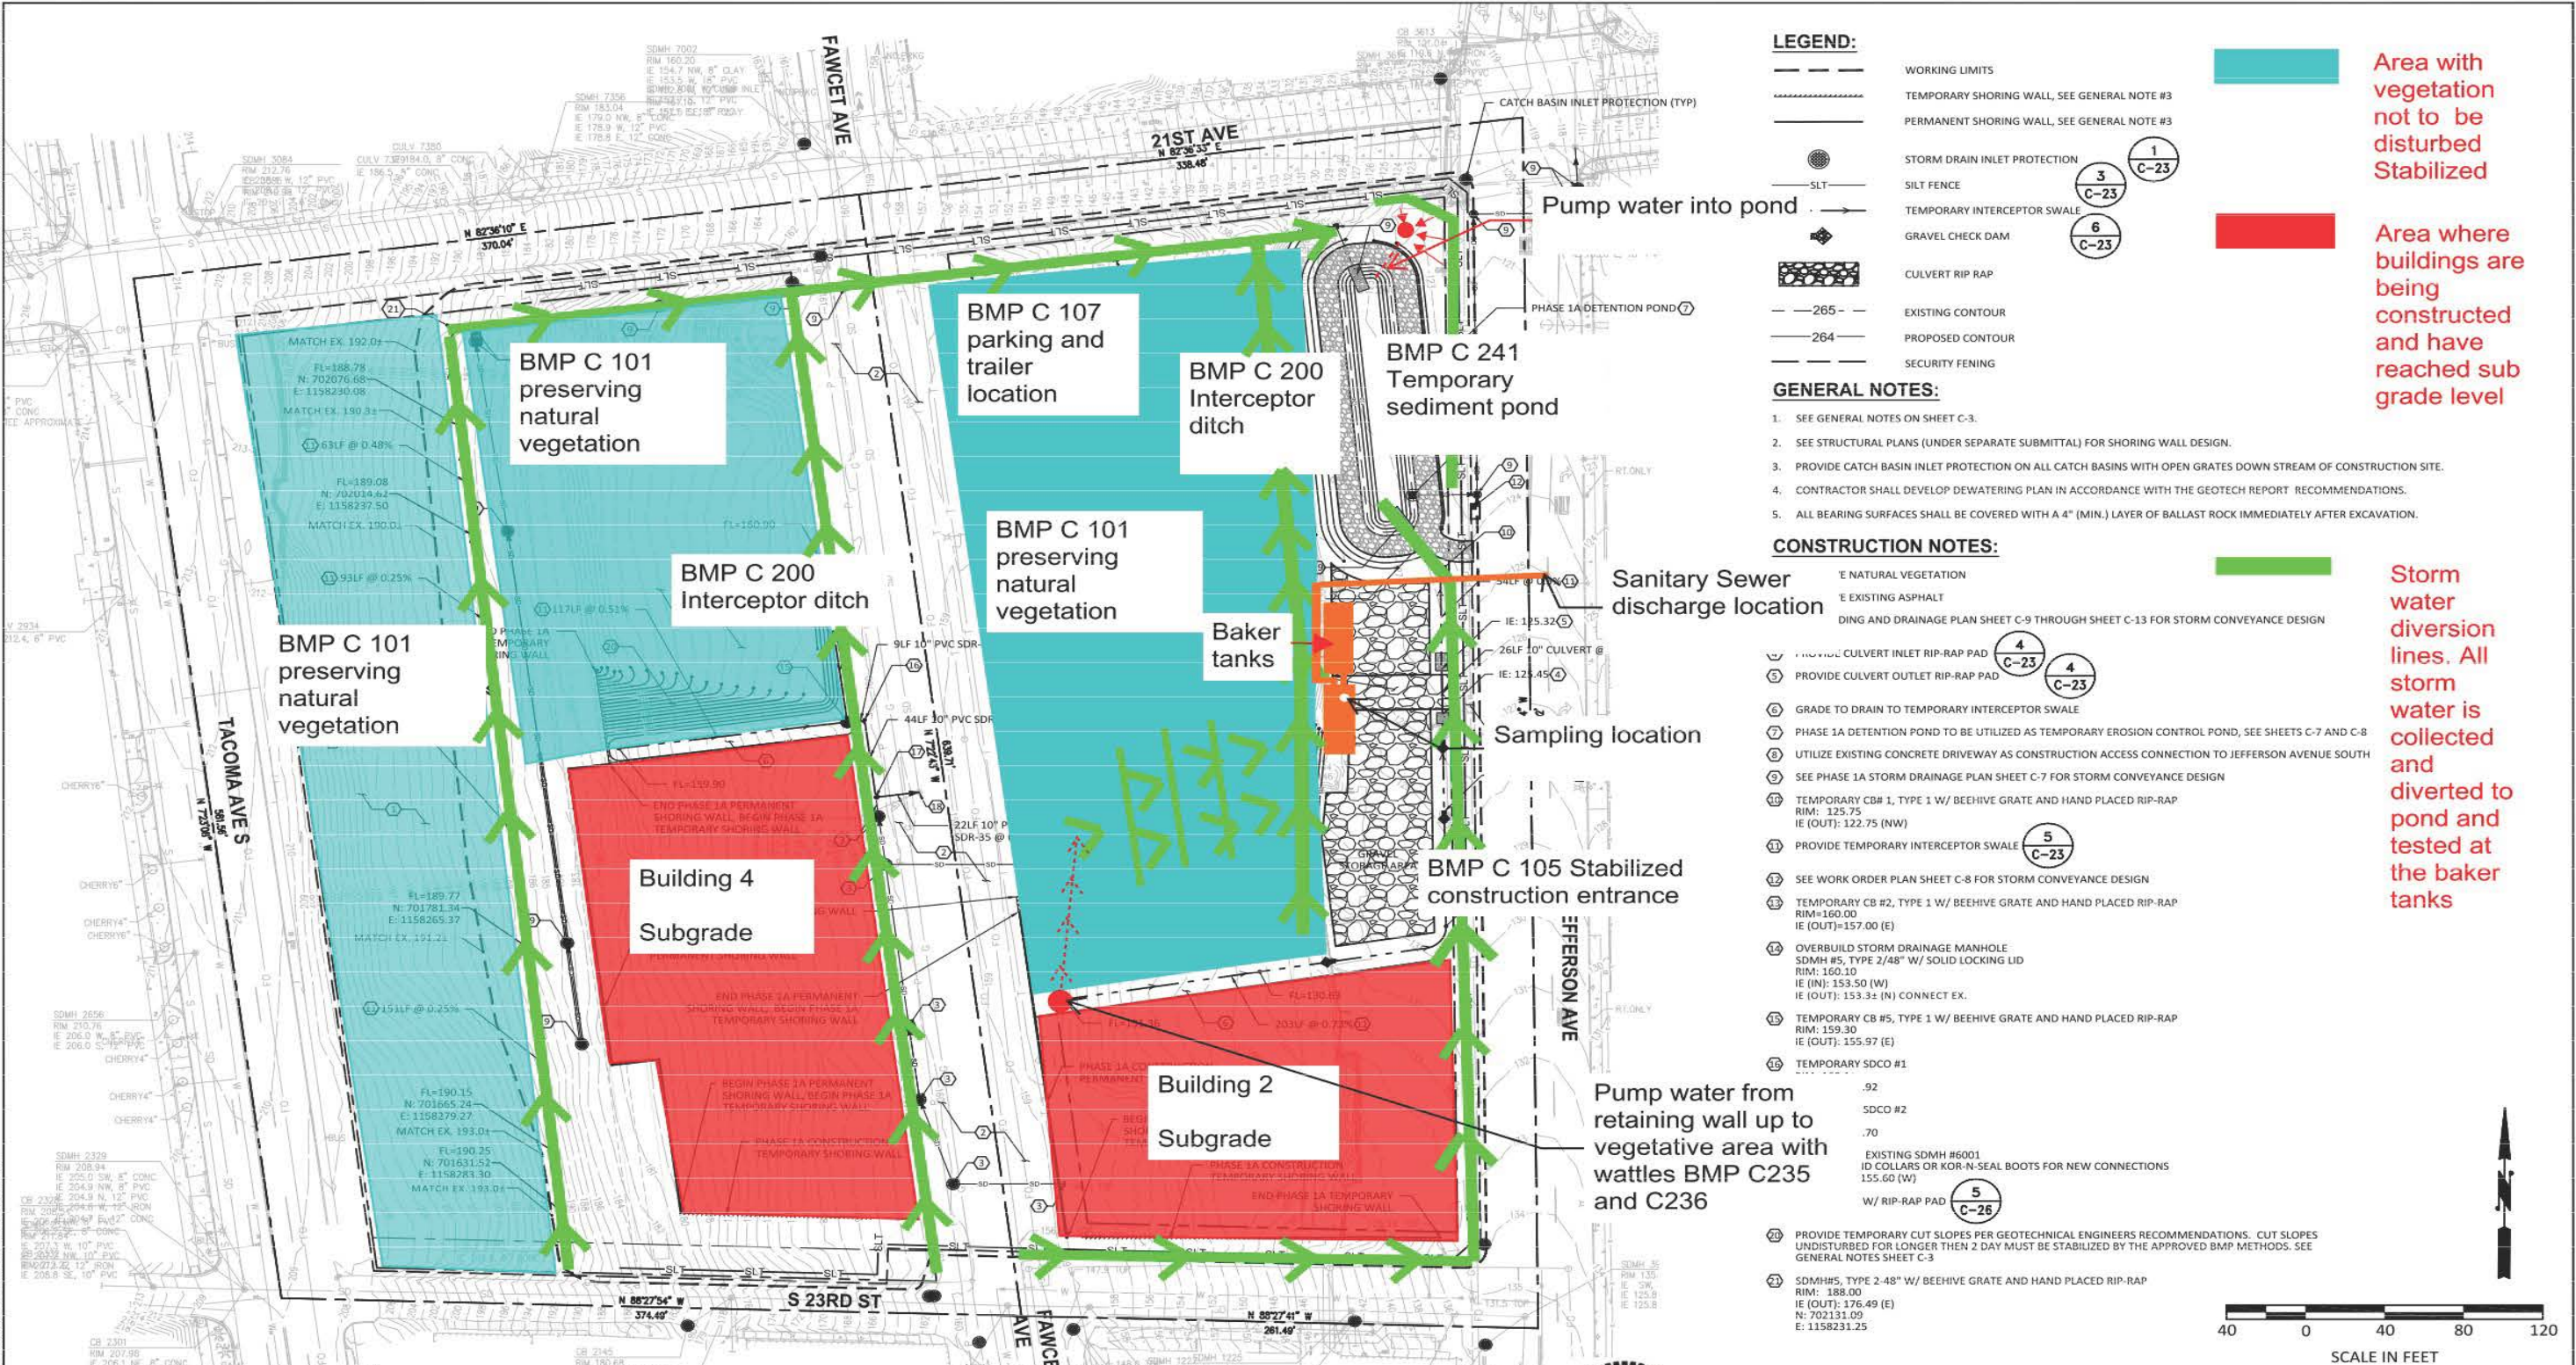
- Stormwater across the site is collected and piped to the temporary sediment pond (pond) in the northeast corner of the site.
- Seepage from the building 2 wall is pumped to a vegetated area where it flows over land and is then collected and piped to the pond.
- Seepage along the northeast edge of the site, adjacent to Jefferson Avenue, is collected and pumped to the pond.
- Water from the pond is pumped into baffled Baker tanks where additional sediment is allowed to settle out before discharge to the sewer system.

Area with vegetation not to be disturbed Stabilized

Area where buildings are being constructed and have reached sub grade level

Storm water diversion lines. All storm water is collected and diverted to pond and tested at the baker tanks

Site Stormwater Collection and  
Treatment

Figure 6 shows stormwater collection and flow across the site. Figure 7 shows the stormwater sample locations.

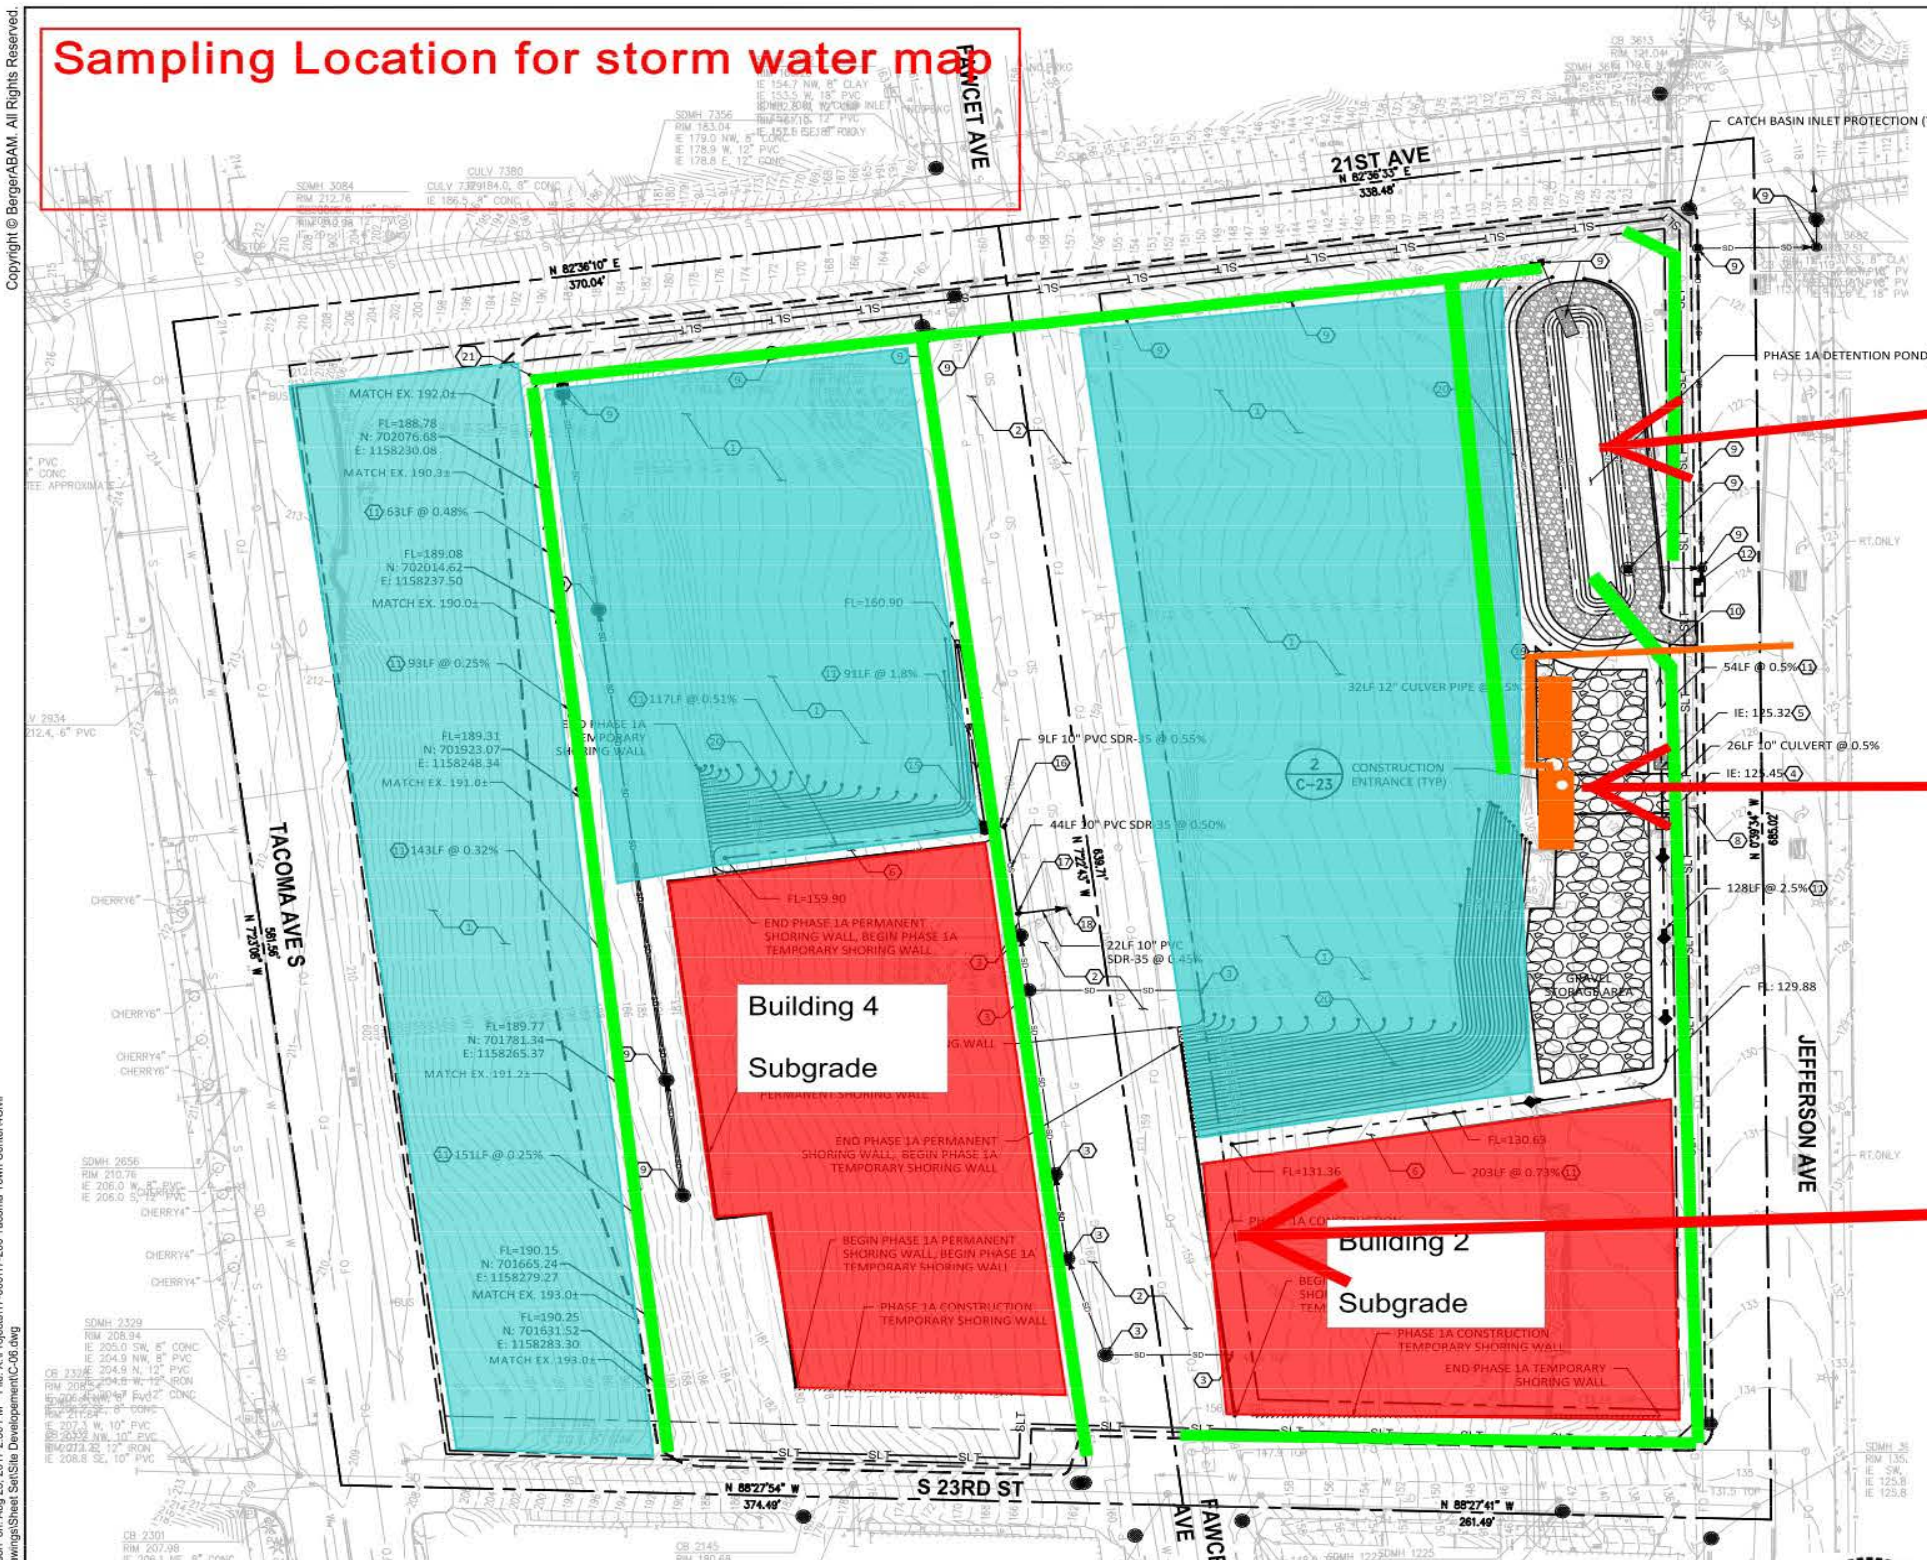
Figure  
7

**Pond Sampling**  
580-74591-1 1/24/2018  
580-76890-1 4/27/2018

**Site water sample. All site water collected and tested before discharge. Results**  
580-74721-1 1/30/2018  
580-75632-1 3/09/2018  
580-76099-1 3/27/2018

**Specific sample taken from shoring wall where ground water penetrates the wall**  
580-76099-1 3/27/2018  
580-76889-1 4/27/2018

Stormwater Sample Locations

Samples were collected in the following locations: Seepage from the Building 2 wall (two samples), the temporary sediment pond (two samples), and the Baker tank (three samples). Oil and grease, VOCs, and SVOCs, were not detected in any of the samples collected. Low levels of arsenic consistent with background groundwater concentrations were detected. Arsenic samples collected from the Building 2 wall had concentrations ranging from 4.8 micrograms per liter ( $\mu\text{g/L}$ ) to 46  $\mu\text{g/L}$ . The samples collected from the storage pond ranged in concentration from 5.1  $\mu\text{g/L}$  to 18  $\mu\text{g/L}$ . The samples collected from the Baker tank, which is the last point before discharge to the sewer system, ranged in concentrations from 2.1  $\mu\text{g/L}$  to 3.8  $\mu\text{g/L}$ . The concentrations at the Baker tank and the pond are well below the range of concentrations found in well MW9, which was located in the vicinity of the pond. The concentrations in the baker tank prior to discharge are less than the mean state background concentration for arsenic in groundwater of 3.9  $\mu\text{g/L}$ . Testing of the stormwater at the site indicates that contaminants, if present, are not making their way to the stormwater discharge point.
