FINAL AS-BUILT REPORT WHATCOM WATERWAY CLEANUP IN PHASE 1 SITE AREAS

Port of Bellingham

Anchor QEA, LLC

September 2018

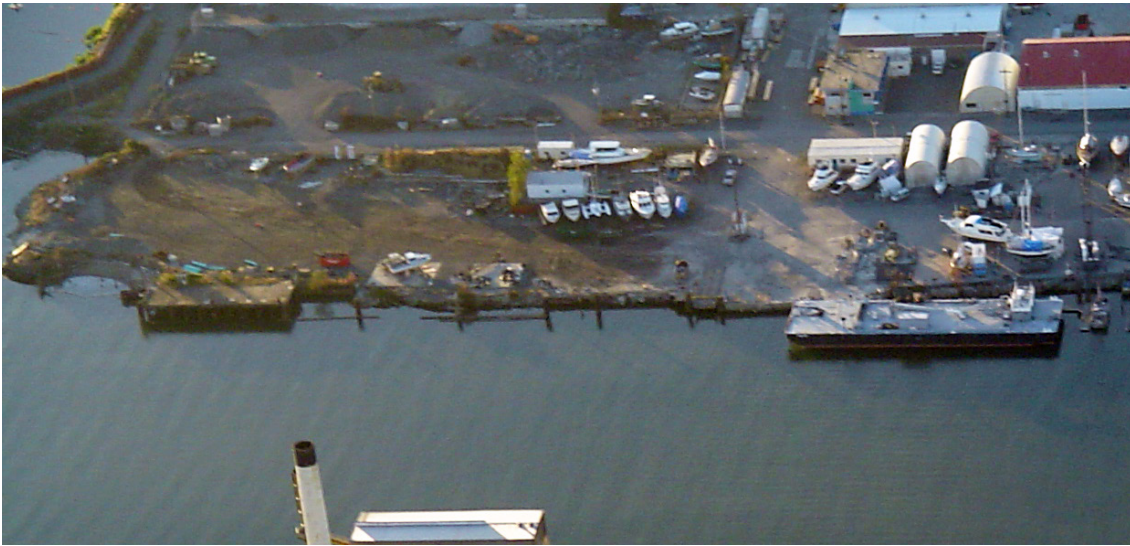
Before Construction: The Central Waterfront shoreline was characterized by unstable shoreline conditions, including extensive infill with concrete and rubble debris, failing concrete and creosote-treated timber bulkheads, and areas of eroding soils. The Chevron pier and dozens of other creosote-treated timber pilings and dolphins were present in shoreline areas. Soil and groundwater source control concerns posed risks for recontamination of sediments.

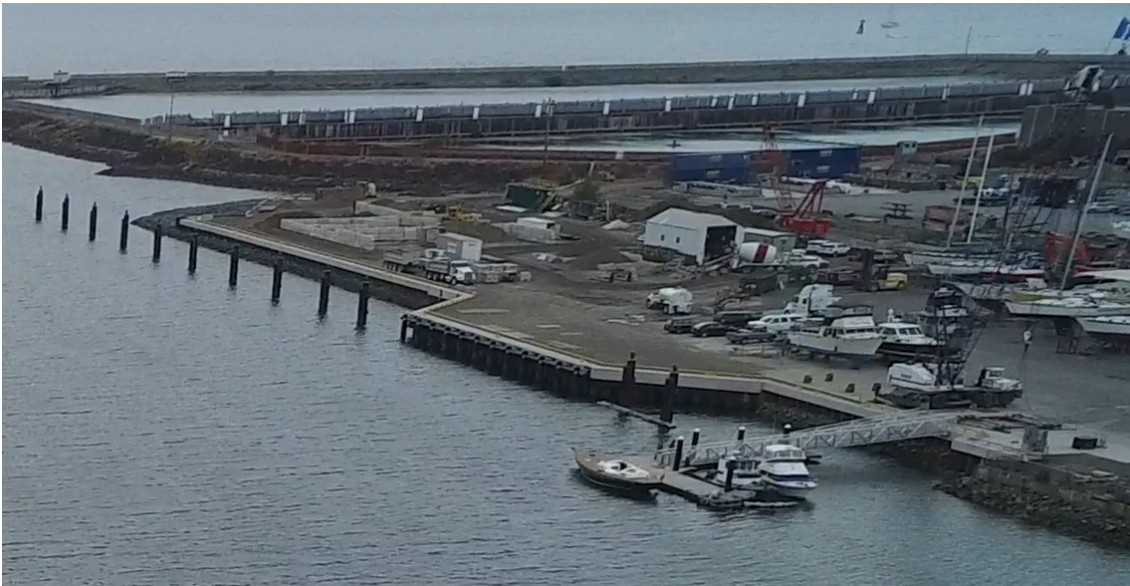
After Construction: Creosote-treated pilings, dolphins, and the former Chevron pier have been removed. Concrete and rubble debris has been removed, and the shoreline has been cut back to provide a stable sloping shoreline with improved aquatic habitat conditions. Soil and groundwater source control concerns have been addressed with the installation of over 700 feet of containment wall, most buried below grade. Pilings and dolphins required for continued operation of marine trades activities have been replaced with structures that serve the same function but are constructed of environmentally friendly materials.

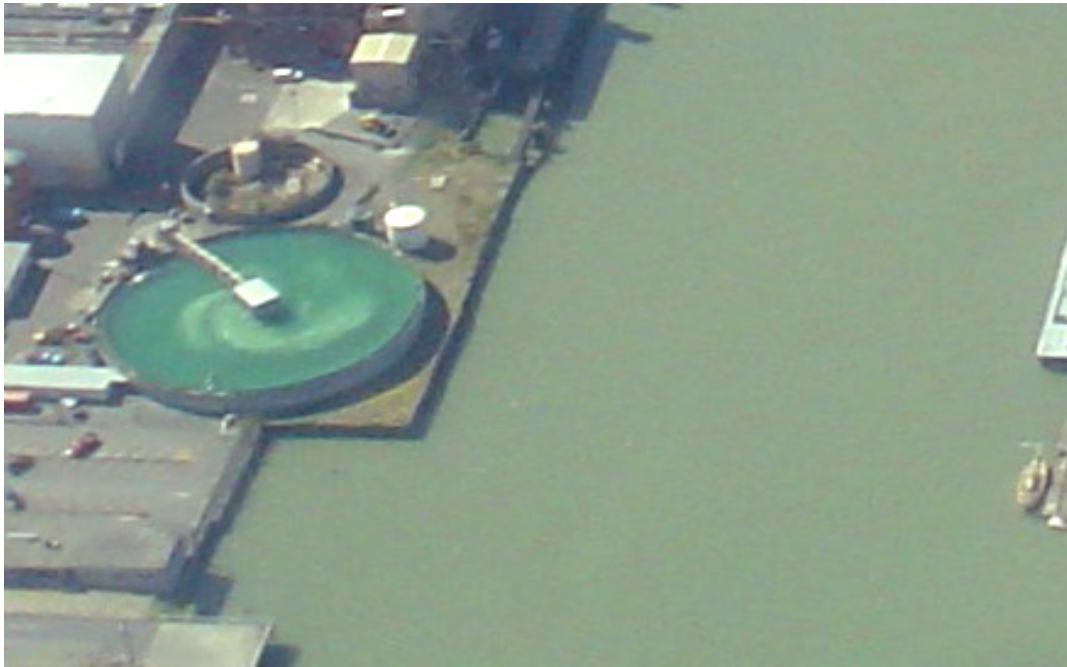
Before Construction: The South Shoreline consisted of a vertical bulkhead and fill area occupied by the abandoned clarifier structure. Numerous creosote-treated timber dolphins and unused structures were present.

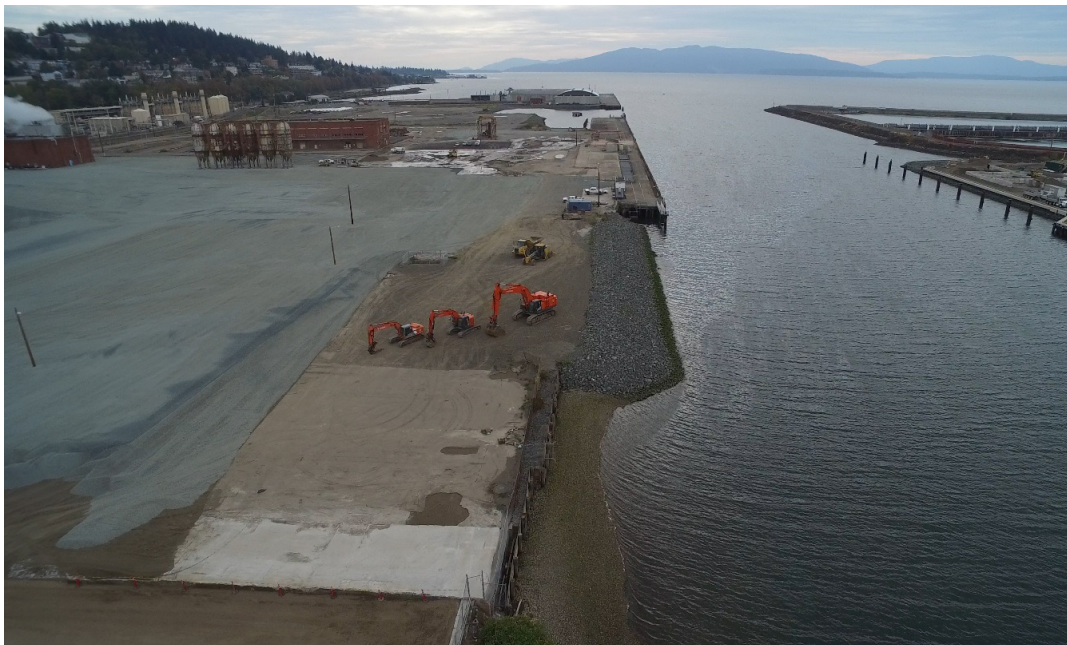
After Construction: Unused in-water structures were removed. The clarifier and associated creosote-treated timber bulkhead were removed. A shoreline cutback was performed to create a gently sloping, stable shoreline. The shoreline and subtidal areas were capped to safely contain residual impacted sediments.

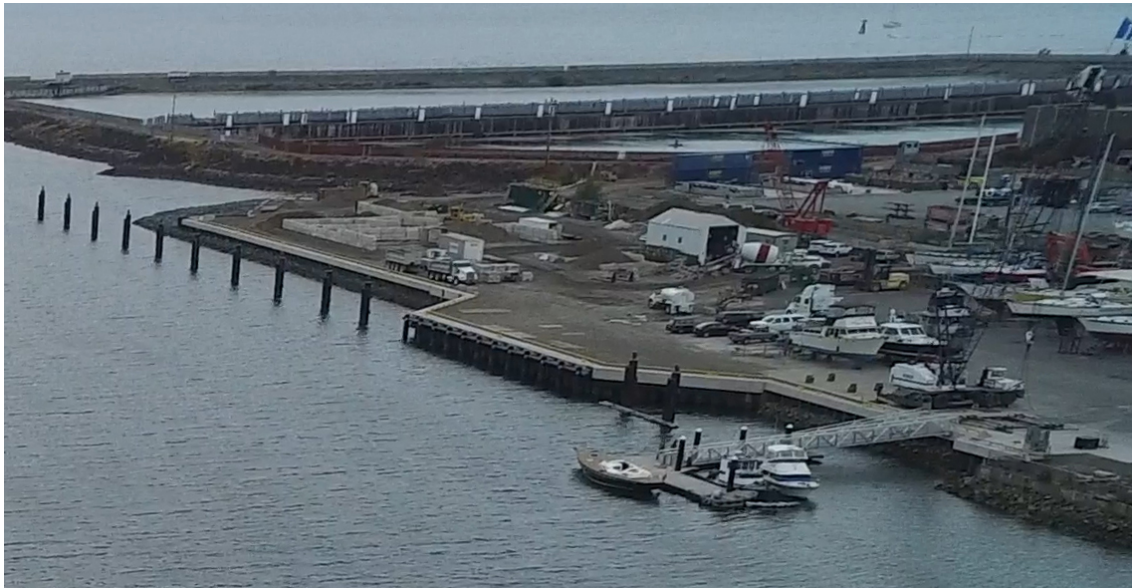
After Construction: Creosote-treated pilings, dolphins, and the former Chevron pier have been removed. Concrete and rubble debris has been removed, and the shoreline has been cut back to provide a stable sloping shoreline with improved aquatic habitat conditions. Soil and groundwater source control concerns have been addressed with the installation of over 700 feet of containment wall, most buried below grade. Pilings and dolphins required for continued operation of marine trades activities have been replaced with structures that serve the same function but are constructed of environmentally friendly materials.

Some of the structures that were removed to facilitate the remediation work required replacement to preserve existing navigation uses. These structures are shown in Figure 4 and Figure 6. Replacement structures served the same function as the removed structures, described as follows:

- Existing piling, dolphins, log booms, and floating piers located along the Central Waterfront Shoreline were removed to enable completion of shoreline stabilization, dredging, and capping. In this area, 12 dolphins, 5 replacement individual piles, and a float system were replaced.
- Along the South Shoreline, a number of structures and dolphins were removed to implement site cleanup (as detailed in Section 3.2.1). A single dolphin and associated catwalk were replaced.
- As discussed in Section 3.2.2, the existing barge ramp landward of the containment wall on the Central Waterfront Site was removed and filled in with clean soil backfill.

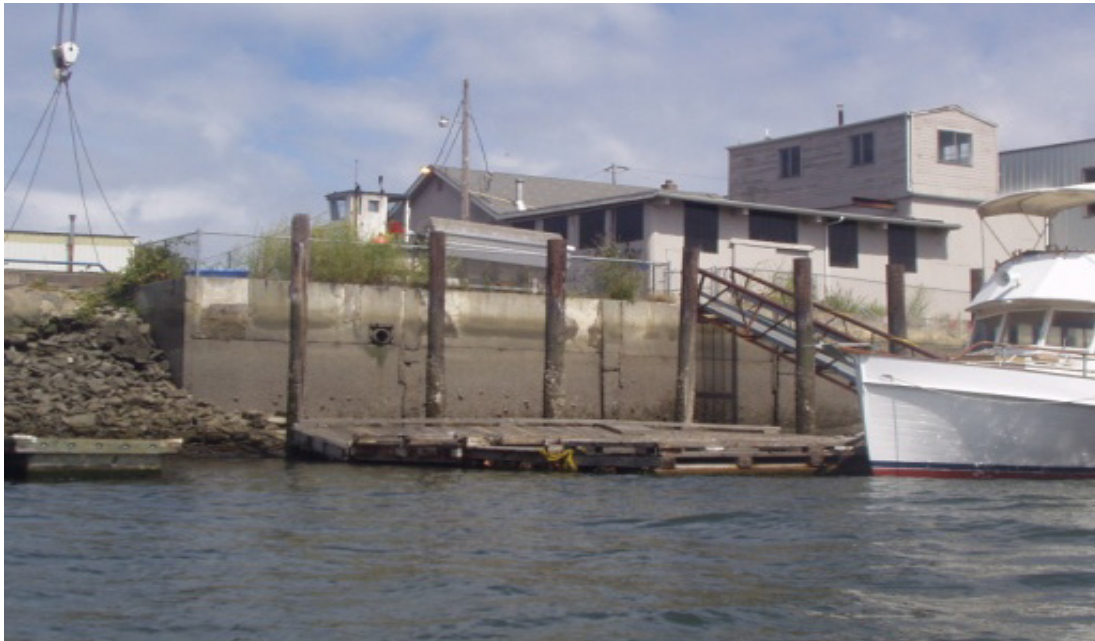
Before Construction: The shoreline was unstable with a damaged concrete bulkhead. Creosote-treated pilings and unauthorized floats were present in the offshore area.

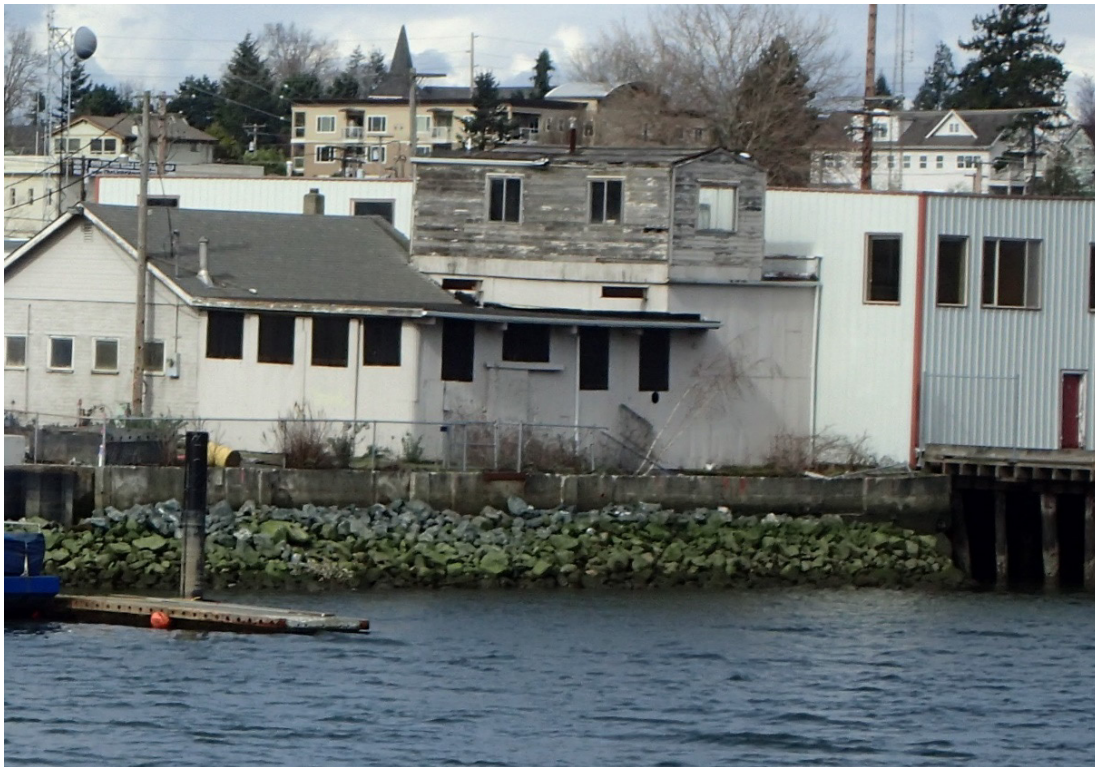
After Construction: The creosote-treated pilings and unauthorized floats were removed. The exposed bulkhead was eliminated and the shoreline was stabilized with a sloping engineered cap.

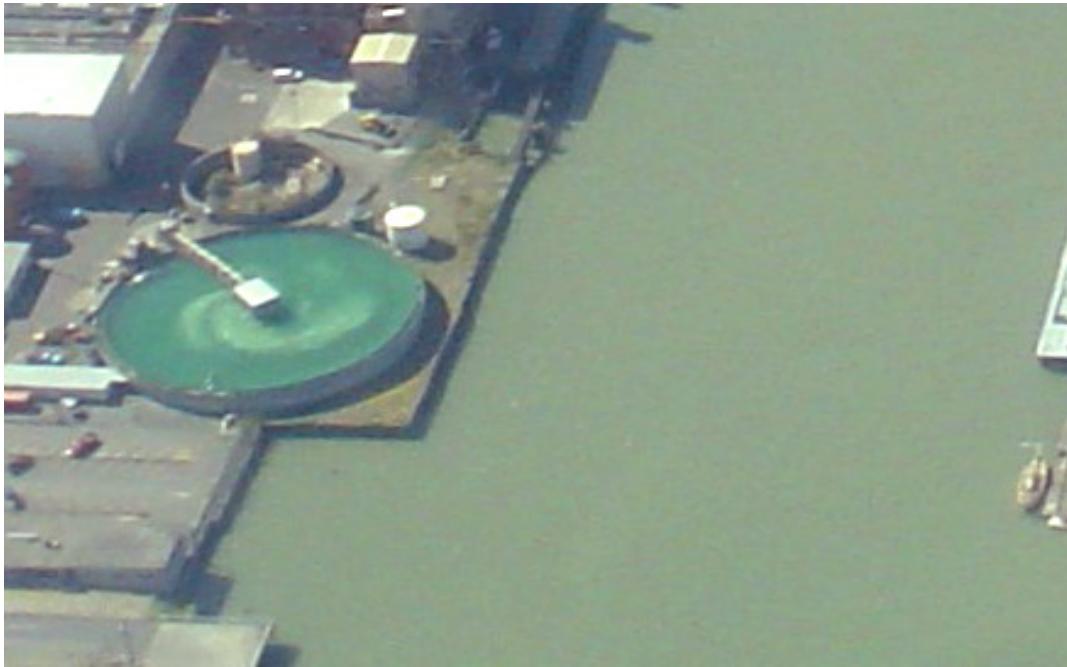
Before Construction: The South Shoreline consisted of a vertical bulkhead and fill area occupied by the abandoned clarifier structure. Numerous creosote-treated timber dolphins and unused structures were present.

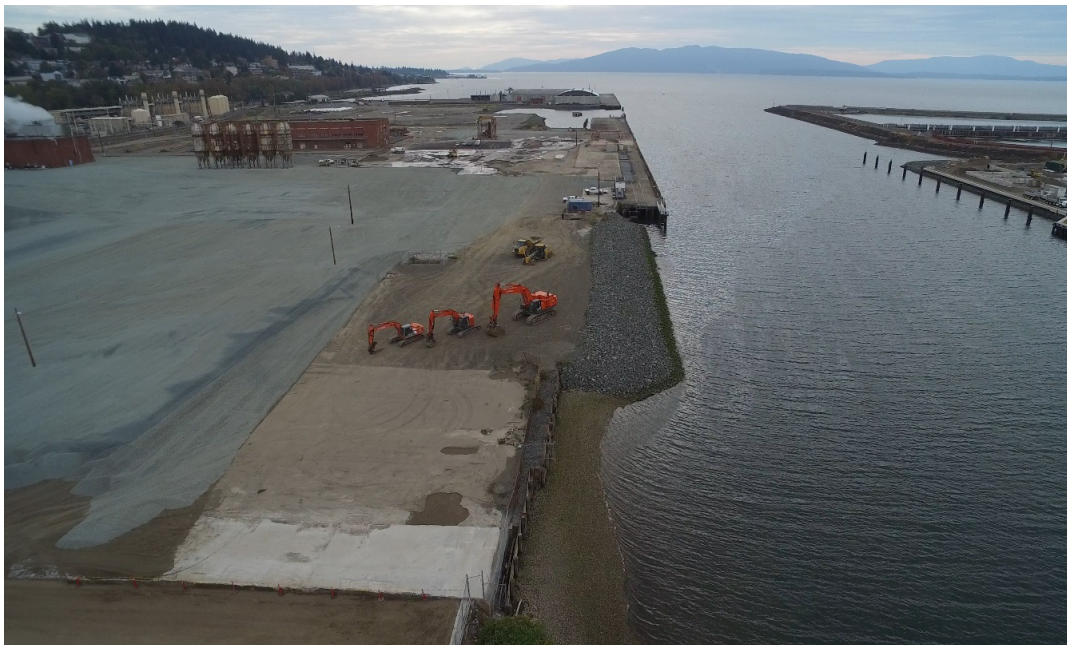
After Construction: Unused in-water structures were removed. The clarifier and associated creosote-treated timber bulkhead were removed. A shoreline cutback was performed to create a gently sloping, stable shoreline. The shoreline and subtidal areas were capped to safely contain residual impacted sediments.

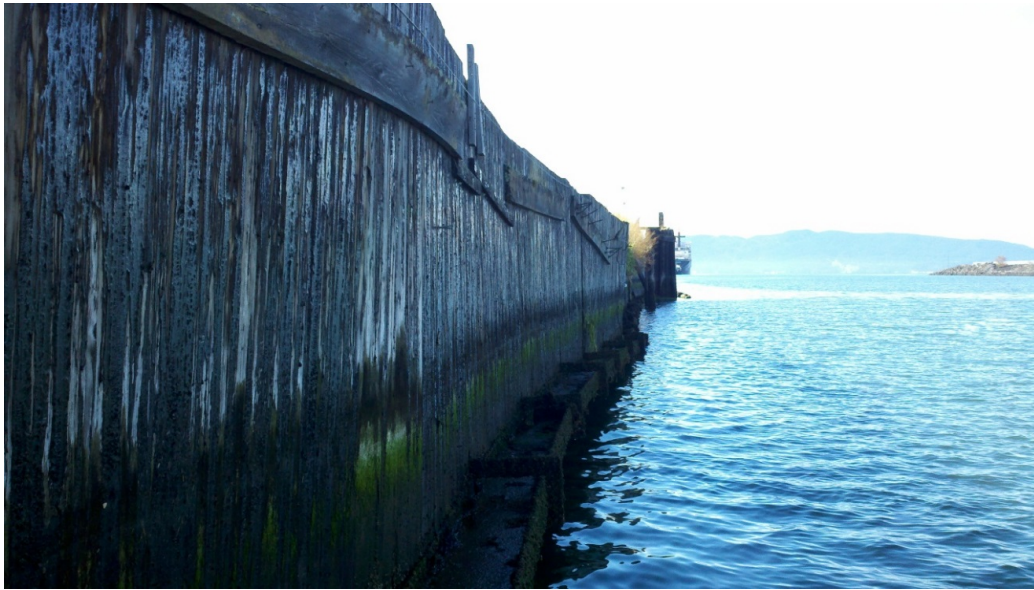
Before Construction: Most of the South Shoreline area consisted of a vertical creosote-treated timber bulkhead supporting an area of fill and the abandoned concrete clarifier structure.

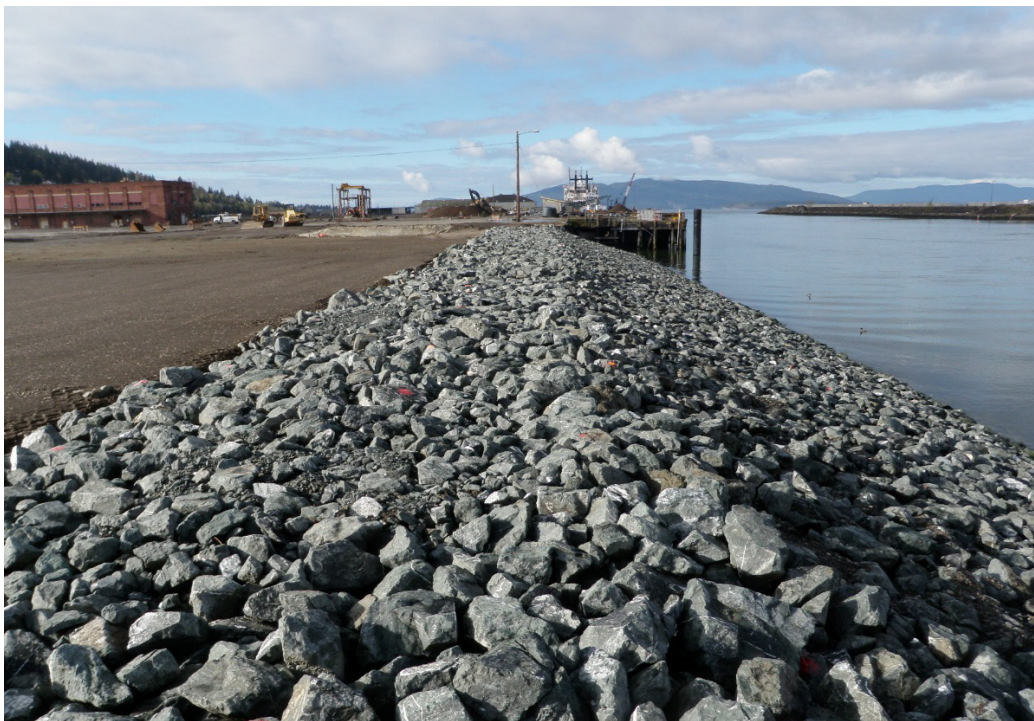
After Construction: The bulkhead in the South Shoreline area was removed along with the clarifier and other structures. The slope was cut back to provide a stable, sloping shoreline and enhance habitat quality and quantity in this area.

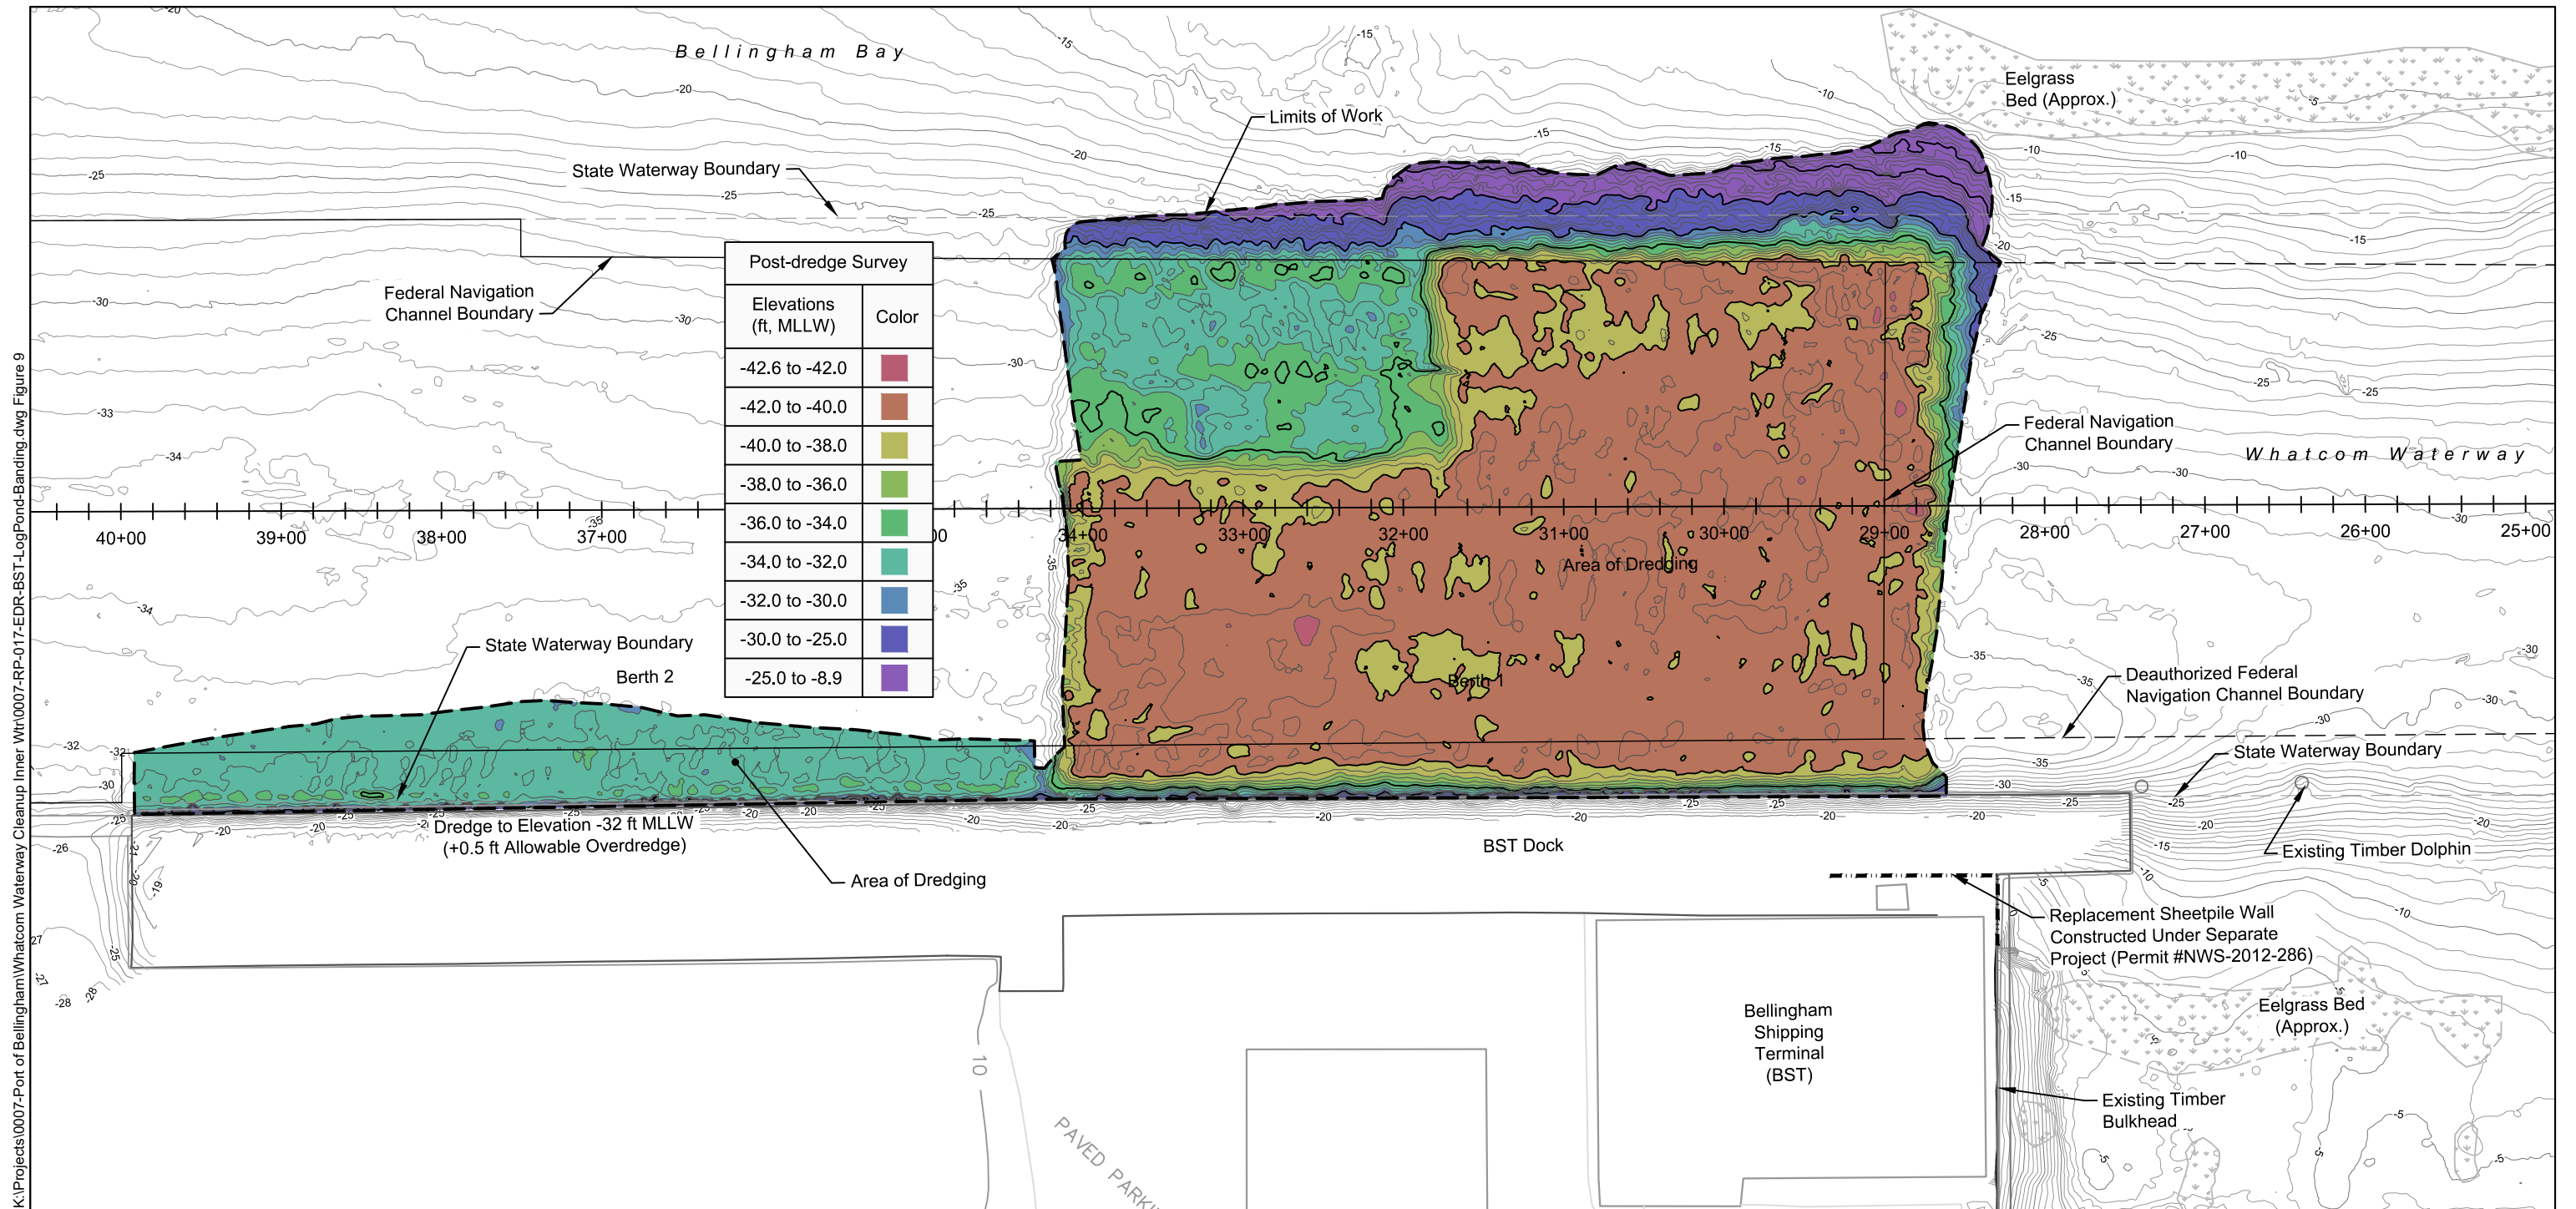
K:\Projects\0007-Port of Bellingham\Whatcom Waterway Cleanup Inner Wtr\0007-RP-017-EDR-BST-LogPond-Banding.dwg Figure 9

Figure 9
 Inner Waterway Elevations Following Cap Placement
 As-built Report
 Whatcom Waterway Cleanup in Phase 1 Site Area

SOURCE: Bathymetric survey from 2016 provided by Northwest Hydro, Inc.
HORIZONTAL DATUM: Washington State Plane North, NAD83, Ft.
VERTICAL DATUM: Mean Lower Low Water (MLLW), Ft.

Dredging in the Inner Waterway was followed by placement of an engineered cap to contain remaining impacted sediments. Engineered cap placement occurred along the Central Waterfront Shoreline, the South Shoreline, and throughout the open-water areas in the Inner Waterway using four different cap types. Each cap type was designed for a specific set of site conditions and uses. The caps included varying thicknesses of sand, filter, and armor rock layers to isolate contamination and provide erosion protection. Details of each cap type (including cap composition, placement thicknesses and tolerances, and placement slopes) are documented in the Record Drawings (Appendix C). Overall, engineered caps were placed over 449,231 sf of area in the Inner Waterway. The extents and final elevations of the engineered cap are illustrated on Figure 9.

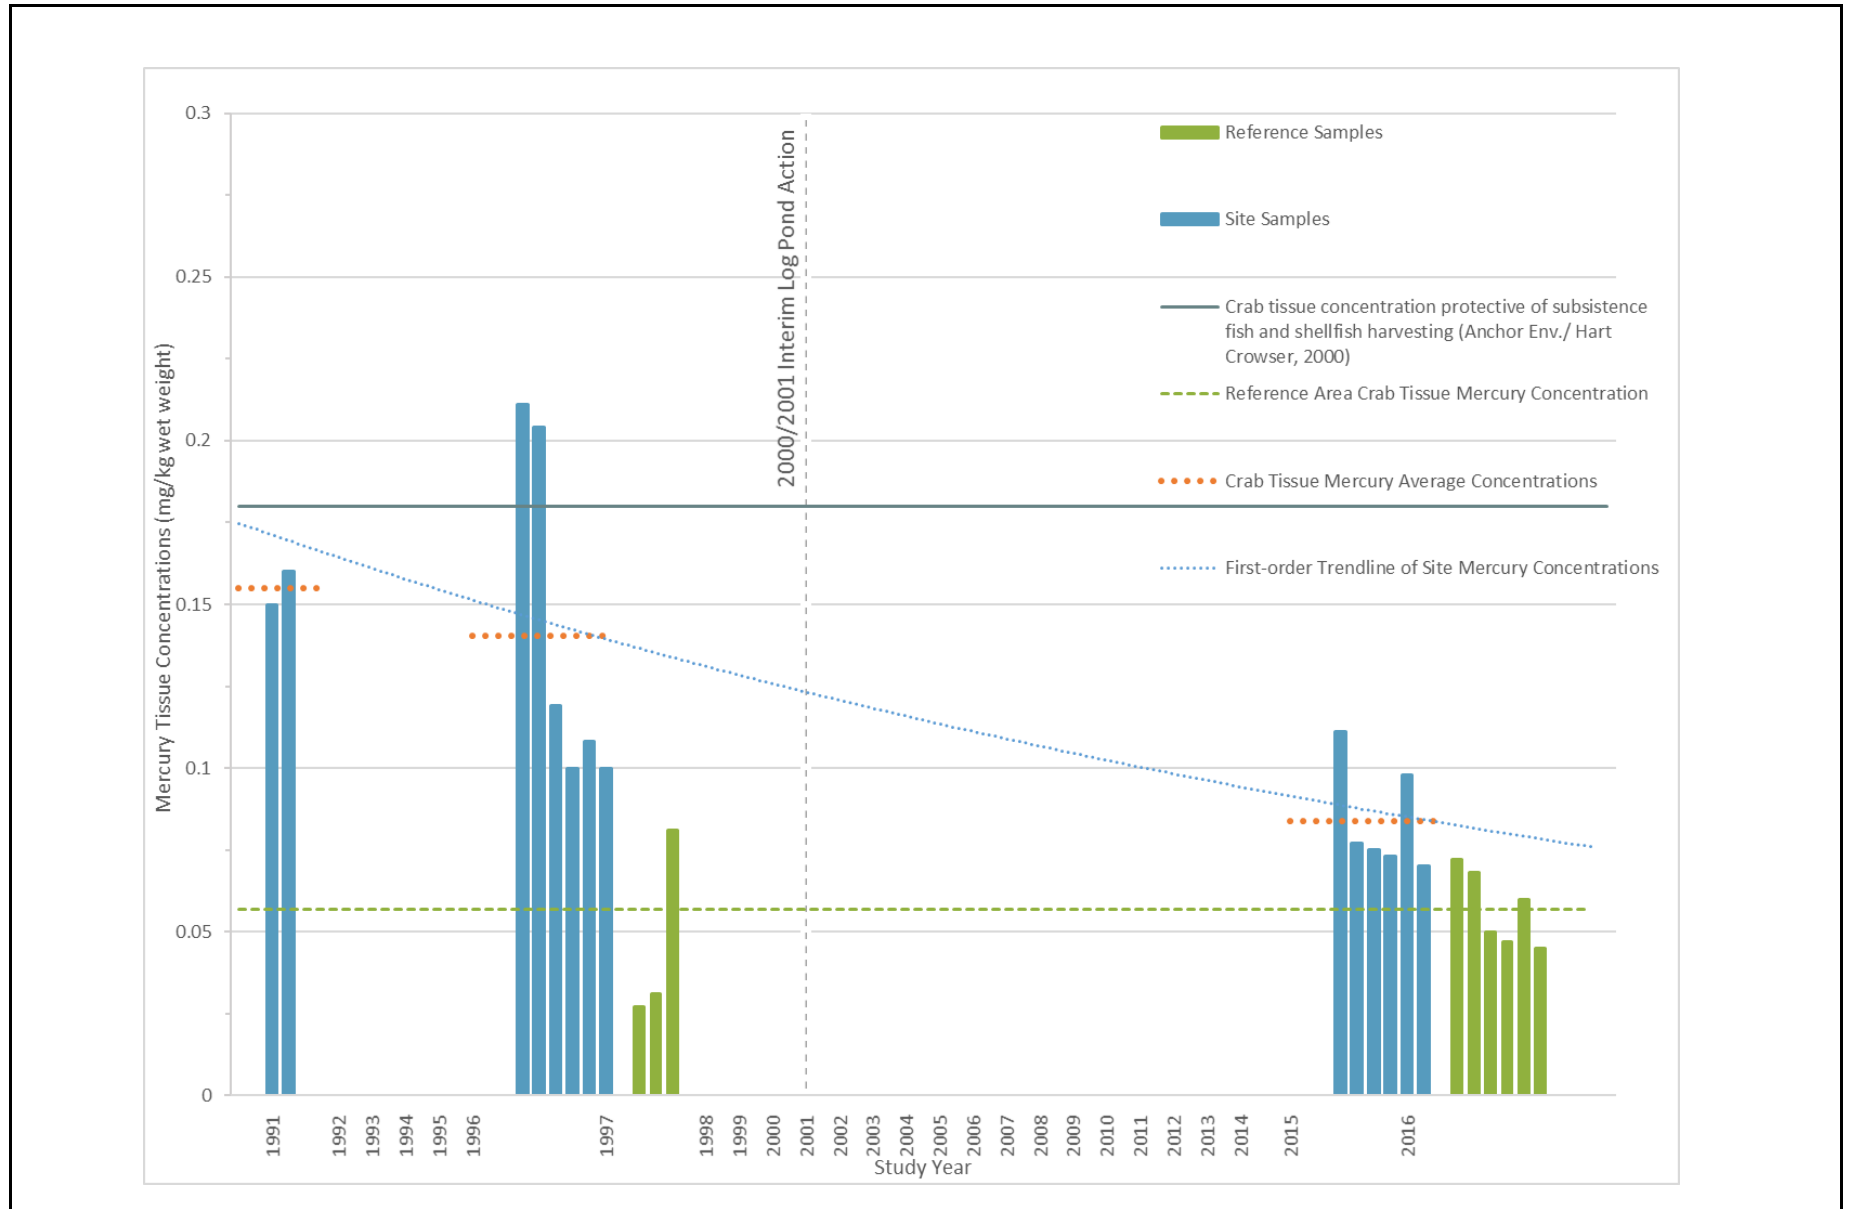
Figure 15
 Mercury Concentrations in Adult Dungeness Crab Tissue
 As-Built Report
 Whatcom Waterway Cleanup in Phase 1 Site Areas

- Performance monitoring included sediment and tissue testing, and documented that construction activities met Ecology requirements as defined in the EDR. Sediment was tested following dredging and placement of the residuals cover. This testing demonstrated that dredging and residuals management activities were effective at meeting Project requirements. Tissue testing was also performed to evaluate whether sediment disturbance during construction resulted in increases in mercury levels in the food chain. Results of that testing did not show any significant impacts to the food chain.
