GEOTECHNICAL MONITORING DATA AND OBSERVATIONS AS-BUILT REPORT FOR THE WHATCOM WATERWAY CLEANUP IN PHASE 1 SITE AREAS

Port of Bellingham

Anchor QEA, LLC

September 2018

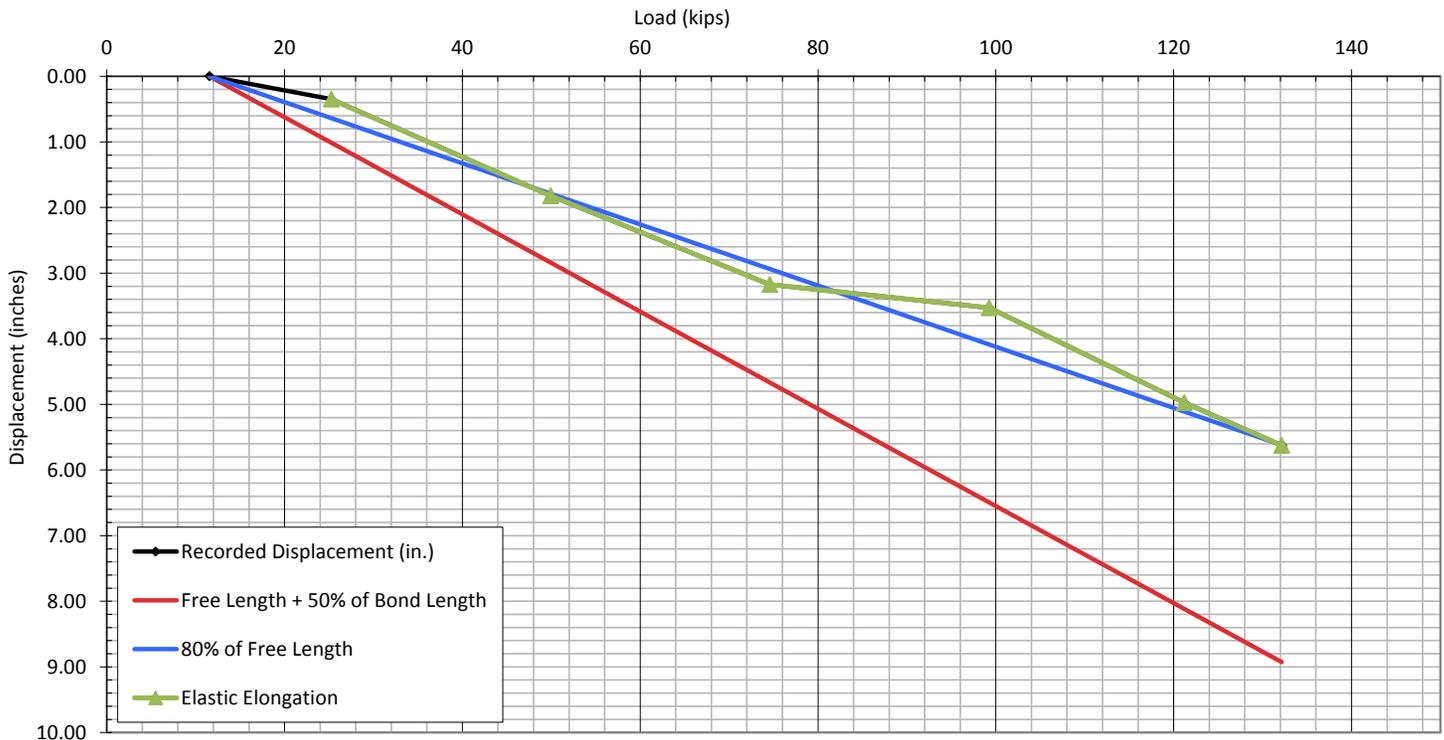
Ram I.D. 2681
Gauge I.D. 16-3

Note: False displacements occurred due to high winds that caused movements of the dial on the testing plate particularly for the 1.33DL hold times.

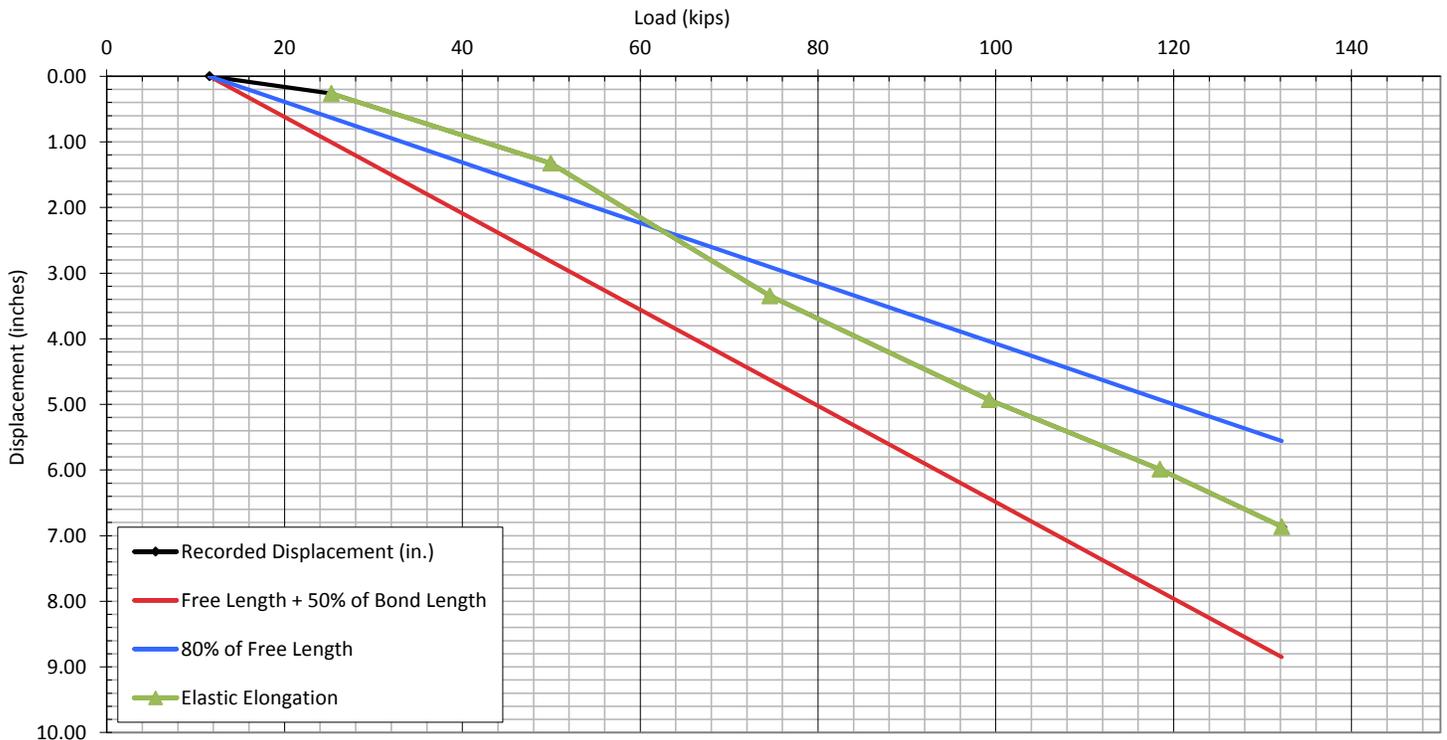
Ram I.D. 2681
Gauge I.D. 16-3

Note: False displacements occurred due to high winds that caused movements of the dial on the testing plate particularly for the 1.33DL hold times.

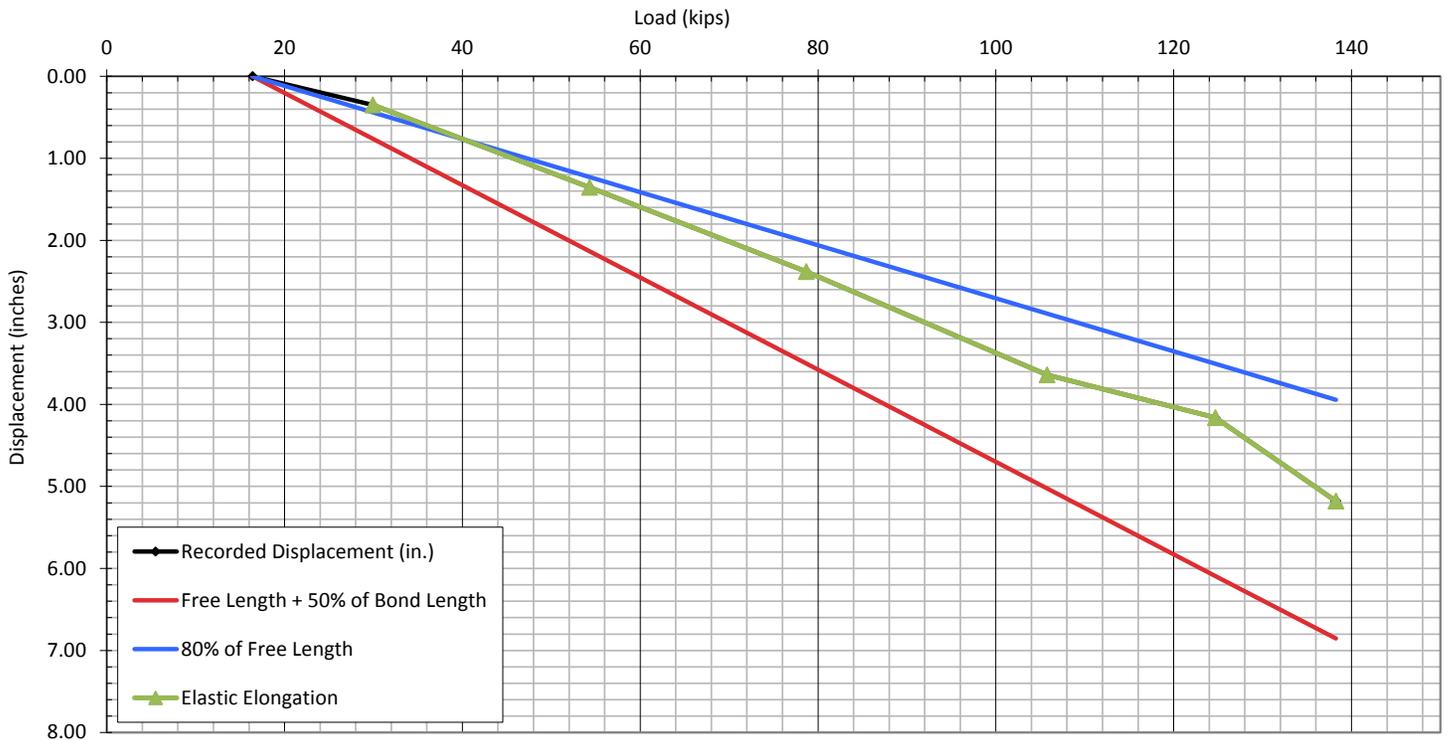
Ram I.D. 141120
Gauge I.D. 12-1

Note: False displacements occurred due to high winds that caused movements of the dial on the testing plate particularly for the 1.33DL hold times.

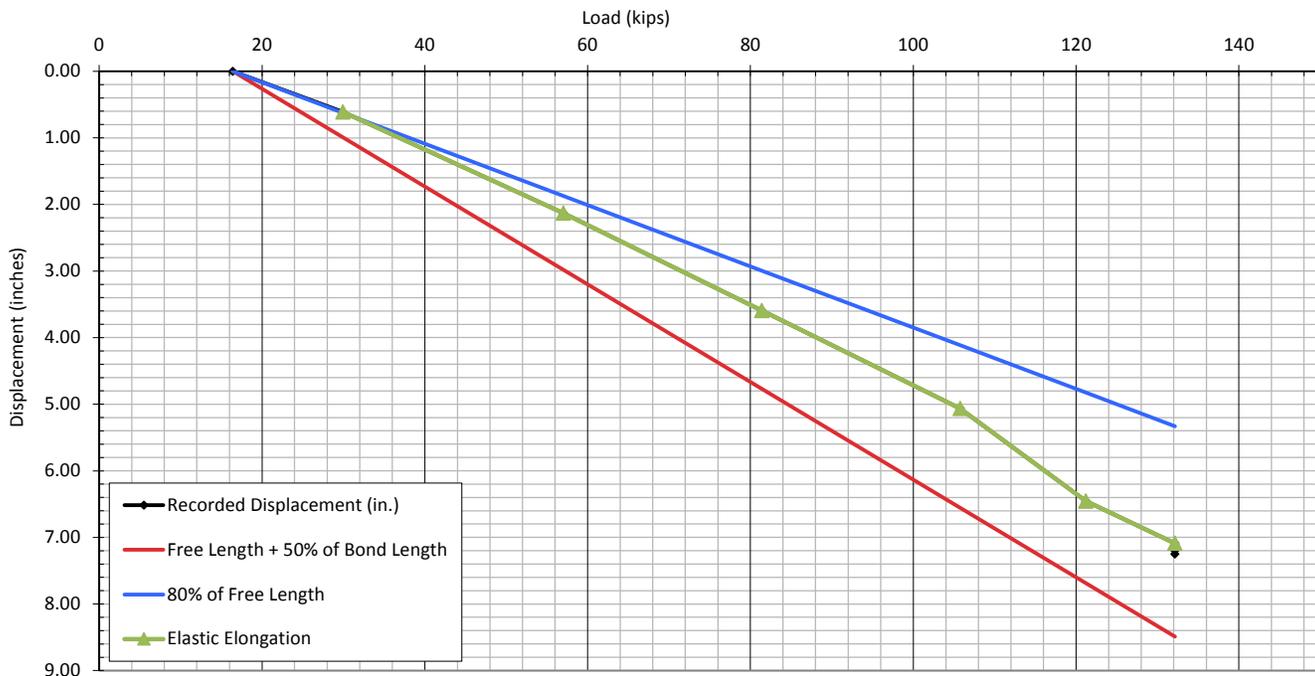
Ram I.D. 2681
Gauge I.D. 16-3

Note: Test results are added to values from sheet 39. False displacements occurred due to high winds that caused movements of the dial on the testing plate.

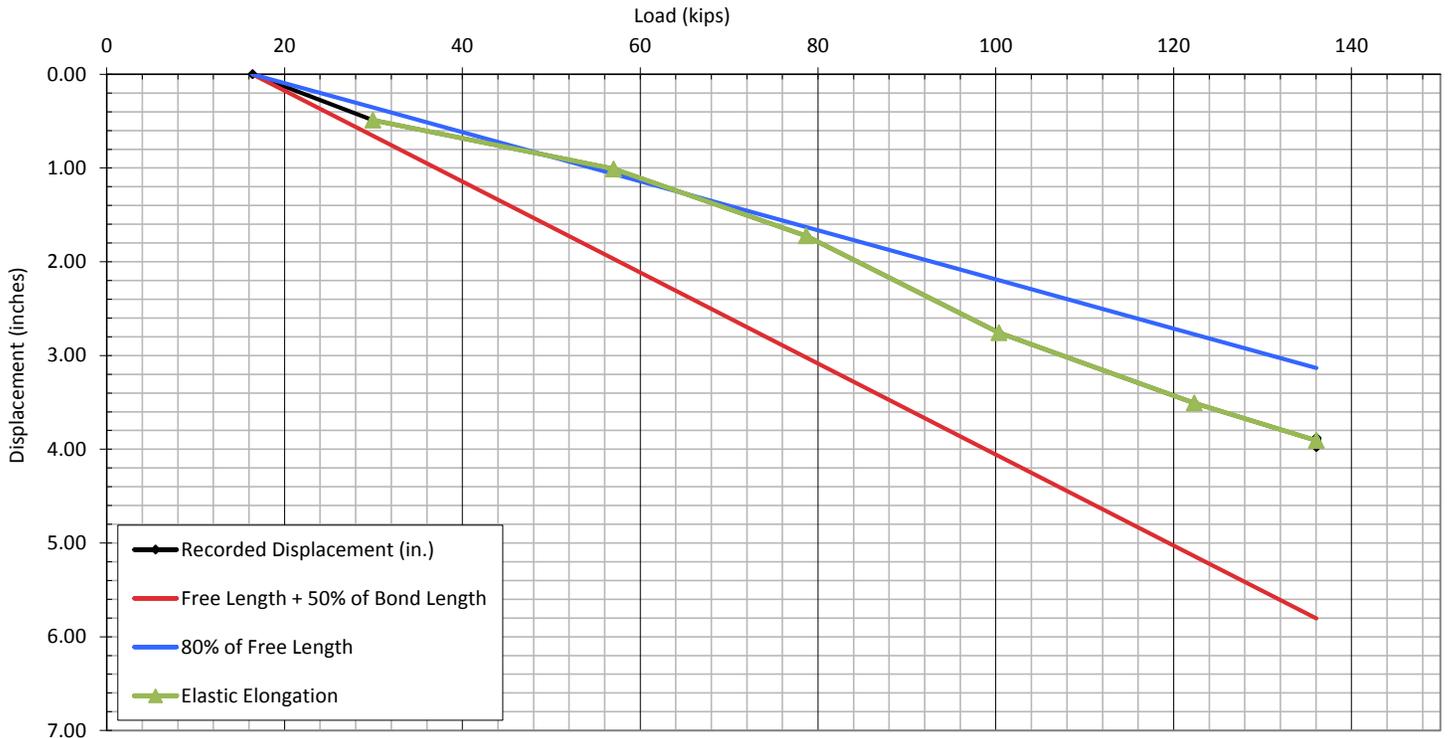
Ram I.D. 141120 for AL to 1.00DL; 141121 thereafter
Gauge I.D. 12-1; 12-4

Note: Jack was unable to hold pressure during 1.33DL holds. Malcolm changed out the jack after testing of this tieback.

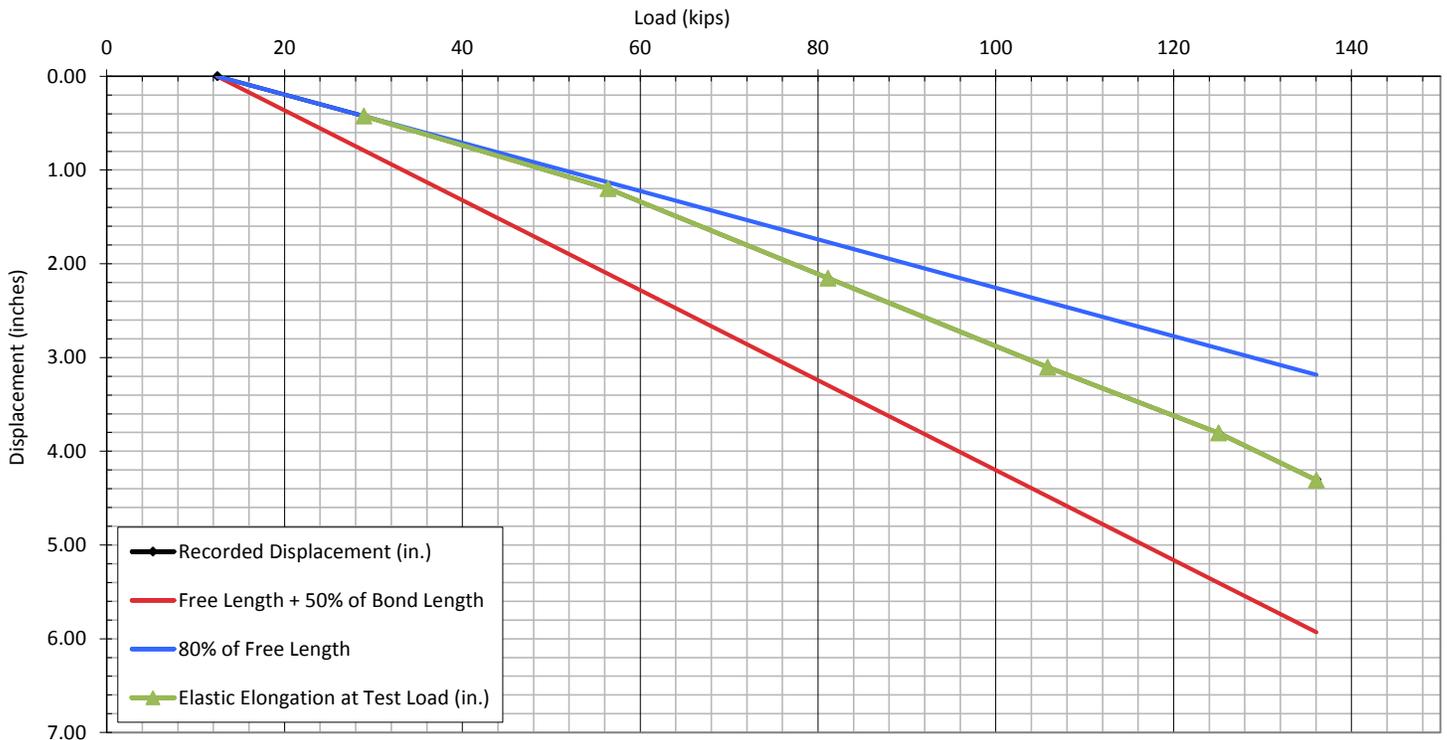
Ram I.D. 141121
Gauge I.D. 12-4

Note: At 1.20DL, insufficient throw of the dial remained therefore the dial was reset to 0 @ 1.20DL and displacement differentials were added

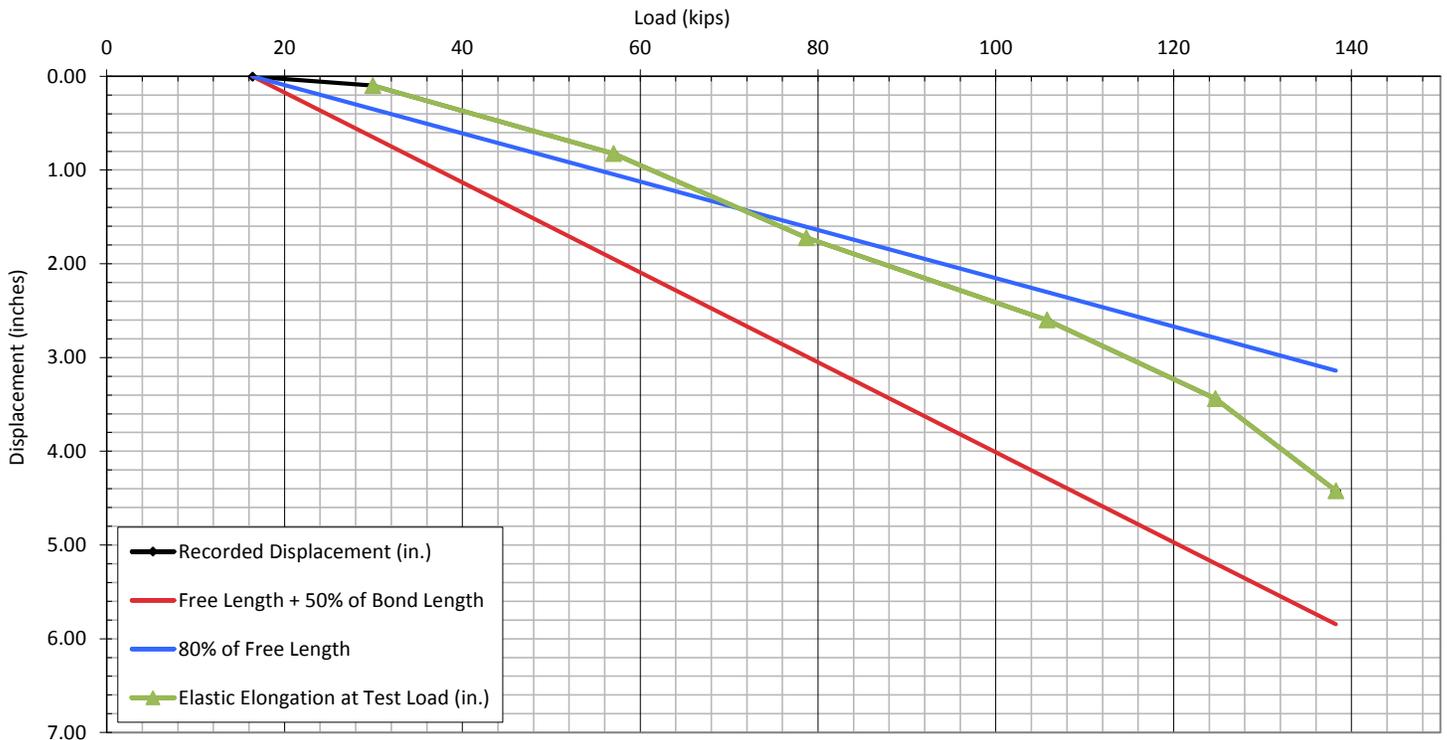
Ram I.D. 141120
Gauge I.D. 12-1

Note: At 1.20DL, insufficient throw of the dial remained therefore the dial was reset to 0 @ 1.20DL and displacement differentials were added

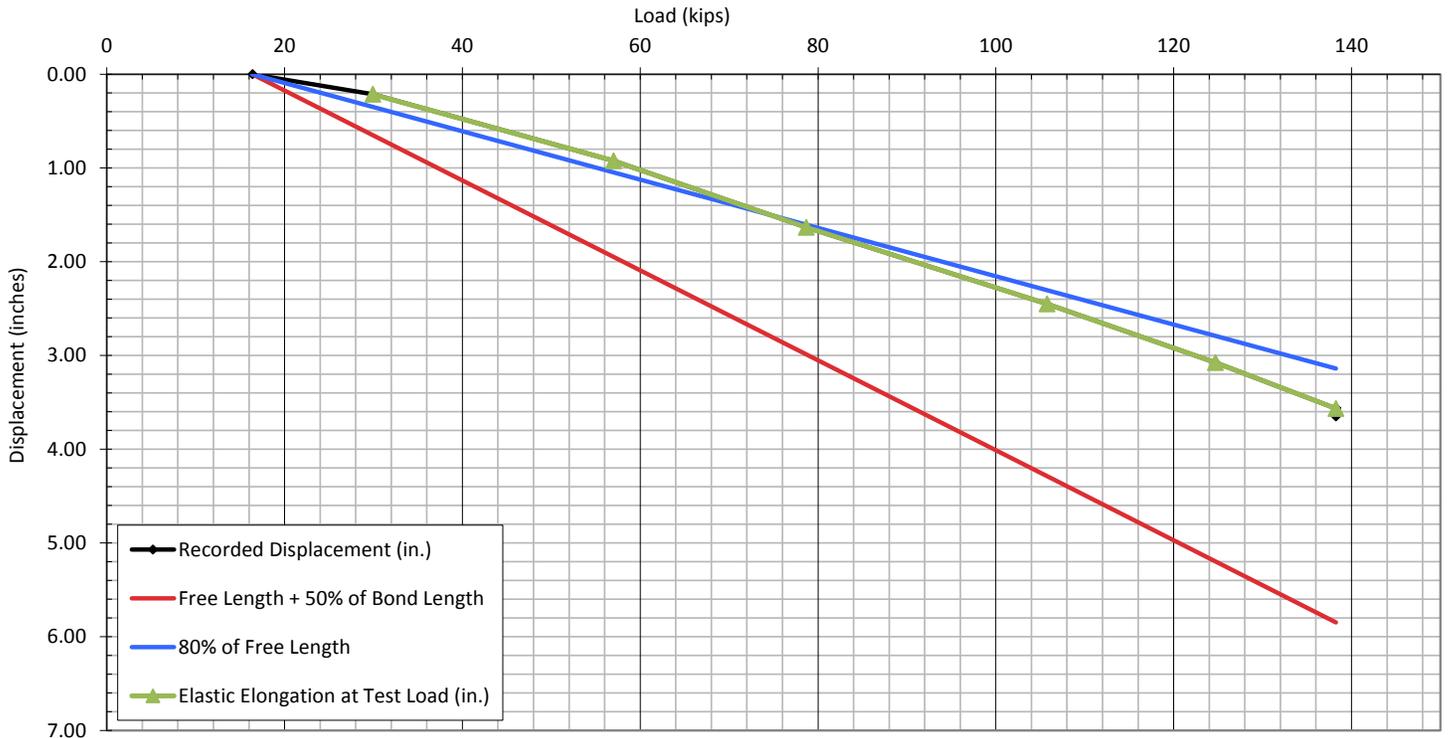
Ram I.D. 141120
Gauge I.D. 12-1

Note: At 1.20DL, insufficient throw of the dial remained therefore the dial was reset to 0 @ 1.20DL and displacement differentials were added

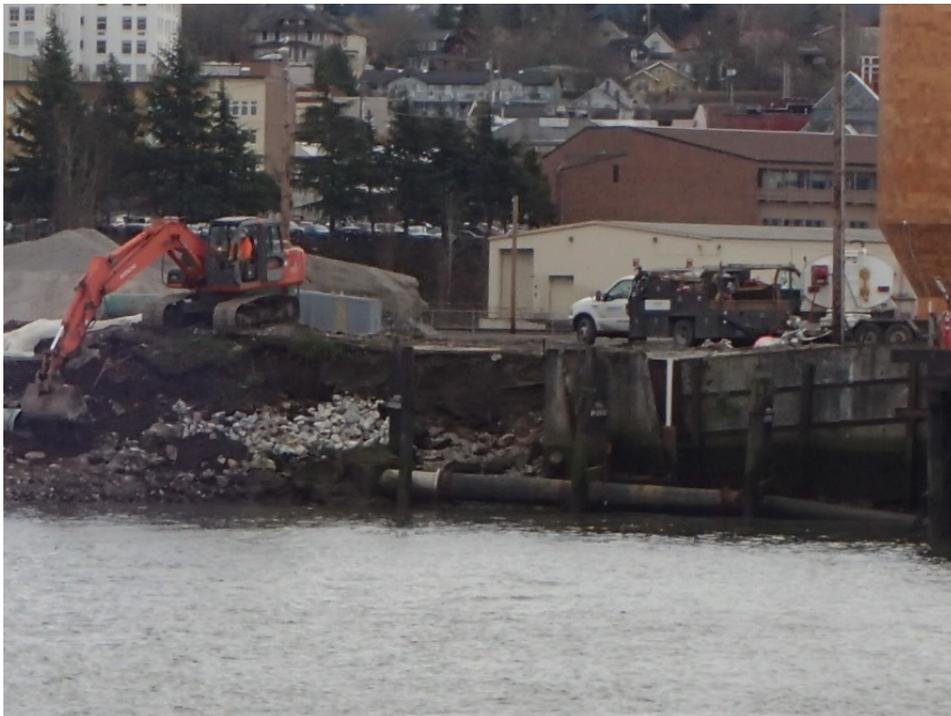
Photograph 12: Foam tank area stormwater conveyance replacement. Facing east.

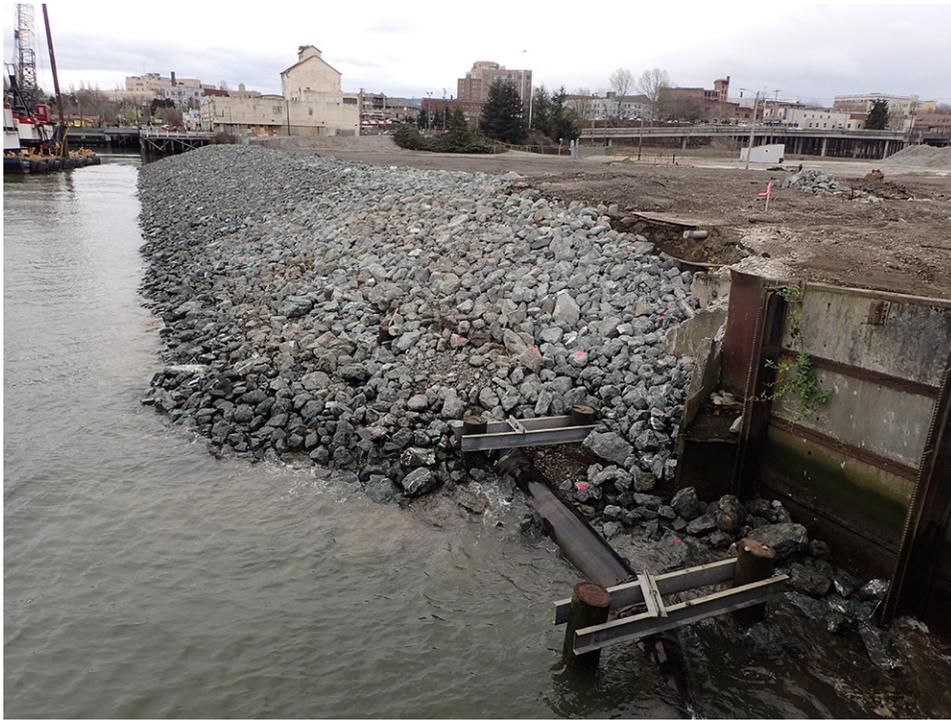
**Photograph 13: Foam tank area during capping.
Facing east.**
