**PHASE I ENVIRONMENTAL SITE ASSESSMENT  
JENSEN'S SHIPYARD  
1293 TURN POINT ROAD  
FRIDAY HARBOR, WASHINGTON**

**November 21, 2017**

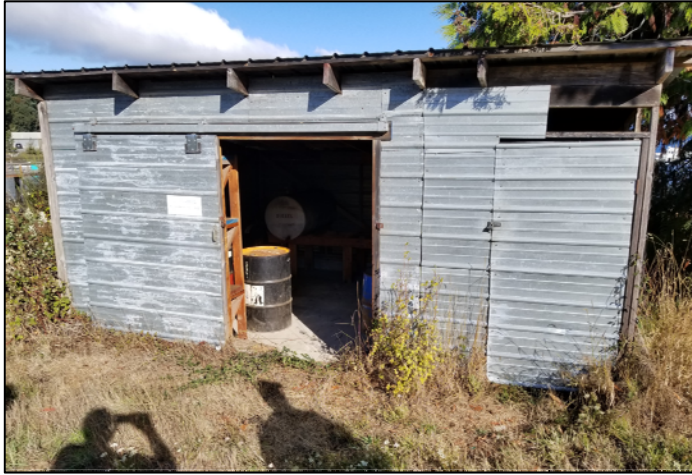
**Photo 1.** A view looking east at the oil storage building located at the northeast corner of the upland portion of the property.

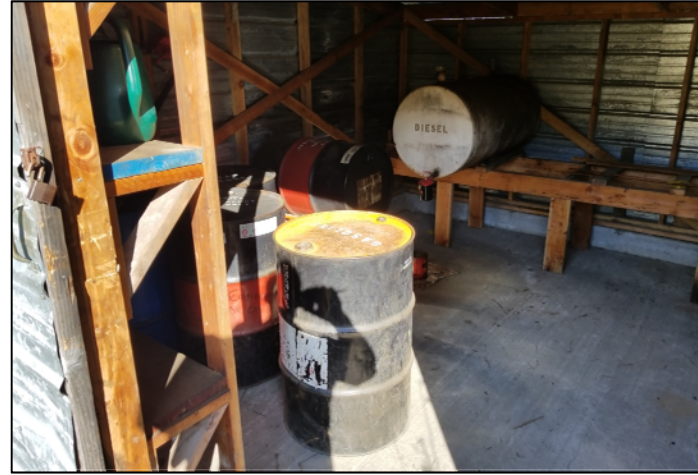
**Photo 2.** A view of the diesel, gasoline, and oil storage in the northern portion of the oil storage building.

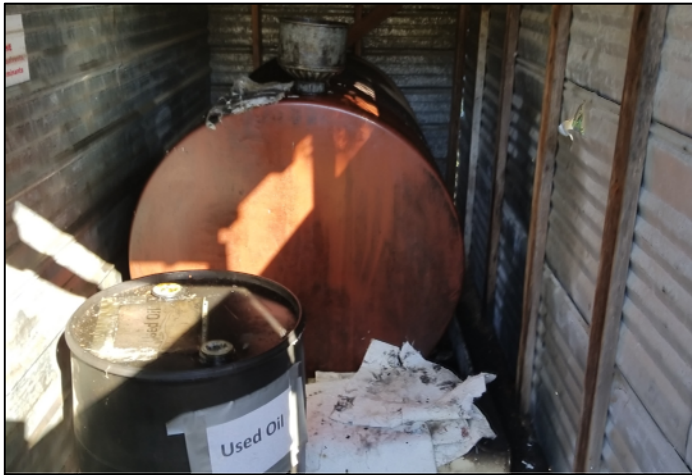
Approximately 45 feet west of the abandoned cabin is a small storage building. The building is used for the storage of fuel and oil. One waste oil AST is located inside the building, along with several smaller diesel, gasoline, and waste oil drums. No evidence of spills or overtopping were noted in or around the building. Concrete flooring is used throughout the building for containment in the event of a spill. The owner reported that a small dump area was located north of the oil storage building. Whatcom Environmental observed the dump area and noted such items as tires, plastic, metal parts, two engine blocks, hoses, cables, a large battery (from a boat or heavy equipment), and other metal and wood debris. No sheen or staining was noted in the area of the debris. The large battery was damaged, and presents a risk for release of hazardous chemicals to the area.

**Photo 3.** A view of a used/waste oil drum and AST in the southern portion of the oil storage building.

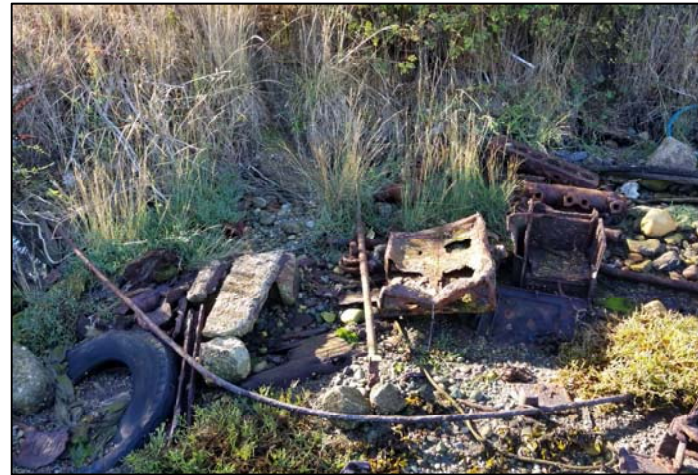
- A small dump site was identified north of the oil storage building. There is a potential that hazardous substances may have been released in the area of the dump.
- A floor drain was identified at the northwest corner of the machine shop building. Hazardous substances used in the machine shop may have made their way to the floor drain in the past, and may have infiltrated into the ground beneath the machine shop depending on the setup/terminus of the floor drain.
- The laydown area, marine railways, and stormwater detention pond are all potential areas of concern for tributyltins and other heavy metals in soil/sediments due to their use for maintenance/repair of boats. Depending on the current and historic use of the site, additional hazardous chemicals may be of concern for these areas including solvents and petroleum products.

**Photo 4.** A view of a portion of the dumping area located north of the oil storage building.

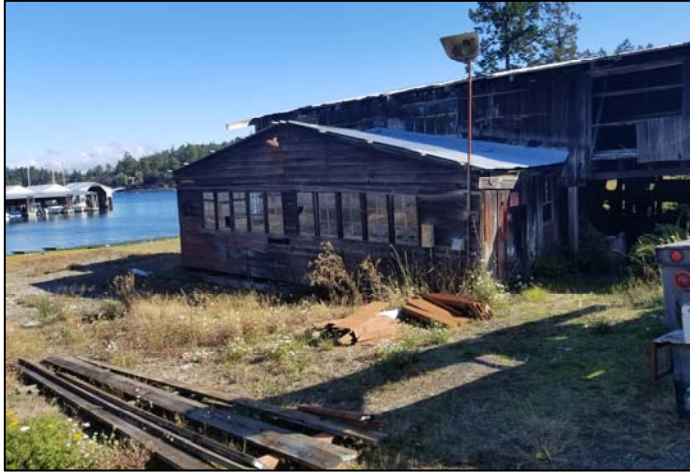
A portion of the original structure used in building the wooden boats is located at the northern portion of the site, south of the railway. The condition of the building made it unsafe to enter, but the perimeter of the building was explored. There was no evidence of dumping, tanks, or other environmental concerns around the building.

**Photo 5.** A view looking north at the old boat building structure. The building's condition made it unsafe to enter.

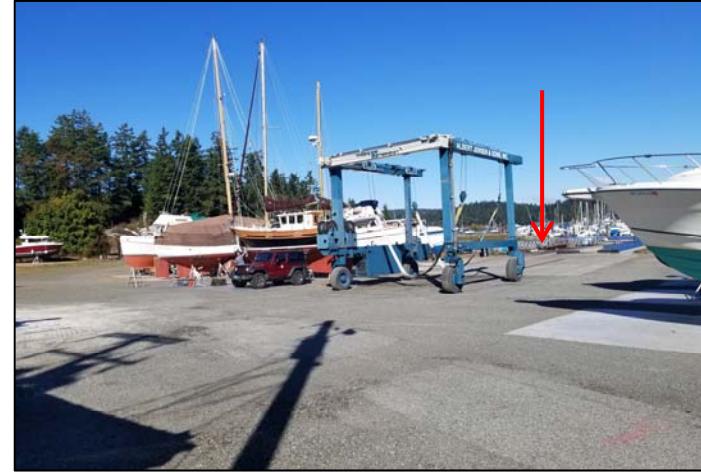
**Photo 6.** A view of the boat pull out and wash pad (indicated by arrow), as well as portions of the laydown area.

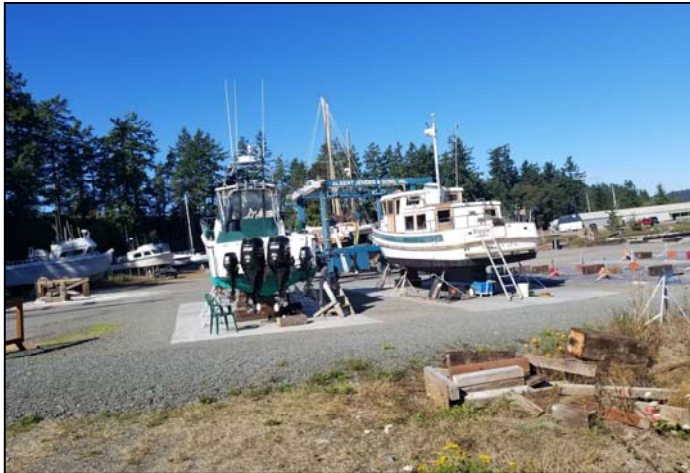
The laydown area for boat repair and maintenance is located in the northwest portion of the property. Current practices at the site include laying an impermeable membrane or tarp down prior to conducting repair or maintenance work. At the completion of the work the paint or other materials are removed from the tarp. The tarps help prevent paint or other materials from reaching the soil. Practices of the past did not include this safeguard, and resulted in unknown amounts of paint or other materials released to the soil in the laydown area.

**Photo 7.** A view of a portion of the laydown area with tarps shown. The boat pull out is visible behind the boats.

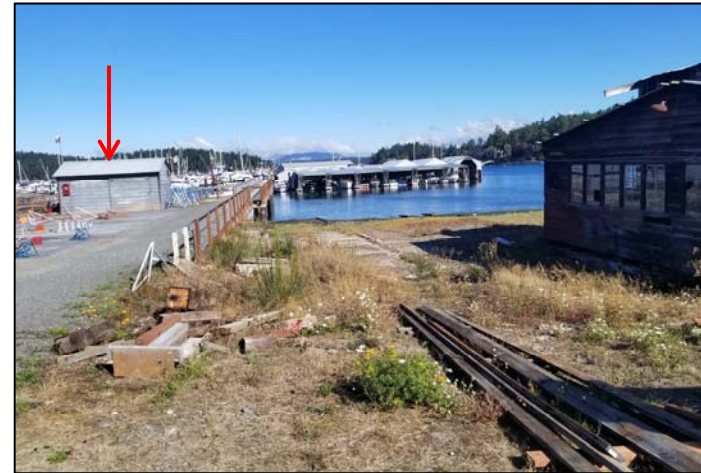
The last area explored during the site visit was the docks. No environmental concerns were noted on or around the docks.

**Photo 8.** A view looking north along the dock. The wash water treatment building is visible in the distance (indicated by arrow).

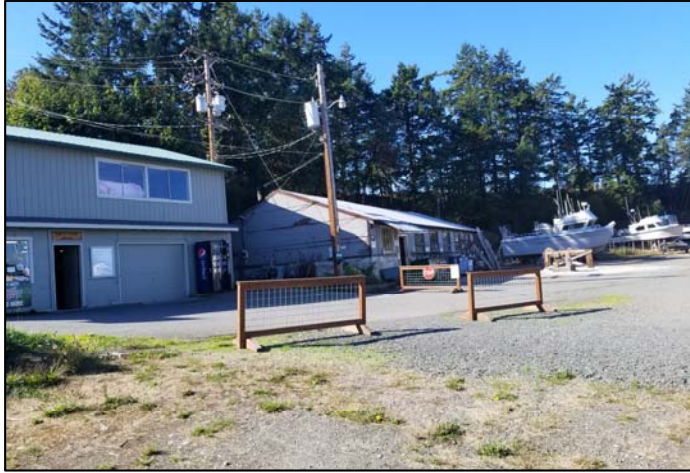
**Photo 9.** A view looking south at the office/retail building and machine shop building.

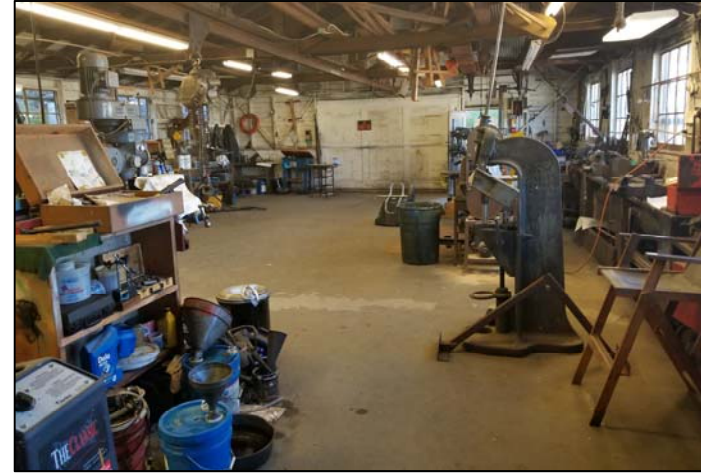
Minor amounts of hazardous chemicals are stored on-site inside the machine shop and oil storage buildings. There was no evidence of significant spills noted during the site visit. There was no evidence of any stressed vegetation at the site.

**Photo 10.** A view looking into the machine shop building. Several chemical containers were observed in the building.

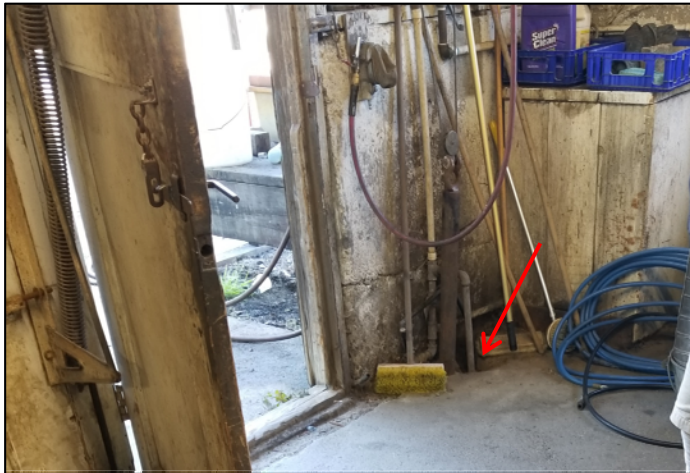
**Photo 11.** A view of the drain hole located at the northwest corner of the machine shop (indicated by arrow).

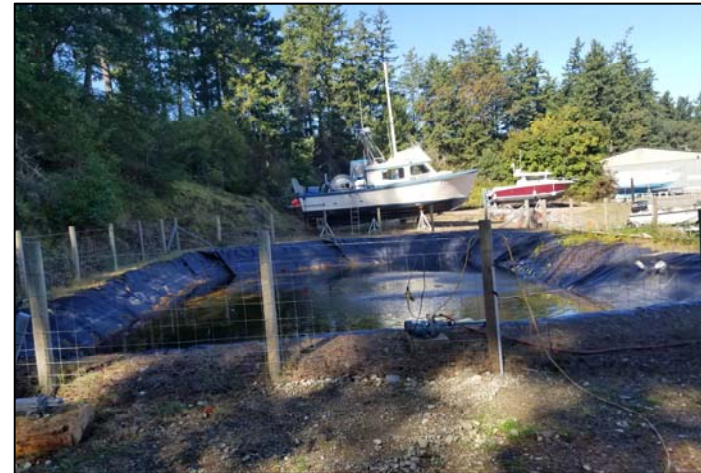
The stormwater detention pond is located in the southwest portion of the property, west of the machine shop. The pond is equipped with a pump and fountain to facilitate evaporation. The owner stated that the pond is emptied of water annually. When emptied, the water is transported offsite and dumped on the ground and allowed to infiltrate. Ordinarily, the water is dumped on the property to the south, across Turn Point Road.

**Photo 12.** A view looking west across the stormwater detention and evaporation pond.

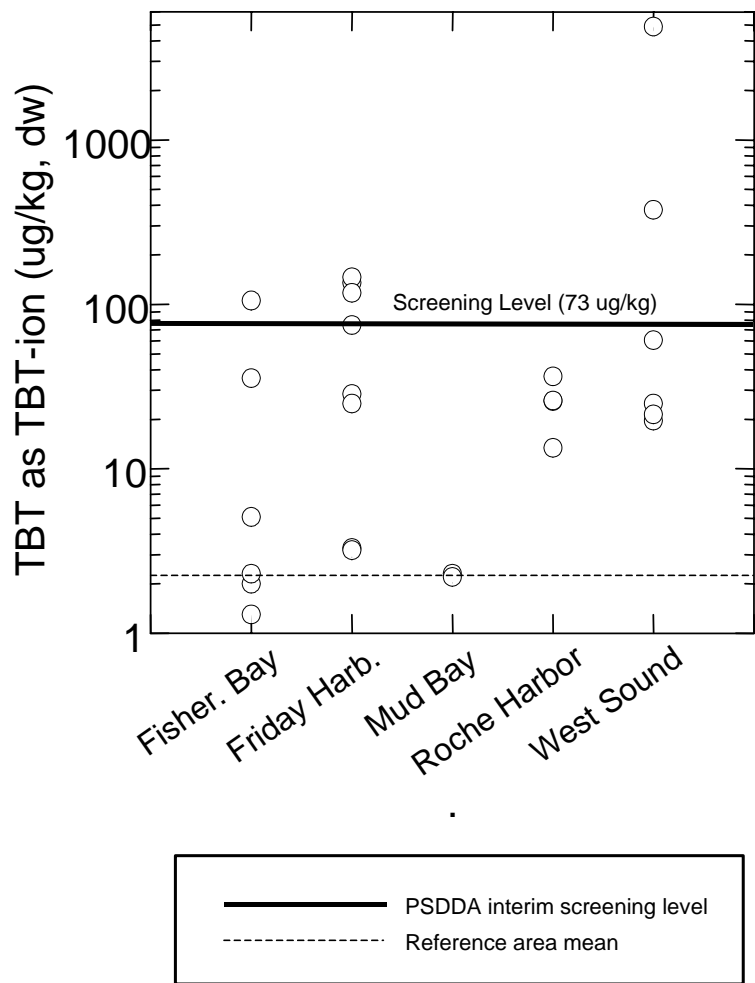
Figure 12. TBT Concentrations in San Juans Harbor Sediments.

Concentrations of TBT are shown in Figure 12. Results for each station are provided in Appendix C. Concentrations were generally elevated above reference levels in all four harbors (Figure 12). Elevated TBT concentrations were most evident in West Sound sediments and the two highest values were from this harbor. Both values exceeded the PSDDA ISL of 73 ug/kg (67× for sample WS5, and 5× for WS2). Except for these two results, TBT sediment concentrations were near or below the ISL. Overall, TBT concentrations tended to be higher in samples from inner harbor sediments than from outer harbor sediments (Figure 13).
