**REMEDIAL INVESTIGATION and
FEASIBILITY STUDY REPORT**

SUNNYDELL DRYKE SHOOTING RANGE

292 DRYKE ROAD
SEQUIM, CLALLAM COUNTY, WASHINGTON, 98382

Prepared By
LaManna Geosciences Inc.

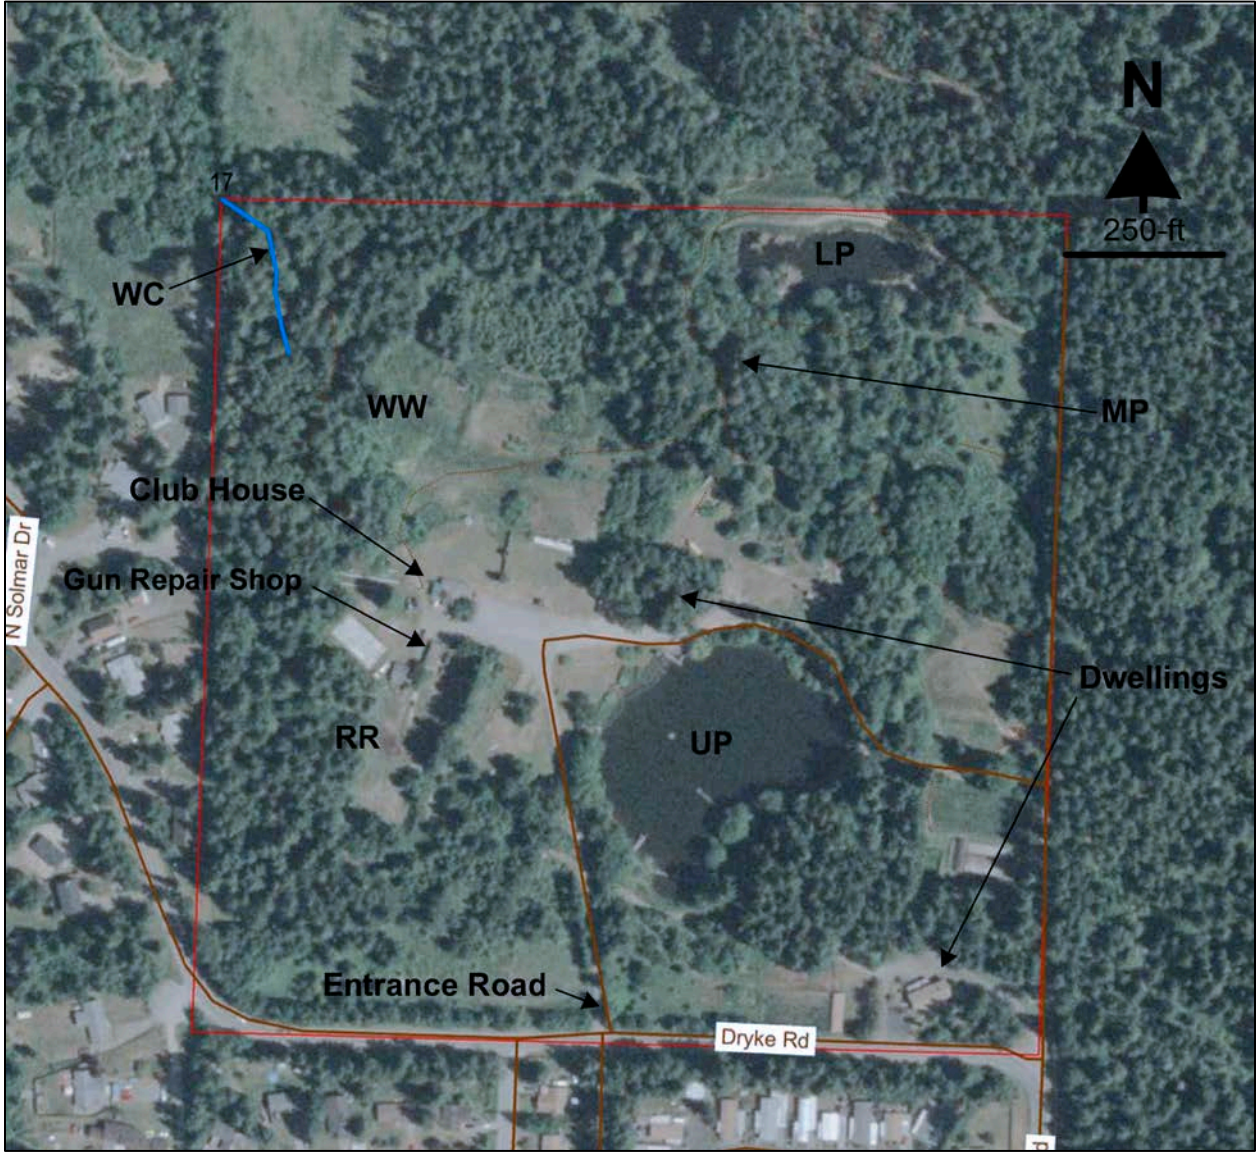
Figure 2. 2009 orthophoto showing locations of the Upper Pond (UP), Lower Pond (LP), Middle Pond (MP), Rabbit Run (RR), Weeping Willow (WW), West Creek (WC), and selected improvements. The approximate site property lines are shown in red. The highest density developments are located to the south and west of the Site.

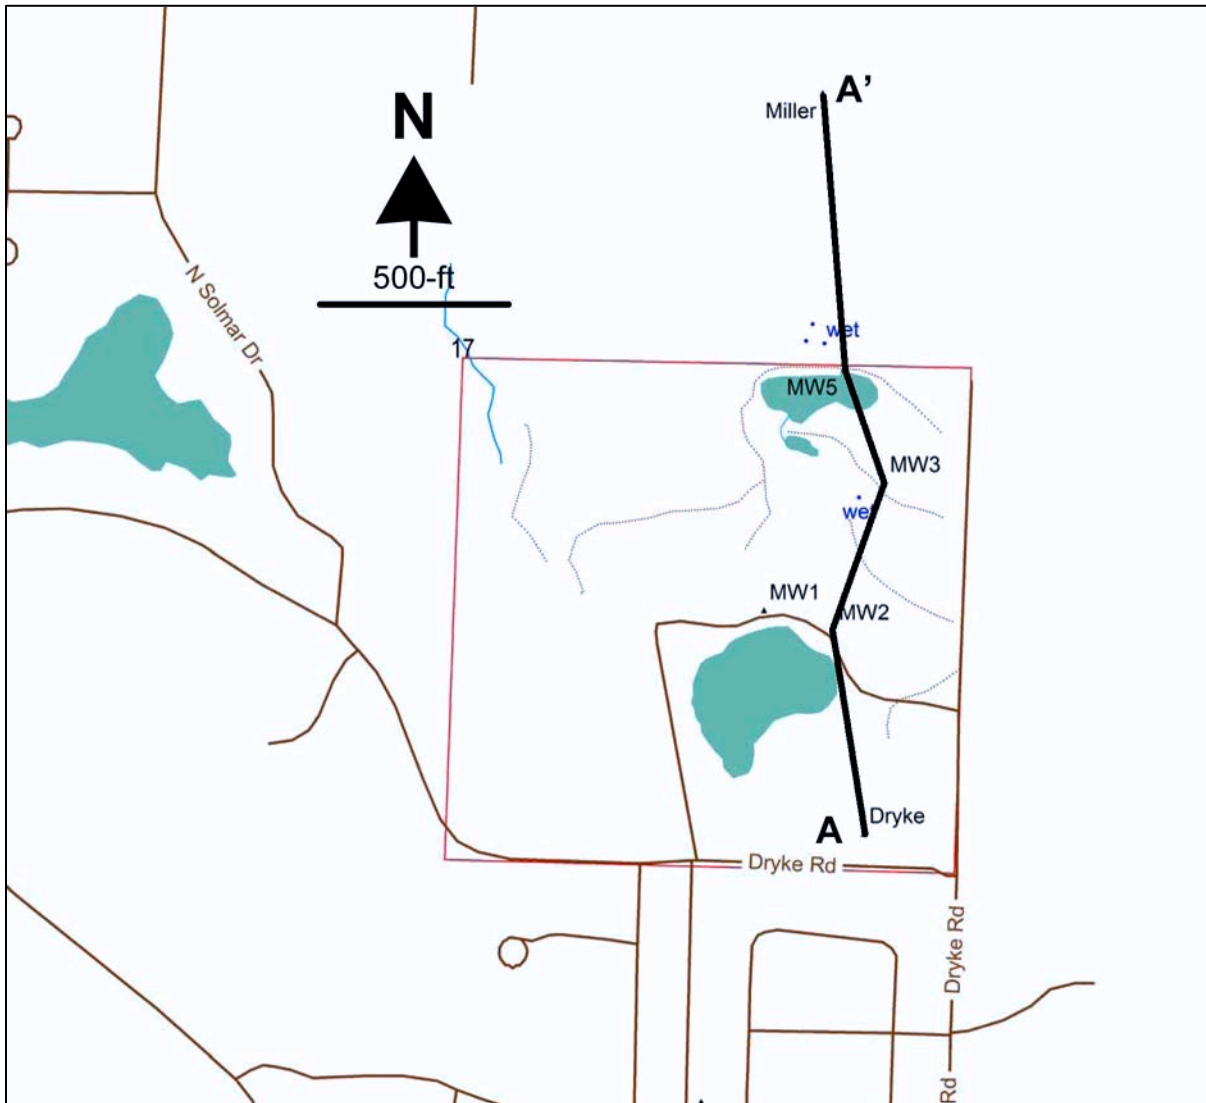
Figure 5a. Location of hydrogeologic cross section.

LGI observed glacial deposits at the Site that are generally consistent with the description in Schasse and Wegmann. At locations MW1, MW2, and MW3, surface soils are dense and appear to be a glacially overridden sandy till (Figure 5a). The till overlies a very stiff silt at MW3 that is about 9-ft thick and that is probably an overridden glaciolacustrine deposit. A water-bearing, poorly graded fine sand is present at all boring locations; this sand may be an advance outwash deposit or other deposit. Sample recoveries were generally not good at boring MW5 (Appendix A; LGI, 2011b).

Observations of surface water in many locations at the Site, wet soils in the northern study area, and shallow groundwater at the Site suggest that there is a continuous and steep groundwater table under the Site. Based on this assumption, LGI prepared a hydrogeologic cross section (Figures 5a and 5b). The cross section lumps the soils at the Site into two categories: the more permeable soils were placed into a higher hydraulic conductivity or Higher K unit and the less permeable soils into a Lower K unit. Groundwater flow occurs mainly in the Higher K unit. LGI prepared this cross section using the November 2010 Geoprobe data and driller's Water Well Report for the Miller well located about 730-ft north of the property line (LGI, 2011b). LGI was unable to locate a Water Well Report for the Dryke well, which is also shown on Figures 5a and 5b.

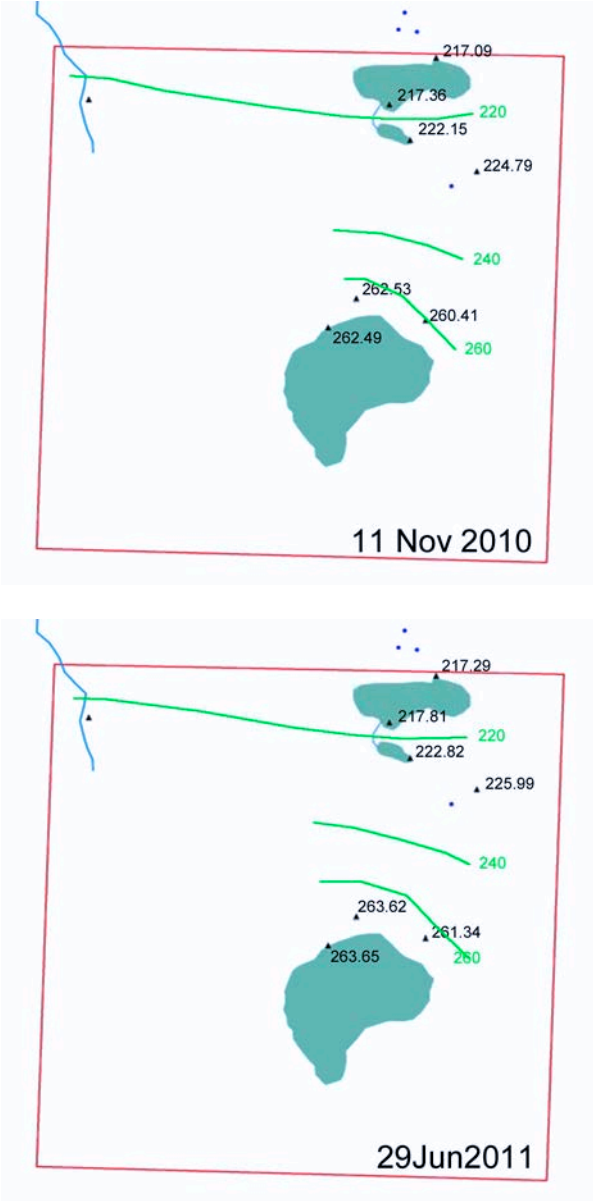
Figure 6. Maps showing inferred water table configurations in November 2010 and June 2011 based on hand-contoured data. At both times the groundwater flow was to the north. These representations assume a continuous water table exists beneath the Site that is in hydraulic contact with the surface water bodies. The contour interval is 20-ft. The Site is delineated in red.

Groundwater measurements were made on November 11, 2010 and June 29, 2011 (Figure 6). The 220-ft contour was extended from the Lower Pond to the West Creek assuming a continuous groundwater table exists and the surface water elevation of West Creek, which LGI inferred from LiDAR-derived topography, is correct. Measurements on both dates show groundwater flow toward the north and confirm that the monitoring wells are correctly positioned downgradient from the ponds. Water level measurements and survey data are presented in Appendix B in LGI (2011b).

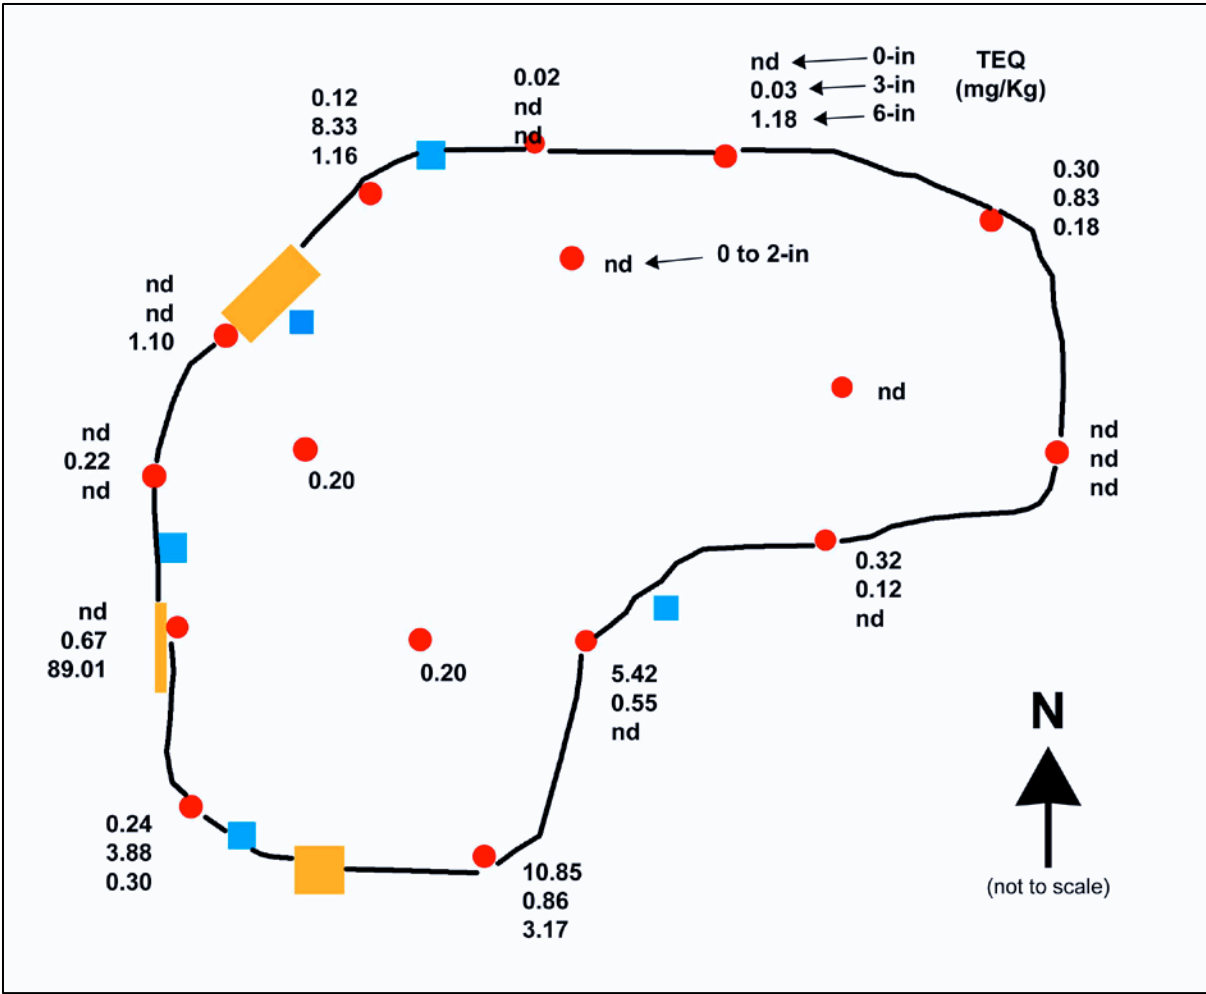
Figure 8. Schematic drawing of Upper Pond showing TEQ concentrations in sediment in July 2010. Samples along the perimeter were collected at depths of 0-in, 3-in, and 6-in. Samples in the pond interior were collected from the top 2-in. An “nd” means PAHs were not detected and TEQ concentrations could not be calculated. This drawing is based on Figure 3 in ESA (2010b). Shown are sample locations (red circles), target release stations (blue squares), and shooting stations (yellow rectangles).

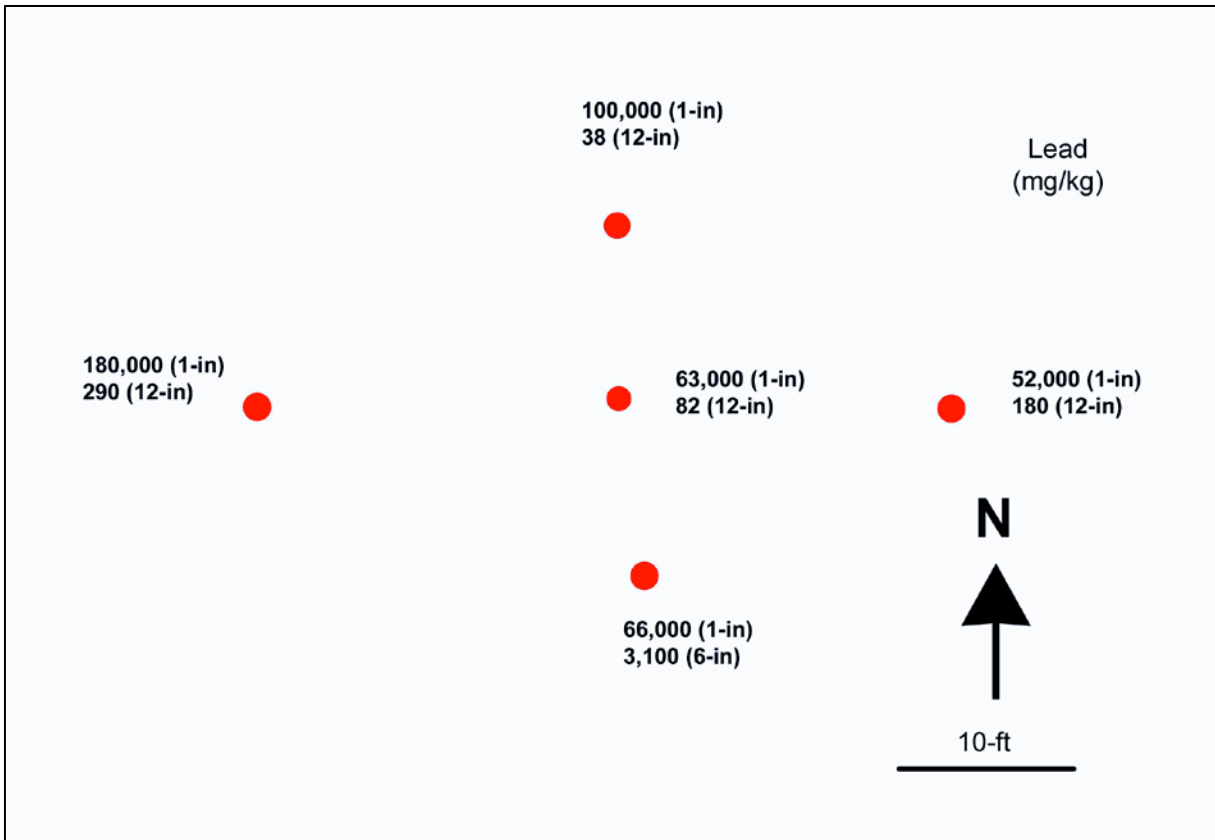
Figure 11. Schematic drawing showing ESA's lead concentrations in the Rabbit Run area in July 2010. Samples were collected at two depths at each location. This drawing was based on Figure 5 in ESA (2010b). ESA's report does not show where these samples were collected relative to site features.

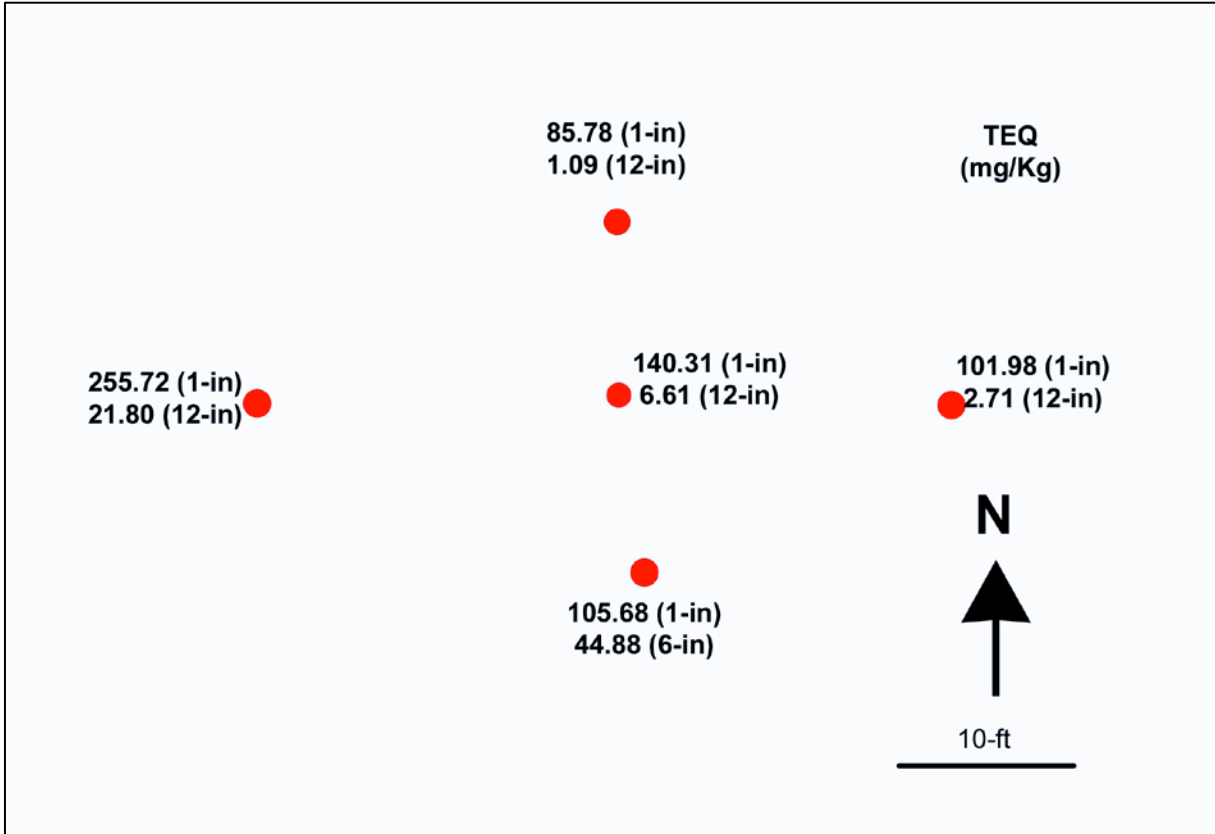
Figure 12. Schematic drawing showing ESA's TEQ concentrations in the Rabbit Run area in July 2010. Samples were collected at two depths at each location. This drawing was based on Figure 5 in ESA (2010b). ESA's report does not show where these samples were collected relative to site features.

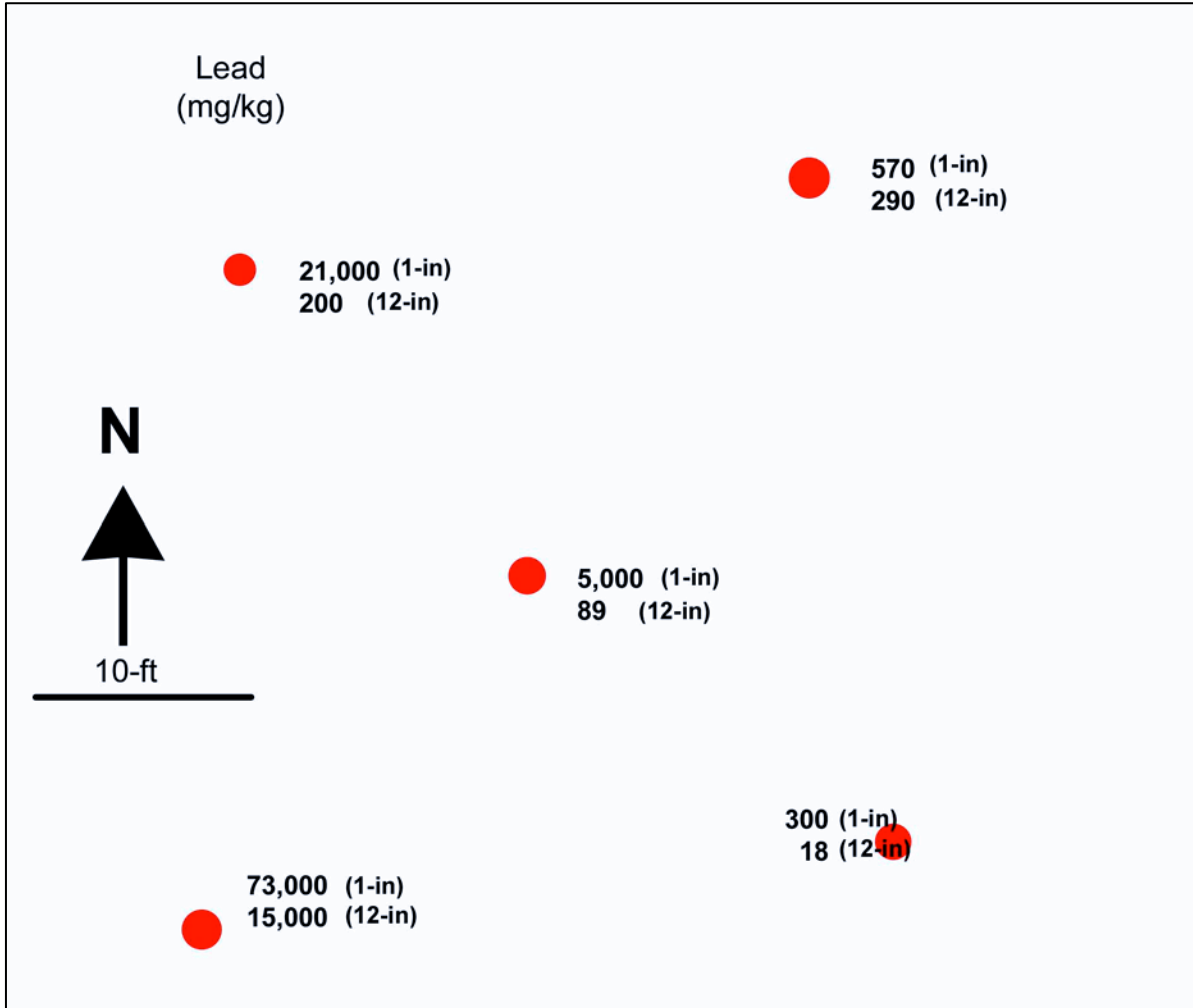
Figure 13. Schematic drawing showing ESA’s lead concentrations in the Weeping Willow area in July 2010. Samples were collected at 1-in and 12-in depths at each location. This drawing was based on Figure 6 in ESA (2010b). ESA’s report does not show where these samples were collected relative to site features.

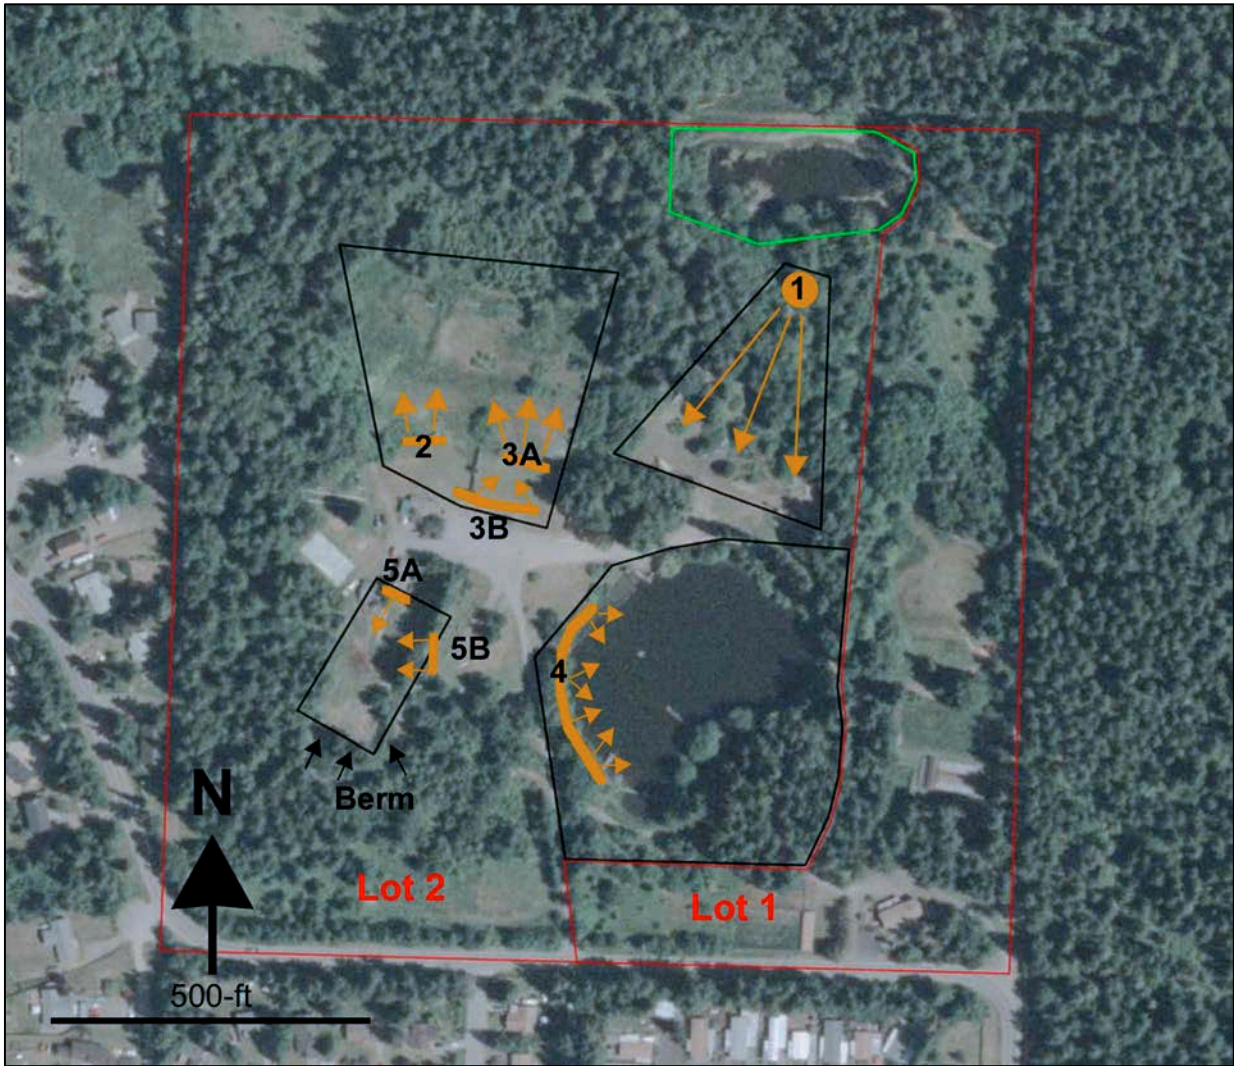
Figure 16. Map showing locations of proposed Active Shooting Range Management Areas (4 black polygons); shooting locations (1, 2, 3A, 3B, 4, 5A, 5B); shooting directions (orange arrows); Lower Pond Management Area (green polygon), and Lots 1 and 2 (red polygons). There are berms located at the south and southeast sides of Management Area 5. These berms prevent stray shot and bullets. The area outside of the black and green polygons in Lot 2 comprise the Non-Shooting Management Areas. The text describes BMPs and an institutional control for these management areas. Lot 1 will be managed separately and is excluded from these BMPs and institutional control.

The Site consists of a 38.89-Ac property that is in the process of being subdivided into two properties, Lot 1 (9.03 Ac) and Lot 2 (29.86 Ac, refer to Figure 16).⁴ The former owners of the Site, Mr. Chuck Dryke and Ms. Rosemary Knotek, started working with Clallam County in 2010 to perform a Large Lot Subdivision. Mr. Dryke's ownership passed to his daughter Ellen Dryke after he died in February 2012. The Site is currently owned by Ms. Dryke and Ms. Knotek.
