February 2019  
Port Gamble Cleanup

# Year-1 Post-Construction Monitoring Report – 2018

Prepared for Pope Resources, LP/OPG Properties, LLC

Anchor QEA, LLC  
720 Olive Way, Suite 1900  
Seattle, Washington 98101

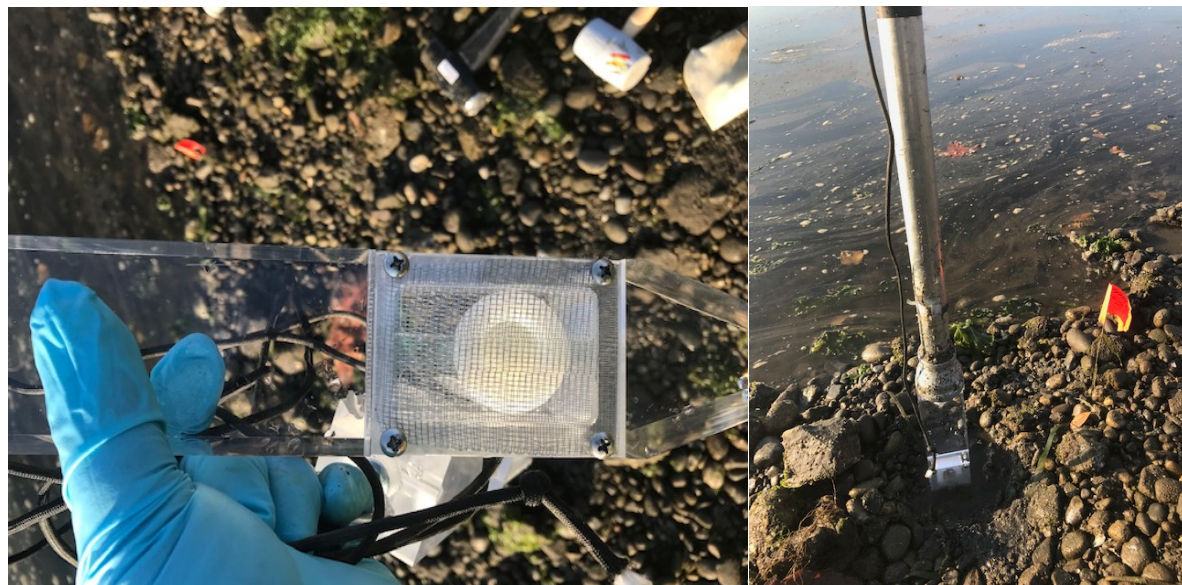
**Figure 8**  
**Probe with DGT Piston Assembly Installed (left) and Probe Installation (right)**

DGT probe field deployment consisted of a DGT piston within a plastic spear, so that the DGT could be deployed to the desired depth while the piston was protected within a wire mesh chamber (Figure 8). DGT probes were advanced at three locations along a single transect in SMA-1 (Figure 3) and at three locations along three parallel transects in SMA-2 (total of nine locations; Figure 4). At each of these twelve DGT sampling locations, probes were installed at 6 and 24 inches below the mudline, for a total of 6 samples in SMA-1 and 18 samples in SMA-2.

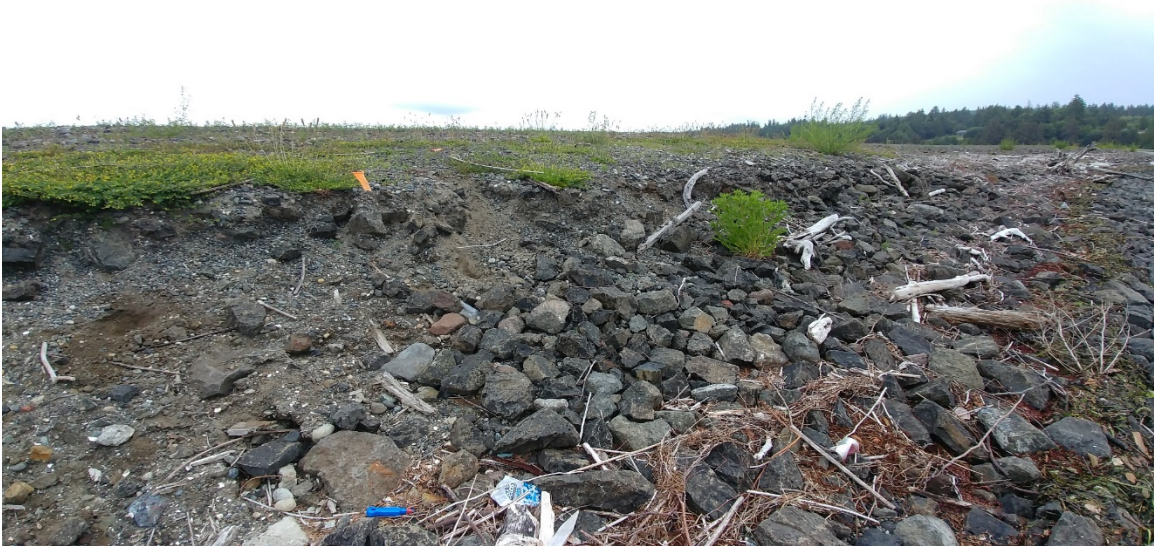
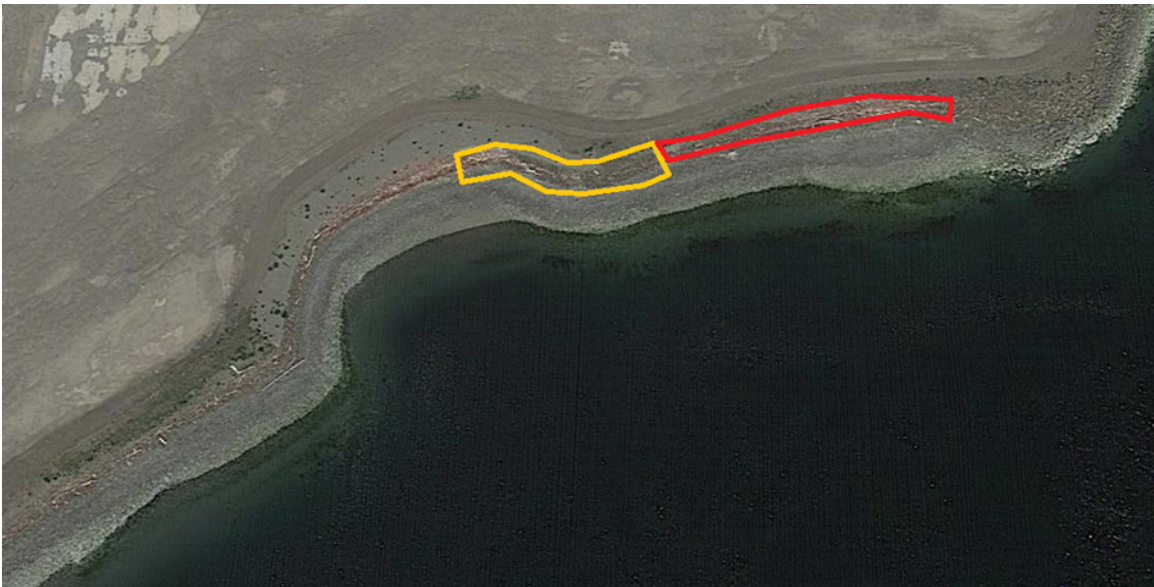
The one area that was not a result of anticipated slope deformation or down-slope migration of habitat substrate was within the upper intertidal cap area of SMA-2 and the adjacent upper intertidal shoreline area near the former Pier 4. Within this area, there were two sub-areas where proactive cap repairs were recommended based on observed movement of cap armor rock. These two areas are outlined in yellow and red on Figure 10. A photograph taken of the armor rock movement in the yellow area (foreground) and red area (background) during the low tide visual inspection on June 13 is also provided on Figure 10.

**Top: Eastern Edge of Armor Movement, Yellow Outlined Area (foreground) and Red Area (background)**

**Bottom: Aerial View of Observed Armor Rock Movement in SMA-2**

Within the yellow outlined area, armor rock was displaced from the upper intertidal slopes over an approximately 25- to 30-foot length; underlying filter material is visible in this area. Adjacent areas of about 20 to 40 feet on either side showed some armor rock removal but no exposure of underlying filter material. This area was repaired, as described in Section 7.

Within the red outlined area on Figure 10, cap performance was determined to be as designed and expected. Movement of armor rock as the slope deformed due to storm waves was observed but was generally within acceptable limits. Although this area did not exhibit movement of the armor rock beyond the acceptable limits, additional rock was also placed here, to provide additional protection for the upslope cap during future large storm events, as described in Section 7.

Based on available guidance documents (USACE 2001; CIRIA 2007), the rock in these headland areas should be 1.3 to 1.5 times the size determined for a straight section of armored shoreline. The armor rock size for the original design in this area had a median diameter of 9 inches; therefore, armor rock recommended to repair this section of the intertidal cap was a median diameter of at least 12 to 14 inches. The repairs were completed in accordance with recommendations described in Section 7.

One corrective action was identified in 2018, during physical integrity monitoring activities described in Sections 2.1 and 4. Minor repairs to the upper intertidal SMA-2 cap and the adjacent upper intertidal shoreline area to the east (Figure 5) were performed on September 4 and 5, 2018, by PR/OPG's subcontractor Seton. Anchor QEA was on site during the repairs, and the work was performed in accordance with the recommendations in the July 11, 2018 memorandum (Anchor QEA 2018b). Representatives from PR/OPG and Ecology were on site to observe the corrective actions on September 4, 2018.

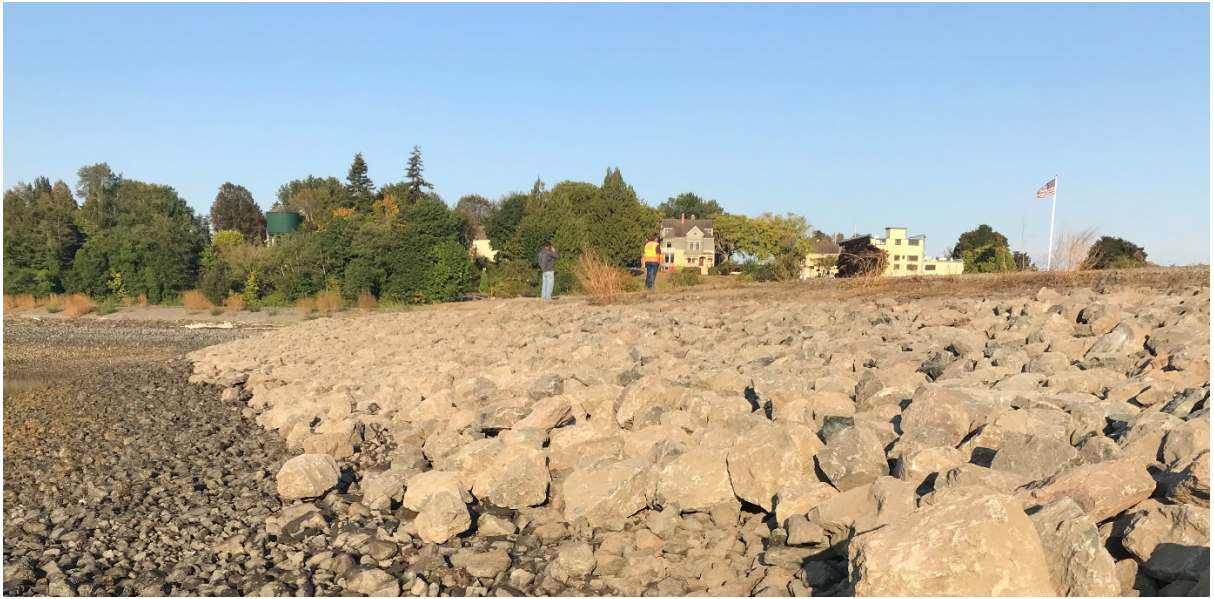
**Figure 11**  
**Photograph of Repaired SMA-2 Intertidal Cap Area**

Figure 5 depicts the as-built area of the repairs. A total of 360 tons of one-man armor rock (Washington State Department of Transportation [WSDOT] Specification 9-13.7(1)) ranging from 12 to 18 inches, was placed within the repaired area; 61 tons of 3-inch minus quarry spalls (WSDOT Specification 9-13.1(5)) was placed in areas where filter material was exposed.

The 3-inch minus quarry spalls were placed in a 0.5- to 1-foot-thick layer prior to placement of the larger one-man armor rock material. The quarry spalls were placed to retain the smaller underlying material within the slope. Other areas where armor rock was lost or moved but filter material was not exposed were re-armored with two layers of one-man rock.

The one-man armor rock was tapered down to a single layer at the edges of the repair area to avoid constructing an abrupt edge between the repair section and existing armored cap. The slope of the repair was re-graded as closely as possible to a 3:1 (horizontal to vertical) slope. A photograph of the repaired area in SMA-2 is shown on Figure 11.
