CONSTRUCTION FIELD PACKAGE (FORM 1)

Project ID: Concourse C Vertical Circulation Site: Concourse C
Location ID: _____ Location: Gates C2, C10/12 & C14 (see Figures 1 - 4)
Project Start Date: 05.16.14 Project End Date: 07.31.15
Report Preparer: Greg Ferris Date: 07.31.15

The purpose of the project was to install new walkways, ramps and elevators (including subsurface infrastructure) to upgrade passenger conveyance routes to and from airplanes at Gates C2, C10/12 and C14 at STIA.

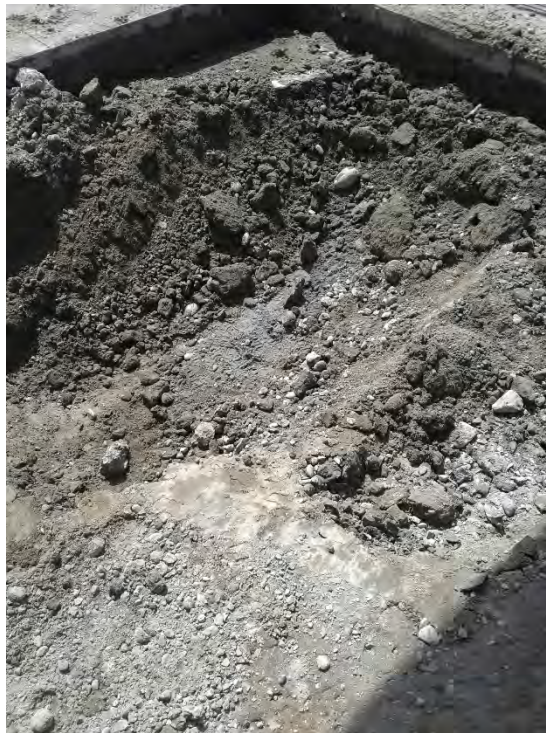
Gate C2 – Photo 051414-01 – May 14, 2014

Looking south at petroleum-impacted soil in a trench excavation in the eastern portion of the Gate C2 work area.

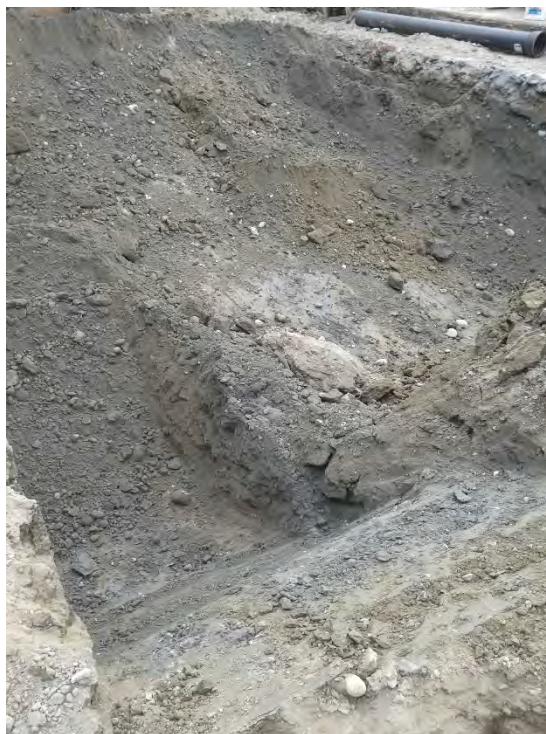
Gate C2 – Photo 062614-01 – June 26, 2014

Looking south into the elevator pit excavation at Gate C2 – Type B glycol-impacted soil was encountered in the north and west walls of the elevator pit.

Type B impacted soil was encountered in the north and west portions of the elevator pit excavation and was described as brown to gray silty sand with gravel, some gray staining, glycol odor, PID<10ppm). Approximately 90 tons of Type B impacted soil was hauled to the stockpile facility for temporary storage.

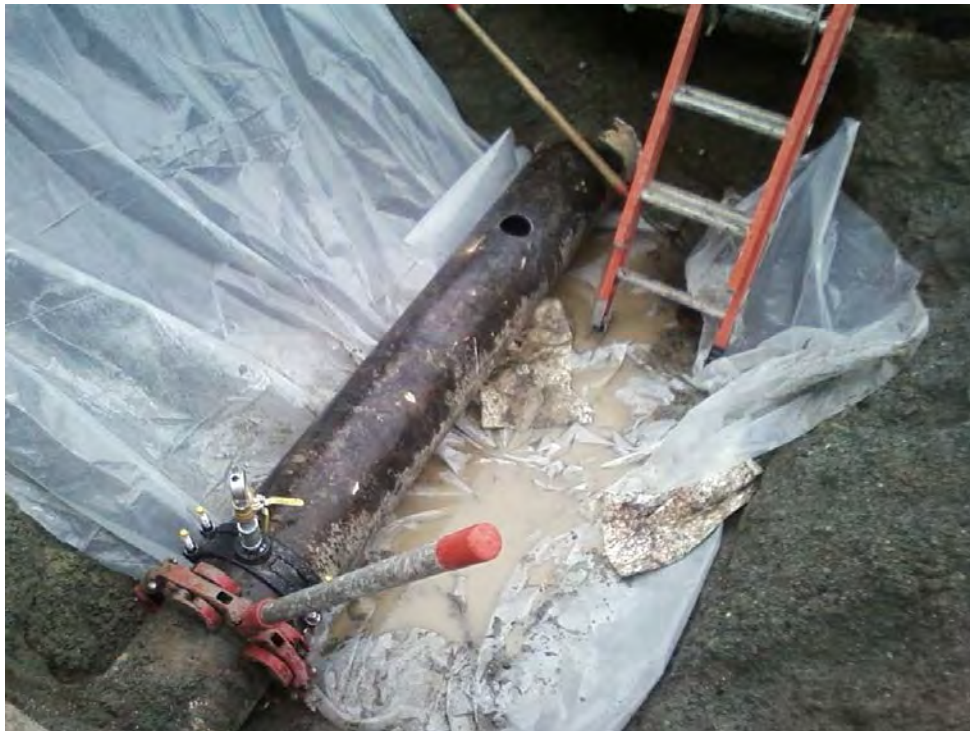
Gate C2 – Photo 103014-01 – October 30, 2014

Looking south at a section of 12" fuel line in the west-central portion of the Gate C2 work area that was cut and capped following removal of product and water from the pipe.

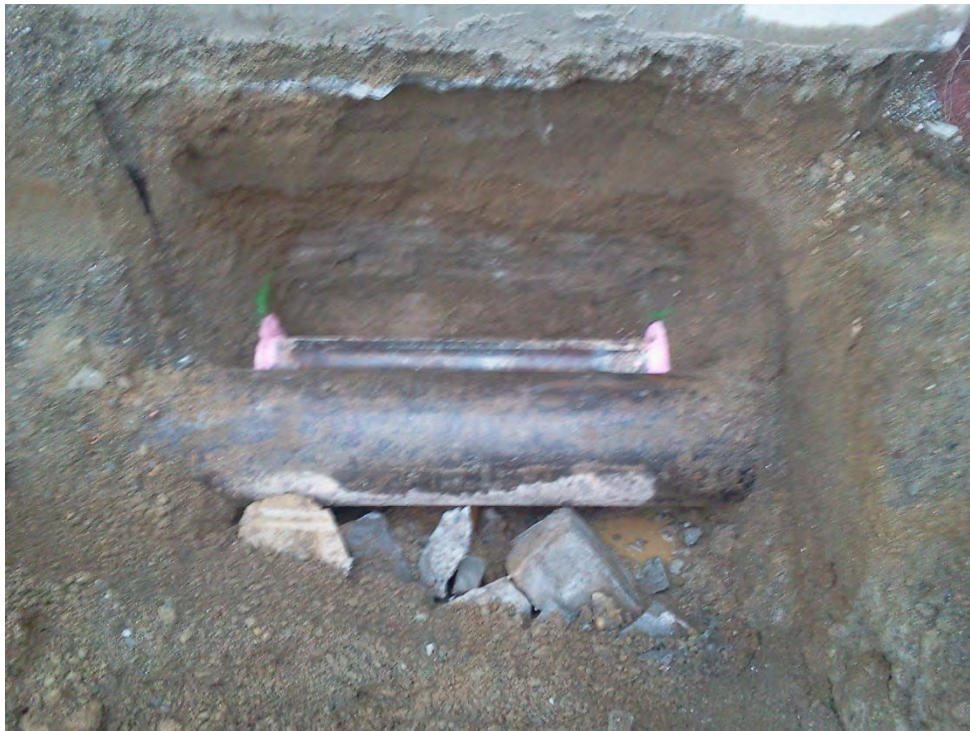
Gate C2 – Photo 121114-01 – December 11, 2014

Looking southeast at the IWS re-route trench excavation in the western portion of the Gate C2 work area – glycol-impacted soil (gray staining) was encountered throughout.

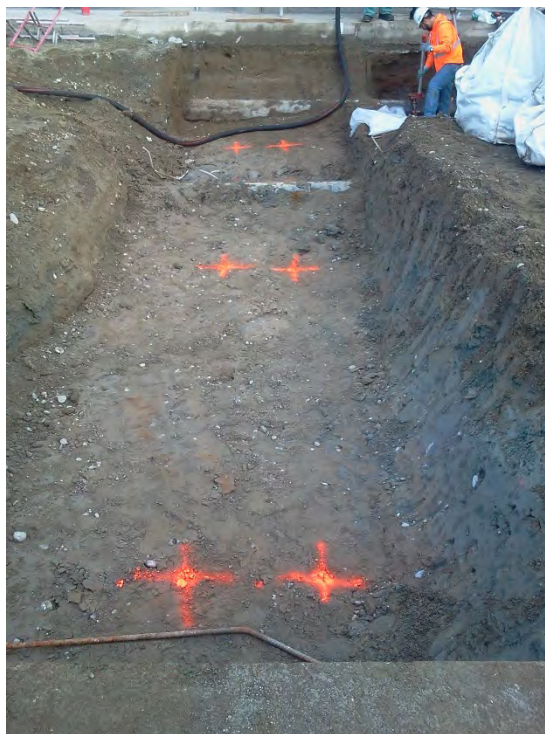
Gate C2 – Photo 121214-01 – December 12, 2014

Looking northeast at the eastern-most grade beam trench in the east-central portion of the Gate C2 work area – petroleum-impacted soil was encountered in the northern section near the fuel lines and glycol-impacted soil was encountered in the southern section.

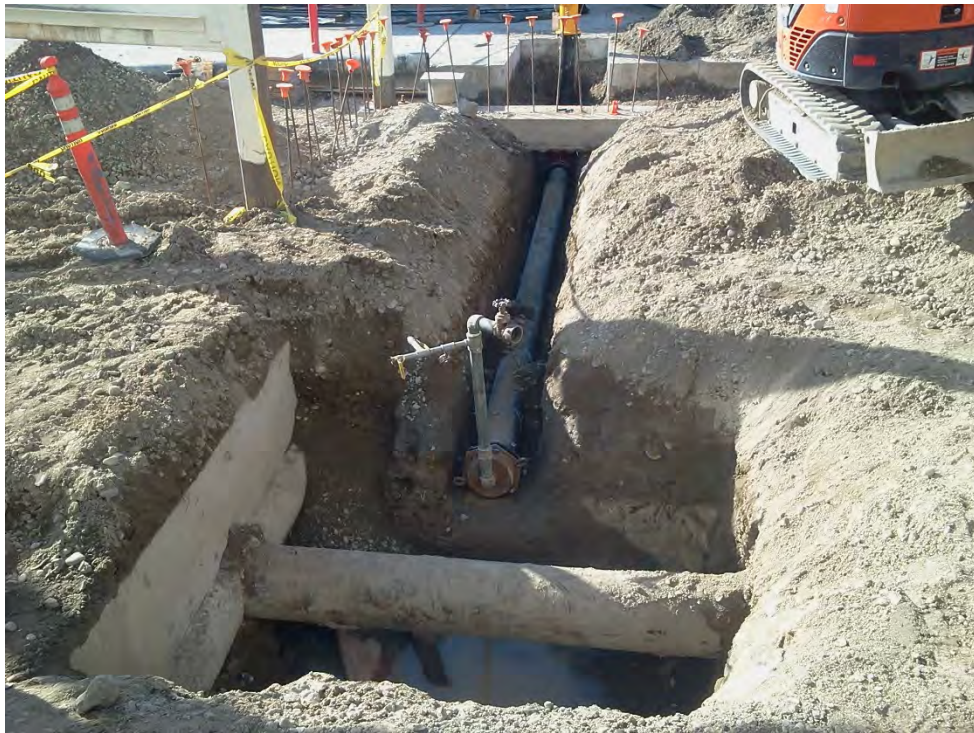
Gate C10/12 – Photo 021715-01 – February 17, 2015

Looking west a water line installed in the excavated trench in the northern portion of the Gate C10/12 work area. The soil was Type D 'clean' material.

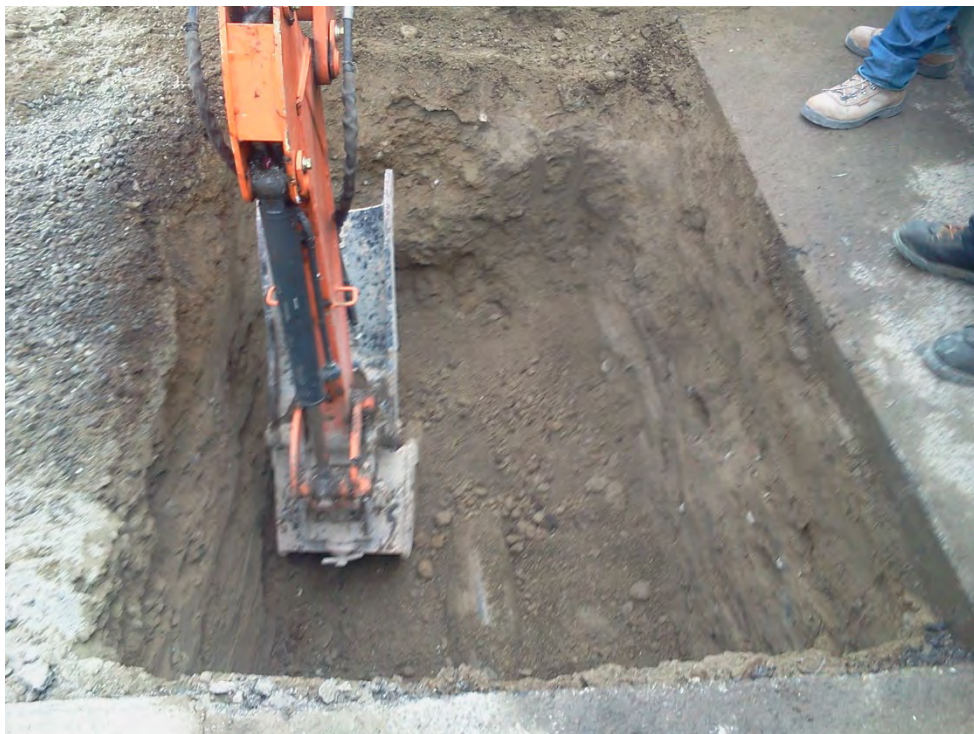
Gate C10/12 – Photo 021915-01 – February 19, 2015

Looking north at an IWS catch basin excavation near the southeast corner of the Gate C10/12 work area. The soil was Type D 'clean' material.

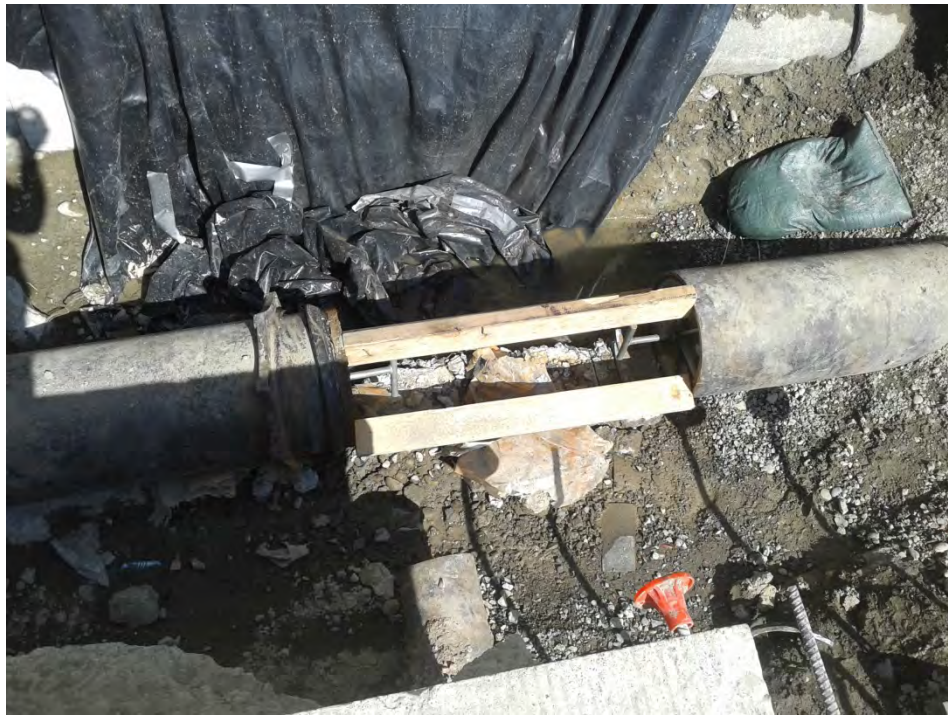
Gate C14 – Photo 060614-01 – June 6, 2014

Looking east at the water line excavation (cut and capped) in the southeast portion of the Gate C14 work area - The soil was Type D 'clean' material.

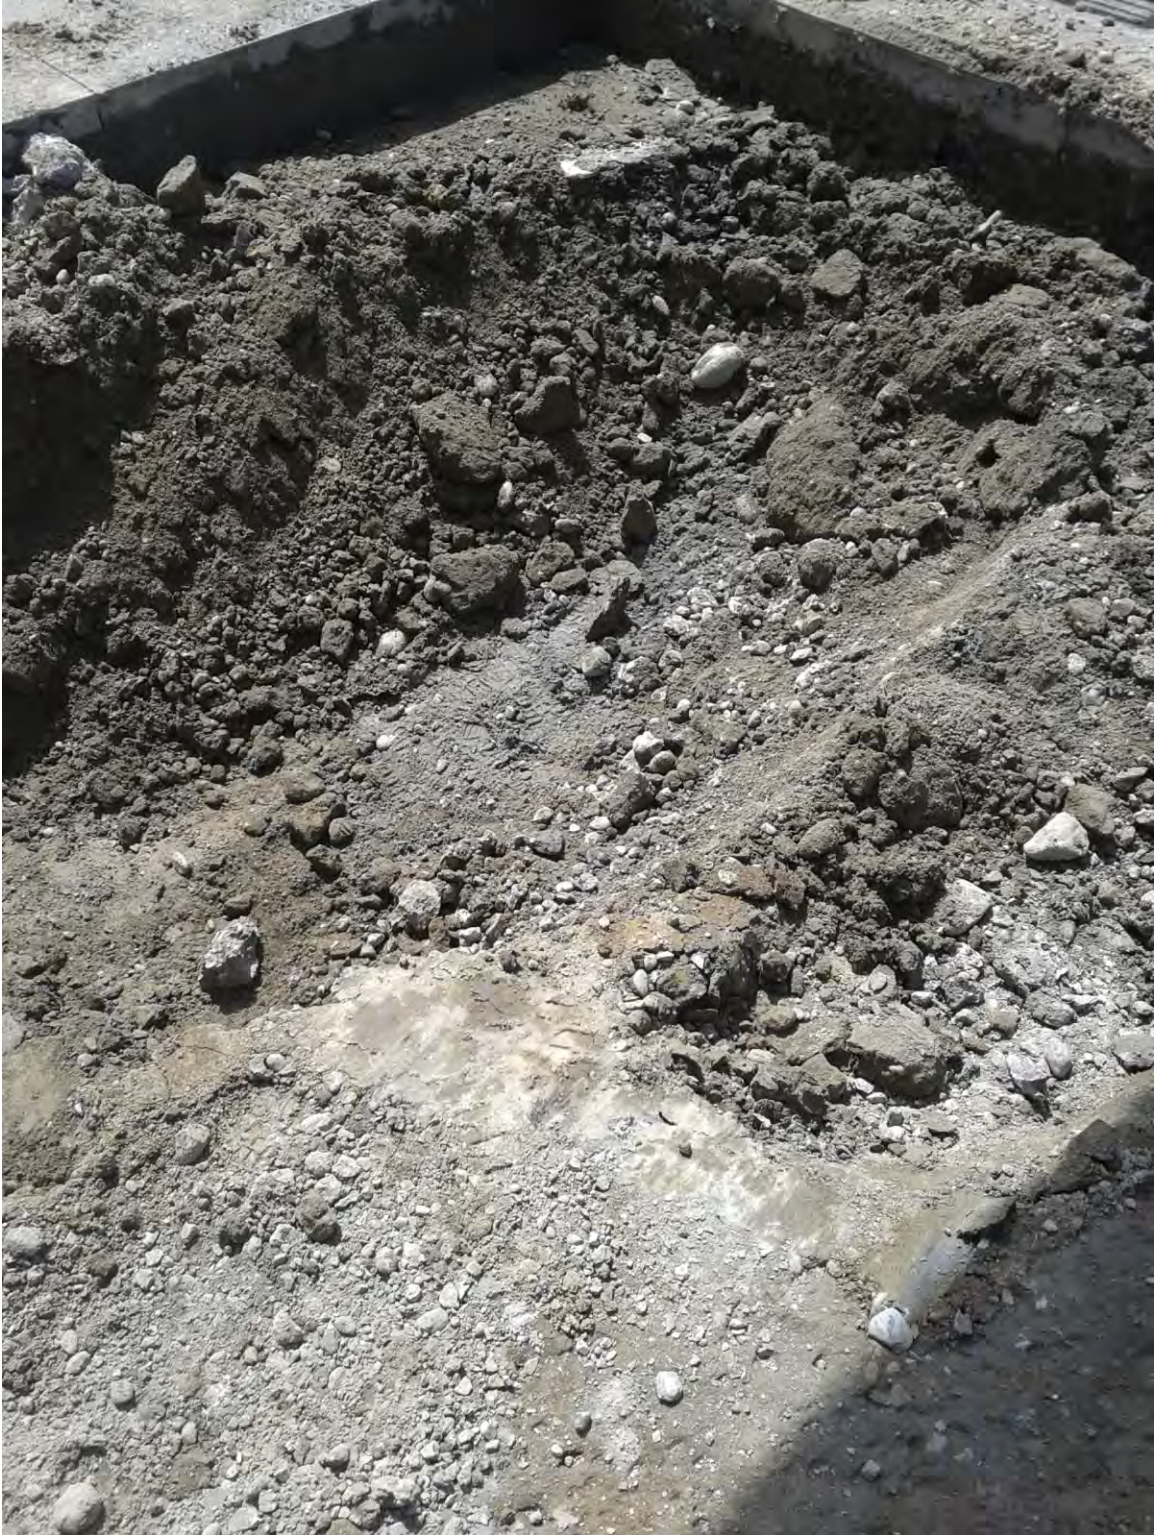
Photo 051414-01

Looking north at petroleum-impacted soil in south end of the central trench excavation at Gate C-2; impacted soil was hauled to the Environmental Stockpile Facility – Center Bay South Wall (ESF-CBSW) for temporary storage.

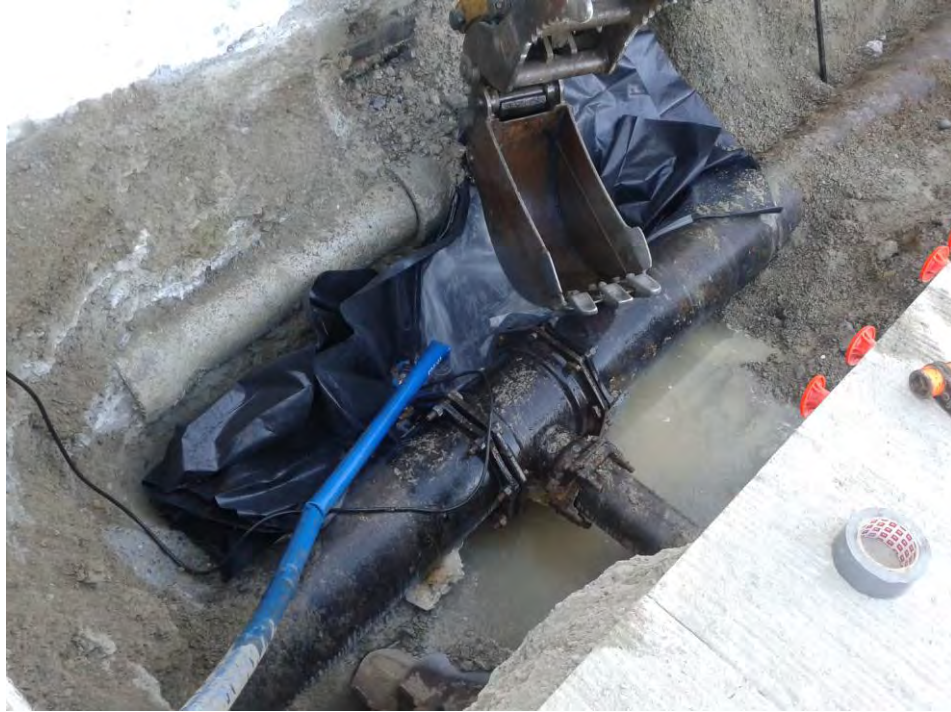
Photo 060614-01

Looking east-southeast at the water line at Gate C14 that was tapped into and found to be under pressure. The trench was lined with plastic and water was pumped to IWS.

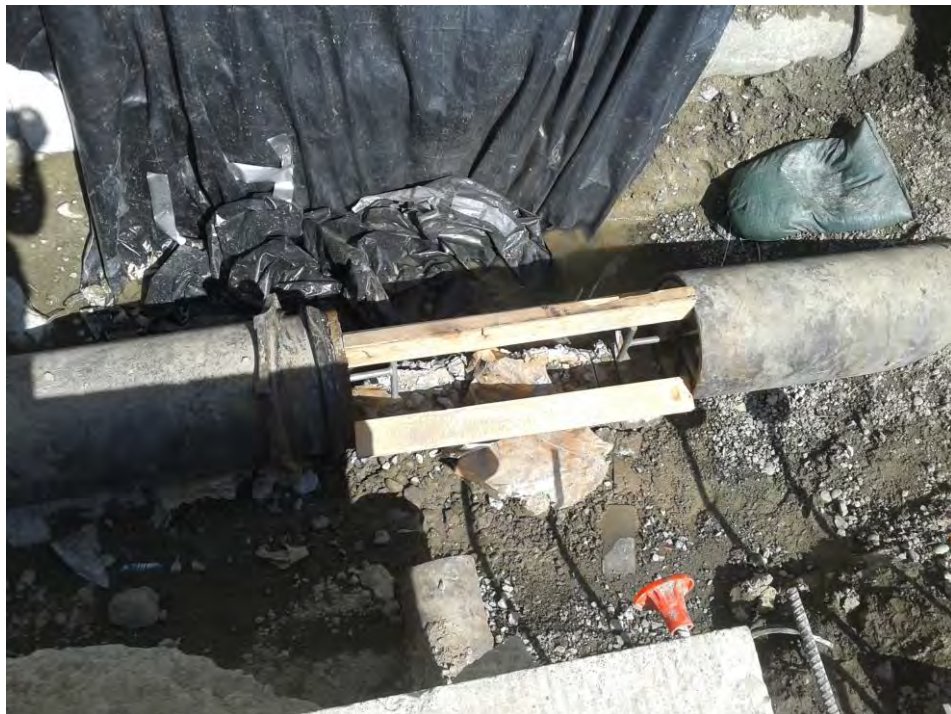
Photo 060614-02

Looking east-southeast at the water line at Gate C14 that was eventually cut and capped.

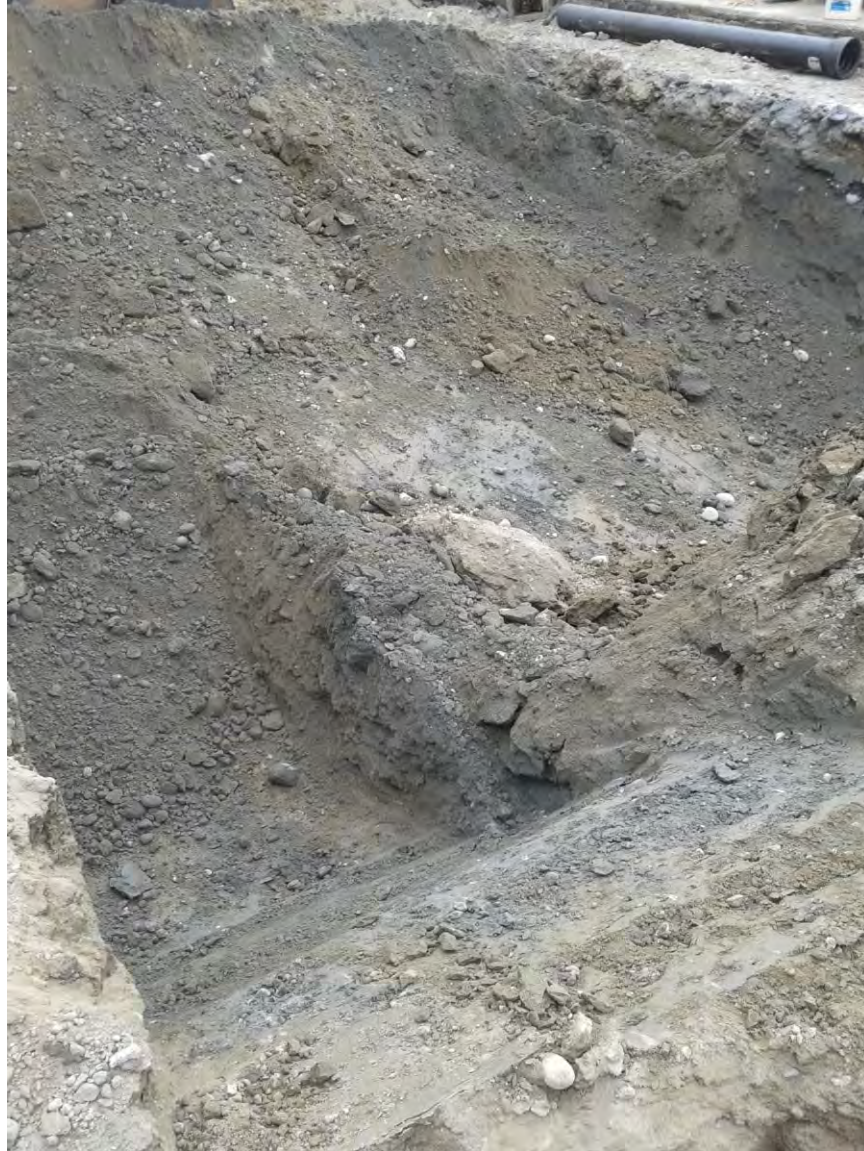
Photo 062614-01

Looking southeast into the elevator pit excavation at Gate C-2; Type B glycol impacted soil was encountered along the north and west walls (left and front of photo).

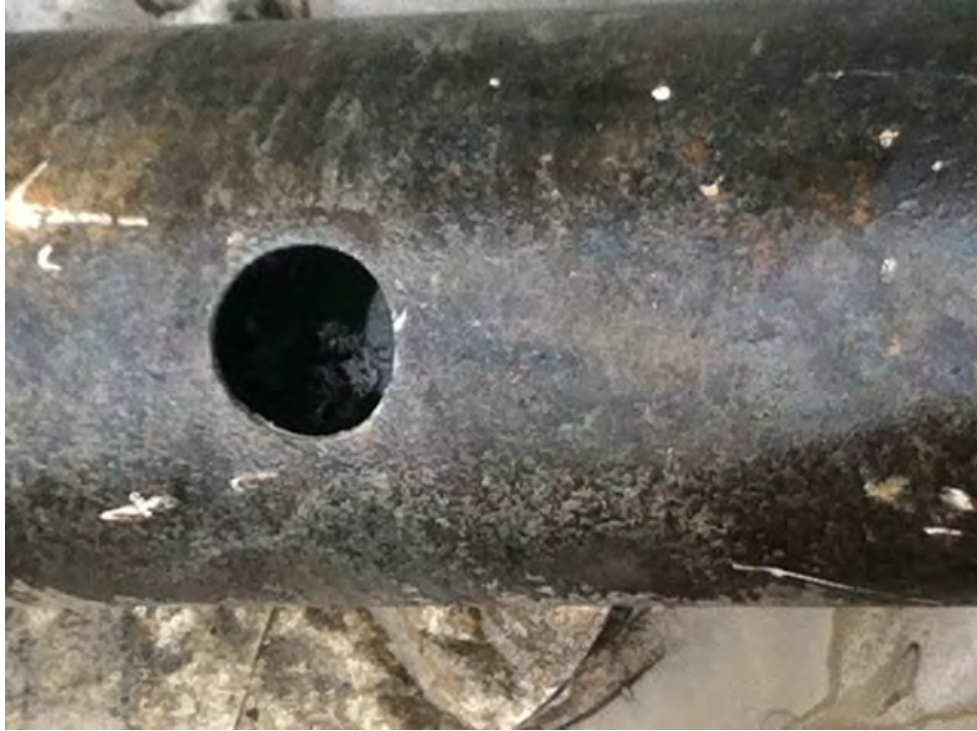
Photo 001-103014

Looking southwest at a hole cut into the 12" fuel line at Gate C2 to facilitate removal of product and water from the pipe.

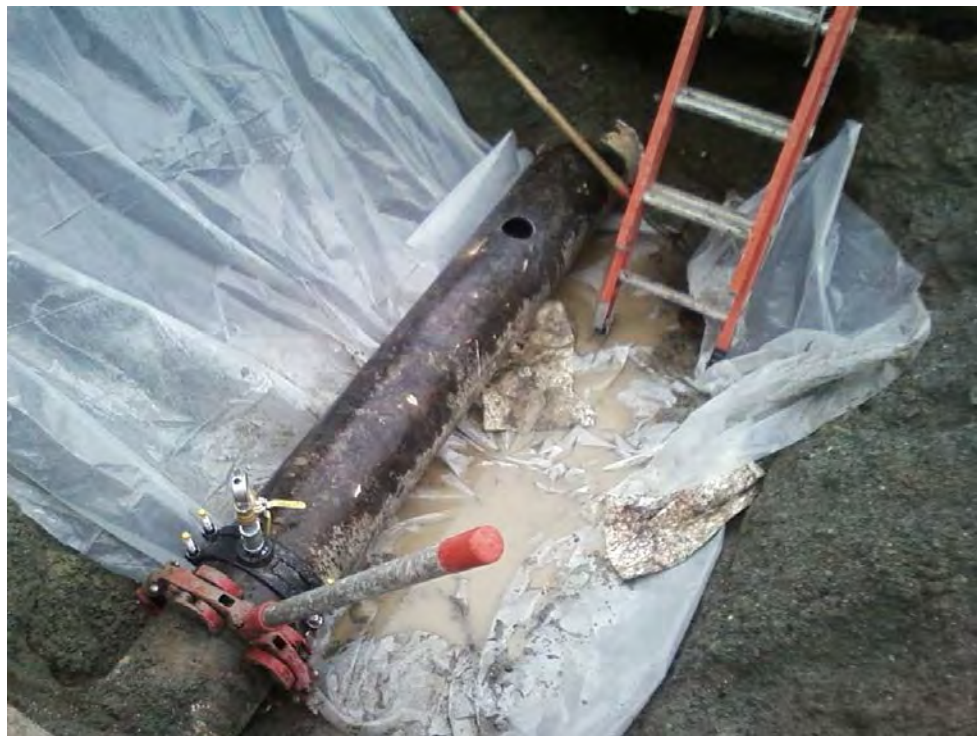
Photo 002-103014

Looking south at the section of 12" fuel line at Gate C2 to be cut and capped following removal of product and water from the pipe.

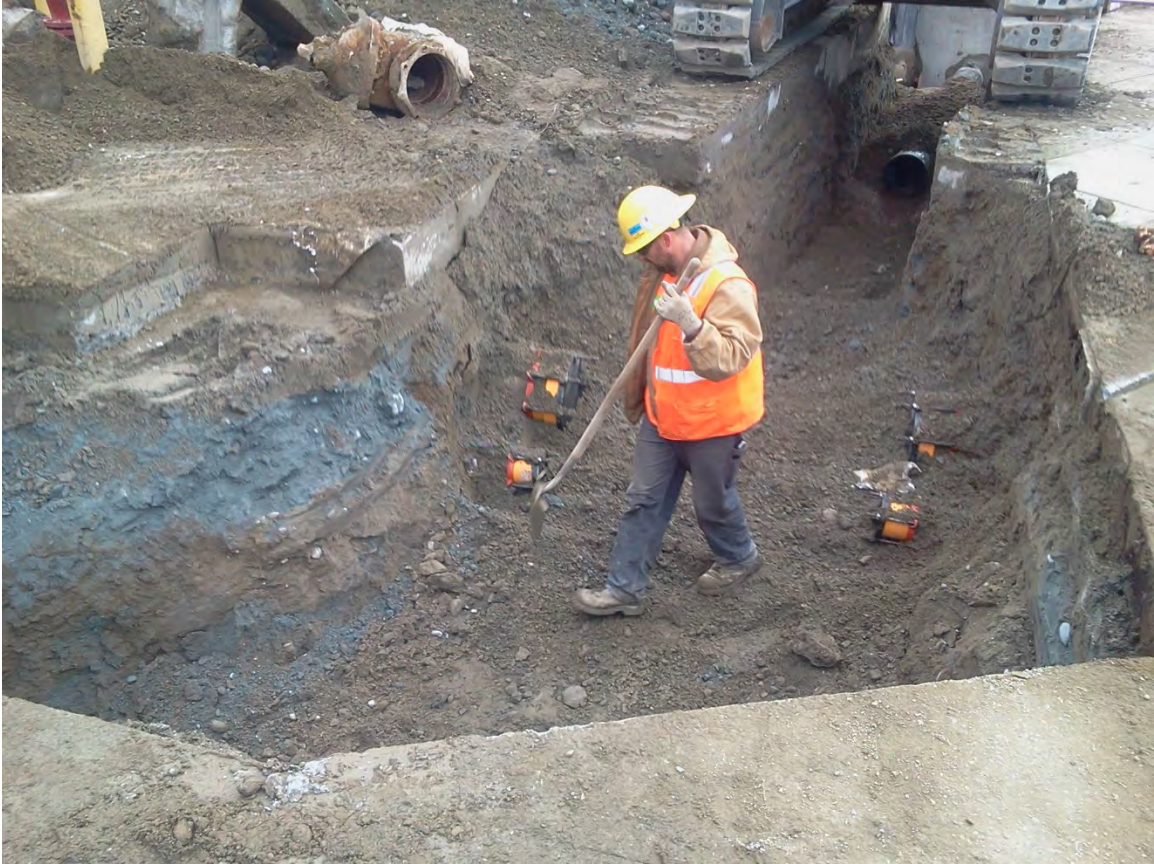
Photo 110514-01

Looking southeast at the IWS re-route trench excavation in the western portion of the Gate C2 work area – glycol impacted soil (gray staining) was predominantly encountered throughout the excavation.

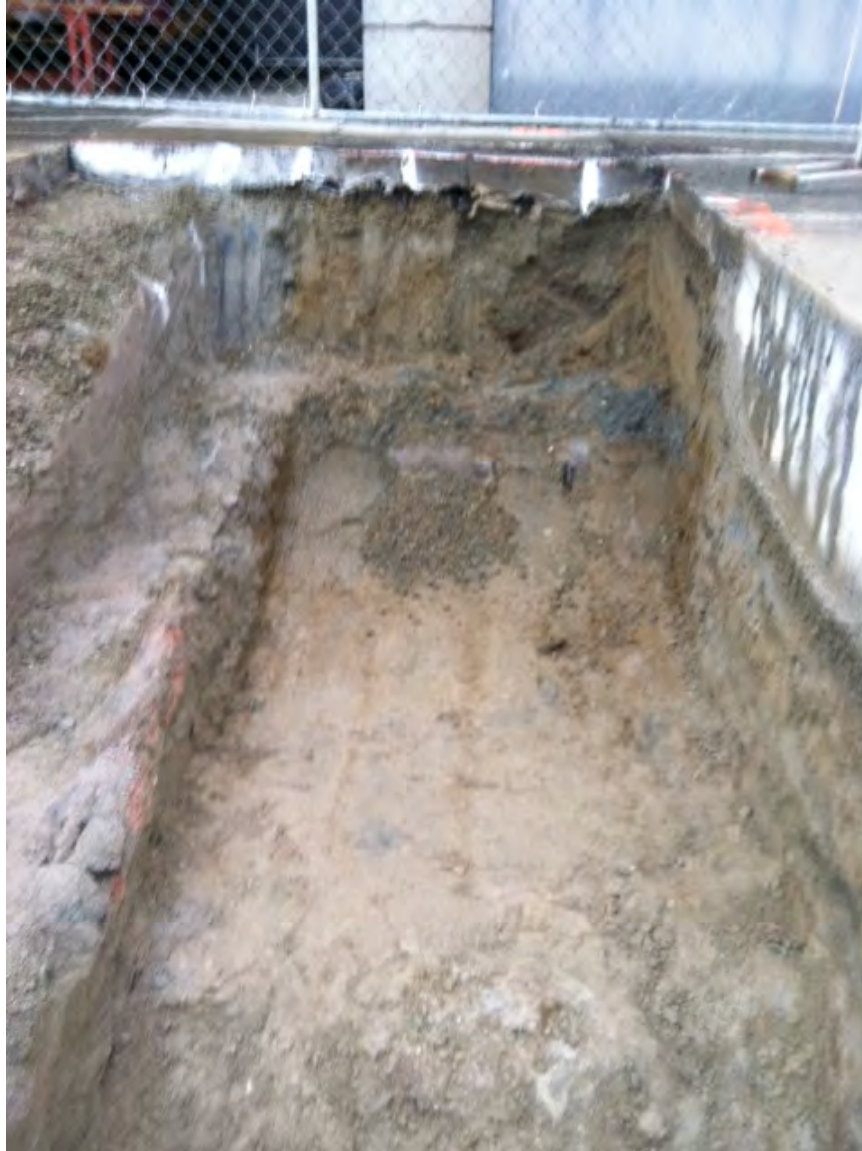
Photo 120514-01

Looking northeast at the center grade beam excavation at Gate C2. All soil was Type D 'clean' material, except for the northern-most portion of the excavation where Type B petroleum-impacted soil was encountered around an abandoned fuel line. Approximately 3 tons of impacted soil was excavated, covered and temporarily stored on site.

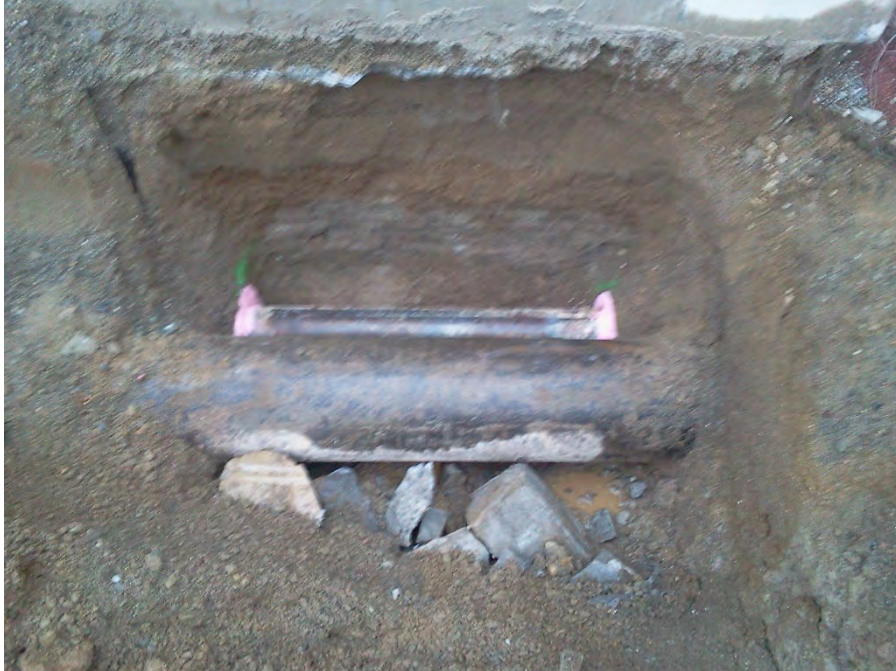
Photo 121114-01

Looking northeast at the 12" and 6" abandoned fuel lines near the northeast corner of the Phase 2 work area at Gate C2. The contents of the fuel lines (mostly water) was removed and the lines cut and capped.

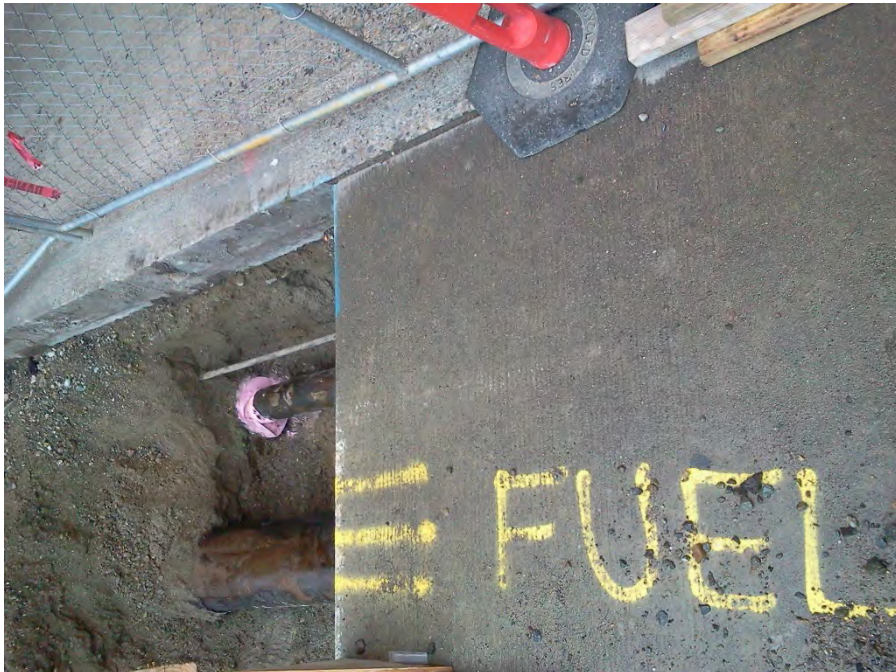
Photo 121114-02

Looking northwest at the 12" and 6" abandoned fuel lines near the northwest corner of the Phase 2 work area at Gate C2. The contents of the fuel lines (mostly water) was removed and the lines cut and capped.

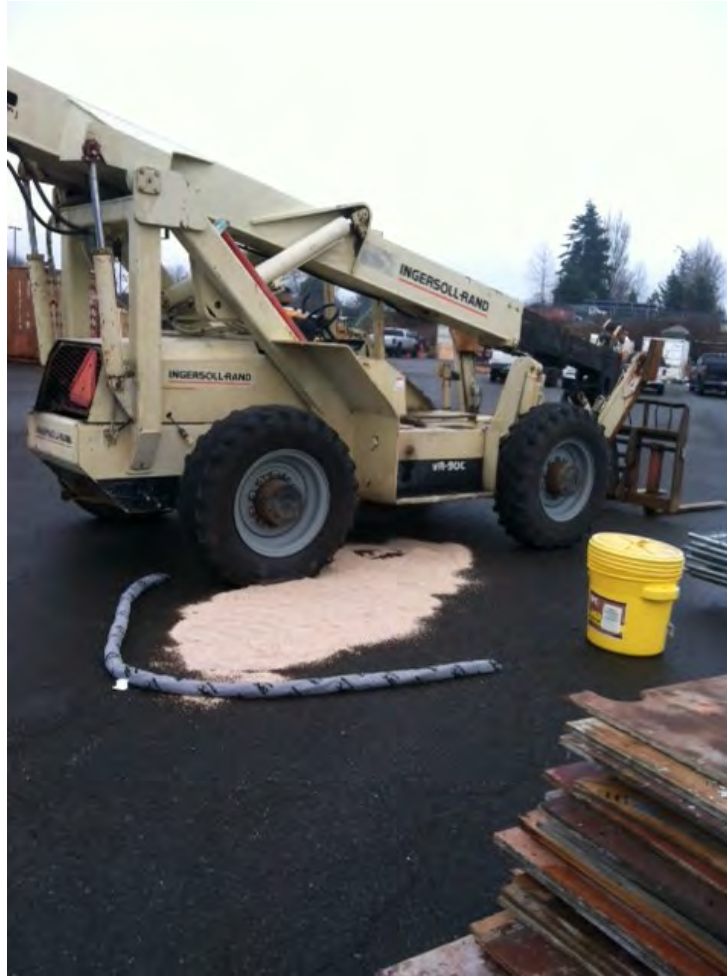
Photo 010715-001 – January 7, 2015

Looking Northeast at the hydraulic fluid release resulting from a line failure on a Forma extended forklift in their laydown area at logistics. The release occurred on asphalt pavement and was cleaned up using floor dry and a sorbent boom.

4. Party Responsible and Cause for Spill: Forma: Hyraulic line failure on forklift
5. Type of Material Spilled (Describe Odor/color, if unknown): Hydraulic fluid

11. Did Material Soak into Soil? Yes ☐ No ☒ Estimated Quantity (gal): ~2-3 Gallons
12. Weather Conditions at Site: Foggy/ Temp=40
13. Action Taken (Description of Initial Containment/Recover Procedures): Crew used floor dry and absorbent boom to contain spill. Removed hydraulic fluid from asphalt using floor dry, placed into trash bags, and stored at Forma's laydown yard to be disposed at later date.

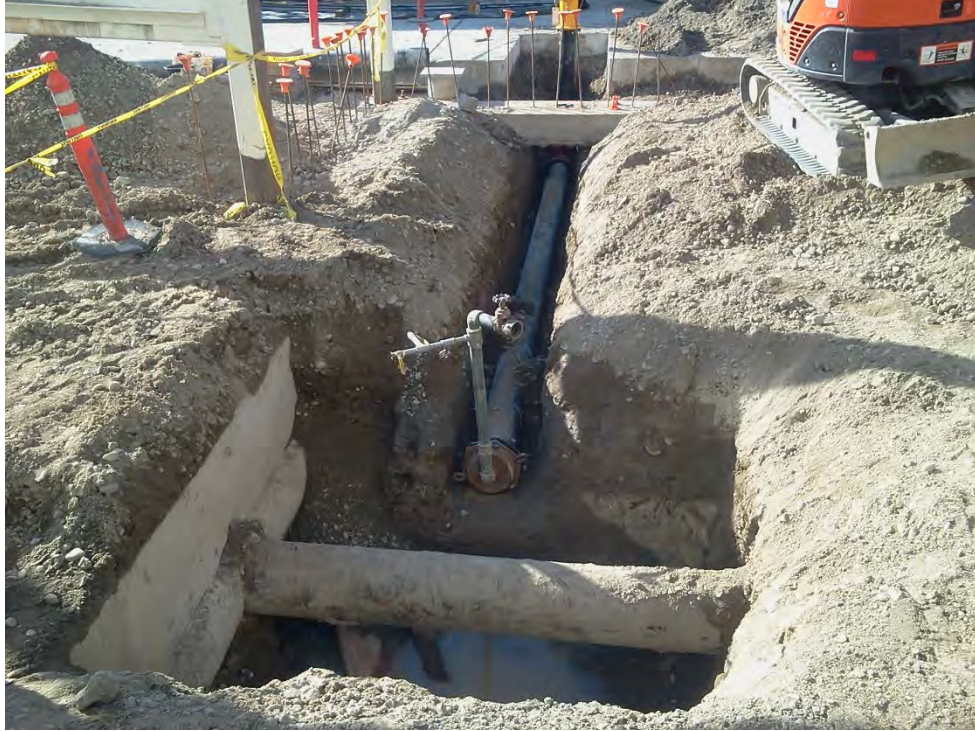
Photo 021715-01

Looking west at a water line installed in the excavated trench at Gate C10/12.
The soil was Type D 'clean' material.

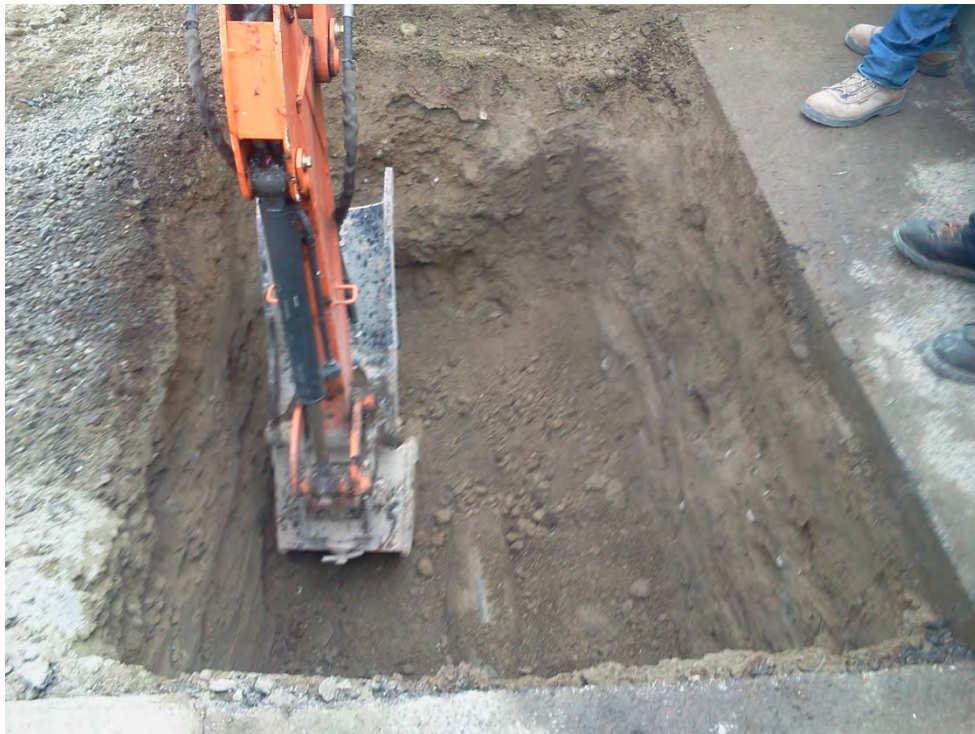
Photo 021915-01

Looking north at an IWS catch basin excavation at Gate C10/12.
The soil was Type D 'clean' material.

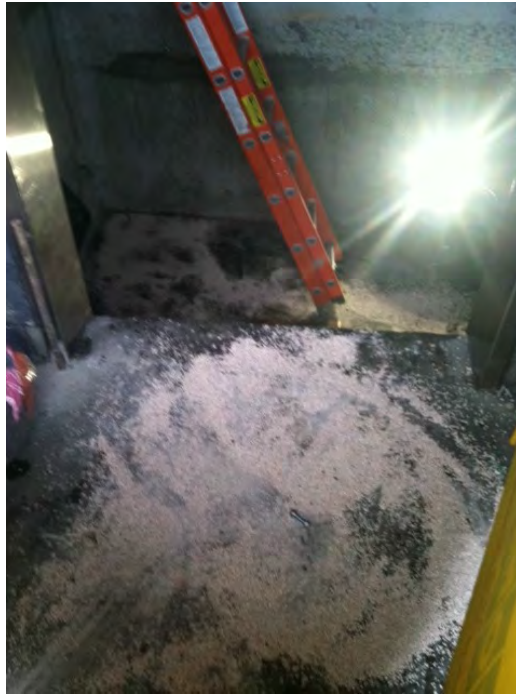
Photo 051415-001 – May 14, 2015

4. Party Responsible and Cause for Spill: KONE: Removing the jack from under the elevator without spill protection.
5. Type of Material Spilled (Describe Odor/color, if unknown): Hydraulic fluid (petroleum odor)

Looking north at the bottom of the C2 service elevator shaft with floor-dry over hydraulic fluid residue, which extends to the first floor. The elevator jack was removed without proper protection to ensure that there would be no hydraulic fluid released.

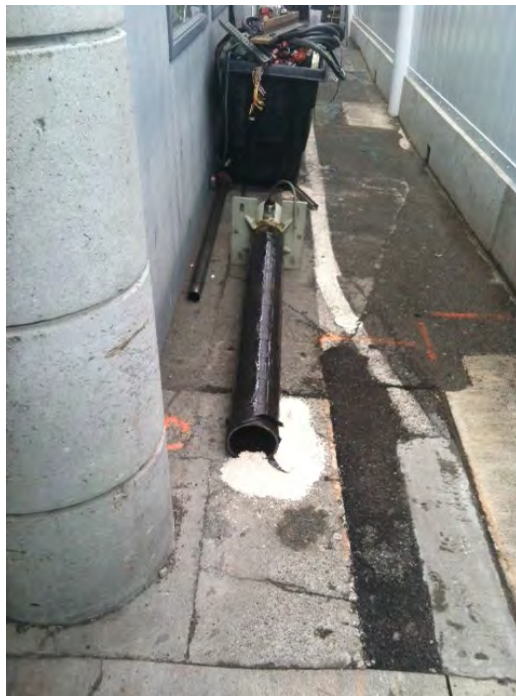
Photo 051415-002 May 14, 2015

Looking east at floor-dry placed down to soak up hydraulic fluid on pavement after the POS inspector notified the contractor that they needed to contain the release.

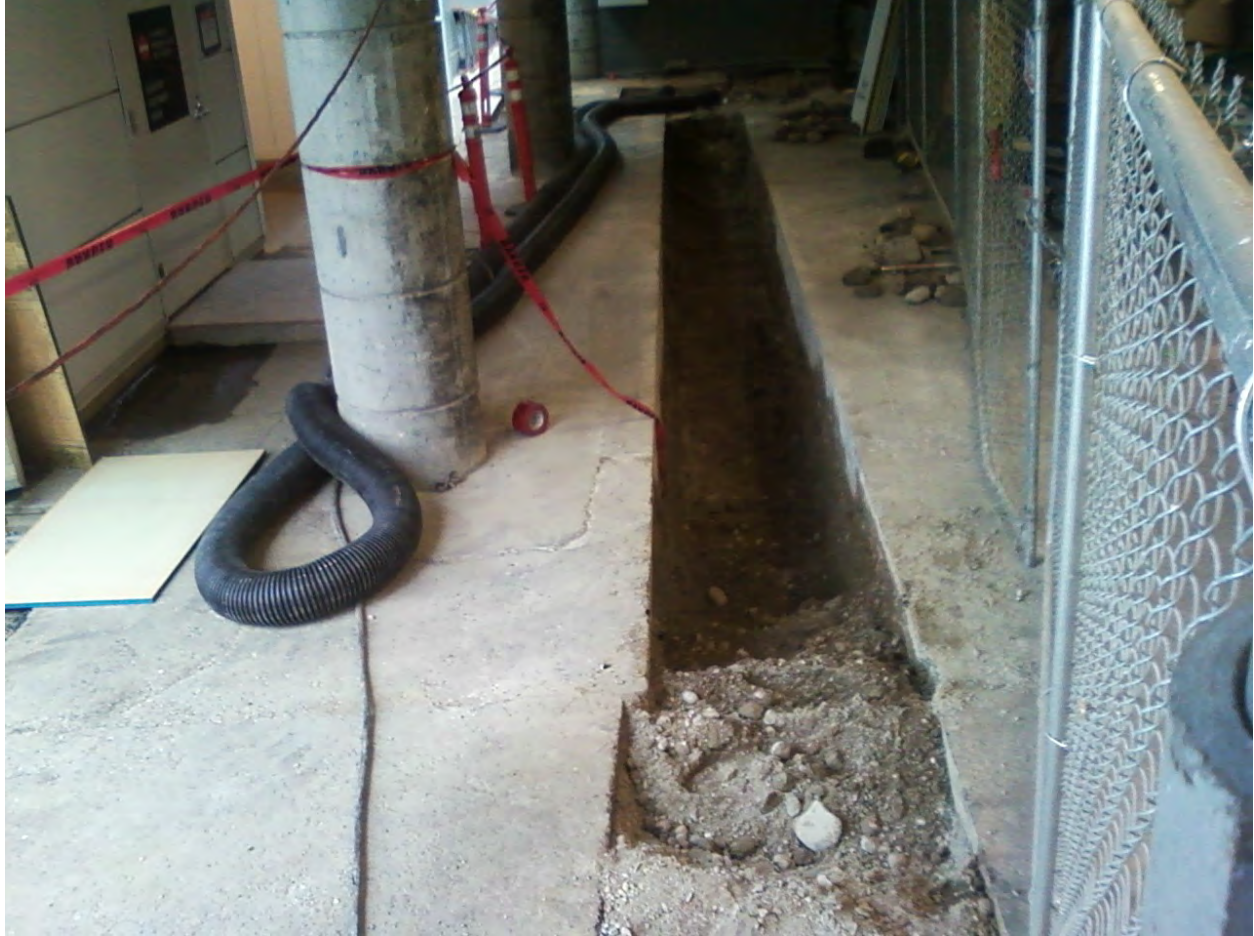
Photo 060315-001

A trench was excavated near Gate 2 to facilitate connection with the grease pits. The trench was approximately 40 feet long, 2 feet wide, 3 feet deep. Soil encountered was brown silty sand with gravel, no staining, no odors, PID = 0.0ppm (Type D 'clean' material).

Looking northwest at a trench excavated for the new grease pit at Gate C2. The trench started near northeast corner of the Horizon Airline elevator at C-2 and continued around to the southwest.

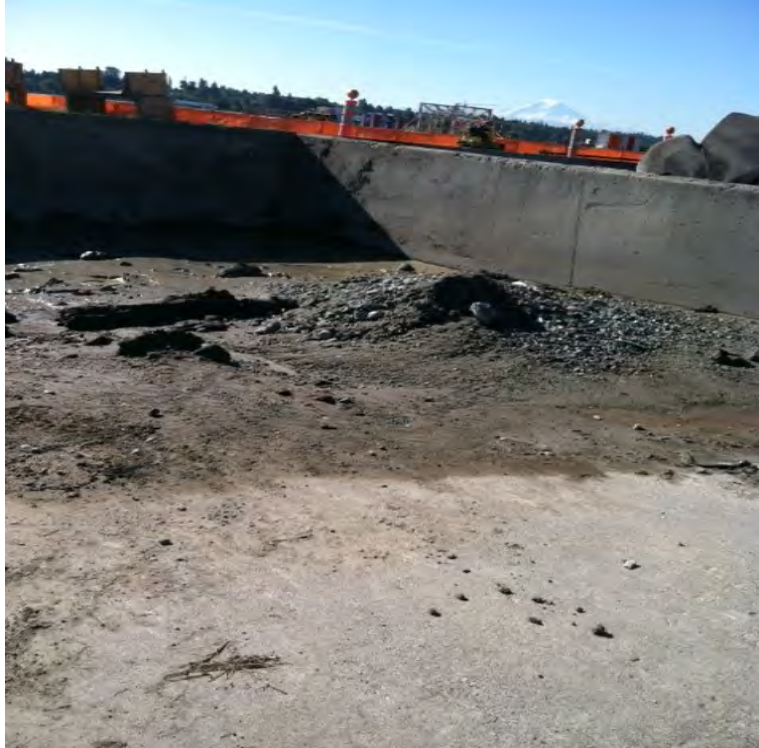
Photo 062515-001

Work during the week at Gate C14 included installing the protective bollards. The soil encountered was gray silty sand with gravel, gray staining, glycol odor, PID=0.0ppm. The Type B soil was removed using a vacuum truck and the material was placed in the Decant Cell #2 to allow it to dewater. The Port has also agreed to dispose of the material at Waste Management.

Looking southeast at Decant Cell #2 where Type B impacted material from Gate C-14 bollard installation work was placed. The small amount of soil will be hauled to Waste Management by Port Maintenance.

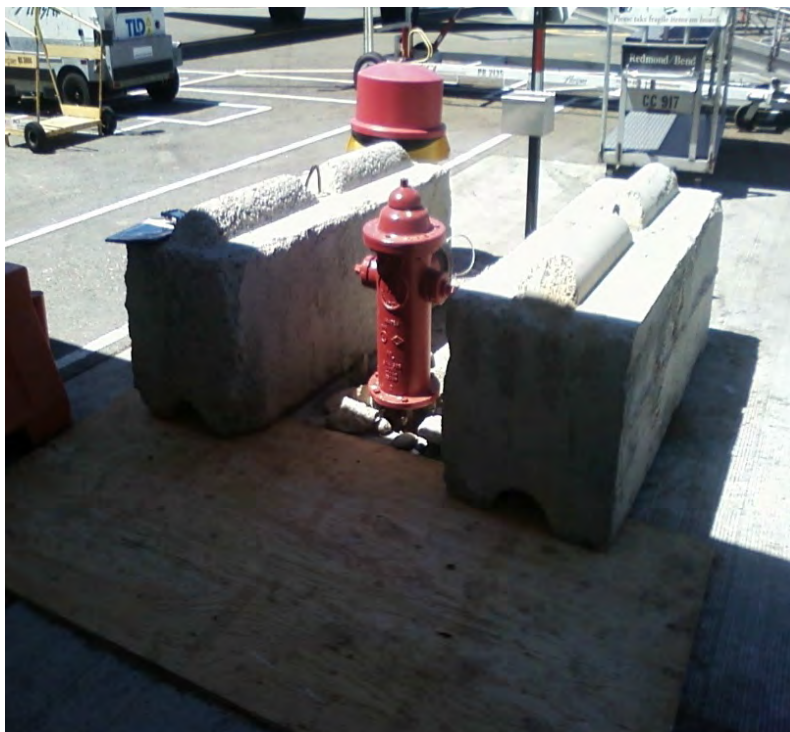
Photo 062515-002

Looking west at the bollard excavation location (under the plywood) at Gate C-14.

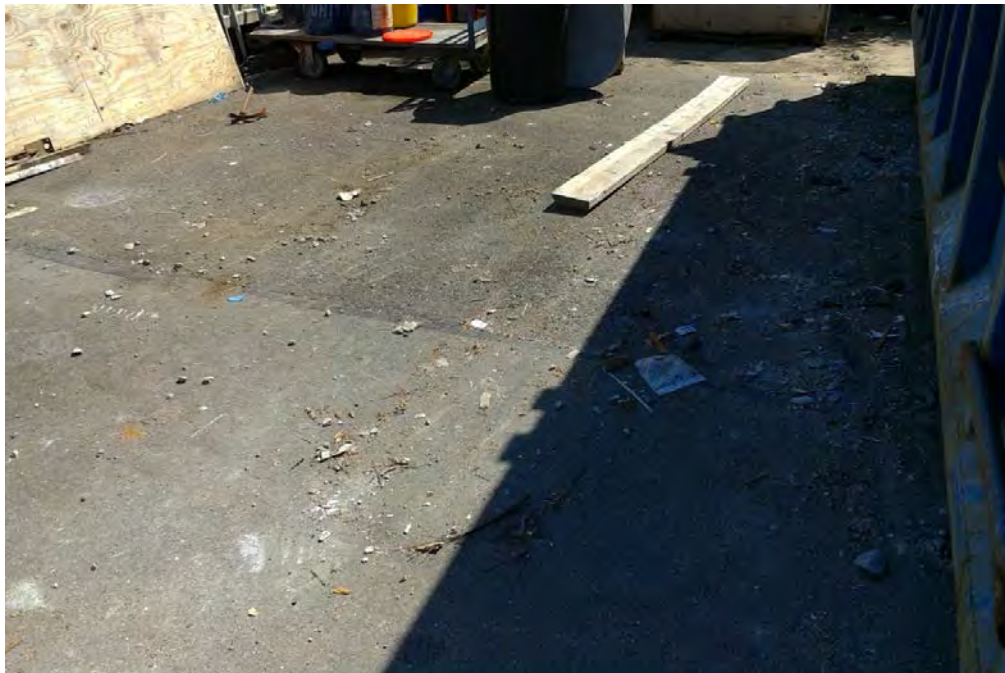
Photo 01: Debris on the asphalt around Forma yard; Lot 1-G.

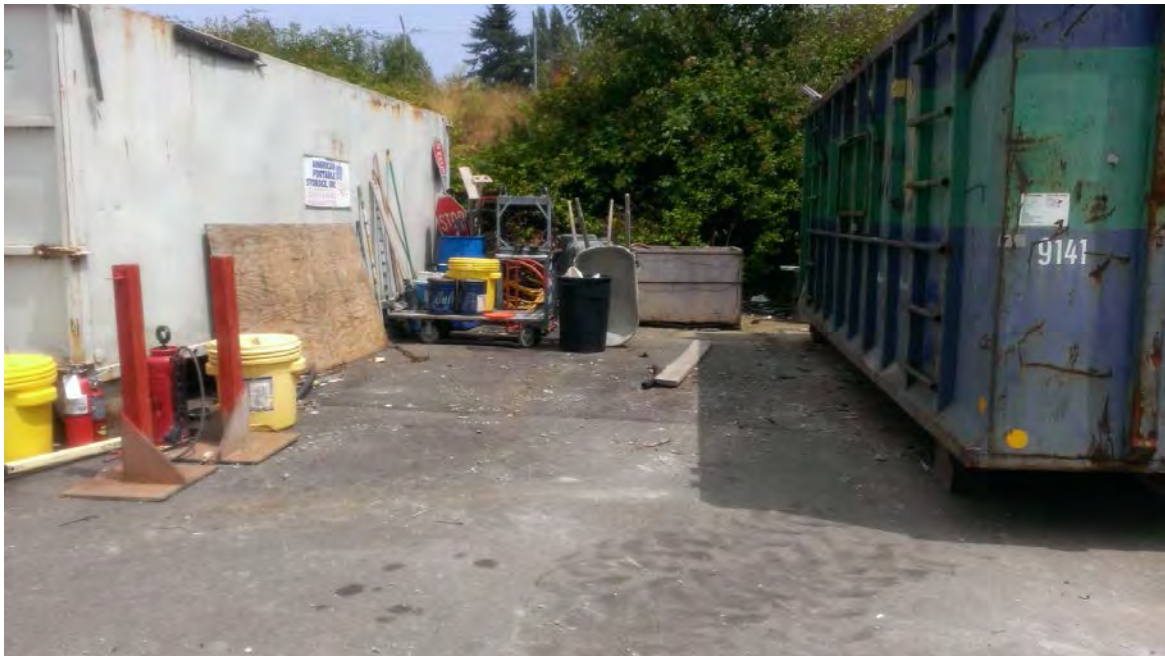
Photo 01: Debris on the asphalt pavement around Forma yard; Lot 1-G
