CONSTRUCTION FIELD PACKAGE (FORM 1)

Project ID: Concourse C Vertical Circulation Site: Concourse C
Location ID: _____ Location: Gates C2, C10/12 & C14 (see Figures 1 - 4)
Project Start Date: 05.16.14 Project End Date: 07.31.15
Report Preparer: Greg Ferris Date: 07.31.15

The purpose of the project was to install new walkways, ramps and elevators (including subsurface infrastructure) to upgrade passenger conveyance routes to and from airplanes at Gates C2, C10/12 and C14 at STIA.

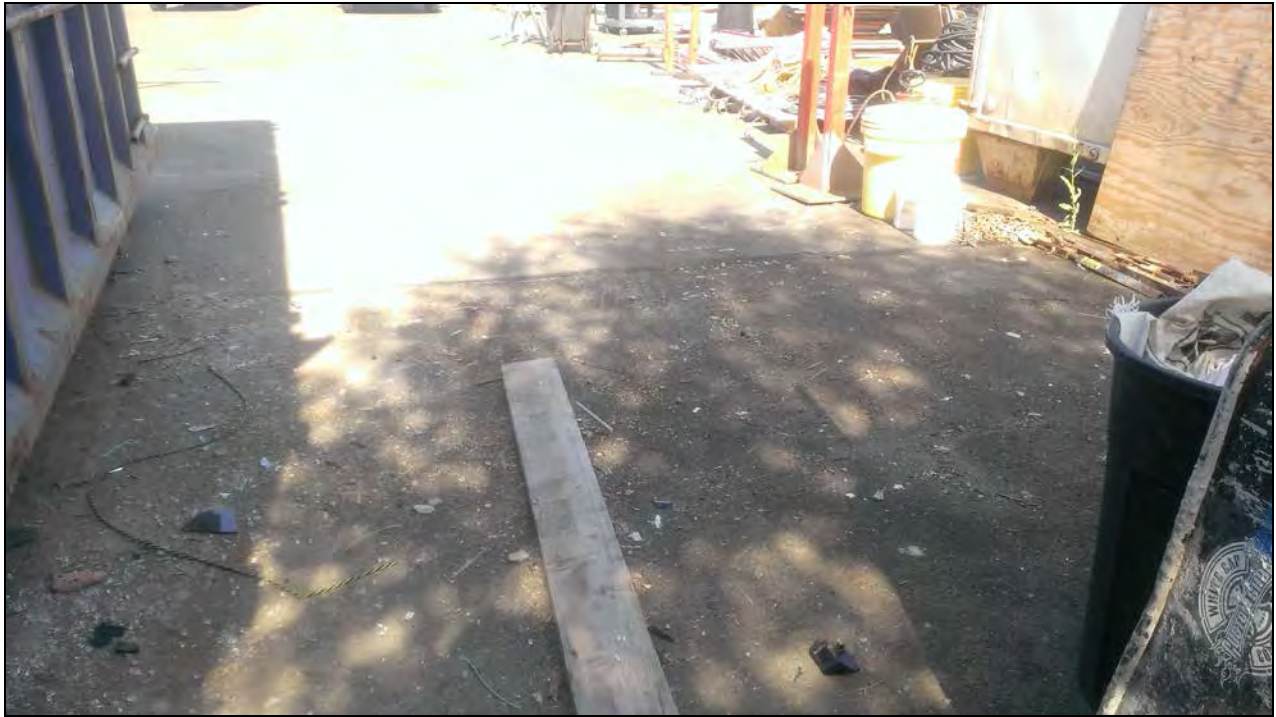
Photo 01: Debris on the asphalt around Forma yard; Lot 1-G

Project	Concourse C Vertical Circulation - 104784		
Construction Prime Contractor	FORMA Construction		
Inspection Date	7/17/2015		
HM Inspector, Company	Rory Petrilli, DH Environmental Inc.		
Distribution	Rad Milosavljević , POS Resident Engineer	milosavljevic.r@portseattle.org	
	David Jenkins, POS Stormwater Engineer	jenkins.d@portseattle.org	
	Stacy Fox, POS Environmental Program Mgr.	fox.s@portseattle.org	
	Christian Heimbigner, POS Construction Inspector	Heimbigner.C@portseattle.org	
	Caleb Peats, FORMA Construction	calebp@formacc.com	
	Brad Shuman, FORMA Construction	brads@formacc.com	
	Greg Ferris, Aspect Consulting	gferris@aspectconsulting.com	
	Dave Hill, DH Environmental, Inc.	hill.d@portseattle.org	
Observations			
<p>Actions Required/Comments:</p> <p>BMPs were implemented as required at all construction areas at the time of inspection.</p> <p>There was debris on the asphalt in the Forma yard in Lot 1-G which was on swept on 7/15/15 which will prevent debris from entering the storm drains.</p>

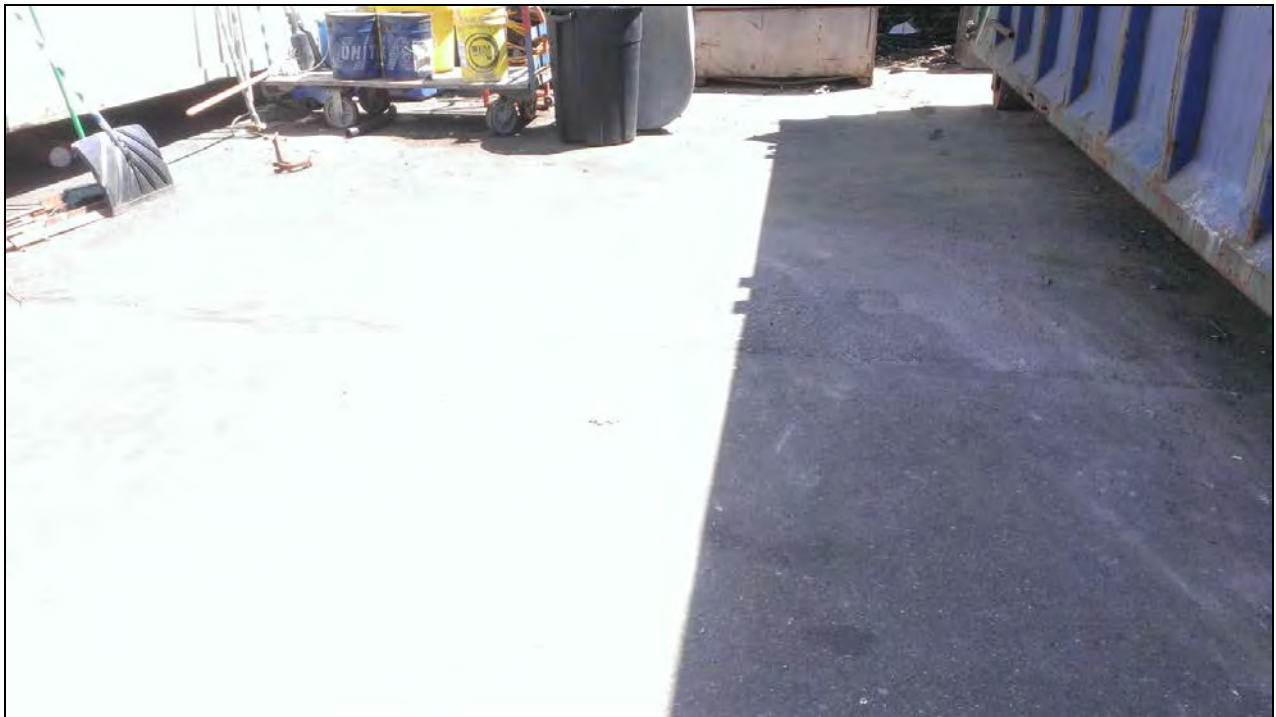
Photo 02: The Forma yard in Lot 1-G was swept on 7/15/15.
