# LUST REMOVAL & REMEDIATION REPORT

1451 Mapleway Road  
Yakima, Washington 98902  
Yakima County Tax Parcel No. 181433-34416

January 7, 2019  
PLSA Project No. 18350

**Re: Leaking Underground Storage Tank Removal & Remediation  
1451 Mapleway Road  
Yakima, Washington 98902**

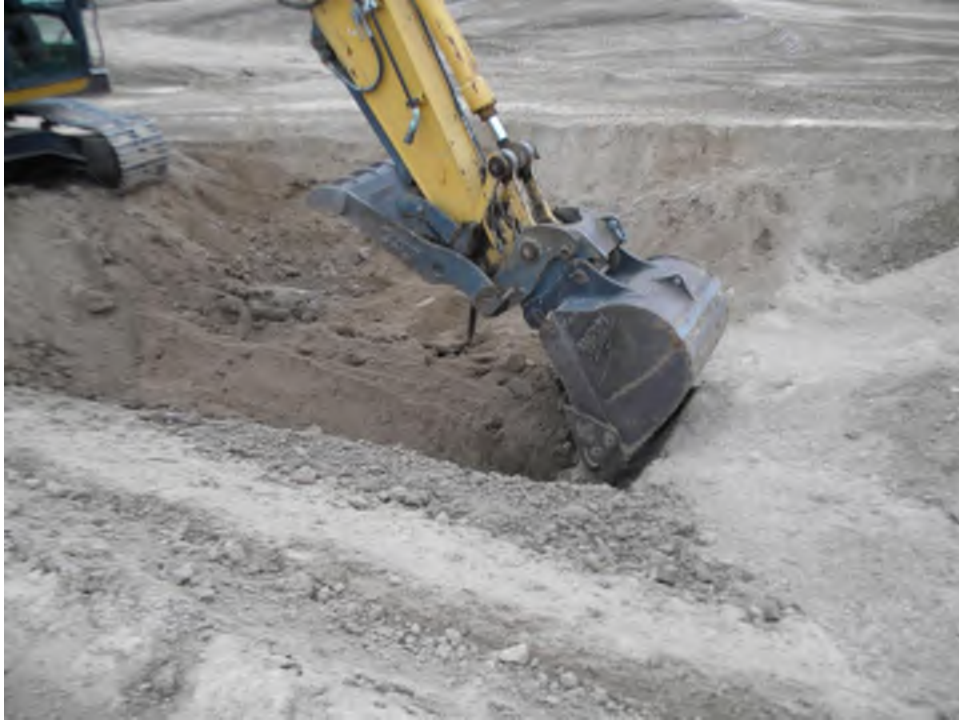
Figure 3: Excavating Tank

On November 21, 2018 Ken Leingang Excavating (KLE) was on site to excavate and remove the leaking tank and the resulting contaminated soils. A total of 91.88 tons of Petroleum Contaminated Soil (PCS) was removed and disposed of at Anderson Rock & Demolition Pits in Yakima, Wa. (Appendix C)

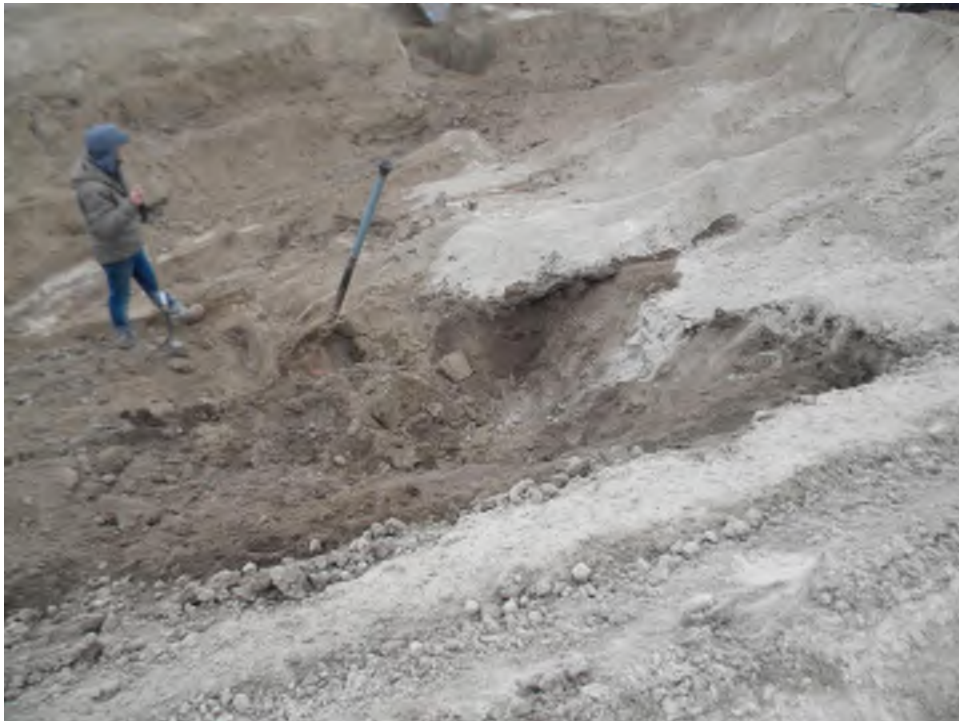
Figure 4: Excavating Tank

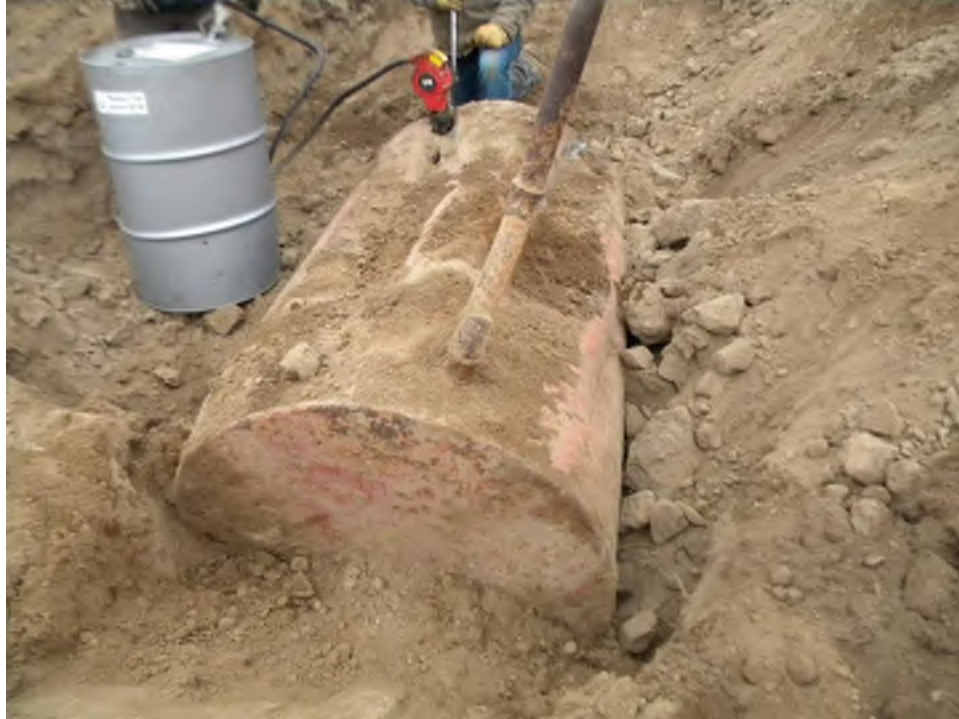
Figure 5: Pumping Fuel from Tank

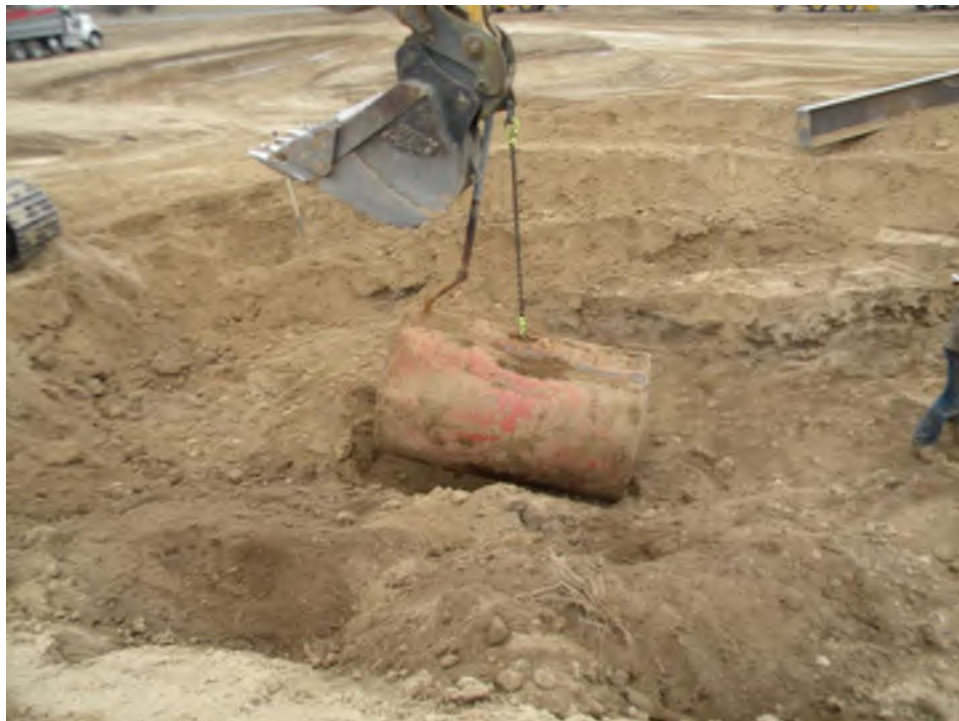
Figure 6: Removing empty tank

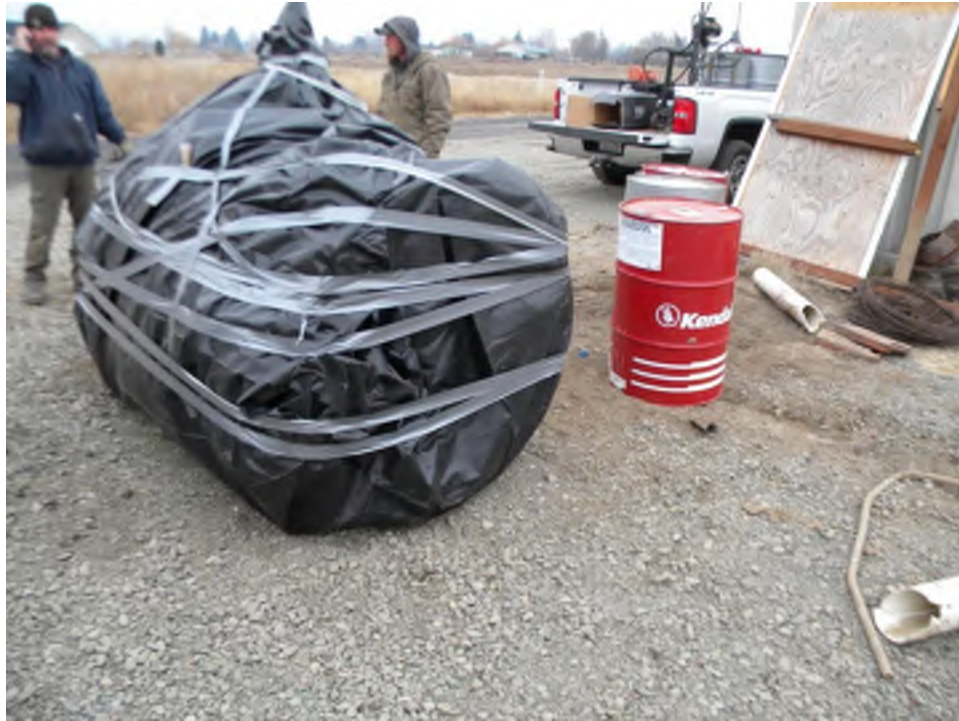
Figure 7: Tank and Barrels stored onsite

On December 11, 2018 Emerald Services Inc. out of Tacoma Washington was onsite to clean and remove contaminated fuel and the gasoline tank that was stored onsite. (see figures 7, and 15-18). The tank was opened after being made inert by filling with 40 lbs. of dry ice. The tank was then cleansed so it could be removed from site. The drums of contaminated fuel were pumped and cleansed as well. The contaminants were disposed of by Emerald Services Inc. The tank was taken to Pacific Steel and Recycling and the contaminated fuel, 213 gallons was disposed of at Emerald in Seattle, Wa. (Appendix C)

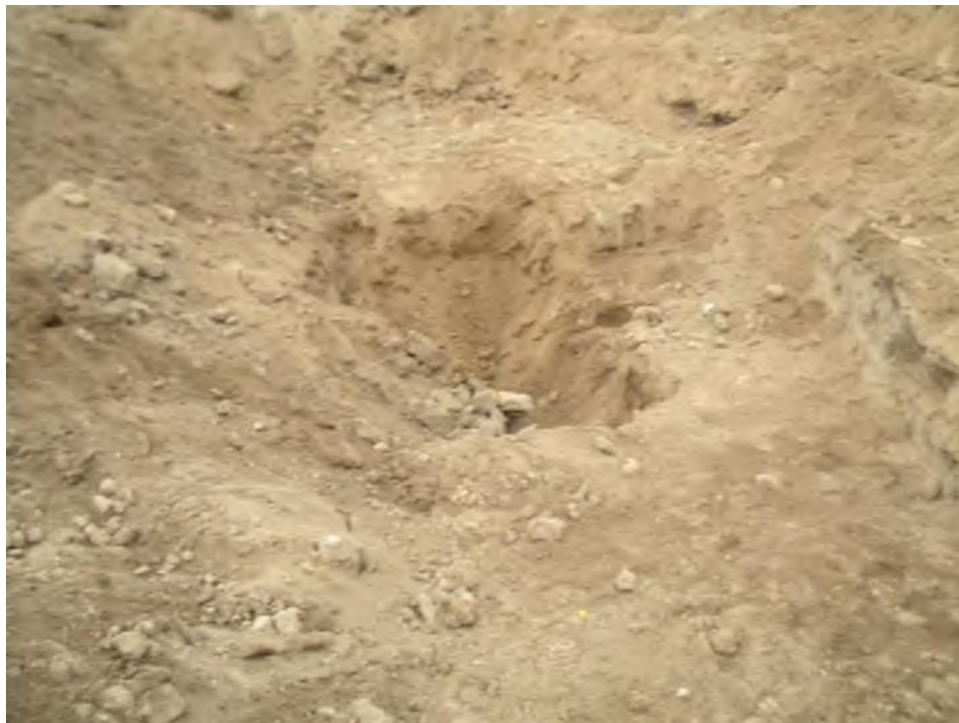
Figure 8: Tank pit

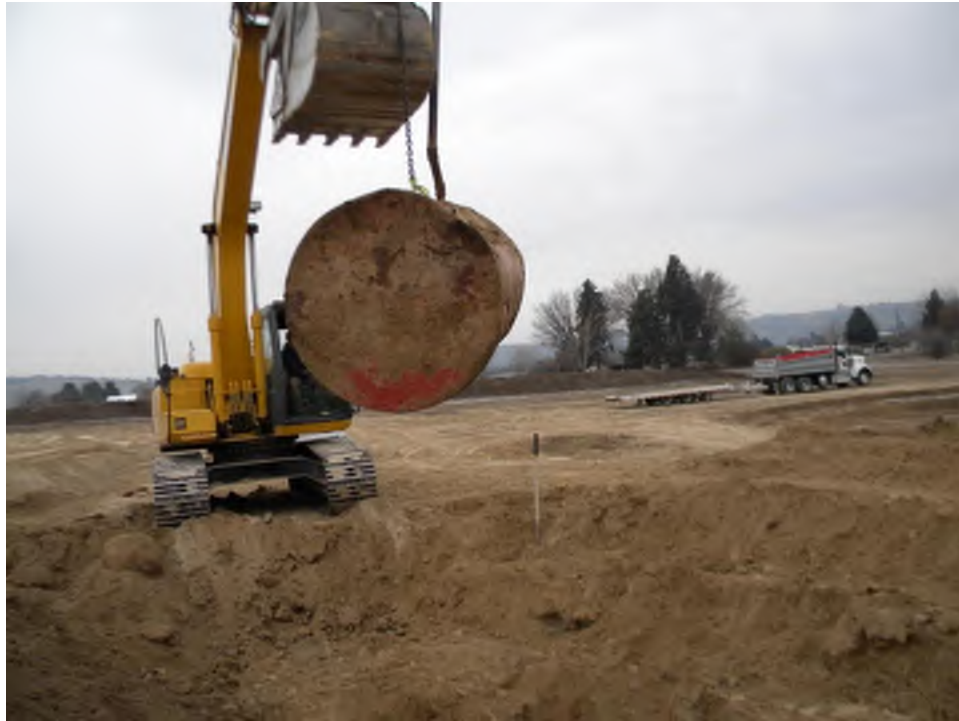
Figure 9: North end of Tank

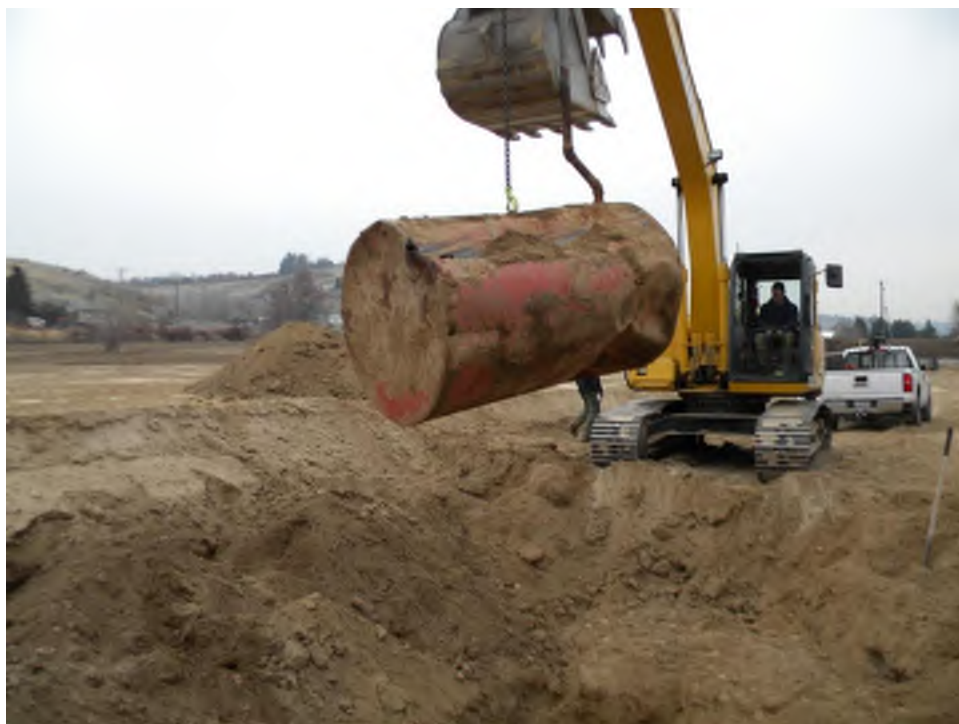
Figure 10: West side of Tank

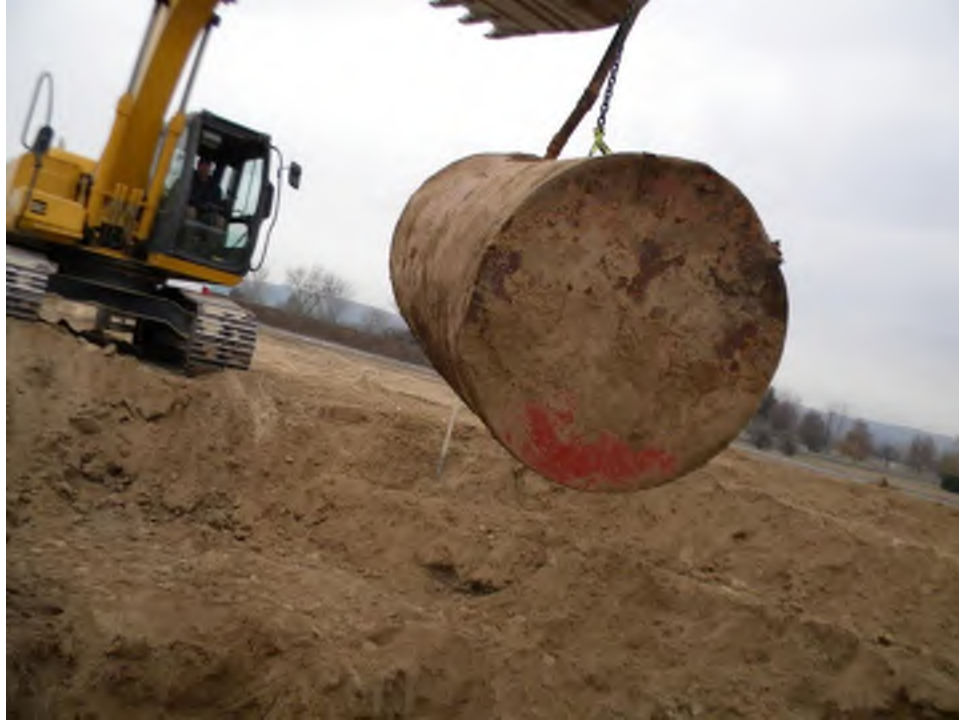
Figure 11: Northeast end of Tank

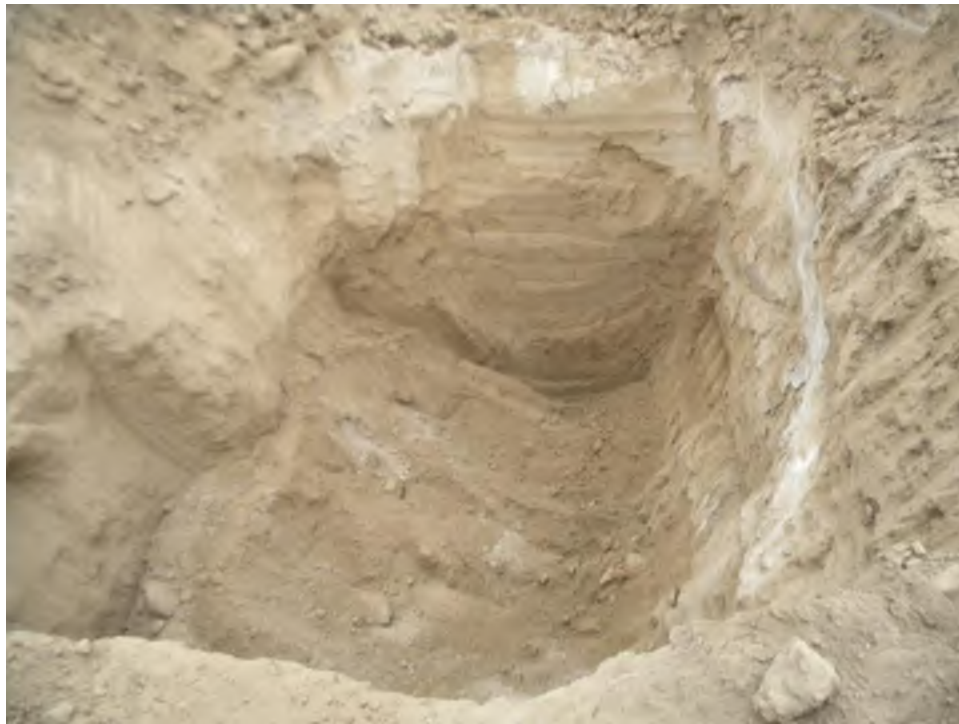
Figure 12: Excavated contaminated area facing west

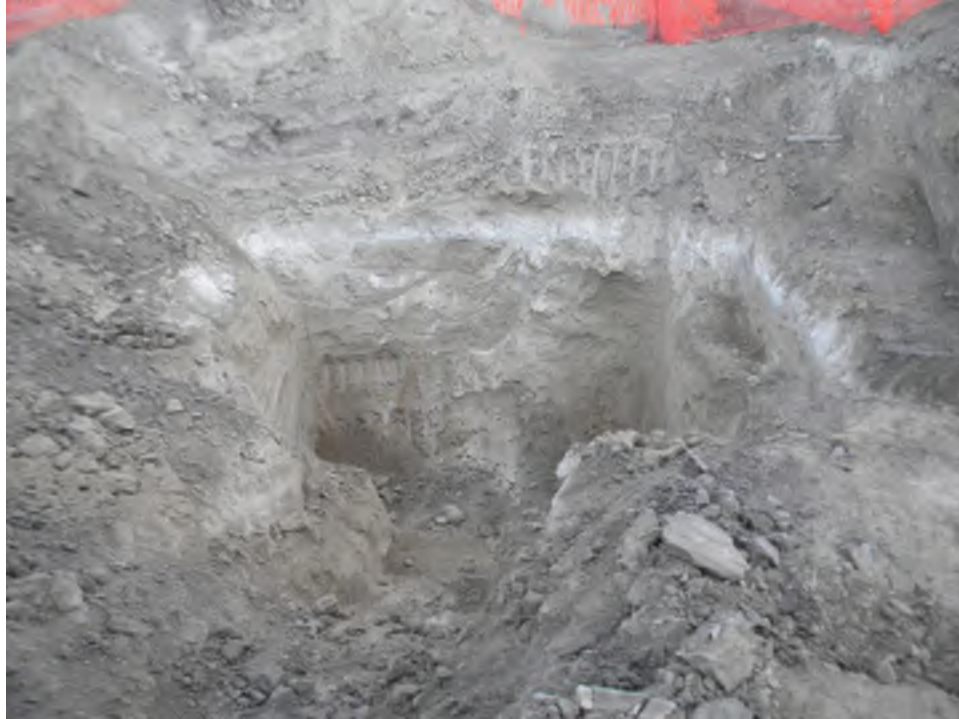
Figure 13: Excavated contaminated area facing north

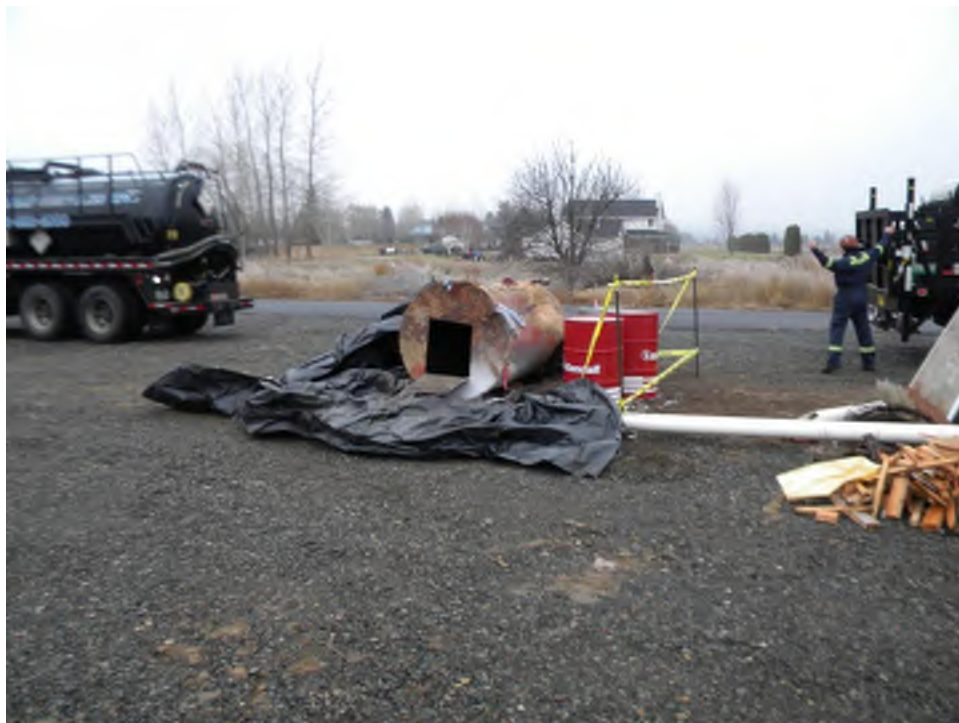
Figure 14: Tank cut for cleanout after inerting with dry ice

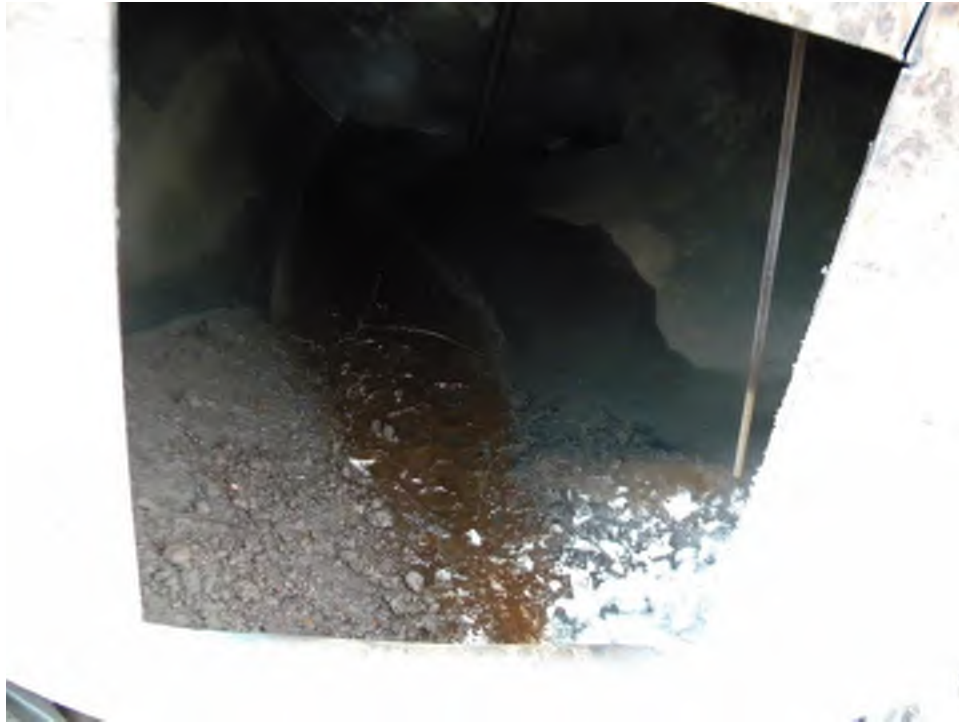
Figure 15: Sediment inside tank

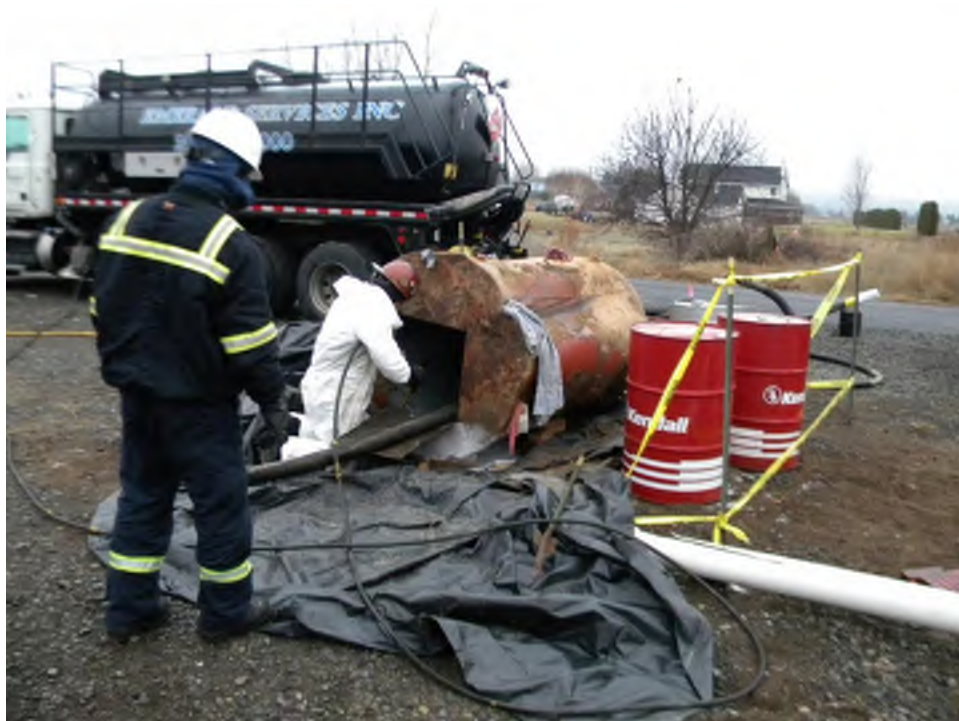
Figure 16: Cleaning out tank

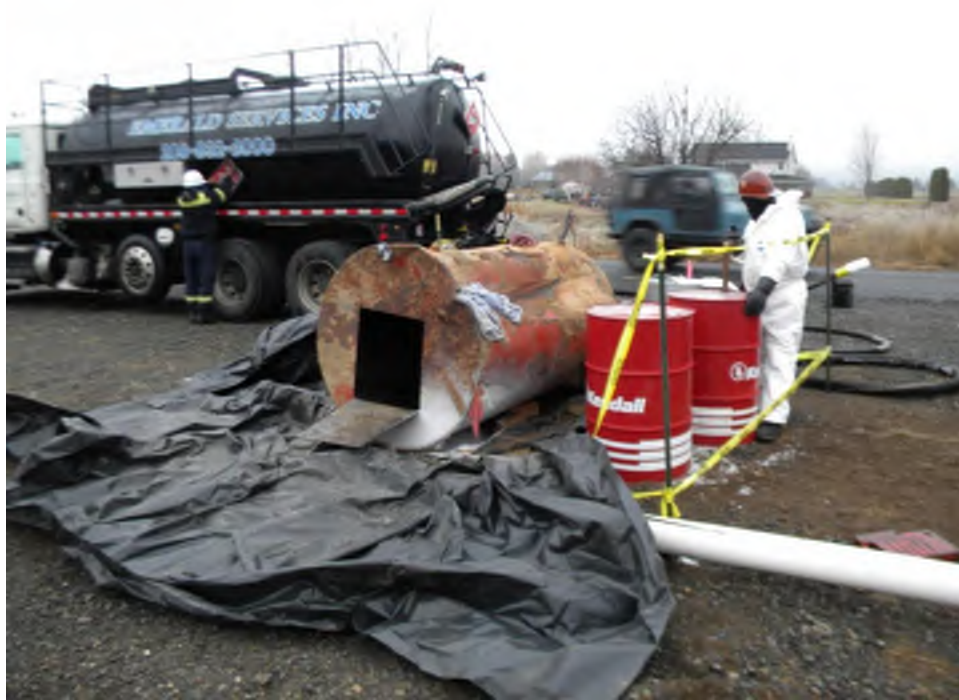
Figure 17: Cleaning out barrels

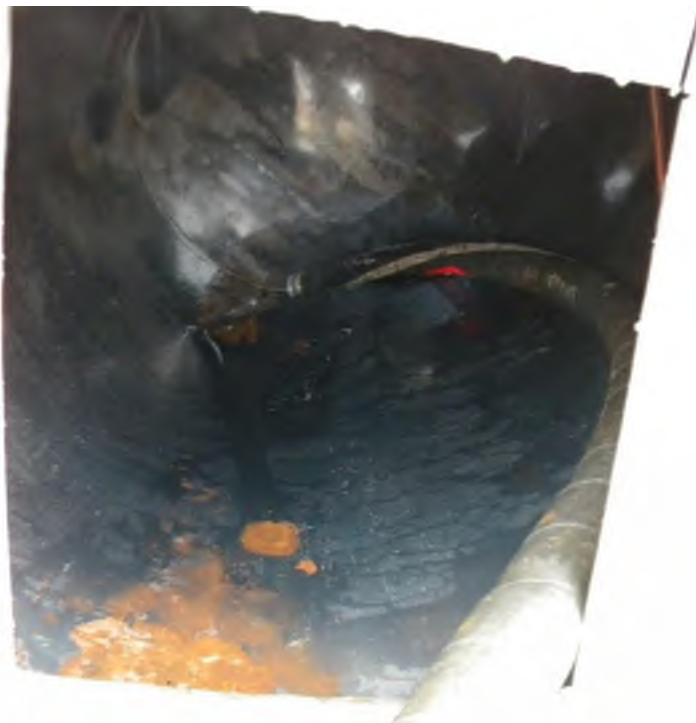
Figure 18: Cleaned tank for disposal

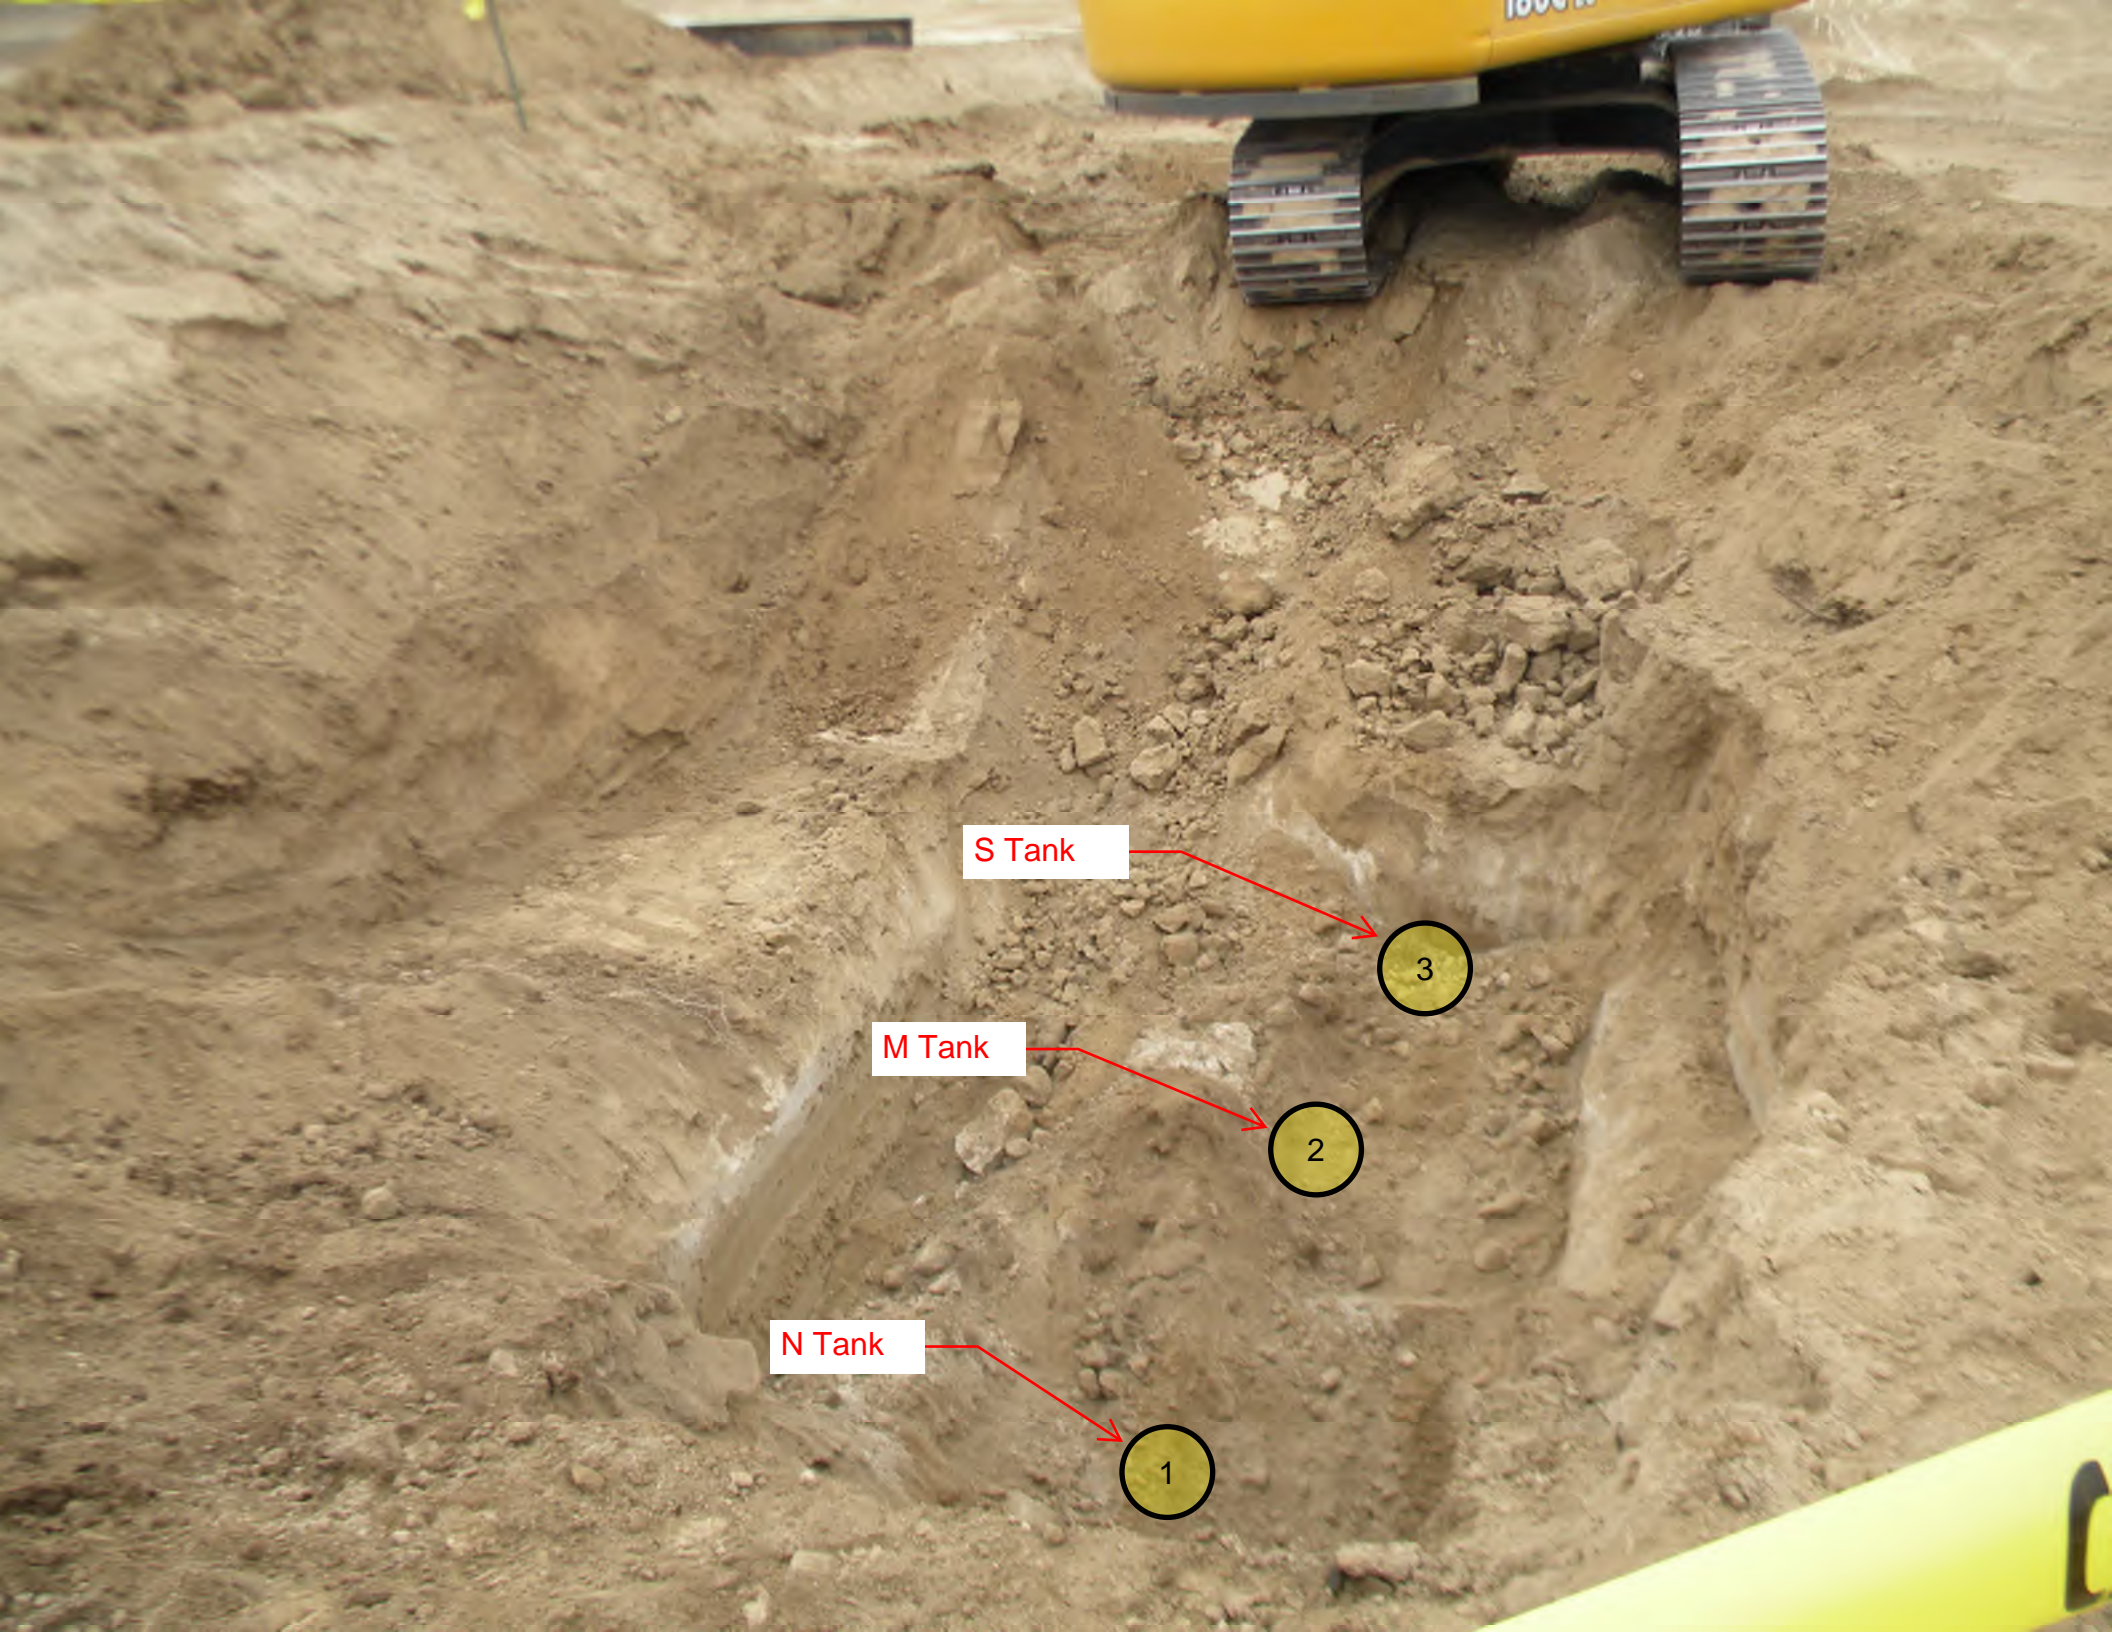
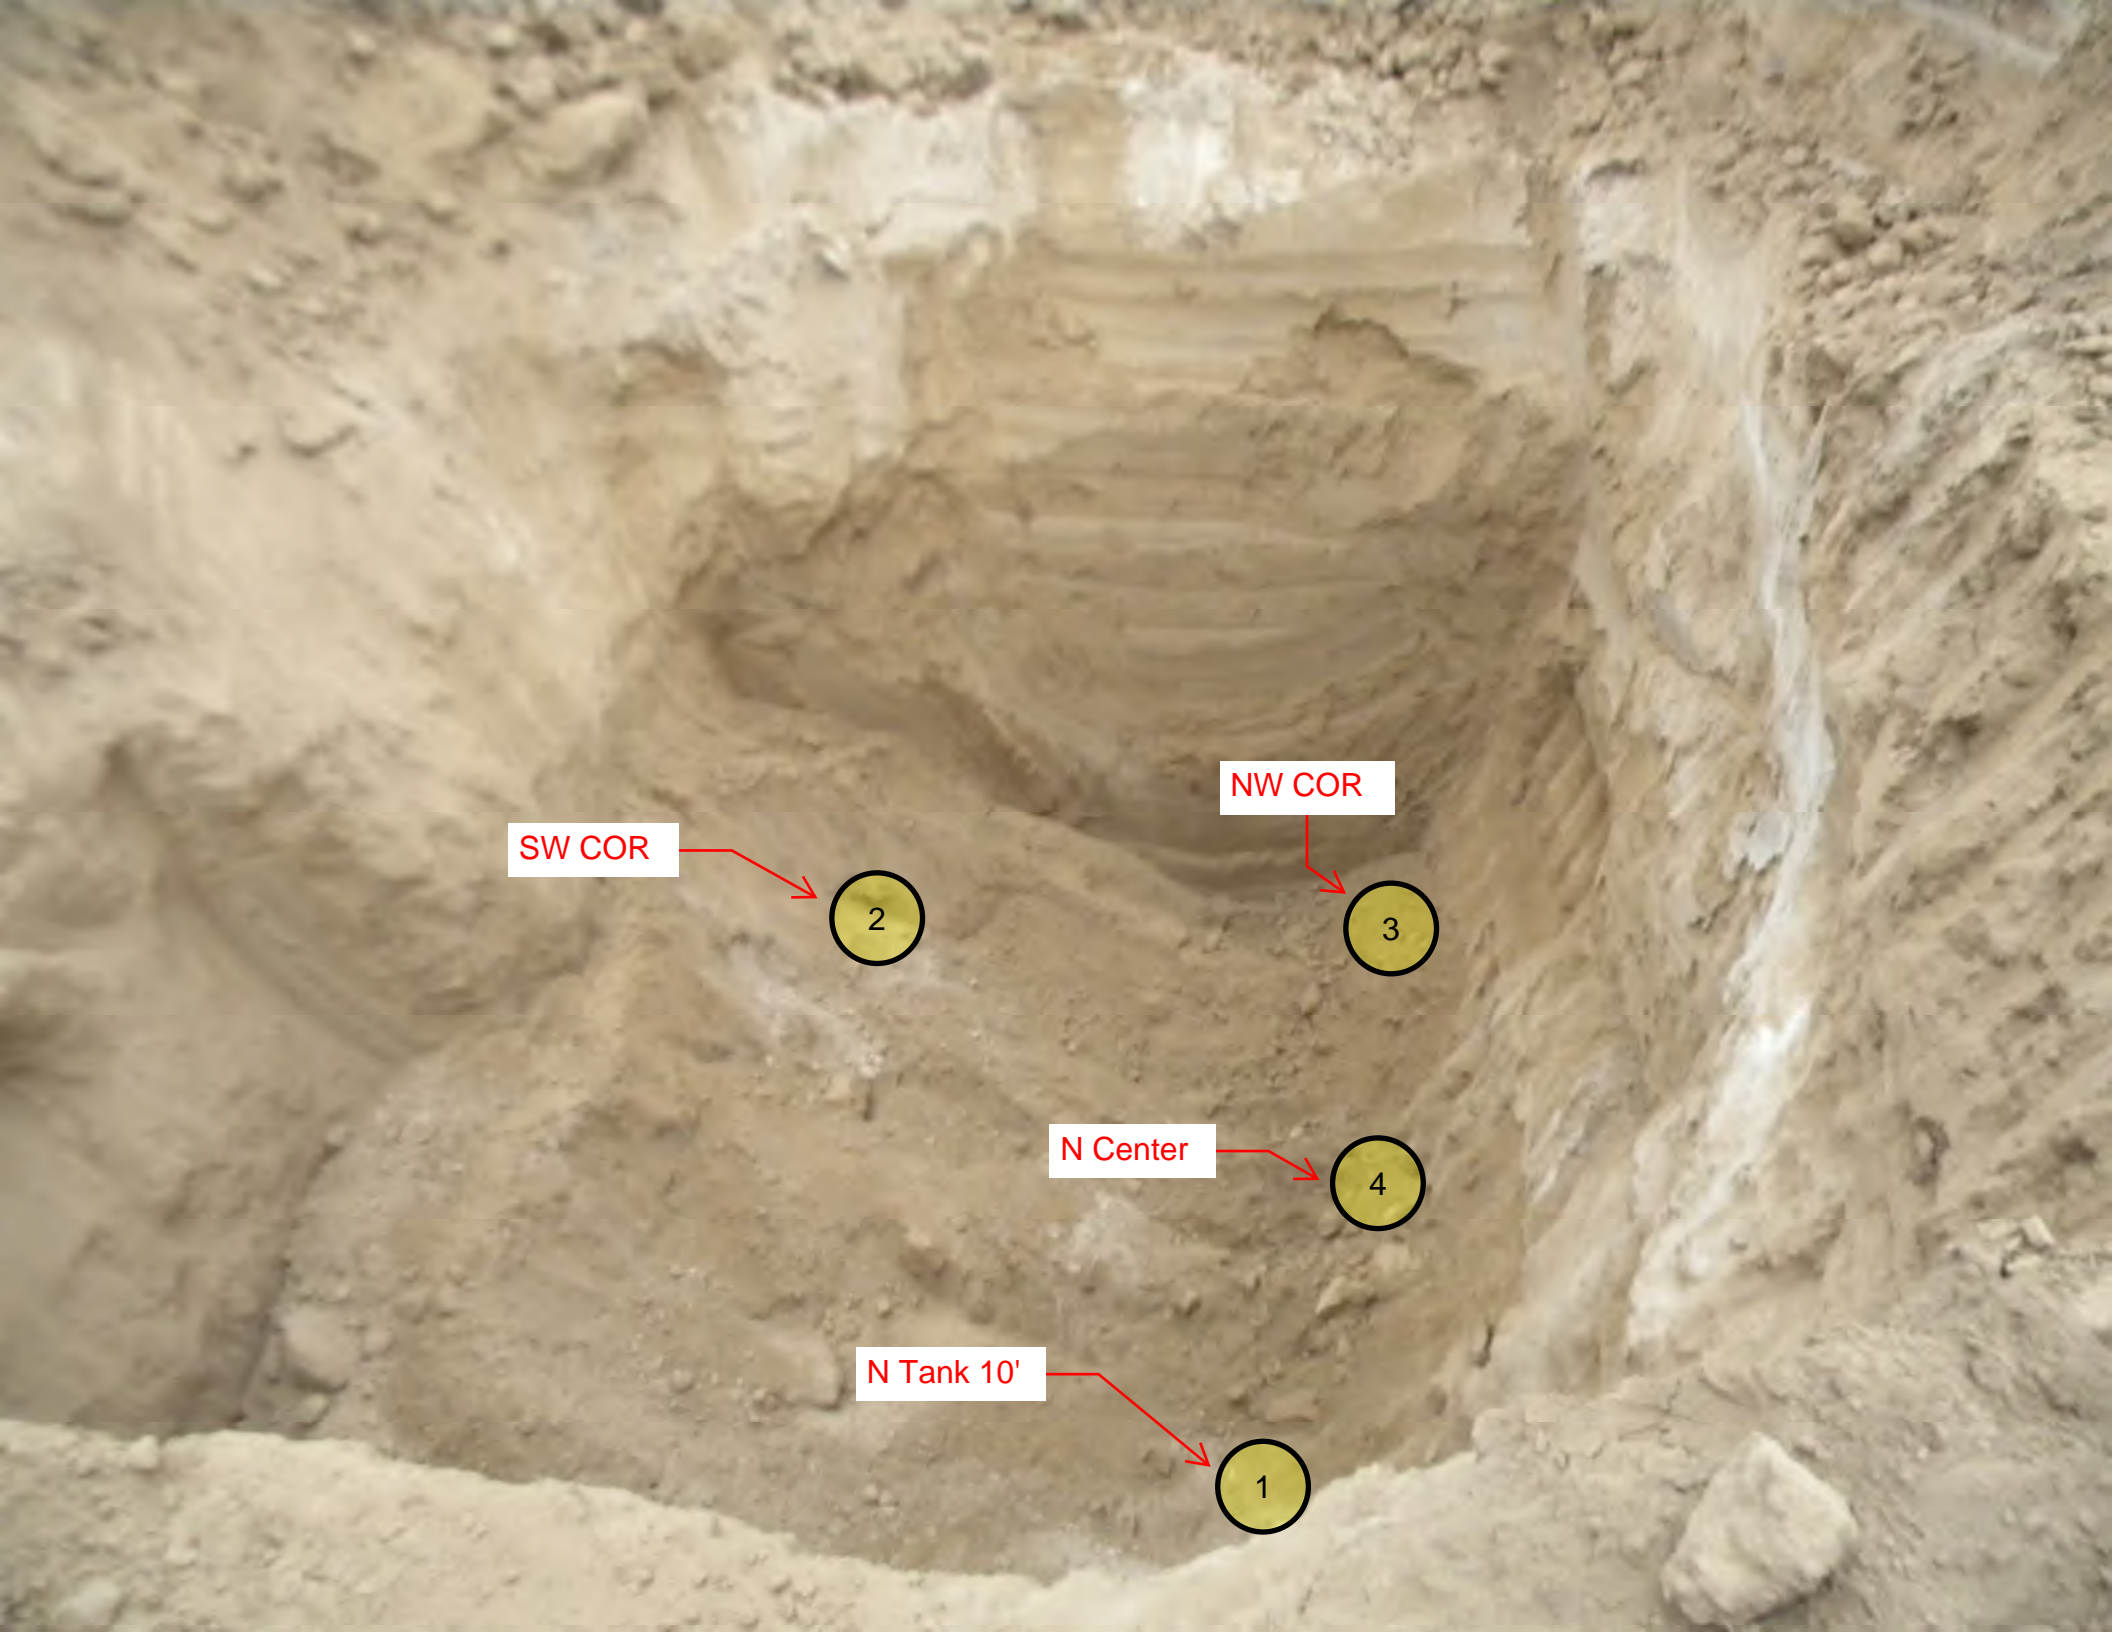
N Tank sample at 5 feet bgs  
M Tank sample at 5 feet bgs  
S Tank sample at 5 feet bgs  
N Tank 10' sample at 10 feet bgs  
N Center sample at 13 feet bgs  
NW COR sample at 13 feet bgs  
SW COR sample at 13 feet bgs
