PHASE I ENVIRONMENTAL ASSESSMENT

Convenience Retailers, LLC Station No. 2702840
Site No: 2702840
12807 Des Moines Memorial Drive
Seattle, King County, WA 98168
BOA Project Number: 14-005522-ENV02-001

Date: September 23, 2014

Property Solutions Project No. 20143047

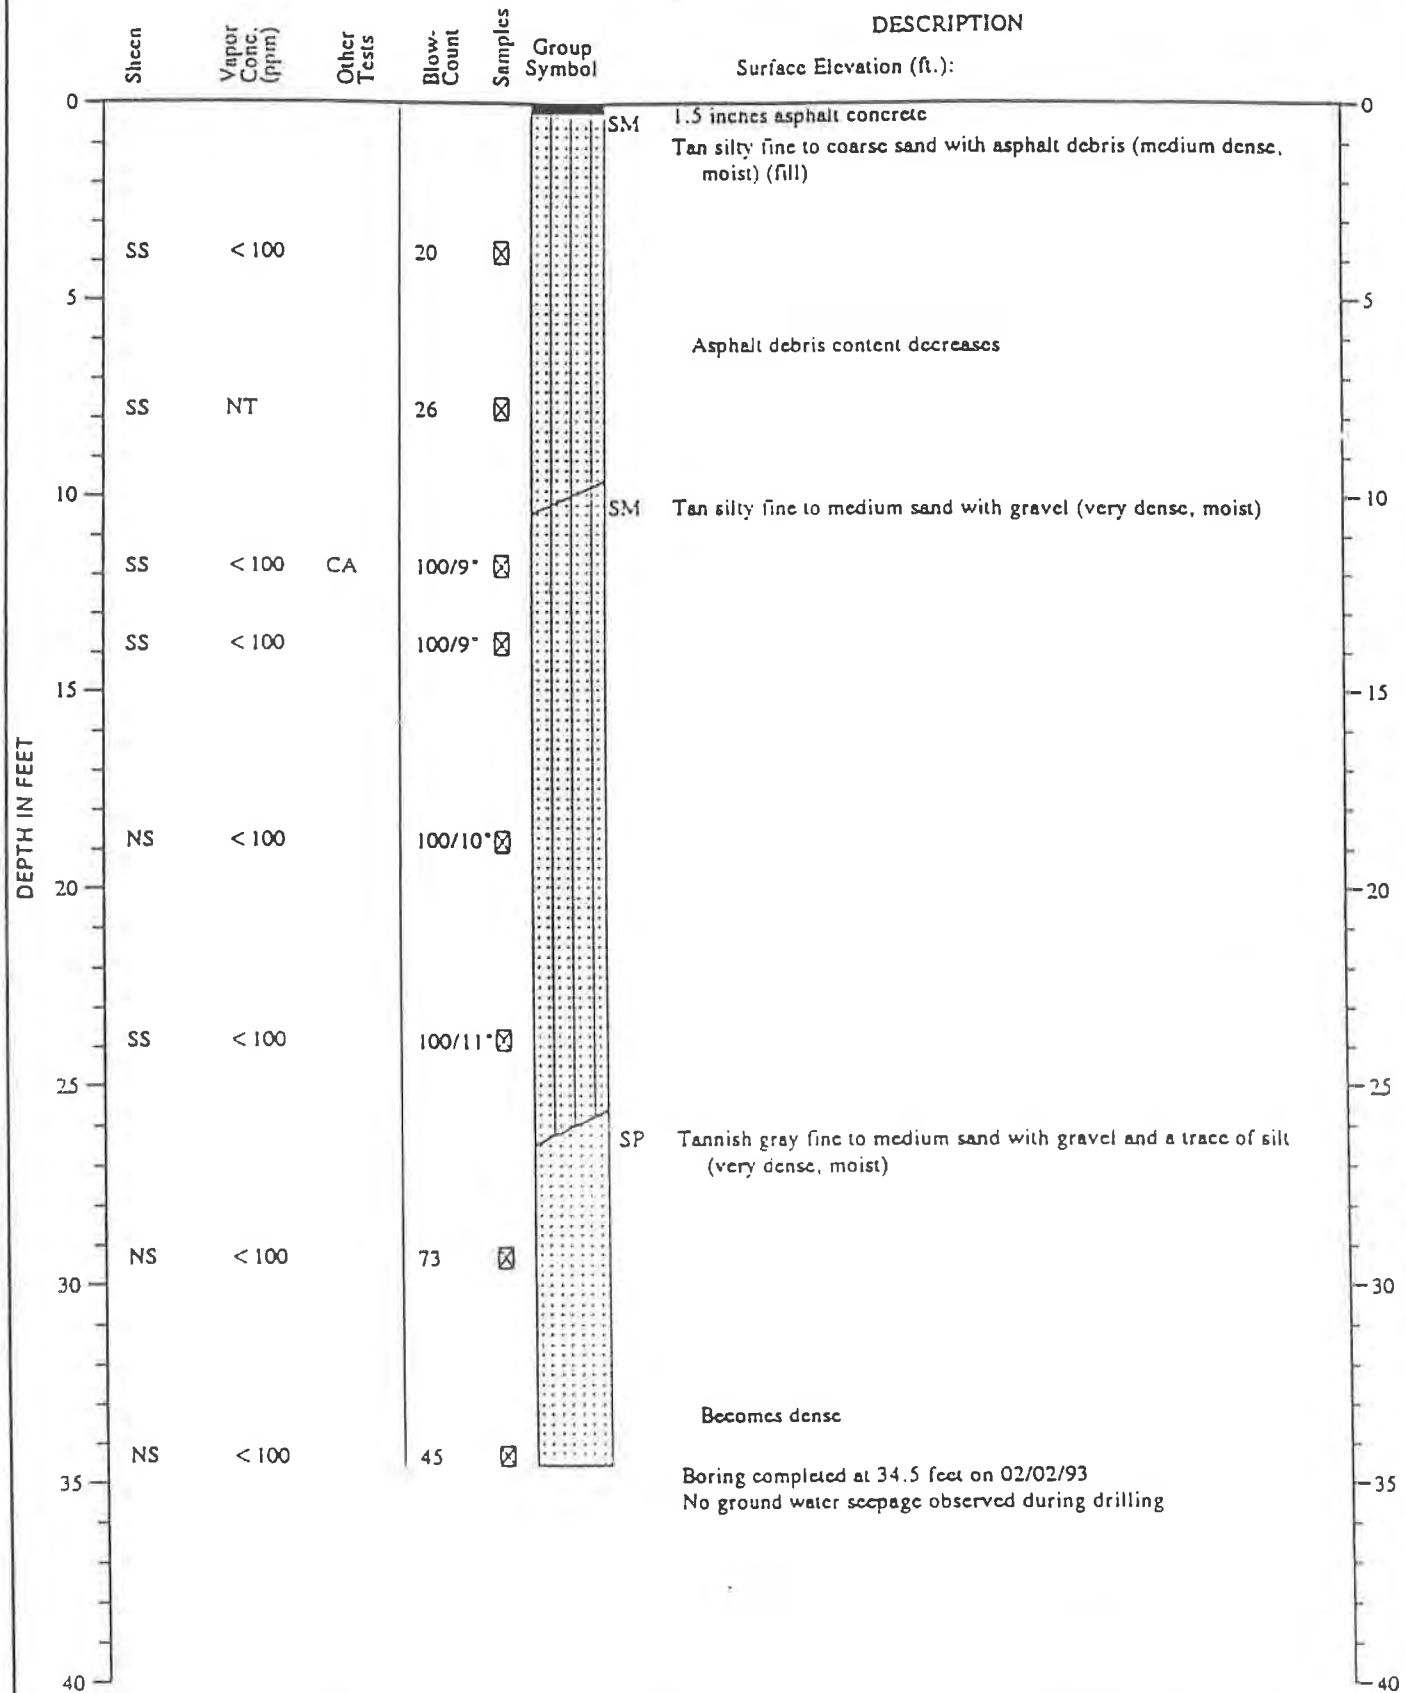
BORING B-2

TEST DATA

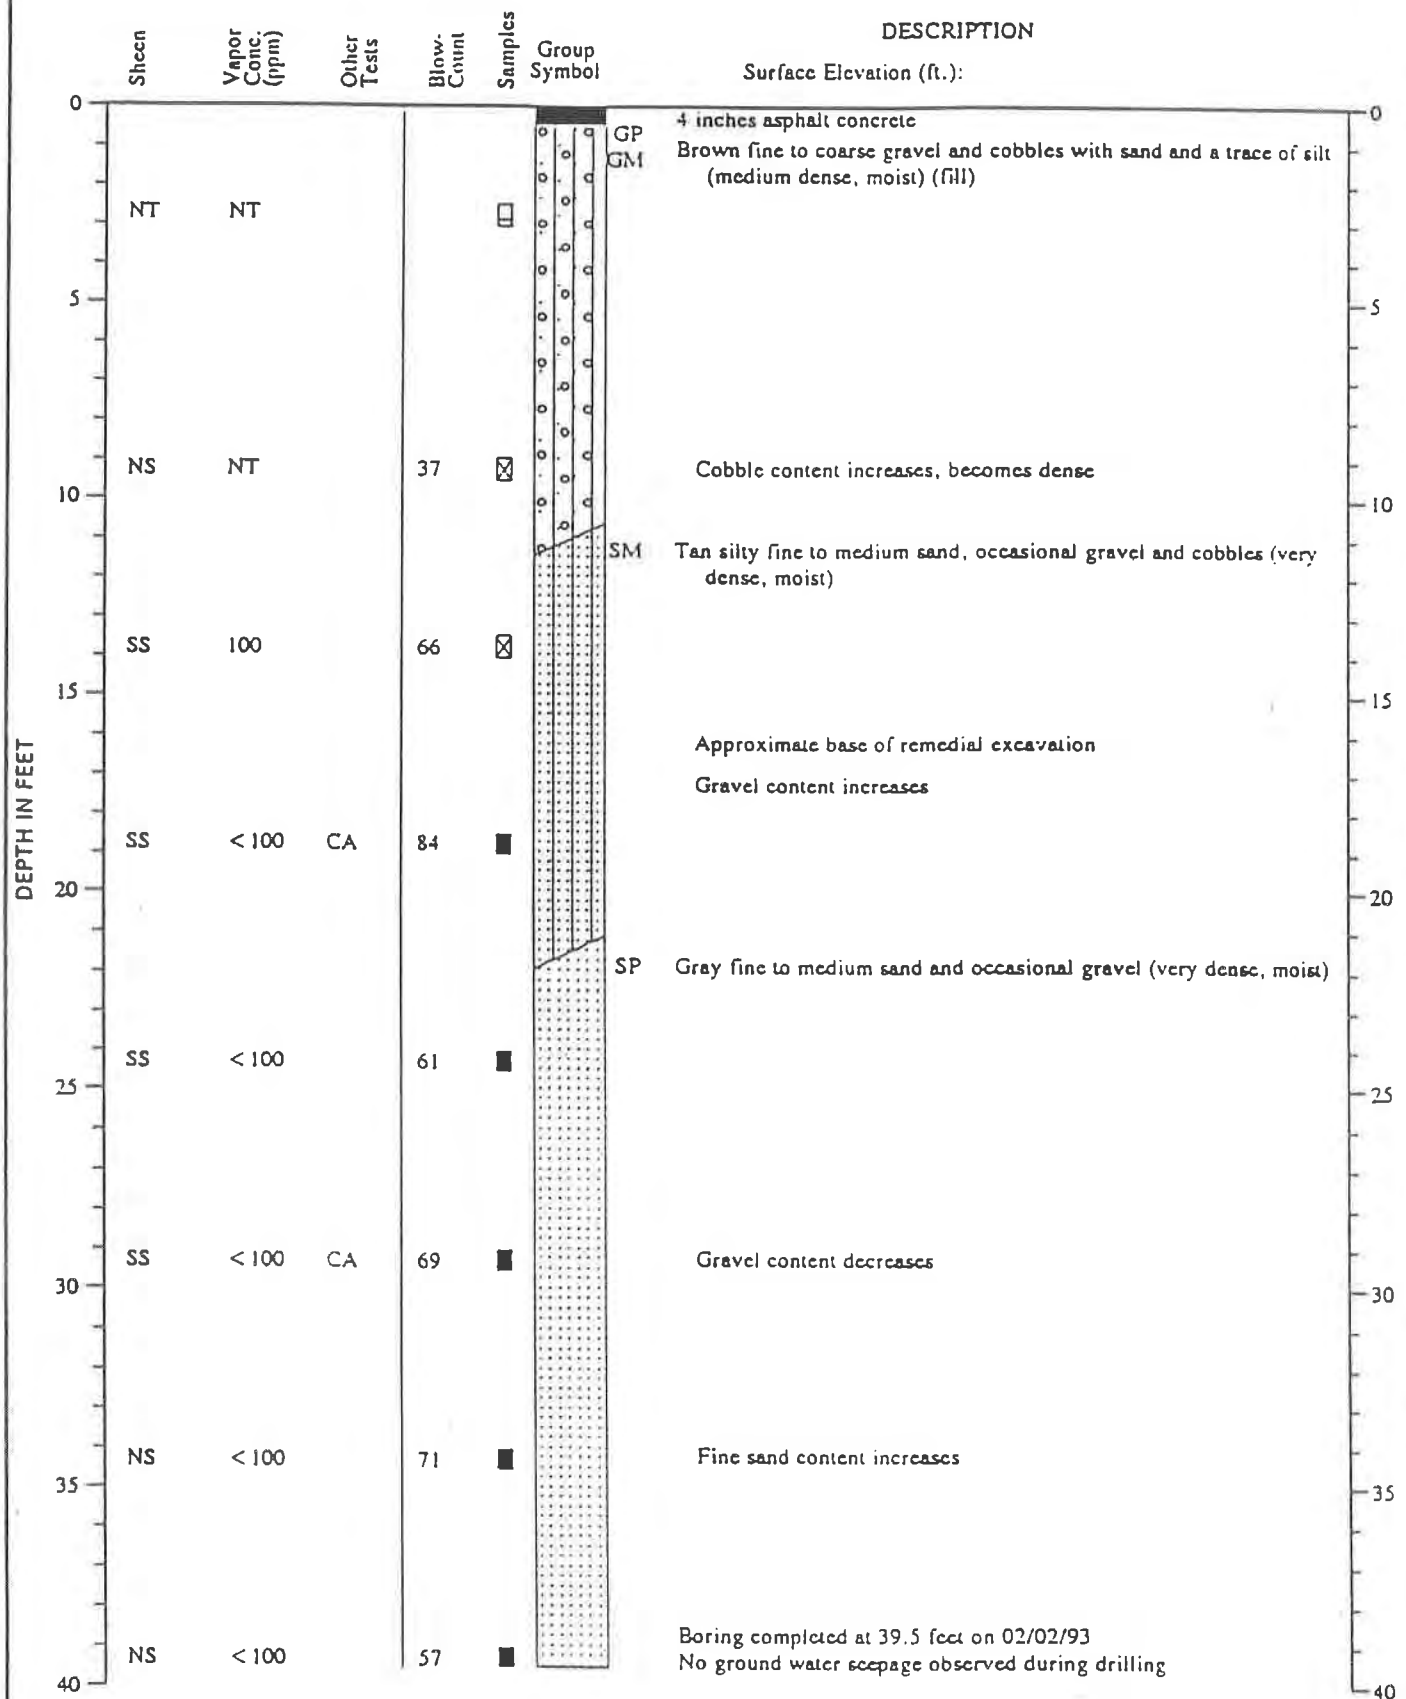
BORING B-3

TEST DATA
