PERIODIC REVIEW REPORT FINAL

**Bank of Pacific Property
Facility Site ID#: 61774897
Cleanup Site ID# 6381**

**20 Butler Street
Cathlamet, Washington 98612**

April 2019

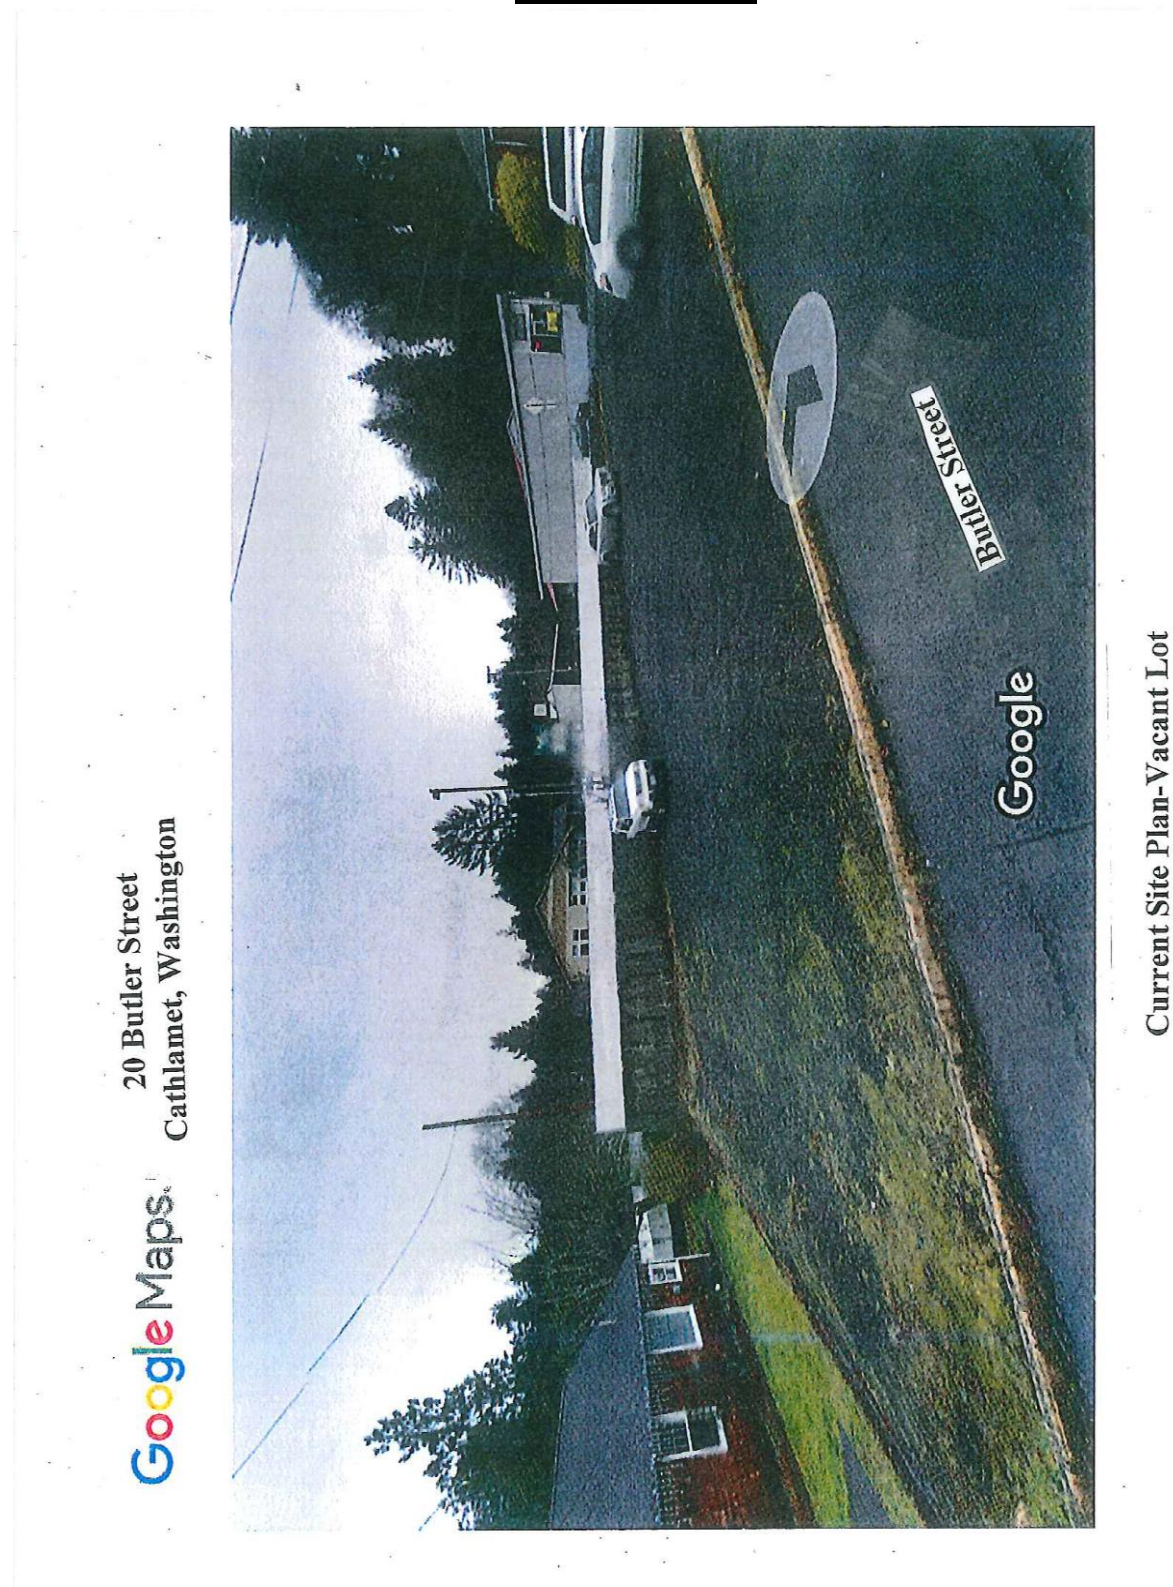
6.2 Current and 1999 Site Plans

Current Site Plan

Current Site Plan-Vacant Lot

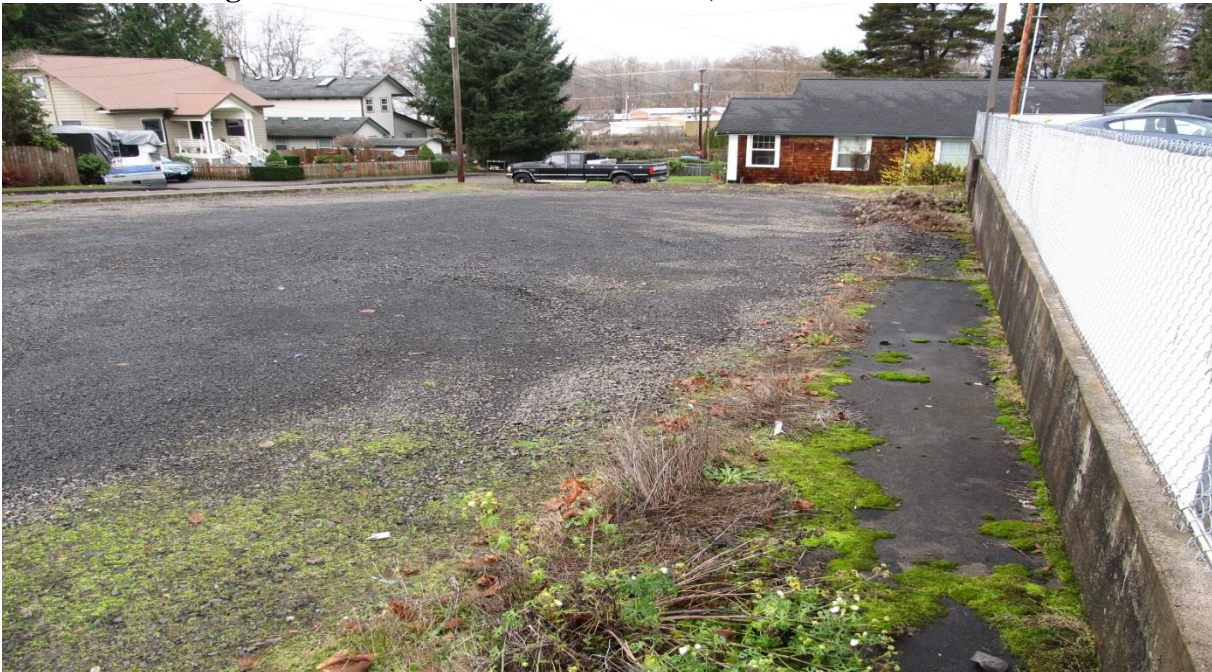
Photo 1: Bank of Pacific Property Site (20 Butler Street Property-Vacant Lot) and Retaining Wall/Fence (Northwest of the Site)—From the Southeast

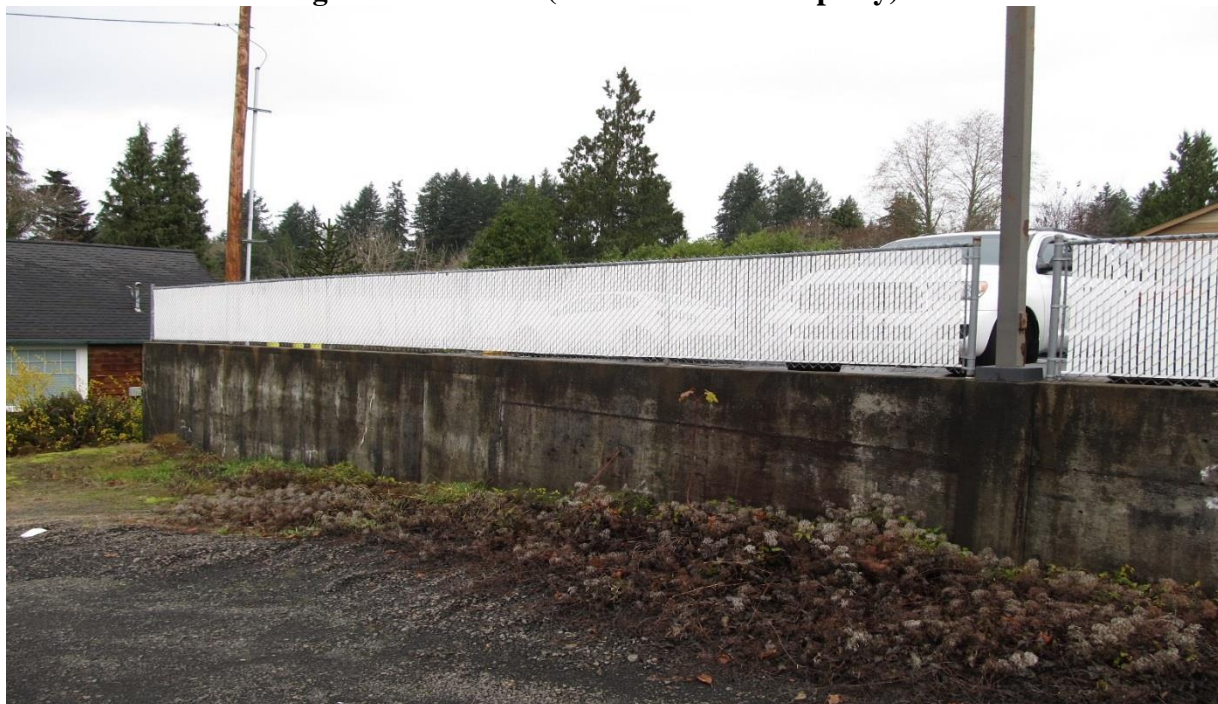
Photo 2: Bank of Pacific Property Site (20 Butler Street Property-Vacant Lot) and Area of Contaminated Soil Left In-Place Next to the Retaining Wall Between Two Poles; Bank's Parking Lot to the East (58 Main Street Property)—From the South

Based upon the Site visit conducted on December 12, 2018 the asphalt cap (Bank parking lot) and clean soil and gravel layers (next to the retaining wall) on the residual contaminated soil continue to eliminate exposure pathways (ingestion, contact) to contaminated soils. The asphalt and clean soil and gravel layers are in satisfactory condition and no repair, maintenance, or contingency actions have been required. Currently the Site consists of a vacant lot and a parking lot. A photo log is available as Appendix 6.10.

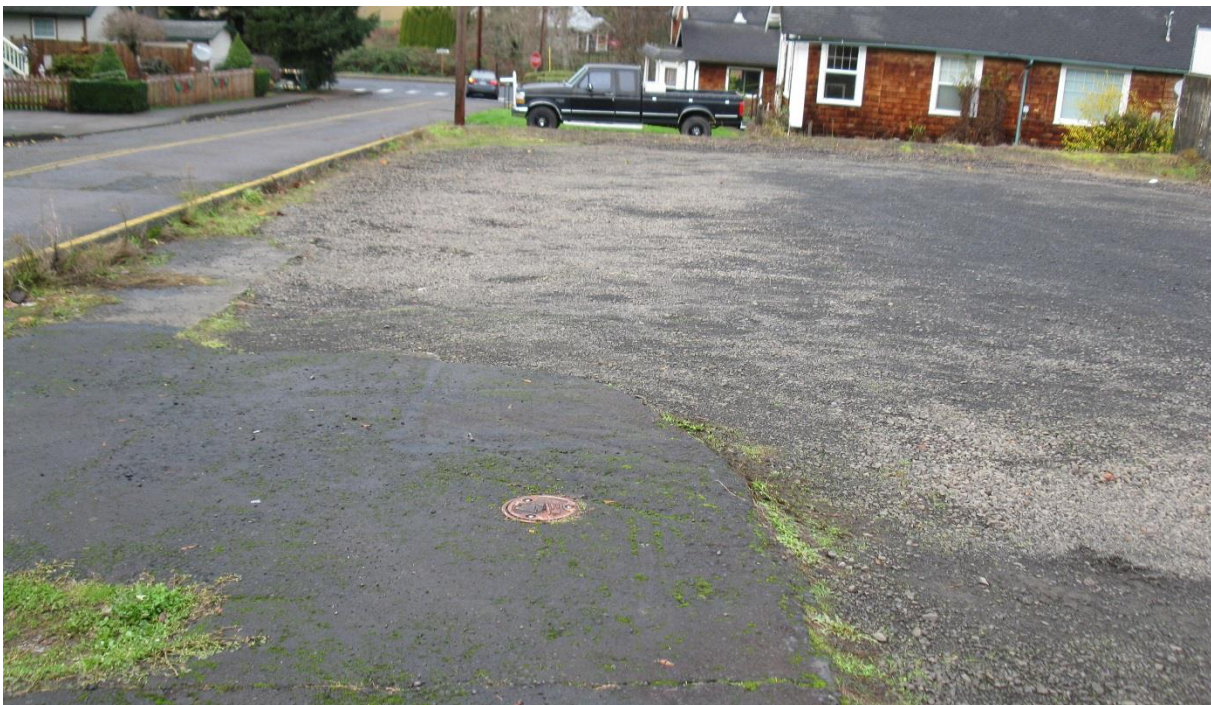
**Photo 3: Bank of Pacific Property Site (20 Butler Street Property-Vacant Lot)
Groundwater Monitoring Well MW-2, Hobson Cottage to the North and Butler
Street to the West—From the Southwest**

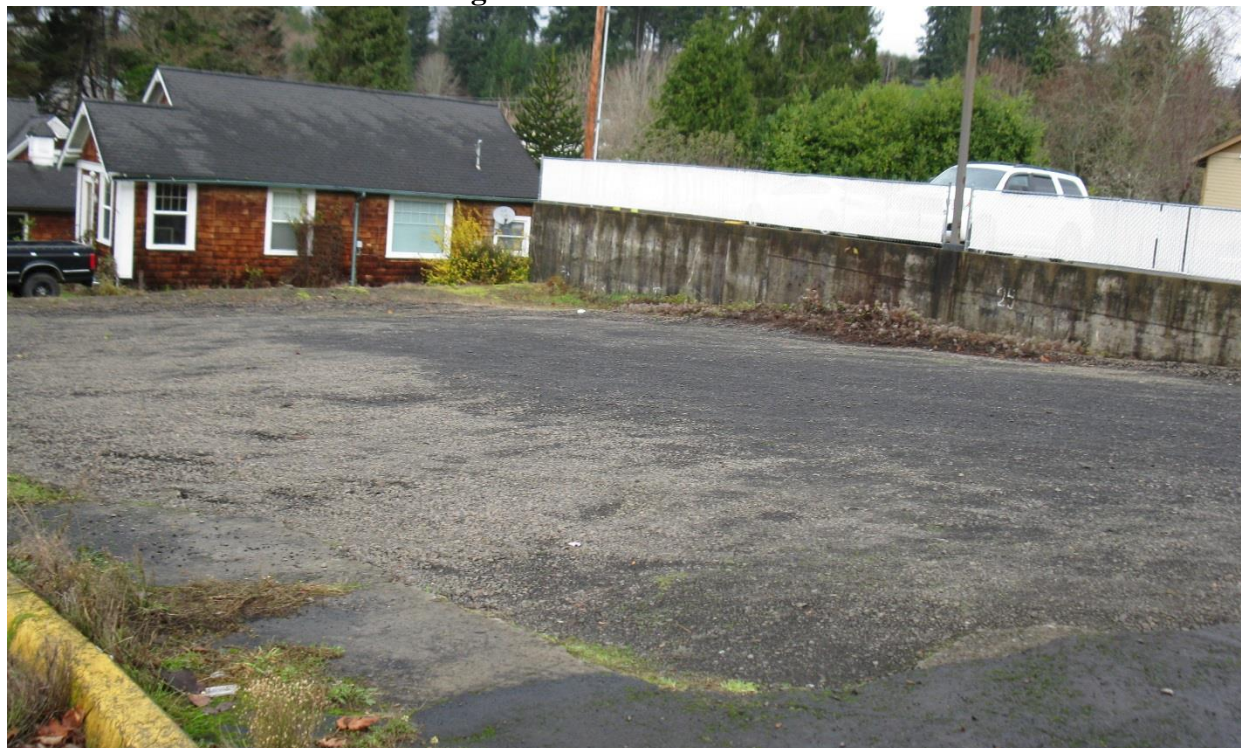
**Photo 4: Bank of Pacific Property Site (20 Butler Street Property-Vacant Lot), Retaining
Wall and Hobson Cottage to the North—From the Southwest**

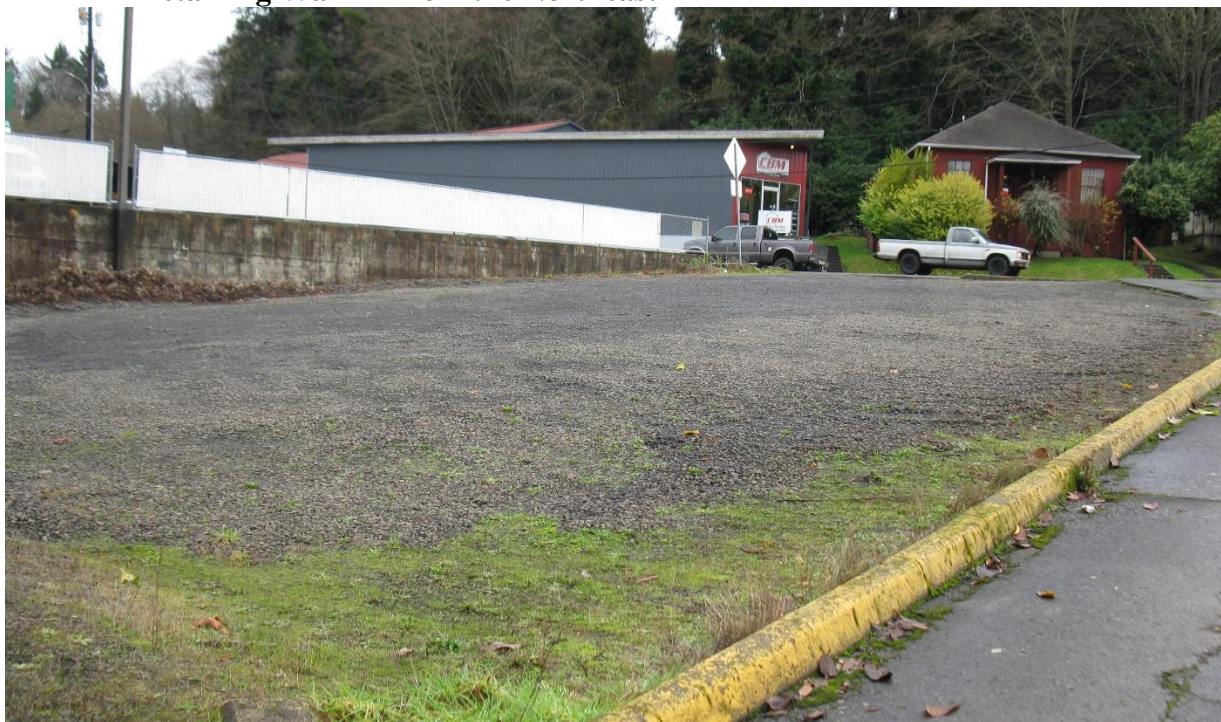
Photo 5: Bank of Pacific Property Site (20 Butler Street Property-Vacant Lot) and the Retaining Wall—From the Northeast

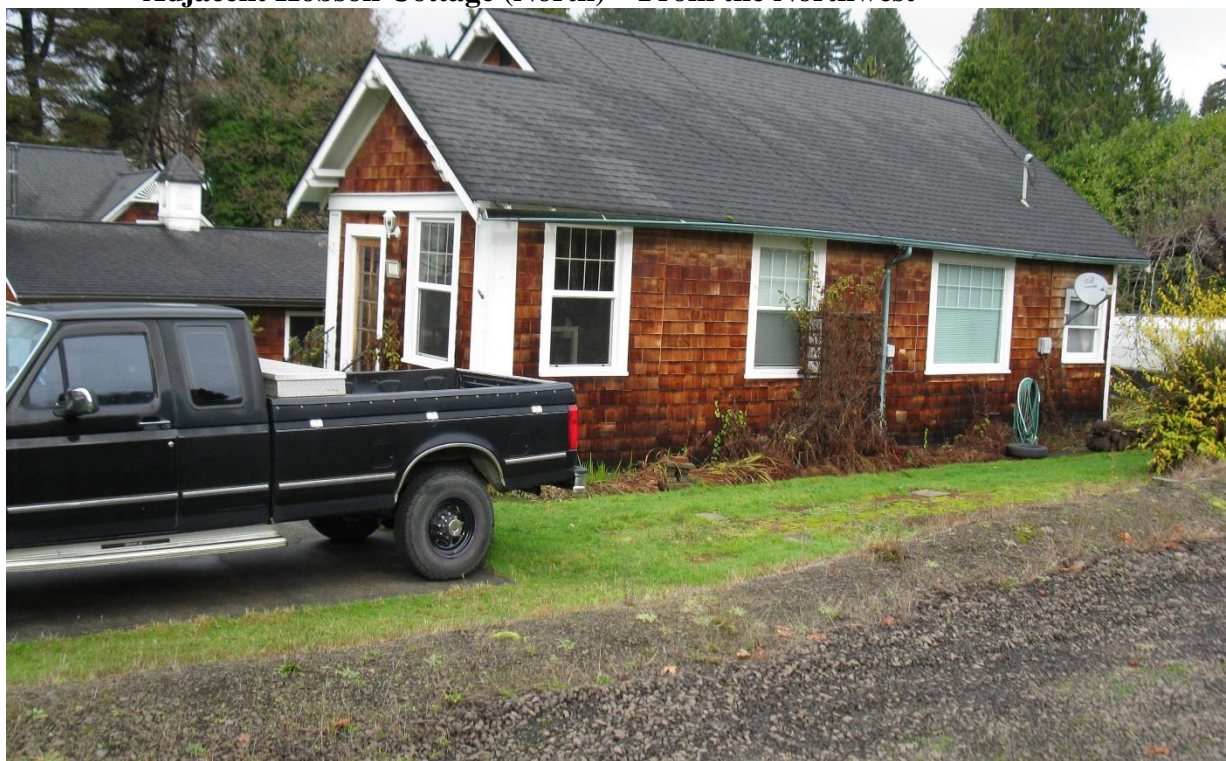
Photo 6: Bank of Pacific Property Site (20 Butler Street Property-Vacant Lot) and the Adjacent Hobson Cottage (North)—From the Northwest

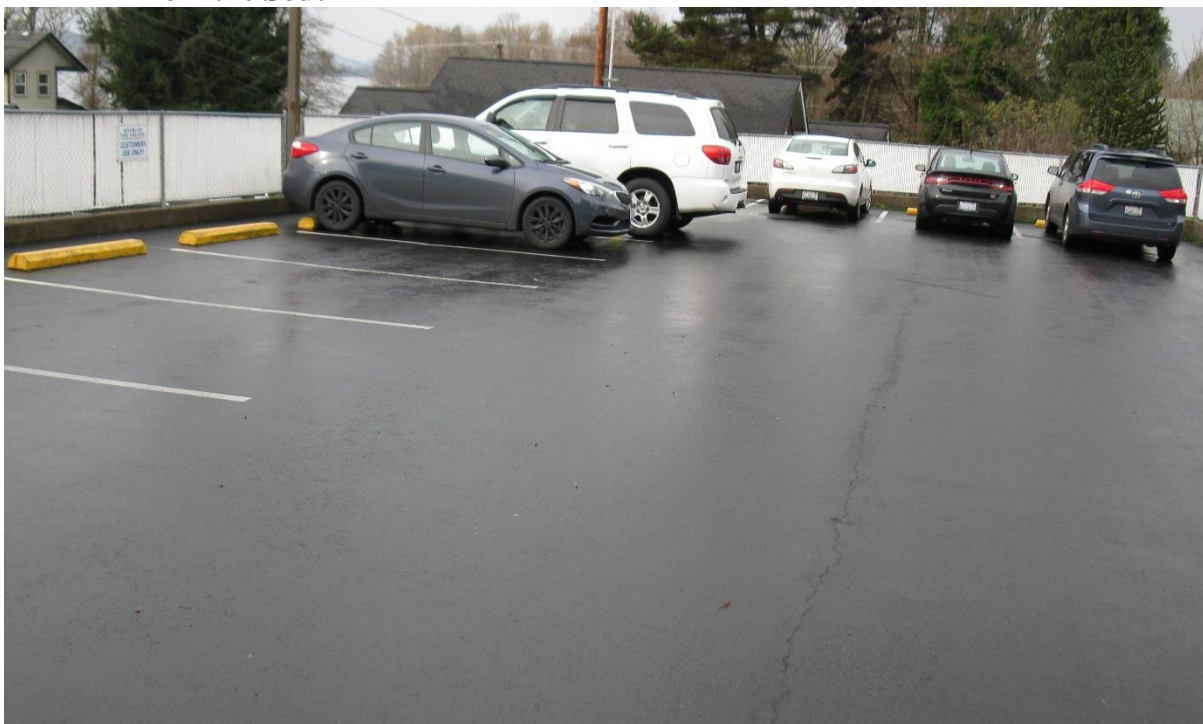
**Photo 7: Bank of Pacific Property Site (58 Main Street Property-Bank's Parking Lot)—
From the South**

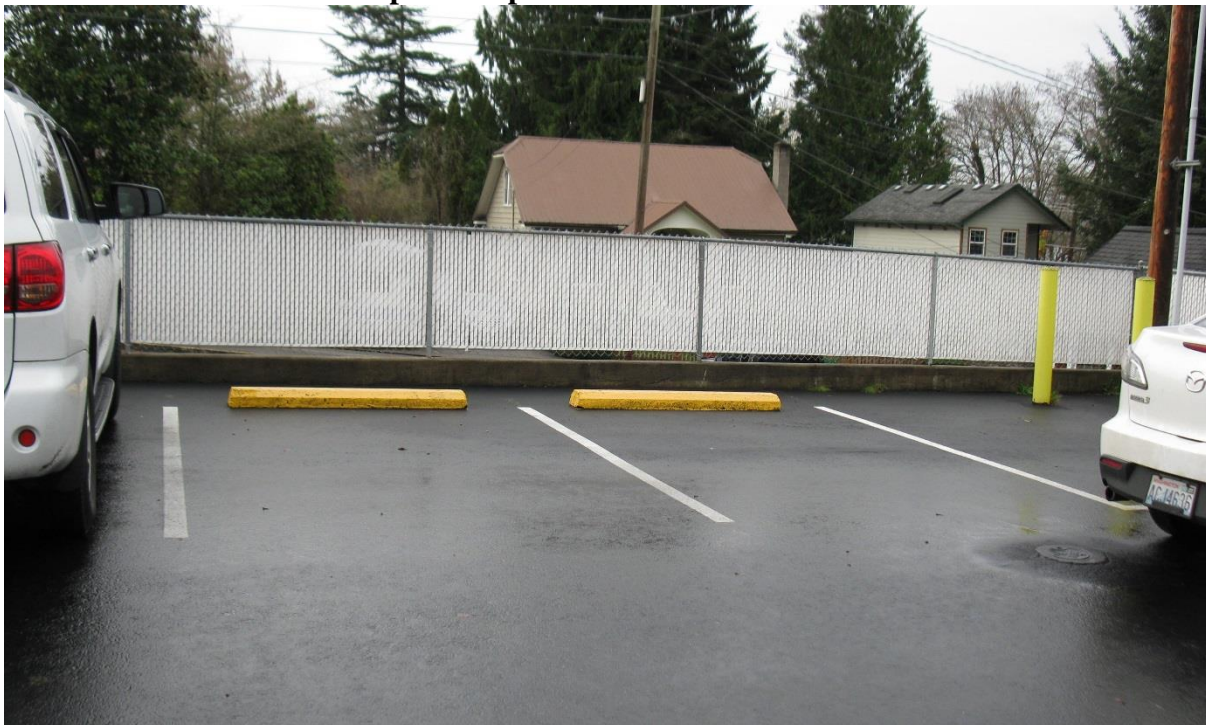
**Photo 8: Bank of Pacific Property Site (58 Main Street Property-Bank's Parking Lot),
Approximate Area of Soil Contamination Left In-Place Next to the Retaining
Wall/Fence and Asphalt Cap—From the East**
