Remedial Action Summary Report

Site Name: **Glenn's Diesel**
Site Address: **14885 State Route 9**
Mount Vernon, Washington 98274
Ecology Facility Site ID No.: **26541964**
Voluntary Cleanup Program Project No.:

Date: April 8, 2019

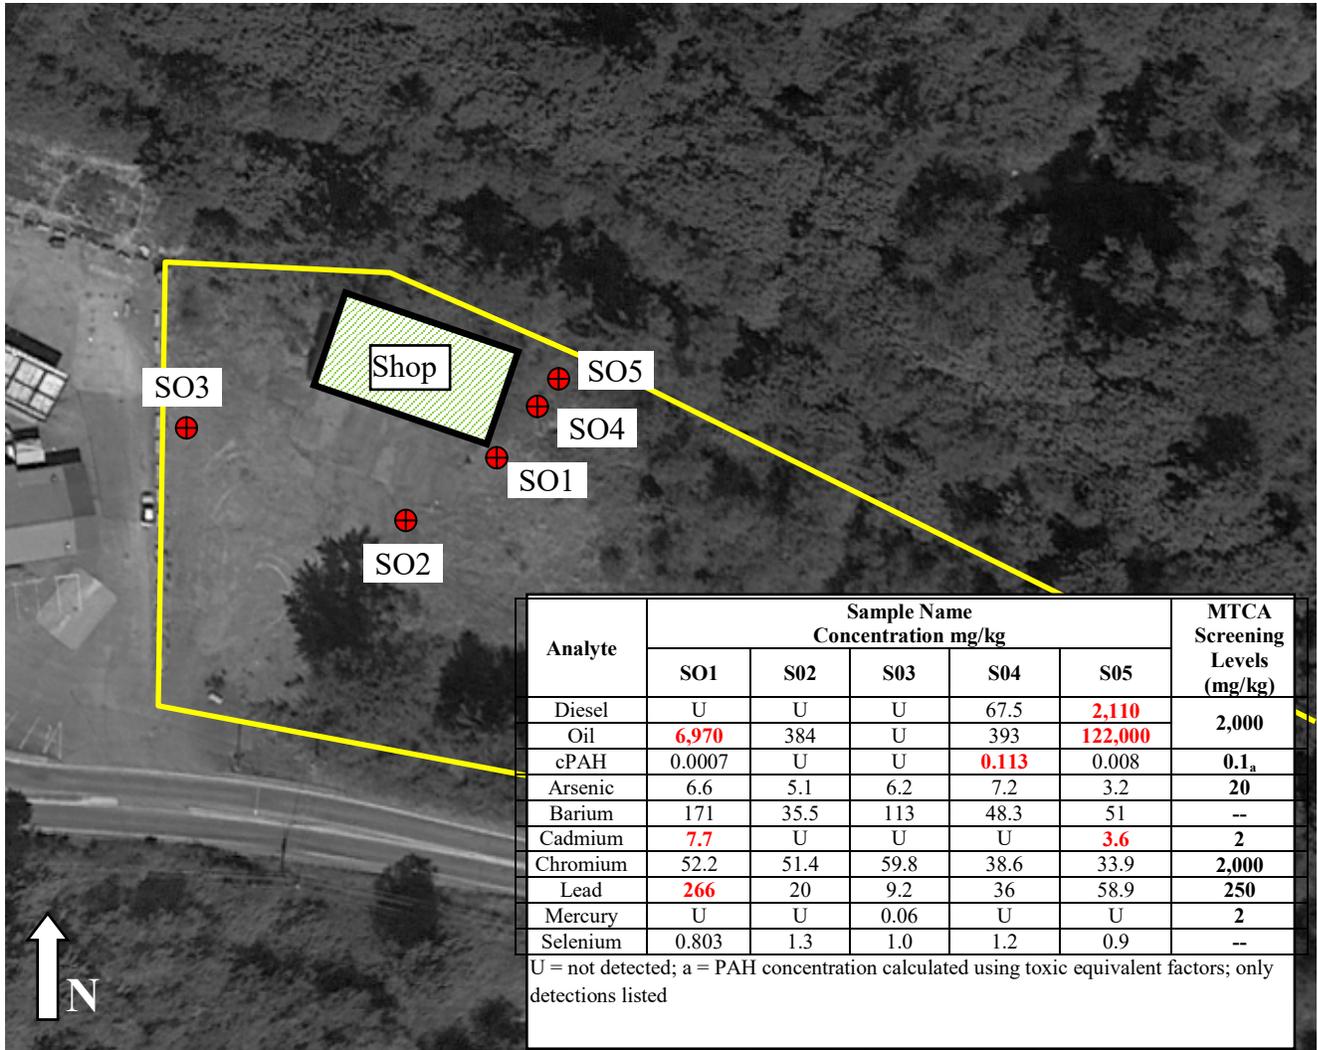
Figure 4. Sample Results from Site Hazard Assessment Sampling in December 2001

The 2002 sampling event confirmed the presence of oil, diesel, cadmium, lead and cPAH in shallow soils around the shop building in three of the five samples collected, located east of the shop building. The samples collected west and south of the building (sample SO3 and SO2) did not exceed cleanup standards.

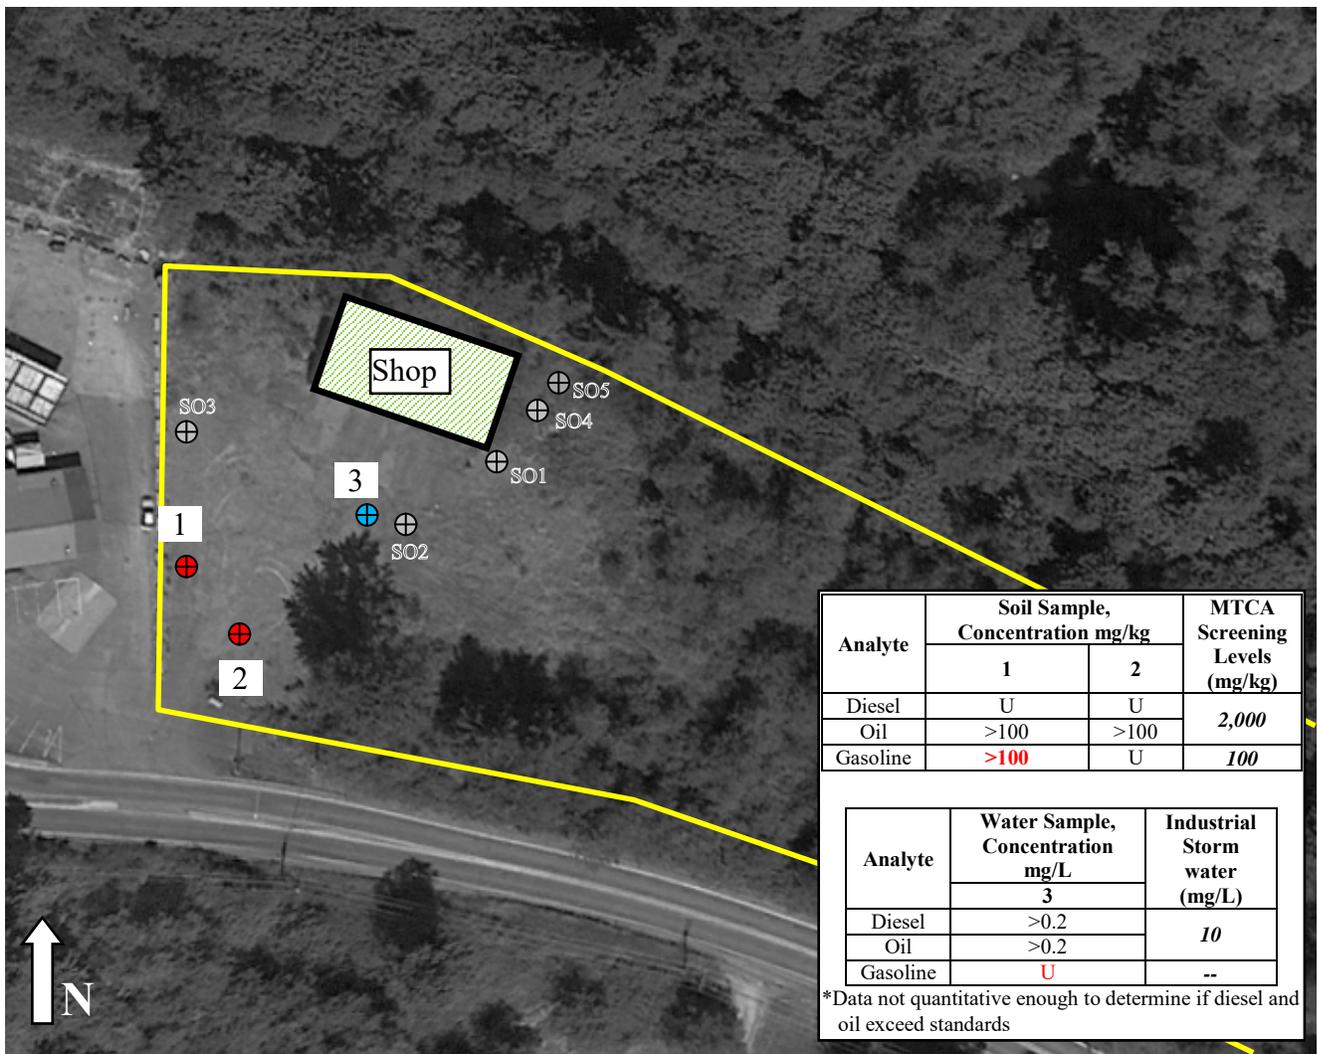
Figure 5. Sample results from spill response sampling in 2008

Gasoline, oil and/or diesel were detected in all of the samples. The reporting limit of gasoline for

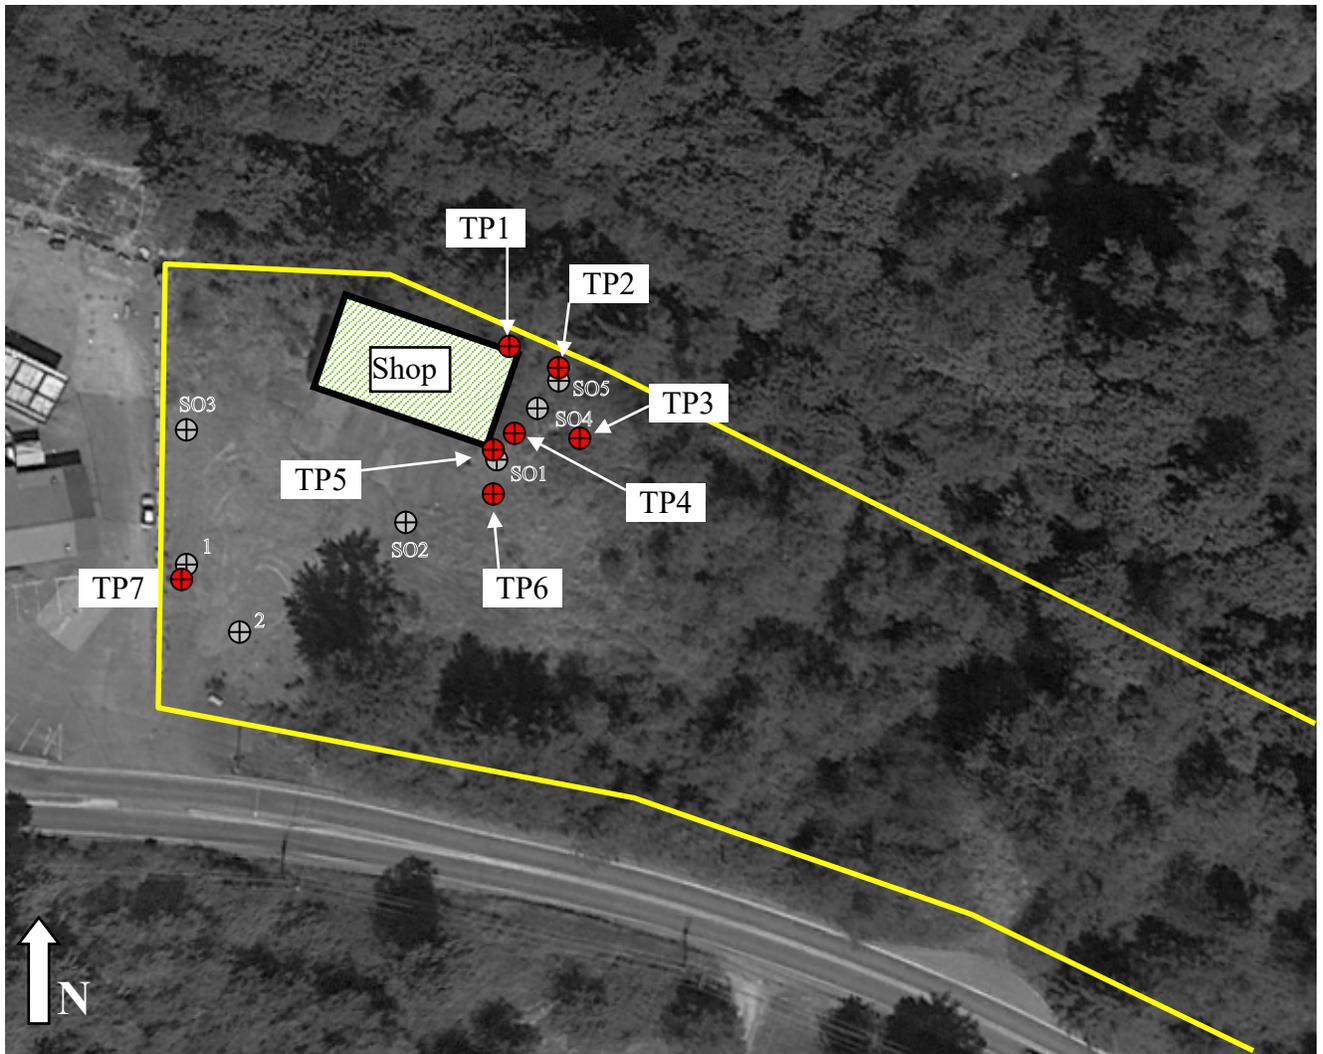
Figure 6. Sample results from test pit investigation, July 2008

No report was completed that summarizes the sampling event; however, the sample locations are presented in Figure 6, the results are provided in Table 2. Site photographs and the laboratory report are provided in Appendix III.

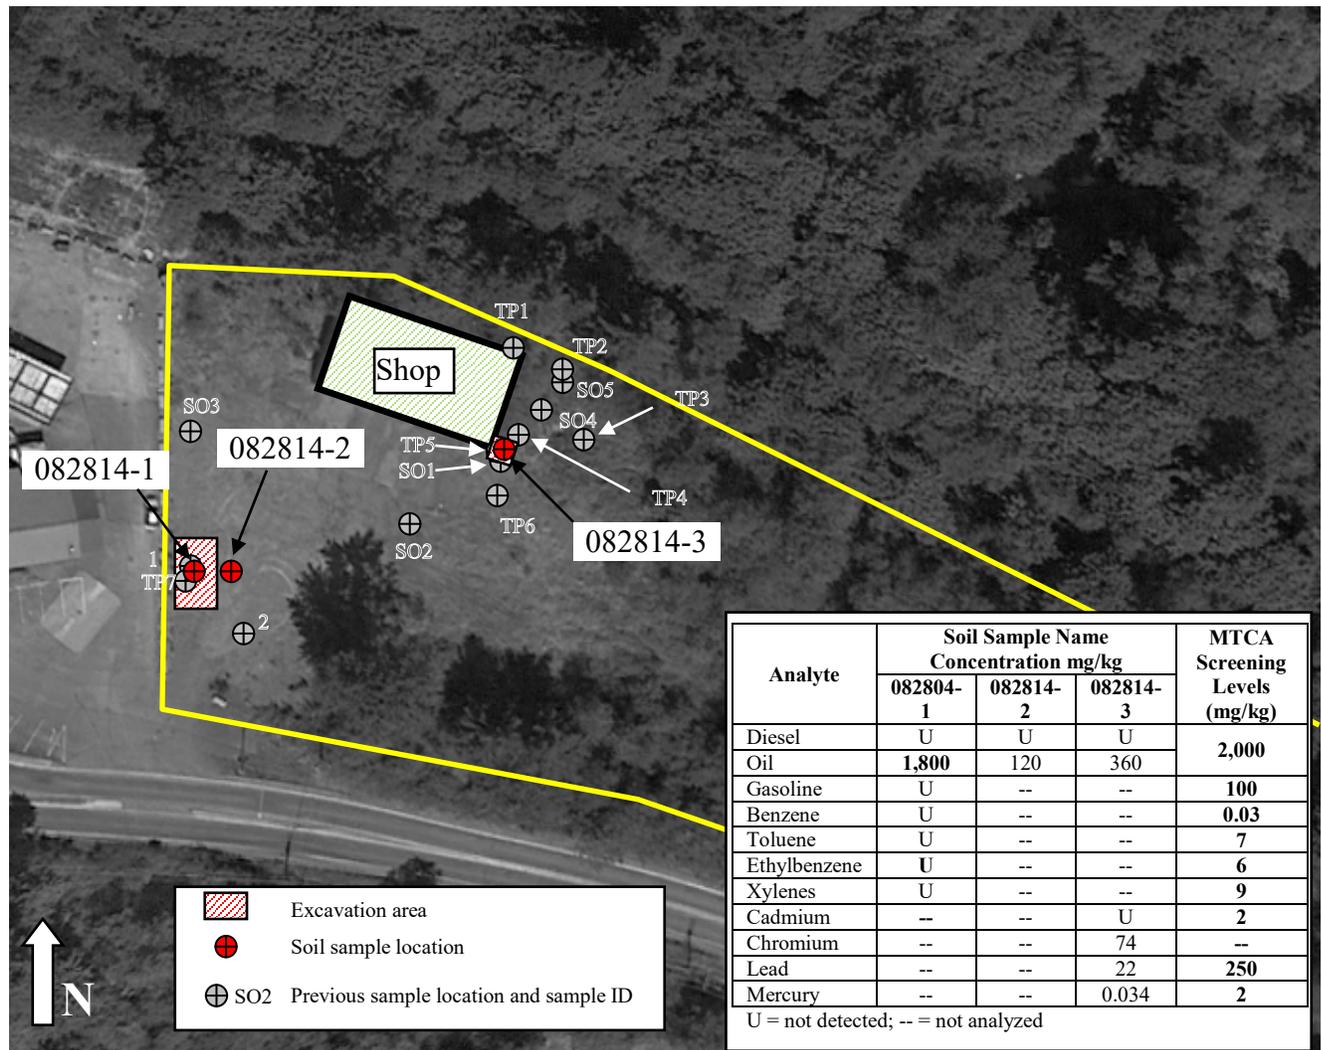
Figure 7. Confirmation soil samples from 2014 soil removal

contamination, but an exceedence of oil-range petroleum. The source of the oil was not determined. An area approximately 12 feet long, 8 feet wide and 0.4 feet deep was excavated from along the western property boundary. No discoloration or sheen was noted during the excavation; however, a minor hydrocarbon odor was noted. One soil sample was collected from the floor of the excavation (082814-1) and one sample was collected from the non-excavated east side of the excavation (082814-2). Both confirmation soil samples were below the MTCA Method A standard.

An area of cadmium-impacted soil (TP6) remained onsite following the 2014 cleanup activities.

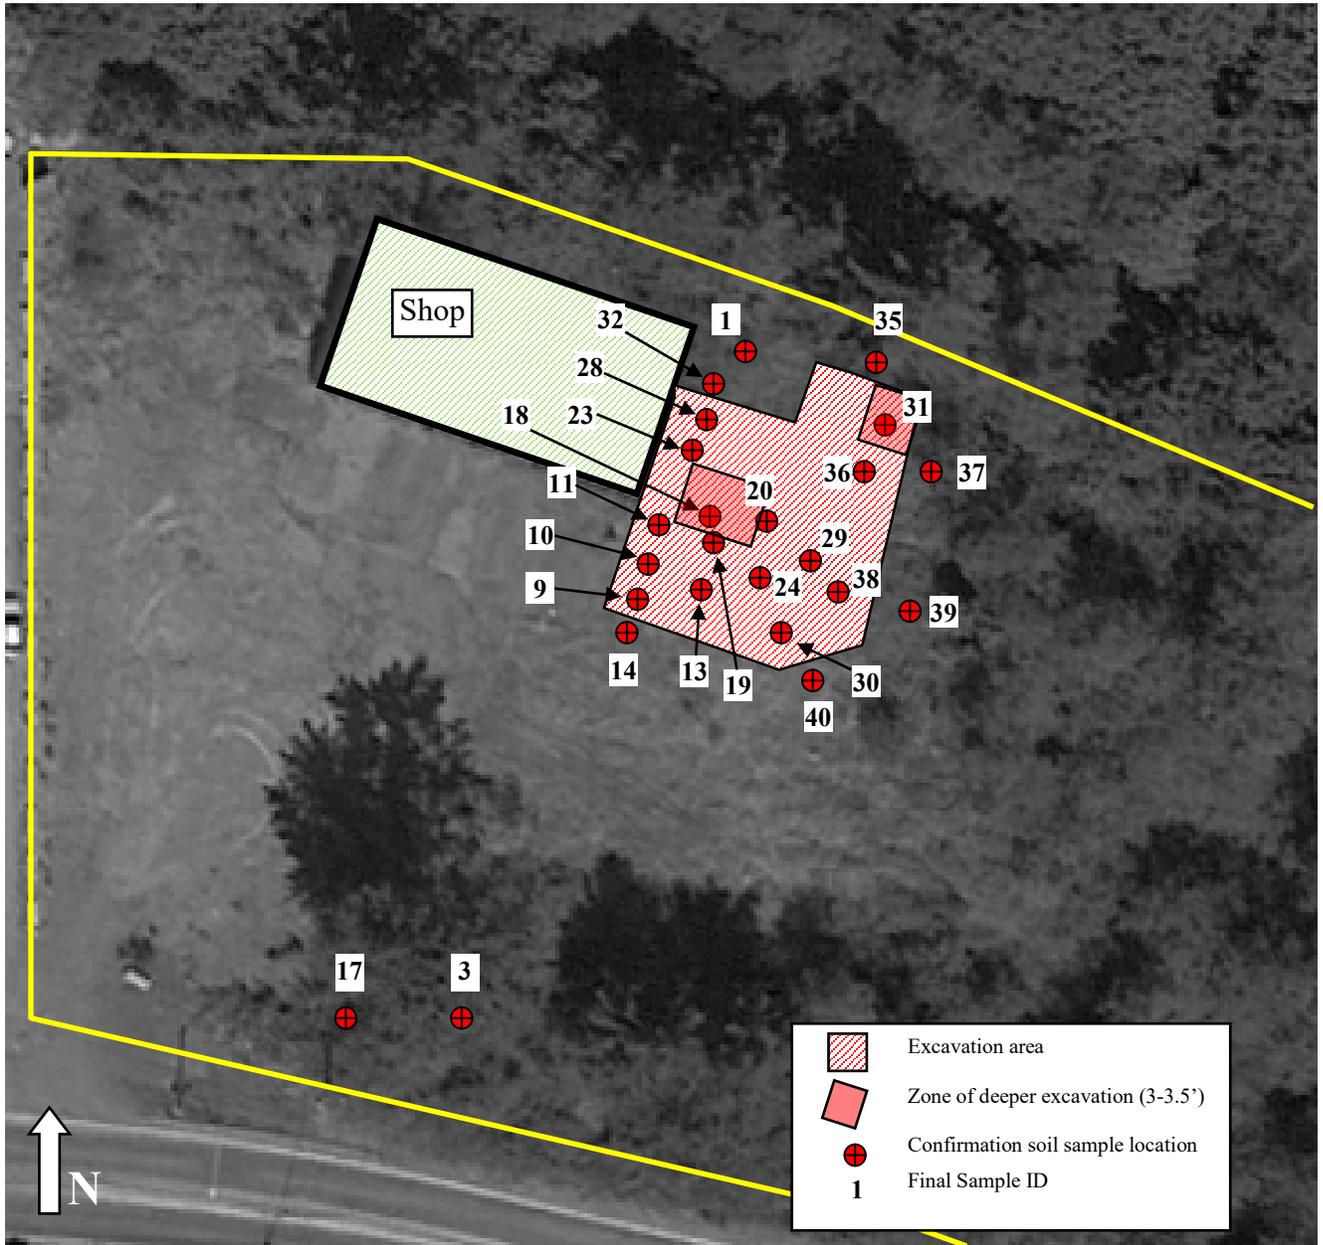
Figure 8. Confirmation soil sample locations from 2018 soil cleanup
(scale is ~1" = 65')

A map of the 2018 excavation area with the confirmation soil sample locations is provided in Figure 8. Sample data from the cleanup is provided in Tables 5 and 6. Table 5 indicates the results of the confirmation samples and represents the soil that remains on the site. Table 6 contains the soil sample data from soil that later over-excavated and removed from the site.

All of the soil represented by samples within Table 6 was over-excavated and the soil was disposed of off-site, except for the soil in the vicinity of Sample 092818-2 (map #17). The soil had been highly disturbed in the area, following the removal of a stump and repair of a broken electrical line. No soil was removed from this area; however, a sample collected from the same location as 092818-2 (Sample 17) after the ground disturbance met cleanup standards.

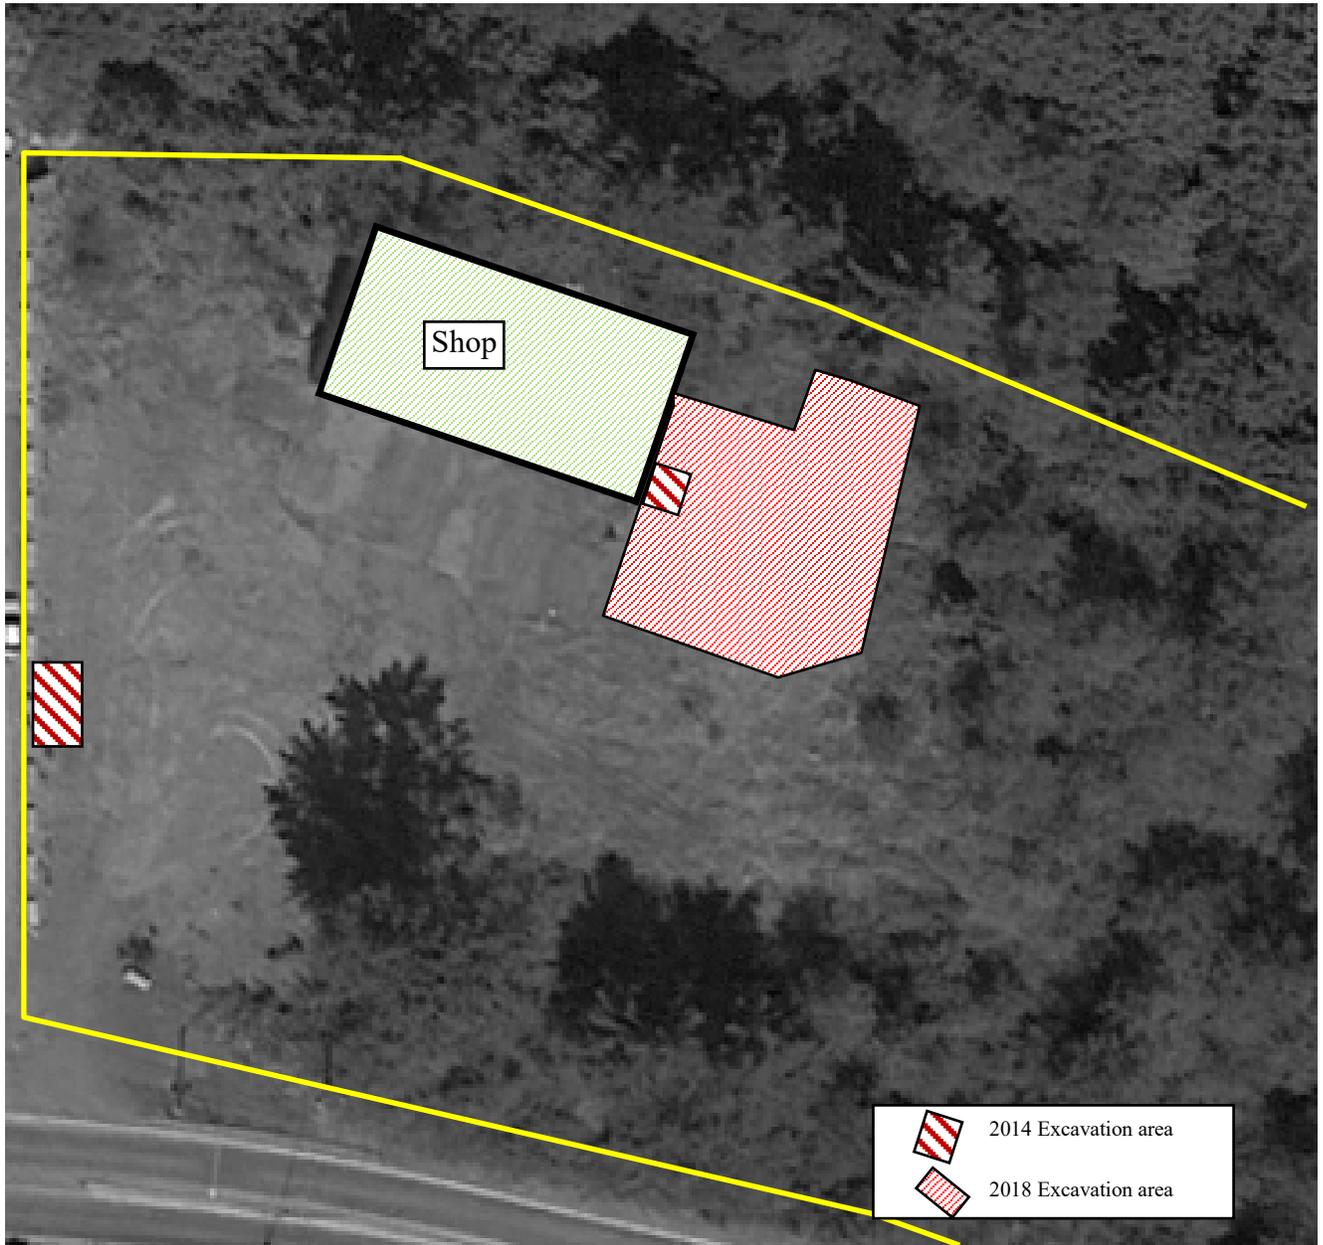
Figure 9. Horizontal Extent of soil contamination

The contamination was limited to the upper soils of site. The excavation work included removal of 4 inches to 3.5 feet of soil. No contamination was identified below 3.5 foot depth and therefore 3.5 feet is the vertical extent of the contamination on the site.

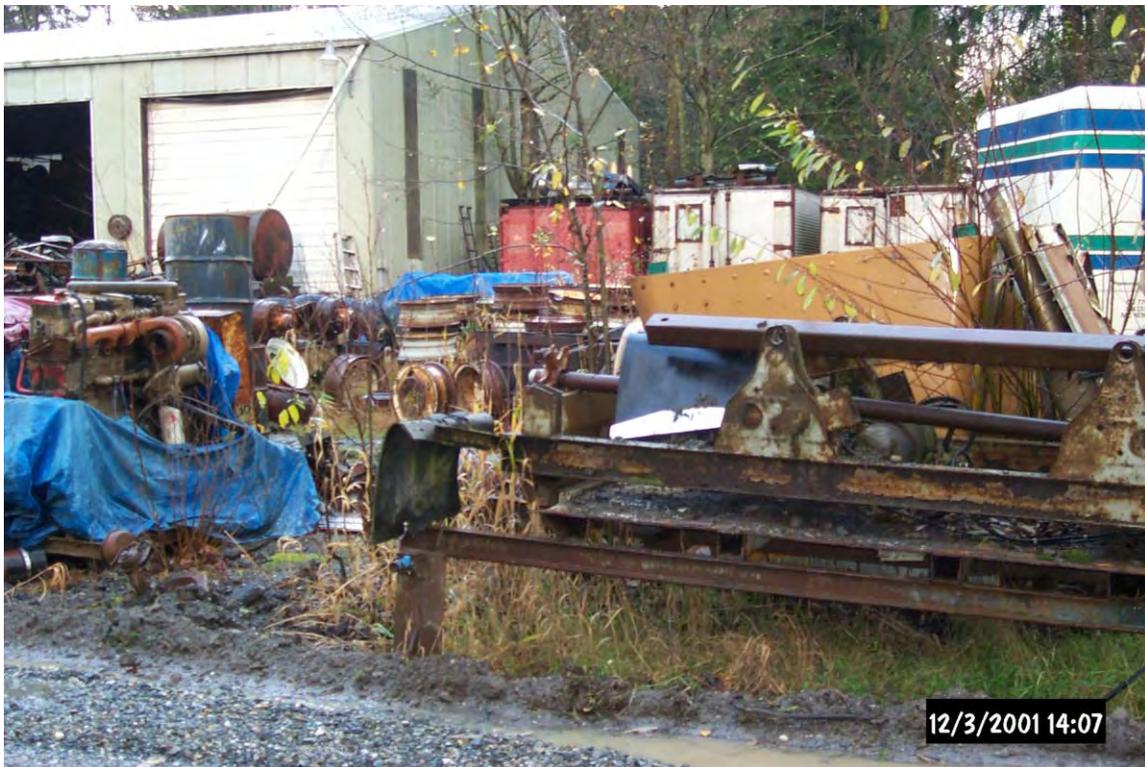
Misc. equipment, metal objects to south of repair garage

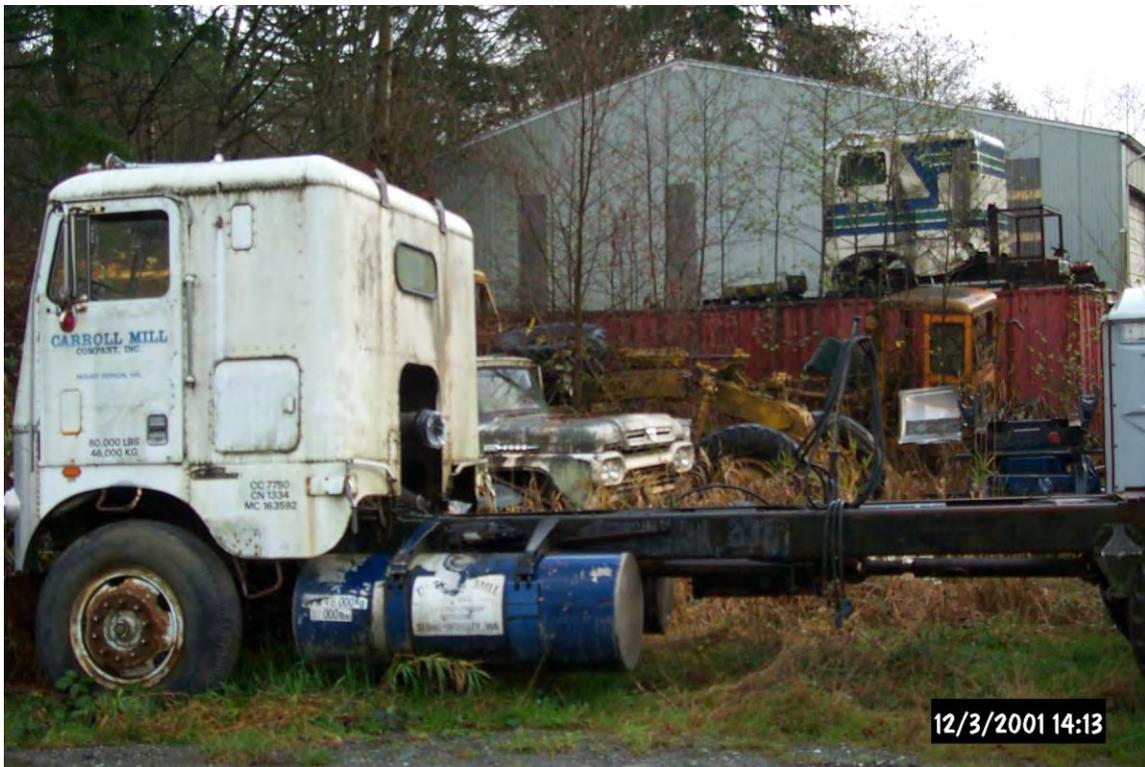
North side of repair garage, junk vehicles

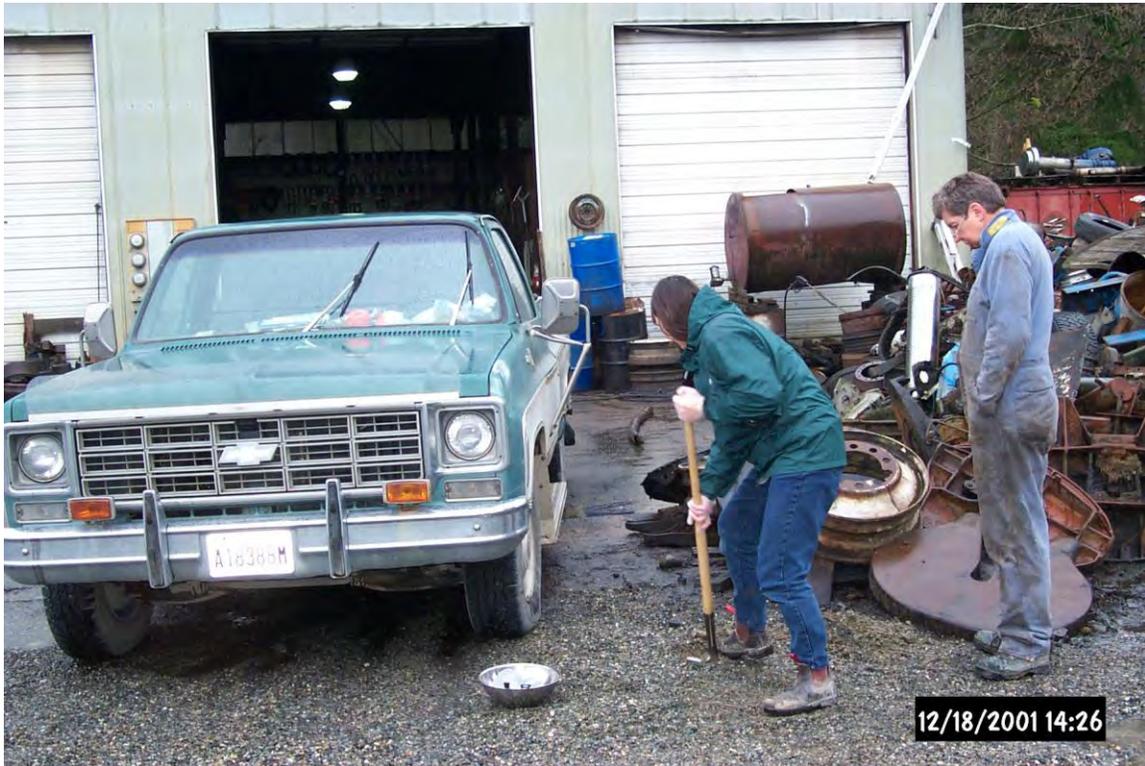
Soil sample 2 location, truck wash area (soil sample 1 location just to southeast)

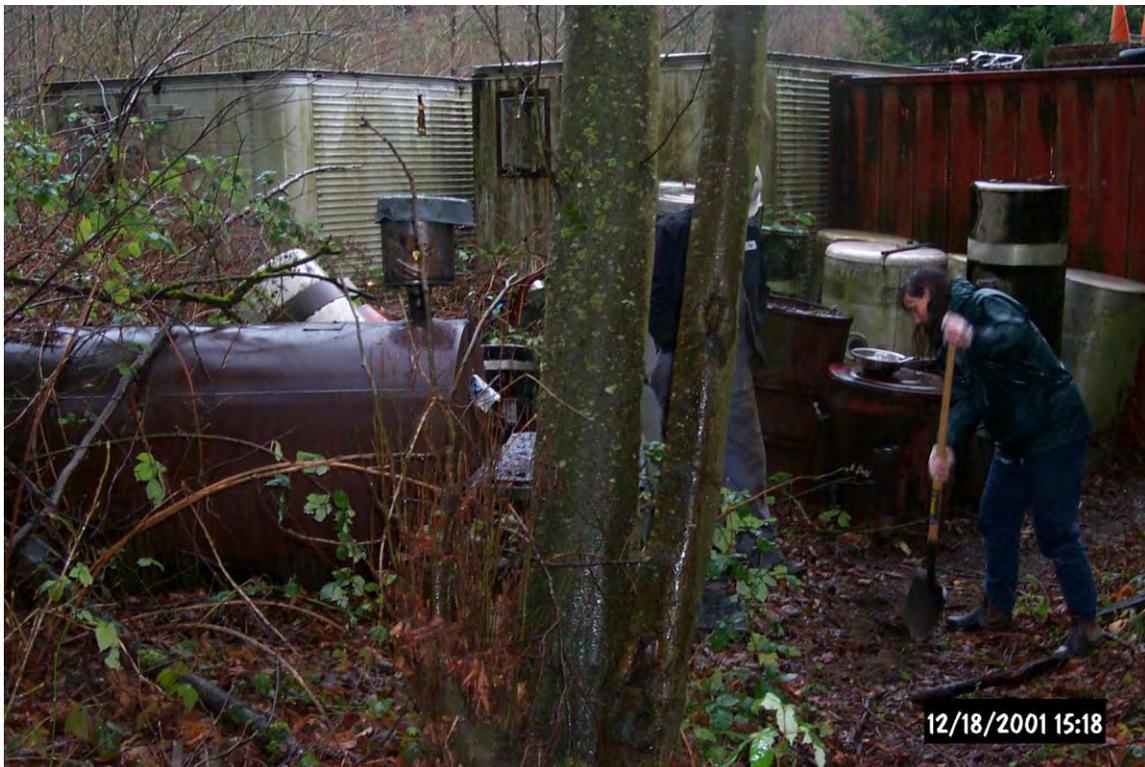
Used oil tank area, soil sample 5 location

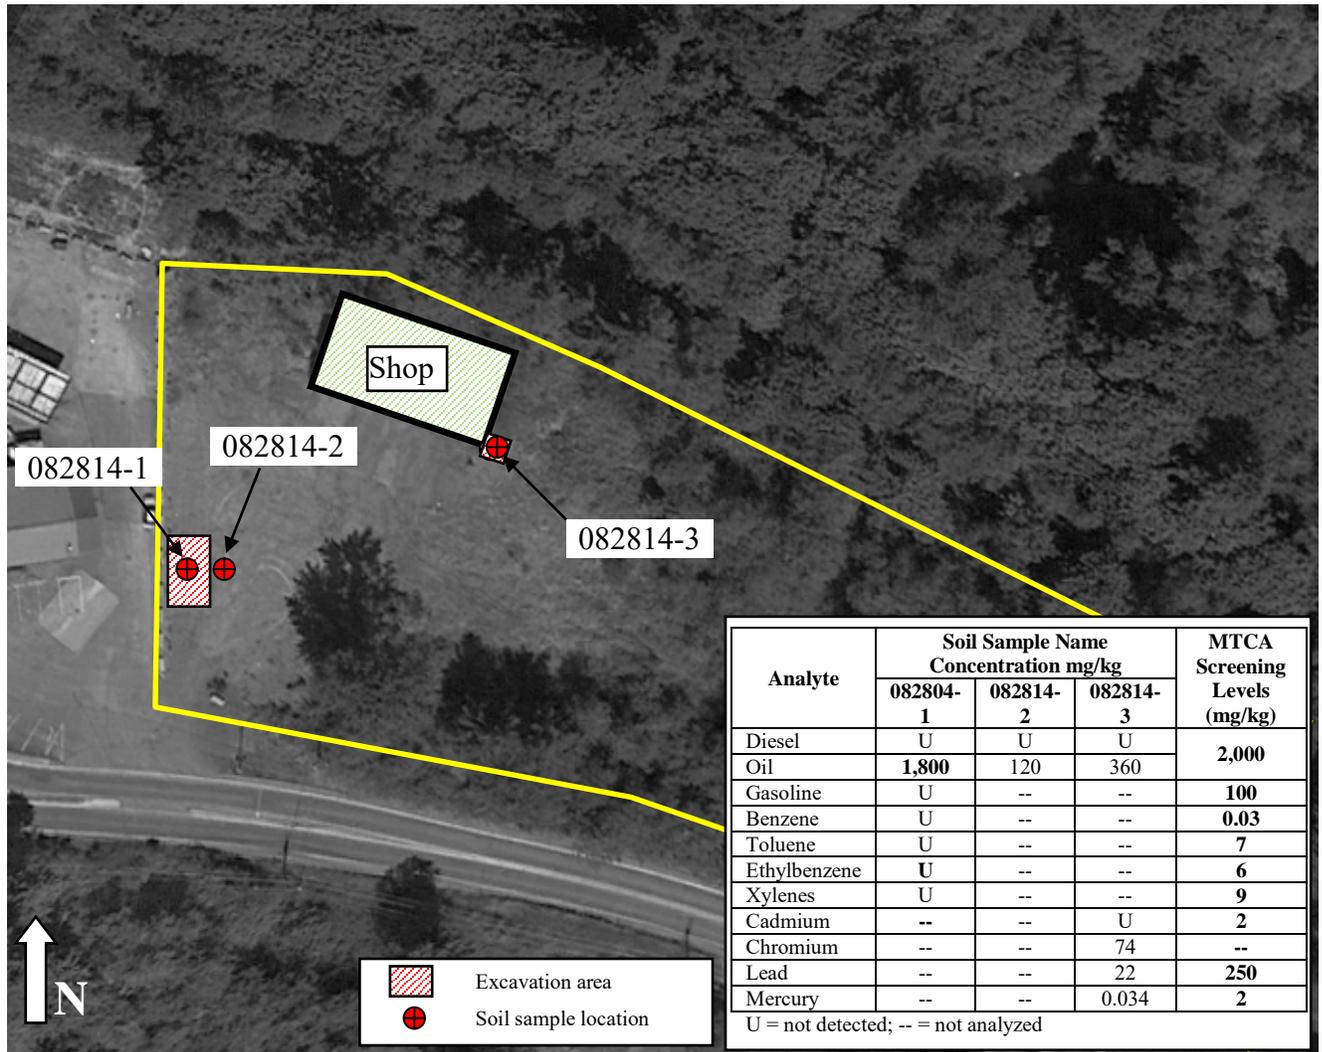
Location and excavation during 2014 soil excavation at Glenn's Diesel

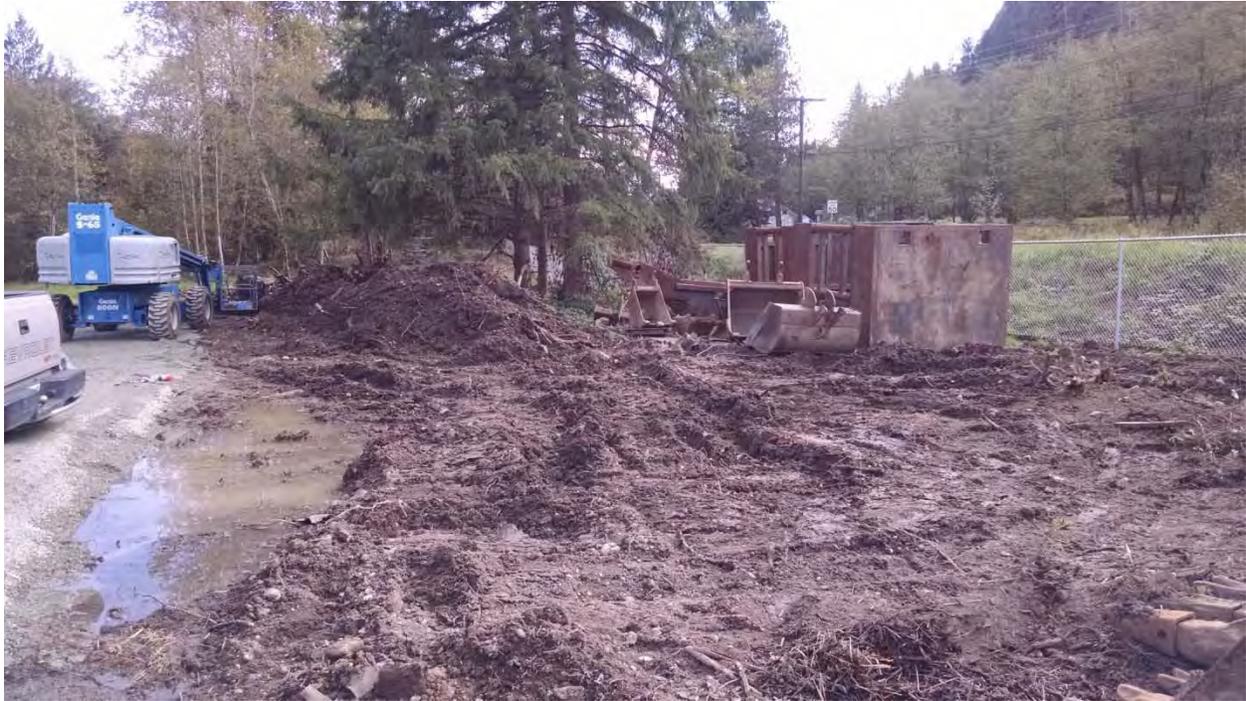
View former tire pile area where significant disturbance took place to repair a broken electrical line (Oct 11, 2018), looking eastward. Area re-sampled.

Additionally one of the samples collected from the former tire area exceeded the cleanup level for cadmium and lead. However, since our last visit, BYK Construction had removed a nearby stump and accidentally broke an electrical line to the shop building. In order to repair the broken line, significant trenching and excavation work was done in the vicinity of the sample that exceeded and the soil was heavily disturbed. One new sample was collected from the former tire vicinity on October 11, 2018. The sample met the cleanup standards. Therefore, no soil removal was undertaken near the former tire storage area.

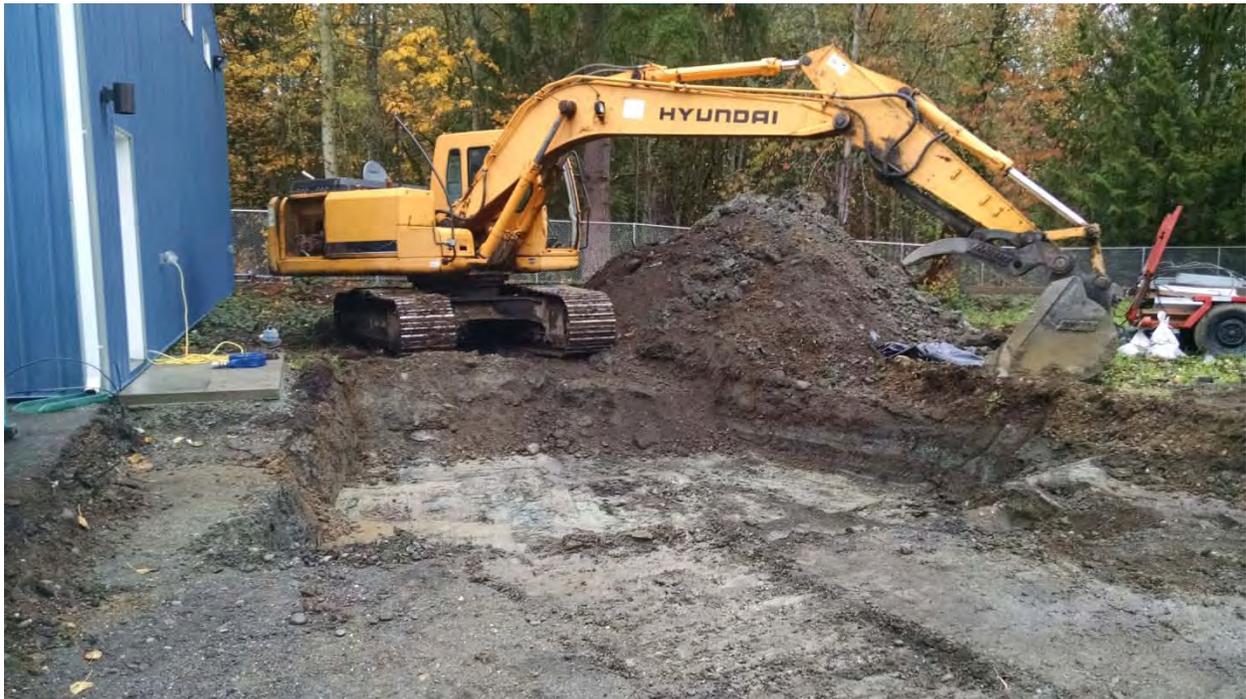
Deeper excavation area (Oct 26, 2018), looking north.

The sample results after the October 11 excavation found the base of the excavation to meet standards, but required an expansion of the excavation to the north and east on October 26, 2018. A deeper area of fill materials with some field indicators of petroleum was encountered east of the southeast corner of the building during excavation and therefore the excavation was extended
