# Supplemental Remedial Investigation and Soil Cleanup Report

Former Bellevue Chrysler Plymouth Site  
At the Bellevue South Project  
126 and 200 116<sup>th</sup> Avenue NE  
Bellevue, Washington

04218014.00 | March 19, 2019

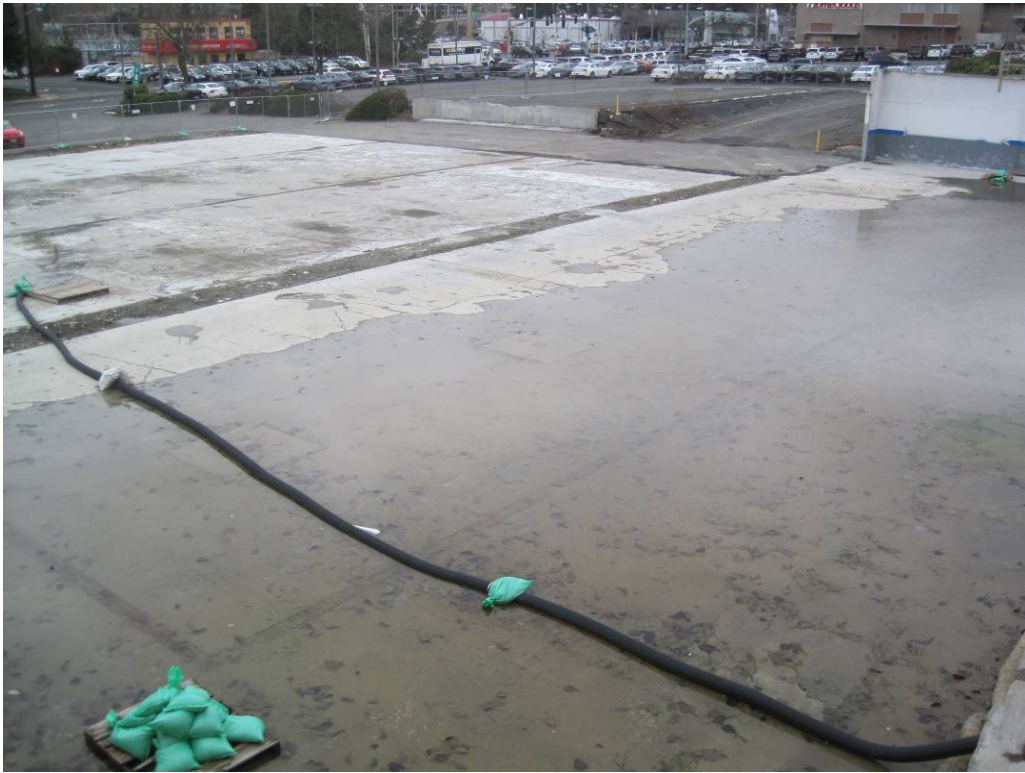
**Photo 1.** View looking northwest from above the southeast corner of the former dealership in February 2018.

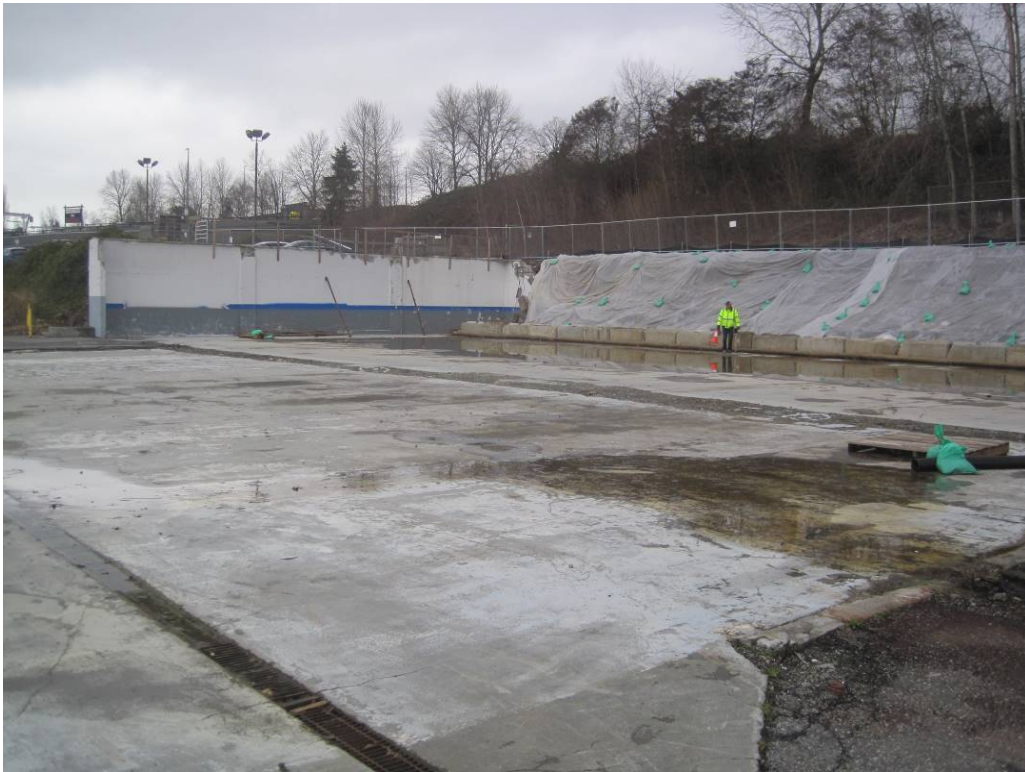
**Photo 2.** View looking northeast from the south side of the western service area. Note the trench drain in the left foreground.

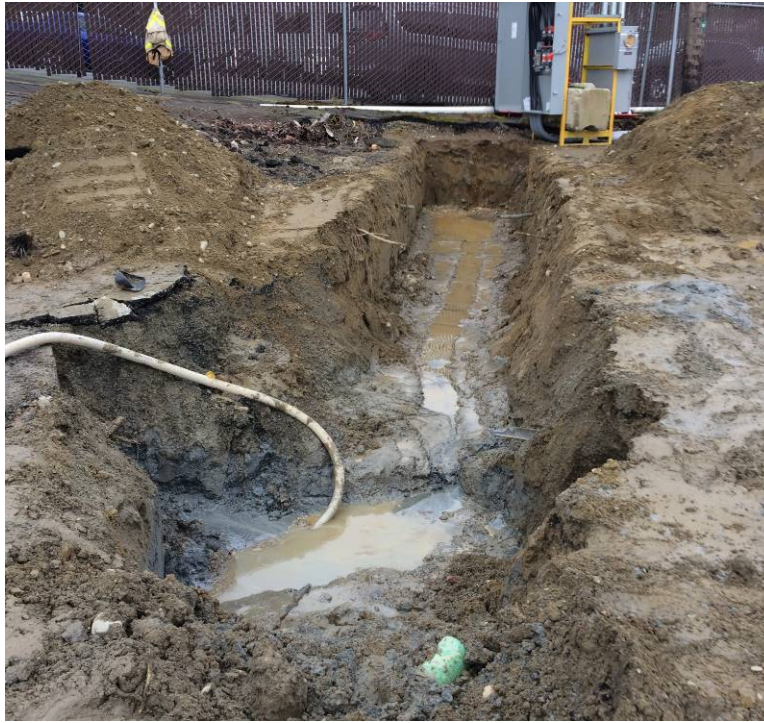
**Photo 3.** Electrical trench excavation, April 2018.

- **Construction Excavations:** Redevelopment required earth removal along an electrical trench and at a 2,200-square-foot stairwell foundation. The electrical trench was installed to a depth of approximately 4 feet bgs from the south edge of the Property northward between the two former service areas. The excavation for the stairwell foundation (Mat Foundation Stair 1) was installed to approximately 7 feet bgs at the southwest portion of the former

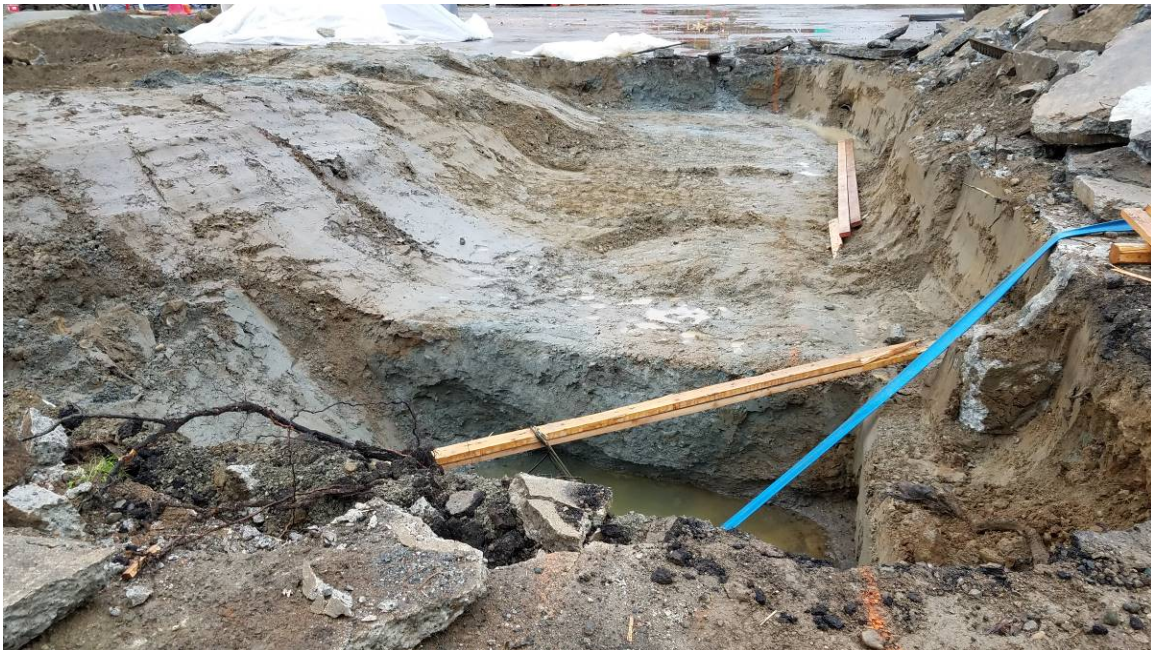
Water initially entered the excavation at the southeast corner, from two drain pipes broken by the excavator, and at the northeast corner, from the coarse gravel bedding layer underlying the trench drain. In both cases, the water was observed to have an odor and a sheen. The contractor installed spot excavations to act as sumps from which the water was pumped out for off-site treatment.

Beneath the floor trench drain, soils generally within 2 to 4 feet of the alignment were stained gray, odorous, and yielded positive PID readings. Field indications of contamination diminished with distance from the trench drain alignment. Suspect soils were removed and stockpiled for characterization. The area investigated around the trench drain was entirely within the planned extent of the stairwell foundation.

**Photo 4.** View looking north from the south end of the trench drain alignment in the former western service area. Sumps were initially installed at the ends of this excavation to collect water, which was pumped out for off-site disposal. June 2018.

Soils surrounding the south end of the trench drain were entirely within the planned extent of the stairwell foundation described above in Section 3.4.6. Suspect soils were segregated and stockpiled for characterization. Confirmation samples were collected under the trench drain near the northeast and southeast corners of the stairwell foundation (MFS1NEFloor7' and I4-4', respectively). The samples were analyzed for TPH in the diesel and oil ranges and in the gasoline range as mineral spirits. The northeast sample was also analyzed for VOCs, including BTEX compounds. The only analytes detected were low concentrations of diesel and oil-range TPH (130 and 150 mg/kg, respectively) reported in the sample from the near the southeast corner. Between these two locations, direct-push sample B-11-7' was referenced to confirm the absence of detectible diesel- or oil-range TPH beneath the trench drain at 7' bgs.

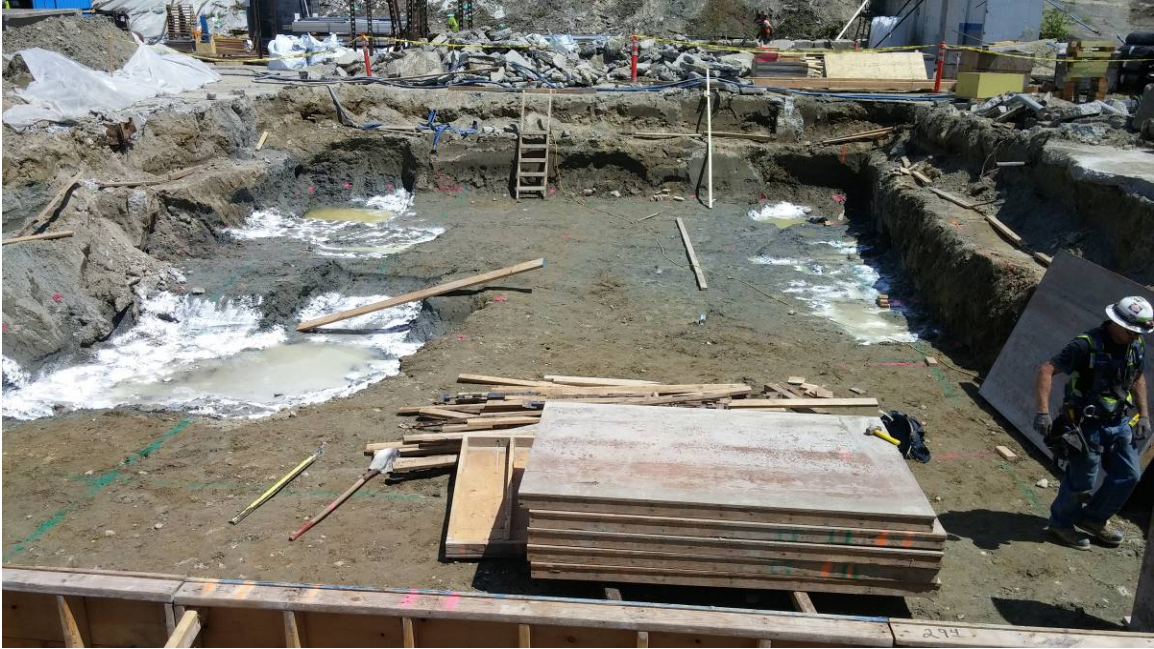
Redevelopment construction involved only one significant excavation within the footprint of the former auto dealership. Specifically, an excavation for a mat foundation supporting a stairwell (Mat Foundation Stair 1) was installed to a nominal depth of 7 feet bgs in the southwest portion of the former dealership (Figure 4). The rectangular excavation covered a total area of approximately 2,200 square feet, measuring approximately 35 feet (N-S) by 63 feet (EW). The eastern portion of the excavation extended past the floor trench drain that had served the western service area. The excavation for the stairwell foundation was advanced from east to west, beginning approximately 4 feet east the floor trench drain that served the former western service area.

**Photo 5.** Looking east into the excavation for Mat Foundation Stair 1. ORC has been placed in over-excavated areas in the northeast and southeast corners and under where lifts were encountered in the north-central portion of the excavation. June 2018.

As the stairwell-foundation excavation was advanced to the west, one hydraulic lift cylinder and two hydraulic lift vaults were discovered and investigated. Three lift cylinders were removed, and water in the two vaults was pumped out and stored for subsequent off-site treatment and discharge. Beneath the hydraulic lifts, the floor of the excavation was advanced into the till layer from 7 to 9 feet bgs, based on PID readings. Confirmation soil samples were collected beneath the former locations of the

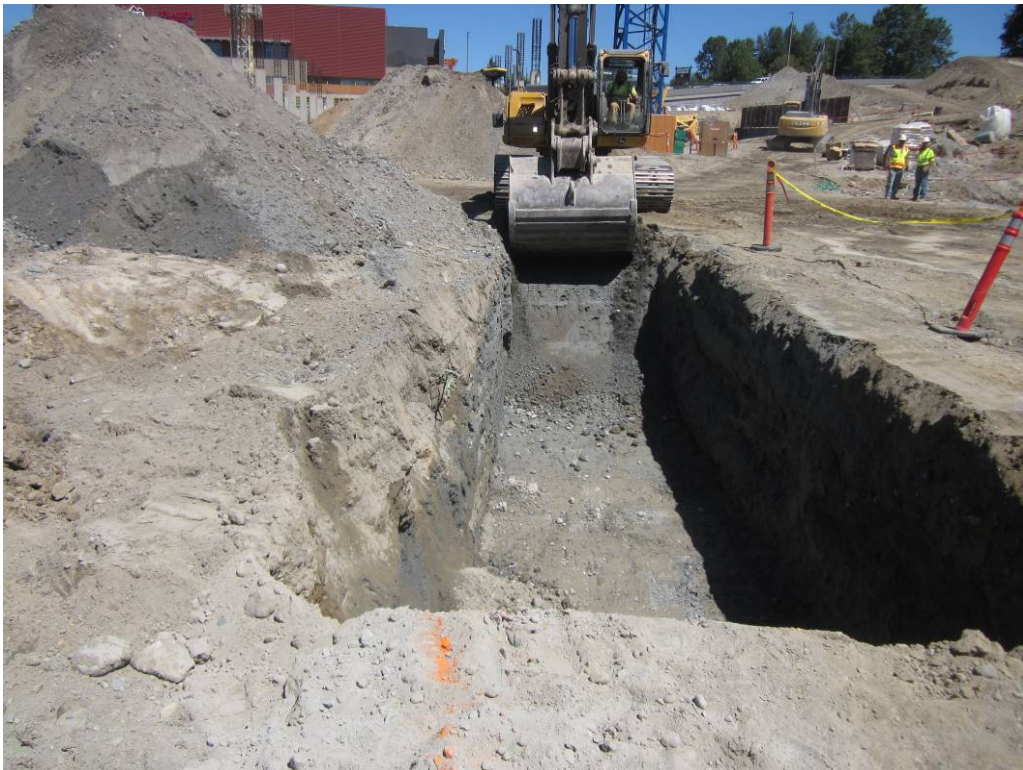
**Photo 6.** Looking north during over-excavation of the northern portion of the former trench drain alignment that had served the western service area. July 2018.

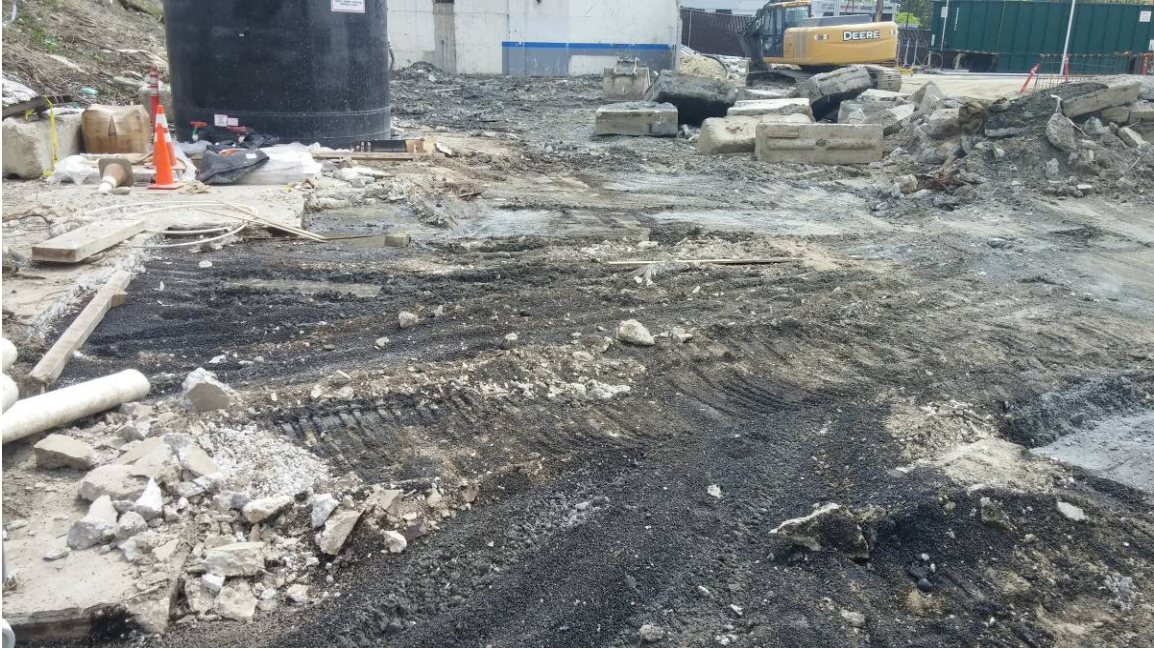
The investigation identified a 6-inch layer of coarse gravel directly beneath the concrete floor slab and trench drain. Near the center of the trench drain alignment, a second trench of coarse gravel was observed intersecting from the northwest. The purpose of the angled, intersecting trench is unknown, but it might have been a French drain. The sub-slab gravel was underlain by gray till throughout the eastern service area, confirming the reports of earlier investigations (e.g., NGI, 1996).

**Photo 7.** View looking south at the former eastern service area after removal of most of the concrete floor slab. Characterization sampling and field observations indicated that the gravel bedding layer was contaminated. July 2018.

Given that the pre-construction sampling had identified petroleum-contaminated groundwater immediately beneath the slab, and the initial sample results had verified contamination in the sub-slab gravel as PCS, the permeable soils were removed and stockpiled as suspect PCS. The area surrounding the dual-piston hydraulic lift was also excavated. The cylinders appeared to be in good condition. No hydraulic fluid was observed, and no reservoir was encountered.

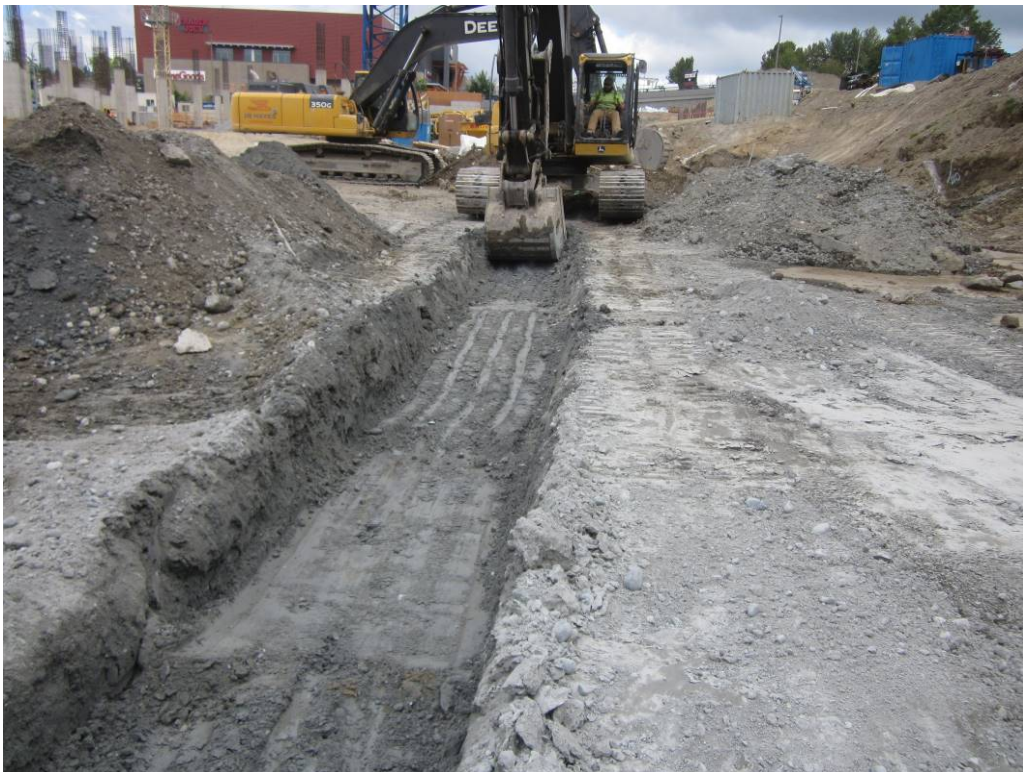
**Photo 8.** View looking north during over-excavation of the former trench drain alignment that had served the eastern service area. July 2018.

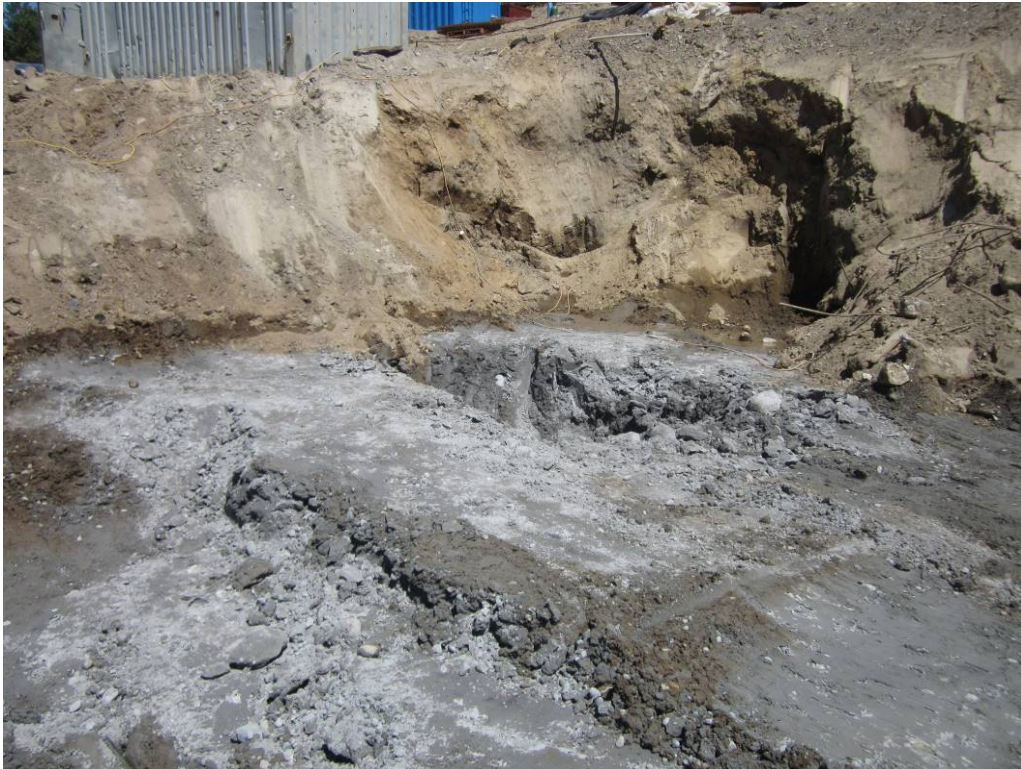
When the redevelopment cut eastward into the hillside, groundwater was encountered perched on the gray Vashon till. Significant on-site flow of perched groundwater continued from the eastern hillside throughout the summer and fall of 2018, despite drought conditions in the area. SCS understands that the volume of on-flowing groundwater was greater than originally anticipated and necessitated revisions to the design of the eastern wall of the development. New construction includes a foundation drain system that captures groundwater along the east wall of the development and conveys it through pipes to a City of Bellevue stormwater line near the southwest corner of the Property. It is unclear what effect this will have on site hydrogeology.

**Photo 9.** View of spot excavations in the northeast corner of the former eastern service area. Note that water is perched on the gray glacial till, which is dry. July 2018.

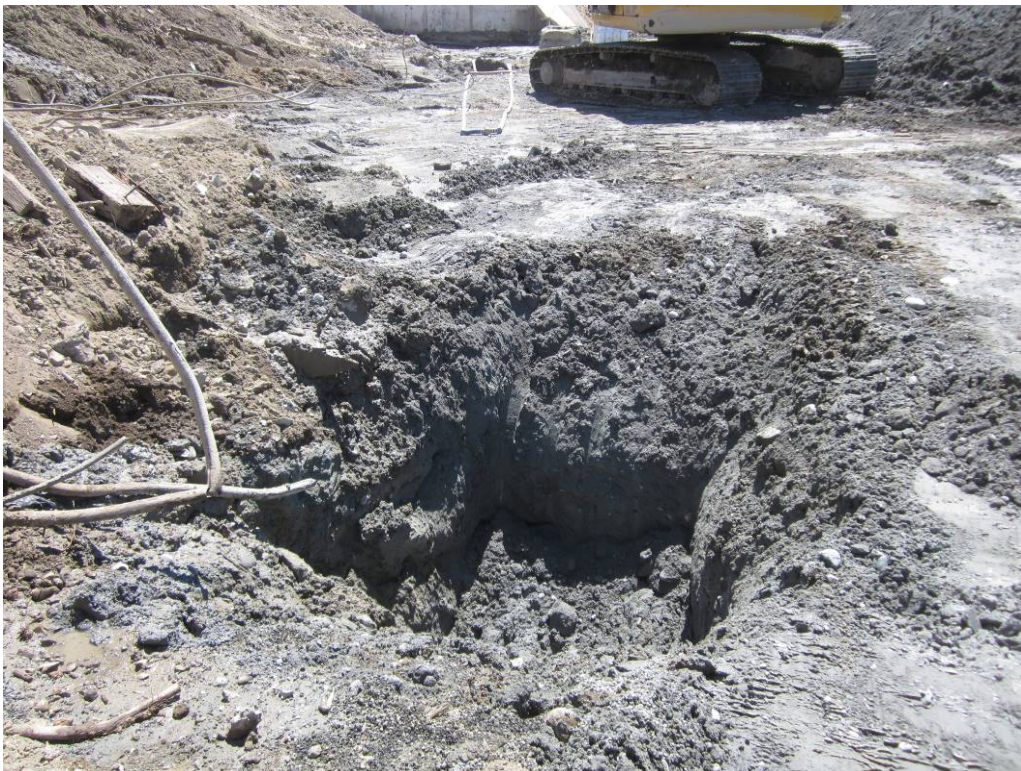
**Photo 10.** View of the excavation installed to remove a dual-cylinder hydraulic lift from near the northeast corner of the eastern service area (R16). No groundwater was identified within the gray till. July 2018.

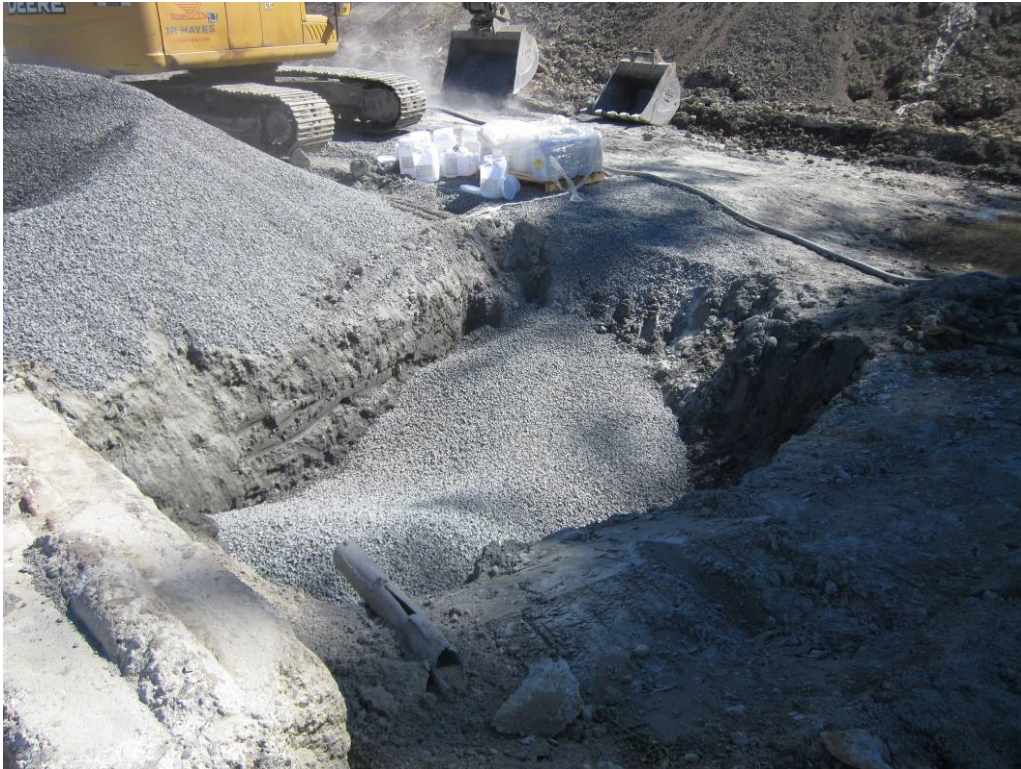
**Photo 11.** Backfilling an excavation in the southwest corner of the eastern service area (looking NE). The excavation was installed to remove an area of sandy fill. SCS suspects that the fill was placed after the removal of a waste oil UST in November 1988. July 2018.

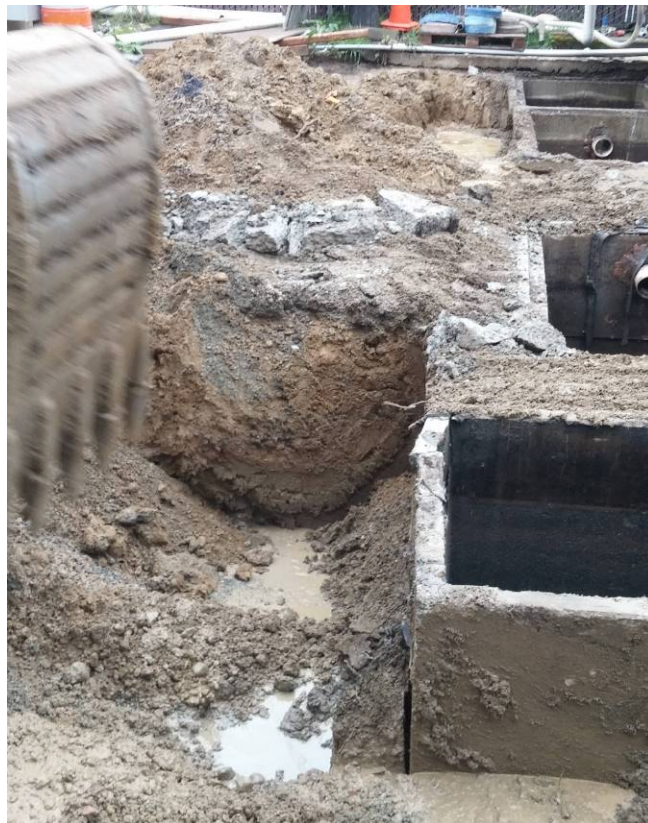
No obvious cracks, loose joints, or other potential sources of leakage were noted for any of the four separators or the associated pipes. The final size of the excavation was 35 feet (north to south) by

**Photo 12.** View of the oil/water separators being removed. October 2018.

The oil/water separators were pumped and rinsed, both immediately prior to the redevelopment and again immediately prior to their removal approximately six months later. SCS observed the excavation and decommissioning process for evidence of contamination in the sand and fine gravel backfill surrounding the separators and the pipes in the vicinity. The four separator vaults themselves were inspected for cracks and other signs of compromised integrity.
