Update on the Lora Lake Apartments Cleanup Site

July 2012

David L. South, Site Manager

DEPARTMENT OF
ECOLOGY
State of Washington

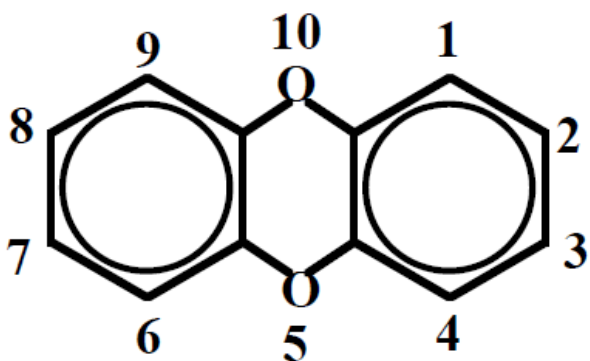
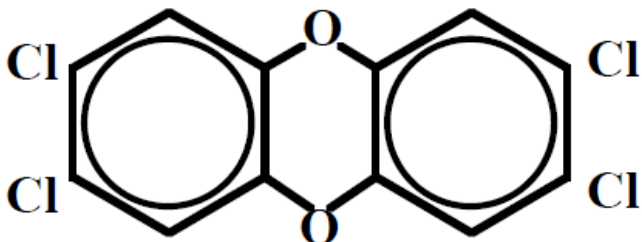
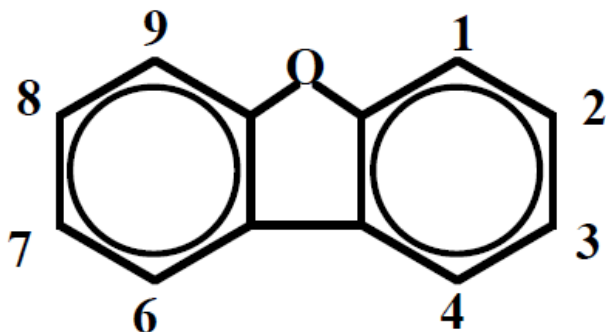
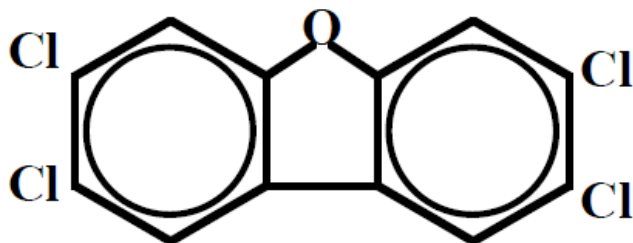
DIOXIN AND FURAN STRUCTURE

- Dioxins and furans are double benzene rings with chlorine atoms attached at various points. They are not just one chemical composition.

2,3,7,8 — Tetrachlorodibenzo(p)dioxin

2,3,7,8 — Tetrachlorodibenzofuran

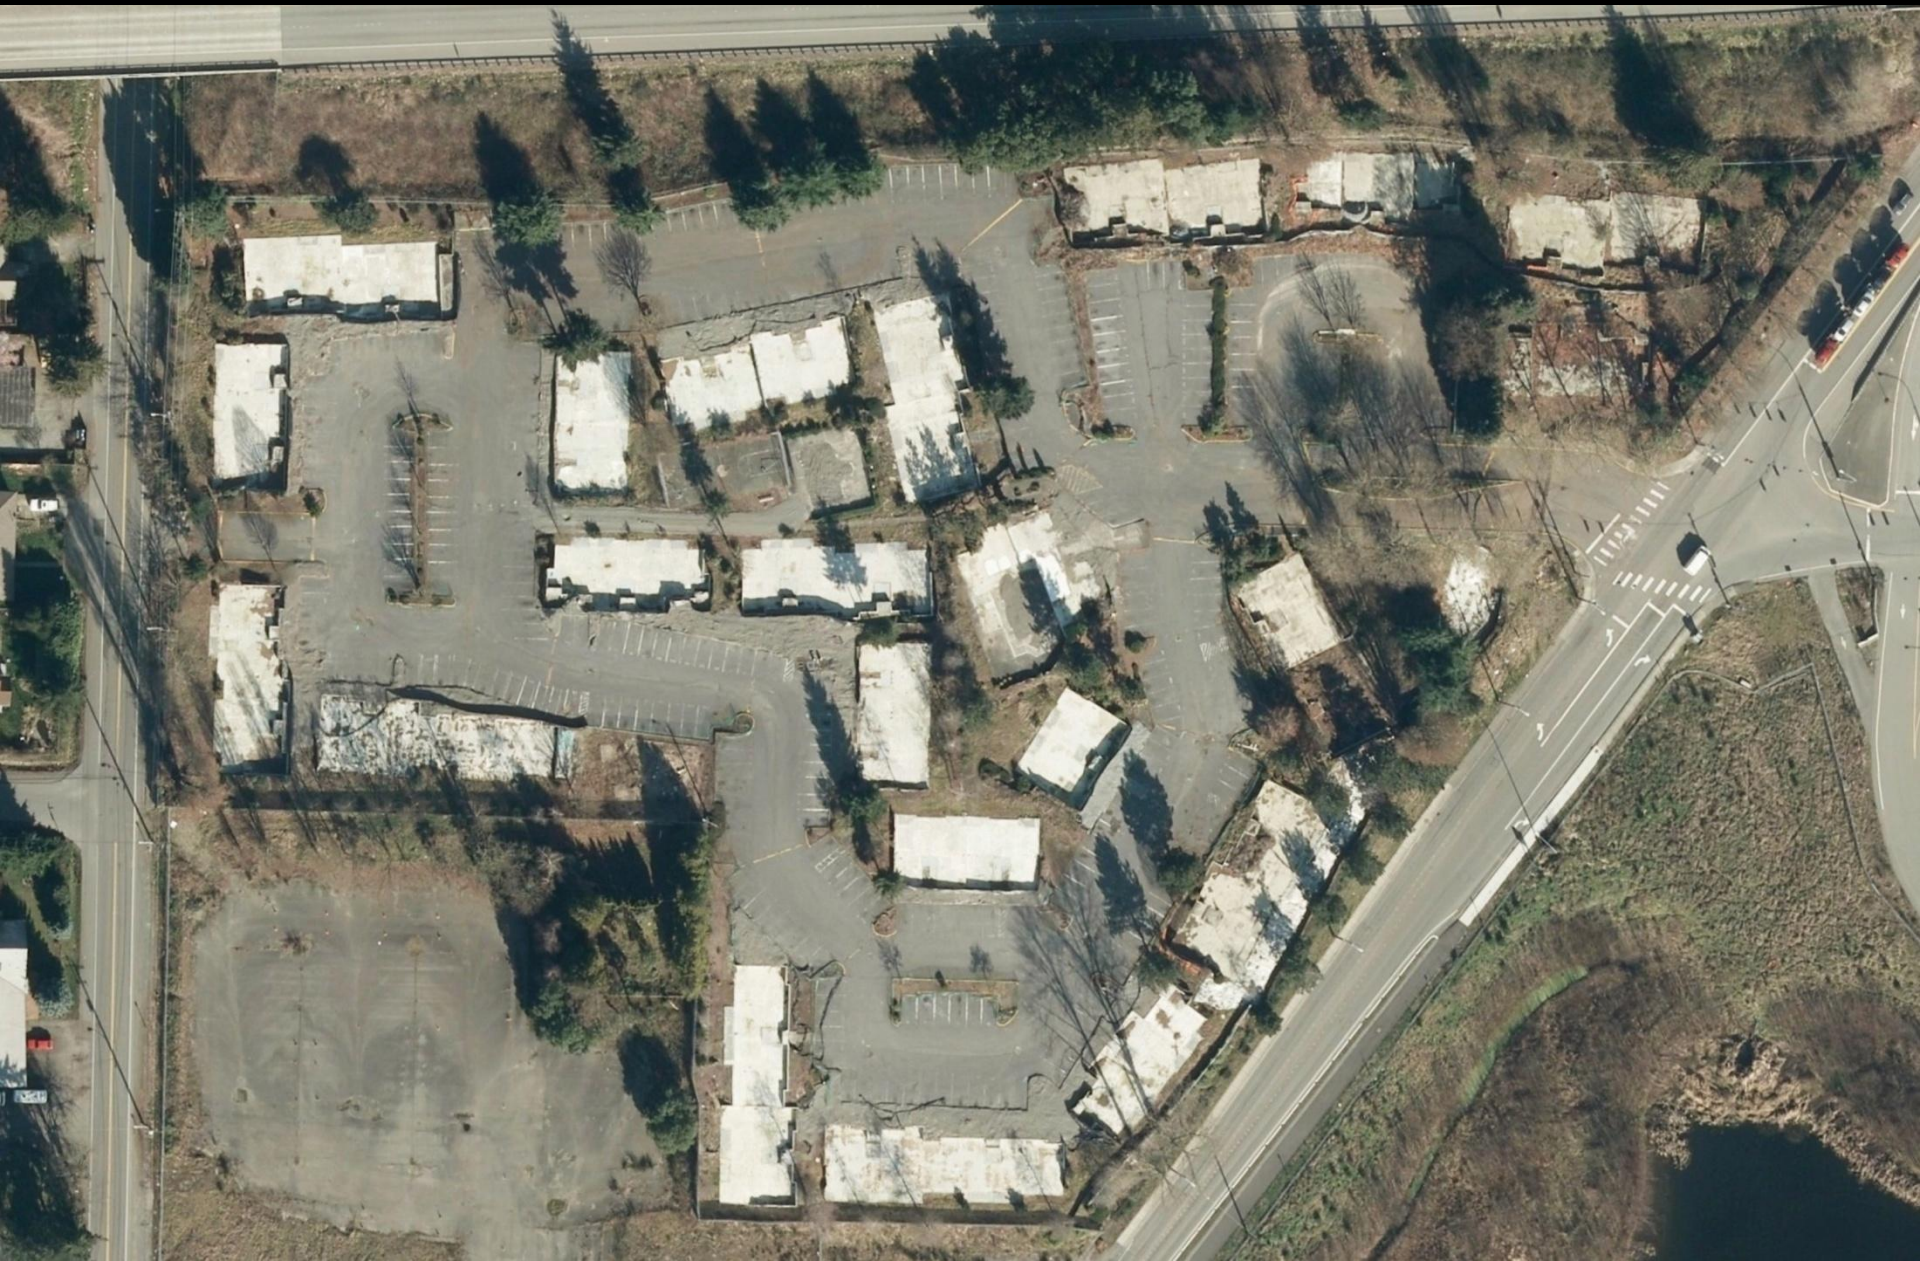
Within the Lora Lake Apartments Parcel dioxin soil contamination is highest at and downhill from the old barrel cleanout area. Over much of the western part of the property dioxin concentrations are < 100 ppt.

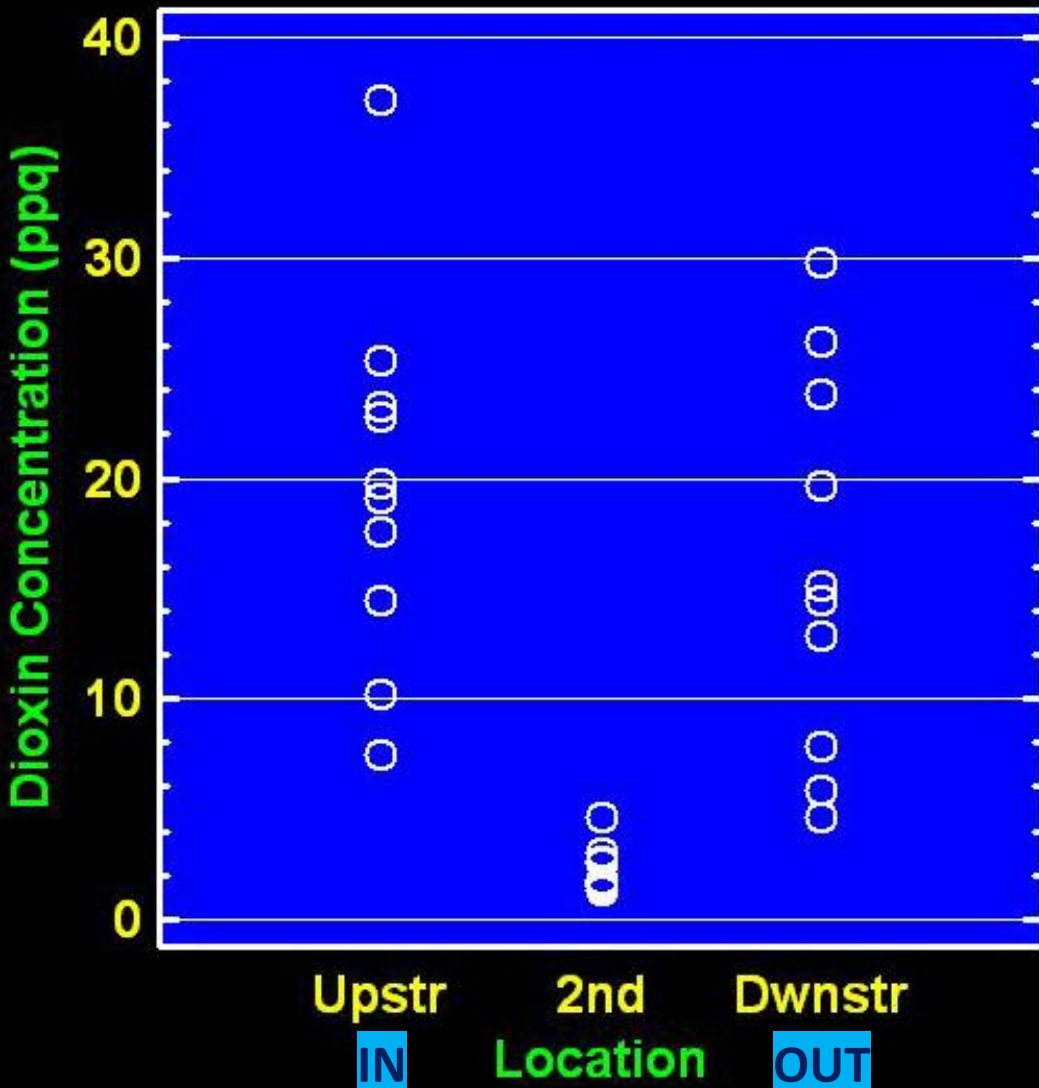
Dioxin in Storm Water

Upstream and downstream stations were statistically the same

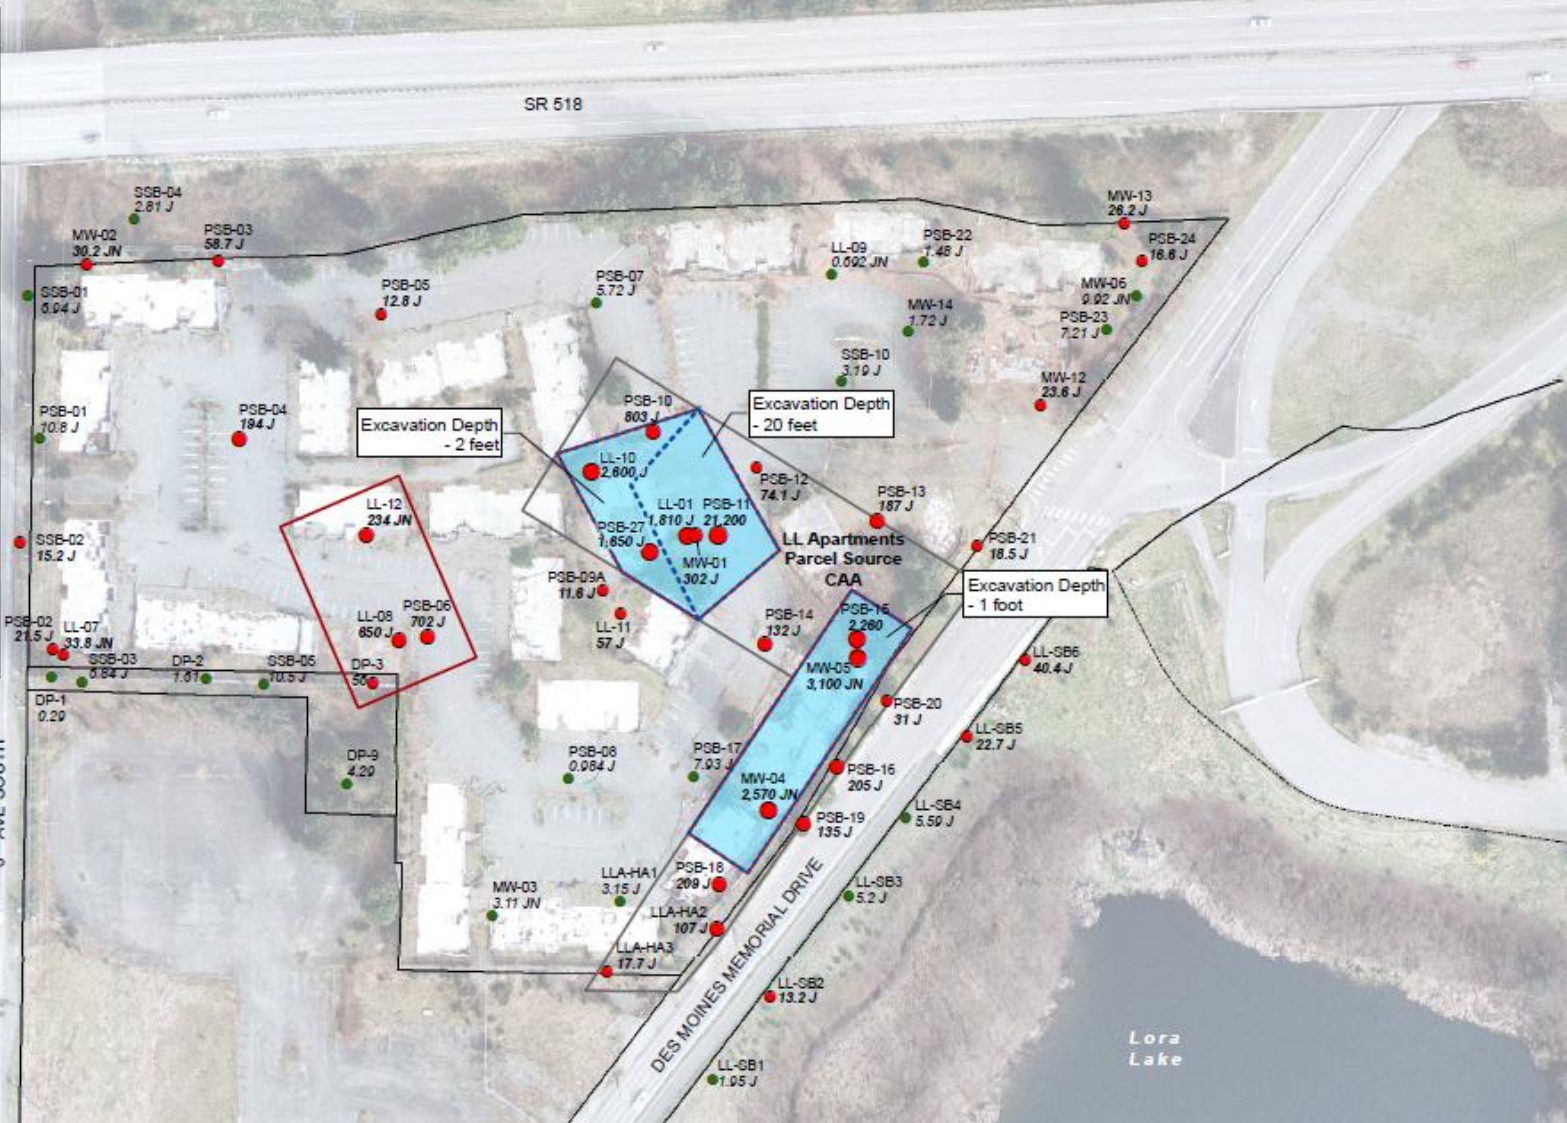
Alternative 3 Excavation Extent – Excavates soil with dioxin over **1,000** ppt. Cap other areas, storm drain system improvements, deed covenants, long-term monitoring. **\$7.9 million.**

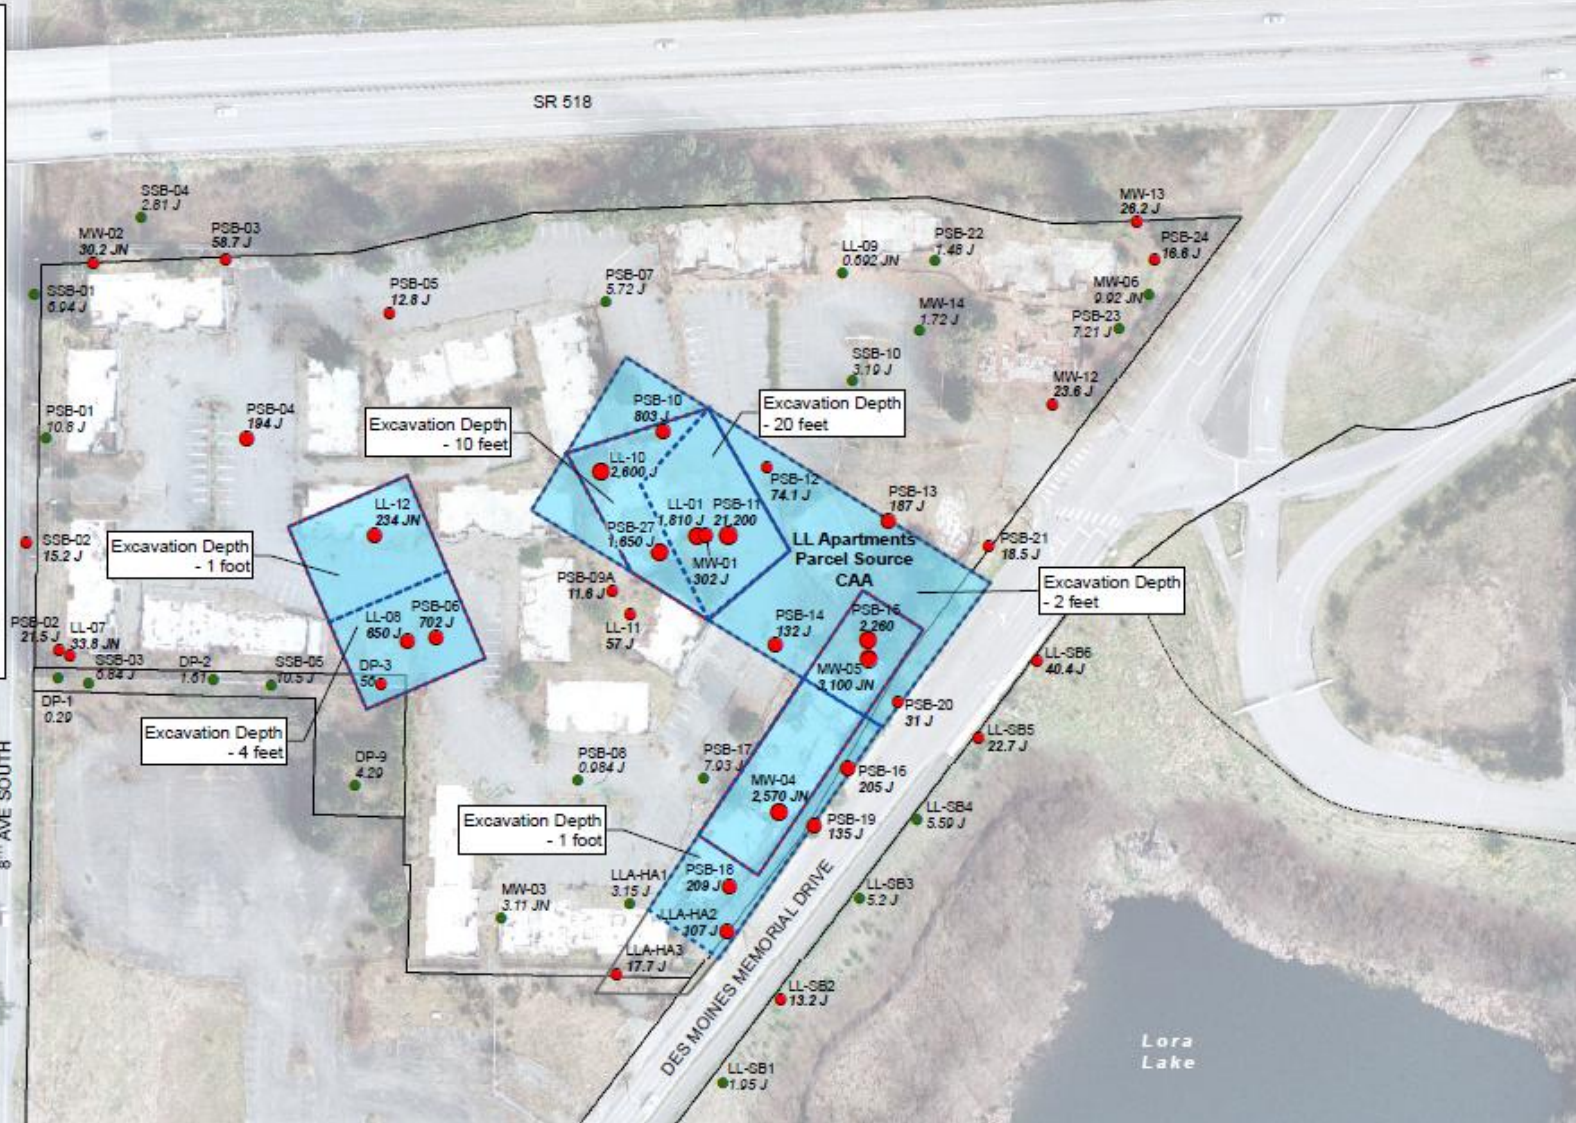
Alternative 4 Excavation Extent – Excavates soil with dioxin over 100 ppt. Cap other areas, storm drain system improvements, deed covenants, long-term monitoring.

\$8.1 million
