2018 ANNUAL REPORT

CASCADE TIMBER #1 SITE

2502 MARINE VIEW DRIVE

TACOMA, WA

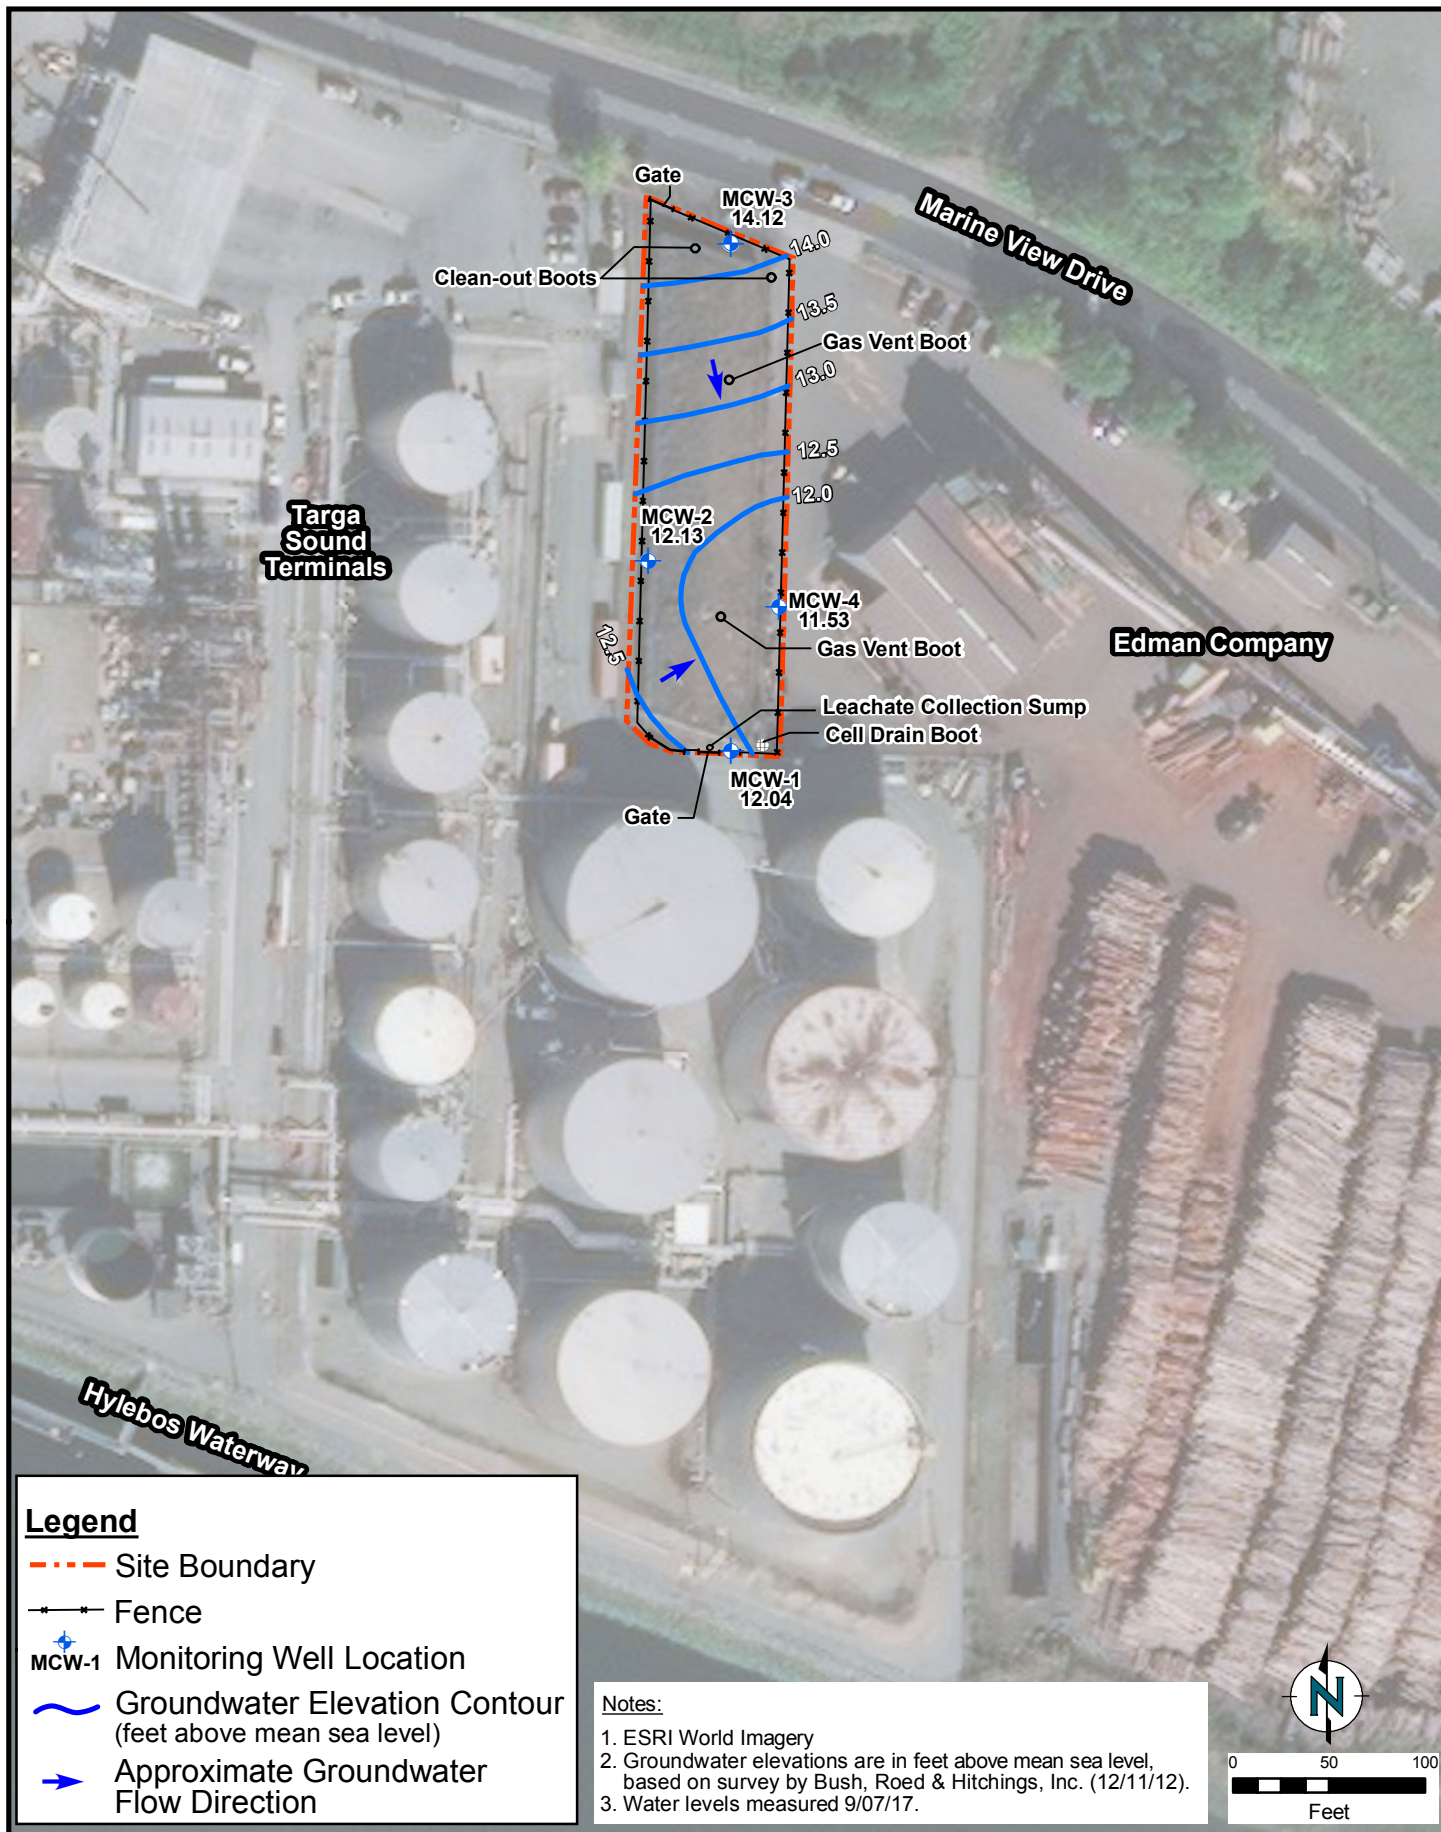
Figure
1

In the July 2018 monitoring event, groundwater depths ranged from approximately 9.12 feet (MCW-2) to 13.62 feet (MCW-4) below the respective top-of-casing (TOC). Based on these measurements and the TOC elevations (surveyed in December 2012), groundwater elevations beneath the Site ranged from approximately 11.53 feet (MCW-4) to 14.12 feet (MCW-3) above mean sea level (amsl; Table 1). The groundwater elevations suggest that shallow groundwater flow beneath the Site is to the southeast (towards the Hylebos Waterway), with a northeasterly component of flow in the vicinity of MCW-1 and is consistent with several monitoring events conducted by Ramboll from 2011 through 2017.

Groundwater Elevation Map - July 2018 Cascade Timber No. 1 Site

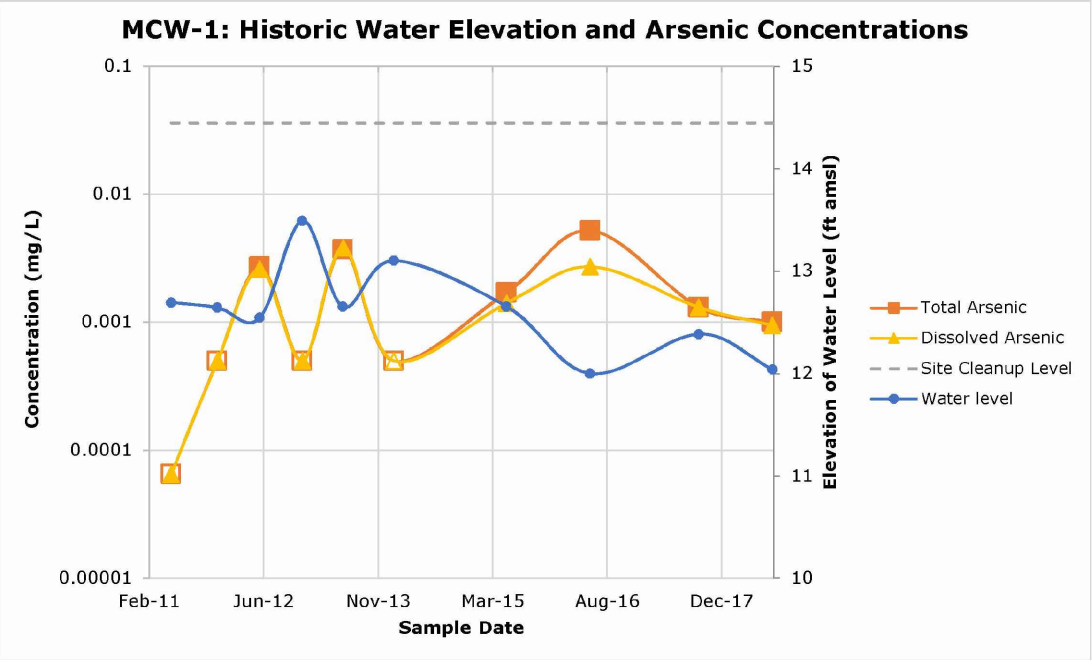
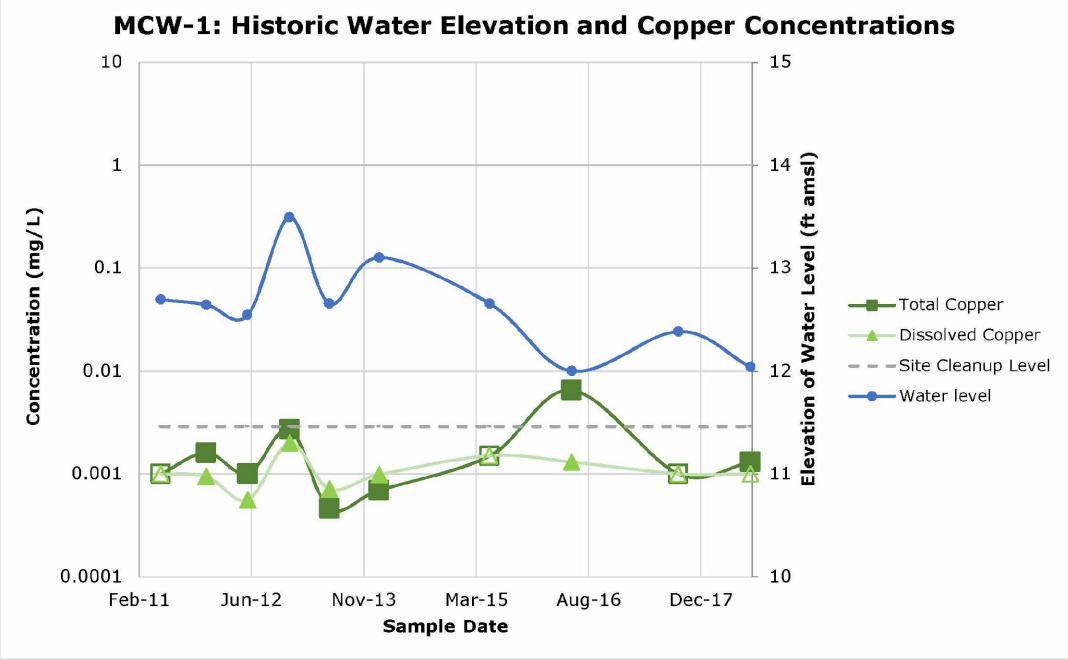
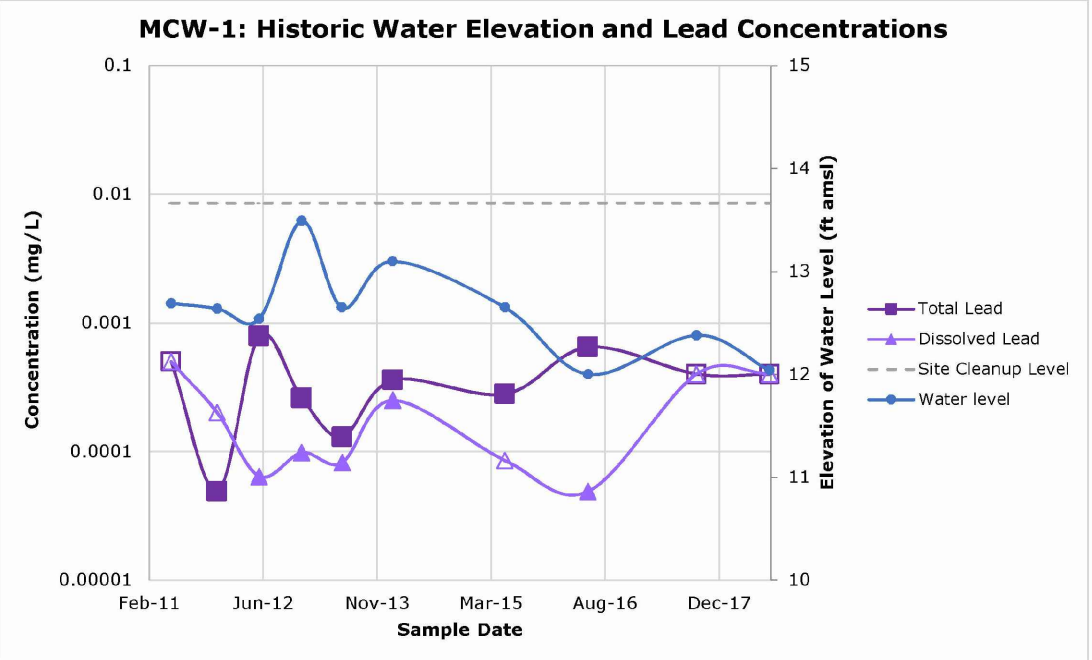
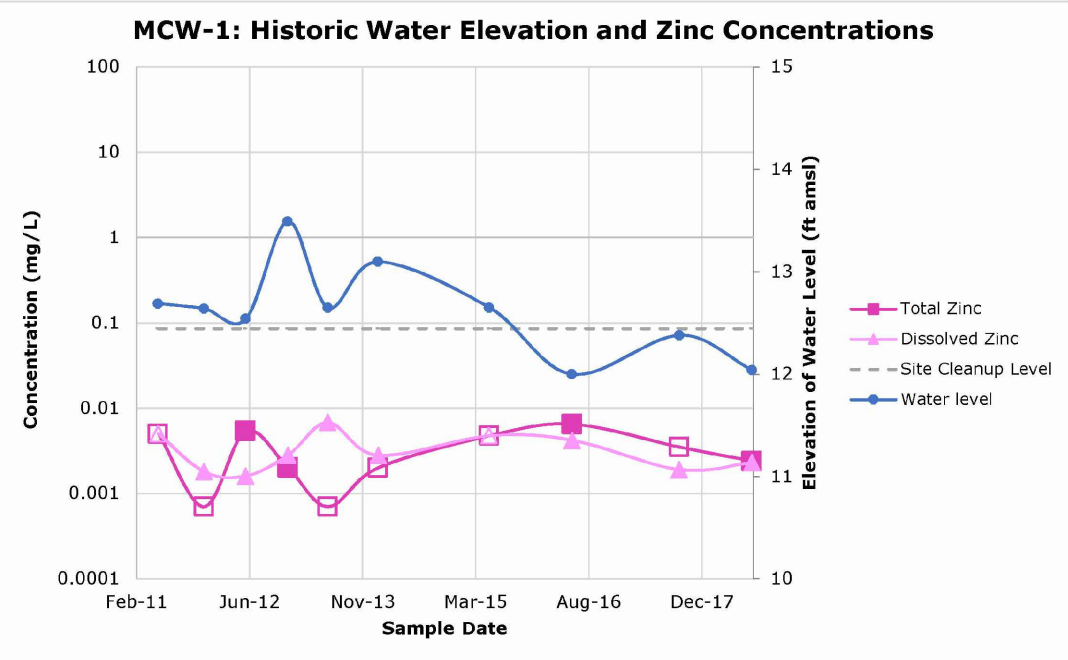
FIGURE
2a

- Although Copper was detected in MCW-1 above the cleanup criteria during one sampling event (i.e., in 2016) it has since returned to below criteria and has been identified as “stable” by the Mann-Kendall analysis.

**GROUNDWATER ELEVATION
AND METAL CONCENTRATIONS -
MCW-1**

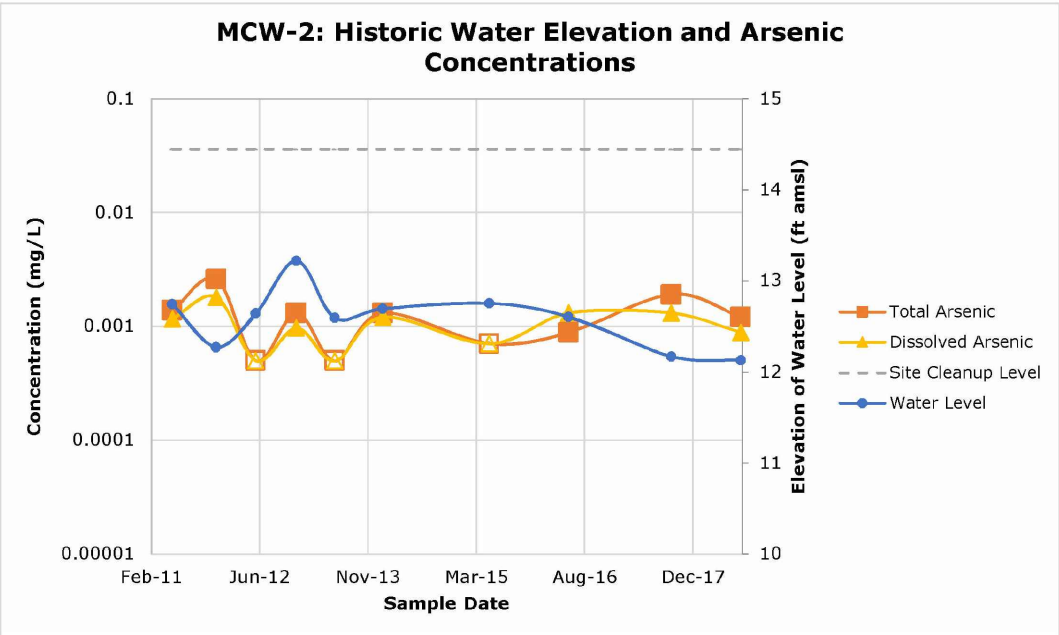
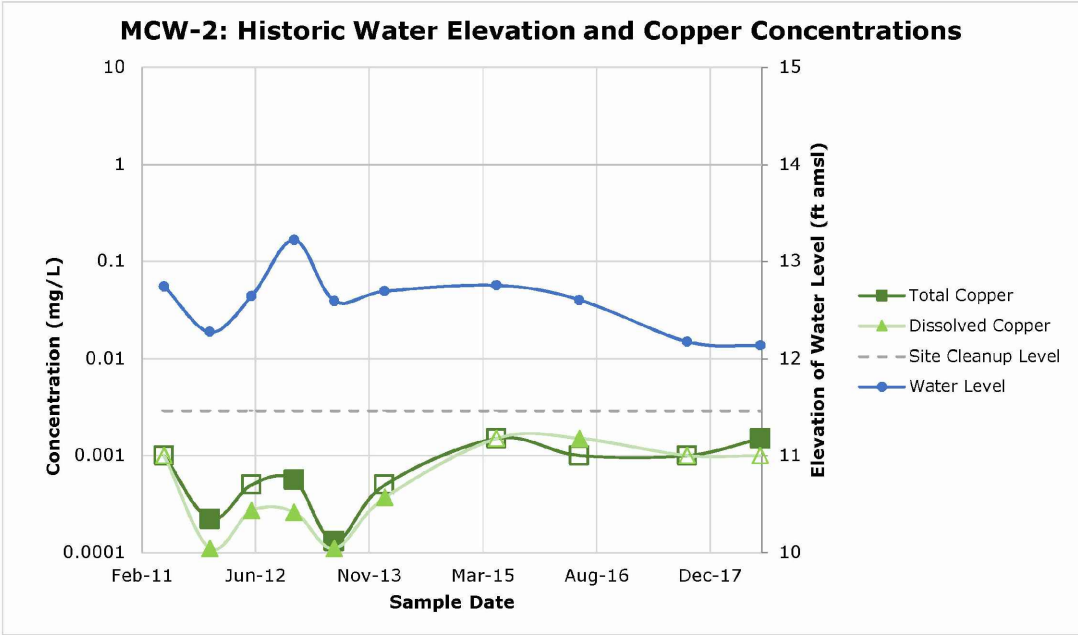
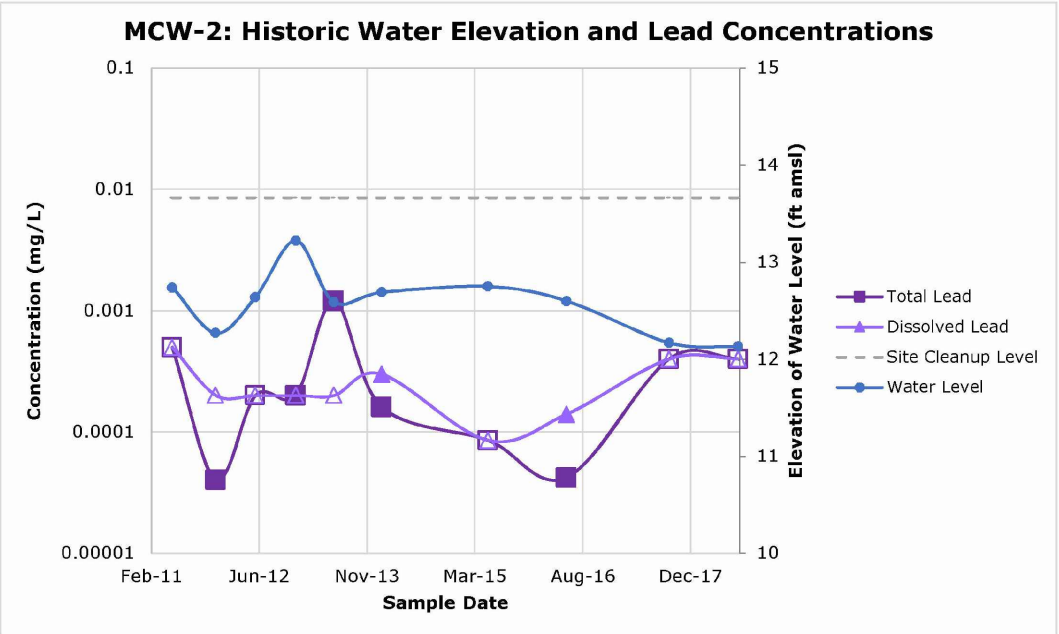
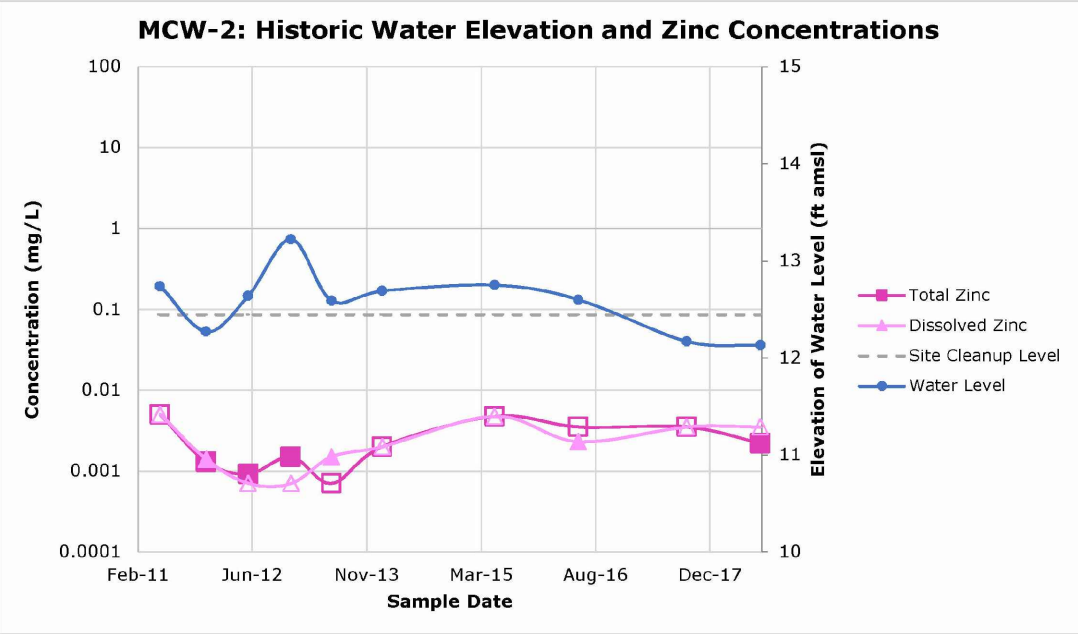
**FIGURE
2b**

- For MCW-2, total zinc concentrations exhibit a “probably increasing” trend according to the Mann-Kendall analysis. However, inspection of Table 2 demonstrates that total zinc concentrations in MCW-2 have only reported above the laboratory reporting limit during one sampling event (December 2012), and the laboratory reported concentrations and historical reporting limits have been less than the cleanup criteria for zinc specified in the Consent Decree (0.086 mg/L).

**GROUNDWATER ELEVATION
AND METAL CONCENTRATIONS -
MCW-2**

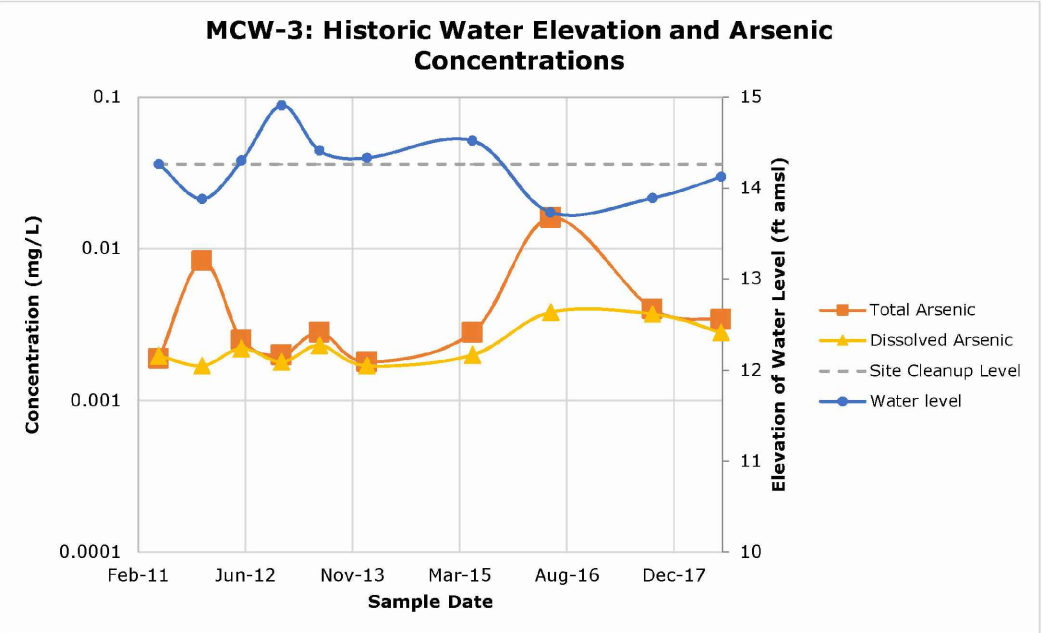
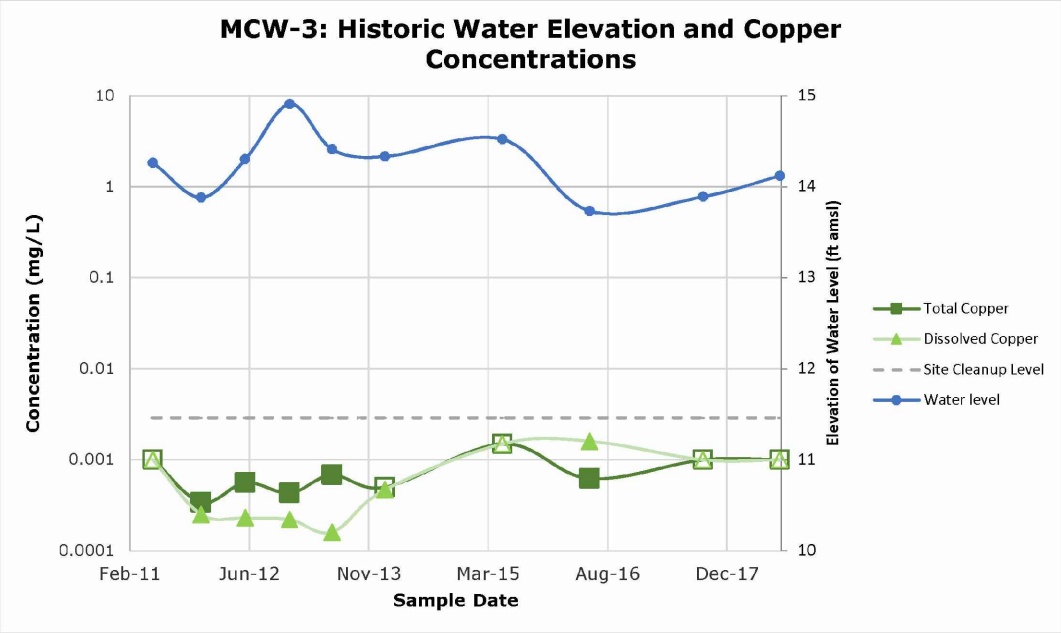
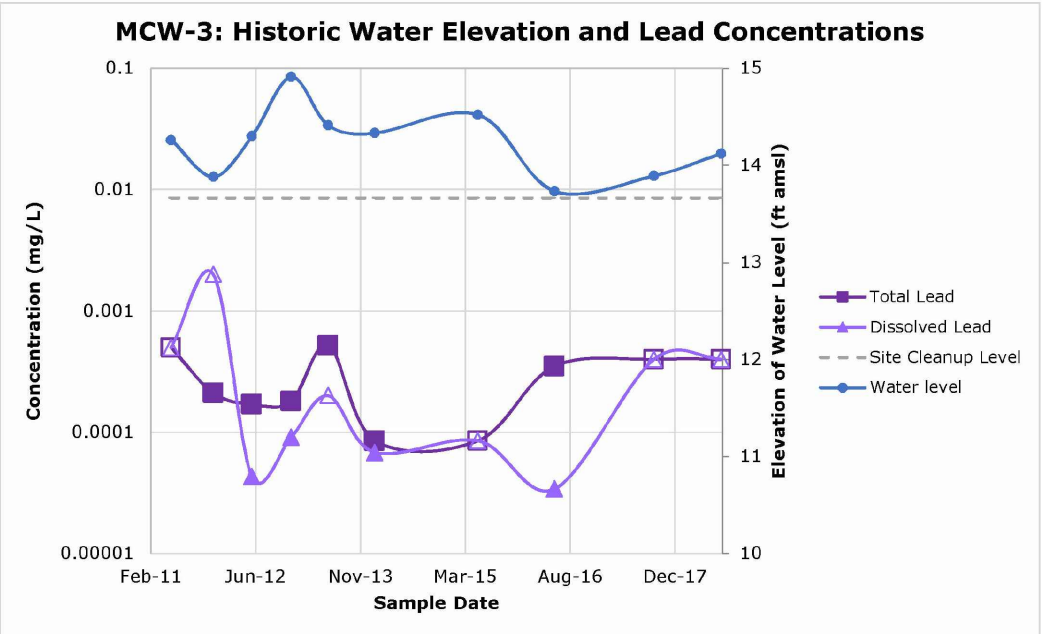
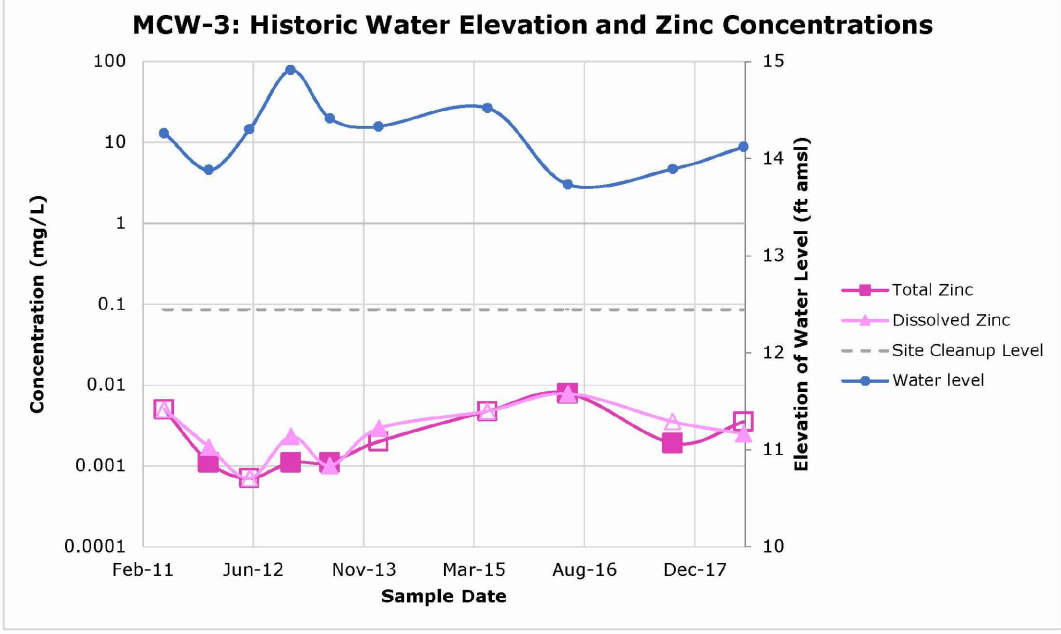
**FIGURE
2c**

- For MCW-3, the Mann-Kendall test indicates a statistically significant increasing trend for dissolved arsenic; however, all detections of dissolved arsenic have been below the cleanup criteria specified in the Consent Decree (0.036 mg/L) and the identified trend is similar to historical fluctuations over time.

**GROUNDWATER ELEVATION
AND METAL CONCENTRATIONS -
MCW-3**

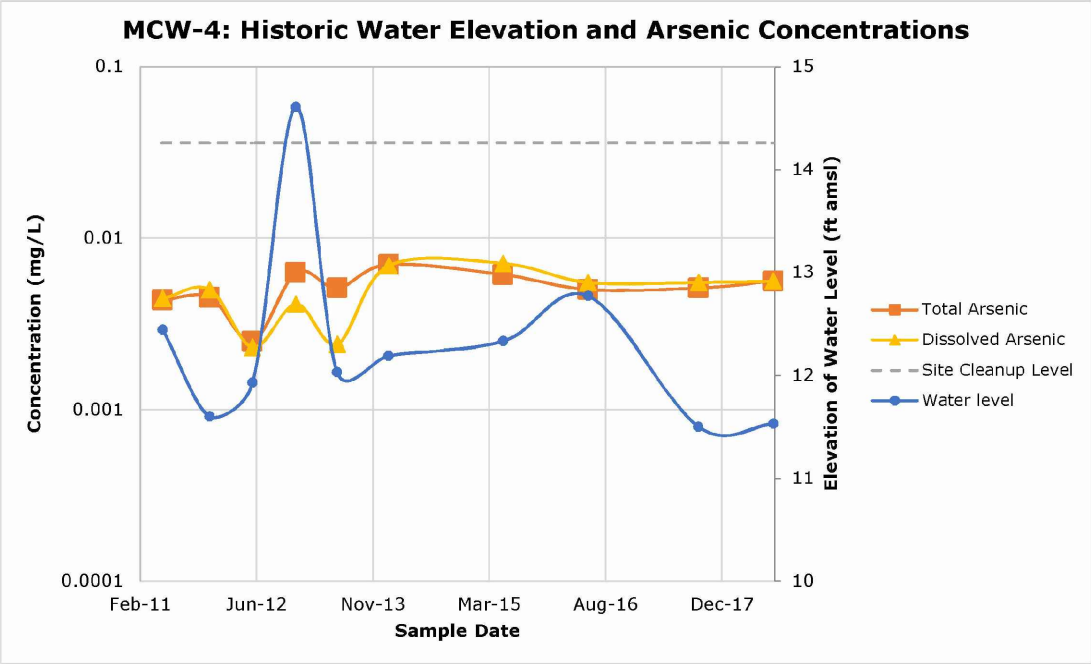
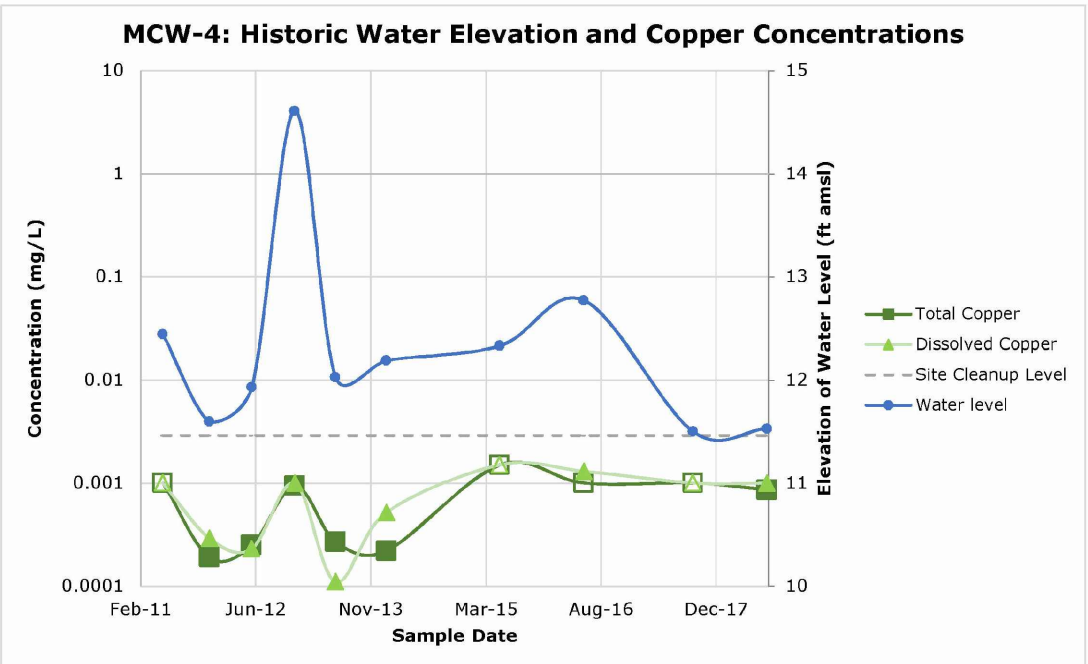
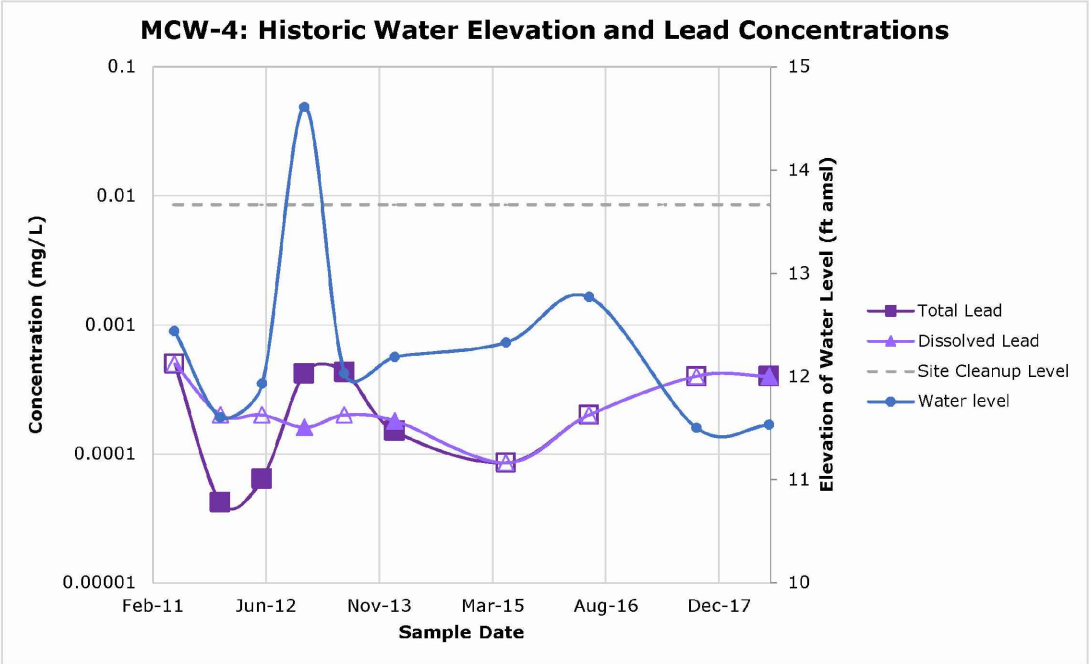
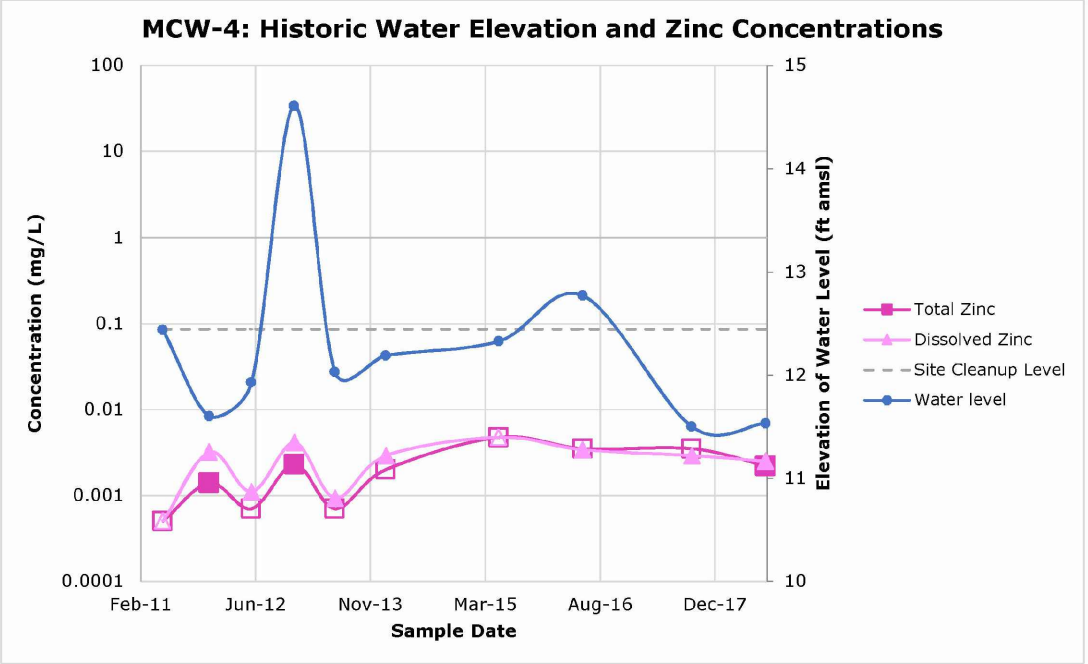
**FIGURE
2d**

- For MCW-4, total and dissolved arsenic concentrations have varied historically and are identified as “probably increasing” by the Mann-Kendall analysis; however, maximum concentrations for

both forms of arsenic (0.0071 mg/L) remain well below the cleanup criteria specified in the Consent Decree (0.036 mg/L).

**GROUNDWATER ELEVATION
AND METAL CONCENTRATIONS -
MCW-4**

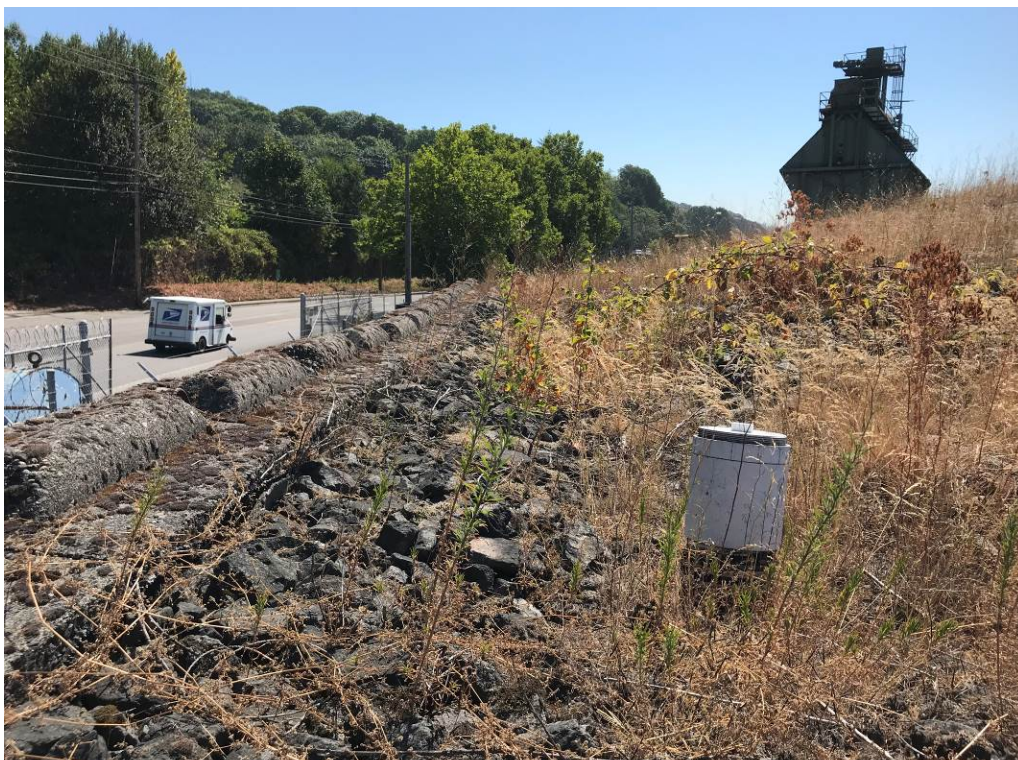
The two "gas vent boots" protruding from the center of the containment cell appeared to be unobstructed, and in good condition. The "cleanout boots" located in the northeastern and northwestern corners of the containment cell were visually inspected and were found to be unobstructed and in good condition. The "cell drain boot" located in the southeast corner of the containment cell was also visually inspected and noted to be in good condition, although the paint coating appeared to be chipping off in some areas.

Photo 1: Top of containment cell looking east from northwest corner, northwest cleanout boot is visible in the foreground.

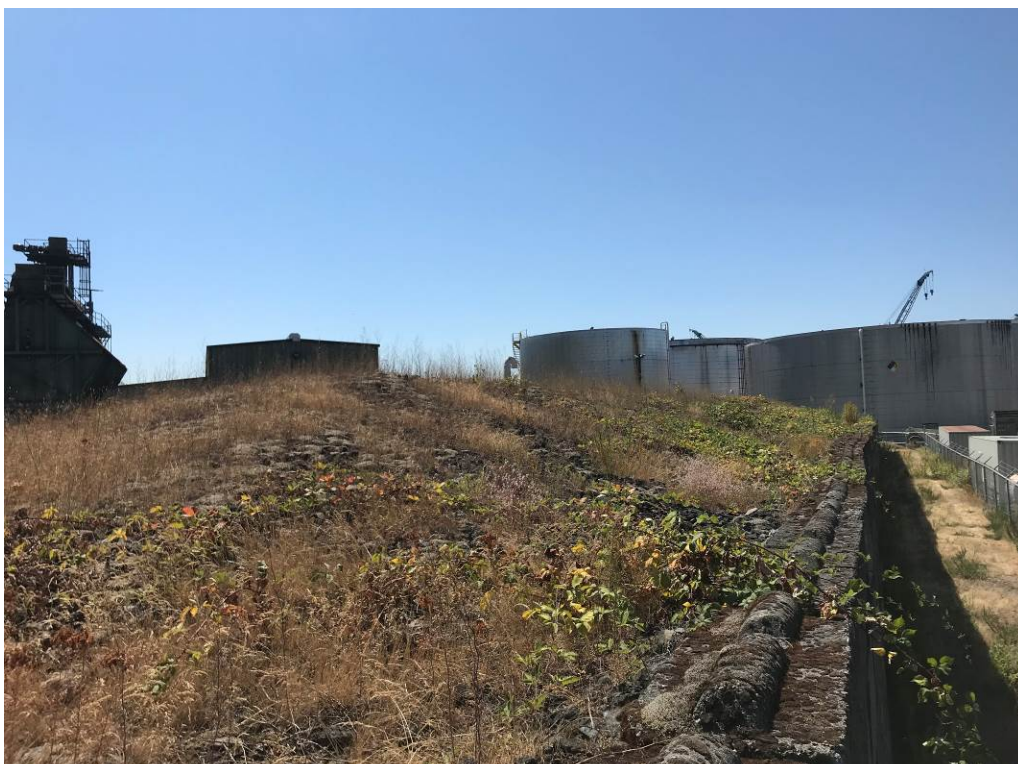
Photo 2: Top of containment cell looking south from the northwest corner, northern gas boot is visible.

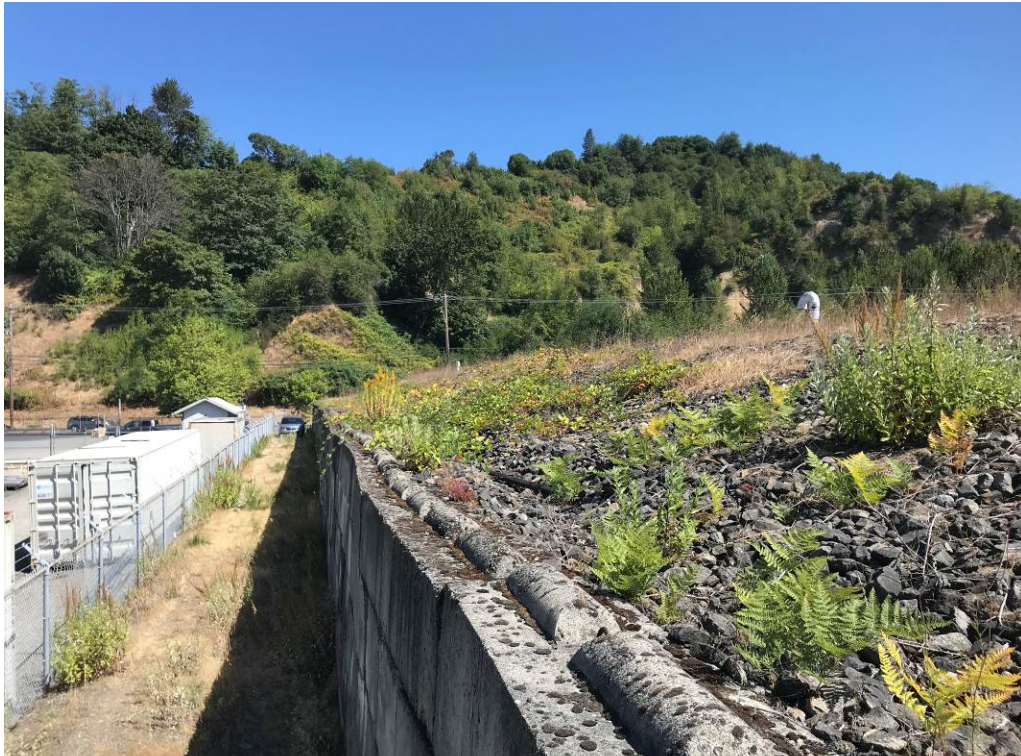
Photo 3: Top of containment cell, view to the north from southwest corner, southern gas boot visible.

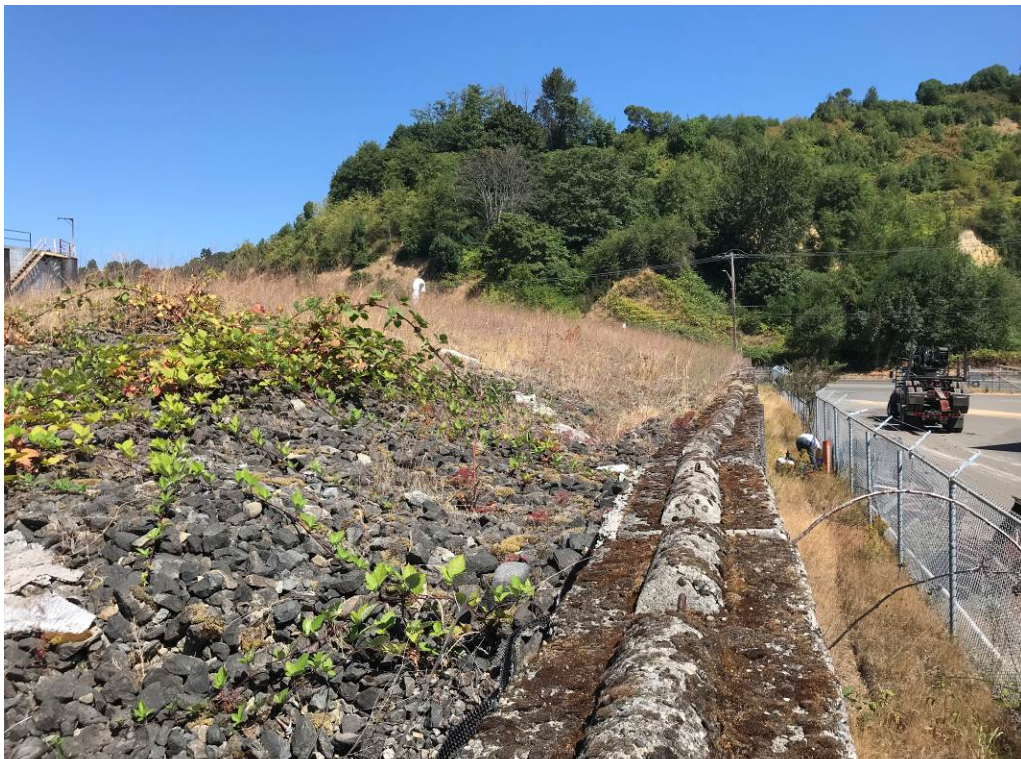
Photo 4: Top of containment cell, view to the north, southern and northern gas boots visible.

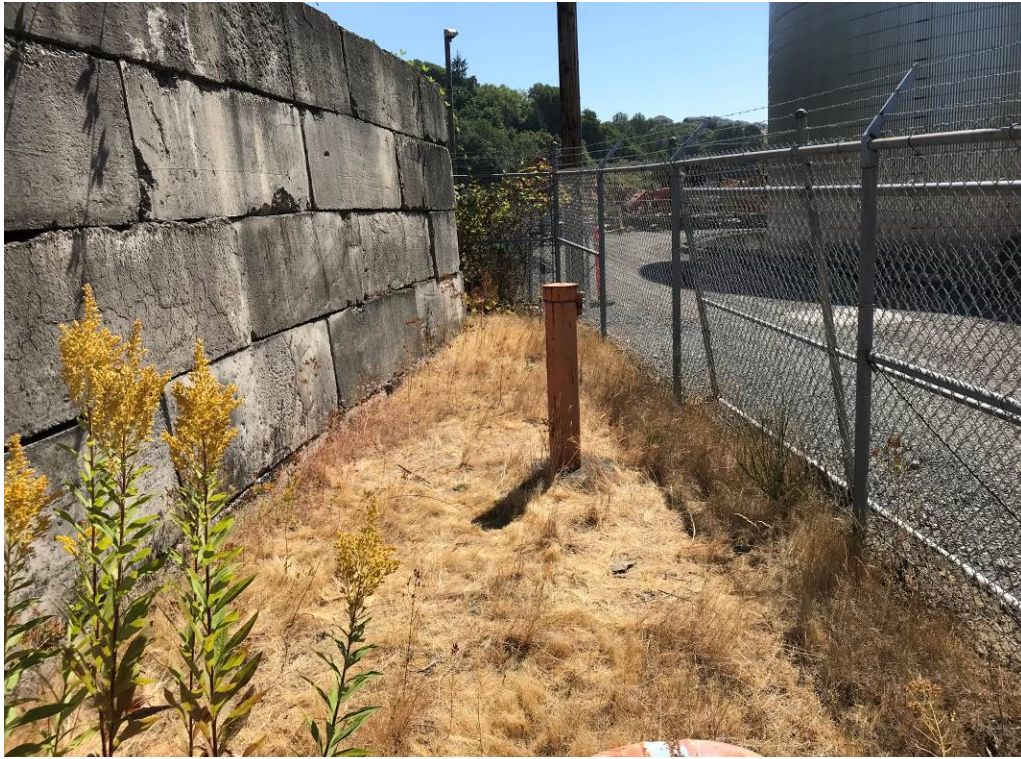
Photo 5: View to the east along the southern side of the containment cell. MCW-1 (standpipe in background) is visible.

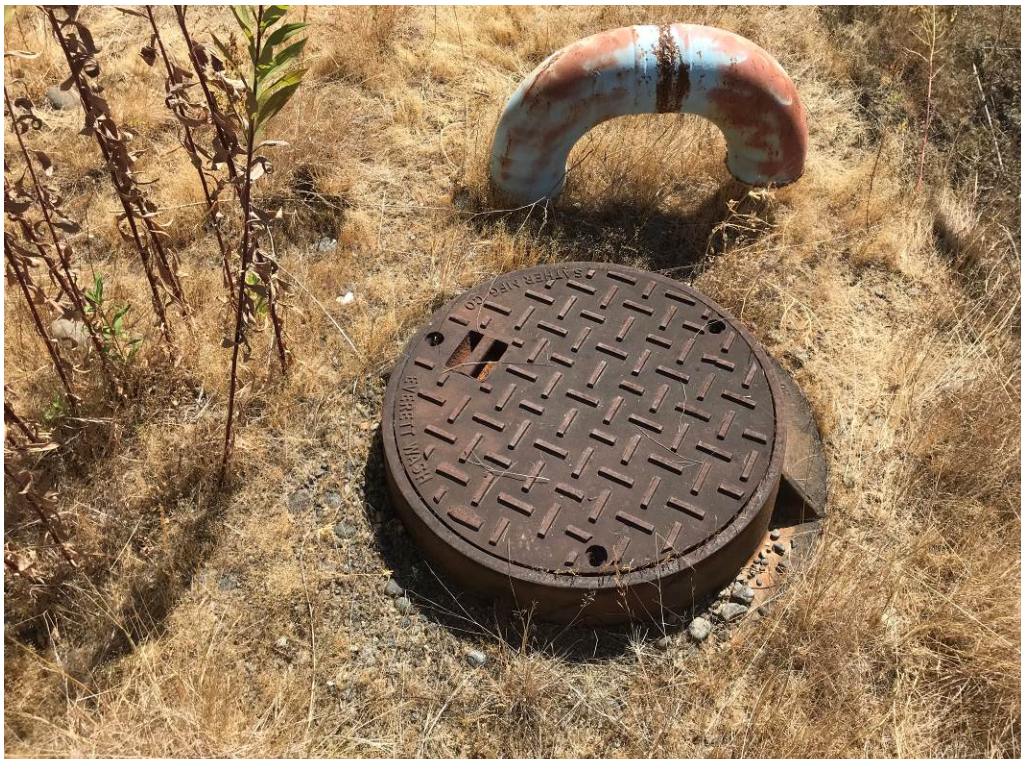
Photo 6: Leachate collection sump (manhole).

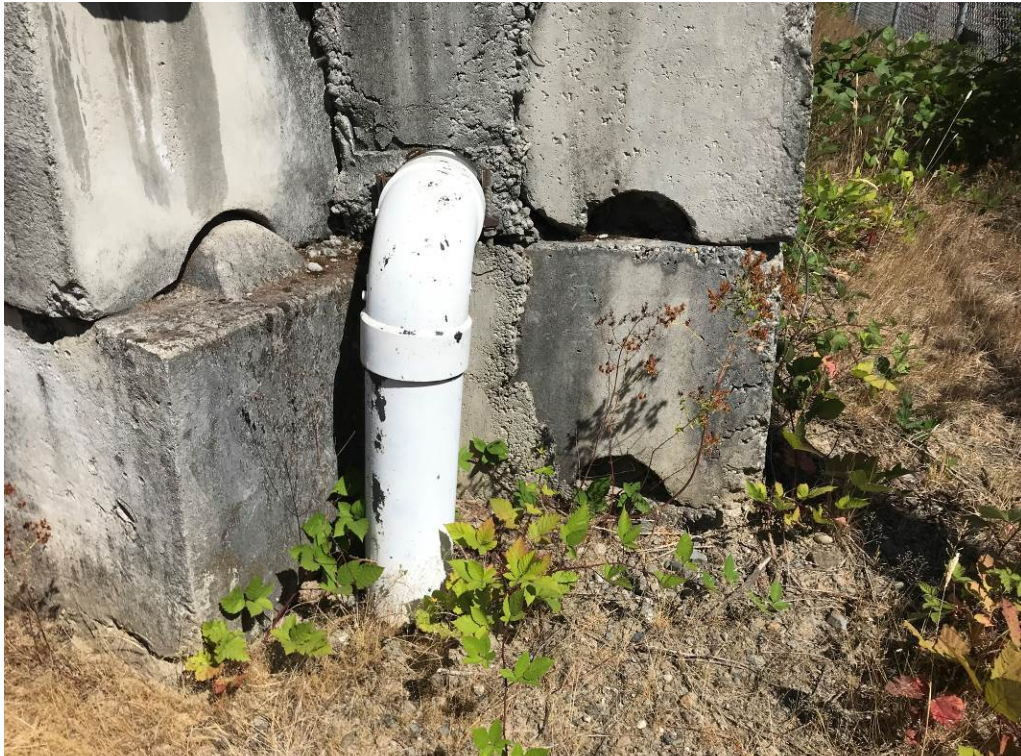
* 3.1 - Pipes and Culverts	Vegetation is not obstructing flow to pipes.
* 3.2 - Pipes and Culverts	Protective coating is present on pipes. Coating wear noted in 2015, 2016, + 2017 visits: still present in similar condition

Photo 7: View to the north of the cell drain boot showing some aging on the paint coating.

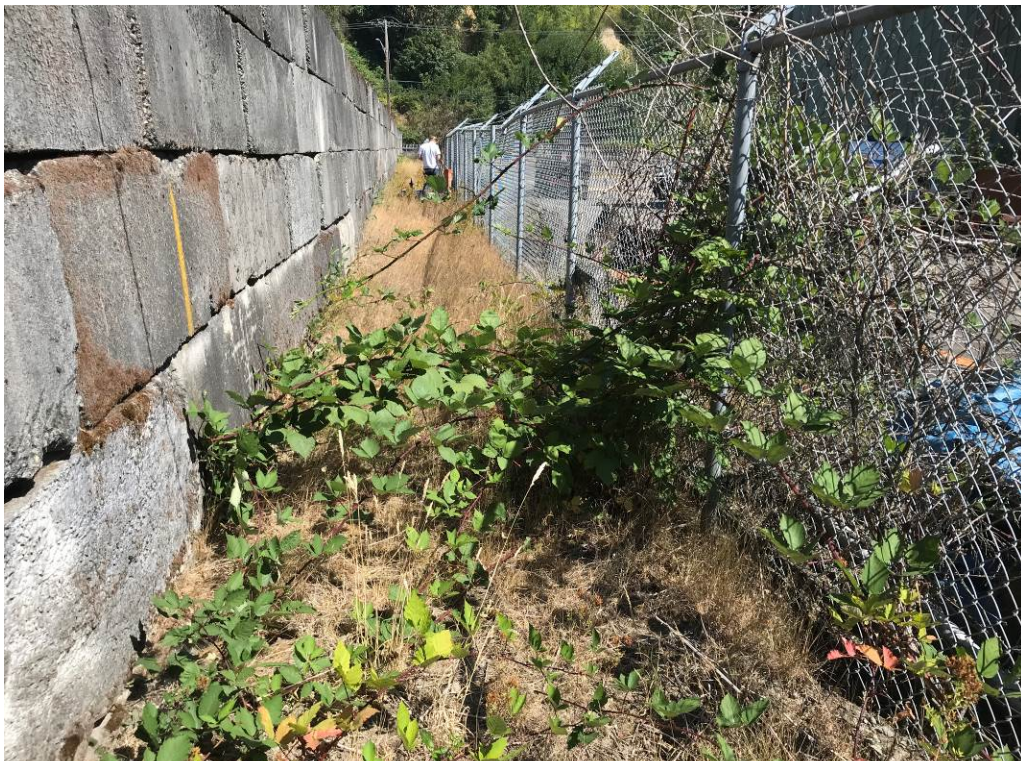
Vegetation was cleared from the Site (including the top of the cell and ground surface) in December 2017. Ramboll personnel visually inspected the surface of the containment cell in July 2018. Vegetation was observed on the surface, consisting of a variety of grasses and young blackberry plants. During the inspection, Ramboll noted growth of a Scotch broom shrub along the base of the southeastern side of the containment cell that appears to have grown into the side of the containment cell at the ground surface. Ramboll also noted an increase in vegetation growth on top of the containment cell and at the base surrounding the containment cell, particularly along the eastern side. Access to MCW-4 is partially obstructed by the vegetation growth from the southeastern corner, such that MW-4 is more easily accessible from the northeastern corner. This vegetation does not pose an immediate concern, but Ramboll will continue to monitor changes and provide recommendations for vegetation control in the future, as necessary.

Photo 8: View to north from southeast corner, vegetation partially blocking access..

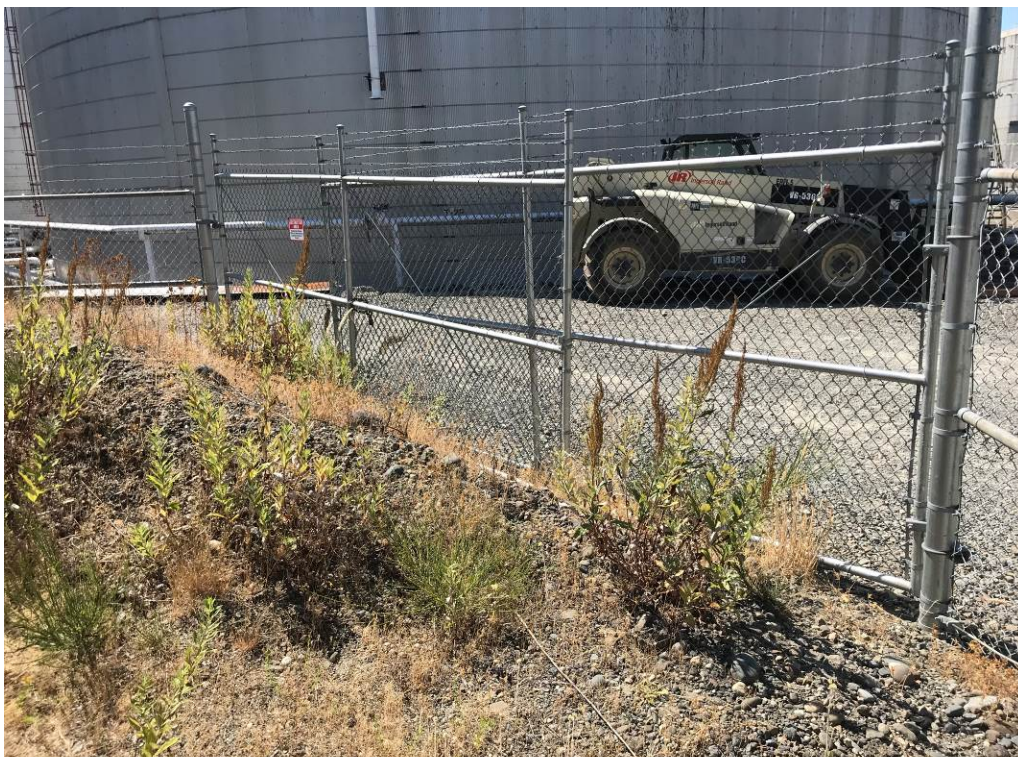
The perimeter fence was inspected in July 2018 and was noted to be in good condition. Appropriate signage was observed in place.

Photo 9: Fence and gate along southwestern boundary.

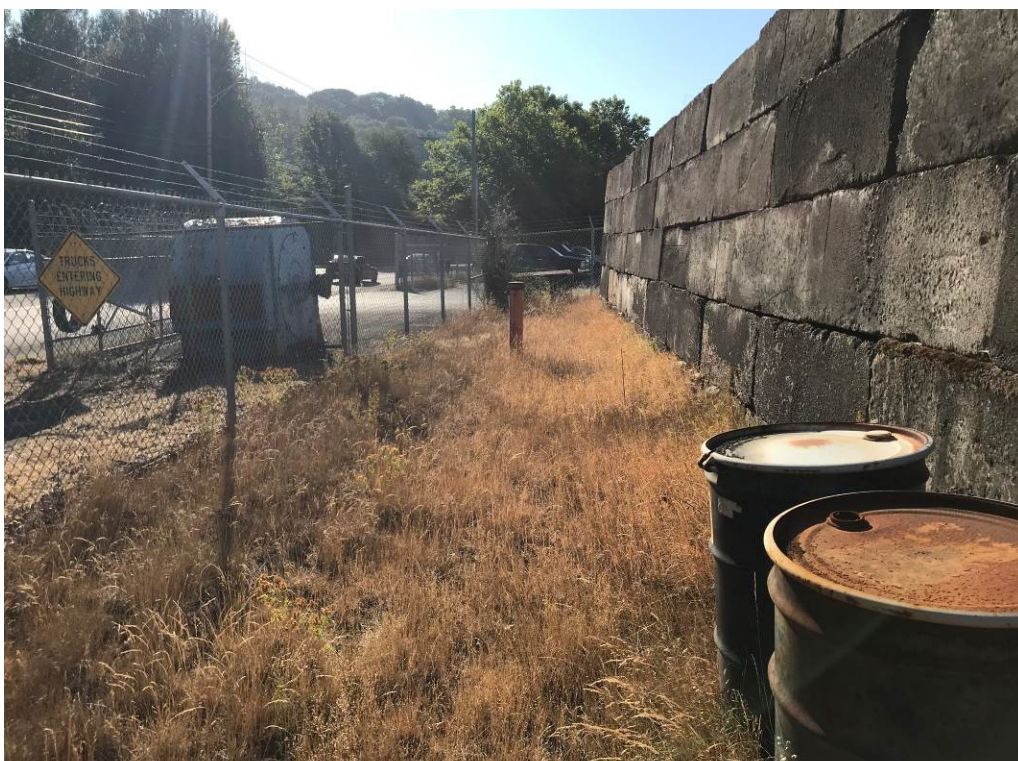
Photo 10: View to the east from northwestern corner, MCW-3 visible in background (standpipe). Purge water containment drums on right side of photograph.
