2018 ANNUAL REPORT

CASCADE TIMBER #1 SITE

2502 MARINE VIEW DRIVE

TACOMA, WA

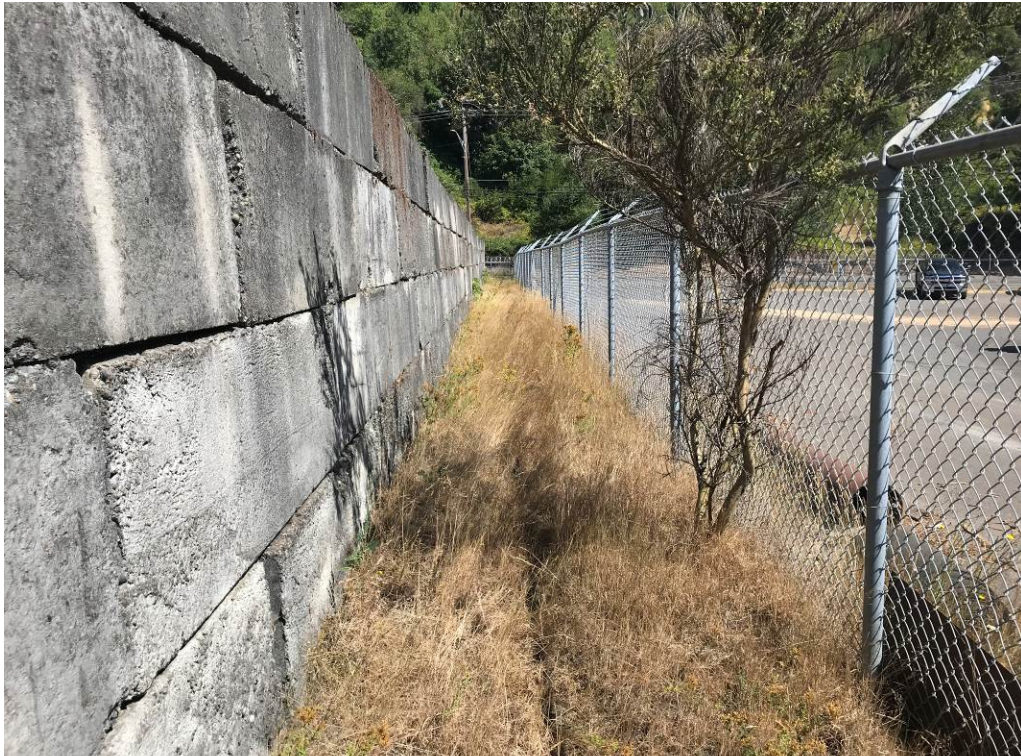
Photo 11: View to the north from eastern side of containment cell.

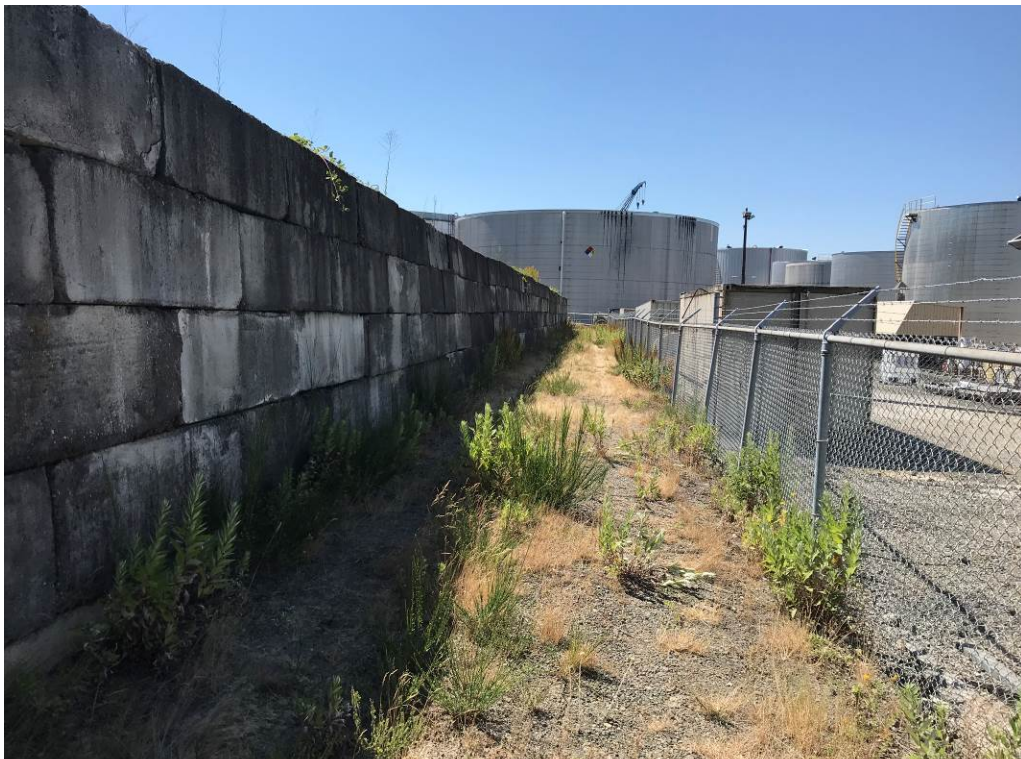
Photo 12: View to the south from northwest corner.
