MEMORANDUM

Project No. 160355

April 16, 2019

Re: Removal Action Report, Ernie's Fuel Stop Moses Lake, Diesel Spill—FINAL

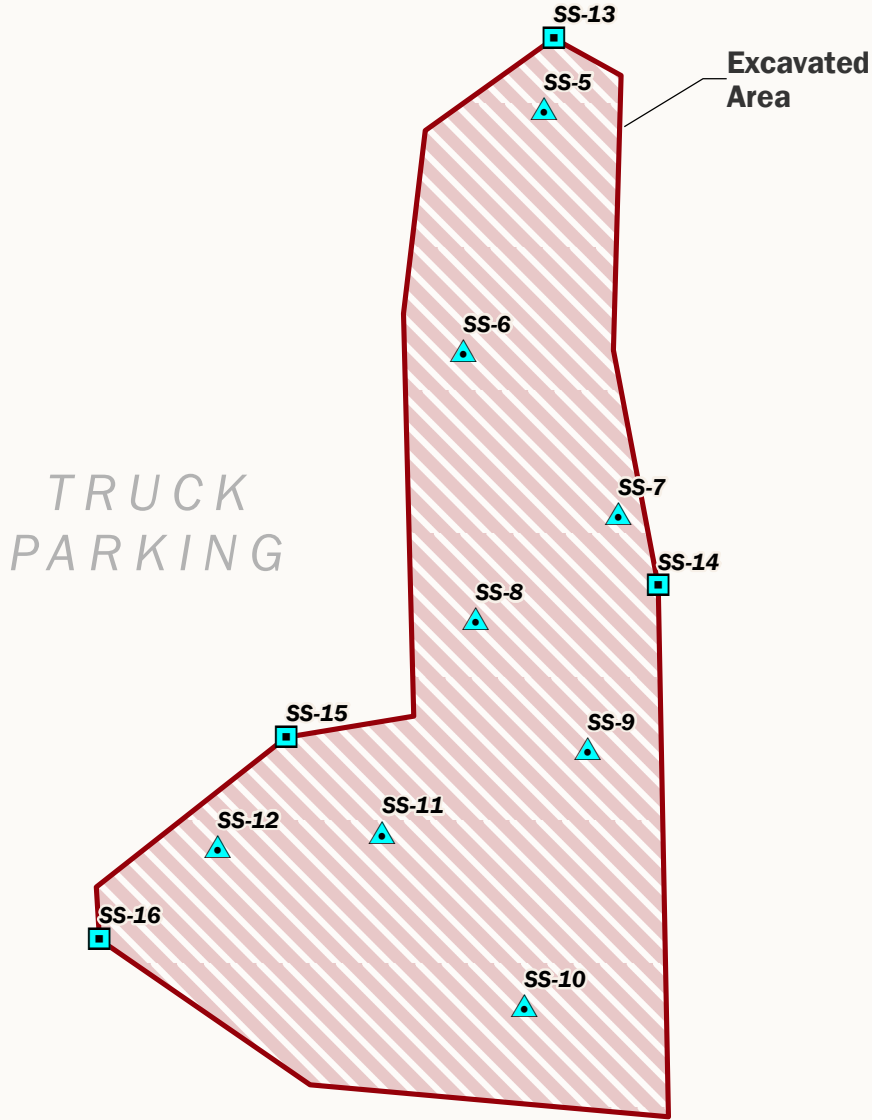
Excavation Confirmation Sample Map

The removal action was completed on March 19, 2019, by DH Environmental, and the work overseen by Aspect. The extent of the excavation is illustrated on Figure 2, and photographs of removal activities are provided in Appendix C. The following summarizes details of the removal action and sampling activities.

Removal action performance was evaluated by collecting confirmation soil samples from the sidewalls and the excavation bottom. Confirmation sampling was conducted on March 28, 2019. A total of 12 discrete grab soil samples were collected from the bottom and sidewalls using a stainless-steel trowel to directly fill one, 4-ounce laboratory-provided jar at each location. Samples were labeled with their respective sample identification and placed in a cooler on ice to meet sample-preservation temperature requirements. Chain-of-custody records provided by the laboratories were initiated at the time of sampling, and the record was signed by Aspect representatives. The coolers were transported directly to the laboratory under proper chain of custody by Aspect. The soil samples were analyzed for diesel- and motor oil-range TPH, using NWTPH-Dx, by Friedman & Bruya, Inc. Laboratory analytical reports for soil confirmation samples are provided in Appendix B.

See Figure 2 for location of samples.

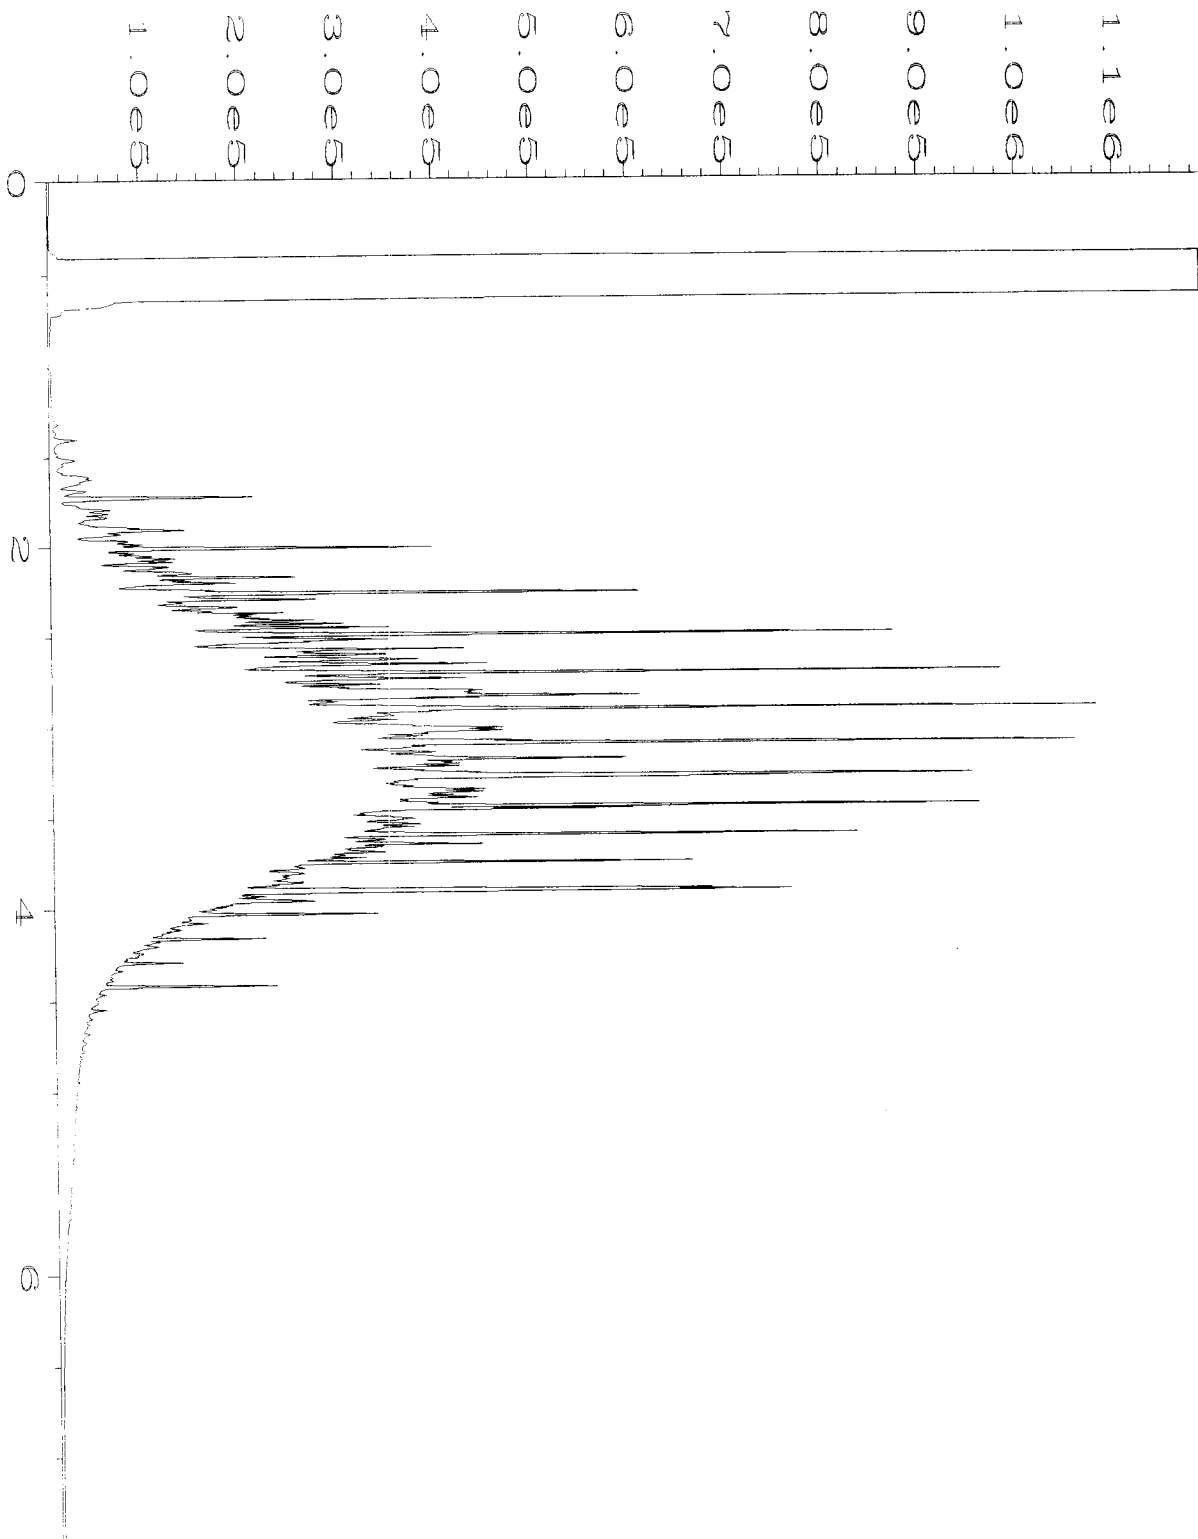
Review of the NWTPH-Dx chromatogram for sample SO-2-031419 showed a pattern of peaks indicating the presence of a middle distillate, such as a diesel fuel. A pattern indicating the presence of a low boiling product, such as gasoline, was not observed in the sample.

Data File Name	: C:\HPCHEM\1\DATA\03-15-19\020F0501.D	Page Number	: 1
Operator	: TL	Vial Number	: 20
Instrument	: GC1	Injection Number	: 1
Sample Name	: 903285-02	Sequence Line	: 5
Run Time Bar Code:		Instrument Method:	DX.MTH
Acquired on	: 15 Mar 19 02:12 PM	Analysis Method	: DX.MTH
Report Created on:	18 Mar 19 10:22 AM

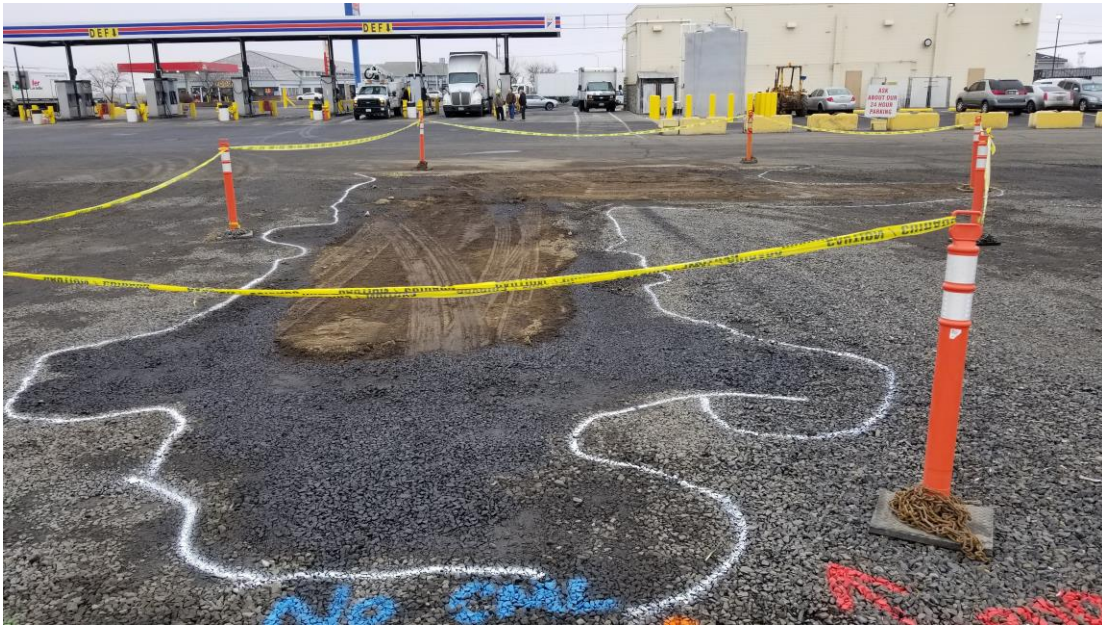
Aspect conducted a preliminary investigation of the release on January 31, 2019. The initial investigation included evaluation the extent of the release, demarcating the release area using spray paint, capturing the boundary using a handheld GPS device, and potholing through the impacted

soil to evaluate the thickness of impacted soil. The release area was “L” shaped and covered an area of 872 square feet. The release area was estimated based on field observations (visual, olfactory, sheen, and photoionization detector [PID] readings) that impacted soil ranged from 8 to 12 inches thick.

Photograph 1. Extent of diesel fuel release. White paint demarcates release boundaries.

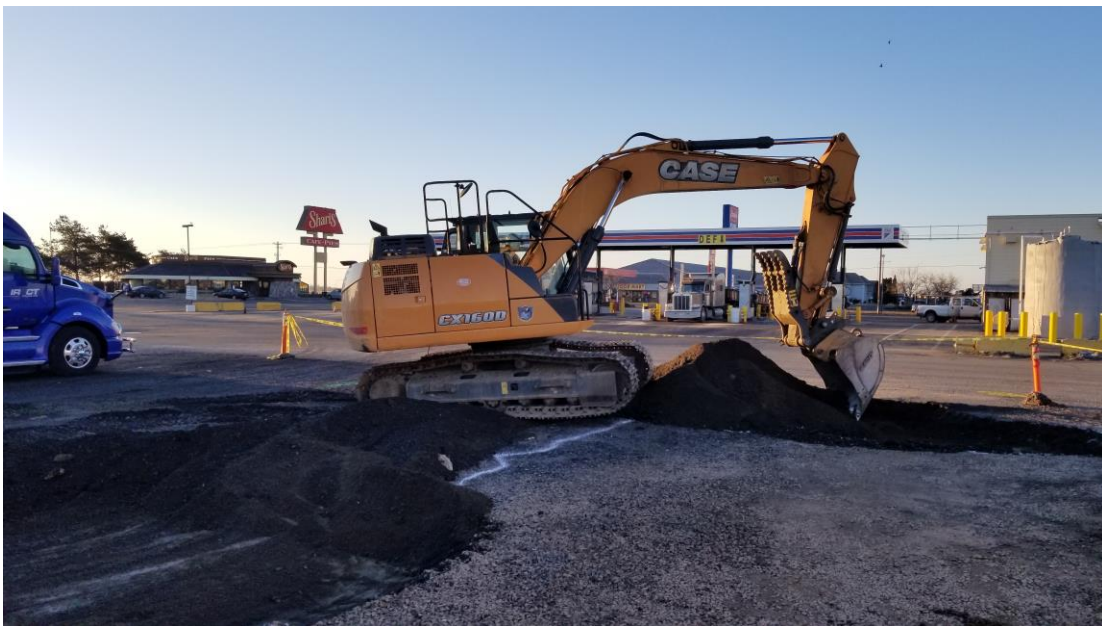
Photograph 2. Excavator beginning excavation.

The impacted soil was excavated using a Case CX160D excavator and direct loaded into a truck-and-trailer for off-site disposal at the Greater Wenatchee Regional Landfill. A total of 69.54 tons of impacted soil were excavated from the release area, to a maximum depth of 12 inches below ground surface. Truck tickets are provided in Appendix D. Disposal certificates will be included in Appendix D upon receipt from the landfill.

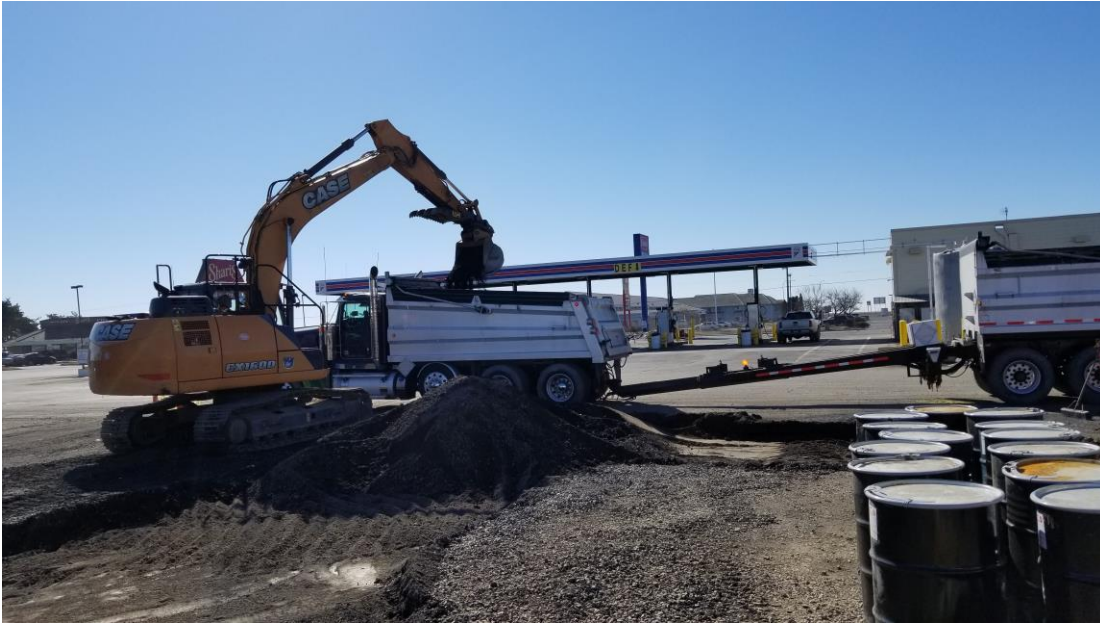
Photograph 3. Excavator direct-loading impacted soil into truck-and-trailer for off-site disposal.

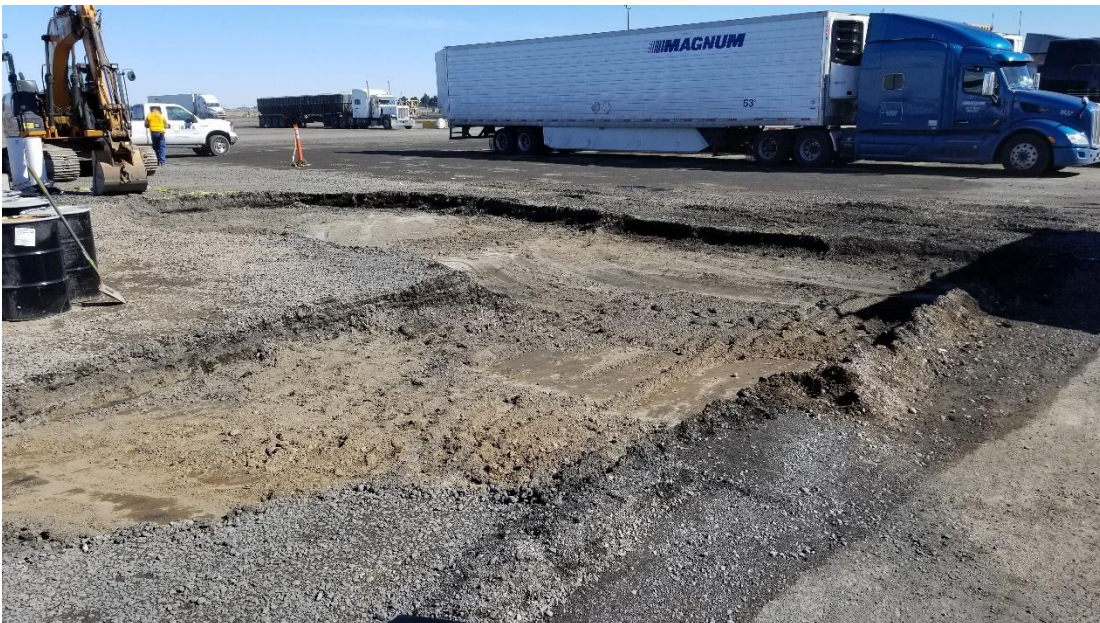
The bottom and sidewalls of the excavation were observed for visual and olfactory indications of contamination, and screened for volatile organic compounds using a PID prior to confirmation sample collection. No indications of contamination were observed, and there were no PID readings elevated over background.

Photograph 4. Completed excavation.

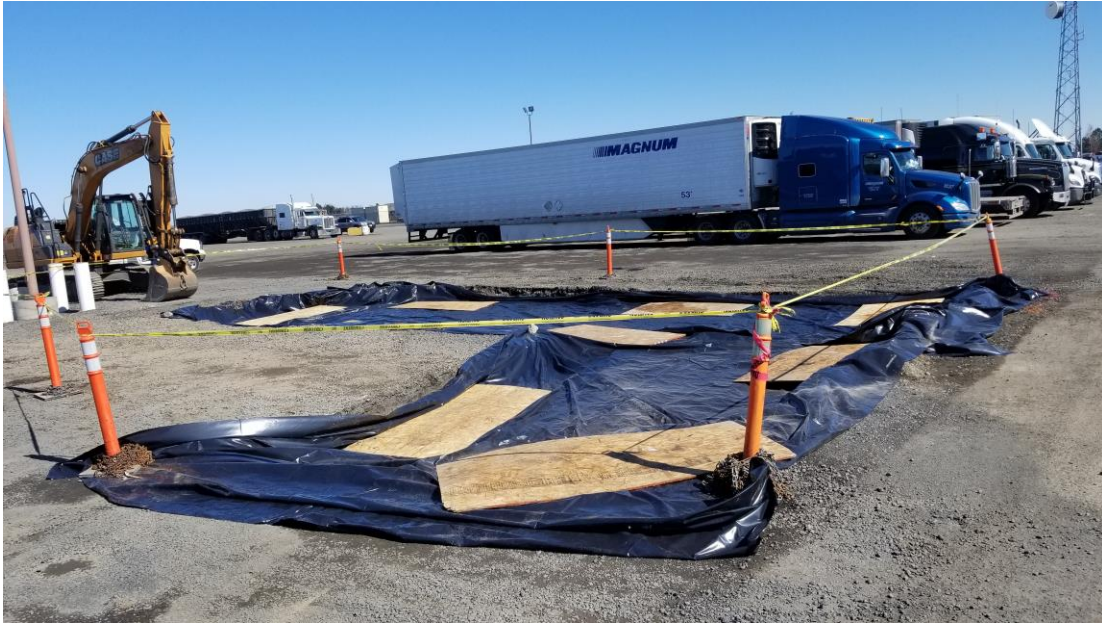
Photograph 5. Excavated area covered and coned off after excavation pending analytical results.

Upon completion of the removal action, the excavation was covered in plastic sheeting, weighed down by plywood sheeting to protect the excavation from precipitation until the Project site is restored. The area was also cordoned off with caution tape and traffic cones to prevent disturbance by truck traffic.
