Former Seattle Naval Supply Depot
Piers 90 and 91 - Port of Seattle
Seattle, WA

Formerly Used Defense Site
#F10WA012501

Remedial Investigation

Final Report

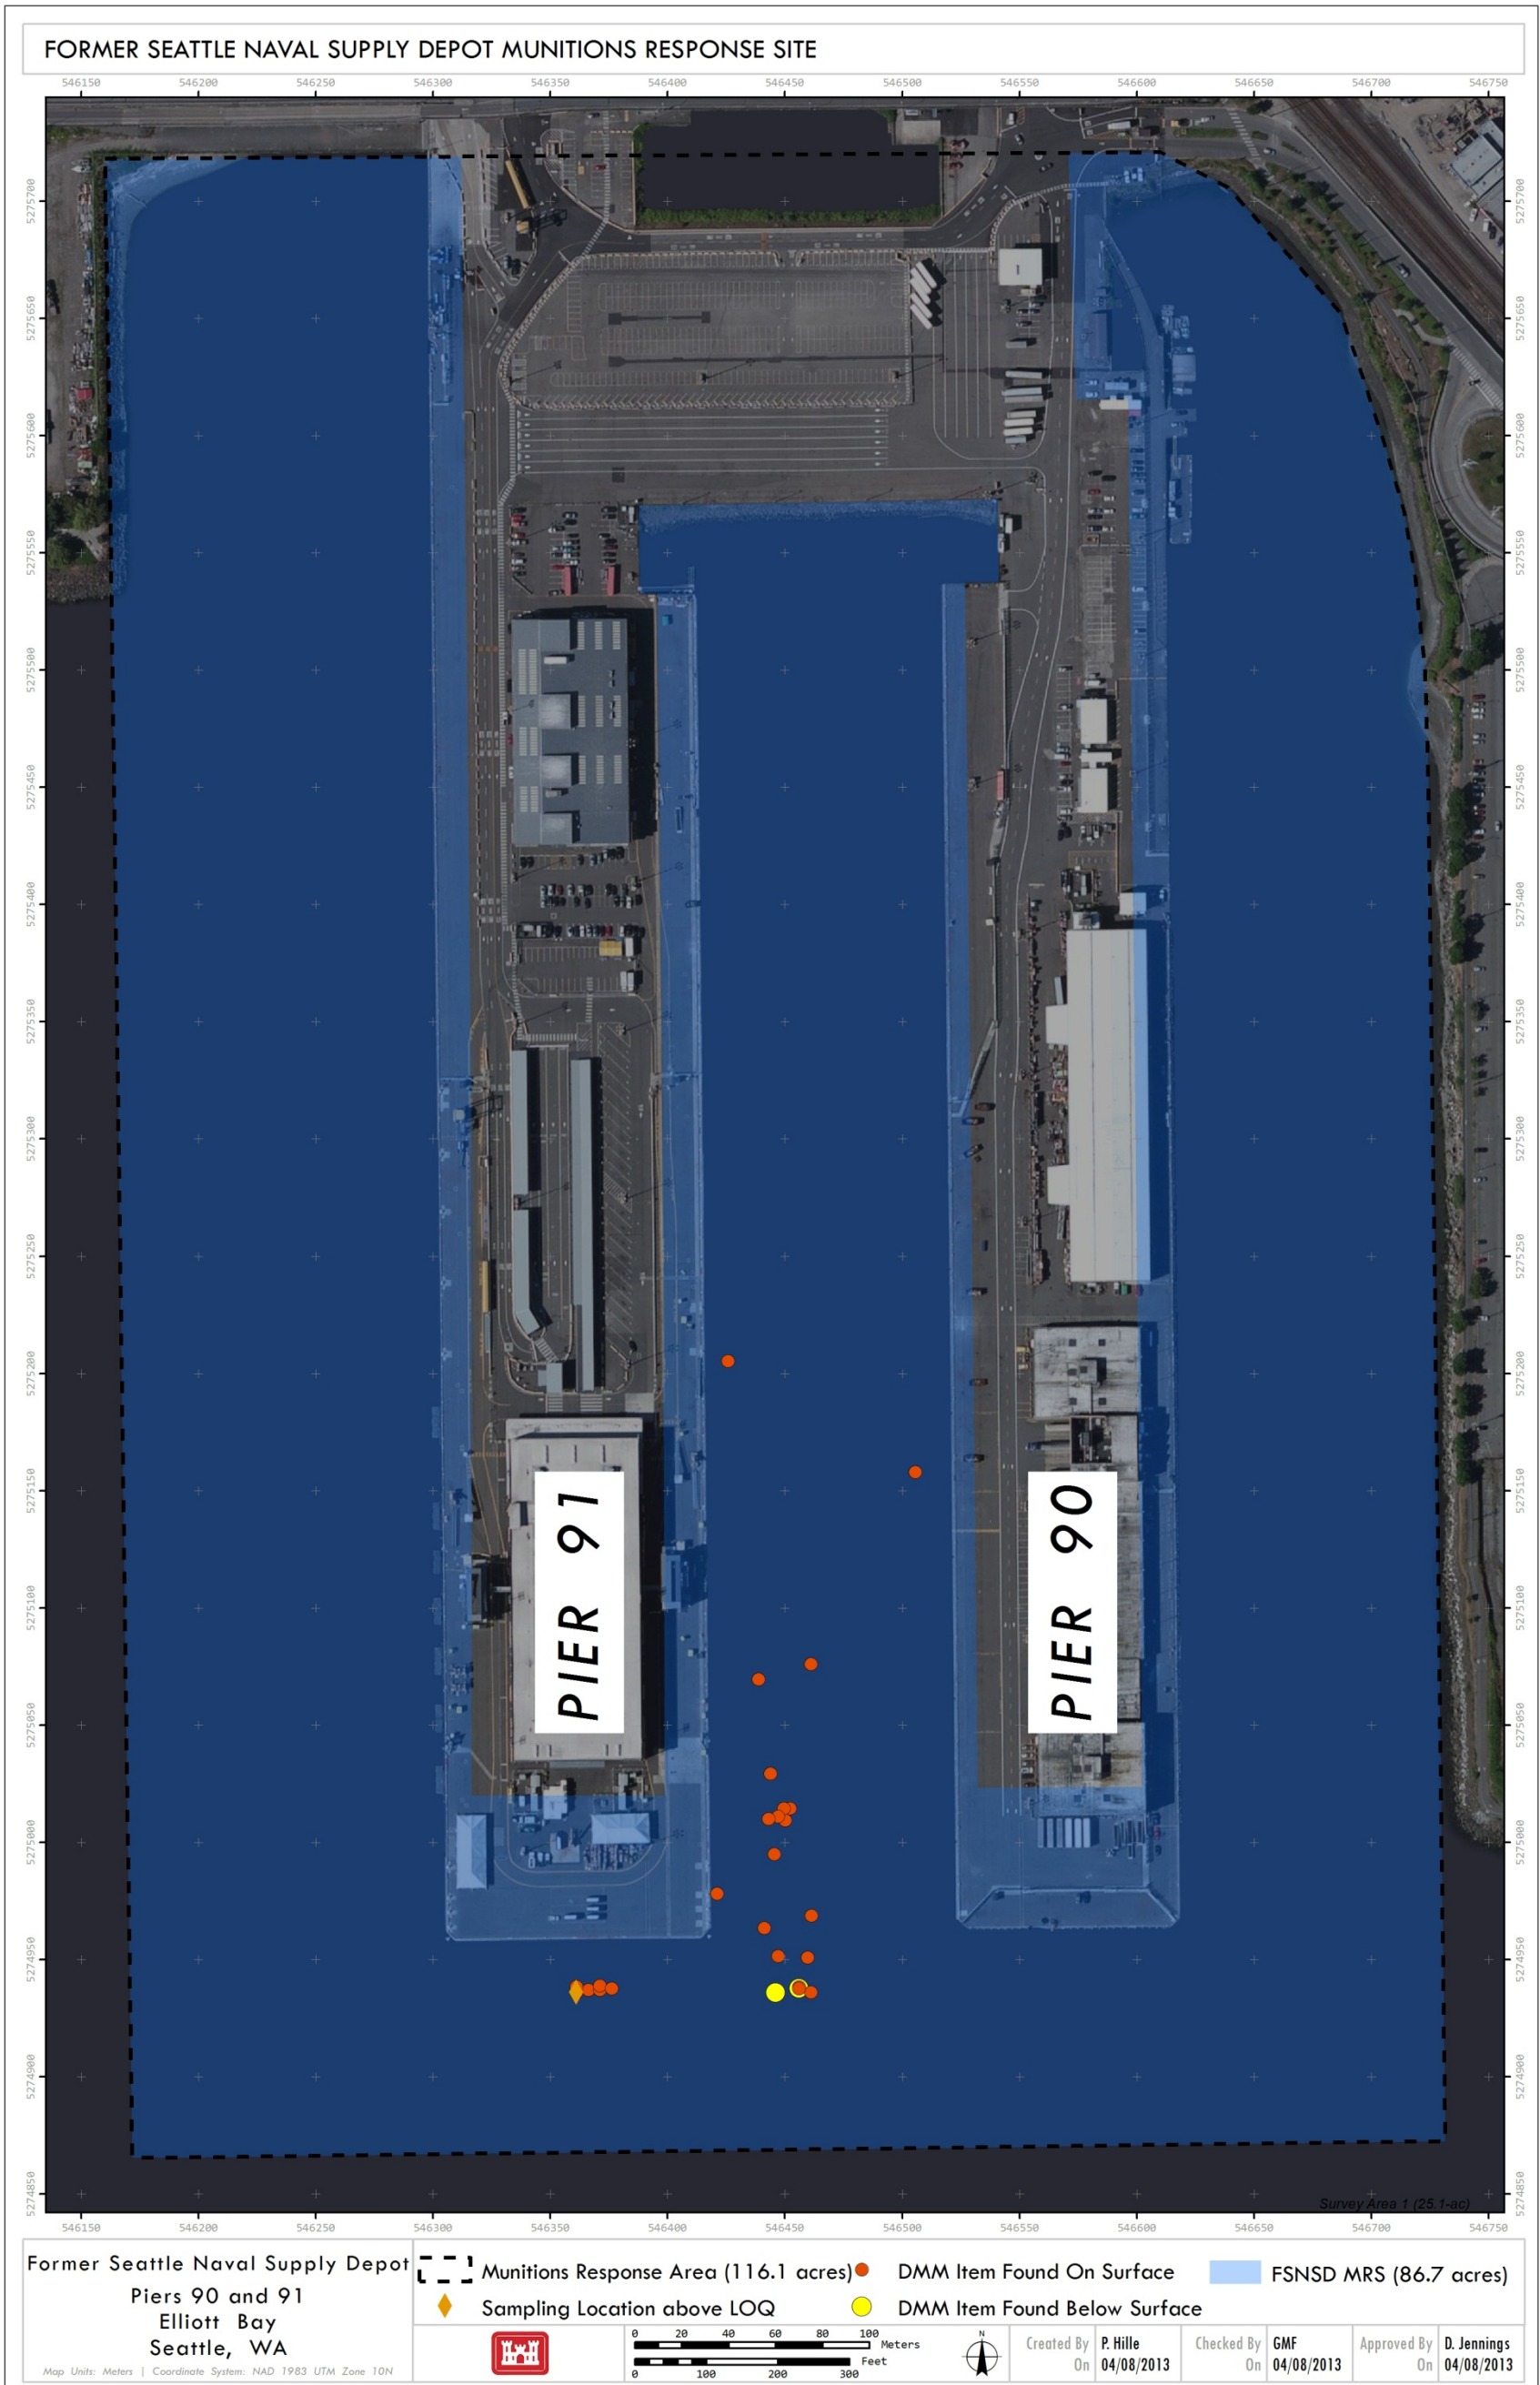
Figure 1-3 Former Seattle Naval Supply Depot Munitions Response Site

The data collected from the FSNSD MRA were evaluated to determine the appropriate designation of MRSs. Based on this evaluation; the report recommends that the MRA be delineated into a single MRS matching the boundary of the MRA (shown in **Figure 1-3**). This MRS potentially possesses DMM and MC contamination and received a Munitions Response Site Prioritization Protocol (MRSPP) score of 5. The MRS is therefore recommended for further munitions response actions consisting of a focused FS and subsequent Comprehensive Environmental Response, Compensation, and Liability Act (CERCLA) remedial response actions.

The efforts and results of the Piers 90 and 91 RI and TCRA are described in this report. Due to the location, use and importance of the site, increased data collection was necessary to satisfy stakeholder concerns beyond the base-level necessary to support a hazard analysis and risk assessment. A qualitative MEC hazard analysis and baseline risk assessment based on these data are presented in the report, as well as summarized below. Three figures are included at the conclusion of this Executive Summary. The first displays the type and location of all DMM items located during the RI and TCRA over a base-layer which displays sediment thickness levels (**Figure 1-1**). The second figure displays the area of potential MC contamination at the site based on the findings of the baseline risk assessment (**Figure 1-2**). The third displays the boundary of the recommended Munitions Response Site (MRS) following delineation based on the findings of the RI (**Figure 1-3**).

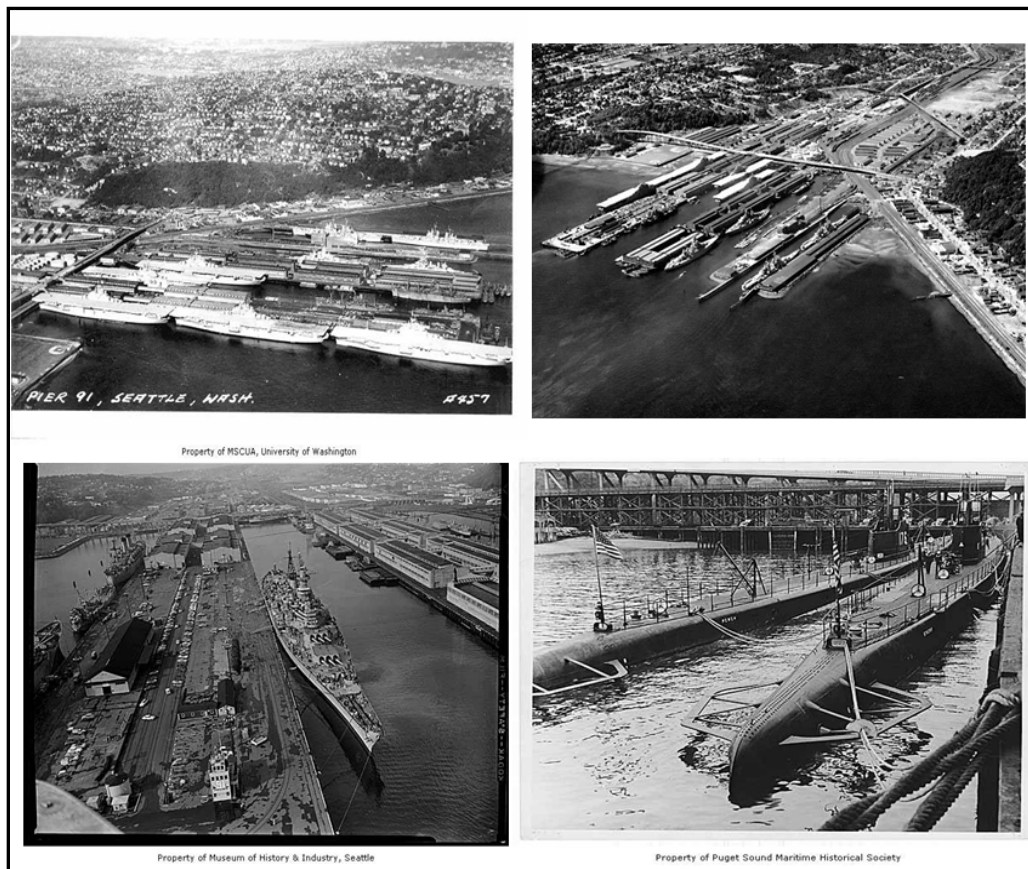
Figure 2-4 Piers 90 and 91 U.S. Navy Use - World War II Era

In 1942, and 1943, the U.S. Navy acquired the property through condemnation, which in total consisted of 242.97 acres, for use as bulk fuel and material storage and as a marine terminal for naval vessels to support WWII. **Figure 2-4** is a set of aerial photographs of the facility while in use by the U.S. Navy. These photographs document the use of the facility by submarines, aircraft carriers, battleships, and cruisers. The property was already a partially developed commercial marine terminal with warehouses and fuel oil storage facilities. The U.S. Navy further expanded these facilities, and constructed approximately 100 buildings including general warehouses, maintenance shops, administration buildings, a heating plant, barracks, and cold storage facilities (SKY, 2012a).

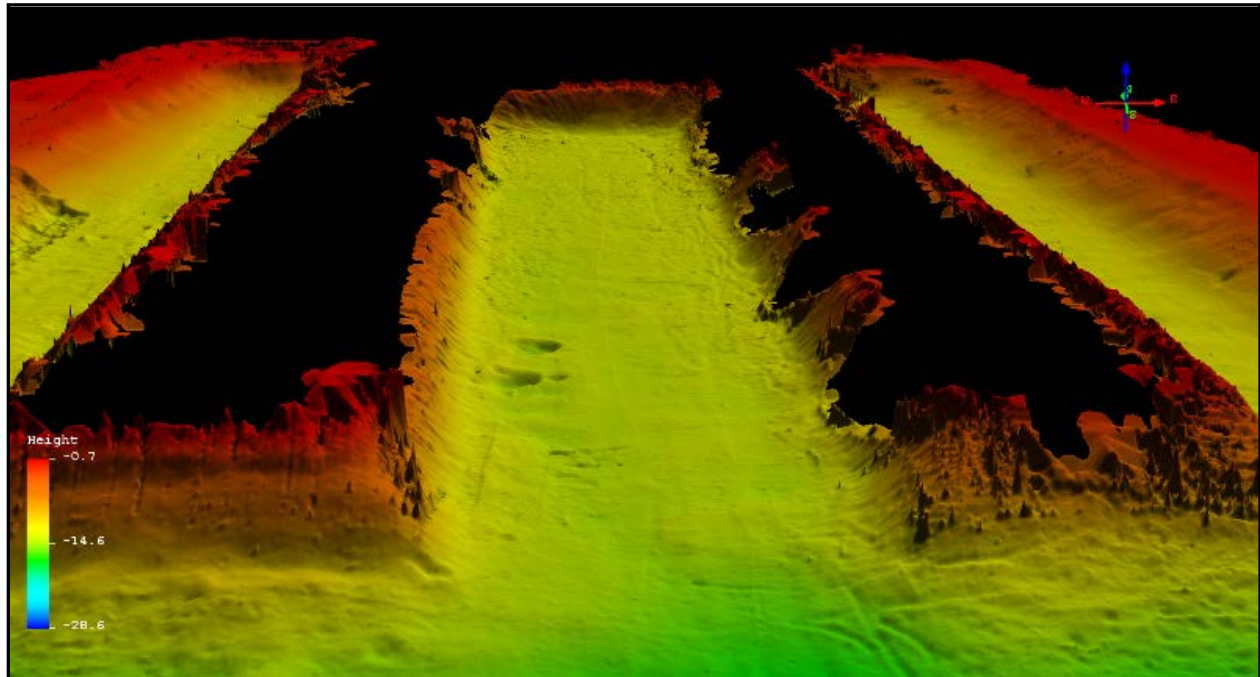
Figure 4-2 3D Rendering of Multibeam Echosounder Data

Multibeam Echosounder Data Details	
Parameters	Data
Total number of points processed	2,163,046
Resolution of surface bathymetry raster (all points)	25 centimeters (cm)
Contour interval of surface bathymetry	1 m
Maximum elevation of bathymetry in MRA	3m mean sea level (MSL)
Minimum elevation of bathymetry in MRA	-21.5m MSL
Mean elevation of bathymetry in MRA	-9.3m MSL

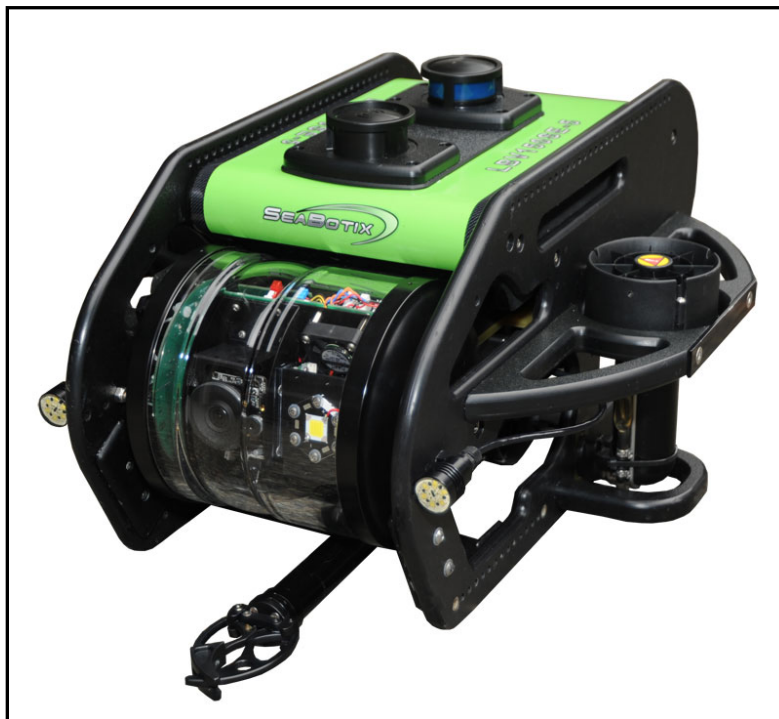
Figure 4-7 Seabotix LBV300-5 Remotely Operated Vehicle

Two Seabotix-LBV300-5 ROVs (shown in **Figure 4-7**) were chosen for the RI and TCRA based on applicable characteristics to perform the assessment tasks, including their small-footprint, launch and recovery capabilities, ease of maneuverability, and integrated sensor package. This system allowed for safe and efficient launch and recovery from either boats or piers while still carrying all sensors required to perform the investigation and assessment activities. The ROVs were equipped with low-light color and black-and-white video, an external 4-head light-emitting diode (LED) multidirectional lighting system, a 120-degree imaging sonar, ground standoff altimeter, a USBL positioning system and a scaling laser. These visual and acoustic imaging tools provided a comprehensive and real-time picture of the seafloor in the area surveyed. The ROV was positioned to approximately 1 m accuracy with the TriTech MicronNAV USBL positioning system, which included multiple transceivers and transponders integrated with RTK-GPS (SKY, 2012).

ROV launch positions were recorded and checked against standard known points on site throughout the TI and TCRA. The ROVs USBL positioning system was verified prior to each survey by utilizing known anomalies. Standard calibration anomalies were routinely imaged with the ROV systems to confirm accuracy of the scaling laser, video systems, and imaging sonar. Output data from the ROV was spot-checked on a daily basis to confirm accuracy of the timestamp and positioning information (SKY, 2012).

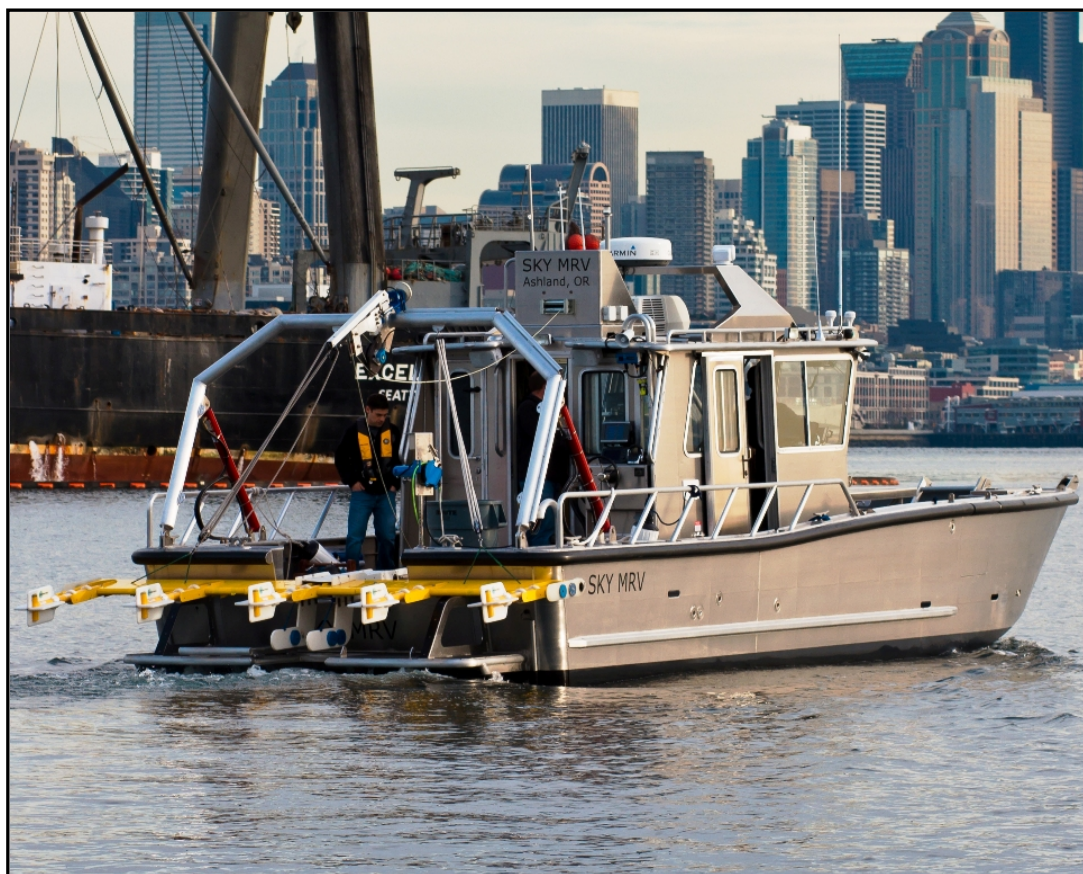
Figure 4-10 Marine Magnetometer Array

A marine magnetometer array (shown in **Figure 4-10**), previously deployed with documented success at the USACE Omaha District's Comprehensive Site Evaluation Phase II at Eglin AFB, was utilized for the Piers 90 and 91 RI and TCRA. The marine magnetometer wing is constructed of high-density foam with a strong fiberglass exterior, making the sensor wing lightweight, durable, and non-magnetic. The platform is equipped with five Geometrics G-882

The marine magnetometer array went through several QC procedures prior to any data collection. The system went through a 15 minute warm-up followed by a sensor check to verify that all systems were operational. After launch, a one minute noise test was collected holding heading and speed with the wing 10 m away from the survey vessel. Four survey lines were then collected at 1.5 m above ground level (AGL) over the IVS lane, with two in each direction to test detection and positional accuracy. The results were compared to the prior IVS survey results. The marine magnetometer array passed all QC checks, and no data quality issues were noted.

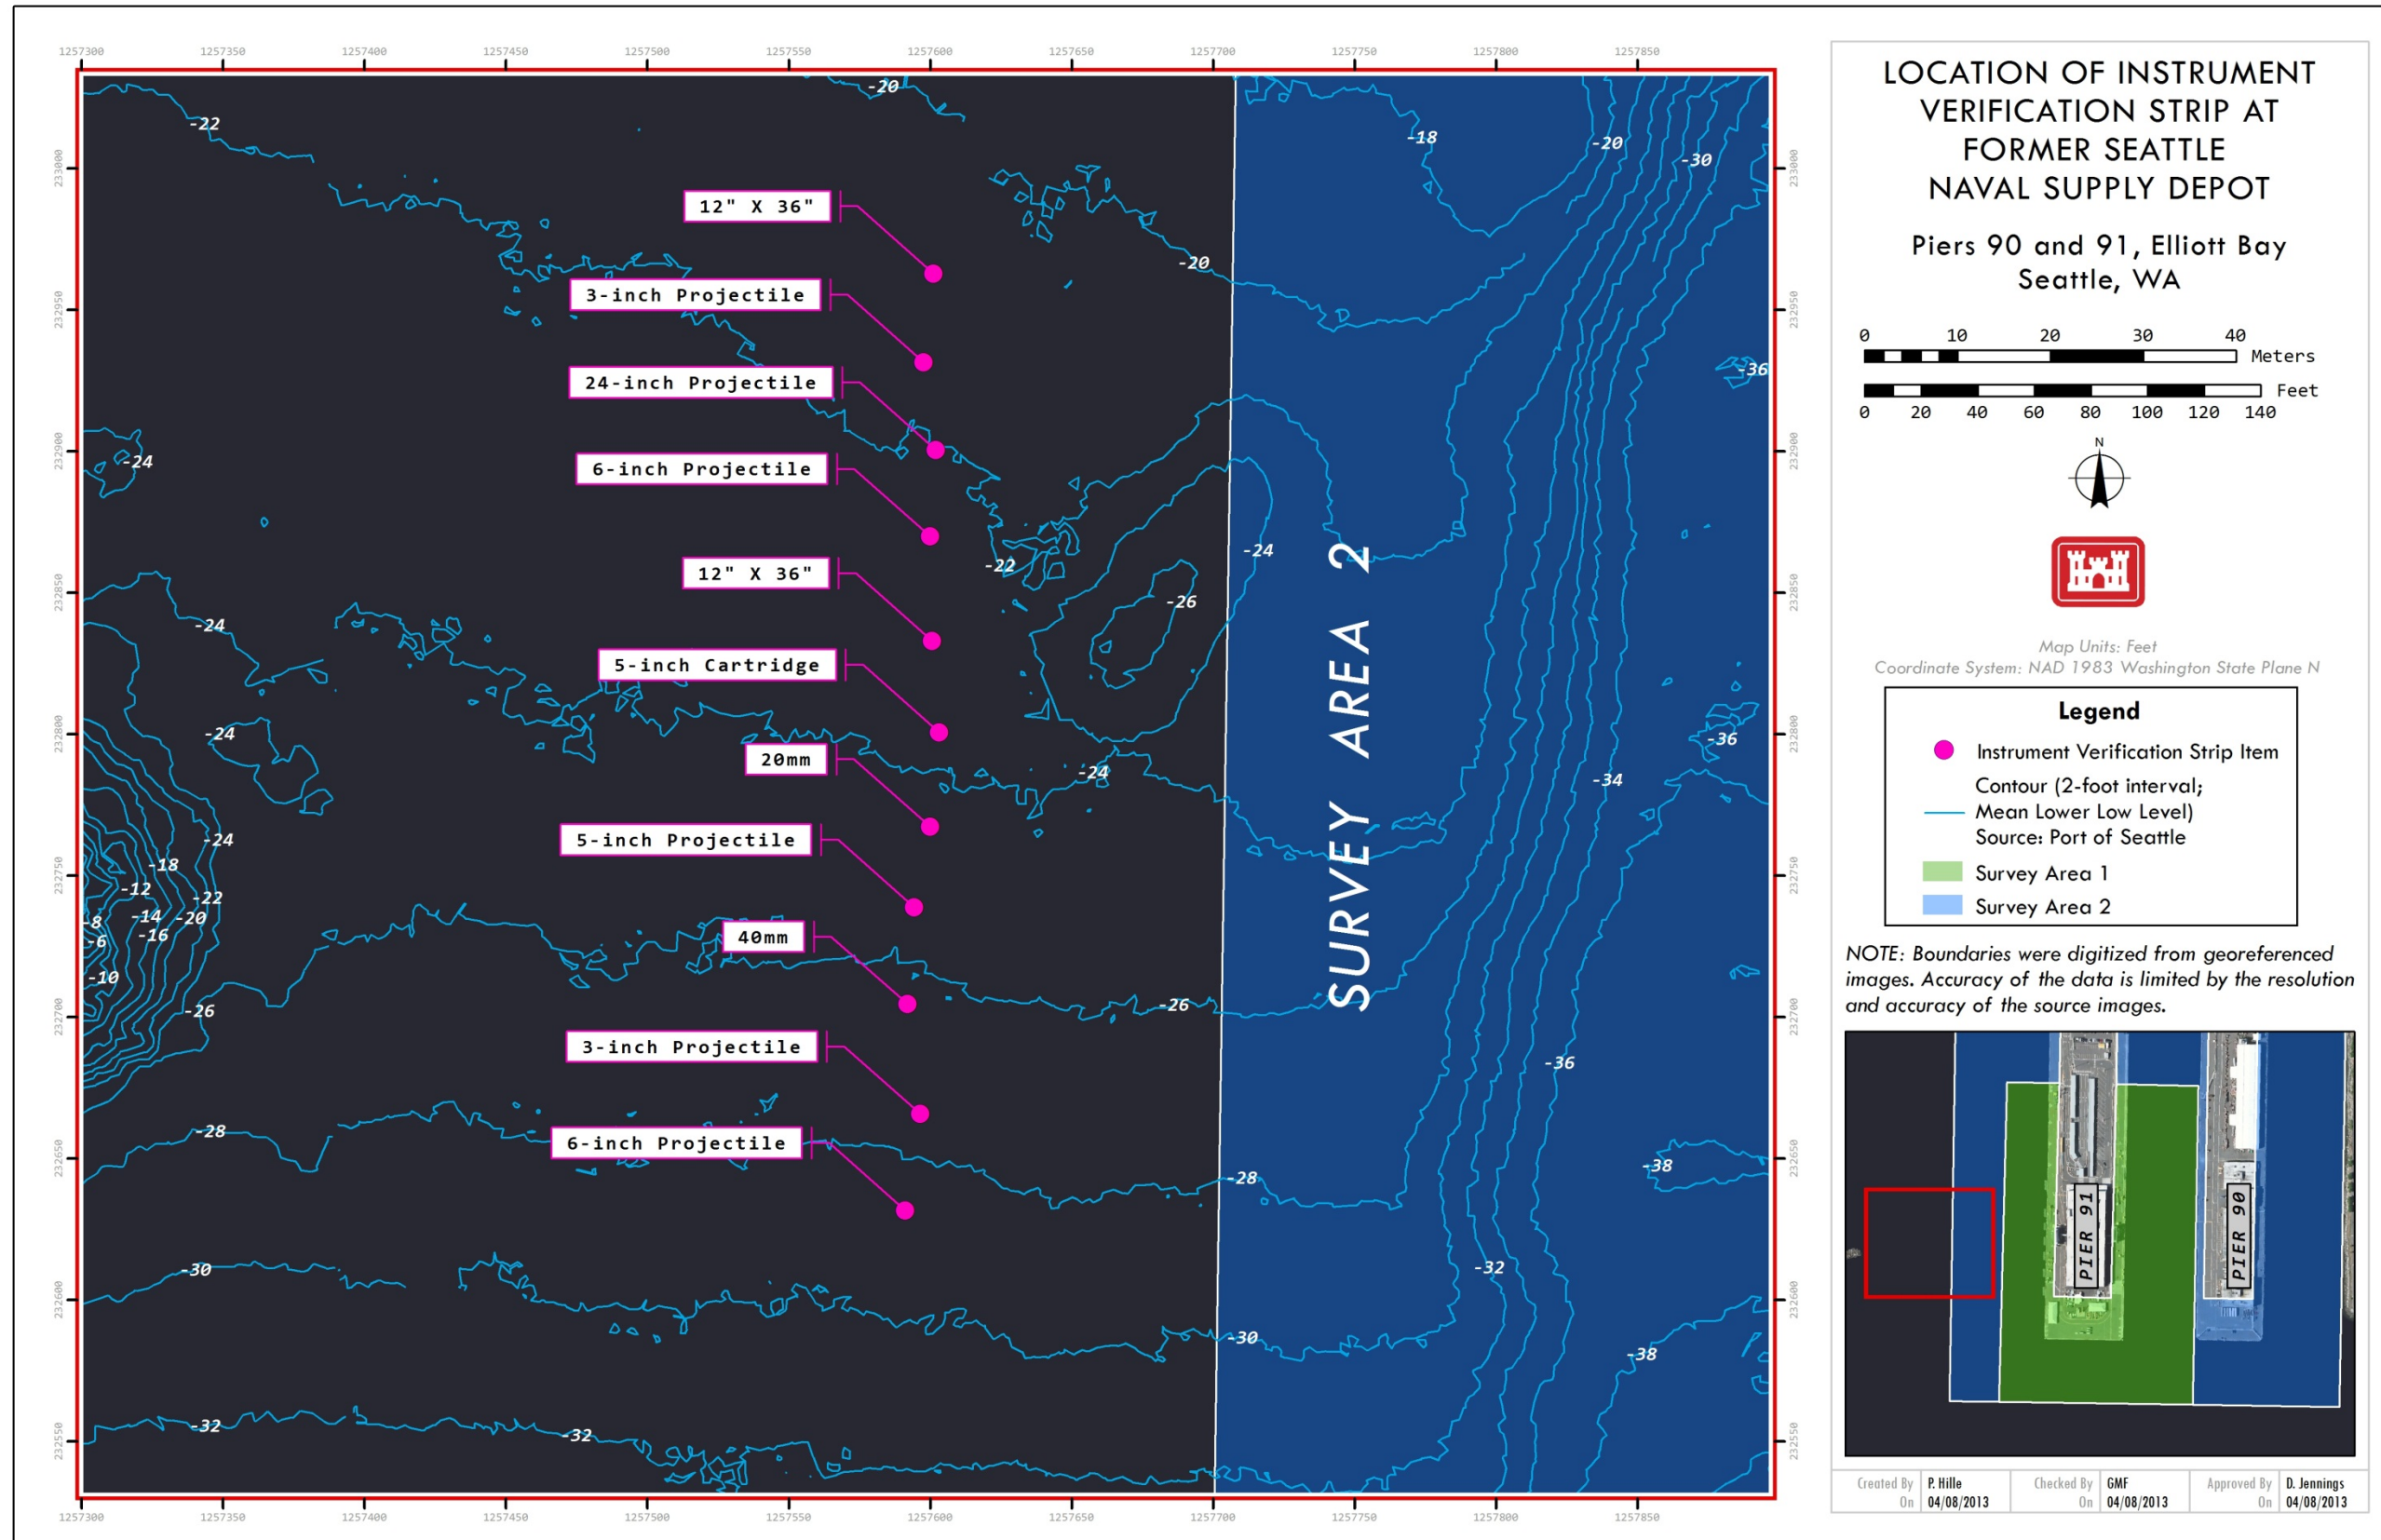
Figure 4-12 Location Instrument Verification Strip at Piers 90 and 91

An IVS (shown in **Figure 4-12**) was installed near the site, west of the MRA. This site was selected as it contained the least amount of seafloor debris in the area. Eleven targets were emplaced for assessment, and RTK-GPS positioning was obtained on each target. Industry standard objects (ISOs) were used to simulate munitions targets. ISO selection was based on the range of munitions and munitions related items expected to be found during the survey. **Table 4-4** lists the quantity, placement, and type of simulant. Note that no munitions were emplaced, only items selected to simulate a munitions item.

The IVS remained in place and was used for multiple magnetometer and diver handheld all-metals detector surveys for the duration of the investigation through 2012. Uses of the IVS separate from TCRA geophysical data verification will be covered chronologically in sections of this report that are based on a specific activity.

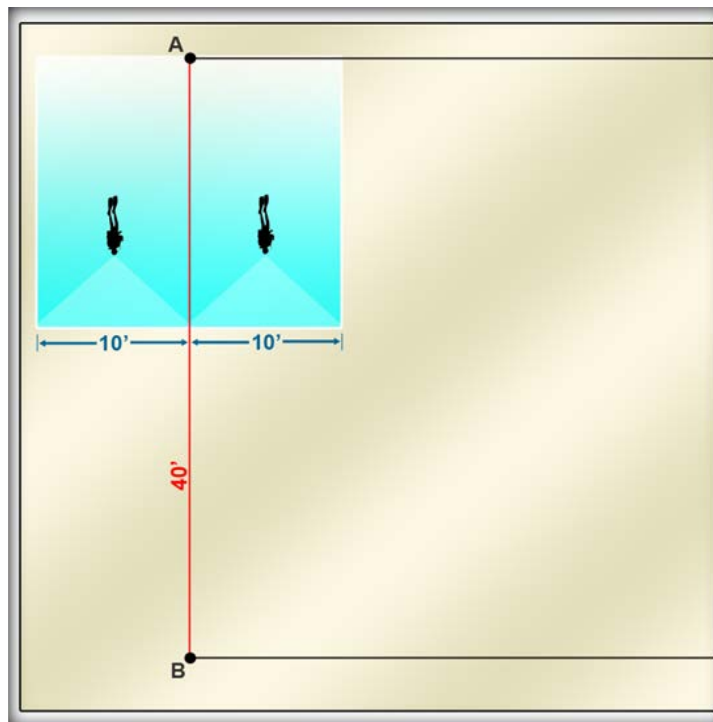
Figure 4-15 Jackstay Surface Clearance Methodology, First Pass

Figure 4-15 displays the first step in the Jackstay method. UXO divers swim in tandem (one on each side of the Highway line) from Point A to Point B (located on the Start/Finish lines). Their distance from the Highway line is determined by visibility conditions in the search area. In this diagram, each diver is able to sweep a swath 10 ft wide. The red line indicates the Highway line (SKY, 2012).

The Jackstay procedure is repeated until the UXO divers have completed a 100% surface clearance of their assigned dive lane. Visibility was the primary factor determining swath width. In periods of lower visibility, UXO divers reduced their swath to the maximum width they were able to effectively cover. Movement of the Highway line (from Point B to Point C and from Point A to Point D) was reduced to a distance proportionate with the swim swath (SKY, 2012).

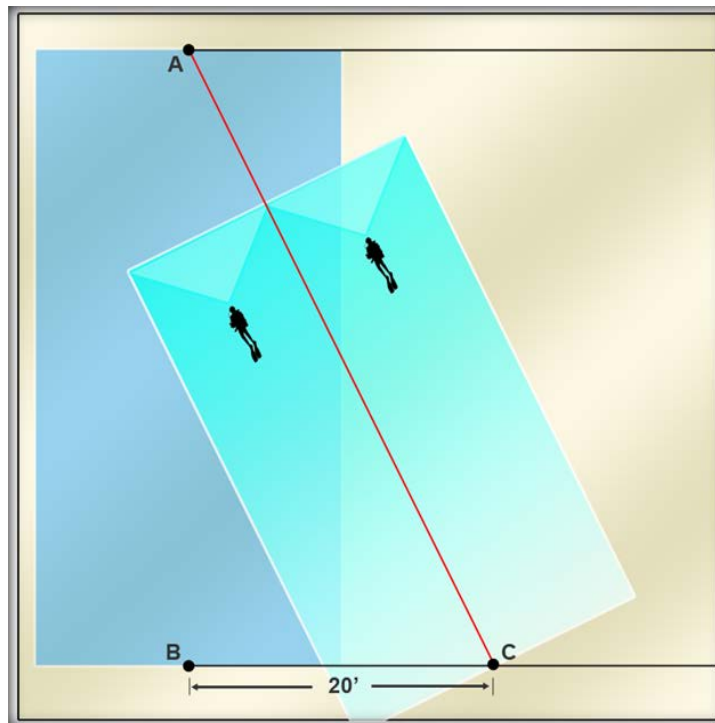
Figure 4-16 Jackstay Surface Clearance Methodology, Second Pass

Figure 4-16 displays the second step in the Jackstay method. Once the divers reach Point B, they disconnect the Highway line and reconnect it at Point C, 20 ft east along the Start/Finish line. The distance between Points B and C is established by swath width. The divers then swim back to Point A along opposing sides of the Highway line, conducting a surface clearance along the way (SKY, 2012).

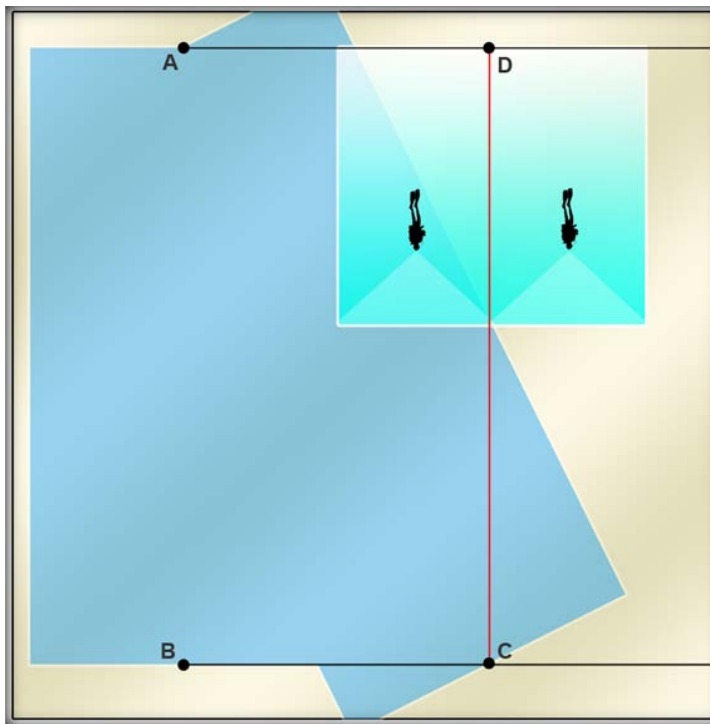
Figure 4-17 Jackstay Surface Clearance Methodology, Third Pass

Figure 4-17 displays the third step of the Jackstay method. When the divers reach Point A, the Highway line is disconnected from the Start/Finish line and reconnected at Point D, 20 ft east of Point A. The divers then swim from Point D to Point C, surface clearing 10 ft swaths (SKY, 2012).

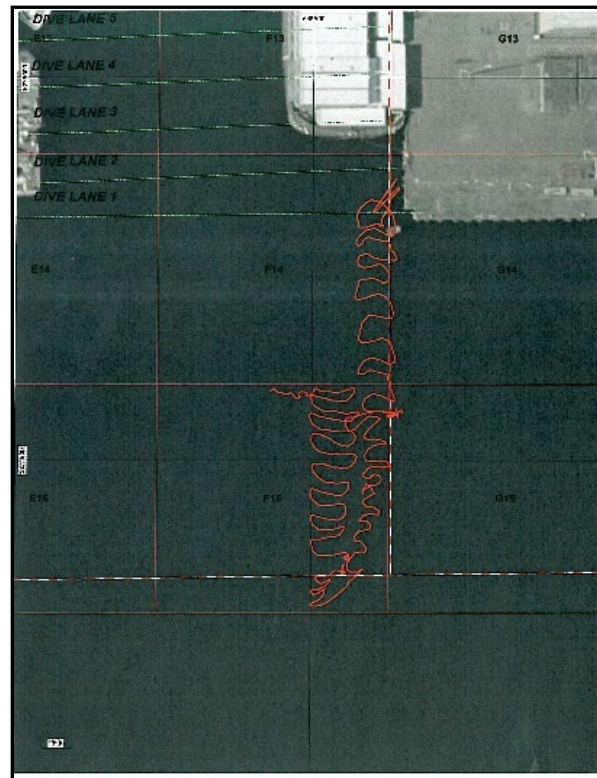
Figure 4-18 Time Critical Removal Action Diver Tracking

UXO divers had direct communication with the Dive Supervisor. Visibility, currents, bottom conditions and munitions-related finds were reported in real-time and logged in the vessel. Upon reaching the surface after completing a dive, the dive set members would board the vessel and doff their dive gear. They would then immediately provide a complete log of the dive, including bottom conditions such as currents and visibility, to verify previously recorded information. Divers would also verify information relating to potential DMM/MPPEH and MD type and quantity located. At the end of each dive day during the TCRA, the Dive Supervisor would compile all written dive logs into one complete Dive Report of the days' activities, and turn that report into the SUXOS. The SUXOS and Site Manager would then review the report with the Dive Supervisor. The SUXOS would also check the Dive Reports against the GPS tracks shown in **Figure 4-18** obtained by the self-plumbing GPS buoy (SKY, 2012).

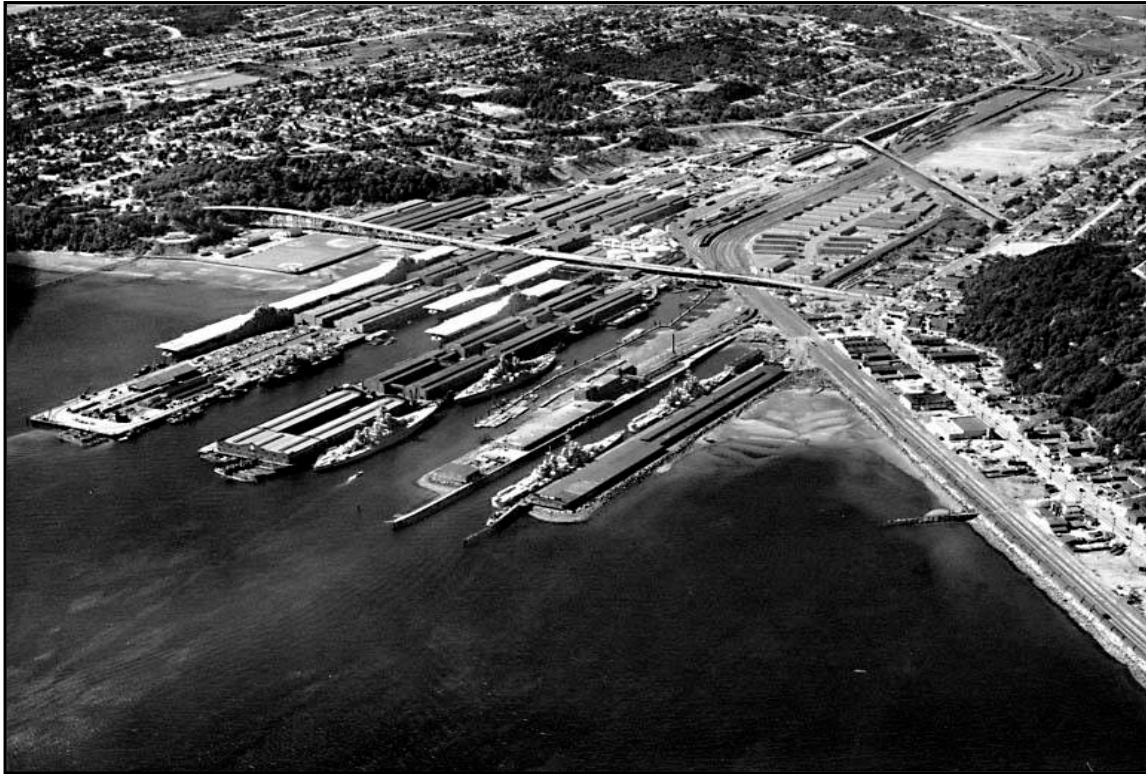
Figure 4-23 Aerial Photograph of Naval Use During World War II Era

Aerial photographs of U.S. Navy vessels berthed at the FSNSD during the 1940s were obtained. Research was conducted to determine the classes of vessels (if names were visible and/or recorded) or to make a class estimation based on size, shape, and vessel configuration (if no names were available). From this research, a list of vessel classes was compiled. Vessel information such as length, width (beam) and armament were tabulated and loaded into the POS-GIS to generate visual representations of past U.S. Navy use within the investigation areas. Current land use and RAFLU at the facility (visualized in **Figure 4-24**, which displays current use as Smith Cove Cruise Terminal) were taken into account and ensured appropriate coverage was obtained in areas of greatest current use. An overlay of the GPS coordinates for DMM items recovered during the TCRA was developed as part of the refinement of the CSM, covered in **Section 6.0**. This overlay supported the assumption that U.S. Navy munitions items were discarded overboard from naval vessels, in that the preponderance of DMM items discovered were in areas aligned with the outboard perimeter of naval vessels that had been moored at the facility (see **Figure 4-25** and **Table 4-7**) (SKY, 2012b).

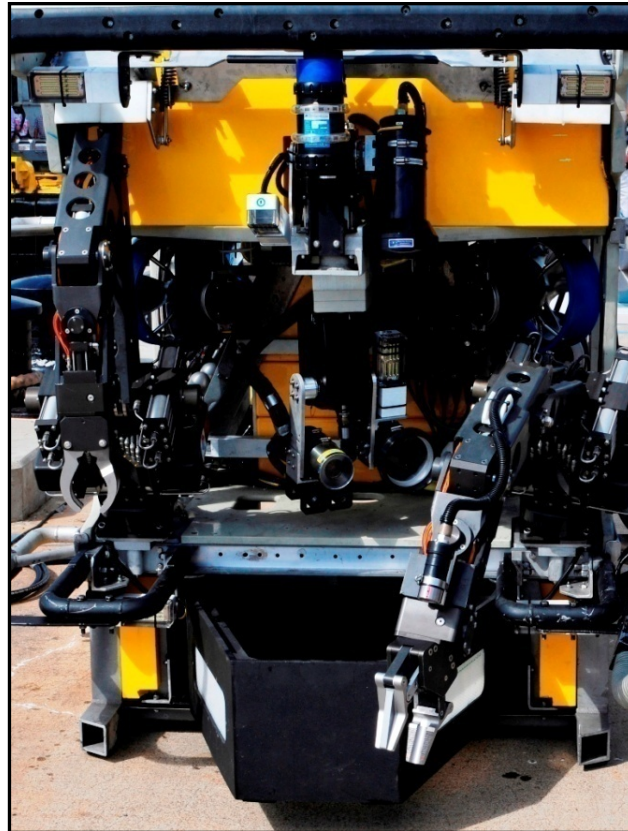
Figure 4-27 Remotely Operated Underwater Munitions Recovery System

All located metallic items larger than approximately 4 inches diameter but small enough to be moved by a diver/ROUMRS were moved a distance outside each segment so as to not present or create edge effects in the geophysical data. Metallic items too large to move were left in place. Type, size and location both in GPS coordinates and relative to the nearest 5 m marking on the fixed line (henceforth referred to as a “tab location”) were documented on daily logs. Large metallic items outside the segment, though close enough to potentially mask nearby anomalies, were also documented with tab locations. GPS coordinates and tab locations were collected for non-metallic objects greater than 1 m proud of the seafloor. This information was used to avoid obstructions in the flight path of marine magnetometer array (SKY, 2012b).

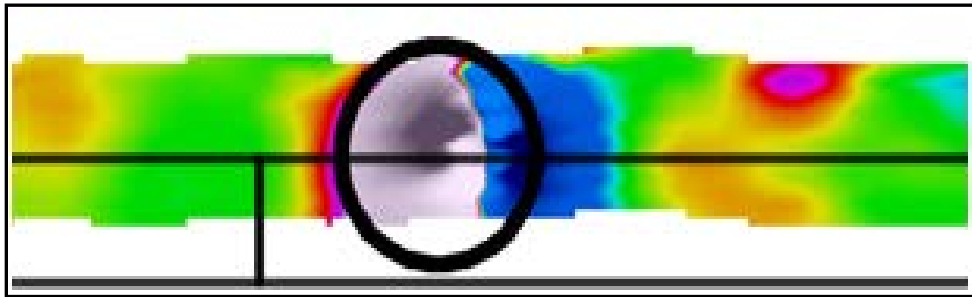
Figure 4-29 Fiducials as Seen in Digital Geophysical Mapping

Data collected by the marine magnetometer array were used to generate a list of subsurface ferrous anomalies. The following techniques were employed to cull the total count of anomalies to a list of subsurface anomalies most likely matching the geophysical profile of a 5-inch projectile. The list of individual subsurface anomalies was:

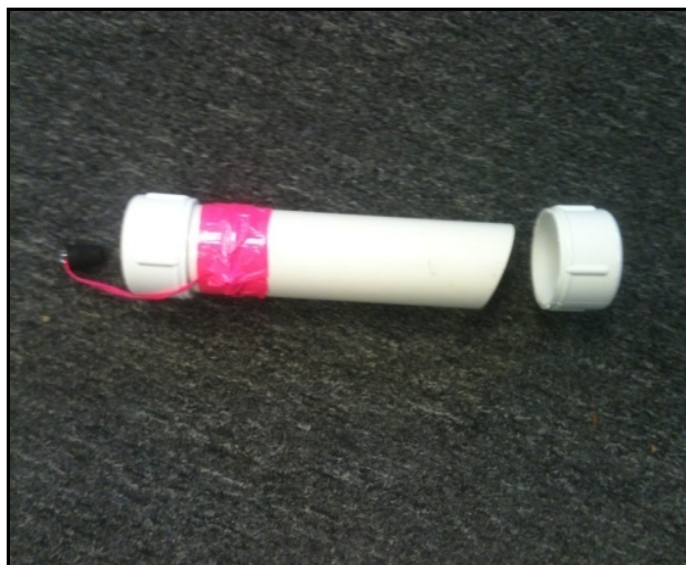
Figure 4-31 Sediment Sampling Device Used During the Piers 90 and 91 RI

Once surfaced, dive logs were completed and the sediment was transferred to 8-ounce glass jars, which were labeled, packaged, and shipped in accordance with the SOPs and laboratory requirements. Sample tubes were decontaminated in accordance with the SOPs and returned to the divers for future use.

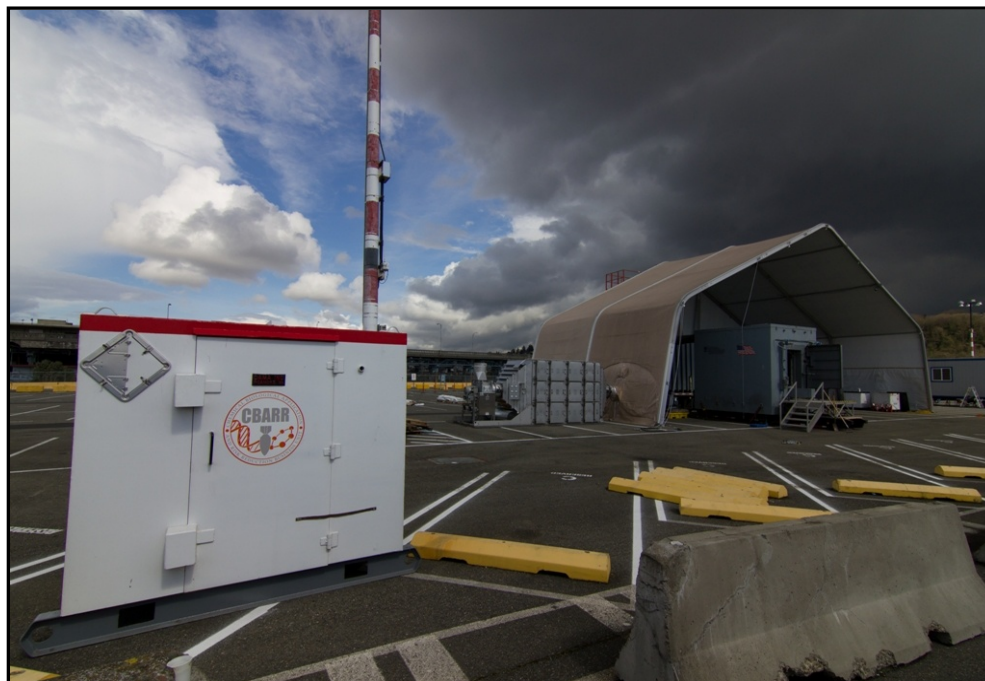
Figure 4-33 T30 Controlled Detonation Center

The U.S. Army's Edgewood Chemical and Biological Center (ECBC) mobilized a T30 Contained Detonation Chamber (CDC) (shown in **Figure 4-33**) to the FSNSD MRA to conduct disposal operations. The CDC and associated facilities provided a method to safely dispose of all munitions-related items recovered during the 2012 field season. The chamber arrived at Terminal 91 on April 2, 2012, and took one week to assemble and become operational (SKY, 2012b).

Following establishment of an exclusion zone enforced by POS police and security, munitions items were raised to the surface at the dive staging area by UXO technicians and transported to the CDC facility. Items were then handed off to ECBC personnel, who operated the CDC facility. Items were photographed and documented (as shown in **Figure 4-34**, a photograph provided by ECBC documenting demolition Shot #4 of six 40mm empty casing MD items), wrapped in datasheet donor charges, hung inside the chamber and detonated. All munitions scrap remaining after safe disposition by controlled demolition of the DMM/MD recovered (scrap is shown in **Figure 4-35**) was collected, inspected, documented as material deemed as safe, and shipped to a munitions scrap metal recycler (RI-ISR). Documentation of the T30 CDC operations and final disposition of all munitions scrap is provided in **Appendix A**.

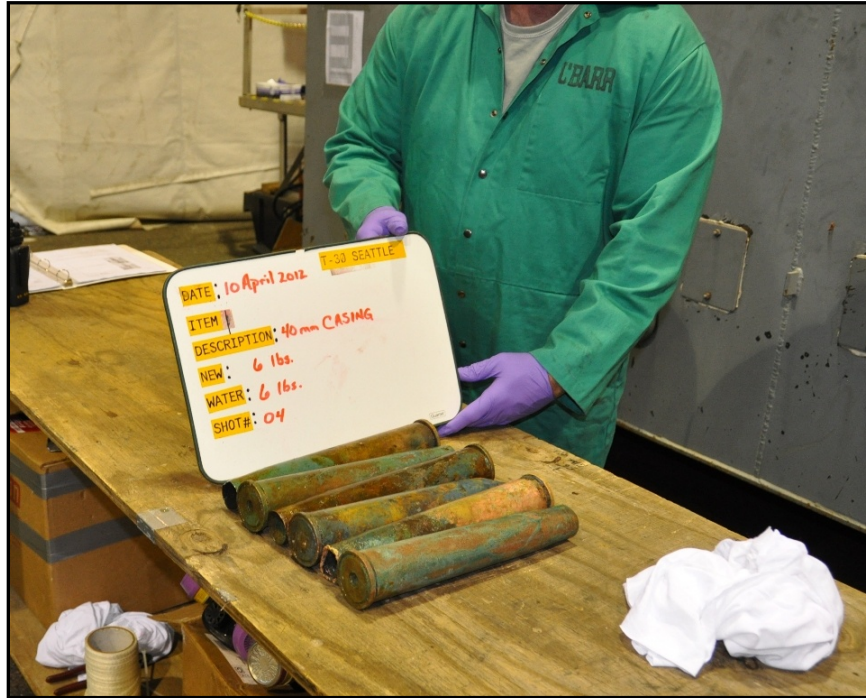
Figure 4-34 T30 Photo Documentation Prior to Controlled Demolition of 40mm Empty Casing Munitions Debris Items

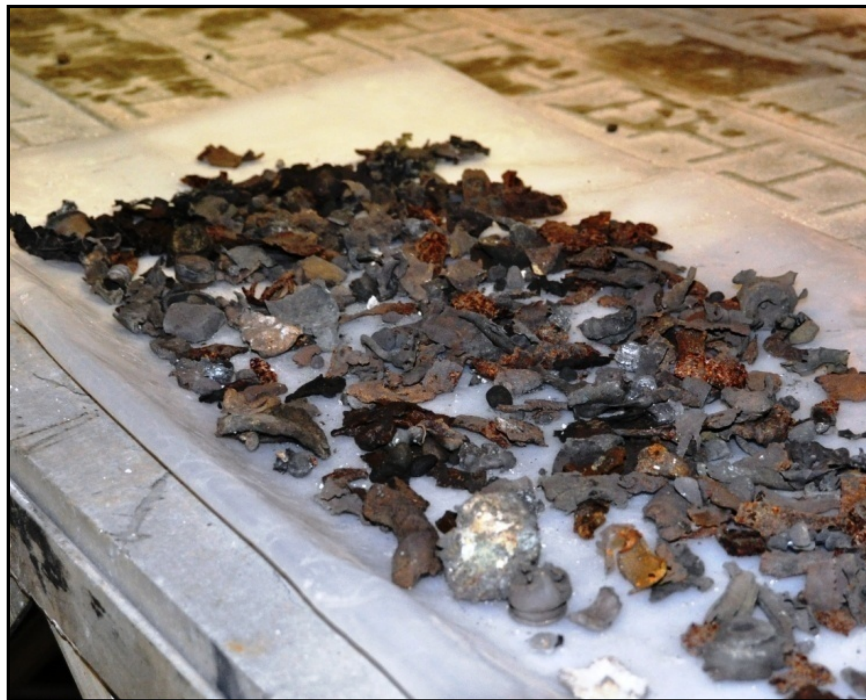
Figure 4-35 T30 Munitions Scrap Collected after Controlled Demolition of All Munitions Items Recovered During the 2012 Field Season

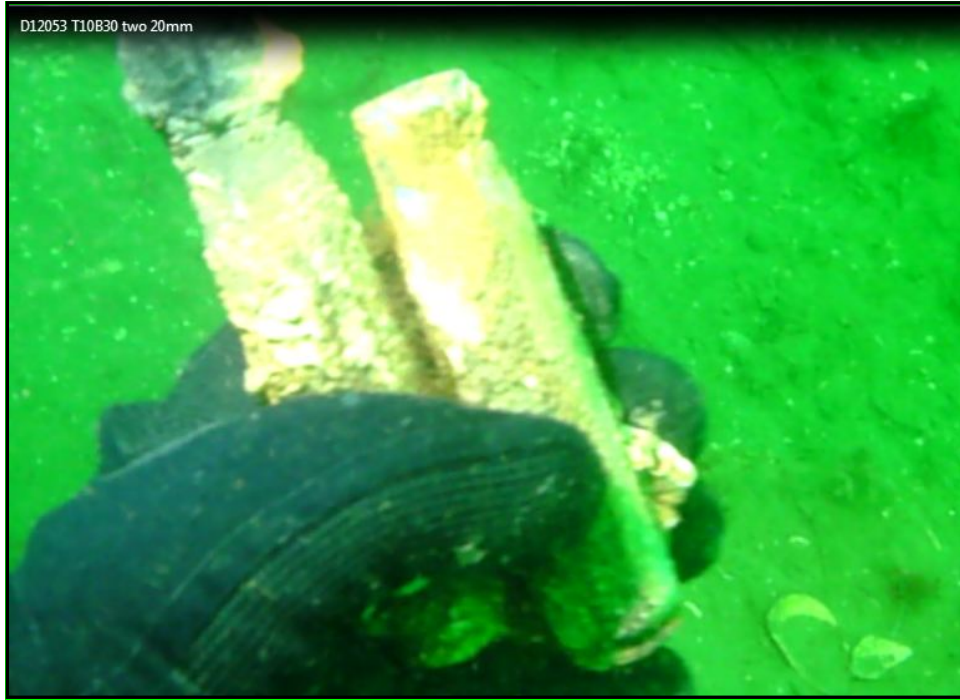
Figure 5-1 20mm Discarded Military Mmunition Item and 20mm Empty Casing Held by Diver Upon Discovery

There are three categories of MEC. UXO (which was not found at the site) is defined as military munitions that have been primed, fuzed, armed or otherwise prepared for action, fired, dropped, launched, projected, or placed in such a manner to constitute a hazard to operations, installations, personnel, or material and remain unexploded either by malfunction, design, or any other cause (10 U.S.C. 101(e)(5)) (DoD, 2010). DMM is defined as military munitions that have been abandoned without proper disposal or removed from storage in a military magazine or other storage area for the purpose of disposal. The term does not include UXO, military munitions that are being held for future use or planned disposal, or military munitions that have been properly disposed of, consistent with applicable environmental laws and regulations (10 U.S.C 2710(e)(2)) (DoD, 2010). The final category of MEC is MC present in high enough concentrations to pose an explosive hazard. All 32 MEC items recovered at the FSNSD MRA were DMM. No UXO or concentrations of MC large enough to constitute MEC were located. A complete listing is detailed in **Table 5-1**. The majority of the DMM items are 20mm projectiles, shown in **Figure 5-1**. The largest item recovered was a 5-inch projectile. A 5-inch projectile is shown before and after cleanup in **Figure 5-2**. These photographs accurately document the general condition of DMM items on the seafloor of the MRA. As seen in these photographs, these items remain intact but have become heavily encrusted with sea growth.
