Former Seattle Naval Supply Depot
Piers 90 and 91 - Port of Seattle
Seattle, WA

Formerly Used Defense Site
#F10WA012501

Remedial Investigation

Final Report

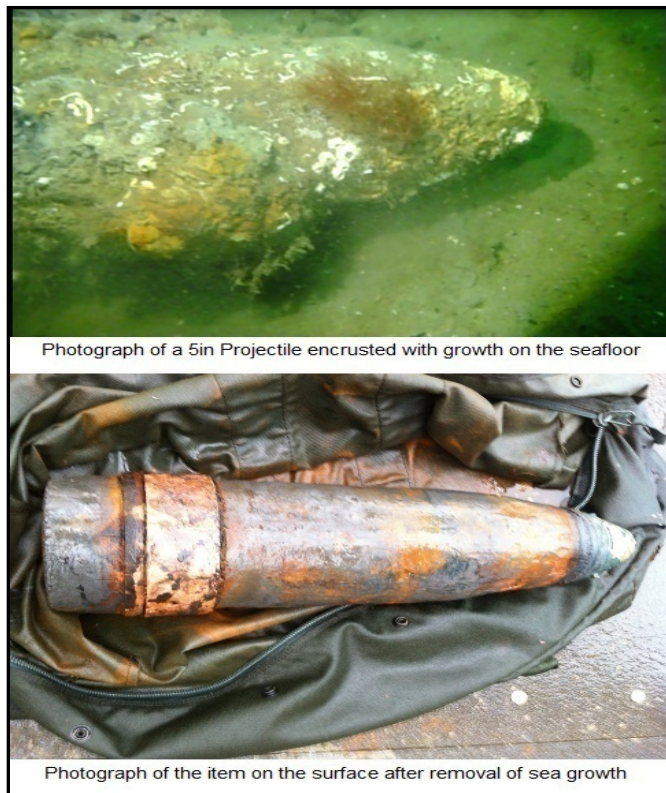
Figure 5-2 Condition of 5-Inch Projectile Upon Discovery and After Cleaning Prior to Disposition

None of the DMM items found to date at the FSNSD have been fuzed and armed. The operational history of the site indicates that none of the munitions items that may have been present on naval vessels were fired or used for their intended purpose, which could have resulted in arming of fuzing mechanisms present on munitions used for this purpose. Therefore, the only possible means of arming fuzes that might be present on DMM items that may remain within the MRA is as a result of disturbance of the items during vessel mooring operations or mechanical dredging activities (USACE, 2012b).

The largest DMM item recovered was a 5-inch projectile, thus the 5-inch projectile was used to determine the possible hazards posed by remaining DMM in the qualitative MEC hazard analysis performed for this report and an Explosive Hazard Assessment performed by elements of the U.S. Army and U.S. Navy for the USACE Seattle District. Although the 5-inch projectile was used to determine hazard, smaller munitions items such as 20 millimeter (mm) and 40mm projectiles may exist at the site and are subject to the same future response measures as the 5-inch projectile. In summary, the analysis found that munitions items most likely came to exist on the seafloor after infrequent and undocumented jettisoning from vessels while berthed at the facility. No significant concentrations were discovered on the seafloor or beneath the seafloor, and all munitions items recovered matched the historical armament of vessels known or suspected of having used the site. The analysis concluded that, to date, no record exists of an encounter with DMM resulting from vessel mooring and berthing operations at the facility, and that the probability of future encounters have been significantly reduced by the removal of the items recovered during investigative and response actions that have occurred at the site. All MEC items recovered at the site were DMM, and no records or findings indicate that UXO may be present, thus the likelihood of detonation of these items, even if disturbed or otherwise encountered during operations at Terminal 91, is extremely low. The qualitative MEC hazard analysis, presented in **Section 8.0** of this report, provided a level of hazard to each identified receptor based on the unlikely event of a detonation of a MEC item. Hazards to receptors were graded in a range that included None, Negligible, Low, Moderate, High, and Imminent. The qualitative MEC hazard analysis occurred for two scenarios: 1) a hazard analysis associated with regular use of the facility and 2) a hazard analysis associated with mechanical dredging activities at the site. For the normal use scenario, the Underwater Construction Worker and Terminal 91 Diver received rankings of Low. Hazards to all other receptors were considered None or Negligible. For the mechanical dredging scenario, the Construction Worker received a ranking of Moderate. Taken together, the Explosive Hazard Assessment and the qualitative MEC hazard analysis determined that:
