**ASTM E1527-13  
PHASE I  
ENVIRONMENTAL SITE ASSESSMENT**

**FORMER DODGE OF BELLEUE &  
EASTSIDE CHRYSLER JEEP PROPERTY  
126 THROUGH 400 116<sup>th</sup> AVENUE NE  
BELLEVUE, WASHINGTON 98004**

July 1, 2015  
File No. 04215036.00

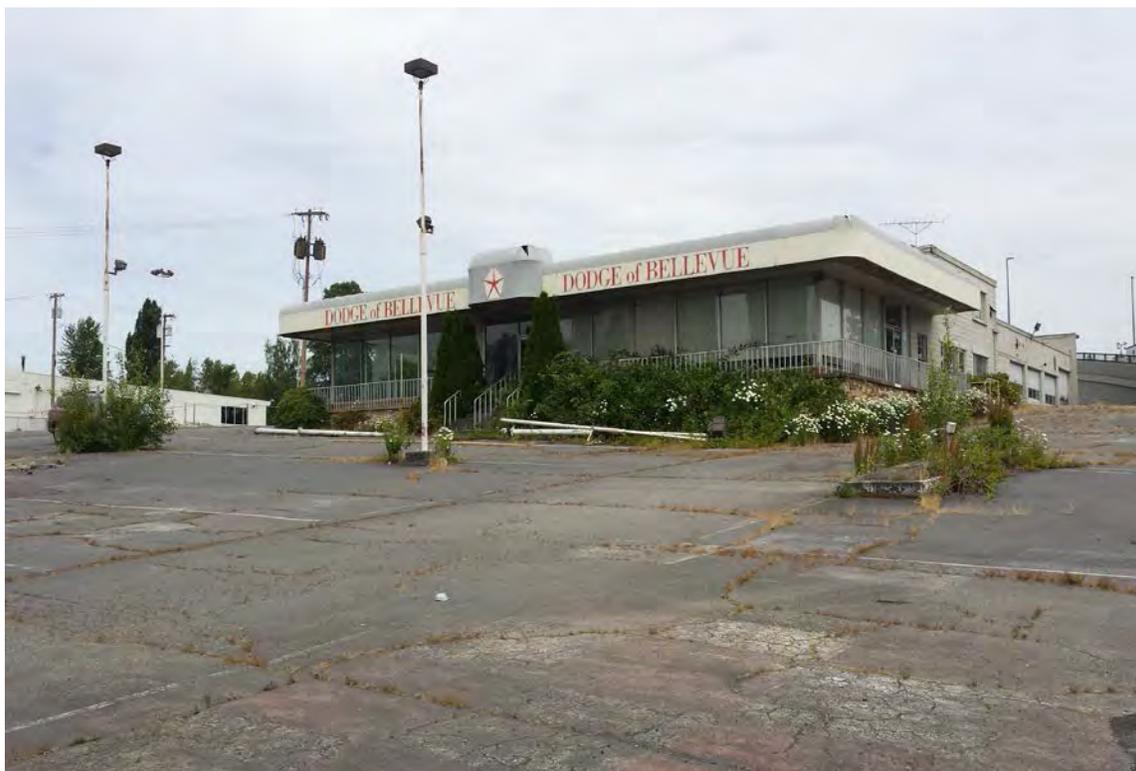
**Photo 1.** View towards the northeast of the former Dodge of Bellevue dealership and service center (316-parcel). The parcel is currently vacant.

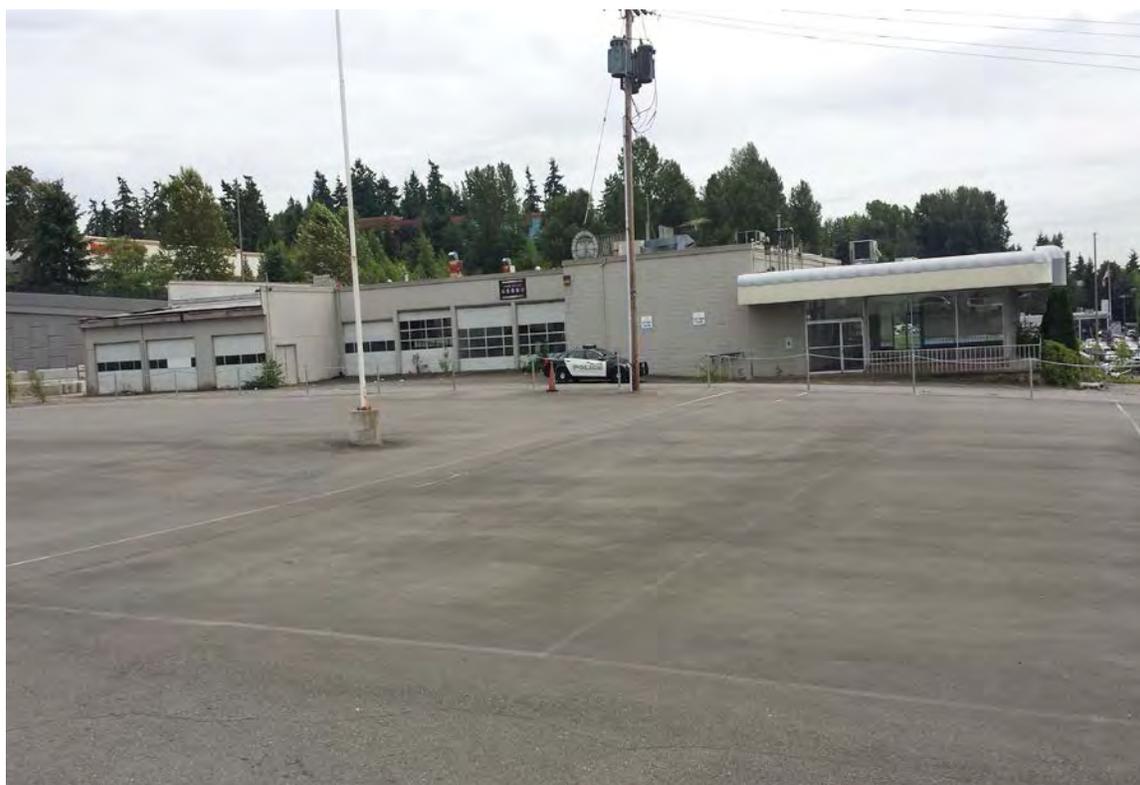
**Photo 2.** View towards the south from the 400-parcel showing the northern exterior of the Dodge of Bellevue building and the connecting service bays. A portion of the ramp wall for the newly constructed 4<sup>th</sup> Street NE extension is visible behind the building on the far left of the frame.

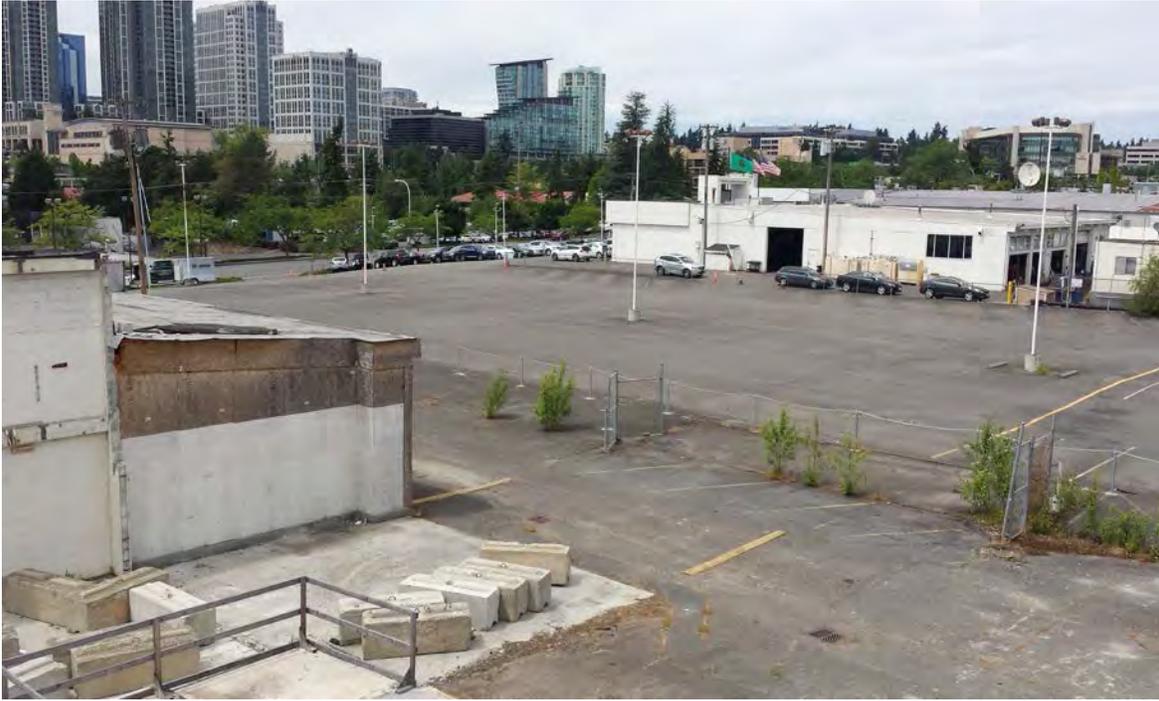
**Photo 3.** Northwestern view from the 4<sup>th</sup> Street NE ramp showing the rear of the Dodge of Bellevue building (in the foreground, with the rear section removed) and the adjacent parking lot (400-pacel). The neighboring Volvo dealership is visible further to the north. A soil vapor extraction system (SVE) is currently being operated in the beige trailer on the far right of the frame.

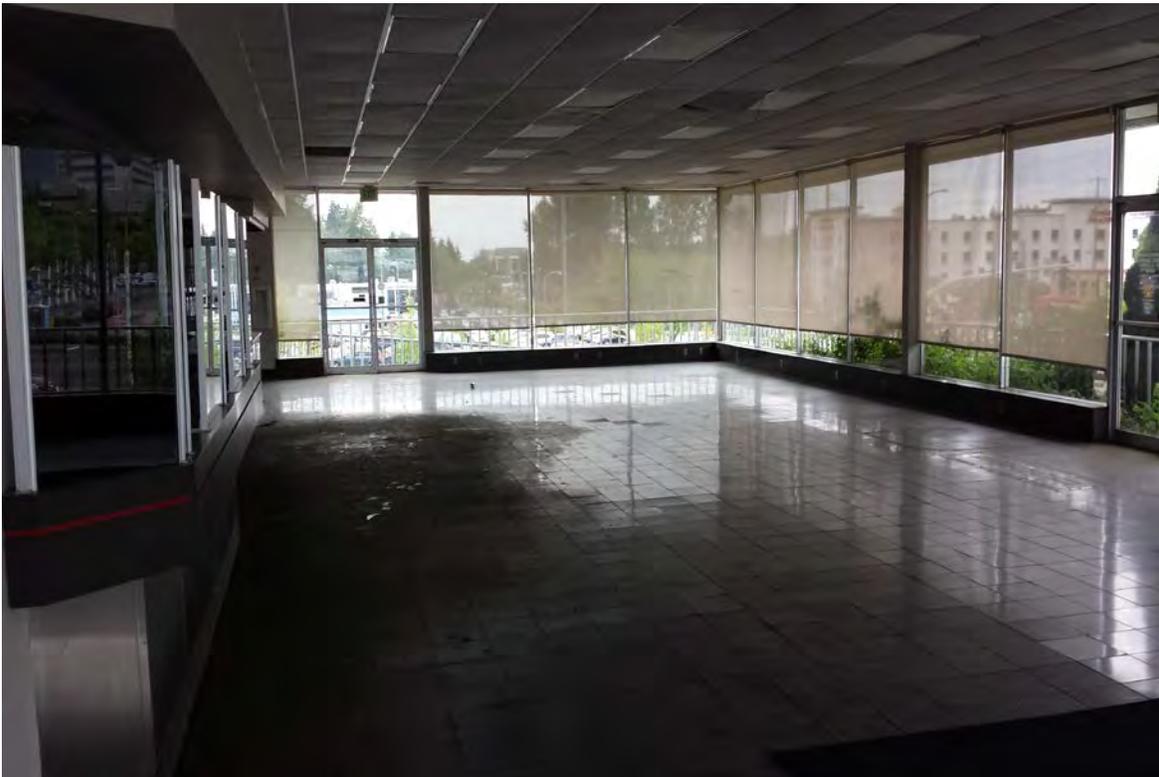
**Photo 4.** Interior view of the former new car sales floor inside the Dodge of Bellevue building. The service bays are situated to the left, in the rear of the building.

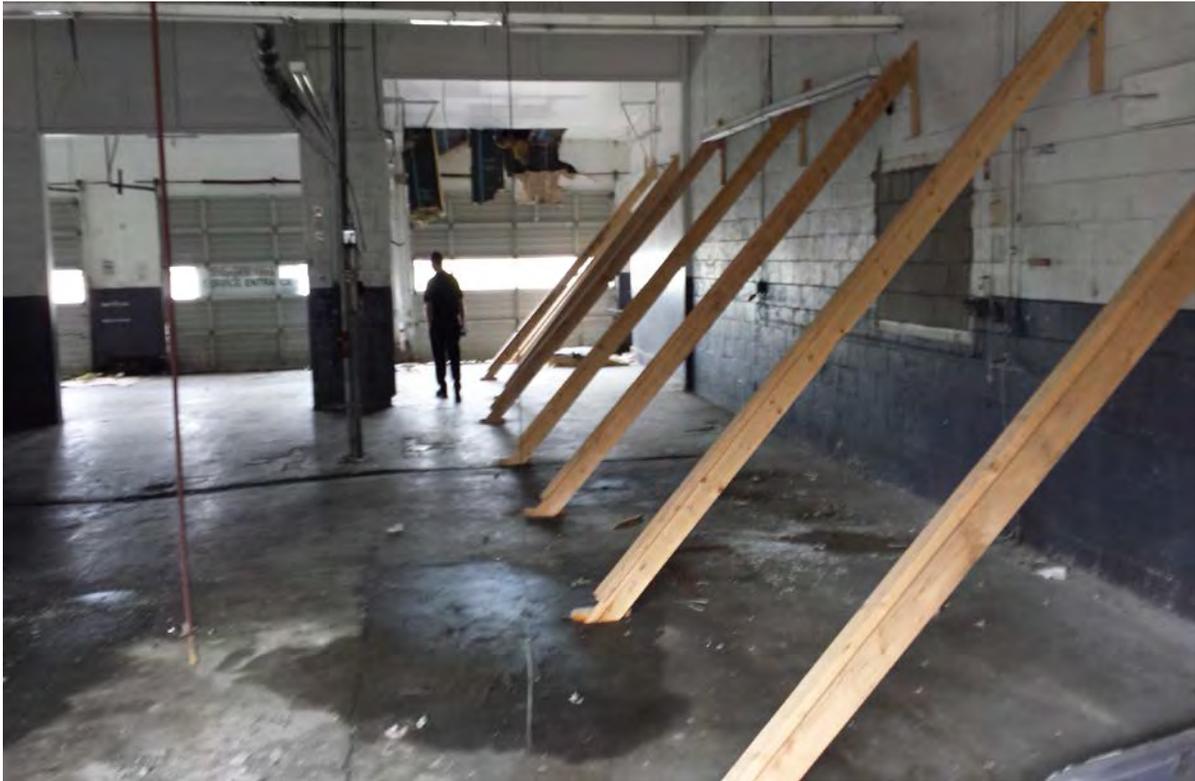
**Photo 5.** Interior view of the rear (easternmost) Dodge of Bellevue service bays. The timbered shoring was installed to support the back wall of the building after the easternmost section was demolished to make room for the 4<sup>th</sup> Street NE extension. Floor drains were observed along the foot of many of the garage doors.

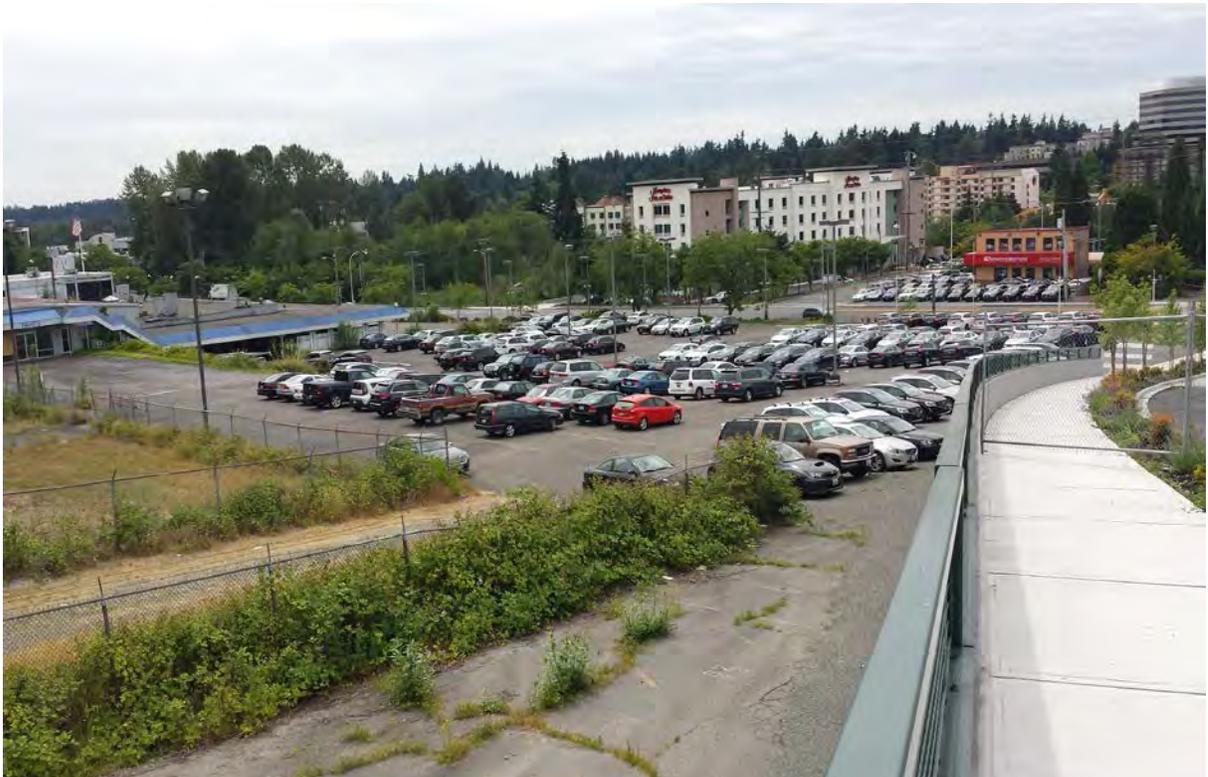
**Photo 6.** Southwest view from the 4<sup>th</sup> Street NE ramp showing the 126 - 200 parcel parking areas (Volvo and Definitive Motors leases) and the former Eastside Chrysler Jeep building (the blue trimmed structure on the center left of the frame). The building is currently vacant.

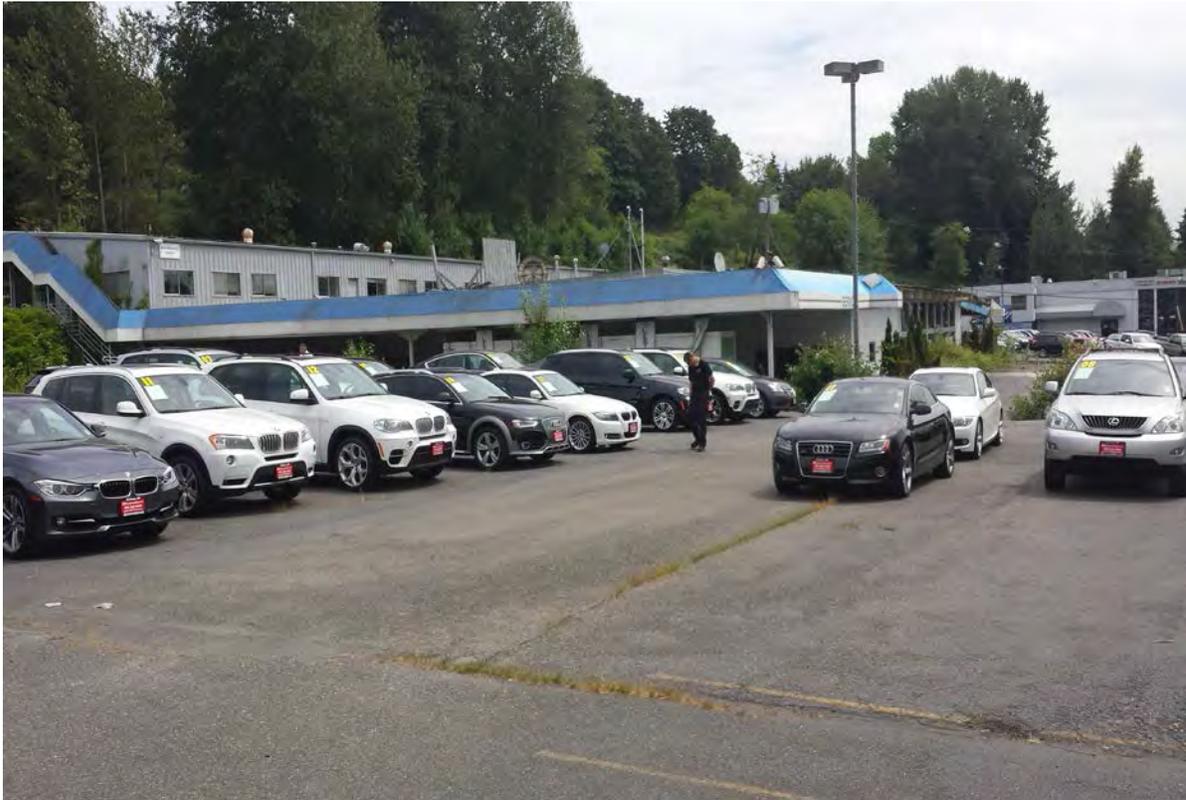
**Photo 7.** View towards the southeast of the former Eastside Chrysler Jeep building, with Definitive Motors overflow parking in the foreground. The neighboring Jeep Dodge Dealership is visible in the far right background.

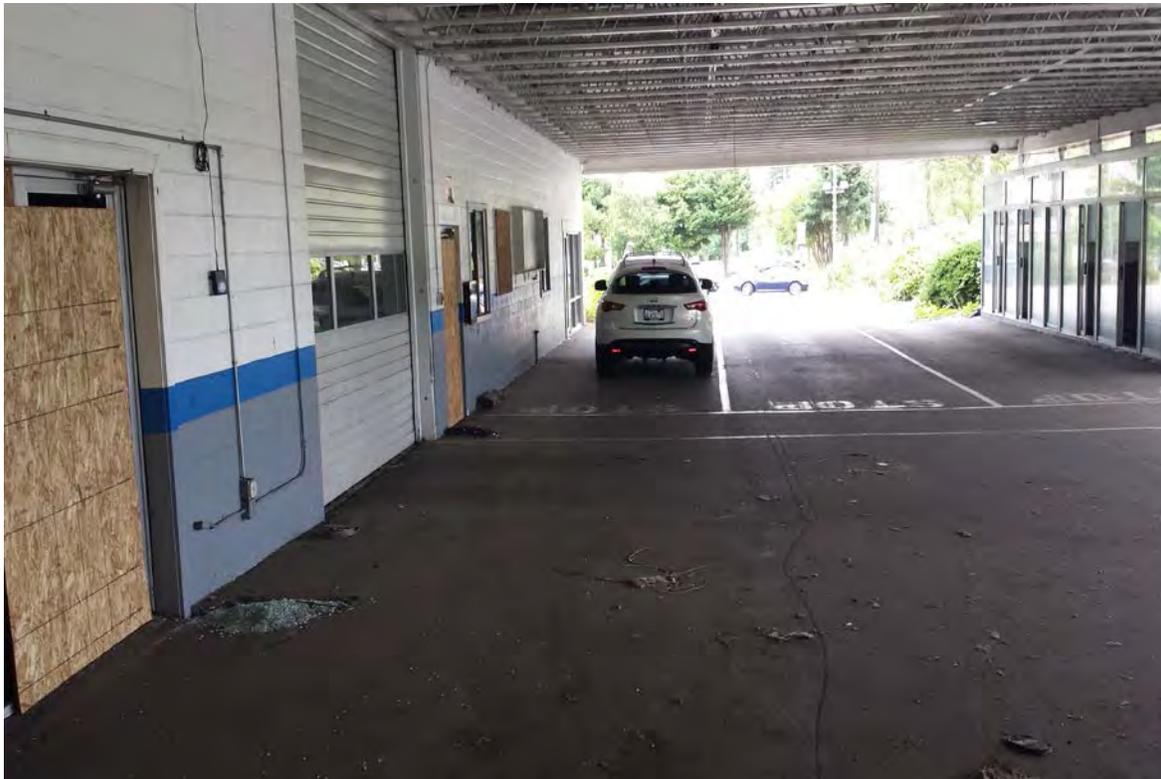
**Photo 8.** Exterior view along the Eastside Chrysler Jeep service canopy which is situated on the north end of the building.

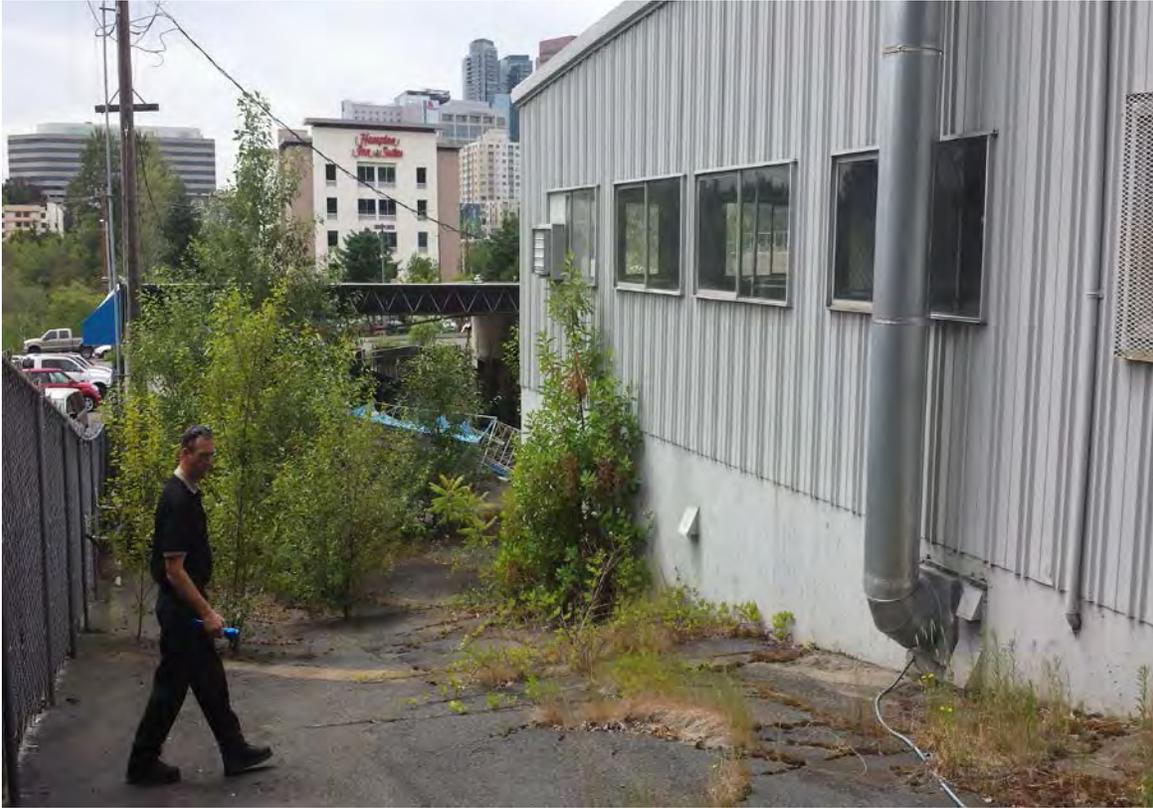
**Photo 9.** Western view from the southeast end of the Eastside Chrysler Jeep parcel showing the southern end of the property. The former car wash enclosure, which is visible behind the overgrown vegetation, was filled with building debris.

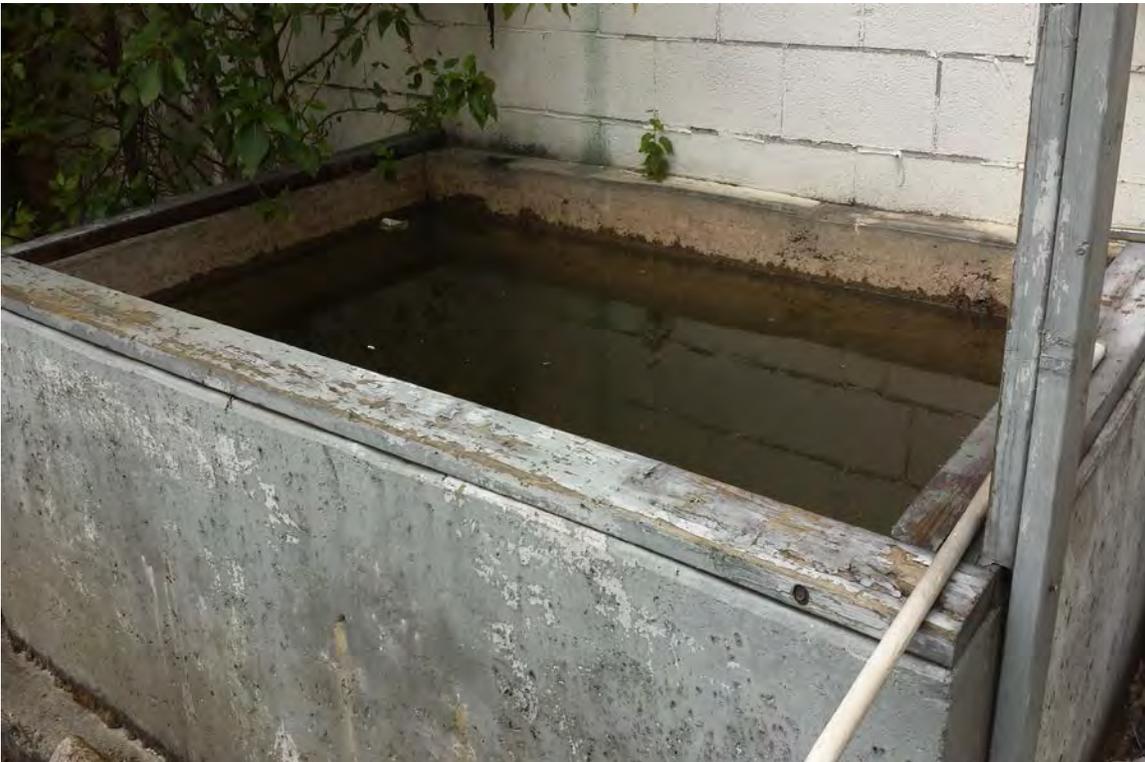
**Photo 10.** Containment vault on the south end of the Eastside Chrysler Jeep building that formerly held an aboveground oil storage tank (AST). The accumulated water was rusty and showed a slight sheen, and should be pumped out for proper offsite (non-stormwater) disposal.

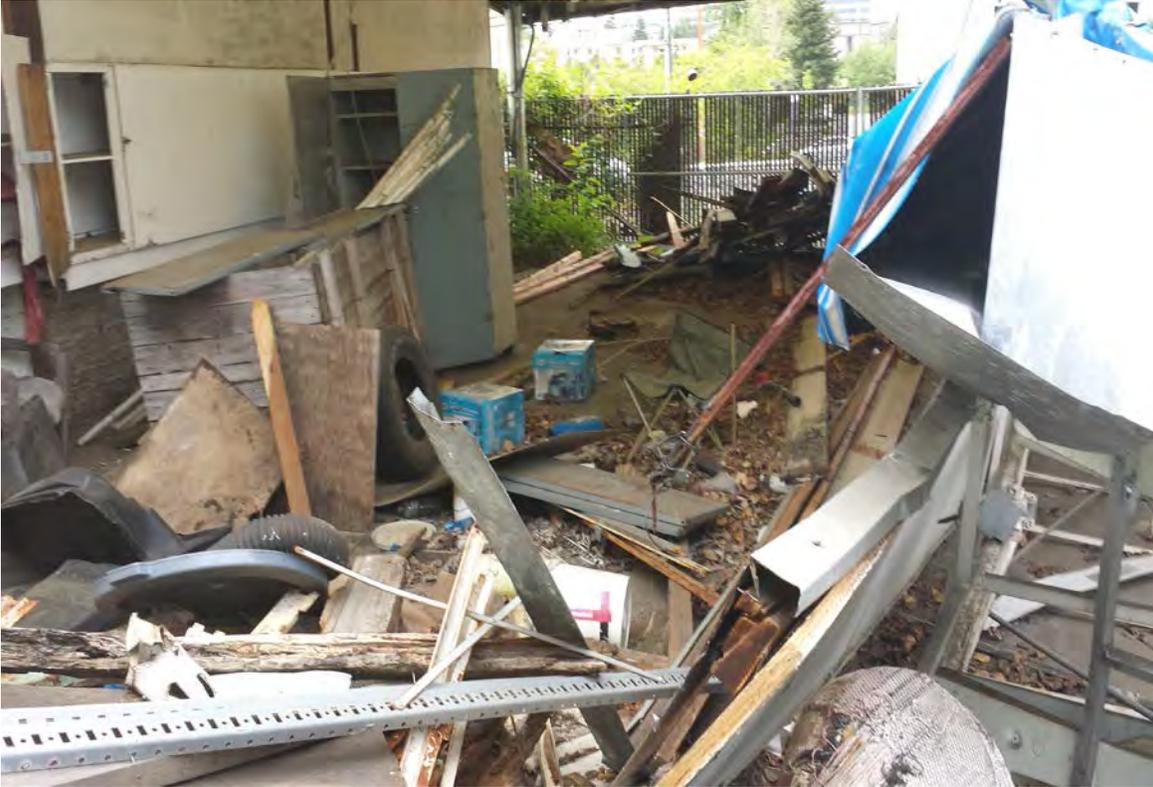
**Photo 11.** Building debris and refuse located within the covered car wash pad that is situated on the southwest end of the Eastside Chrysler Jeep building.

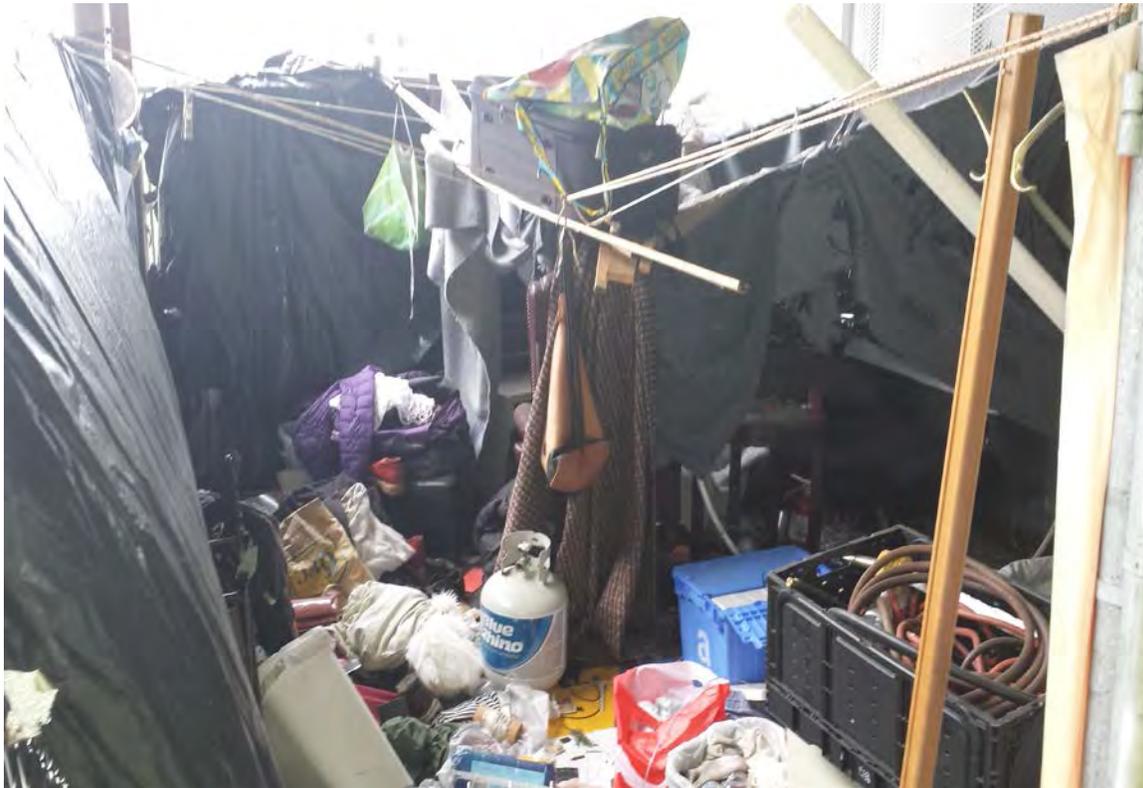
**Photo 12.** Suspected vagrant belongings and associated debris observed beneath the building overhang located near the southwest end of the Eastside Chrysler Jeep parcel. Evidence of illegal occupancy of the building was also noted inside the eastern service bay.

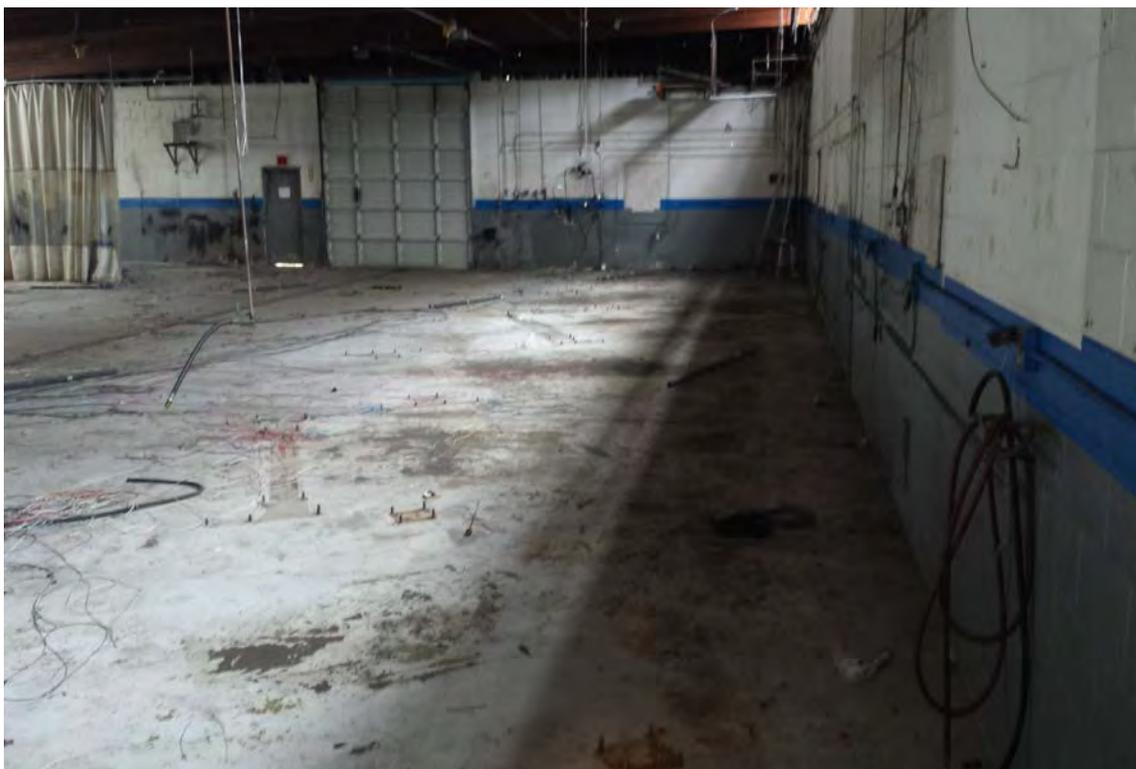
**Photo 13.** Interior view of the western service bay area located on the ground floor of the Eastside Chrysler Jeep building. Floor/trench drains are present near the center bays and near the garage doors. The bays were empty, and no oil or chemical storage was observed to be present in the building.

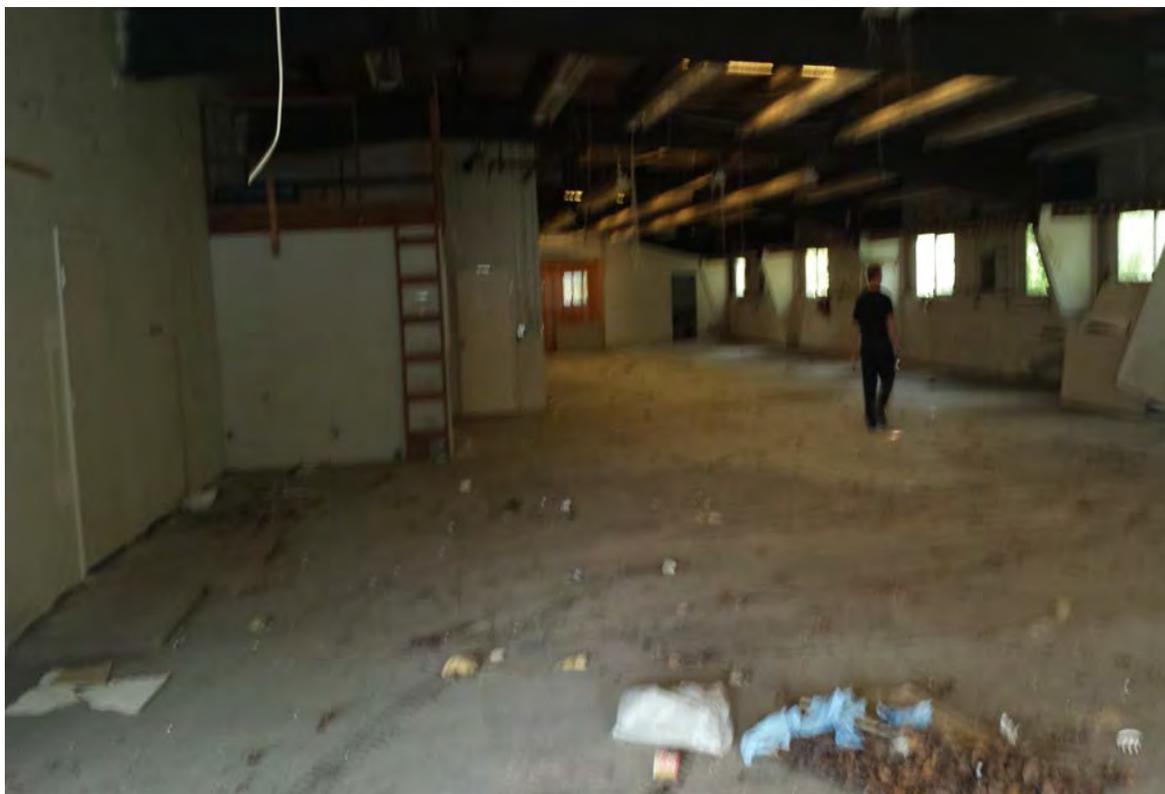
**Photo 14.** Interior view of the eastern service bays which are situated on the second floor of the Eastside Chrysler Jeep building. Some garbage and suspected vagrant belongs were observed within the eastern interior of the building.

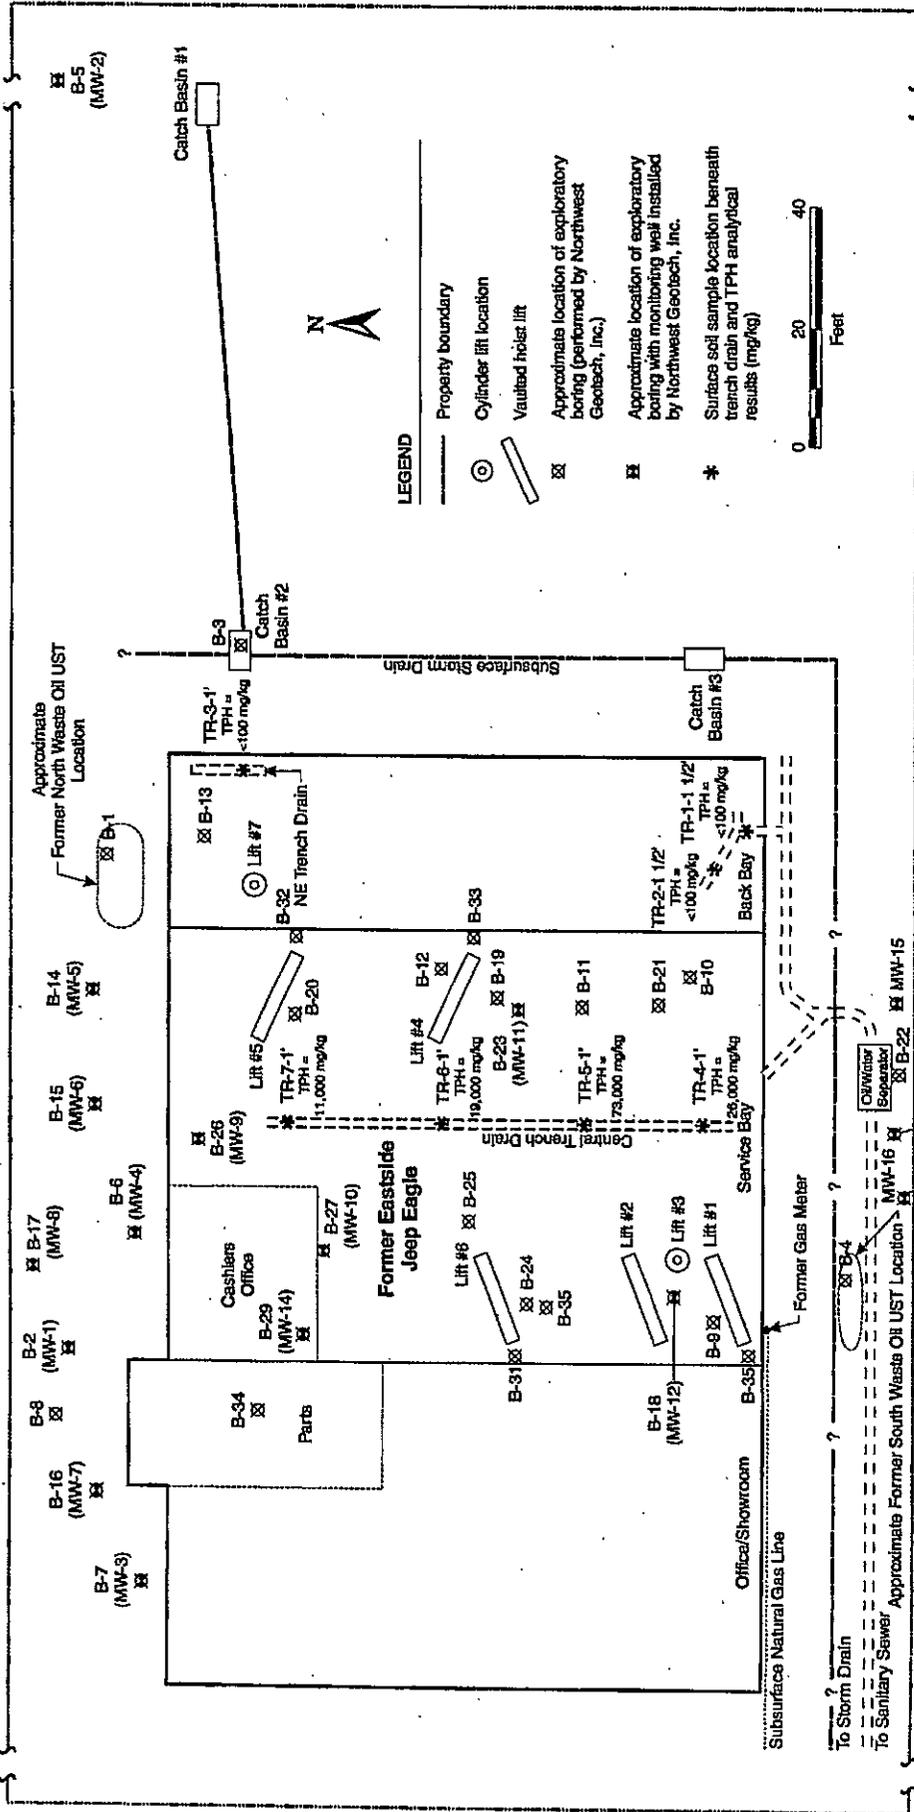
**PREVIOUS INVESTIGATION BORING AND MONITORING WELL LOCATIONS**  
 Former Chrysler Eastside Jeep Eagle Dealership  
 Bellevue, Washington  
**FIGURE 3**

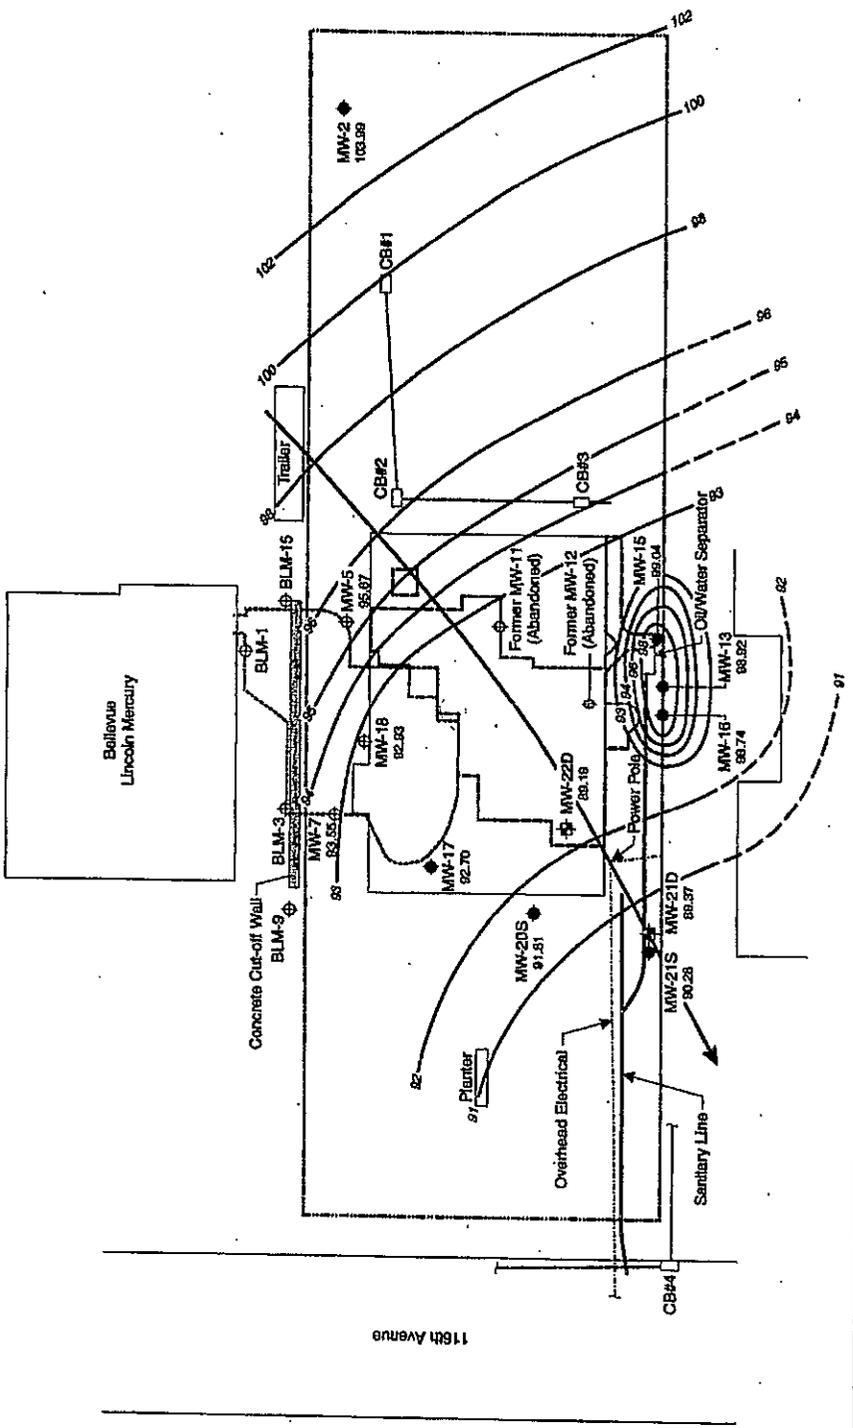
**MONITORING WELL LOCATIONS**  
 Former Chrysler Eastside Jeep Eagle Dealership  
 Chrysler Realty Corporation  
**FIGURE 5**

- Legend:
- ◻ CRC excavation area
  - ◻ BLM excavation area
  - ⊕ BLM monitoring well location and water level elevation (feet MSL)
  - ◆ CRC water table monitoring well and water level elevation (feet MSL)
  - ⊕ CRC deep monitoring well and water level elevation (feet MSL)
  - Groundwater elevation contour
  - Approximate groundwater flow direction

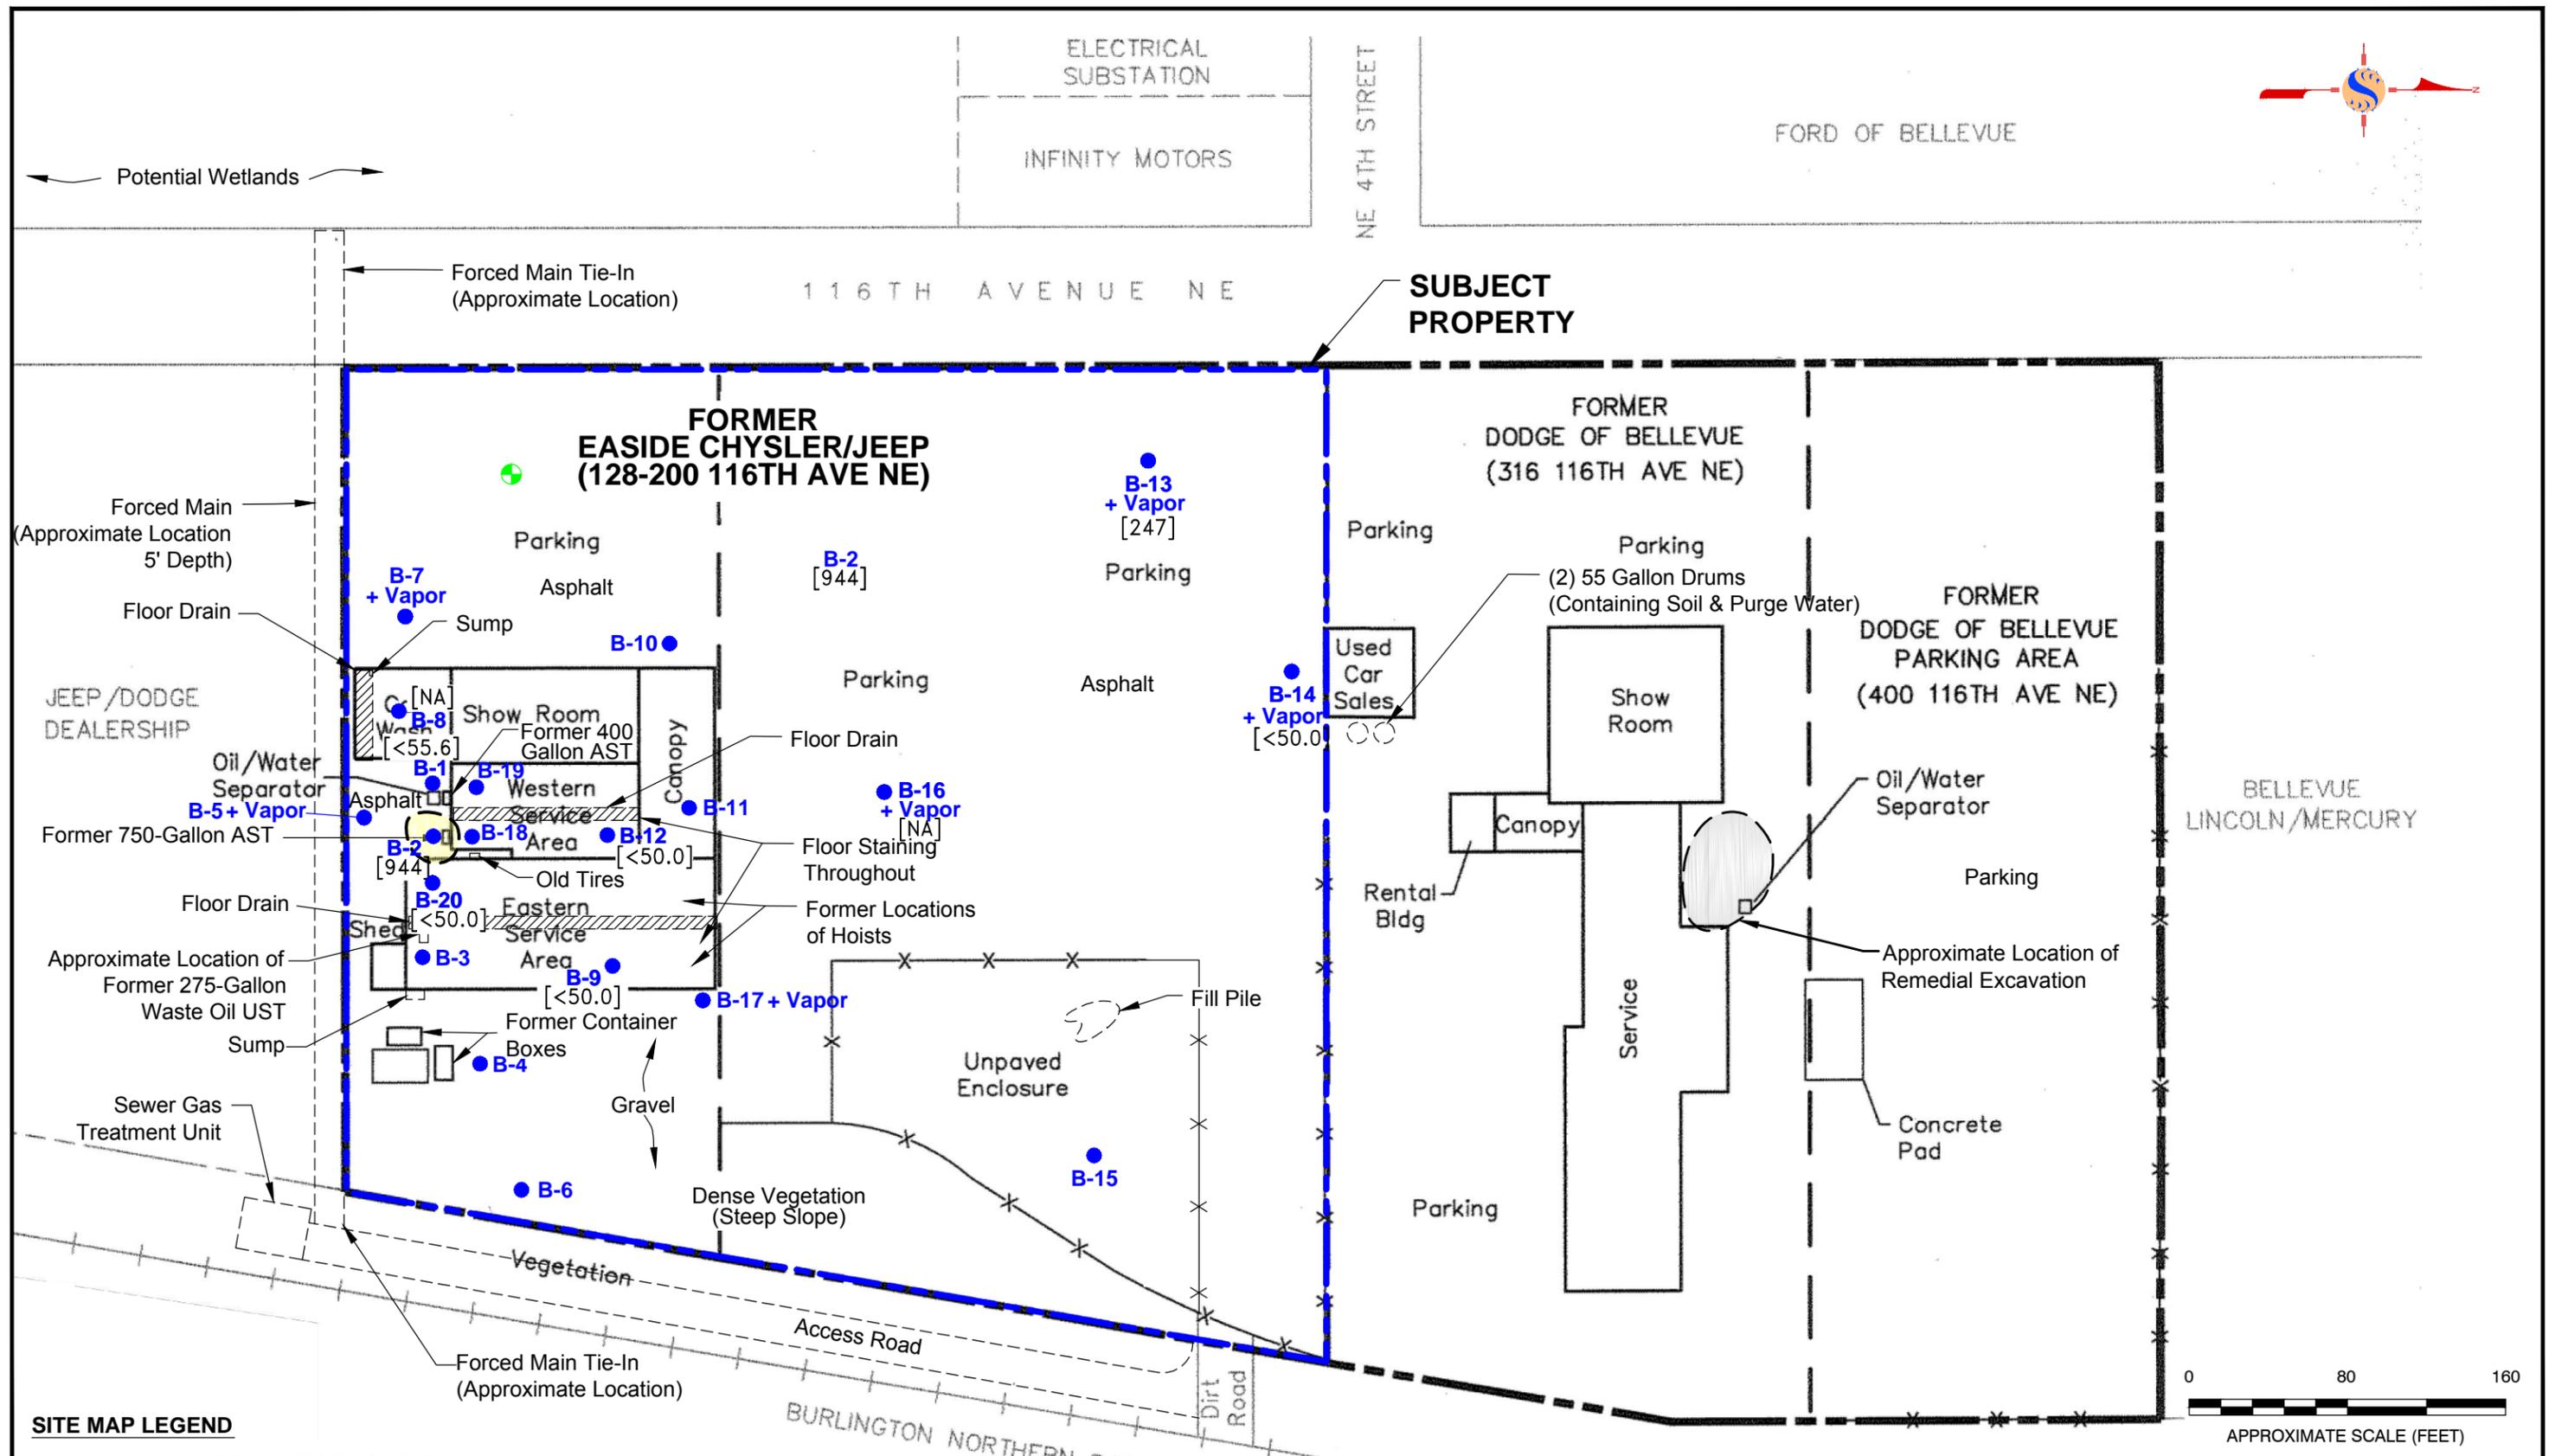
<b>TPH-D CONCENTRATION IN GROUNDWATER</b>		<b>FIGURE: 5</b>
CHECKED BY: J. Stagno	APPROVED BY: L. Simons	DATE: 06/21/13

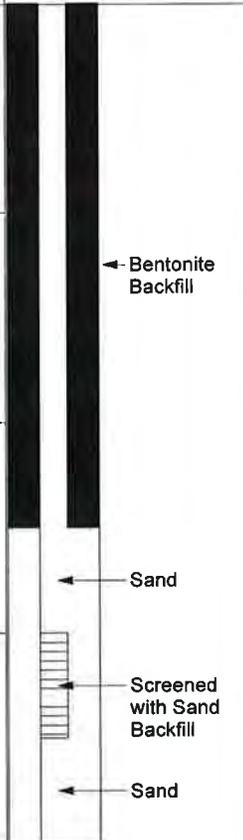
Time & Depth (feet)	Graphic Log	USCS	Description	Sample	Time Sample ID	Measured Recov. (feet)	Blow Count	Headspace PID (units)	Depth (feet)	Borehole Backfill
			Asphalt							
		SM	SM; Silty SAND, yellowish brown to grayish brown, moist.							
			Borehole terminated at 4 feet.

← Bentonite Backfill

← Sand

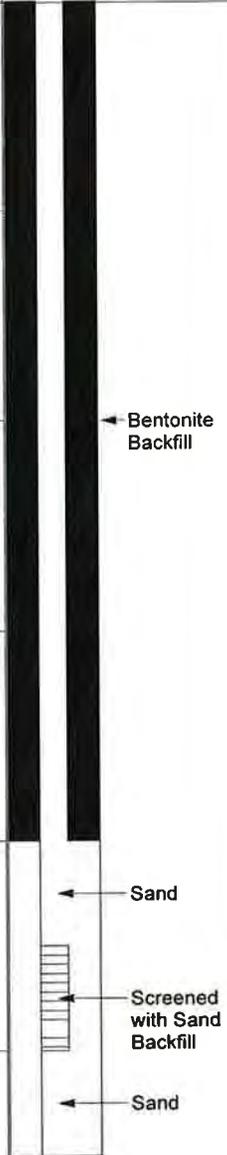
WELL / PROBEHOLE / BOREHOLE NO:  
**B-16** PAGE 1 OF 1

Vegetation/Topsoil							
		SM	SM; Silty SAND, yellowish brown to grayish brown, moist.							
5			Borehole terminated at 5.5 feet.						5

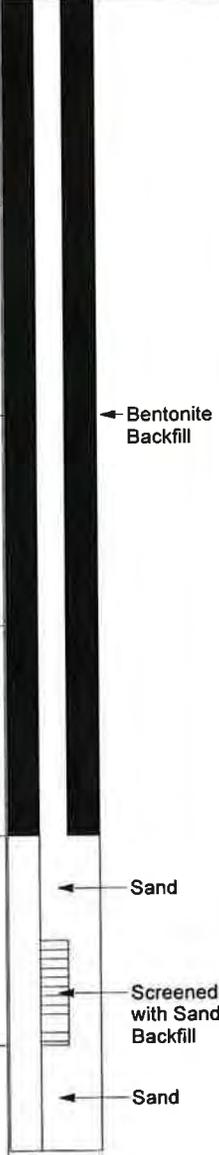
WELL / PROBEHOLE / BOREHOLE NO:  
**B-18** PAGE 1 OF 1

SM	SM; Silty SAND, yellowish brown to grayish brown, moist.							
5			Borehole terminated at 5.5 feet.

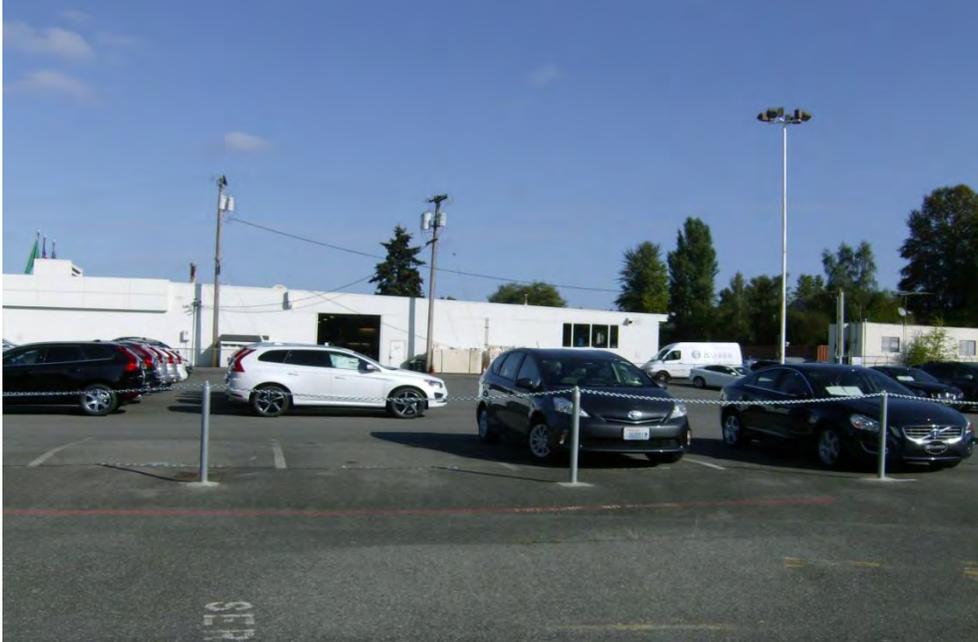
**Photo 1: View of the property looking north - from the south property line**

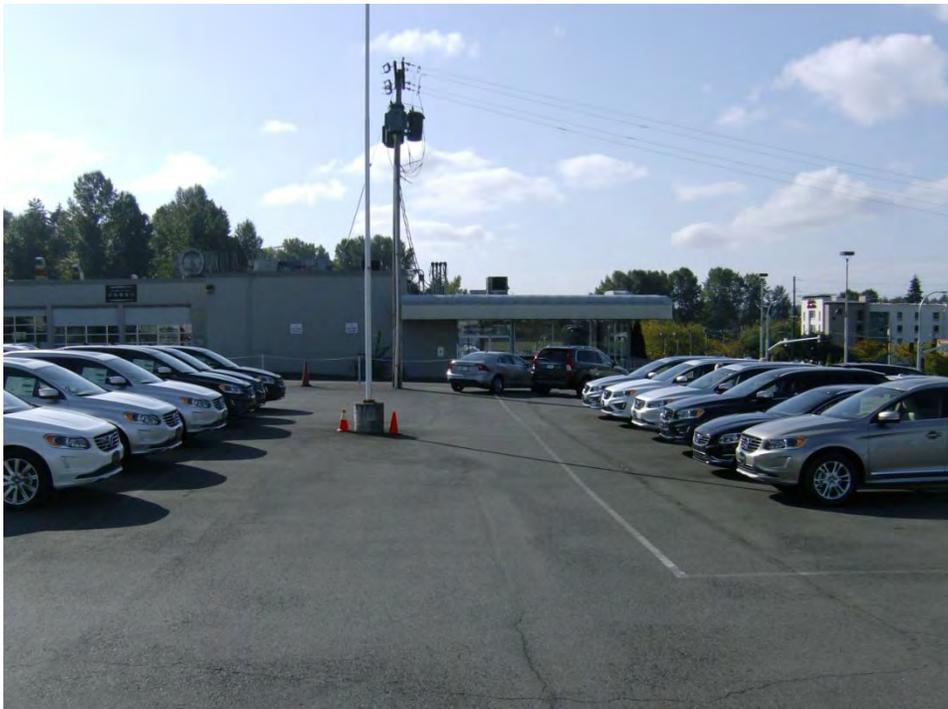
**Photo 2: View looking south - from the north property line**
