**ASTM E1527-13  
PHASE I  
ENVIRONMENTAL SITE ASSESSMENT**

**FORMER DODGE OF BELLEUE &  
EASTSIDE CHRYSLER JEEP PROPERTY  
126 THROUGH 400 116<sup>th</sup> AVENUE NE  
BELLEVUE, WASHINGTON 98004**

July 1, 2015  
File No. 04215036.00

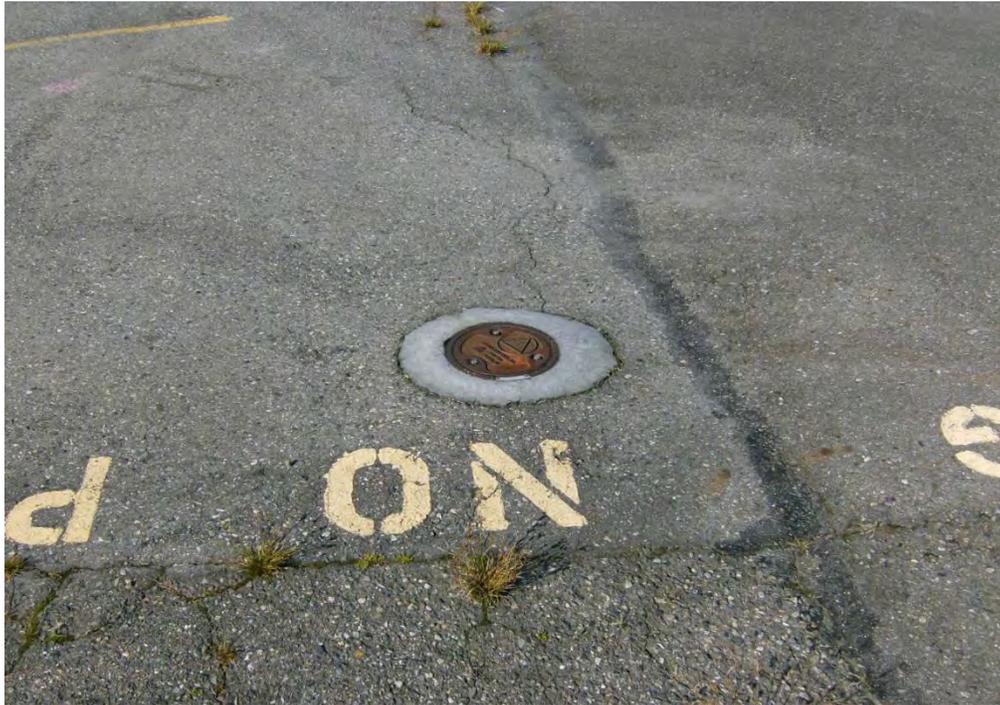
**Photo 3: Monitoring well at south boundary**

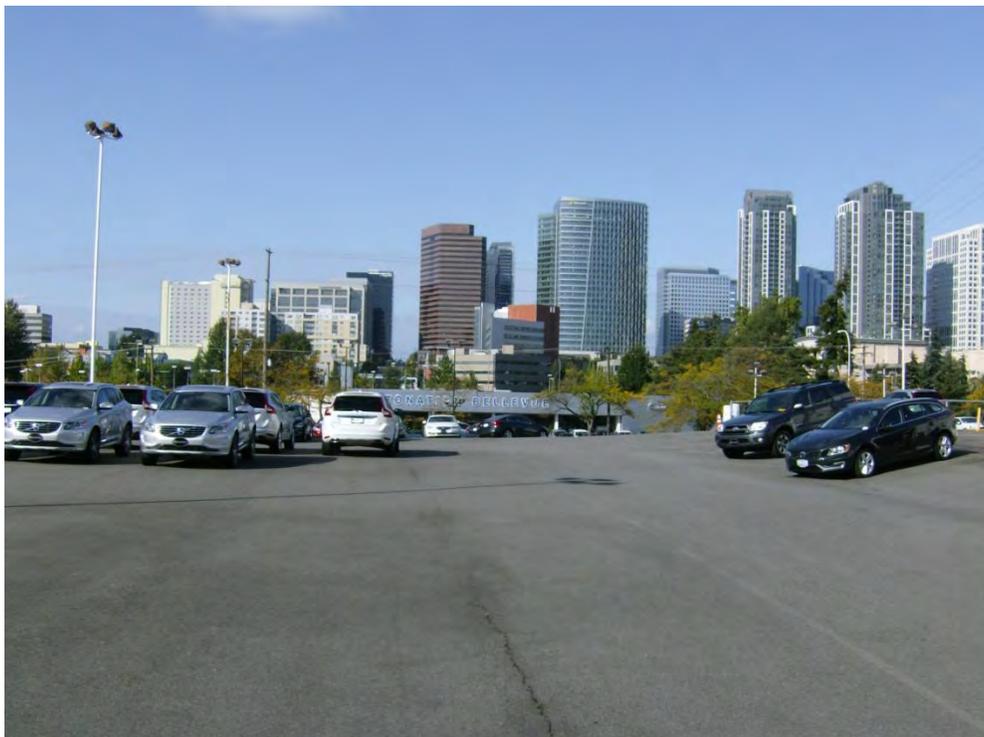
**Photo 4: View from east looking west**
